**NATIONAL TRANSPORTATION SAFETY BOARD
OFFICE OF HIGHWAY SAFETY
WASHINGTON, D.C.**

**VEHICLE FACTORS GROUP CHAIRMAN'S
FACTUAL REPORT**

NORTH LAS VEGAS, NEVADA – HWY22FH004

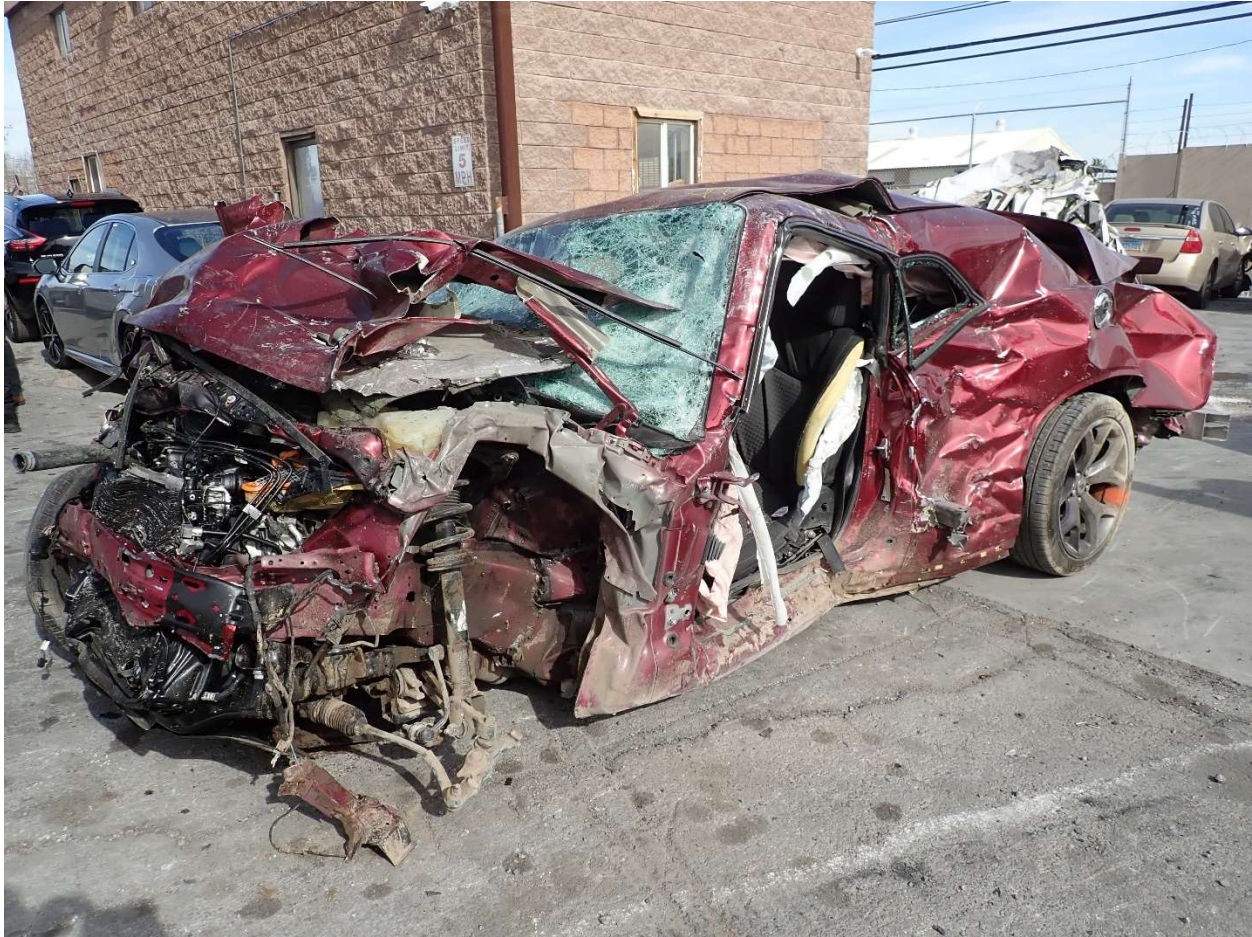
1.1. Vehicle #1: 2018 Dodge Challenger

The front bumper was displaced up, rearward, and was flush with the radiator. The engine block was also displaced rearward into the driver's seating area. The hood was folded and torn in multiple locations. The bumper horns on the front of the frame rails were shifted right and were flush with the engine. The bumper fascia was missing and located in pieces near the Challenger. The windshield was shattered but remained in the frame. The hood was displaced rearward into the windshield.

The driver's door was missing from the Challenger but was located in the impound yard and had been cut off during emergency extrication. The sheet metal of the door had been displaced to the right approximately 13-inches at the midpoint of the door. There were 10-inch and 7-inch tears in the sheet metal in the lower left corner of the door. The door latch was fractured, and the driver's mirror was missing. The inner door lining was detached from the outer door panel. The top of the left A-pillar was folded rearward into an approximate 90-degree angle and was partially torn at the top of the engine compartment.^{5 6} The left frame rail was displaced to the right approximately 13-inches and was folded at the B-pillar. The middle support beam of the unibody frame under the vehicle had detached from the left frame rail and had torn through the sheet metal just aft of the driver's door and B-pillar. The sheet metal on the roof was folded and separated from the driver's door frame sheet metal exposing the roof insulation. The left rear fender was folded and displaced to the right, just behind the B-pillar. There was a fold in the fender located near the fuel cap.

The rear bumper fascia was missing and located under the Malibu. The trunk lid was shifted left and folded forward. The top of the rear bumper had an approximately 31-inch portion of the metal torn from the body of the bumper. The entire bumper was shifted left approximately 12-inches. The right muffler was folded and displaced forward.

The right rear fender was missing. The roof sheet metal was separated at the seam on the right side at the seam with the passenger door frame. The passenger door was removed during the extrication process and found nearby. The glass in the door was still intact. This glass, and the small window behind the passenger door was the only intact glass on the Challenger. The passenger side mirror was still in place. The right-side A-pillar was displaced down and was folded near the top of the engine compartment.

Vehicle Photo 1 – 2018 Dodge Challenger - Damage viewed from the left front corner

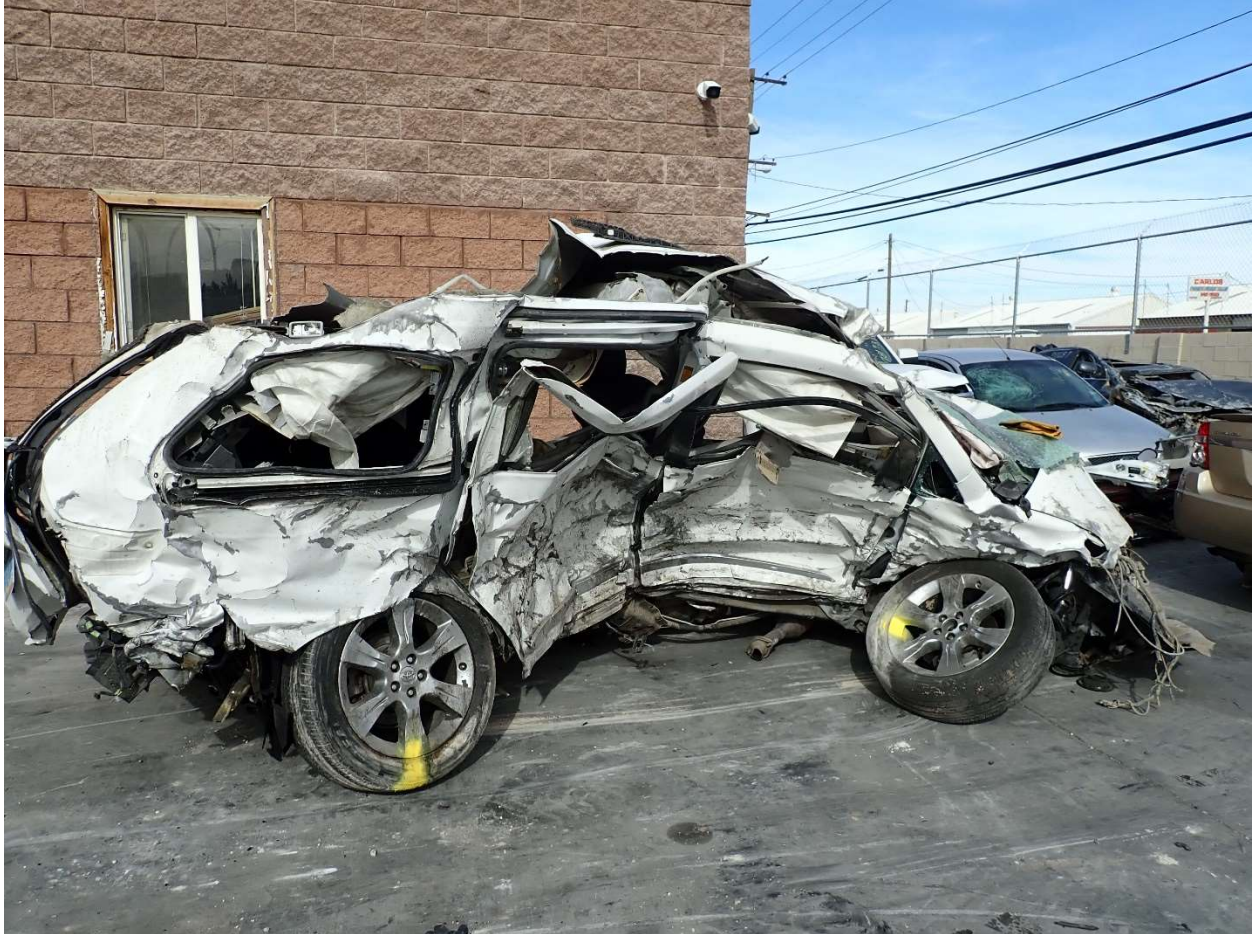
1.2. 2013 Toyota Sienna Minivan

The front bumper fascia of the Sienna was torn away from the top mount and was hanging from the bottom mounts. The right side of the bumper was displaced aft into the radiator and shifted upward. The hood was folded in half and the windshield was dislodged from the frame and laying on the hood. All other glass in the Sienna was missing.

There were striations in the paint and sheet metal beginning at the front of the left fender extending rearward to where the B-pillar would be. The left doors were missing due to extrication but were located nearby. The B-pillar had been cut at the top and bottom and removed during extrication. The front of the left fender was deformed and folded aft and to the right. The left mirror was missing. The bottom frame rail trim was missing. The portion of the van from the B-pillar to the left rear was displaced down and to the right. The left rear fender was displaced forward and to the right. All lights in the van were missing or severely damaged.

The rear of the roof was displaced down onto the top of the third-row seats. The roof sheet metal was separating from the top of the door frames at the seams on both the right and left sides. The rear hatch was deformed and shifted right. The rear bumper fascia was missing, exposing the energy absorbing foam underneath. The right side of the rear bumper was displaced forward to the D-pillar.

The right doors were still on in place on the van but had been shifted up and left approximately 41-inches at the B-pillar. The right B-pillar was displaced to nearly the centerline of the van. There was a tire transfer mark in the right rear door panel.

Vehicle Photo 2 - 2013 Toyota Sienna - Damage viewed from the right side

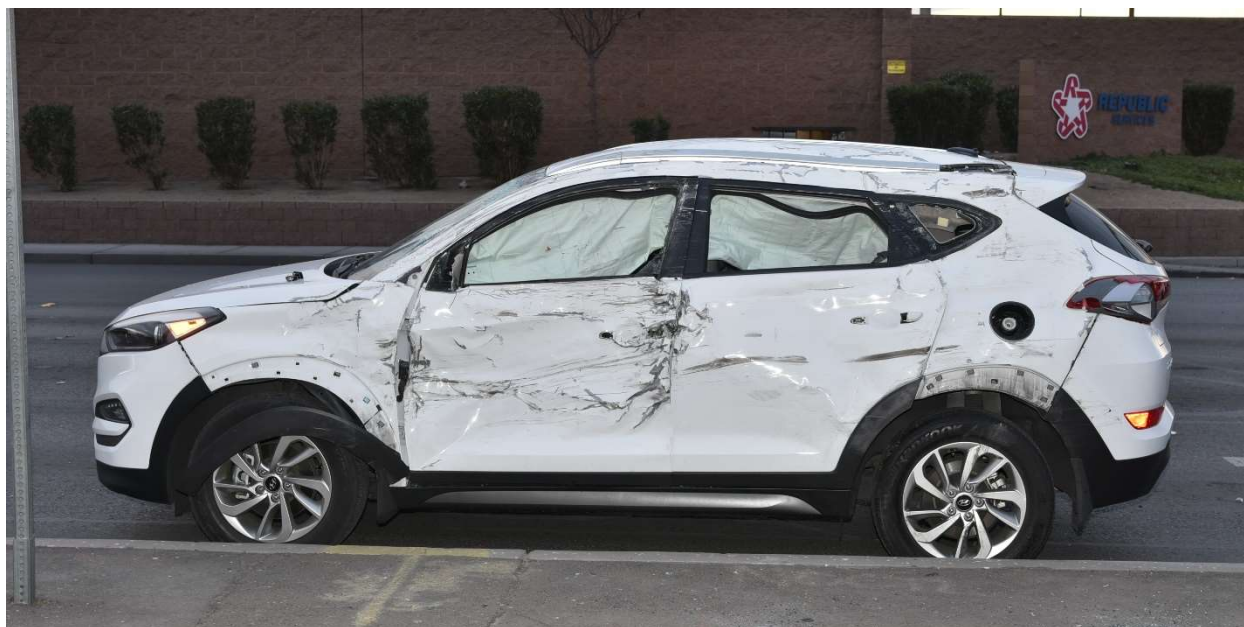
1.3. 2016 Hyundai Tucson Crossover SUV

There was no damage to the front portion of the Hyundai. The driver's mirror was missing, and the left front fender was displaced to the right beginning at the front axle. The fender trim around the left front and left rear wheel well was either detached or missing. The driver's door was also displaced to the right approximately 4-inches and the door handle was missing. The left front and rear door glass were missing. The left side of the windshield was shattered, but in place in the frame. There were striations in the paint and sheet metal beginning at the front axle extending to the left rear corner of the Hyundai. The fuel filler cover was missing. There were striations on the roof rail and the last 12-inches was missing. The left rear turn signal lens was broken.

Vehicle Photo 3 – 2016 Hyundai Tucson - Damage viewed from left side

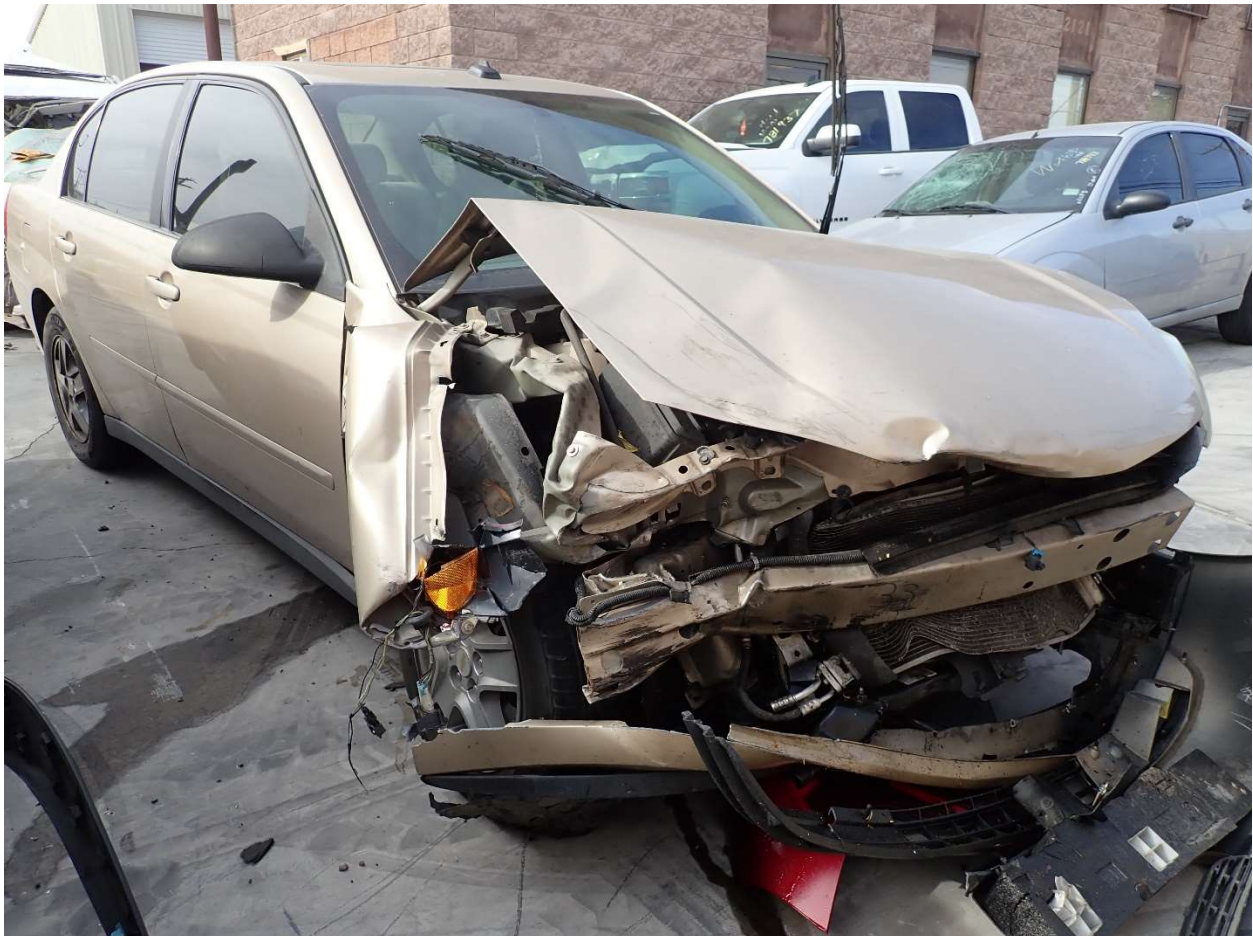
1.4. 2005 Chevrolet Malibu LS, 4-Door Sedan

The front bumper fascia was displaced from the front of the vehicle but was laying under the bumper. The front bumper frame was displaced rearward approximately 12-inches on the right side into the radiator and right front tire. The right-side bumper horn was displaced right. The right headlight was missing. The right front portion of the hood was deformed aft and folded at the midpoint.

The right front fender was displaced aft and downward. The left rear corner of the bumper had tire transfer marks. The left rear tail lens was broken.

Vehicle Photo 4 - 2005 Chevrolet Malibu - Damage viewed from the right front corner

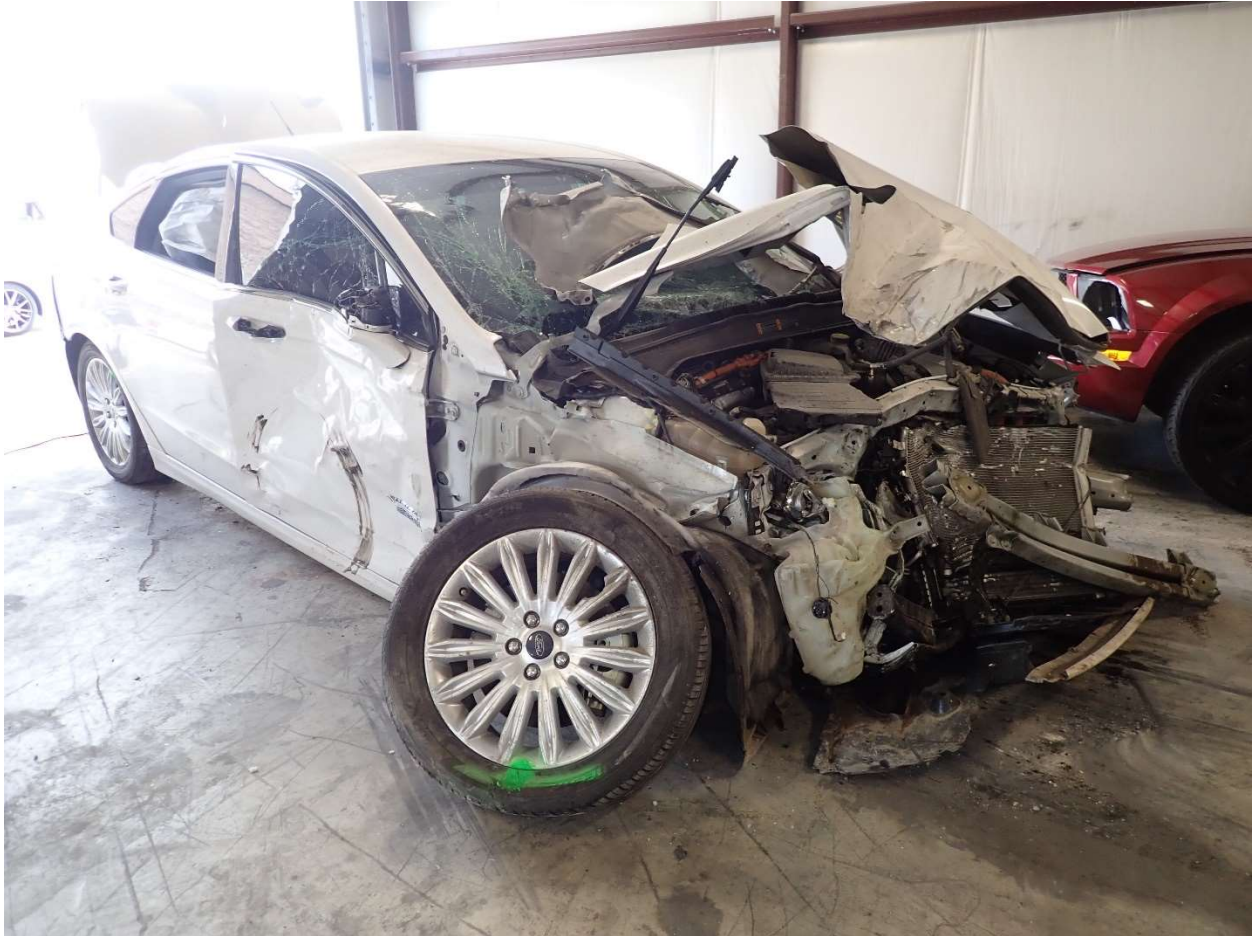
1.5. 2016 Ford Fusion SE Hybrid, 4-Door Sedan

The front bumper fascia was missing, and the bumper was detached from the frame horns and shifted up approximately 16-inches. The left front bumper horn was displaced to the left and the right horn was displaced aft and to the left, flush with the engine block. The radiator was displaced aft into the engine block. The hood frame top was displaced aft. The hood was folded

and torn on the right side and shifted left approximately 32-inches. The windshield was shattered but in place in its frame.

The right front fender was detached and missing. The right front wheel was also detached and found next to the Fusion. The passenger side mirror was folded flush with the door and the fascia was missing. The right front door panel was displaced left approximately 3-inches and aft approximately 1-inch. The door handle was fractured. There was a tire transfer mark in the center of the right front door. The right rear door was deformed at the leading edge, and the glass was missing.

The rear bumper fascia was loose and detached from its mounts on the right side. The fascia was torn away entirely at the midpoint left with red paint transfer visible. There was contact damage to the bottom of the trunk frame at the midpoint, and the trunk lid also showed contact damage at the midpoint.

Vehicle Photo 5 -2016 Ford Fusion – Damage viewed from the right front corner

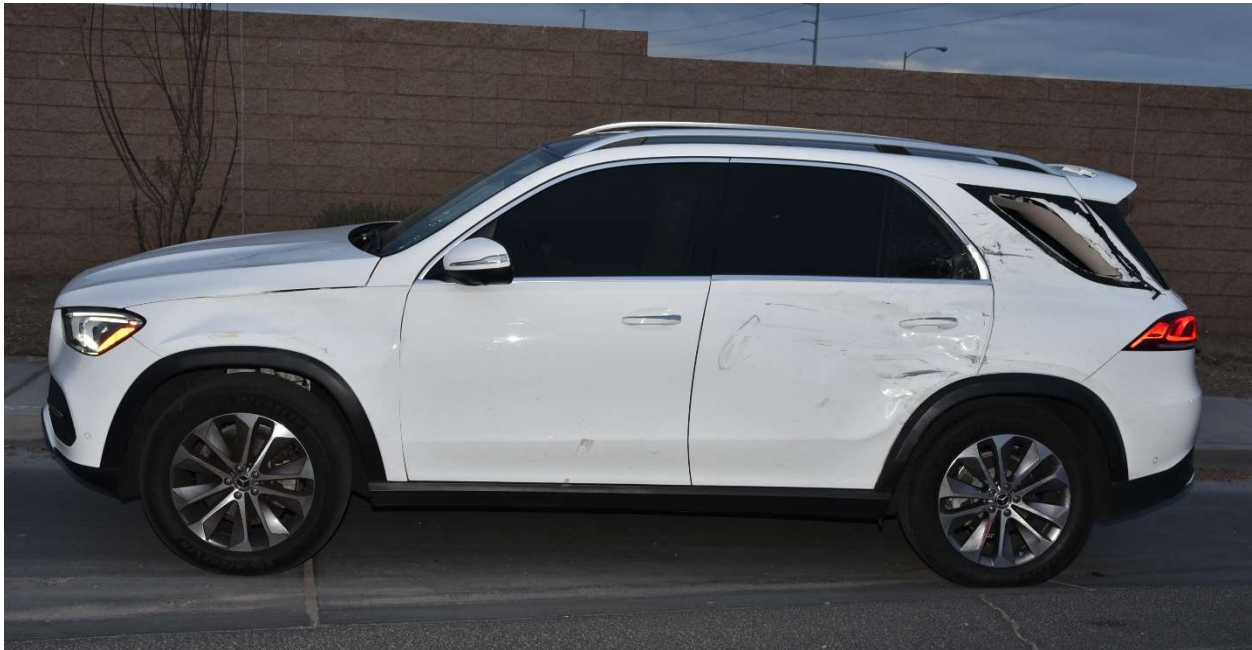
1.6. 2021 Mercedes Benz GLE-350, Crossover SUV

This vehicle was not available for NTSB investigators to inspect. Photos taken at the scene indicate damage to the left front fender. There was minor damage to the driver's door. The left rear door and fender sustained more severe damage and the left sidelight window was missing.

Vehicle Photo 6 -2021 Mercedes GLE 350 – Damage viewed from the left side
