**NATIONAL TRANSPORTATION SAFETY BOARD (NTSB)**

**Group Chairman's Factual Report**

**OPERATIONAL FACTORS**

**ERA17MA316**

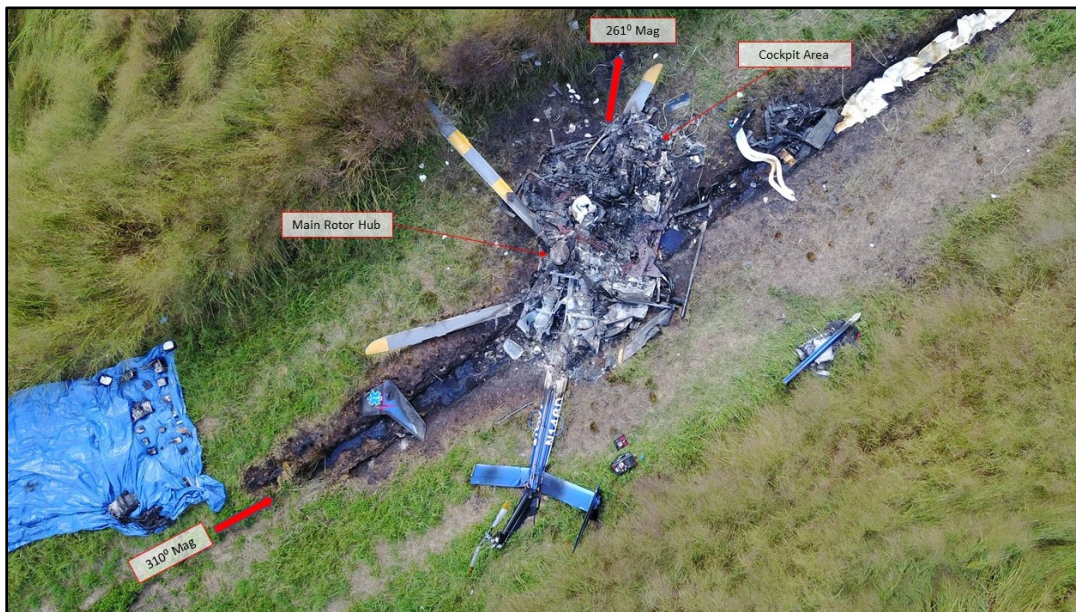
Figure 4 – Aerial view of the wreckage.

The helicopter impacted a shallow turf drainage pathway, about 30 ft wide and 2,000 ft long, located between two fields of eight ft tall grass, on a wind turbine farm. The fuselage came to

rest in a seven ft wide ditch in the center of the pathway and was oriented on a heading of 261° magnetic as shown below in figure 4 and figure 5. The terrain surrounding the accident site can be seen below in figure 6.

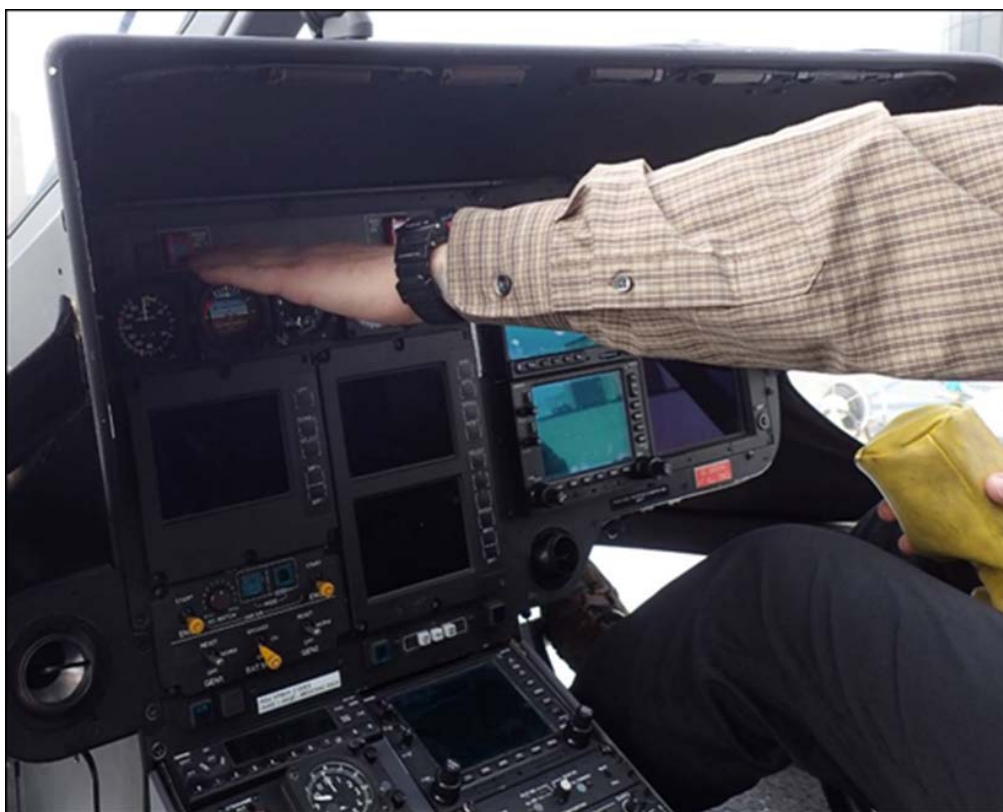
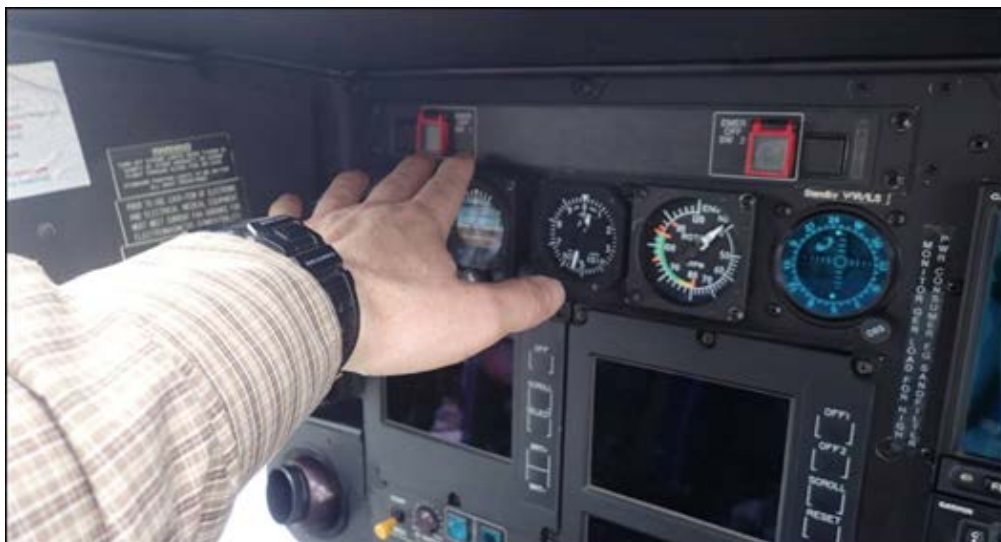
The operations group chairman, who is 5' 10" (70 inches tall) sat in the pilot's seat in N145DU, which is the front right seat. The seat was adjusted for flight operations. The five-point restraint system was fastened with the inertia reel locked. It was noted that with the cockpit design, depending on the pilot's seat adjustment, it may not be possible to reach all switches/buttons with the inertia reel locked as shown below in figure 10 and figure 11.

Figure 10 – View of the cockpit, N145DU.

Figure 11 – View of the cockpit, N145DU.

This denial of access was particularly noticed with the “MASTER” and “EMER OFF SW 1” buttons located on the upper left side of the cockpit display, in the caution and warning unit. The inertia reel could be locked manually by the pilot (as shown below in figure 12) by activating a lever or can be locked automatically by a certain degree of rapid forward motion of the pilot’s body (such as during an accident sequence).

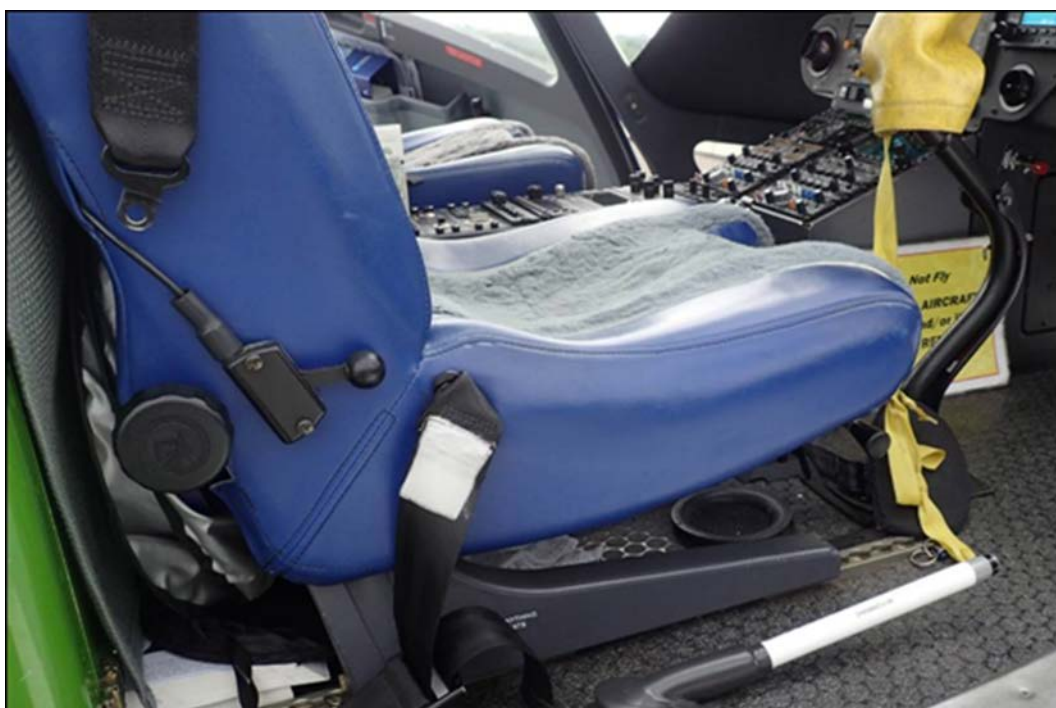
Figure 12 – View of the five-point restraint system and the inertia reel lock lever mounted on the outer right side of the seat, N145DU.

pilot flew with the inertia reel locked during the accident flight due to the impact damage and postimpact fire sustained to the cockpit.

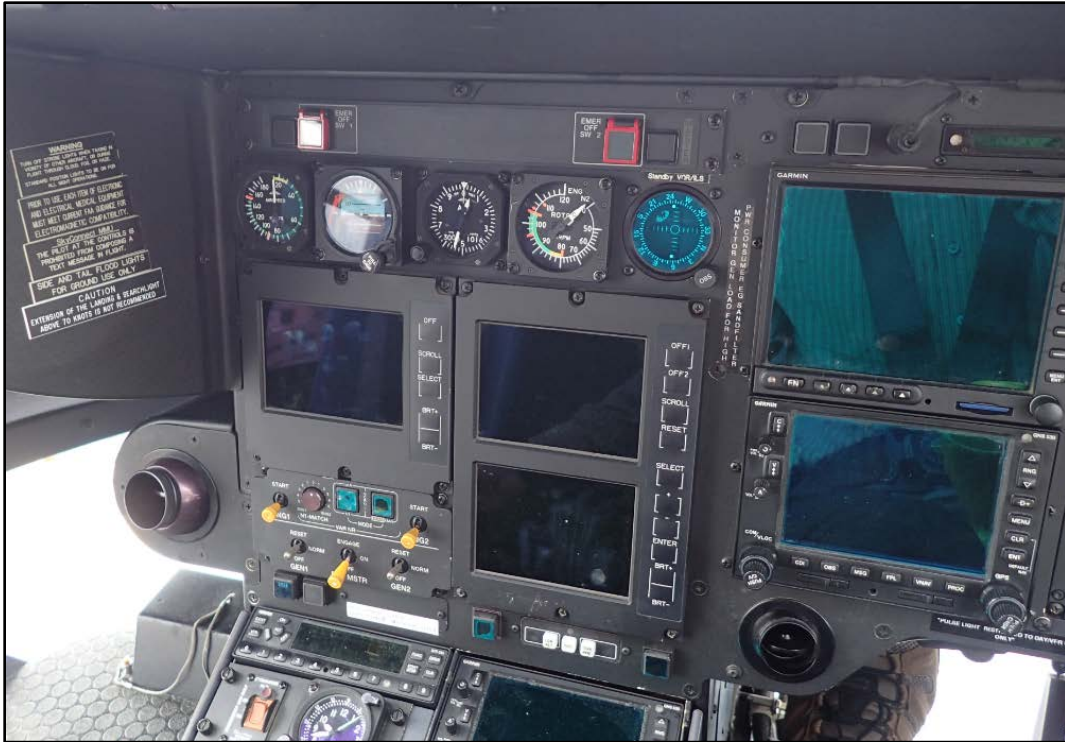
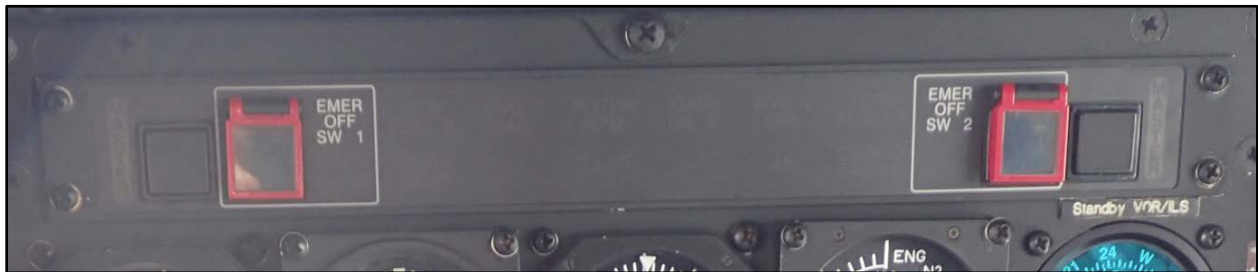
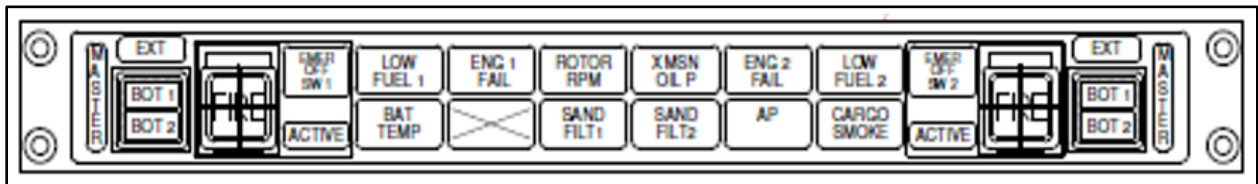
The engine “FIRE” warning lights are mounted on the caution and warning unit as shown below in figure 16, figure 17, and figure 18. Both warning lights are housed in a clear and red outlined guard, that can be flipped upwards to press an illuminated warning light button as part of an emergency procedure, which activates the respective engine fire suppression system (for example, pressing the left side button will activate the engine fire suppression system for the left engine). The Eurocopter Deutschland GMBH MBB-BK 117 C-2 has six fire sensors stationed in the engine compartment (three on each engine side), that based off a certain temperature reading, will send a signal to the cockpit, which will cause a “FIRE” warning light to illuminate for the respective engine side. In addition to the warning light illumination, a subsequent audio warning is also heard by the pilot. For additional information on the fire sensor system, refer to the NTSB Airworthiness Group report.

A recovered portion of the caution and warning unit was submitted to the NTSB Materials Laboratory for examination. The four light bulbs for the number 2 engine fire indicator were x-rayed to examine the filament in each bulb. The radiographs for the “FIRE” annunciator bulbs showed that the filaments for all the light bulbs were stretched. The radiographs also showed that all but one of the bulb filaments were intact. The bulb 1 filament was broken and stretched while bulbs 2-4 filaments were intact and stretched. The bulb numbering is arbitrary because the bulb positioning could not be determined due to fire damage. Radiograph images of all four bulbs are
