**NATIONAL TRANSPORTATION SAFETY BOARD  
OFFICE OF HIGHWAY SAFETY  
WASHINGTON, D.C.**

**TECHNICAL RECONSTRUCTION GROUP CHAIRMAN'S  
FACTUAL REPORT**

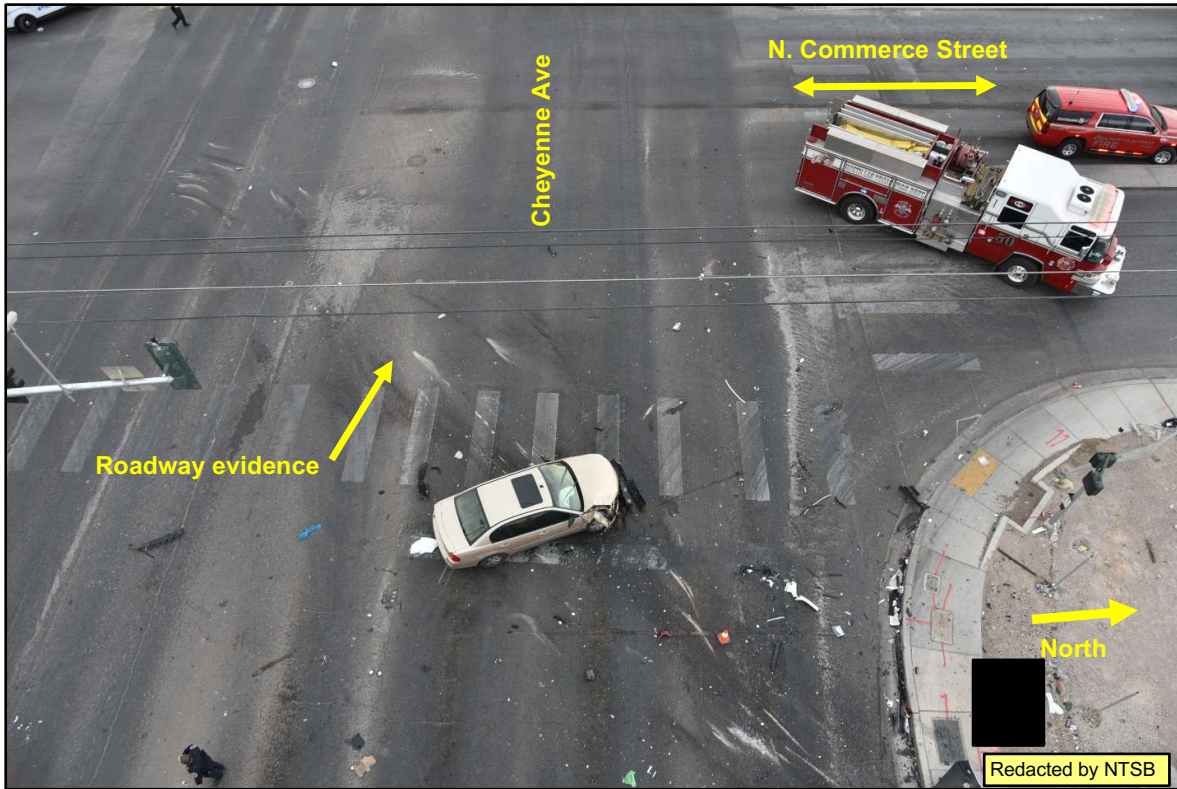
Tire friction marks, road surface gouging and marking paint applied by NLVPD investigators were observed by NTSB investigators at the scene. The roadway evidence was within the Cheyenne Ave intersection and appeared to originate near the intersection of the northbound N. Commerce Street left turn and through lane, and the center travel lane of eastbound Cheyenne Avenue. The evidence of impact was approximately 23 feet into past the northbound N. Commerce Street intersection threshold and 53 feet past the through traffic stop line. As measured from the eastbound Cheyenne Ave intersection threshold, evidence of impact was about 30 feet into the intersection. The evidence extended northeastward and departed the highway at the northeast corner of the intersection. A chain-link fence bordering undeveloped property at the northeast corner was damaged and evidence of vehicle positions of rest was observed on the property ranging from about 19.6-45.6 feet off the roadway travel surface. The road surface evidence was consistent with an impact and post-impact vehicle movement. No pre-collision roadway evidence, such as tire friction marks, was observed. **Figure 5** is a photographic image taken by police investigators depicting roadway collision evidence that progressed northeastward from the apparent area of impact.

**Figure 5:** Modified photographic image taken by police investigators depicting roadway evidence from the vantage of an aerial ladder fire truck. One of the involved vehicles, the Chevrolet Malibu, is depicted at its position of rest.

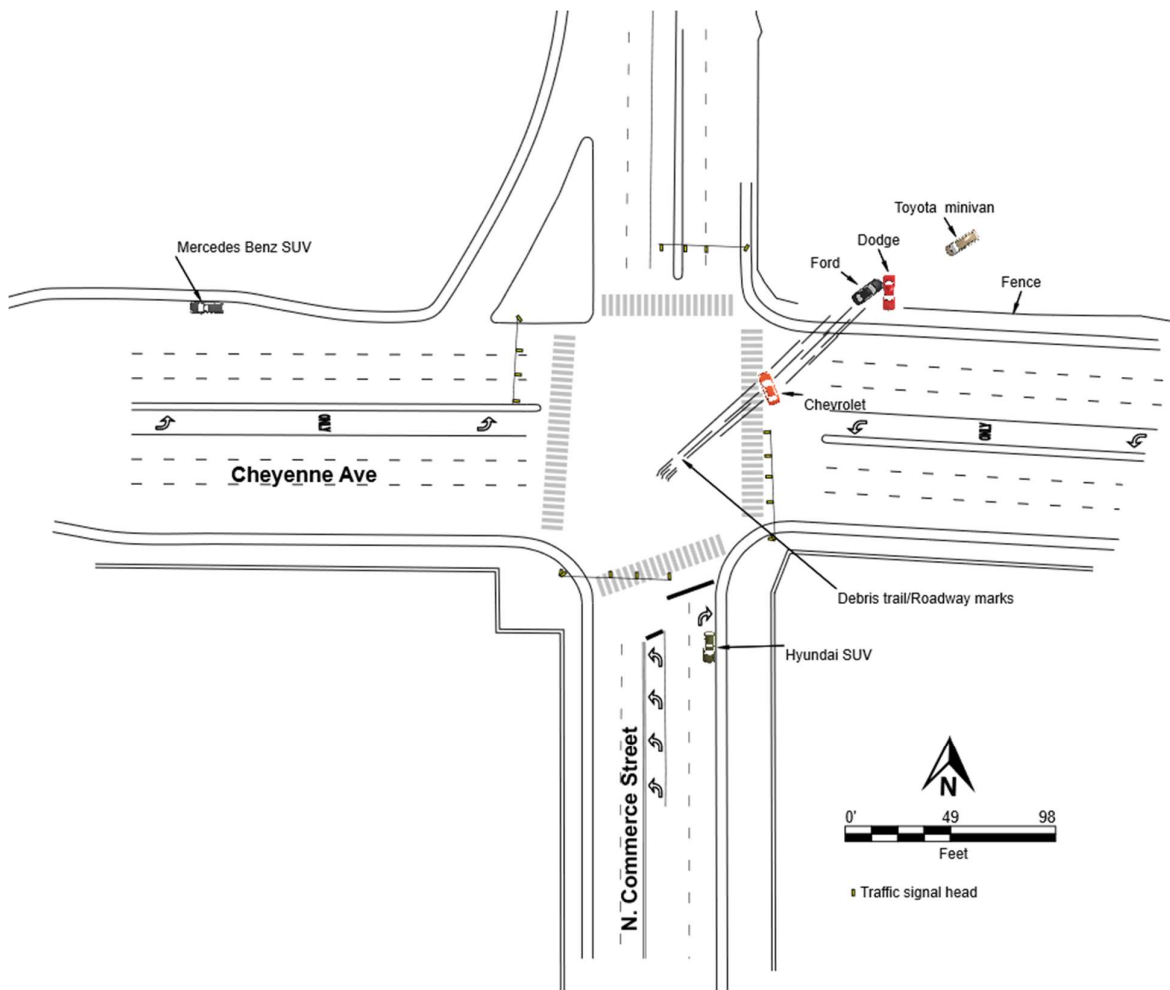
**Figure 7:** Diagram depicting vehicle positions of final rest following the collision events. Lane widths were extracted from highway plans as the delineation RPMs were not visible in the 3D scan documentation. Lane markings as drawn do not accurately depict the delineation RPMs.

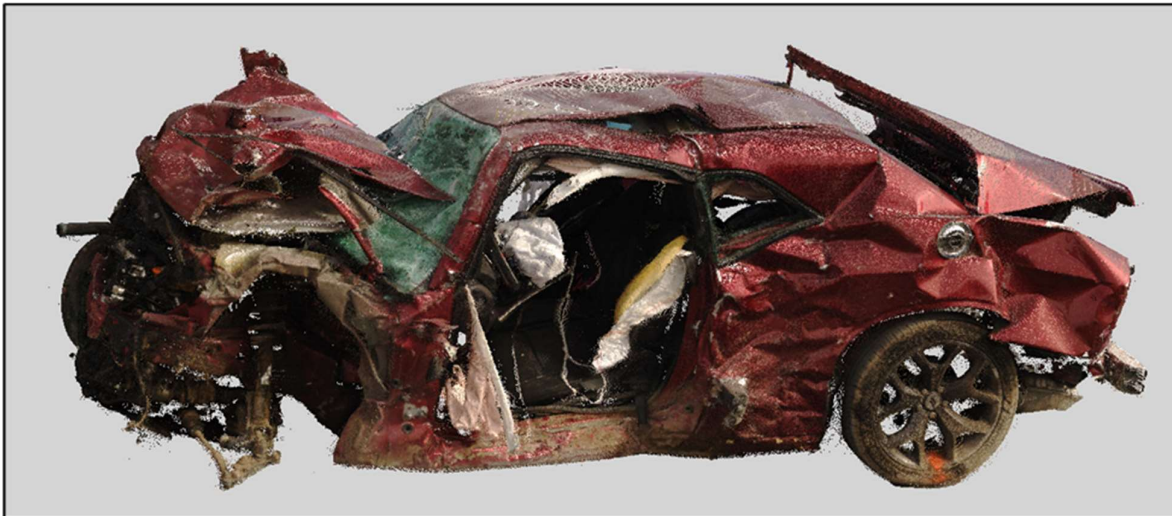
The Dodge, which had been identified by police investigators as having been traveling northbound on N. Commerce Street, exhibited evidence of contact damage to the front, rear and driver (left) side. The most substantial impact was at the front, which induced deformation to the vehicle body throughout the entire occupant compartment. At the passenger side of the front bumper cover, near the cutout for the driving/fog light, an impression in the painted surface consistent with the design of a Toyota wheel center cap was observed. Evidence of additional contact was observed at, and just aft of the driver's door with these areas also exhibiting areas of white-colored material transfer. Contact damage at the rear of the vehicle exhibited a passenger to driver side displacement. Embedded in the rear bumper bar, remnants of bumper energy absorption material consistent with that found on the Chevrolet was observed at the passenger side edge. The rear bumper cover and lower fascia from the Dodge were entrapped beneath the Chevrolet.

**Figure 8:** Screen capture image depicting colorized 3D point cloud of Dodge as viewed from left side of vehicle.

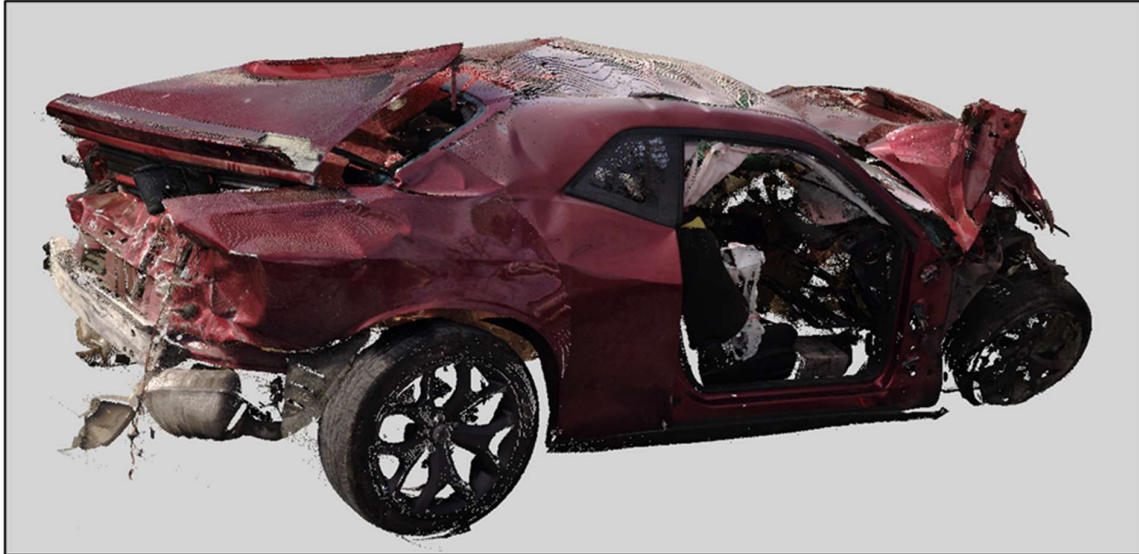
**Figure 9:** Screen capture image depicting colorized 3D point cloud of Dodge as viewed from right side of vehicle.

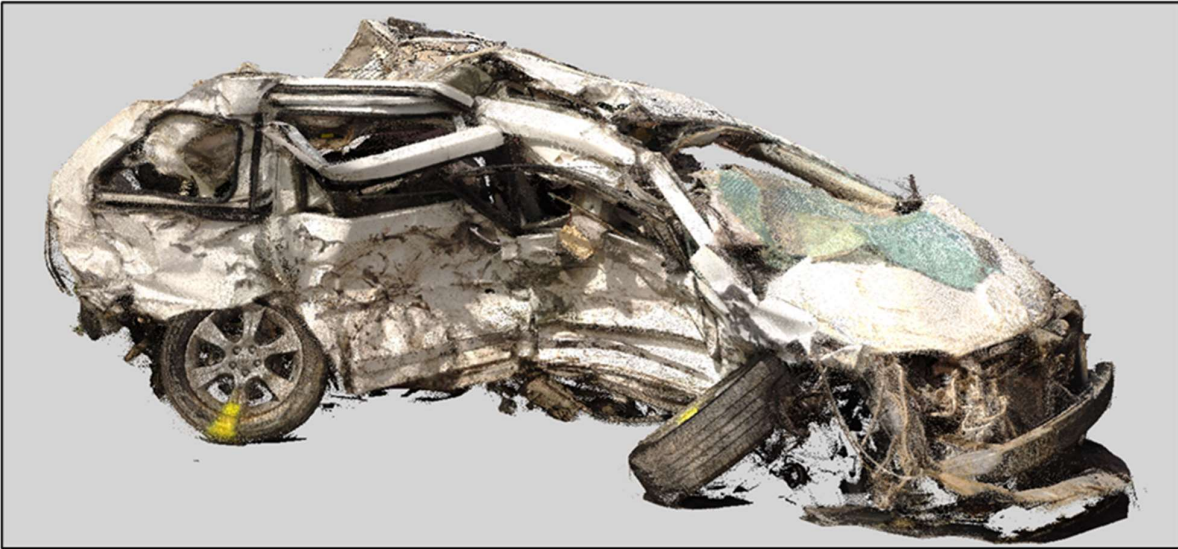
The Toyota exhibited substantial contact damage to the passenger side of the vehicle. Another area of contact damage was noted at the driver side rear. In addition to the areas of contact damage, the vehicle body, generally above the windowsill line, exhibited displacement toward the passenger side. Other exterior body surfaces such as the roof, hood and driver side exhibited scarring and paint displacement consistent with a rollover event. Upper body surfaces including the roof, hood and door frames exhibited scarring primarily oriented passenger front to driver rear, although the hood surface exhibited additional scarring that was oriented driver front to passenger rear.

**Figure 10:** Screen capture image depicting colorized 3D point cloud of the Toyota as viewed from right side of vehicle.

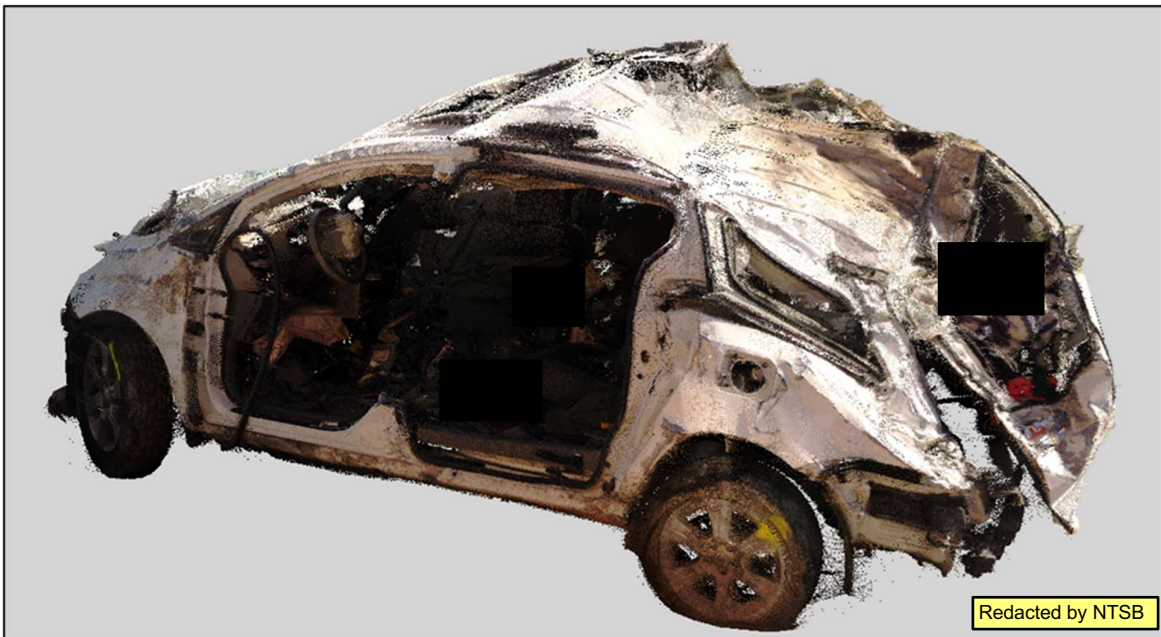
**Figure 11:** Screen capture image depicting colorized 3D point cloud of the Toyota as viewed from right side of vehicle.

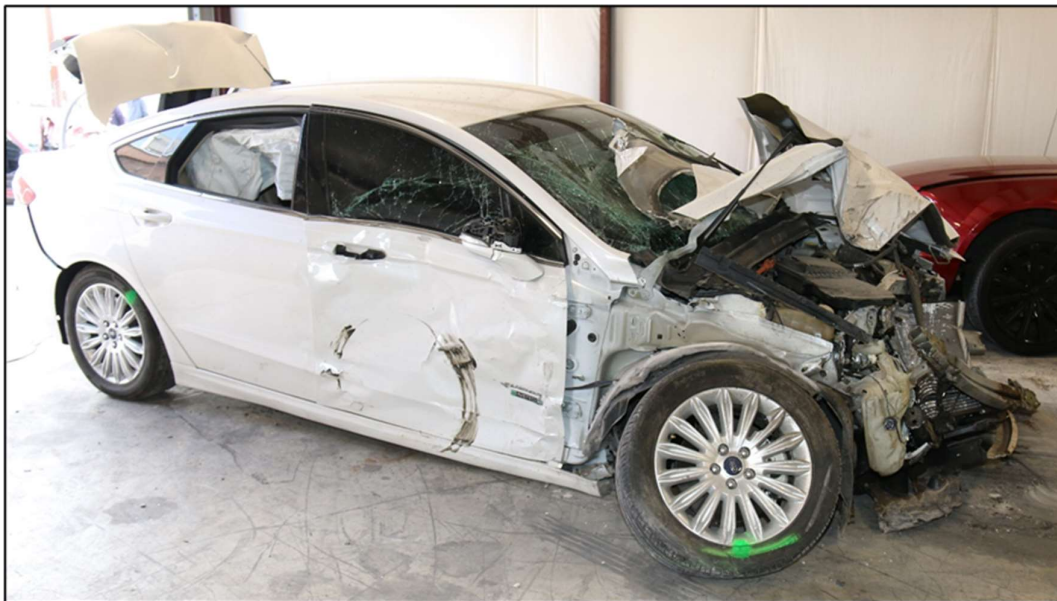
The Ford exhibited contact damage at the passenger side front that resulted in a lateral displacement of the hood and other front-end structures toward the driver side. The passenger side front wheel assembly was skewed but did not separate from the vehicle. Contact damage appeared to extend across about one-third of vehicle width at the front with some indication of downward vertical displacement. Contact damage was also observed at the rear of the vehicle, near the center, and at the upper driver side corner of the trunk lid. Red-colored material transfer was observed within the trunk lid area of damage. Deployment of supplemental airbag restraints was observed.

**Figure 12:** Photographic image of the Ford's passenger side.

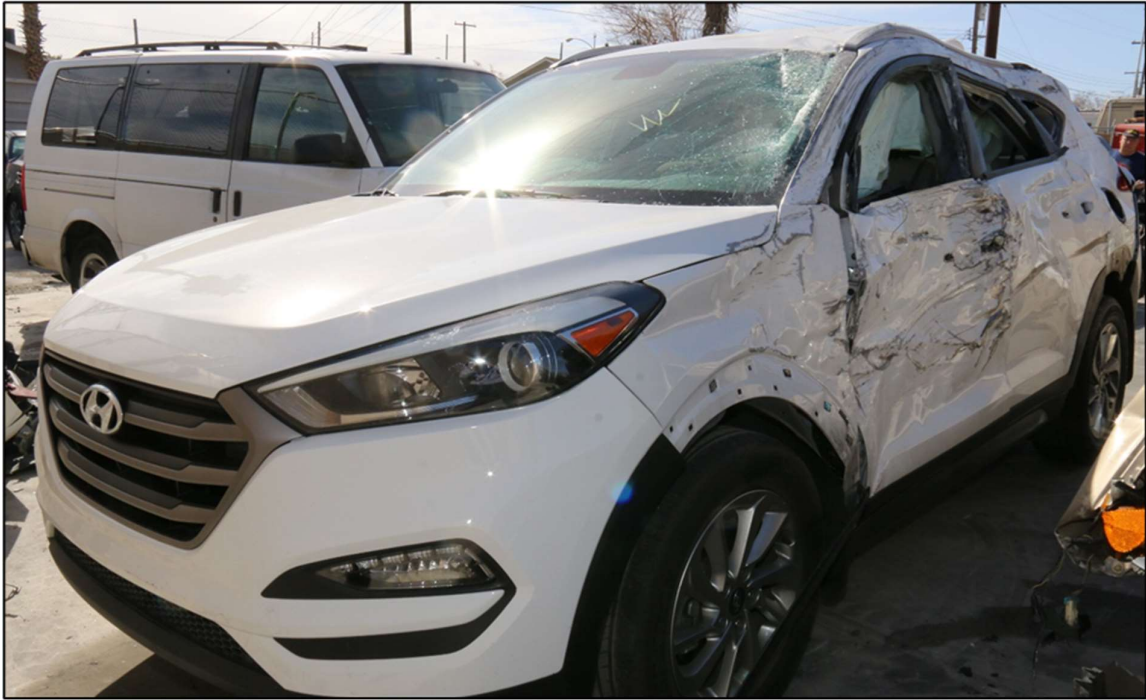
The Hyundai SUV sustained contact damage, characteristic of a sideswipe impact, which extended rearward along the driver side from about the front axle to the rear of the vehicle. Damaged areas included the doors, upper door frames and roof edge, and rear quarter panel. Some evidence of white-colored material transfer was observed on the dark areas of the door window frames. The damage appeared sufficient to render the doors inoperable. Deployment of supplemental airbag restraints was observed.

**Figure 13:** Photographic image of the Hyundai's driver side.

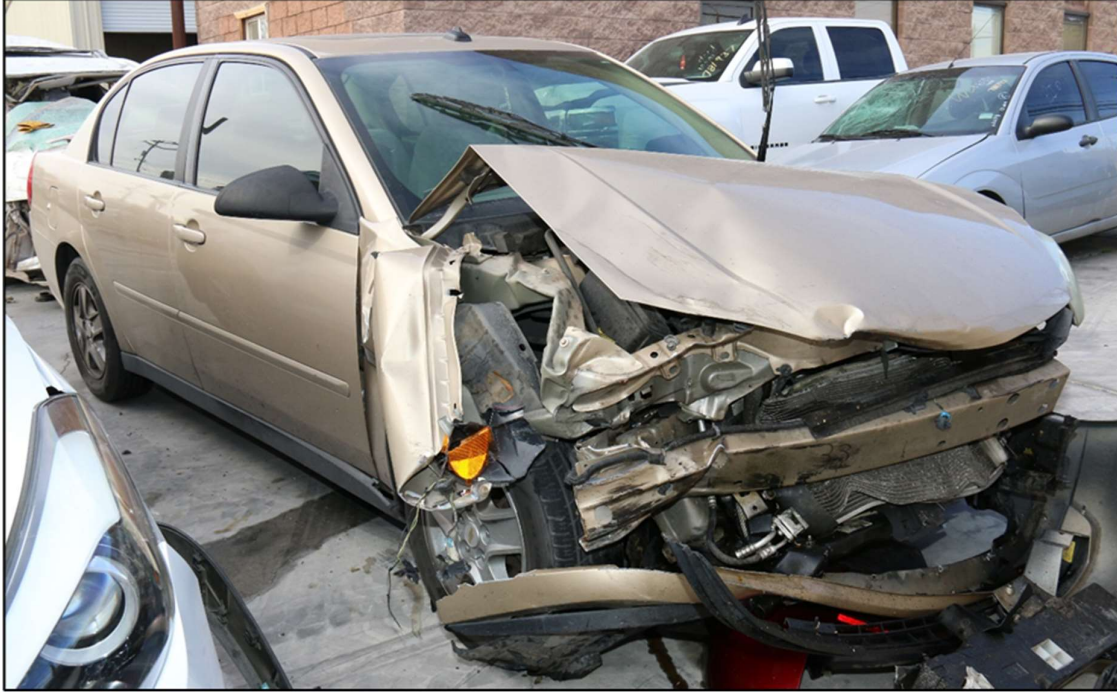
The Chevrolet exhibited contact damage at the passenger side front of the vehicle. The damage extended laterally across the front of the vehicle to about the centerline from the outboard edge, although additional front-end components were also displaced. Front-end components at the passenger side front including the fender were also displaced outward from the vehicle. The displaced fender was observed to be in contact with the front tire. The rear bumper cover and fascia from the Dodge was observed entrapped beneath the vehicle.

**Figure 14:** Photographic image of the Chevrolet depicting the passenger side front of the vehicle.

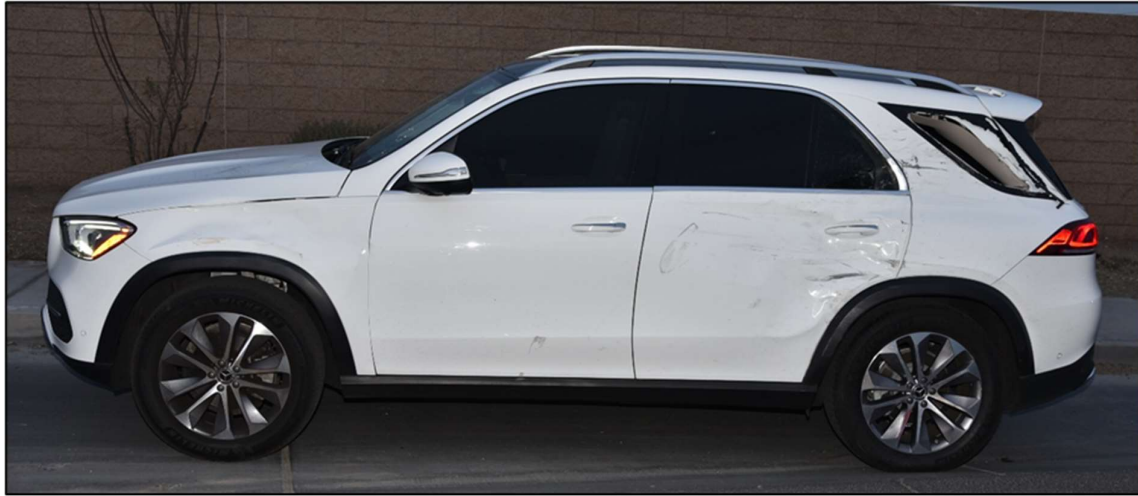
The Mercedes Benz SUV was not impounded by police investigators and was unavailable for examination. Photographs provided by NLVPD depicted the vehicle as having sustained damage along the left (driver) side. Material transfer that appeared consistent with biological substance splatter was observed on the driver side front fender and driver side of the hood. The driver side of the front windshield exhibited scrapes, minor debris deposits and other evidence consistent with an impact. Black-colored scuffing and material transfer was observed near the bottom of the driver's door below the handle. The driver side rear door exhibited material transfer and contact damage. The damage extended rearward to encompass the C-pillar and included the shattering of the small window aft of the C-pillar.

**Figure 15:** Photographic image depicting the driver side of the Mercedes Benz. (Source NLVPD)

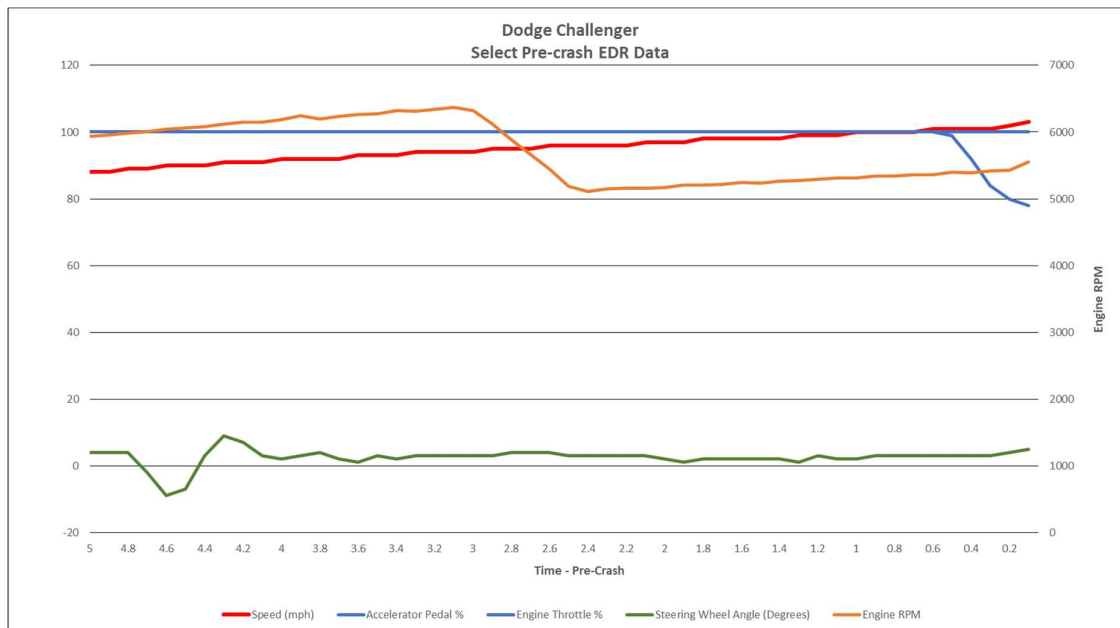
Five (5) seconds of precrash data (up to time zero) that reported multiple vehicle performance parameters was also retrieved. The data was reported at a rate of 10Hz and overlapped both events. While about one additional second of data appeared relative to the second event, not all parameters were reporting as a result of the initial impact. Consequently, this additional second of data provided little useful information. Recorded data indicated that at five seconds before time zero the vehicle speed was reported as 88 mph. At about time zero, the reported speed had reached 103 mph. During the entire five-second precrash period, the engine throttle reported a 100%.<sup>13</sup> Similarly, the reported value of the accelerator pedal remained constant at 100% until about ½ second before time zero where some reduction was reported.<sup>14</sup> At about time zero, the accelerator pedal position data reported 78%. Throughout the five-second period there was no indicated service brake application and steering input remained consistent. **Figure 16** is a graph depicting certain precrash data.

**Figure 16:** Graph depicting select precrash data from the Dodge Challenger EDR. Parameters are asynchronous.
