## INSPECTOR STATEMENT

Date: 02/21/2018  
To: Todd Fox, NTSB  
From: Edward S. Janos, FAA ASI  
Subject: N471RA Accident.

The purpose of this statement is to document the observations, findings and statements collected during my initial on site investigation of the accident involving a Schweizer Helicopter Model 269D, S/N 0071A, N471RA.

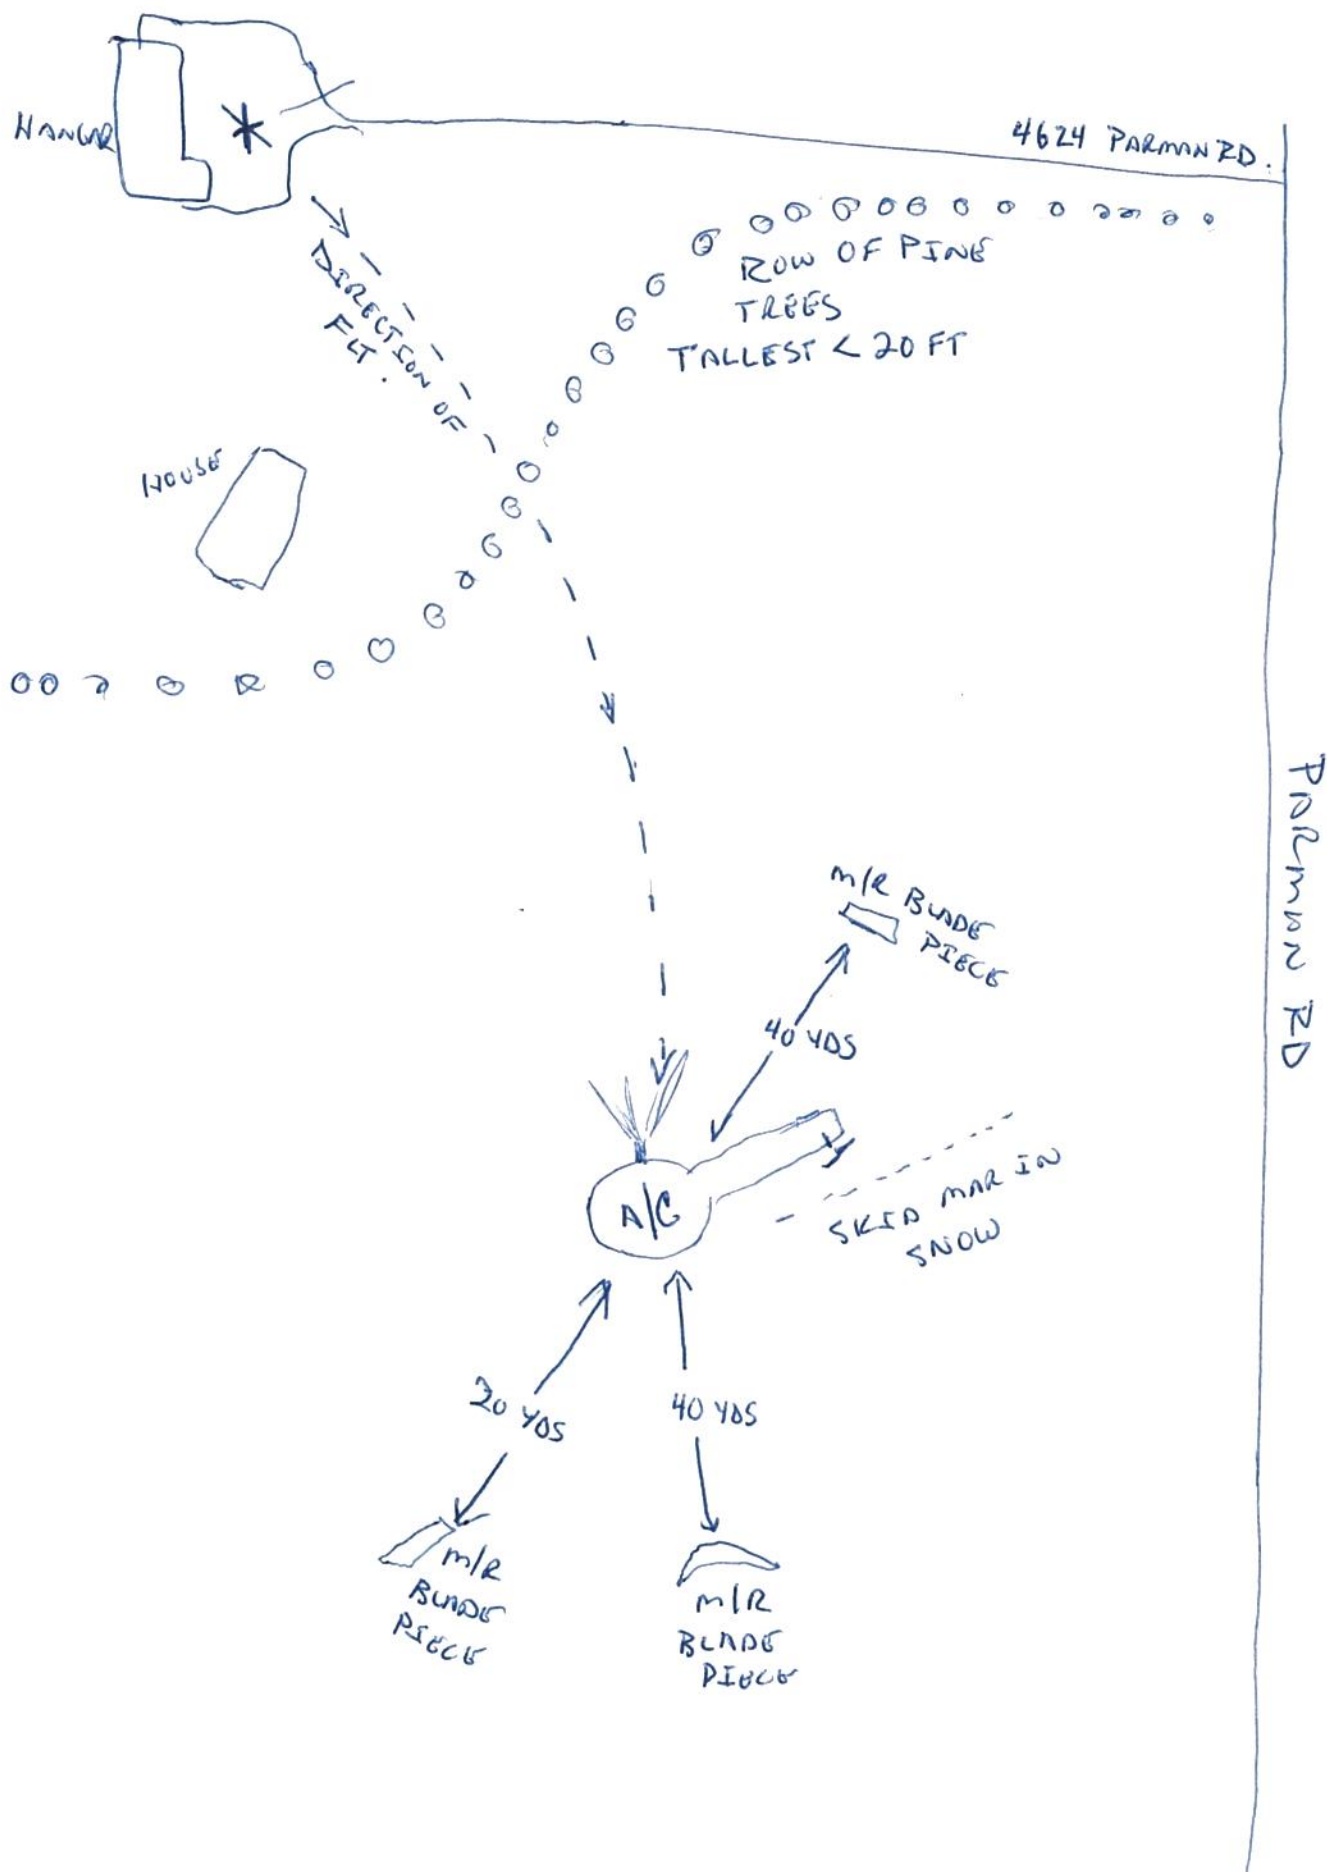
Mr. Salow drove me to the aircraft where I began taking pictures and notes. The aircraft was laying in the snow on it's right side with substantial damage to the r/h fuselage, r/h skid and main rotor blades/rotorhead. Three pieces of main rotor blade were located in the snow approximately 20-40 yards from the fuselage. Reference hand drawn sketch for actual locations.
