Investigative Update HWY22MH003

Collapse of the Fern Hollow Bridge

Pittsburgh, Pennsylvania

January 28, 2022

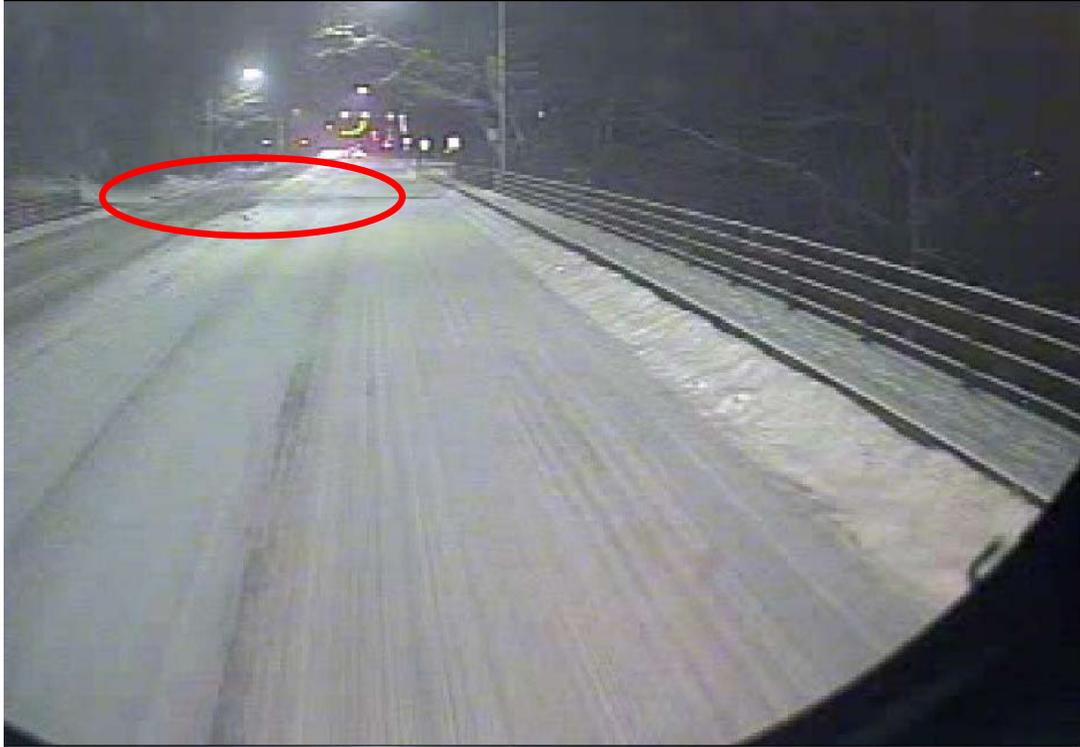
On March 16, 2022, investigative party members convened at NTSB headquarters in Washington, DC, where they reviewed video footage from the time of collapse, captured by the transit bus's camera system. Footage from two cameras, one forward-facing and one rear-facing along the curbside of the bus, was determined to have investigative value, and the group members collaboratively selected the frames depicting events of interest. Two frames, captured by the cameras and shown as figures 1 and 2, provide some information on the sequence of the collapse. The first frame (figure 1) is from the forward-facing camera and shows the bridge deck separating at the east expansion joint (the red oval highlights the expansion joint). The second frame (figure 2) is from the curbside camera and shows that, at nearly the same time, the west end of the bridge has already fallen off the west abutment (the red arrow points to the abutment).¹

Figure 1. Video frame from the forward-facing camera, showing the opening expansion joint.

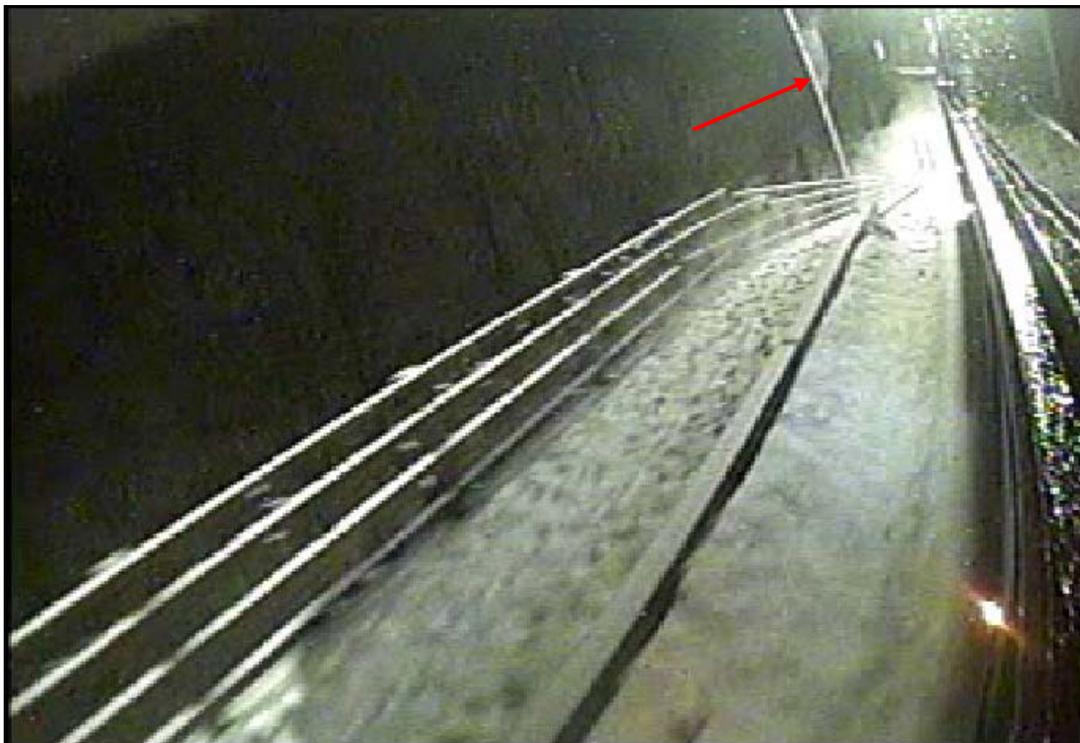
Figure 2. Video frame from the rear-facing curbside camera, showing the west end of the bridge already fallen off the west abutment.
