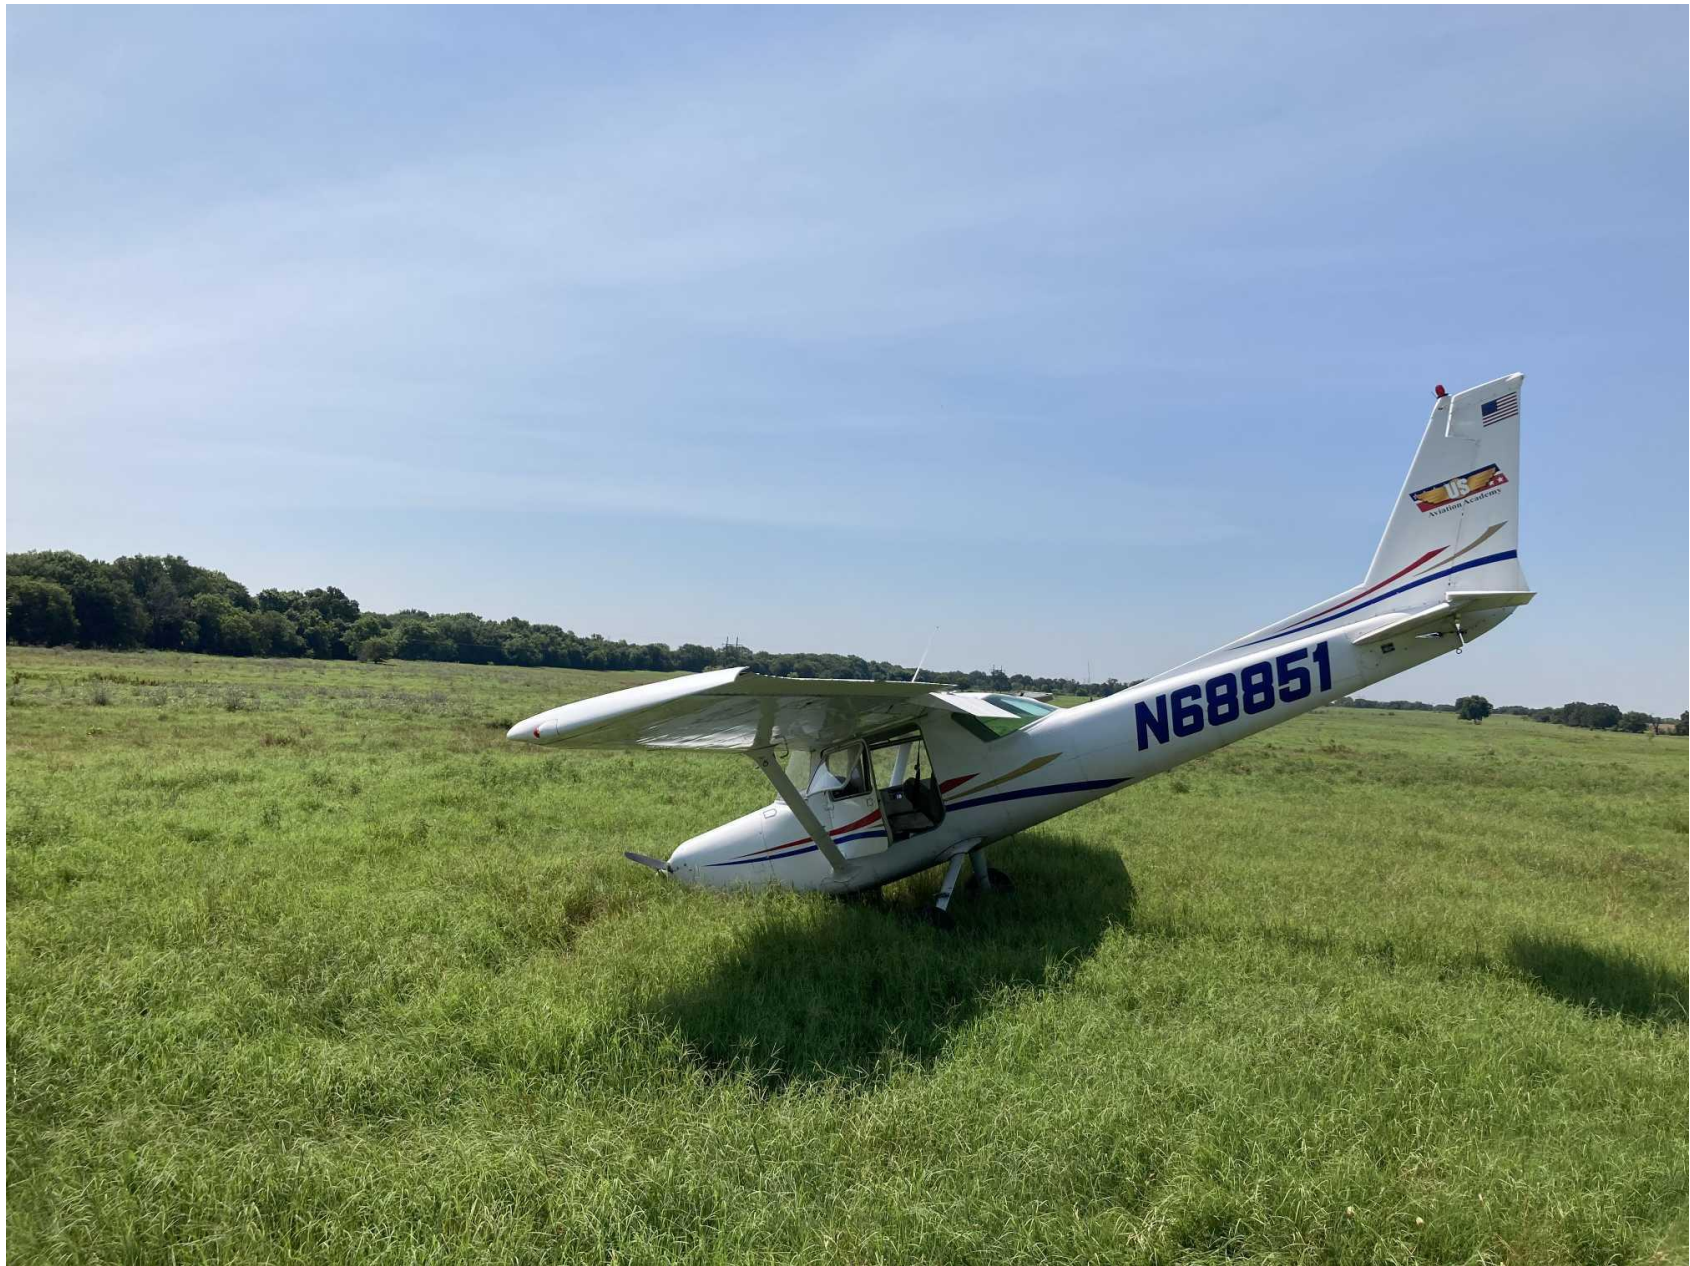
Photo 1 – Airplane at Accident Site (Photo Provided by Airplane Owner/Operator)

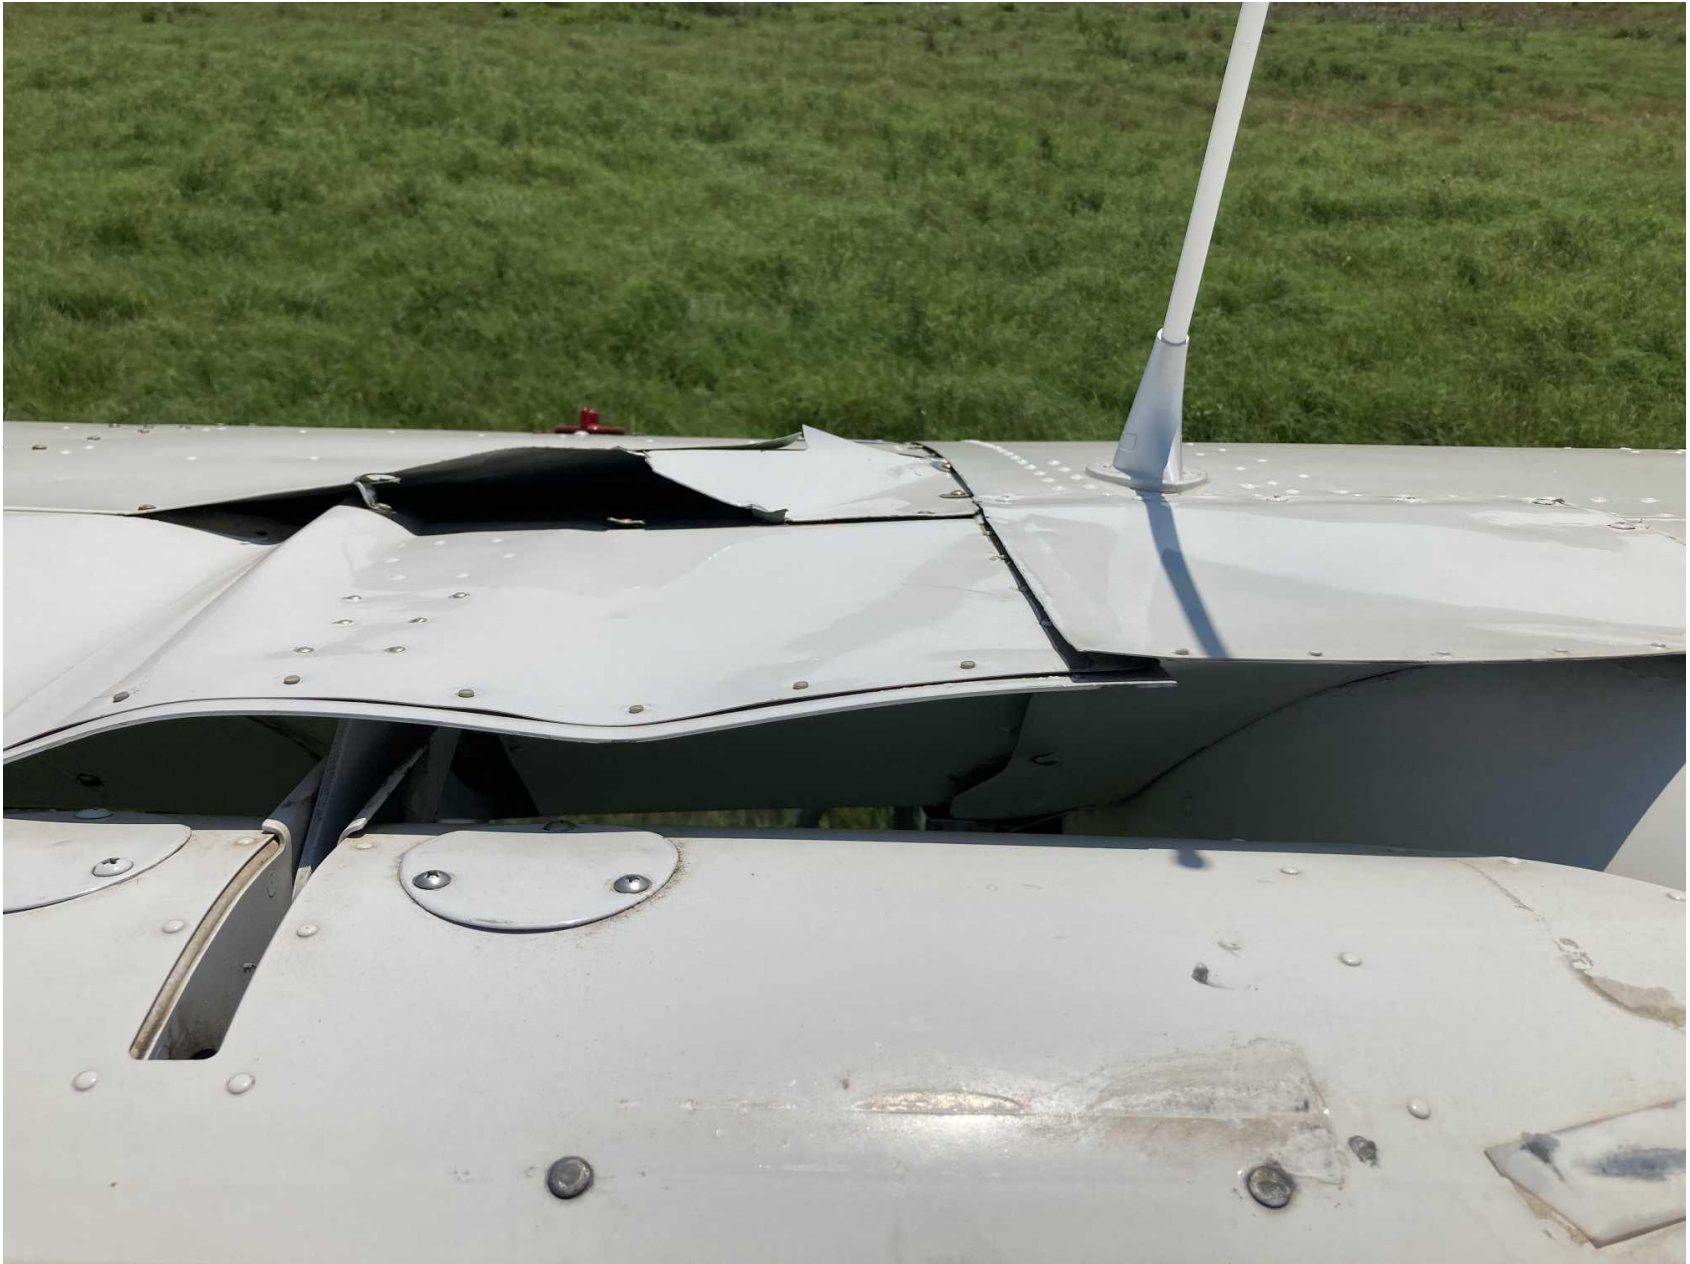
Photo 2 – Left Wing Rear Spar Damage (Photo Provided by Airplane Owner/Operator)
