MDTA 2023 Bridge Inspection Report (S17-S19)

MARYLAND TRANSPORTATION AUTHORITY
FSK-Francis Scott Key Bridge
Bridge - Biennial
FOR
STRUCTURE No. BCZ472001(S17-S19)
IS 695 OVER PATAPSCO RIVER

BIN: BCZ472001(S17-S19)

Date: 01/09/2023

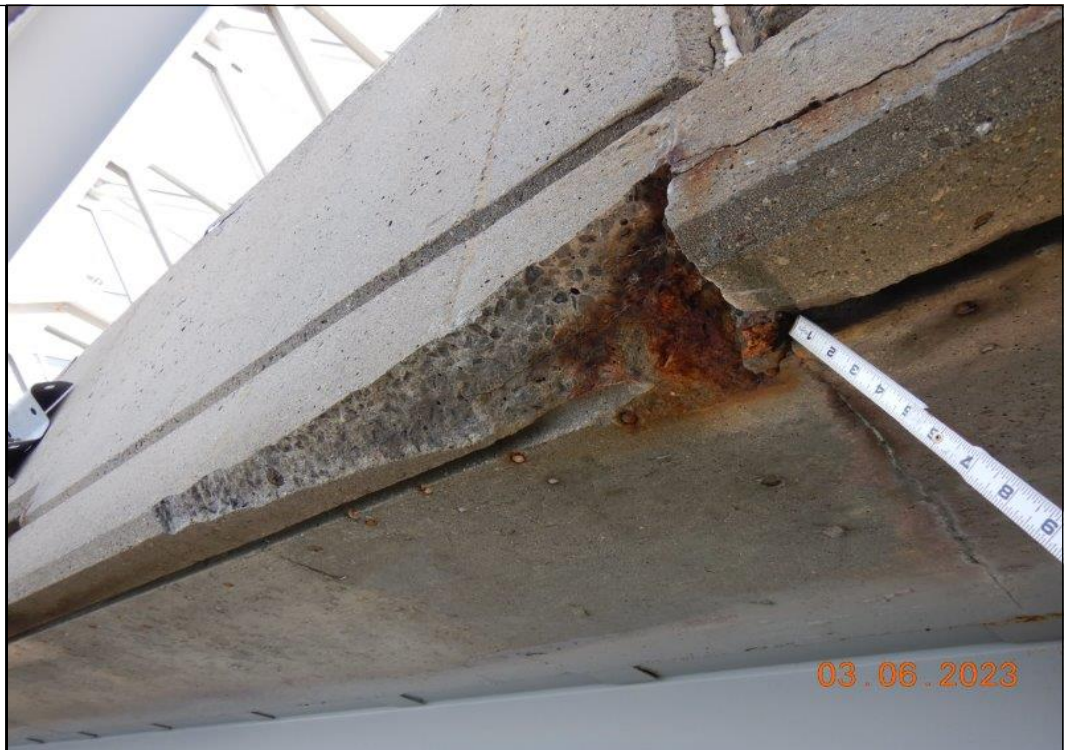
PHOTO NO.: 4

Location: Span 17, East Fascia, just south of PP8

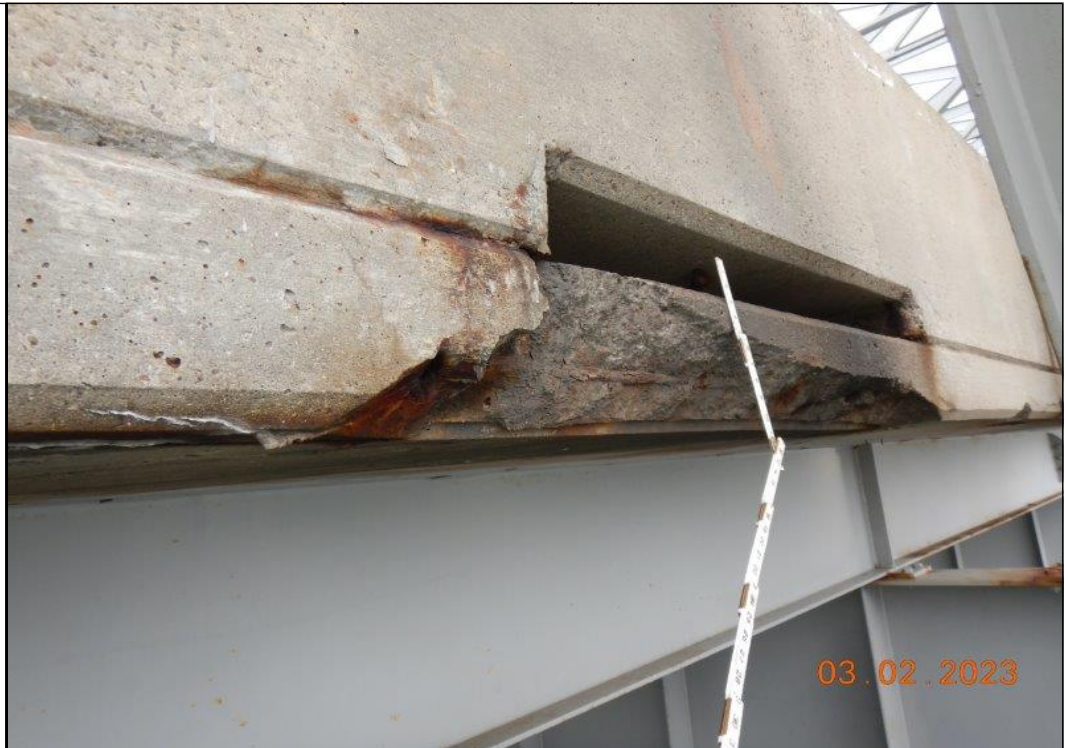
PHOTO NO.: 8

Location: Span 17, East Fascia, Between PP15 and PP16, 8'-0" south of PP16

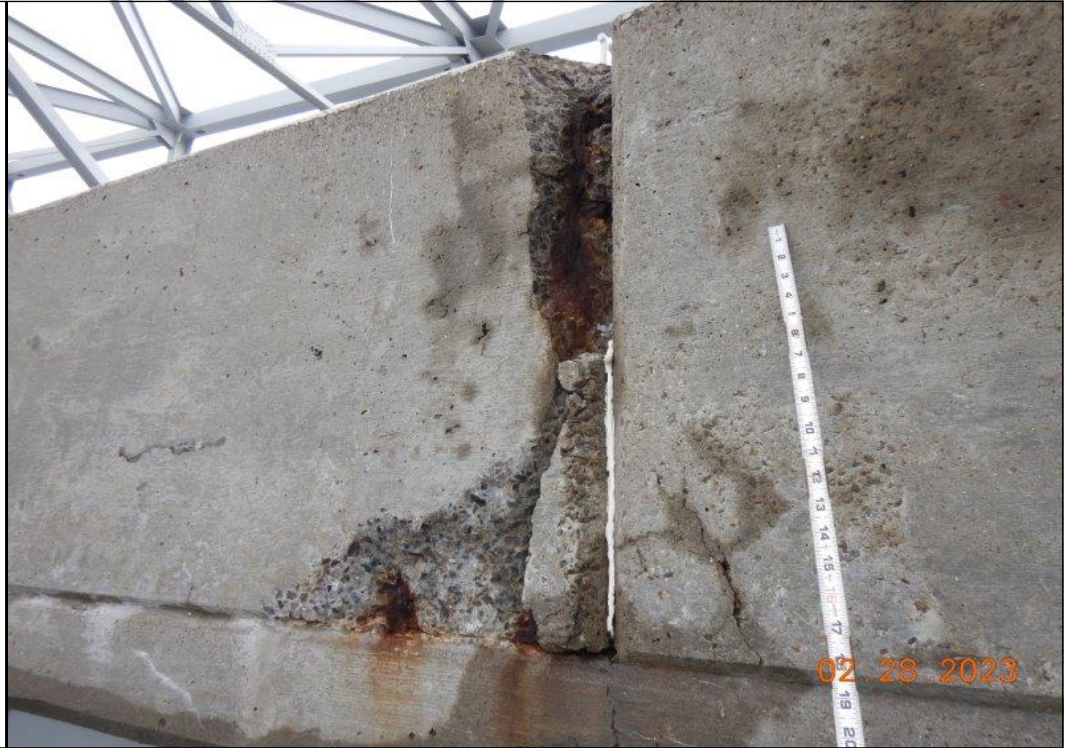
PHOTO NO.: 10

Location: Span 17, West Parapet, Base of the East Face, between PP15 and PP16

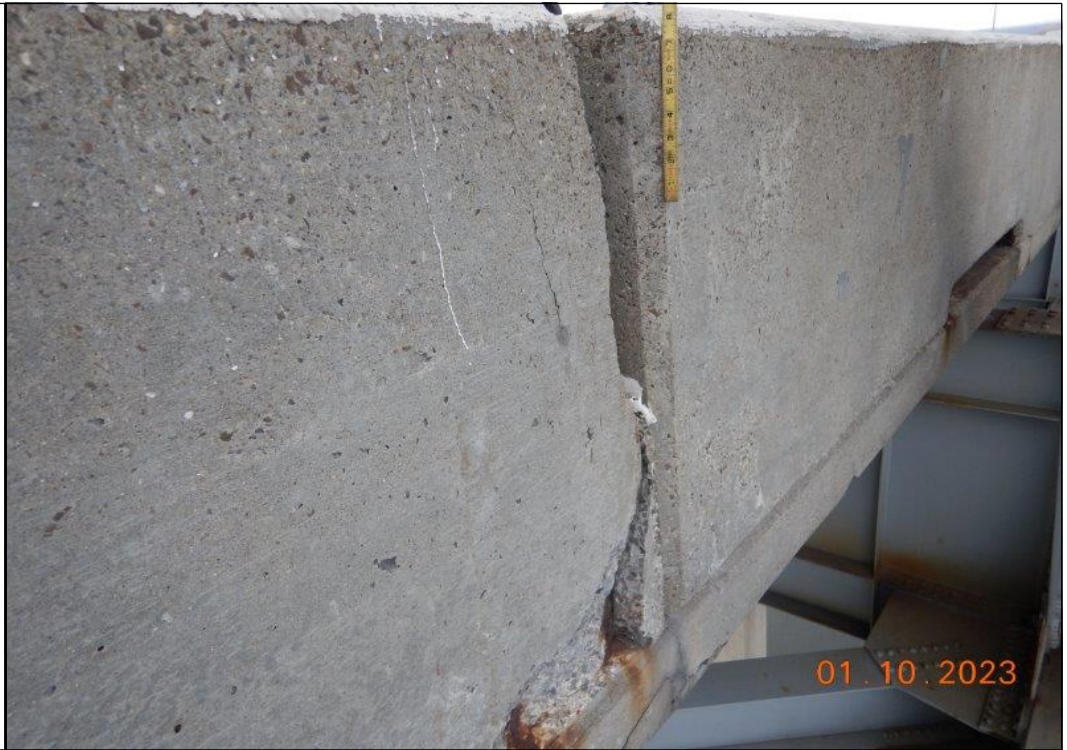
PHOTO NO.: 12
Location: Span 17, Median, West Face, 15'-0" north of PP19
Direction: East
Description: There is a 9" wide x 1'-0" high x 2" deep spall with exposed corroded steel reinforcement.
Element #: 58.06 - Median
Rating #: 5
MDTA Repair: 2
Repair Id: 2021-BCZ472001(S17-S19)-00008

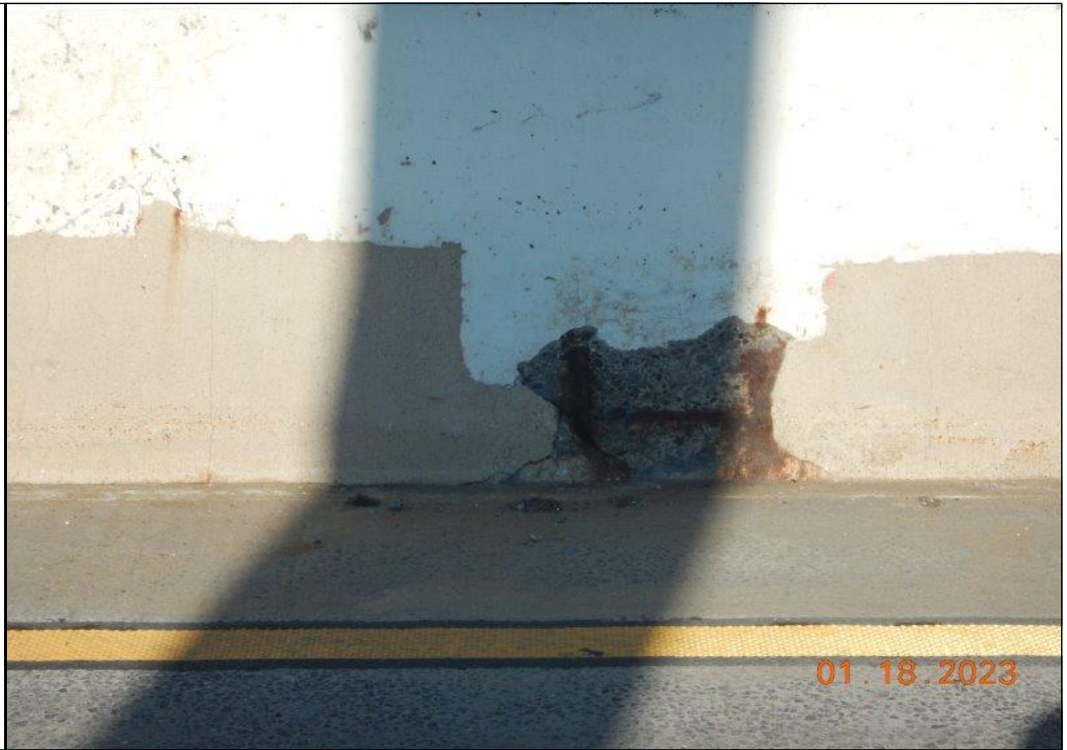
PHOTO NO.: 14
Location: Span 17, Median, East Face, at the base, 4'-0" south of PP17
Direction: West
Description: There is a 2'-6" wide x 1'-2" high x 1" deep spall with exposed corroded steel reinforcement and an adjacent 1'-6" wide x 1'-0" high delamination.
Element #: 58.06 - Median
Rating #: 5
MDTA Repair: 2
Repair Id: 2013-BCZ472001(S17-S19)-00176

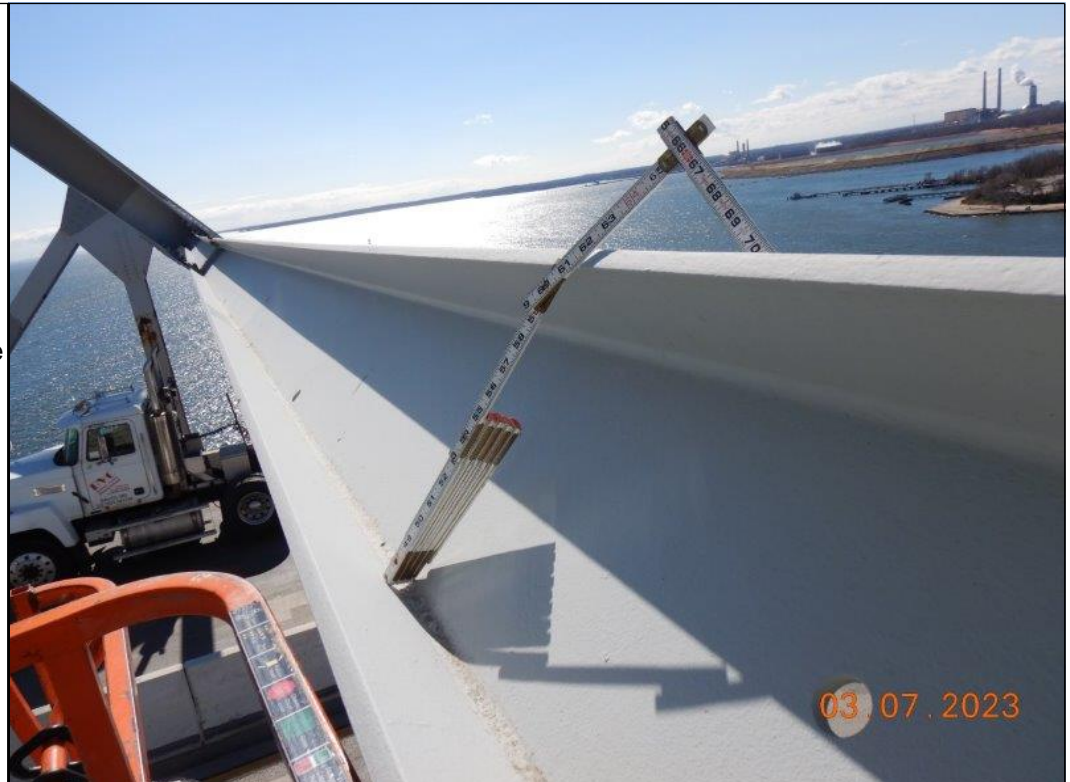
PHOTO NO.: 16

Location: Span 17, West Truss, Bottom Chord, near L5, Top and Bottom Splice Plates

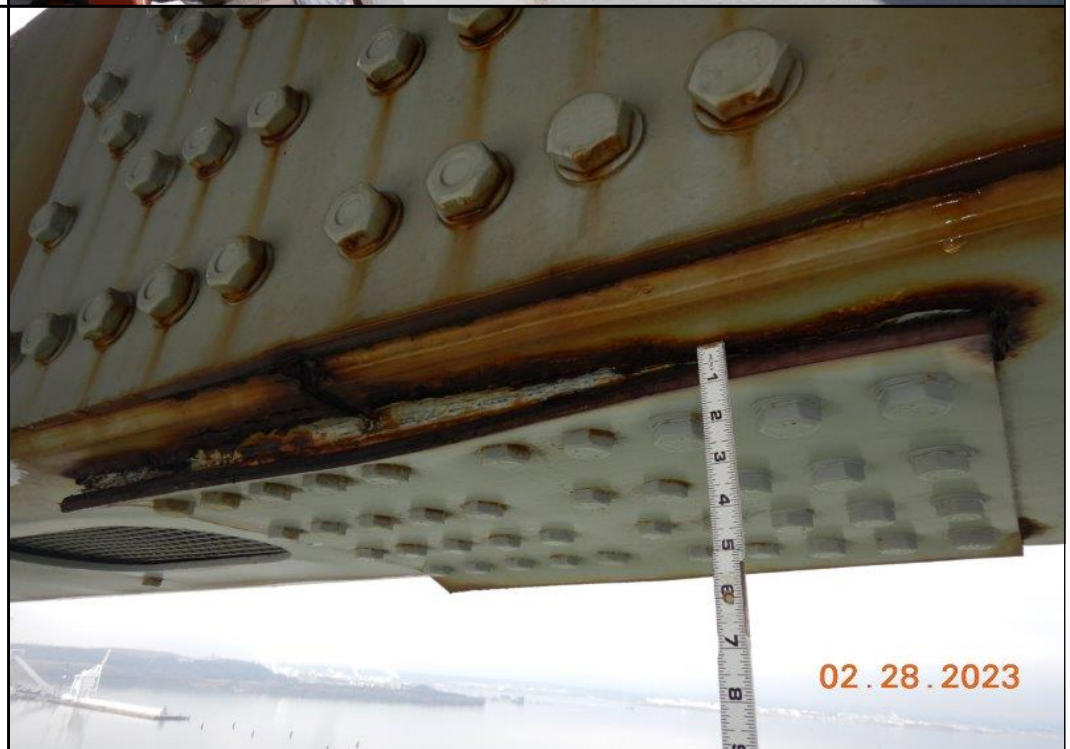
PHOTO NO.: 17

Location: West Truss,
Bottom Chord, bottom face,
just north of L6

It is recommended that the laminar fold crack in the West Truss, Bottom Chord, bottom face, just north of L6, inside the south vertical edge of the access hole be ultrasonically tested to determine the extent of the crack and monitored in the future.

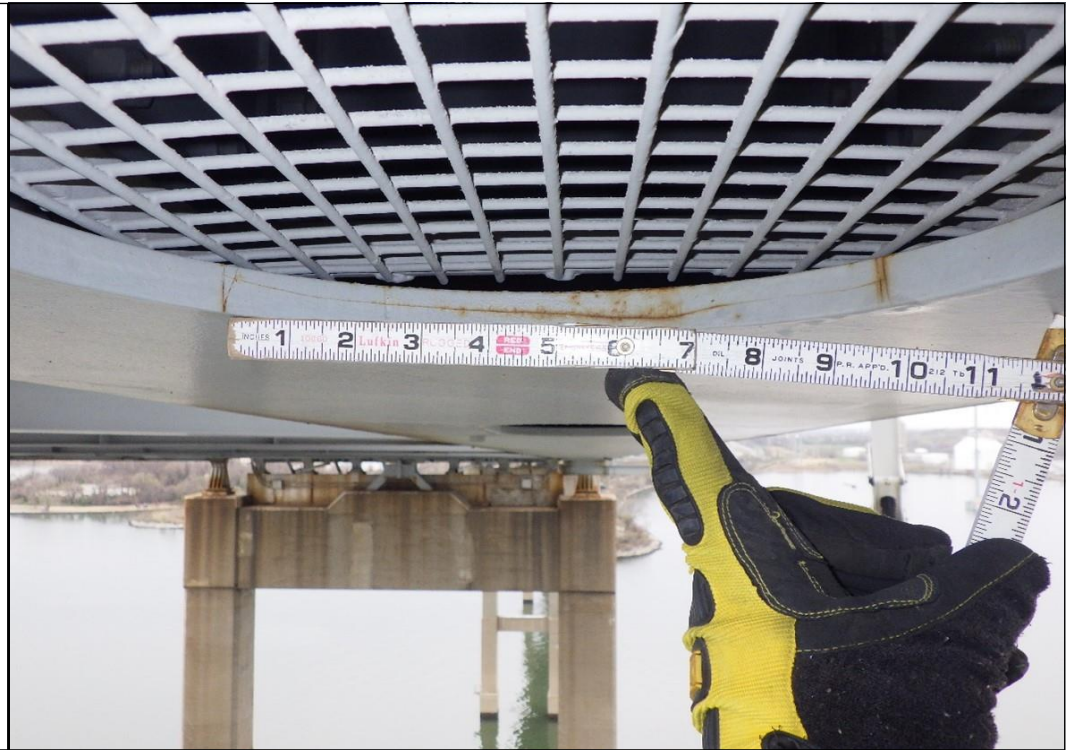
PHOTO NO.: 18

Location: Span 17, West
Truss, Bottom Chord, Field
Splice near L9, Interior Top
Plate

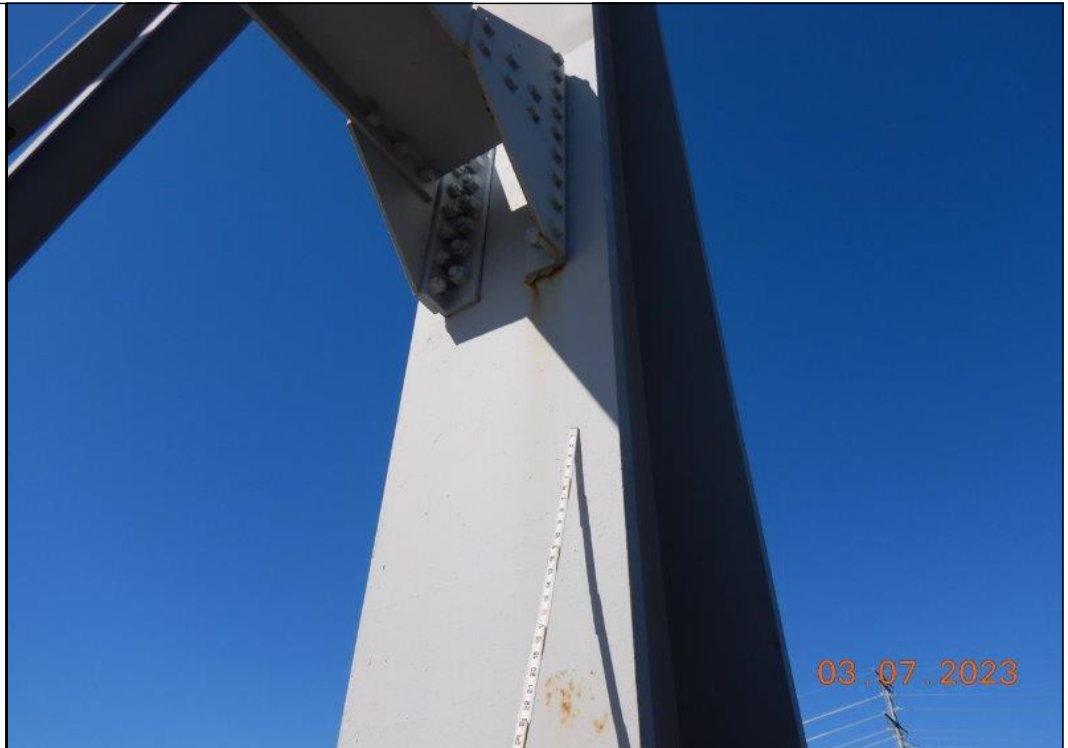
PHOTO NO.: 22

Location: Span 17, Floorbeam 12, Bottom Flange, Top Face, South Side, in Bay 1

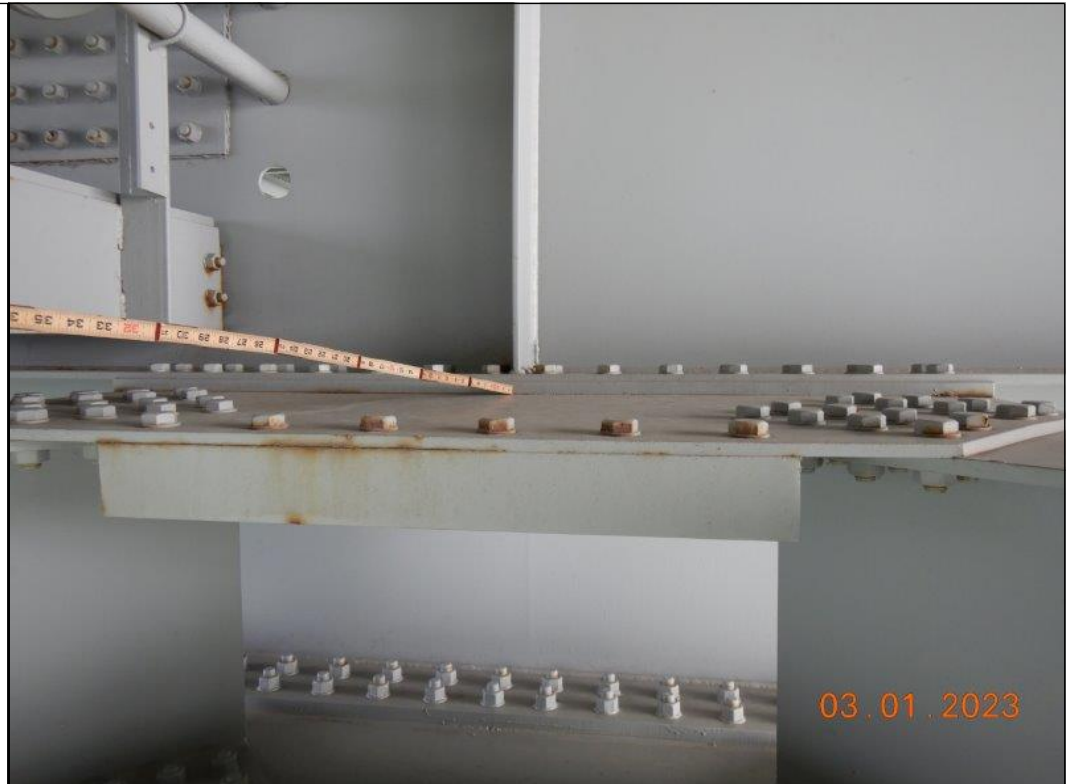
PHOTO NO.: 26

Location: Span 17, Floorbeam 13, connection to the West Truss, Bottom Flange T-Connection, north edge

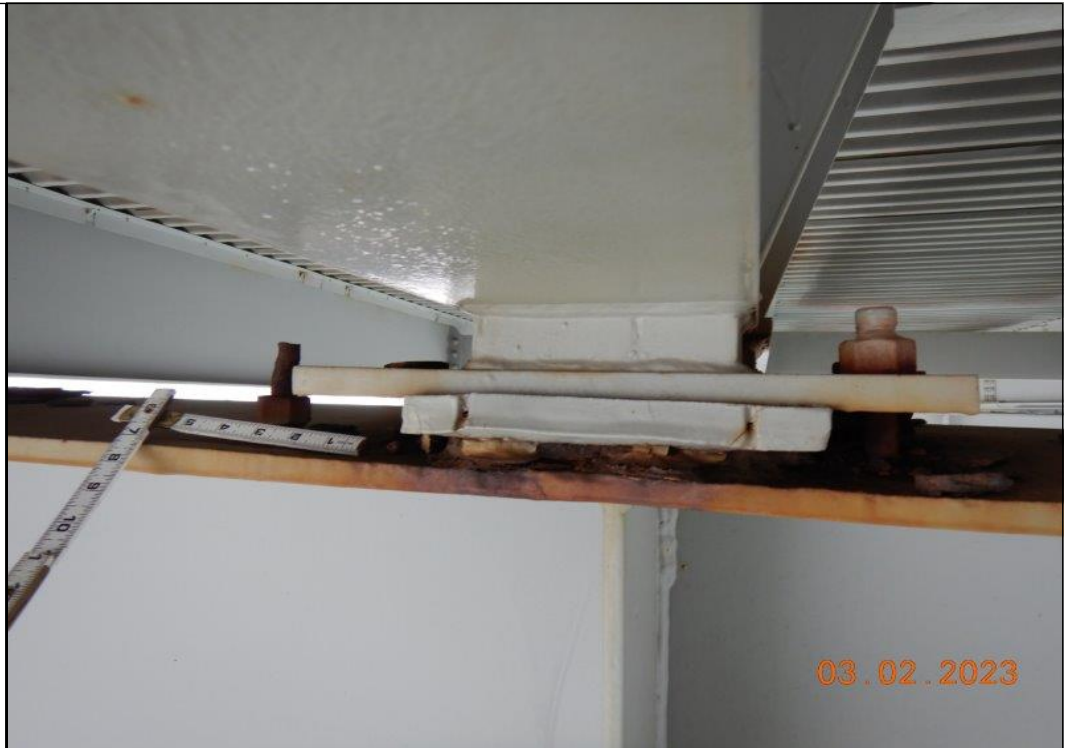
PHOTO NO.: 30

Location: Span 17, East
Truss, L17-M18, Top
Handhole at M18

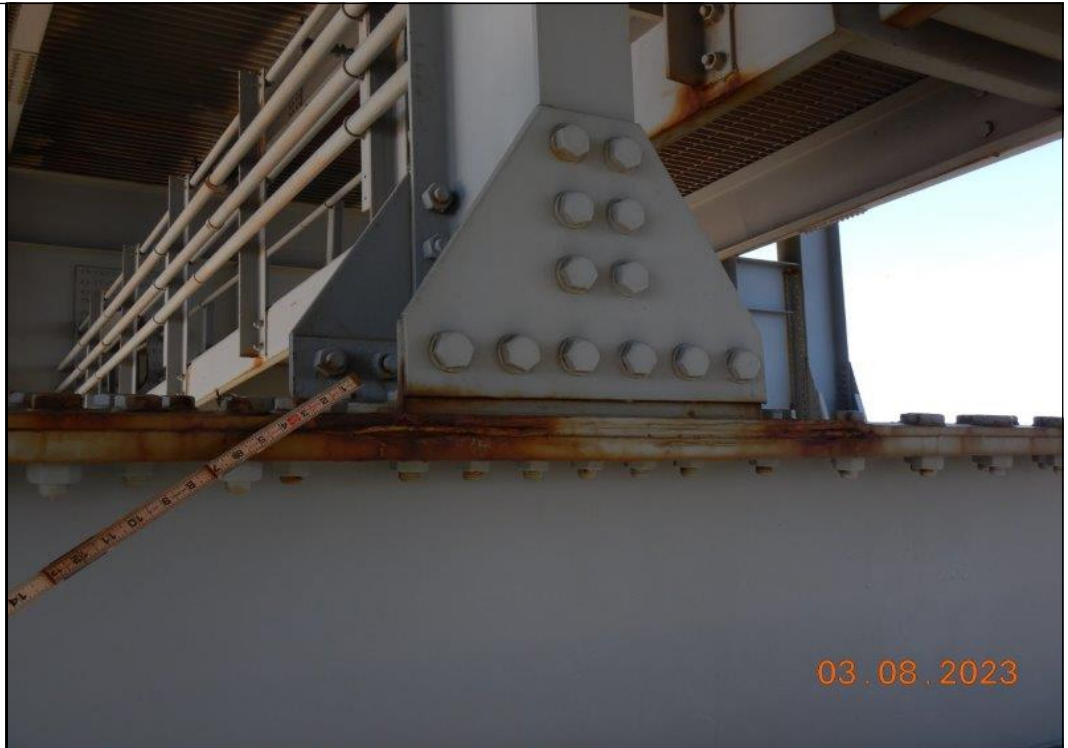
PHOTO NO.: 35

Location: PP25, West Truss Bearing at Pier 18

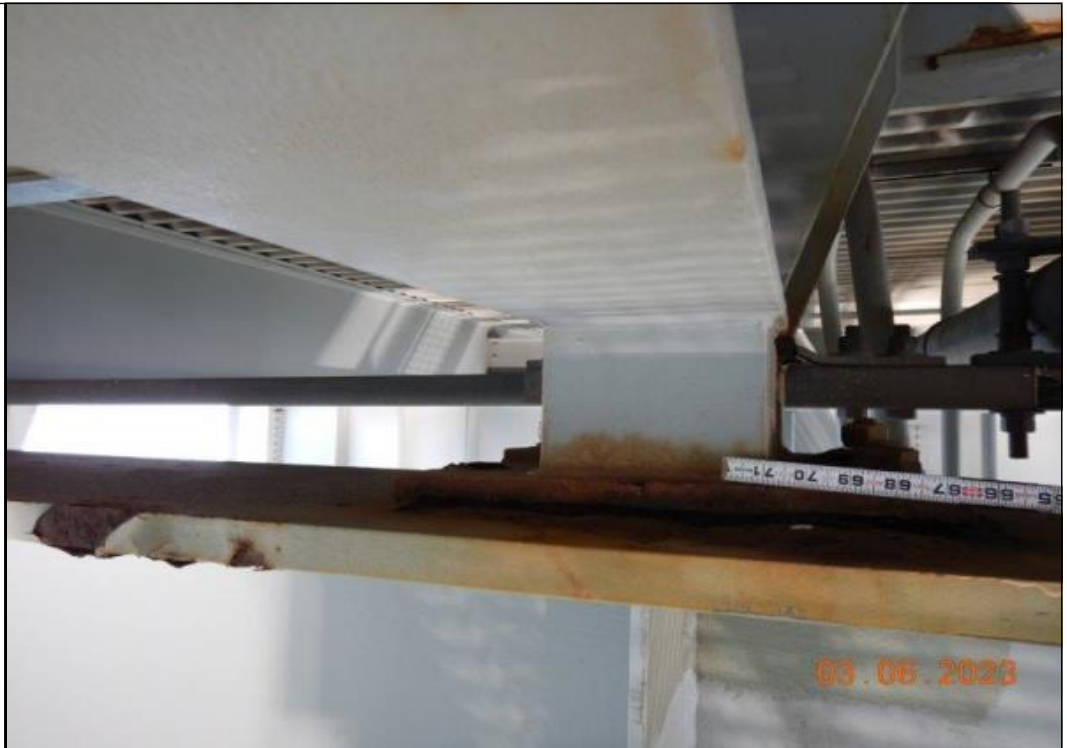
PHOTO NO.: 37
Location: Span 17, West
Truss, L25-U25, Interior
Direction: Northeast
Description: There is 6" of
standing water and heavy
debris in members being
retained between gusset
plates. Water is leaking from
inside member immediately
above bearings from L25 and
sitting at the bases of the
bearings.
Element #: 59.PP 24- PP 25
Rating #: 6
MDTA Repair: 3
Repair Id: 2010-BCZ472001-
00198

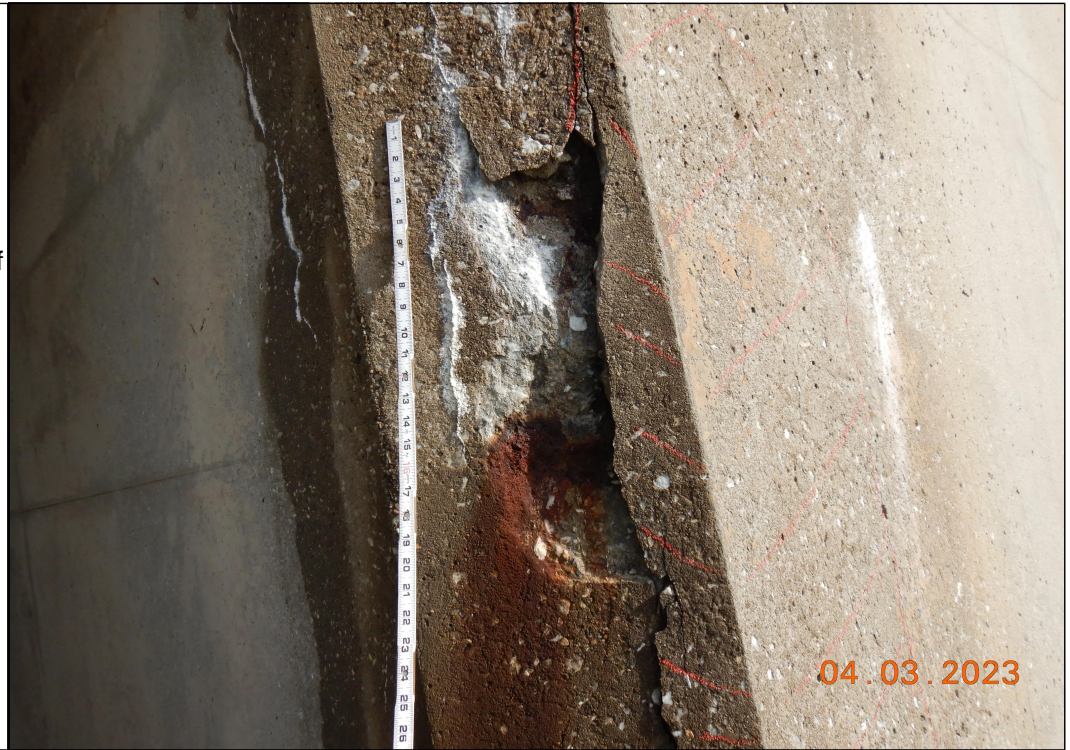
PHOTO NO.: 39

Location: Pier 17, Southwest Dolphin

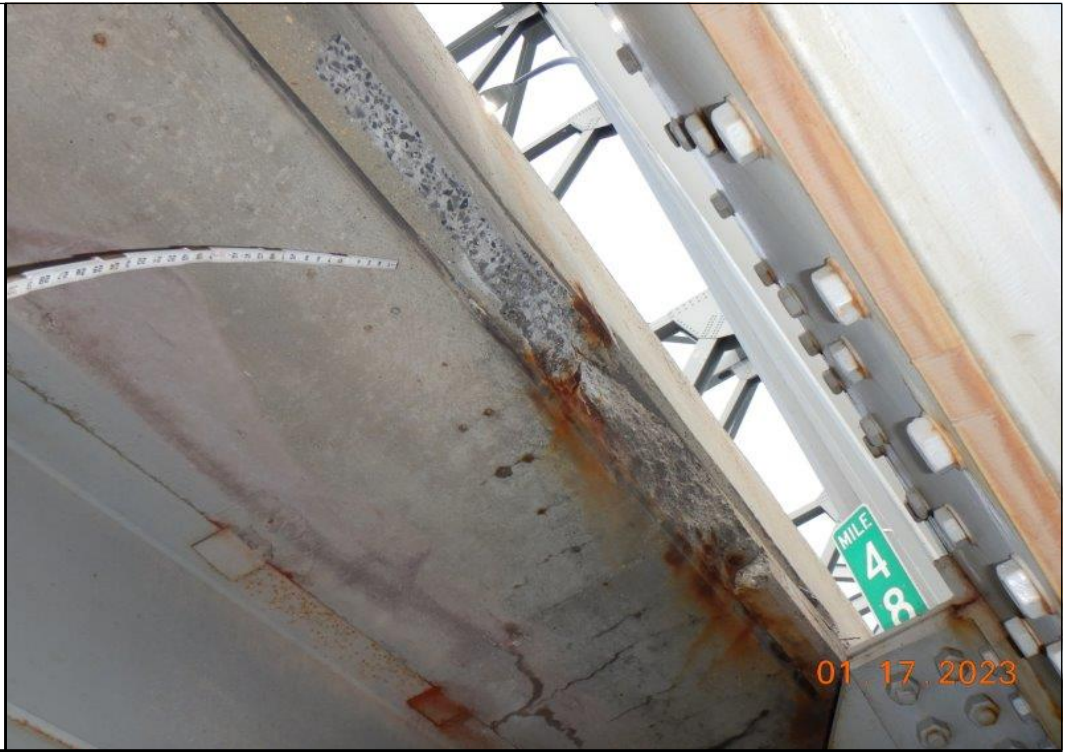
PHOTO NO.: 45
Location: Span 18, West Parapet, East Face, 5'-0" north of PP61 at scupper
Direction: West
Description: There are two (2) 1'-6" long x 7" high x 2 1/2" deep spalls with exposed corroded steel reinforcement.
Element #: 58.04 - Railings & Parapets
Rating #: 5
MDTA Repair: 3
Repair Id: 2017-BCZ472001(S17-S19)-00018

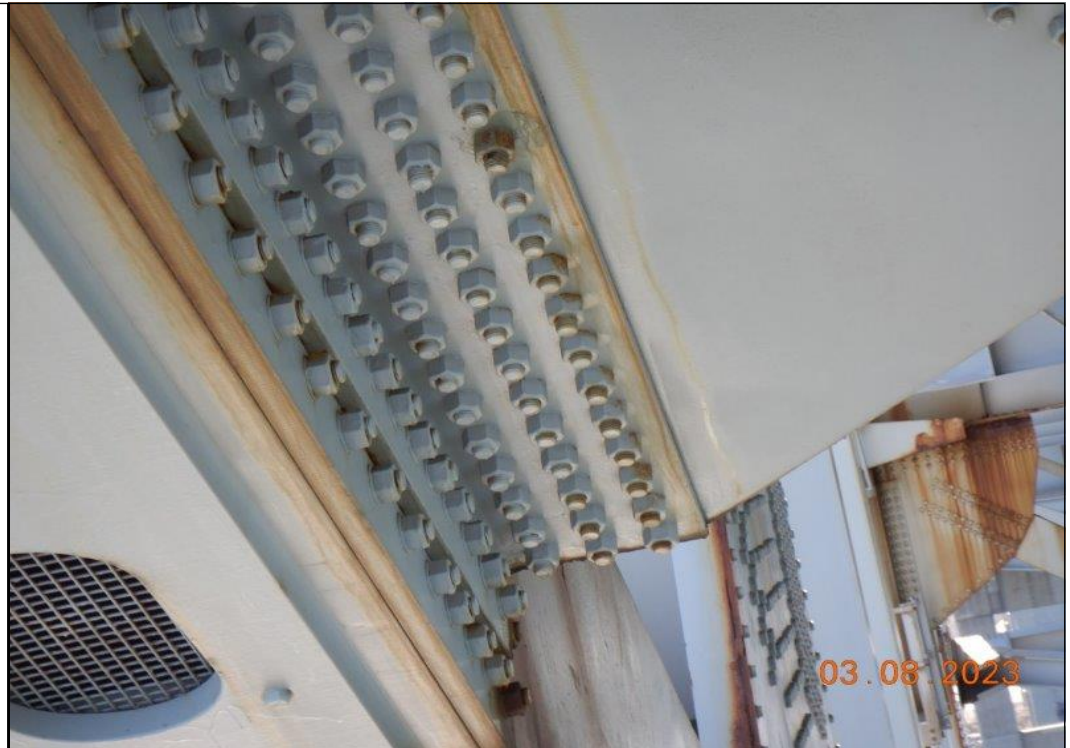
PHOTO NO.: 49

Location: Span 18, West Truss, at U29, Suspende Cable, North Face

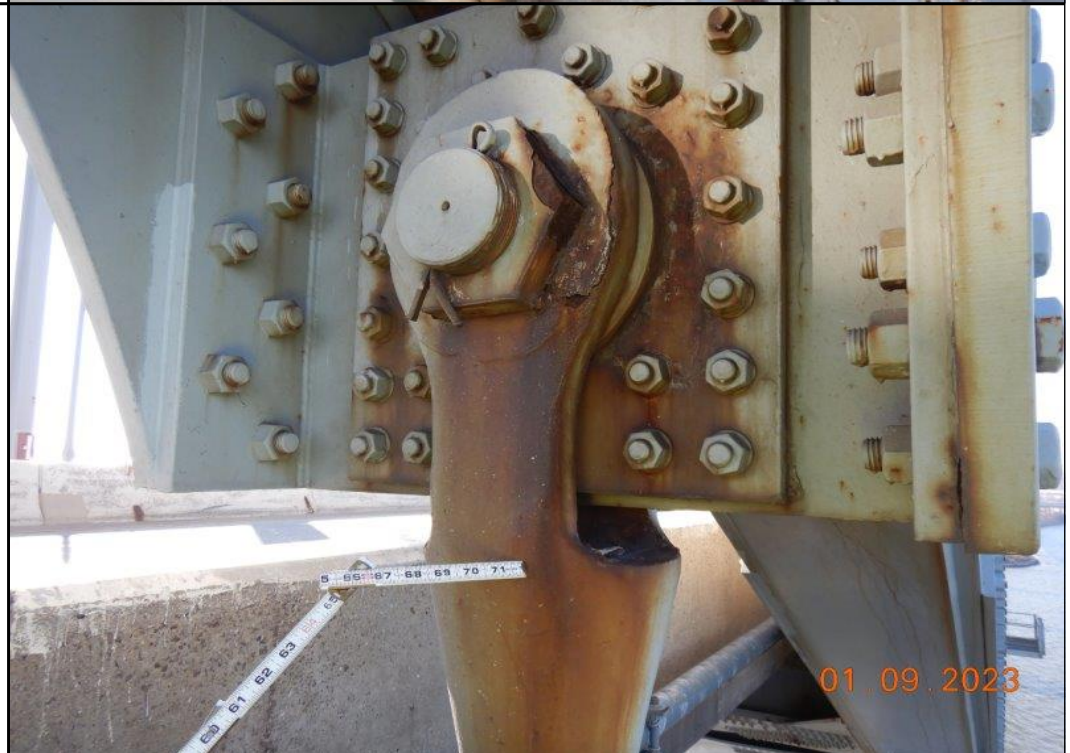
PHOTO NO.: 50

Location: Span 18, Lower Lateral Brace, at PP 28, Wind Tongue, west end, Bottom Connection Plate, north edge and top face

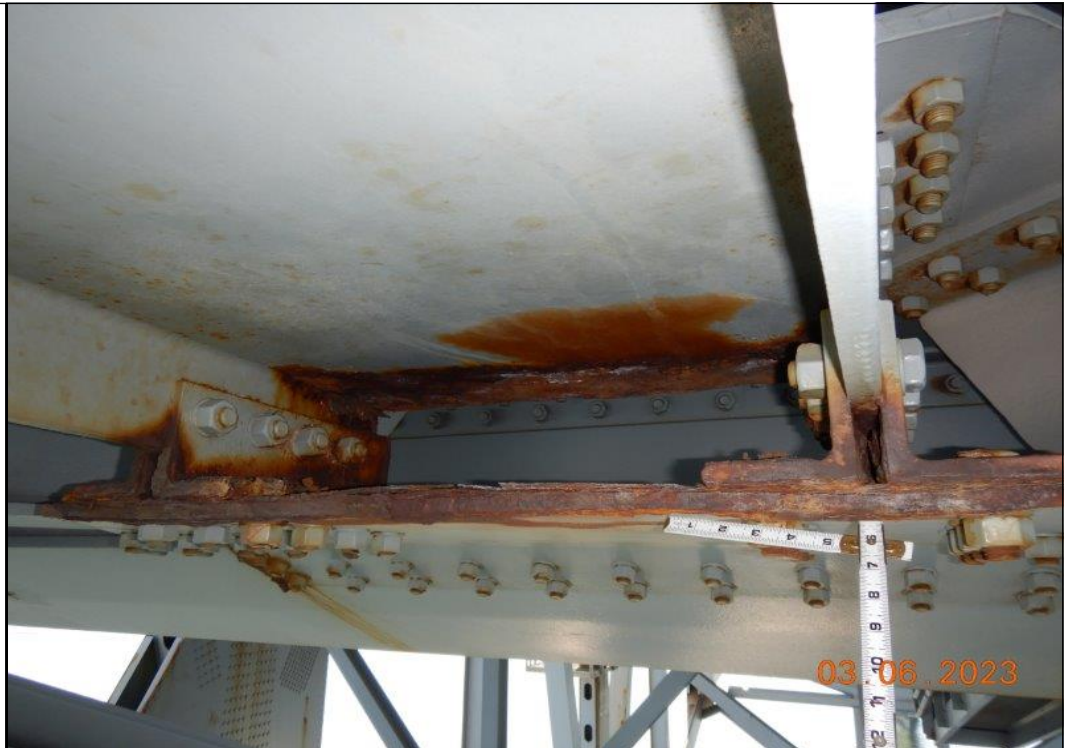
PHOTO NO.: 51

Location: Span 18, First Diaphragm from Floorbeam 29, Bay 2, at mid-length.

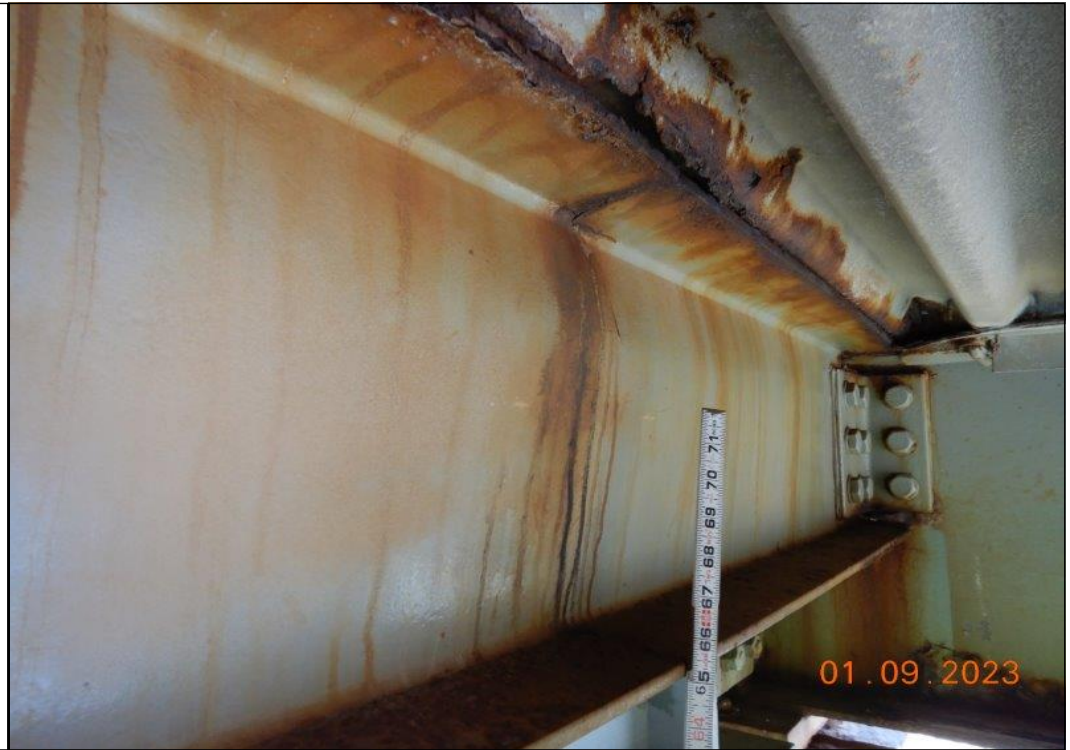
PHOTO NO.: 53

Location: Span 18, Floorbeam 29, North Face, Top Flange, Bay 4

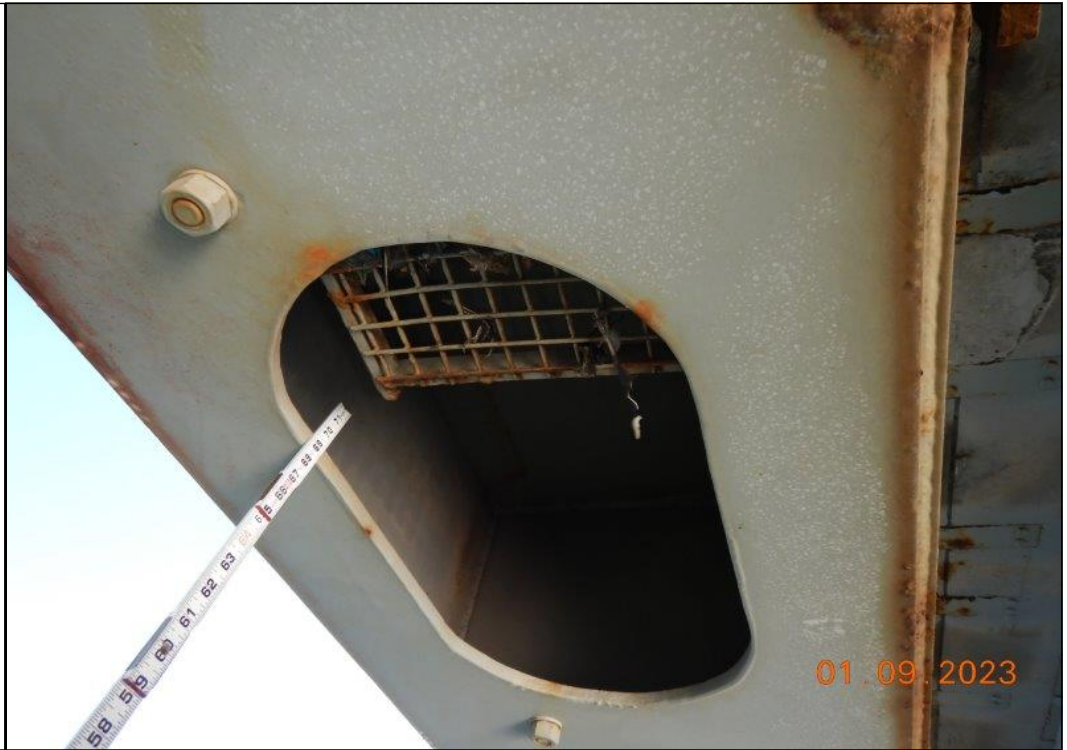
PHOTO NO.: 57
Location: Span 18, East Truss, Suspended Bottom Chord, B29-B30, near B30, West, Top and Bottom Faces
Direction: Northwest
Description: There is heavy corrosion, paint failure up to 6'-0" long x full-width x full-height and corrosion staining with up to 1/16" deep section loss.
Element #: 59.PP 29- PP 30
Rating #: 6
MDTA Repair: 3
Repair Id: 2021-BCZ472001(S17-S19)-00264

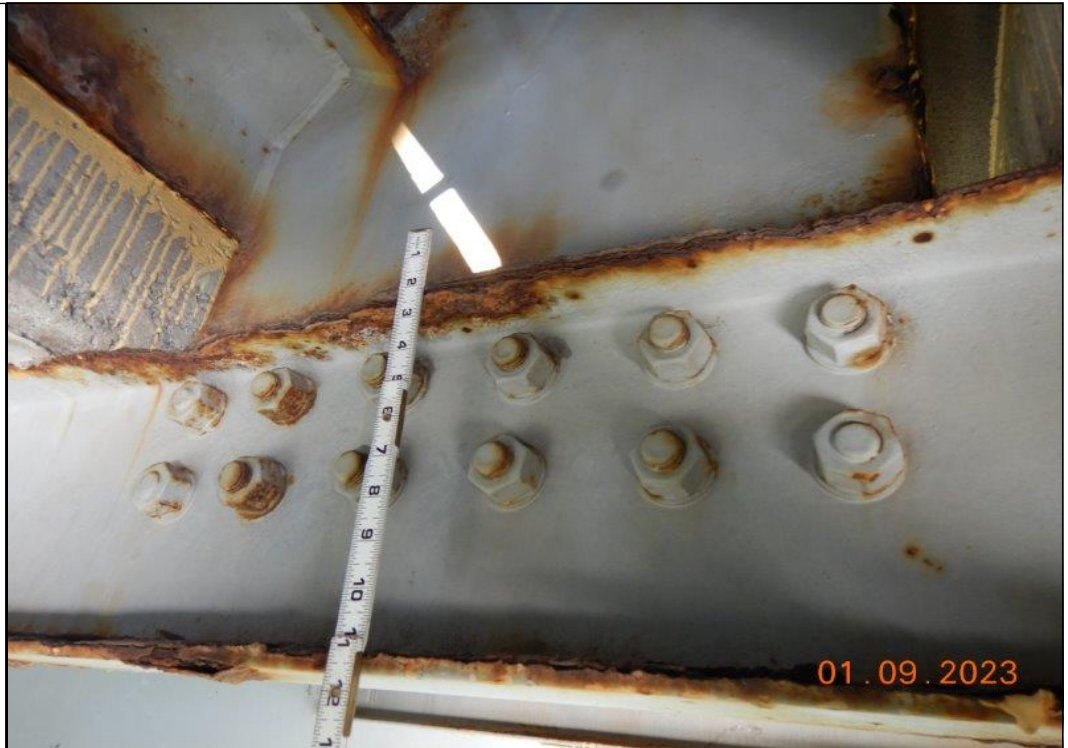
PHOTO NO.: 59

Location: Span 18, East
Truss, PP32, Suspender
Cable, Top Hanger

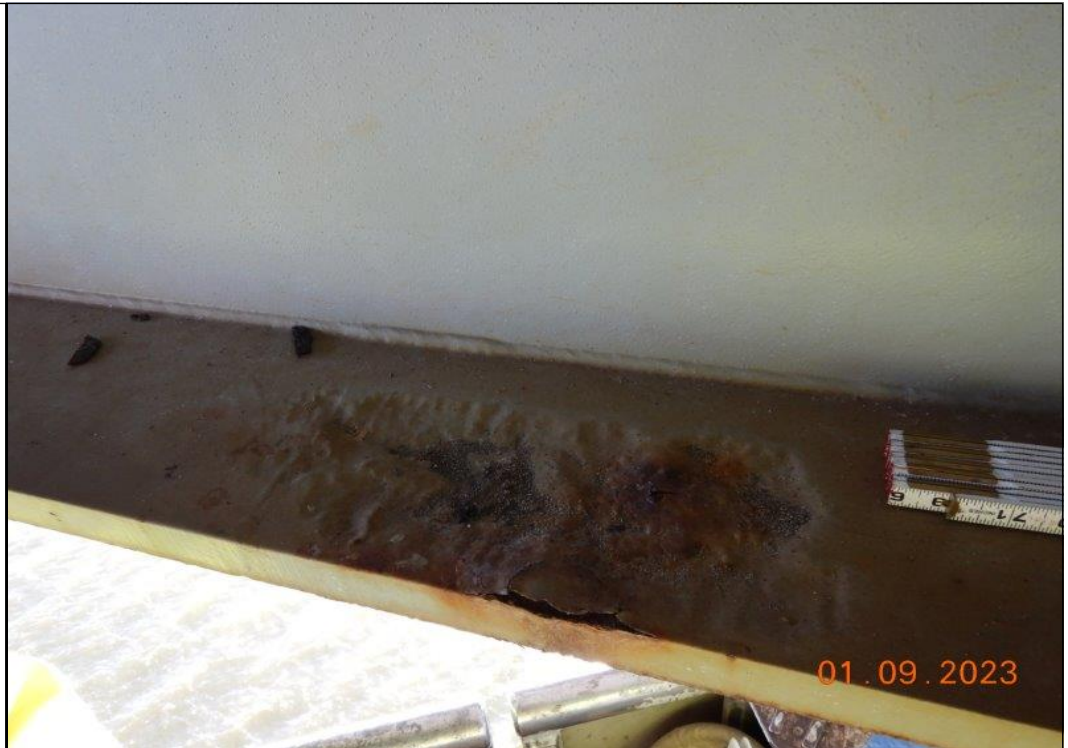
PHOTO NO.: 63

Location: Span 18, East
Truss, Bottom Chord, East
and West sides of Splice
along bottom edge, at B32

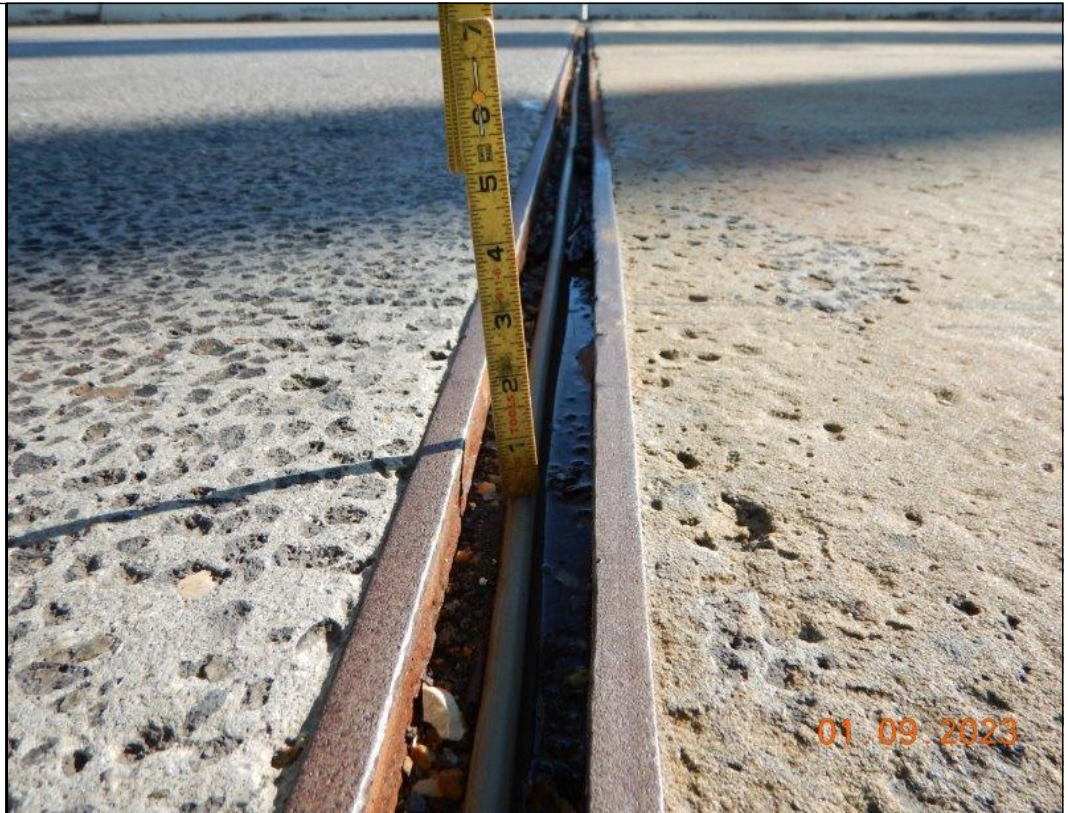
PHOTO NO.: 67

Location: Span 18, PP37 Joint, Southbound Right Lane, near the centerline

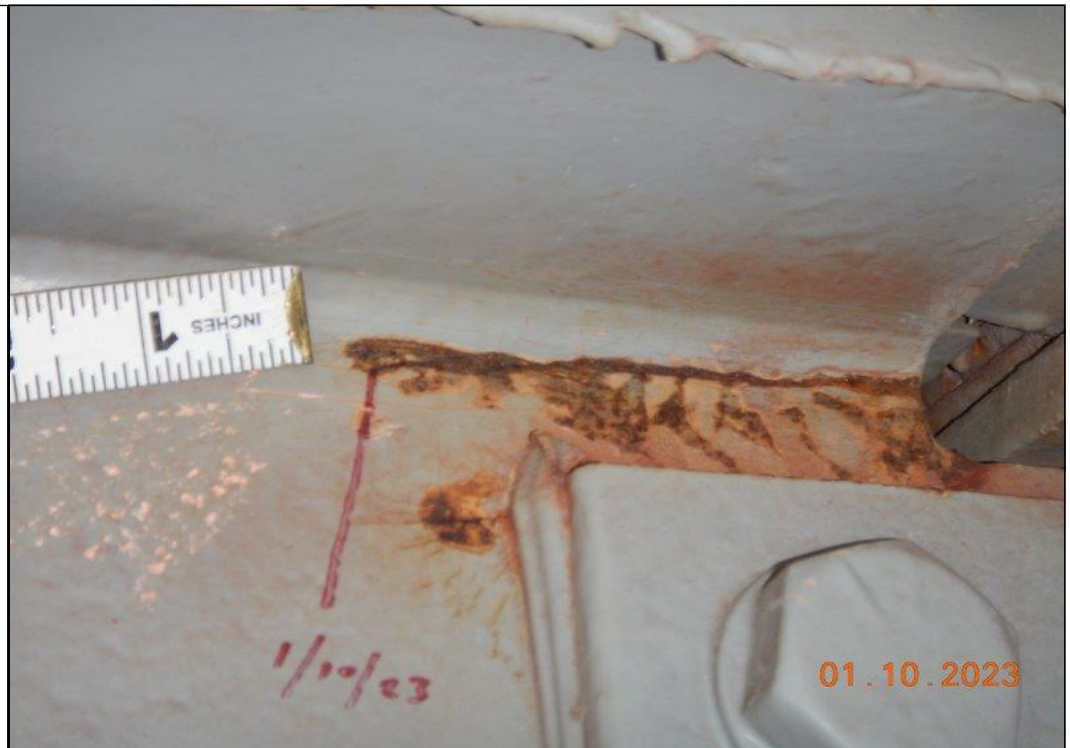
PHOTO NO.: 73

Location: Span 18, East Truss, at B42, Outboard Gusset Plate

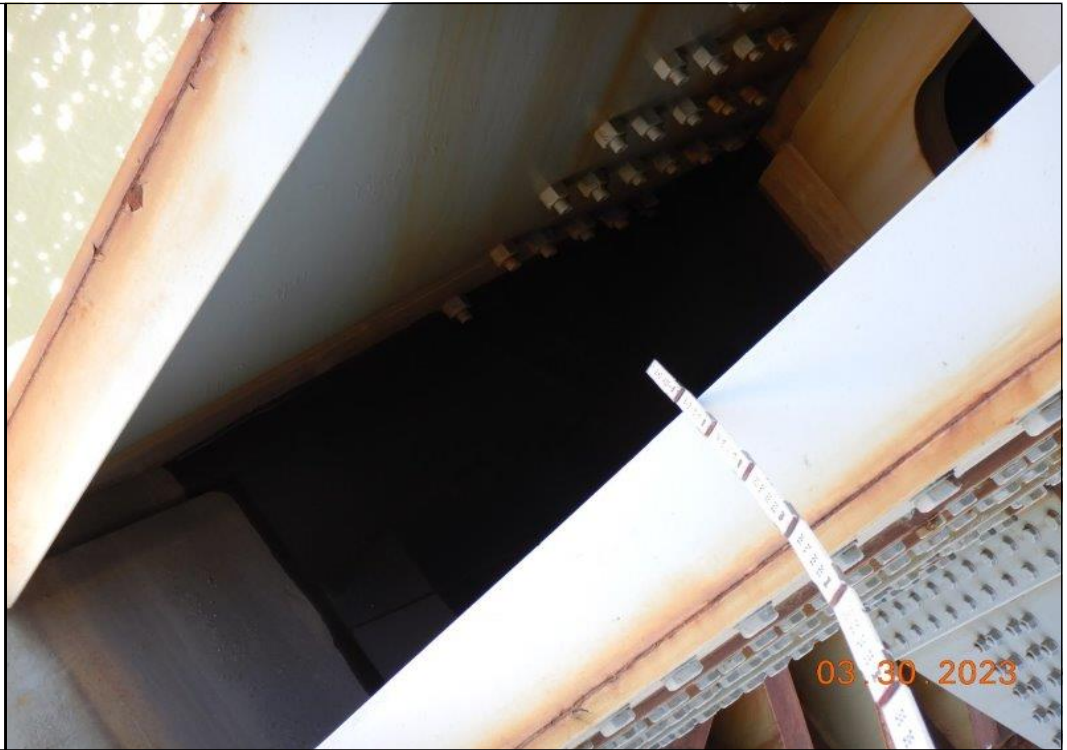
PHOTO NO.: 101
Location: Span 19, East Truss, U67-M68, Top Handhole at U67
Direction: North
Description: There is minor debris accumulation at the diaphragm with evidence of ponding water and corrosion bleeding from the hole. FY 2023 Inspection: This defect has been repaired. Repair status changed to CLOSE-CONSULTANT.
Element #: 59.PP 67- PP 68
Rating #: 6
MDTA Repair: 3
Repair Id: 2019-BCZ472001(S17-S19)-00498
