ERA24LA064

INVESTIGATION PHOTOGRAPHS

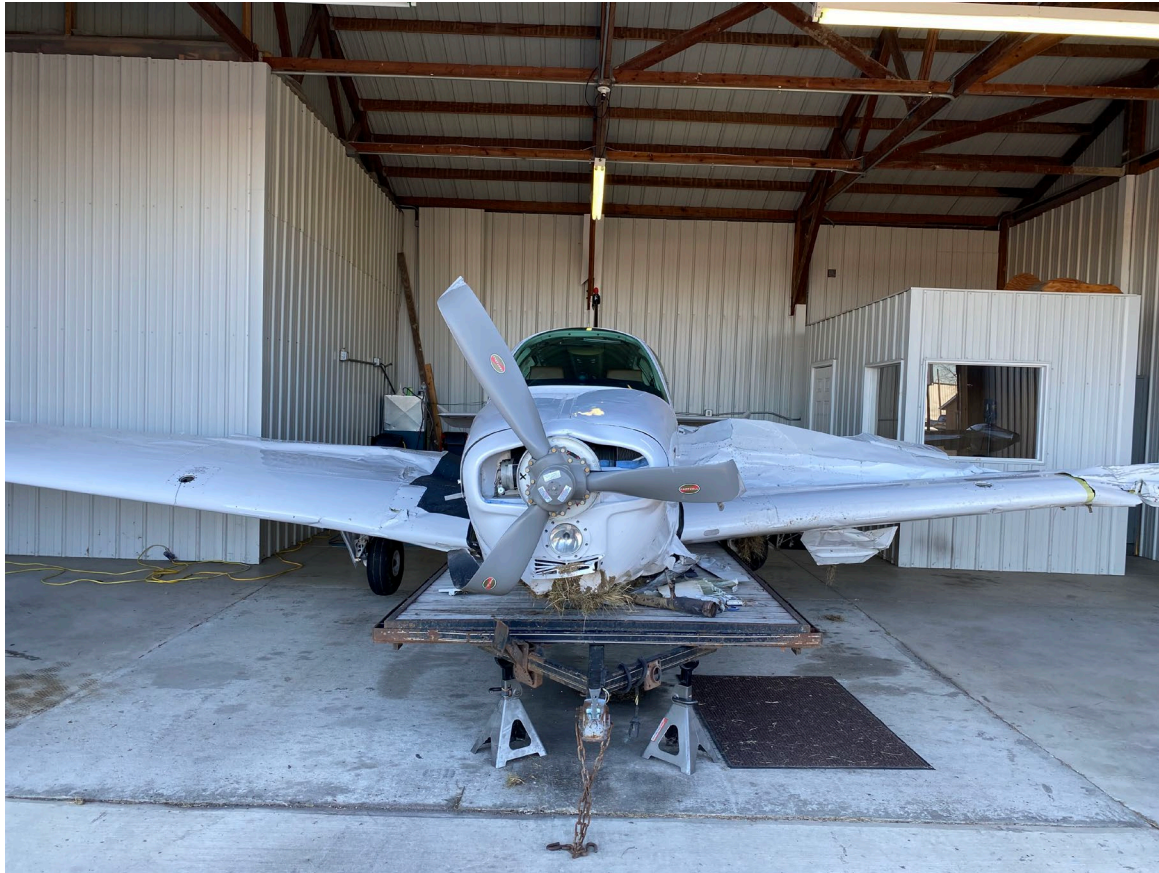
Photograph 1 - Aircraft Overview (Courtesy of FAA)

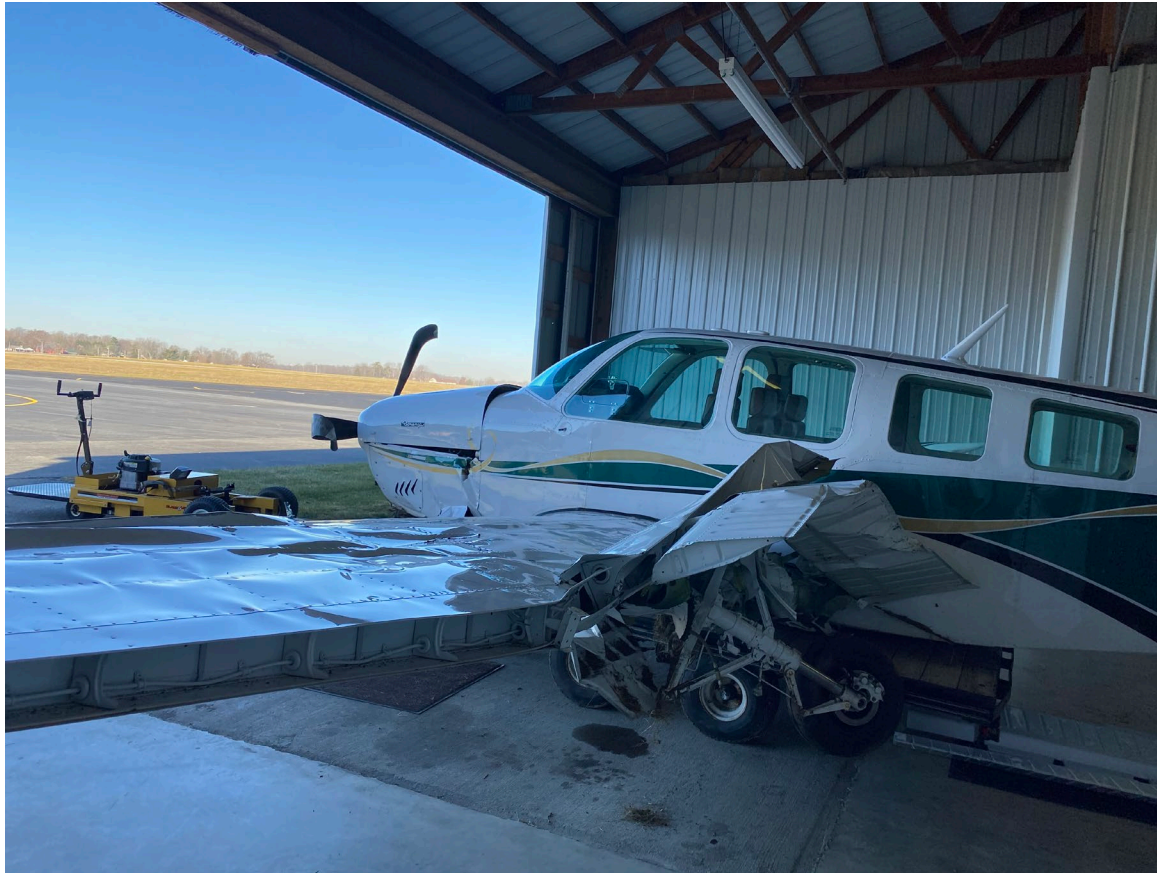
Photograph 2 - Damage to left wing (Courtesy of FAA)

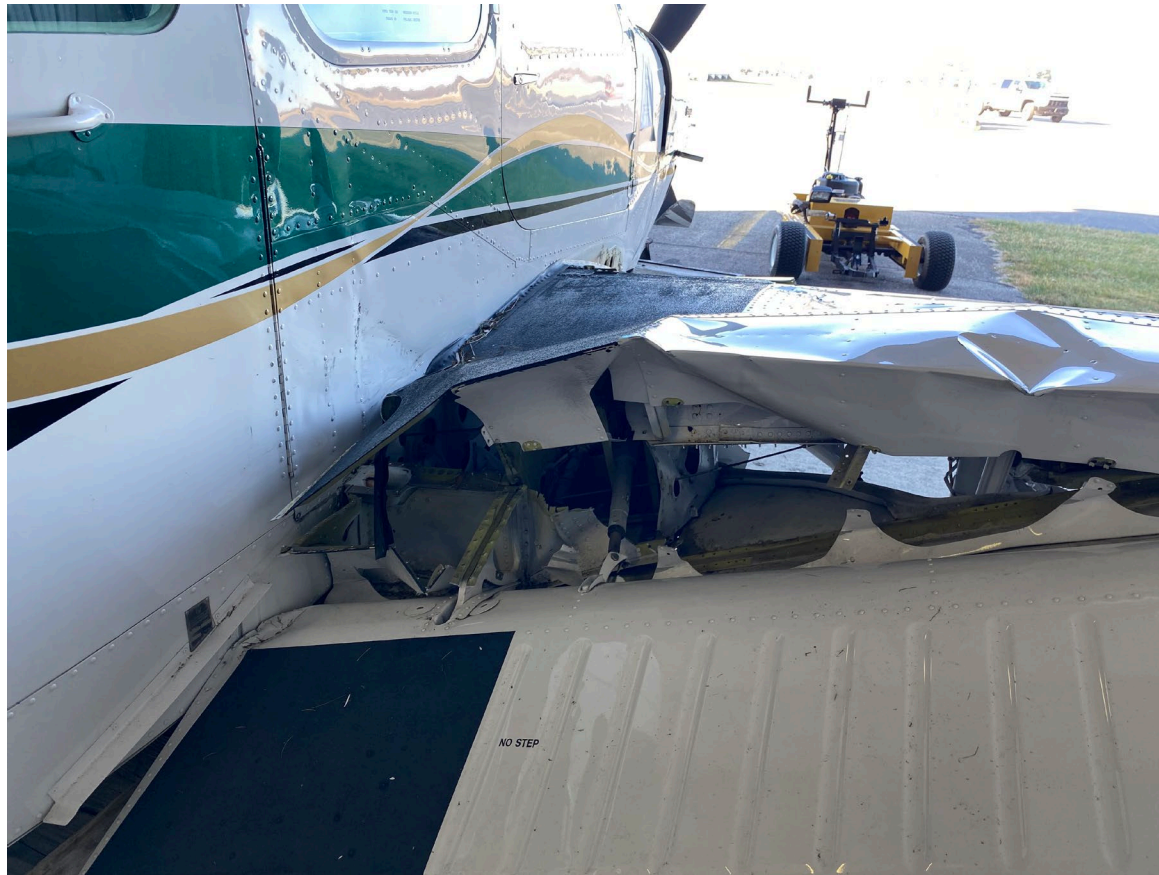
Photograph 3 - Damage to right wing (Courtesy of FAA)

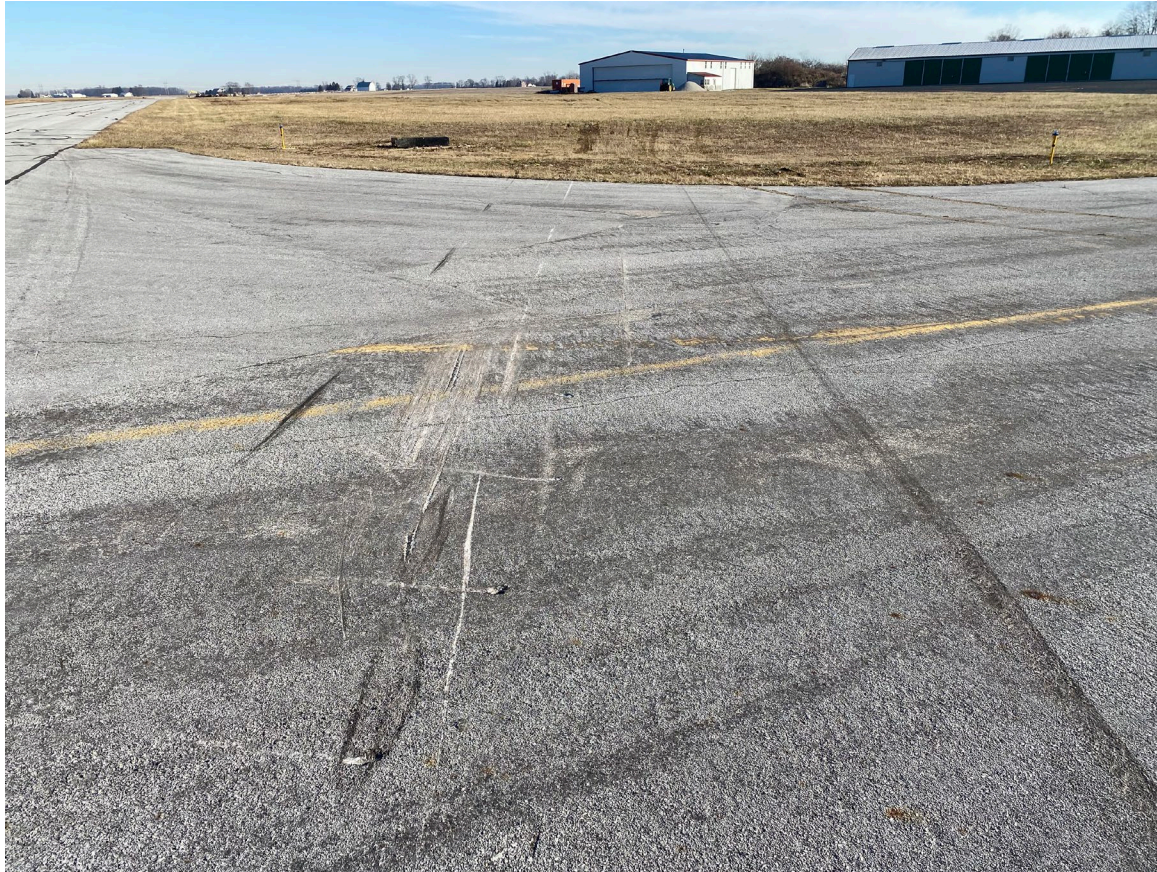
Photograph 4 - Runway/Taxiway skid marks and propeller strikes (Courtesy of FAA)
