ERA24LA138

INVESTIGATION PHOTOGRAPHS

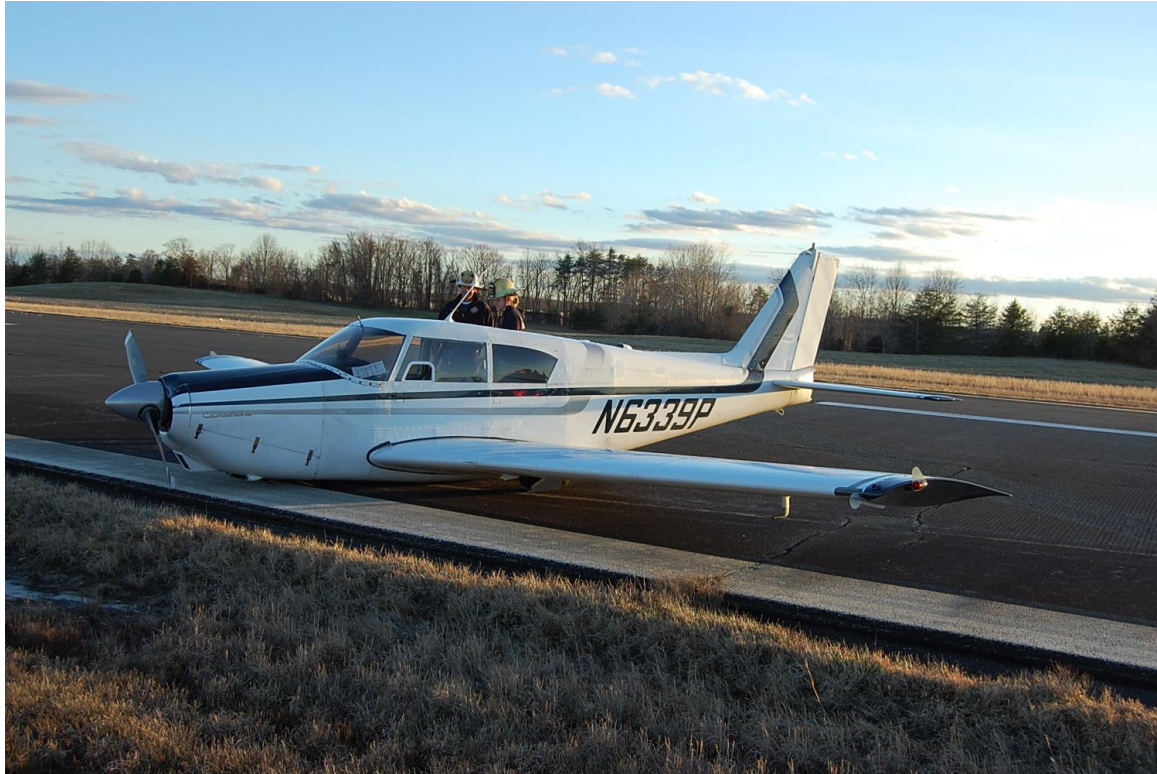
Photograph 1 - Photograph of airplane on runway (Courtesy of FAA)

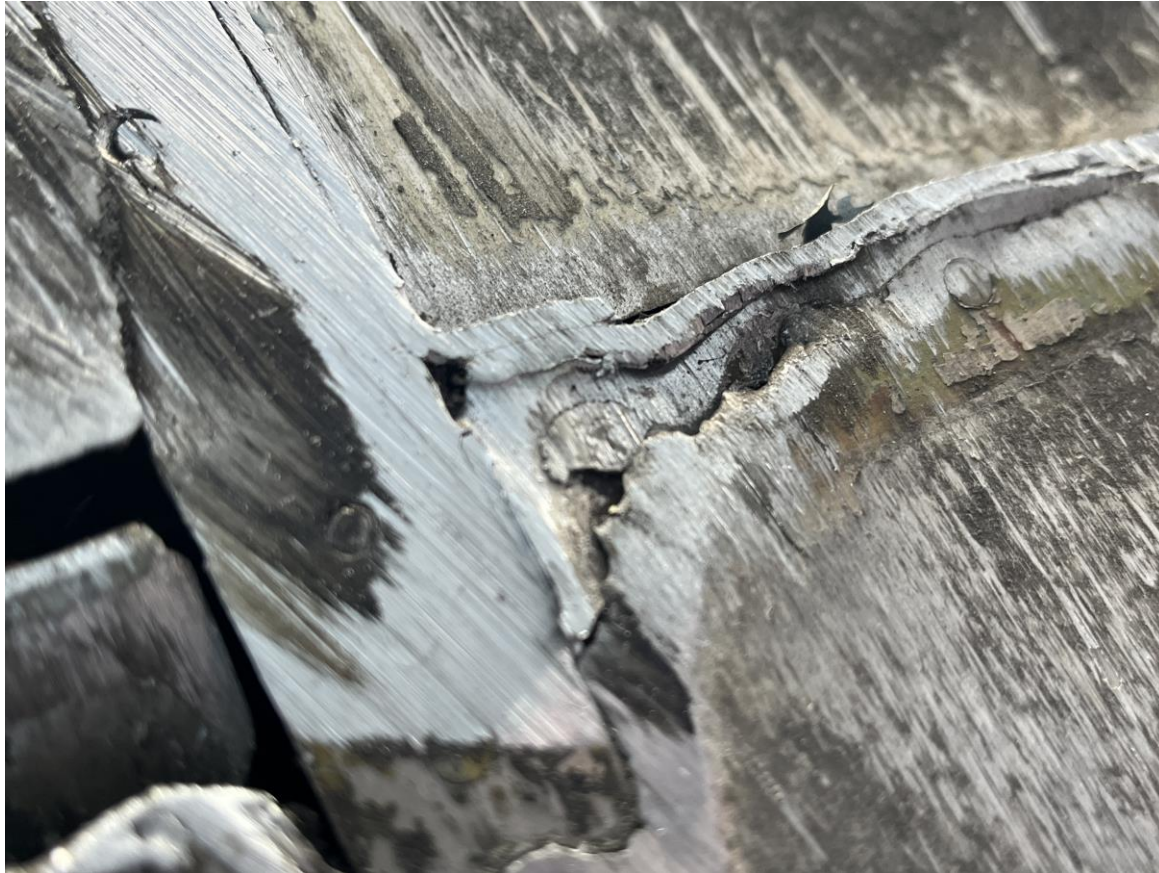
Photograph 2 - Damage to airplane structure (Courtesy of FAA)

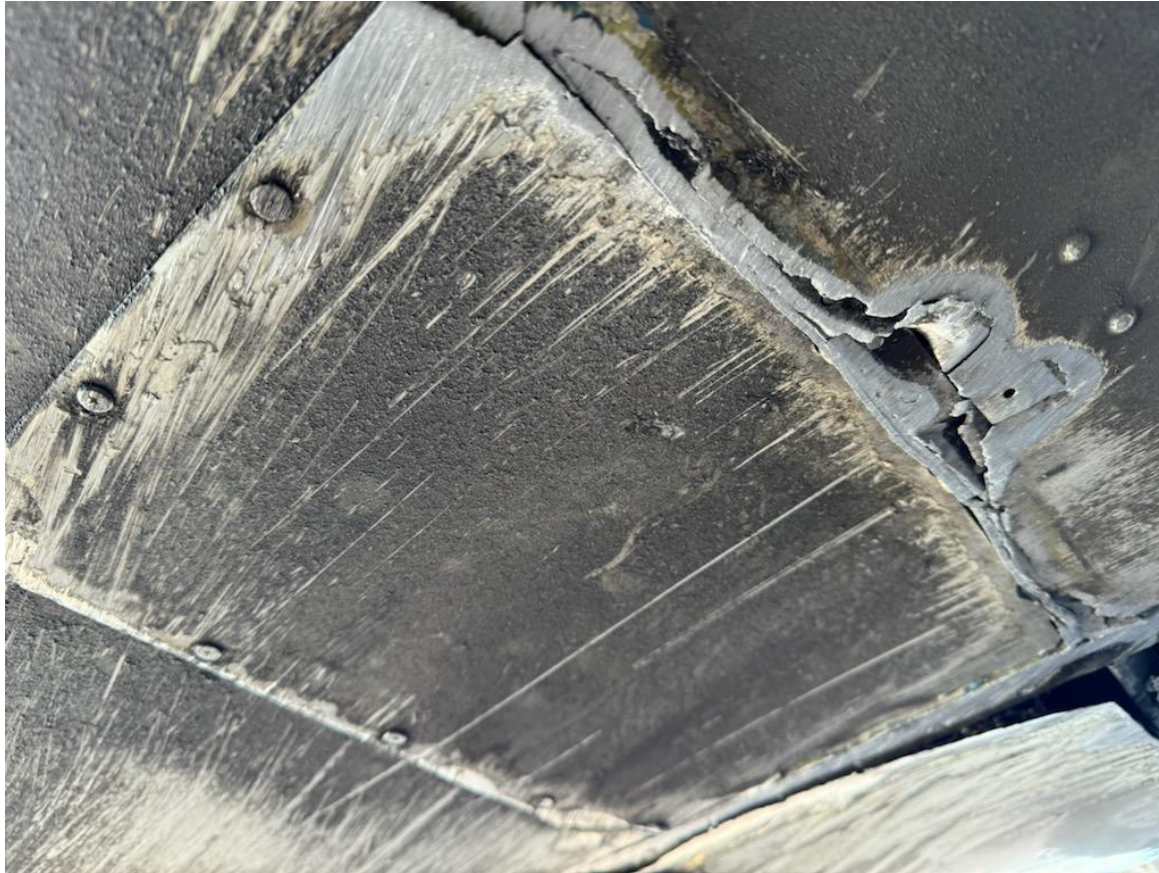
Photograph 3 - Damage to airplane structure (Courtesy of FAA)

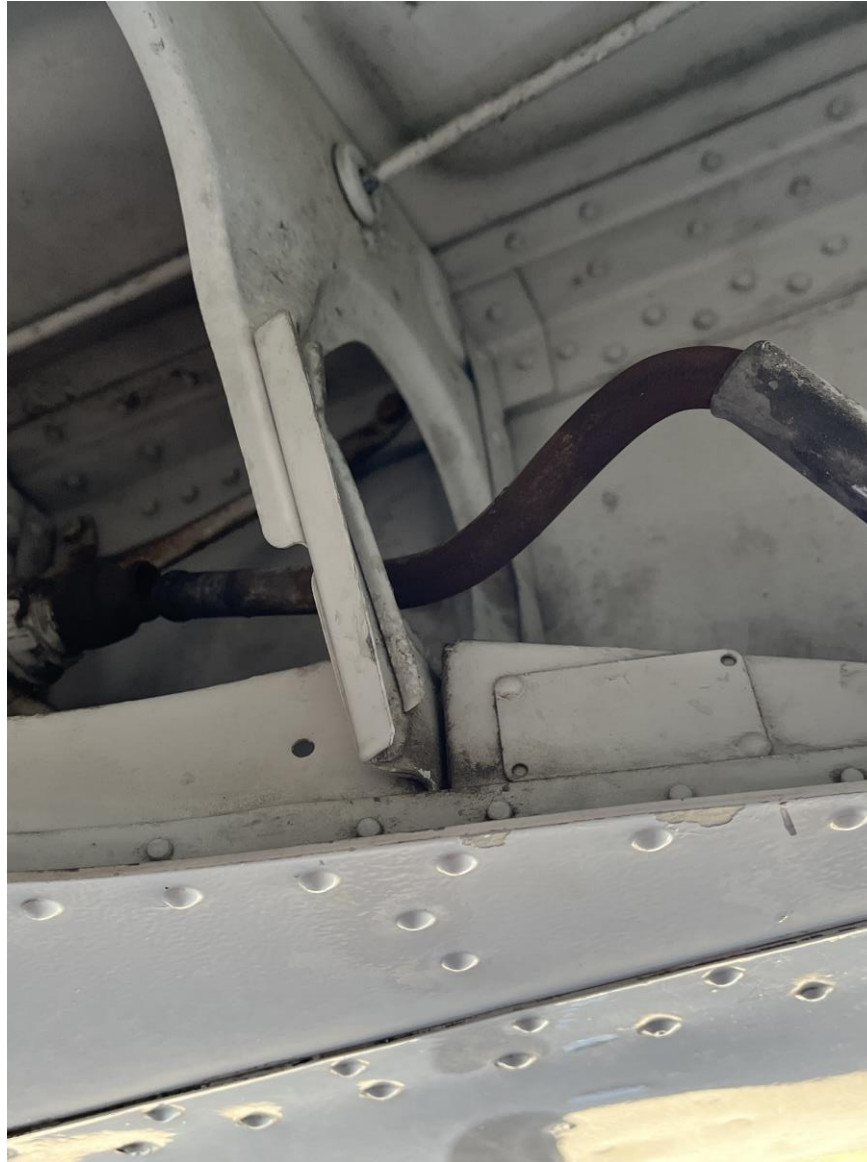
Photograph 4 - Bent right main landing gear push rod (Courtesy of A&P mechanic)

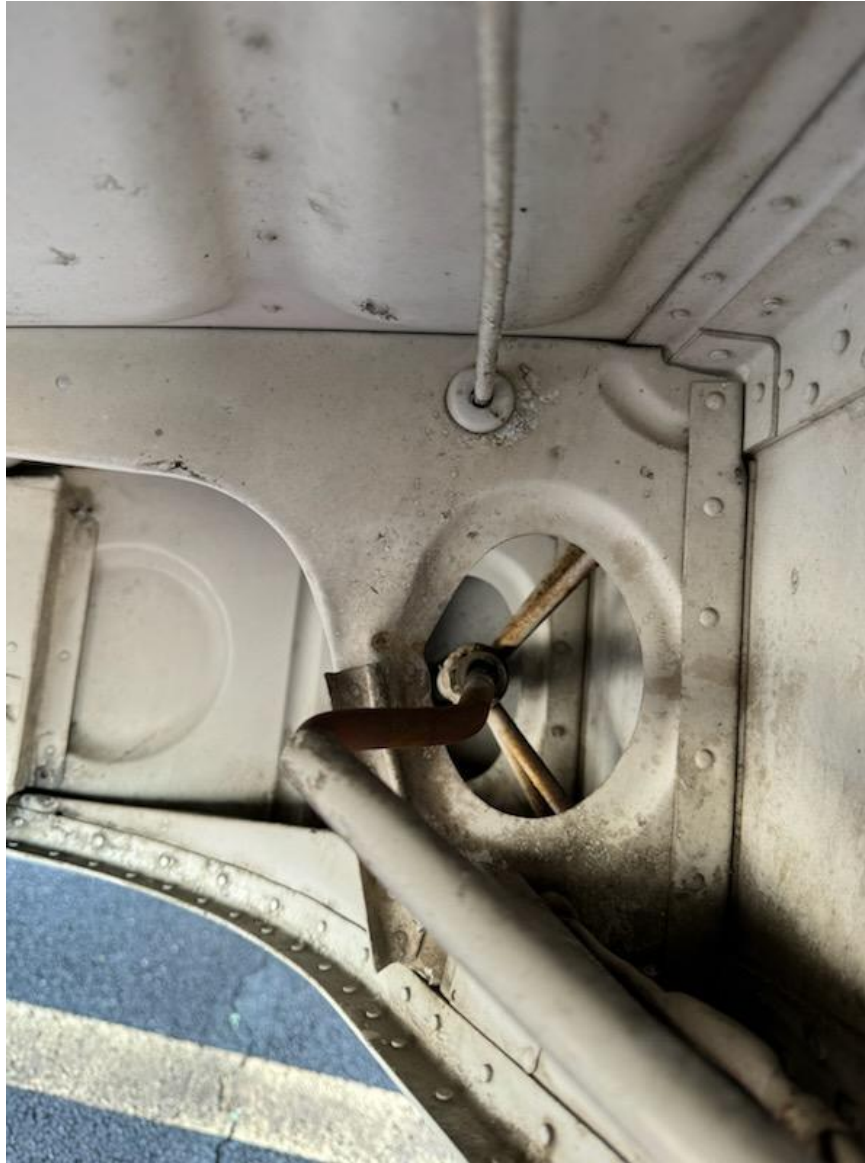
Photograph 5 - Bent right main landing gear push rod (Courtesy of A&P Mechanic)

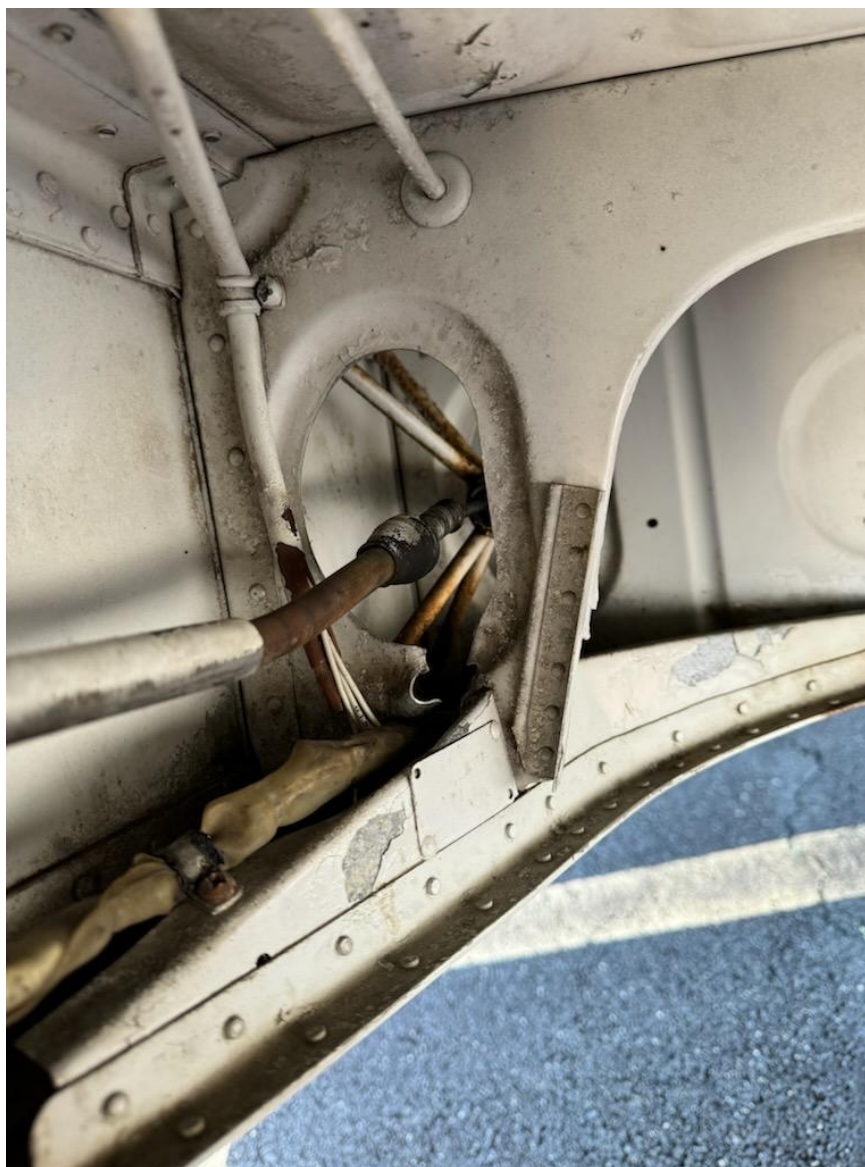
Photograph 6 - Bent left main landing gear push rod (Courtesy of A&P Mechanic)
