**NATIONAL TRANSPORTATION SAFETY BOARD
OFFICE OF HIGHWAY SAFETY
WASHINGTON, D.C.**

**SURVIVAL FACTORS GROUP CHAIRMAN'S
FACTUAL REPORT**

GREENVILLE, ALABAMA – HWY21MH009

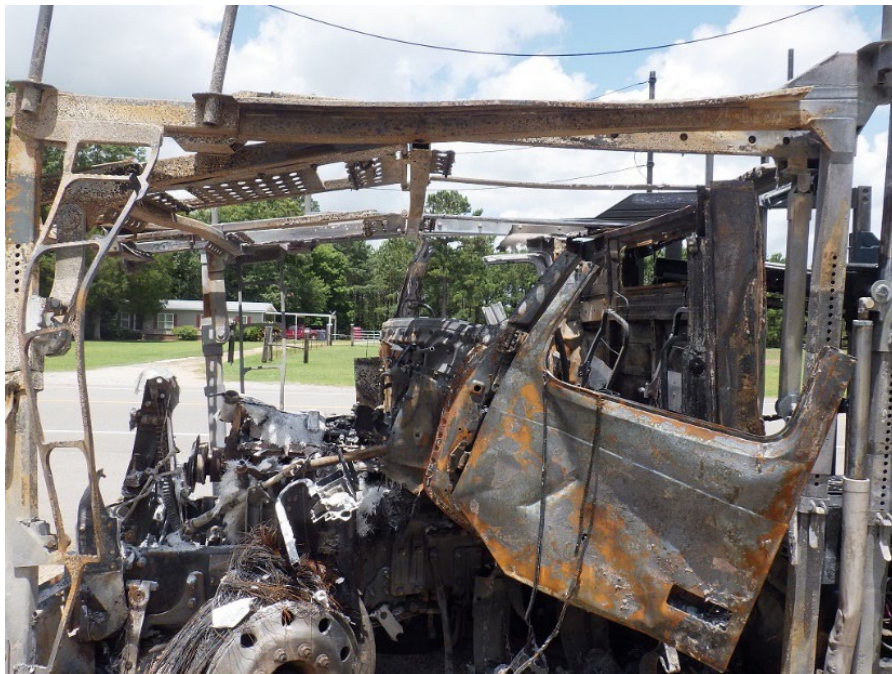
The upper firewall and lower windshield frame were deformed in the aft direction, progressing from no deformation on the passenger side, to about 8 inches of aft deformation on the outboard driver side edge. The driver side A-pillar and driver door frame were cut at approximately the mid-window level, apparently during the wreckage recovery. The driver door and aft portion of the driver side cab exhibited deformation across the surfaces, as shown in Figure 1.

Figure 1. Driver side view of the Volvo truck-tractor showing fire damage, deformation of the firewall, driver door, and aft portion of the cab.

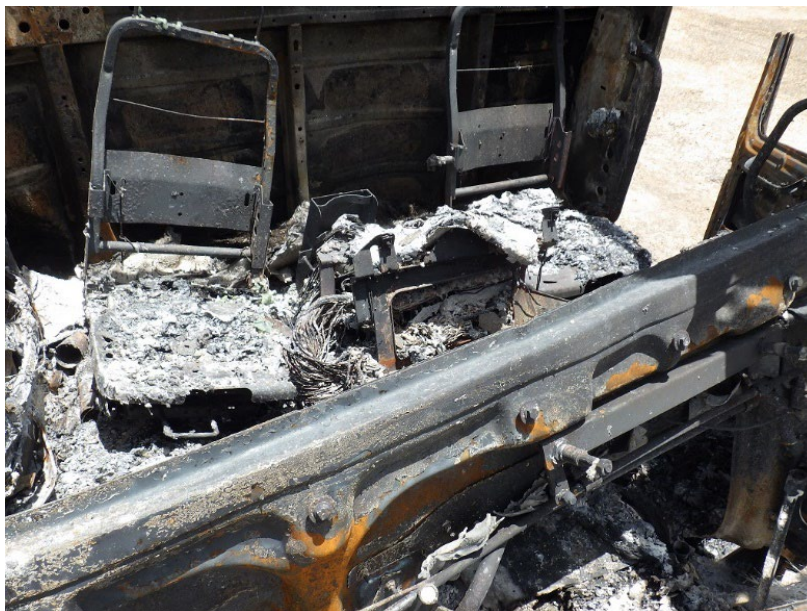
seat was deformed inward and upward, causing the passenger seat to be rotated inboard at an angle of approximately 12 degrees, as shown in Figure 2.

Figure 2. View from the firewall looking aft of the Volvo truck-tractor showing fire damage, the driver and passenger seat frames, and deformation of the passenger seat.

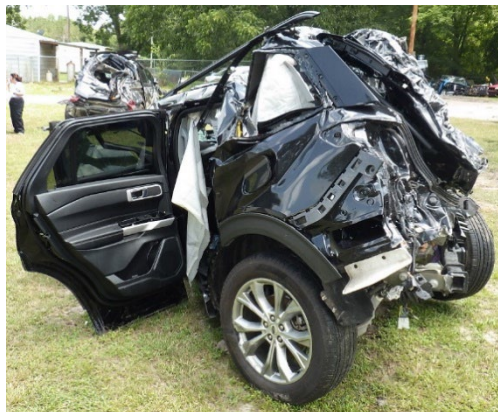
Figure 3. Left-rear view of the Explorer

The 2020 Ford Explorer had VIN: 1FMSK8DH6LGCXXXXX. The vehicle was destroyed, having sustained several severe impacts that crushed or deformed all exterior surfaces. The most severe impact was at the right rear and right side of the vehicle. The rear end was crushed inward, compromising the rear seat survivable space on the right side, as shown in Figure 3. Upon inspection, the right-side doors were missing, and the entire right side of the vehicle had intrusion and was exposed, as shown in Figure 4. The fuel tank of the Explorer was intact, and the vehicle exhibited no fire damage.

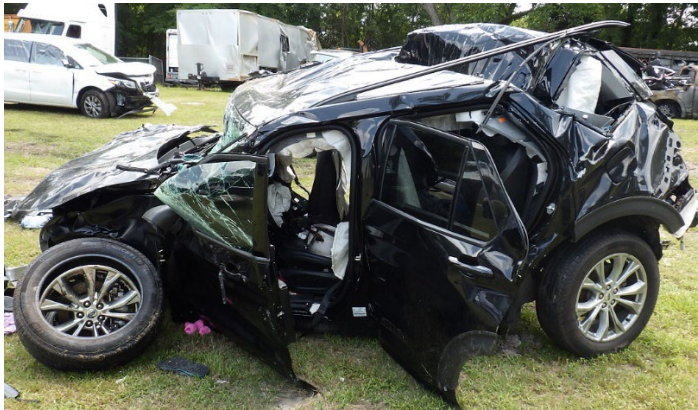
Figure 5. Left-side view of the Explorer

The roof of the Explorer was buckled at the location of the C-Pillar from the rear impact. The roof was also crushed downward about 10 inches at the front and displaced several inches to the left, as shown in Figure 5. The front of the vehicle was not crushed aft, but the lower portion and front surface of the vehicle was displaced, and the hood exhibited deformation and deep scratches, as shown in Figure 6. The left front and right rear tires were displaced from the wheels. Only the left-rear passenger door glass was intact.

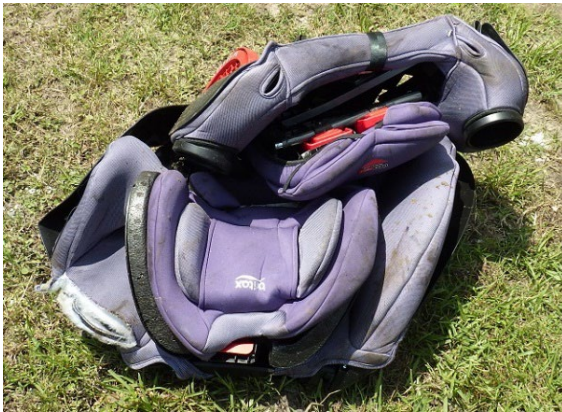
Figure 7. Front view Britax infant seat

There was a Britax Safecell rear-facing infant seat installed in the right-rear passenger seat during the crash. Responders removed the child and seat after the crash. The infant seat was severely deformed. The upper right portion of the seat (as oriented from a child seated in the seat) was twisted and crushed downward and forward, with the upper right corner nearly in contact with the bottom seat cushion, as shown in Figure 7. The bottom left corner of the seat was deformed upward, and the left side was crushed inward, as shown in Figure 8.

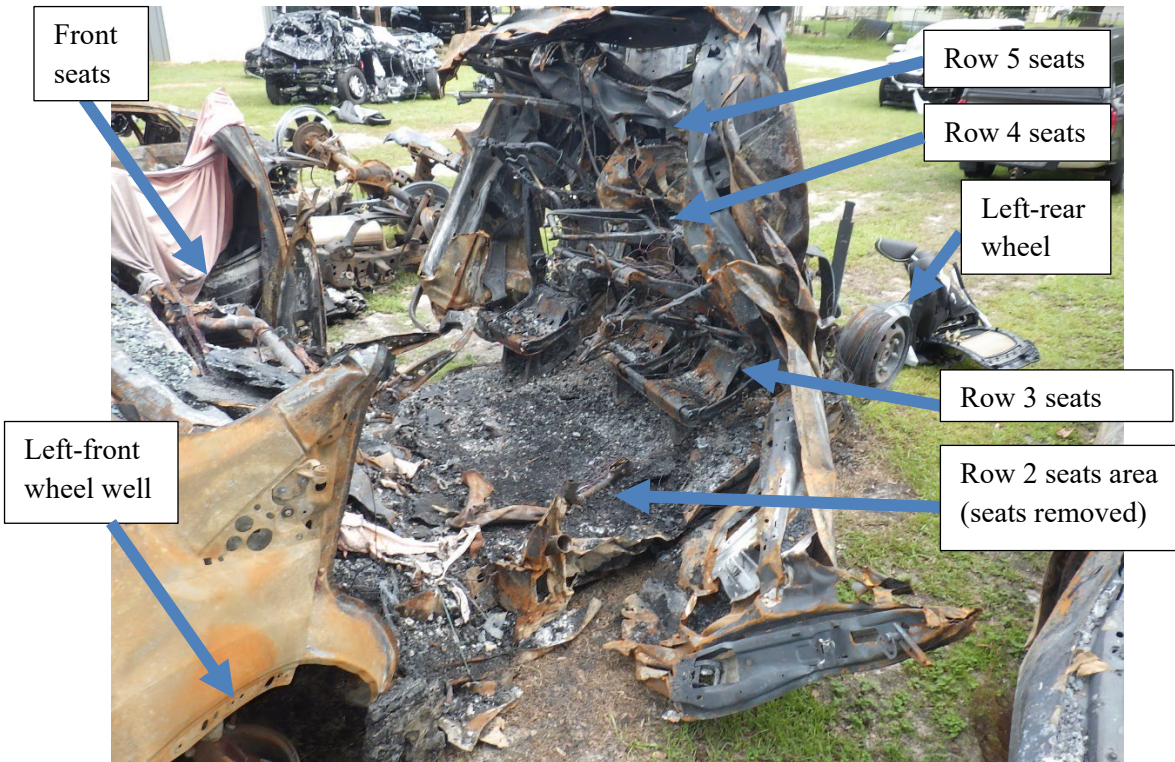
Figure 9. Right-Front view of the Transit Van

The van sustained a severe impact to the rear of the vehicle. The roof structure was cut away from the van and pulled forward, resting in to the right and in front of the van at the time of inspection, as shown in Figure 9. The rear half of the vehicle sustained a broad, severe impact which caused intrusion that extended through the rear half of the occupant compartment. The middle-rear of the van had somewhat more intrusion than the outboard portions. The entire floor structure buckled, with a severe bend in the floor at a location approximately in the middle of the van. The aft half of the van body was displaced upwards to varying degrees, from about 30 to 90 degrees upward from horizontal. The region from just forward of the rear wheels to the back was the most severely displaced.

The middle of the van structure was destroyed. The roof and upper sidewall panels were cut away and displaced. The structure above the sliding cargo door on the right side was resting on the ground at the right-front of the vehicle as previously described. The structure above the passenger windows on the left side had an aft portion bent downward, still attached to the aft structure. The forward portion was displaced and remained with the front roof structure. The cargo door displaced and found in a debris pile. The floor structure below the cargo door and outboard of the passenger seats was cut and bent upwards and aft, at an angle of approximately 80 degrees. The lower sidewall structure on the right side remained roughly in place but was severely deformed. The middle and forward floor structure remained relatively flat and sustained severe fire damage with portions burned completely through.

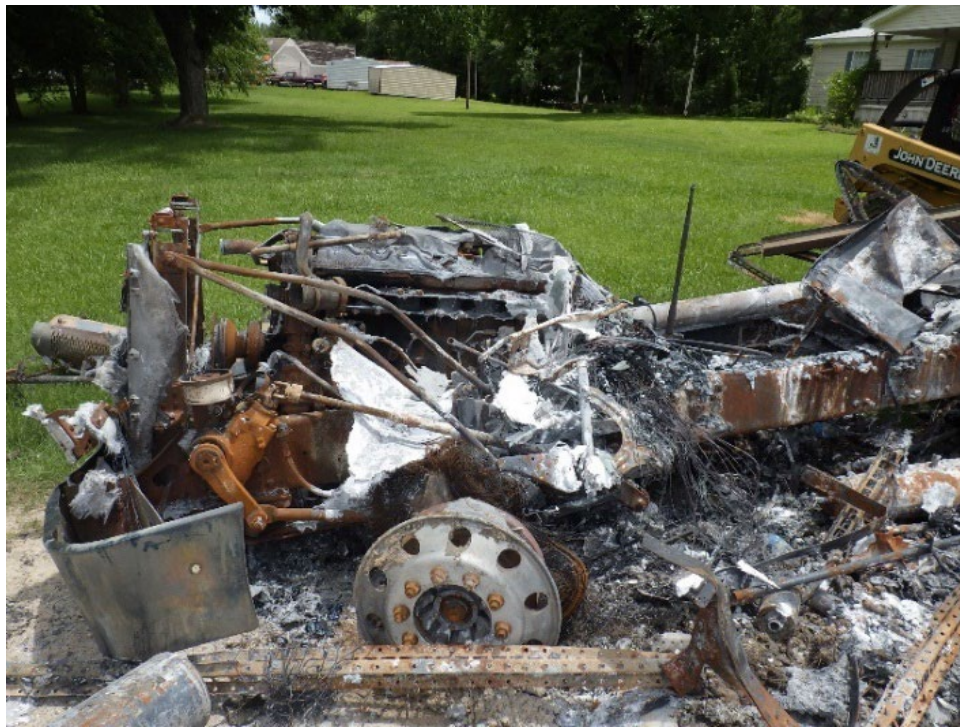
Figure 10. Left-side view of Freightliner truck-tractor

The 2015 Freightliner Cascadia had a VIN of 1FUJGLD61FLGLN96875. The trailer had a VIN of 1JJV532W99LXXXXXX. The vehicle had severe fire damage and the cabin portion was destroyed, as shown in Figure 10. The driver seat frame was found in a debris pile and had no deformation. The seat belt buckle was attached and did not have a latchplate mated to it. The steering wheel frame was found in the middle of the burned chassis and had no deformation. The Freightliner had dual, aluminum fuel tanks located outside the frame rails and just aft of the doors on each side. The fuel tanks were missing and presumed consumed in the fire.

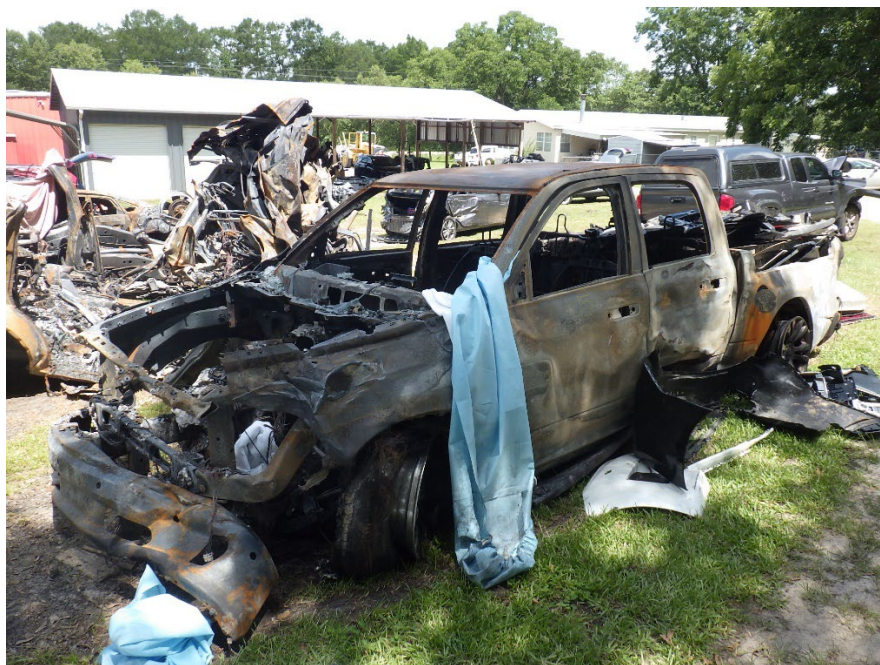
Figure 11. Left-front view of the Ram 1500

The 2016 Ram 1500 pickup had a VIN of 1C6RR7PT9GSXXXXXX. The pickup was severely fire damaged, as shown in Figure 11. Parts of other vehicles had been placed in the bed of the truck, including the driver seats from the Pacifica and the Acura (see below).

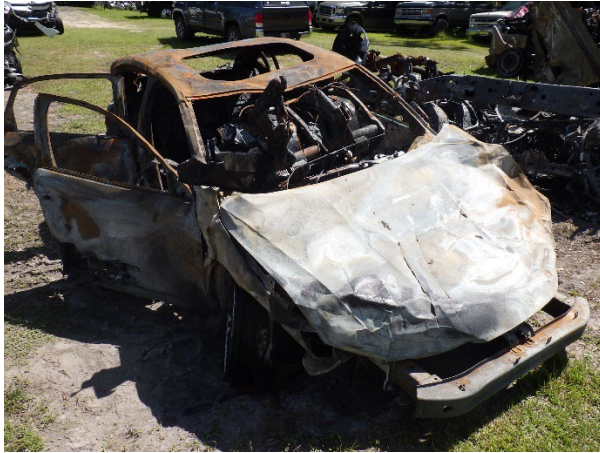
Figure 12. Right-front view of the VW

The 2017 VW Passat had VIN: 1VWBT7A36HCXXXXXX. It was severely fire damaged as shown in Figure 12. All non-metal materials were burned and one of the Ford Transit Van seats was placed in the interior of the VW (apparently during recovery of the wreckage). The windshield frame and roof exhibited a V-shaped crushing deformation at the middle-top of approximately 2 inches deep. The A and B pillars were not deformed. The driver door was not deformed. The steering wheel was missing. The right-rear corner of the vehicle sustained a severe impact which crushed the trunk area on the right side and buckled the left-rear portion of the car outward, as shown in Figure 13. The crush did not intrude into the back seats.

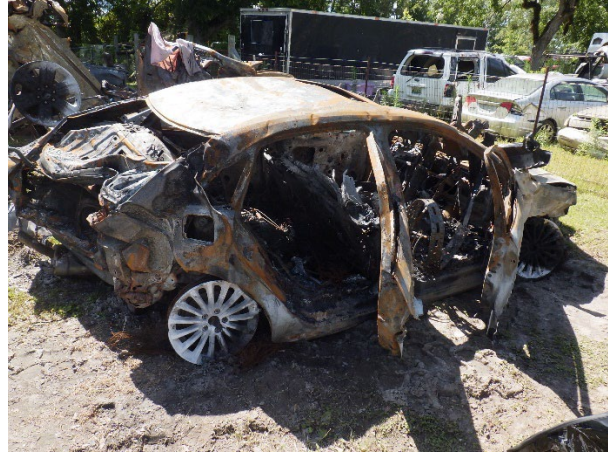
Figure 13. Right-rear view of the VW

There was C pillar damage on passenger side, which was crushed downward about 3 inches and inward 1 inch. The rear left side C pillar was crushed downward 1 inch and outboard 4 inches. The left rear door had impact damage and was buckled 21 inches from the B pillar and crushed inward 3 inches.

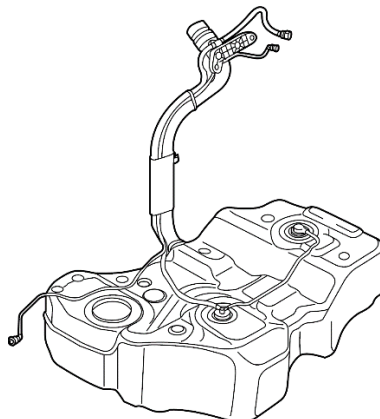
Figure 14. Right-rear view of the VW fuel tank

The VW had a 18.5 gallon plastic fuel tank located along the midline of the vehicle with the filler neck on the right side just aft of the rear axle, and a portions of the tank located above and forward of the rear axle. Figure 14 shows the VW fuel tank and filler neck.

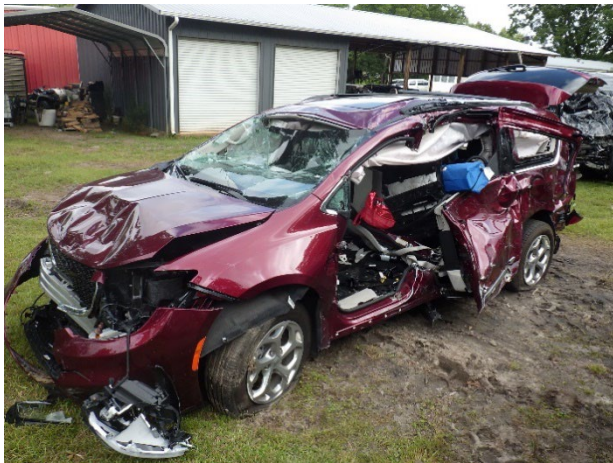
Figure 15. Left-front view of the Chrysler

bolster airbag had a small amount of blood on the right side. The curtain airbag was dirty but had no apparent biological material. The driver side footwell was undamaged. The driver side dashboard did not exhibit deformation. The driver side of the windshield was broken inwards, and it did not have obvious sign of occupant impact. The driver side headliner was clean. The driver door was cut off the vehicle, and the left front portion of the roof was deformed downward about 3 inches, as shown in Figure 15.

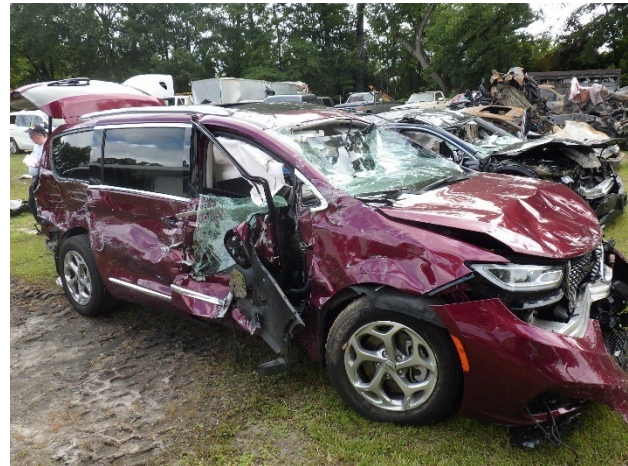
Figure 16. Right-side view of the Chrysler

The front passenger area had the front portion of the roof deformed downward 1.5 inches, as shown in Figure 16. The windshield showed no sign of occupant impact. The passenger side curtain airbag and the front passenger airbag had no apparent biological material. The front passenger door in the vicinity of the rear-view mirror was crushed inward about 13 inches. The seat belt was intact and unbuckled, with the inertia reel non-functional. The passenger side seat side and knee bolster airbags had no apparent biological material. The passenger seat was undeformed. The front passenger interior door handle was deformed inward about 3 inches and was in contact with the base of the seat. The right front side of the dashboard was displaced aft, with a distance to seatback measuring 33 inches on the outboard side and 35 inches on the inboard side of seat. The right front door was not functional.

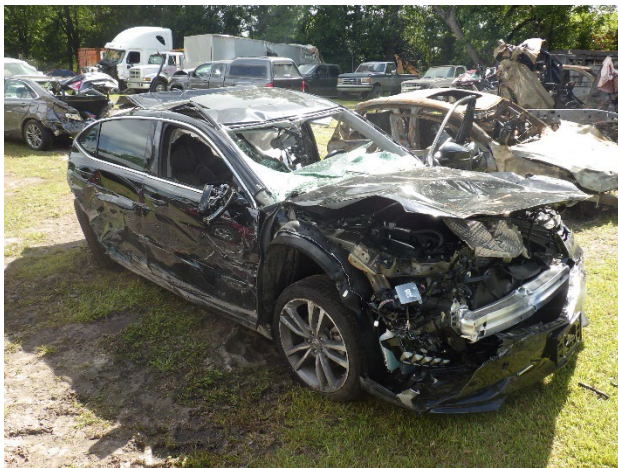
Figure 17. Right-front view of the Acura

The 2020 Acura TLX had VIN 19UU33F87LAXXXXXXX. This vehicle came to rest under the Buick. The car sustained damage on all surfaces and a severe impact to the left-rear corner, as shown in Figures 17 and 18. The roof was crushed downward a few inches, and distance on the right side of the car, from the right front passenger seat pan to the roof measured 32 inches.

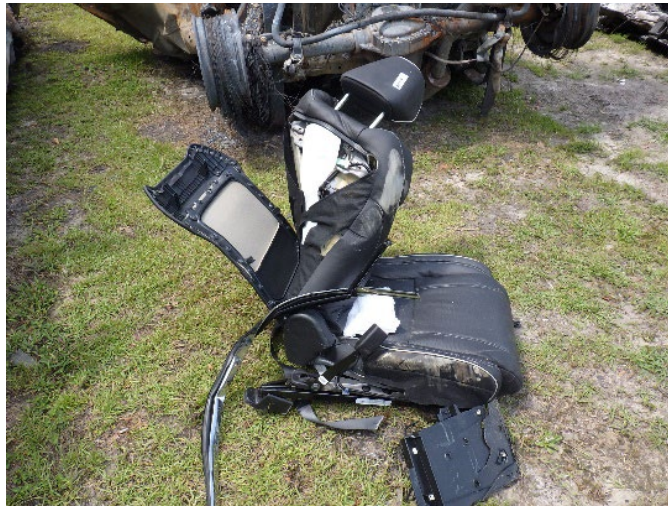
The driver seat was cut out of the vehicle, and the seatbelt was cut. The driver seat was severely deformed with the seat back twisted to the right, as shown in Figure 19.

Figure 19. Right-front view of the Acura driver seat

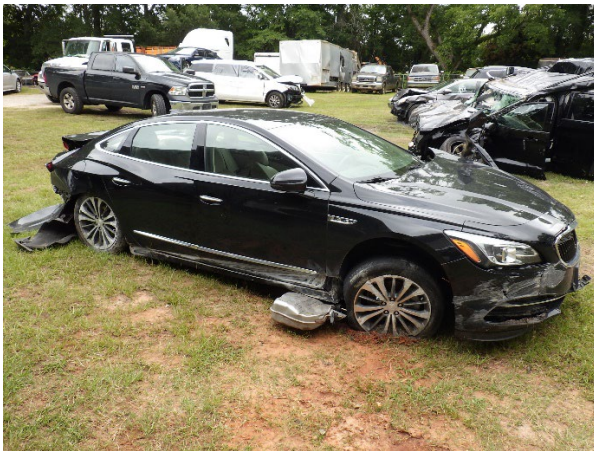
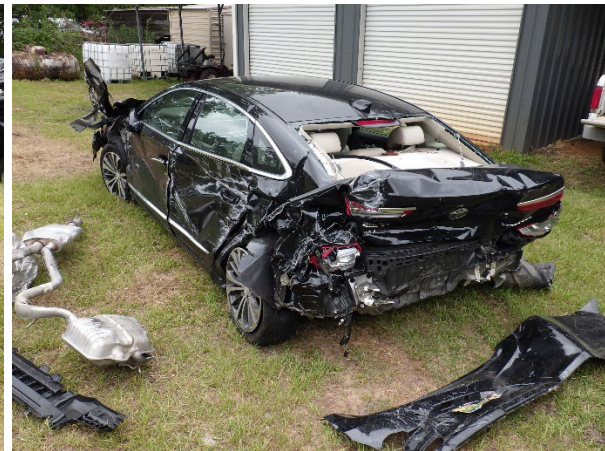
The 2017 Buick Lacrosse had VIN 1G4ZN5SS8HUXXXXXX. The Buick sustained a significant impact to the rear end, impacts along the left side that were focused on the front and rear, and scraping damage at the right front, as shown in Figures 20 and 21.

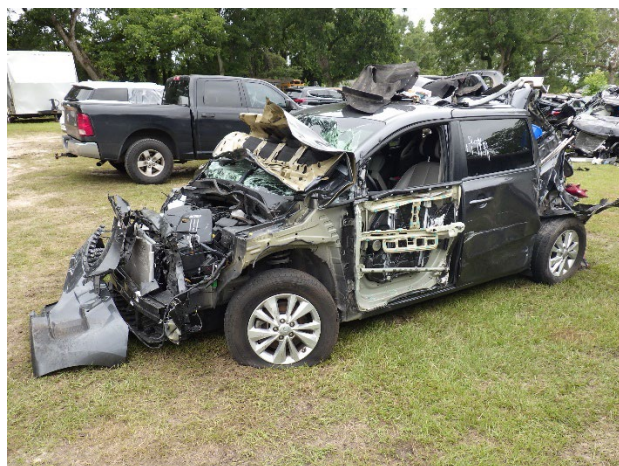
Figure 22. Left-front view of the Kia

The 2017 Kia Sedona had VIN: KNDMB5C13H6XXXXXX. The Kia sustained impact damage on all sides. The front fenders and left front door body work were displaced, and the hood was buckled and resting on the windshield, as shown in Figure 22. The right-rear corner of the Kia sustained a severe impact, as shown in Figure 23. The rear impact resulted in intrusion into the rear cargo area, and partial intrusion into the row 3 seats.

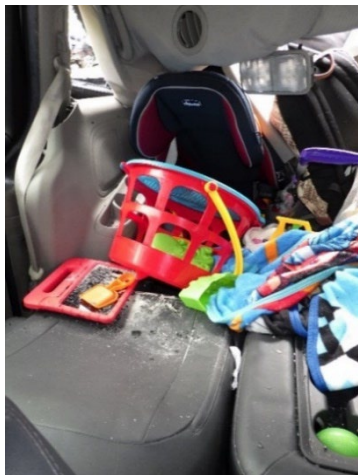
Figure 24. Kia interior looking aft from row 1, passenger side

The right-rear and middle seats of the second row had the seatbacks folded down into a stowed position at the time of the vehicle inspection, as shown in Figure 24. The left rear row 2 passenger seat had a forward-facing child car seat with a 5-point harness, as shown in Figure 25. The child car seat was labeled: Graco 4ever and was displaced inboard approximately 20 degrees with the right inboard edge depressed about 3 inches into seat pan. There was blood on the (folded down) middle headrest. The aft surface of the right-rear, second-row seat was deformed in the center at the lower left inboard quadrant.

The third-row, right-side seat had a forward-facing child booster seat without restraint (for use with the OEM seatbelt) labeled as a Chicco seat, as shown in Figure 24. The booster seat was displaced forward at an angle of approximately 35 degrees from seat pan to seat back. The roof of the vehicle was crushed inward and forward and was in contact with top of the Chicco seat. The vehicle 3-point seat belt was unbuckled. The left side third row seat had intrusion at the roof and side wall. There were several pieces of luggage and toys in the cargo area.

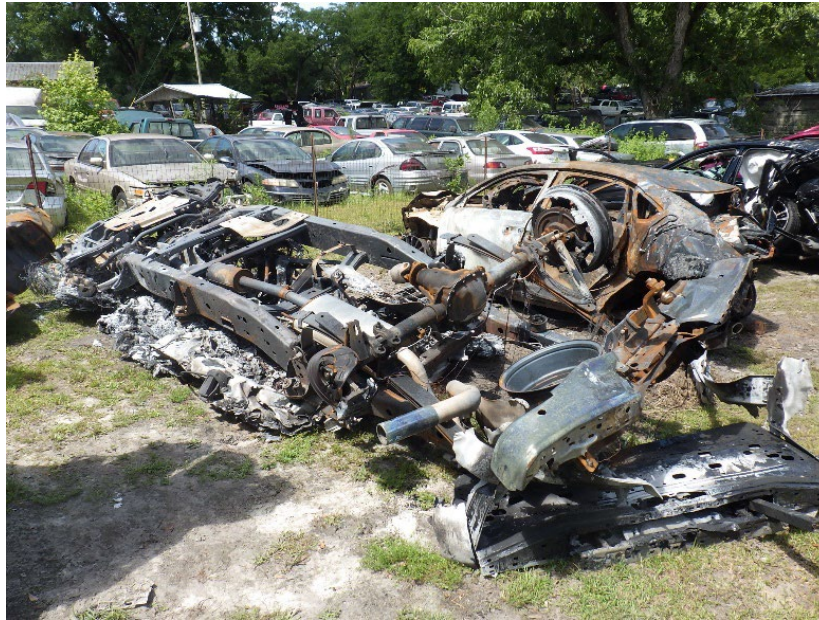
Figure 26. View of the upside-down Ford from the rear

The 2019 Ford F-150 was found at the impound lot inverted and severely fire damaged, as shown in Figure 23. The front seats were displaced to the left. The rear seat frames were also displaced left about 5 inches. The right rear seat was displaced forward about 45 degrees.
