BRIDGE PROTECTION SYSTEMS ATTACHMENT

MDTA 2021 Underwater Inspection Report

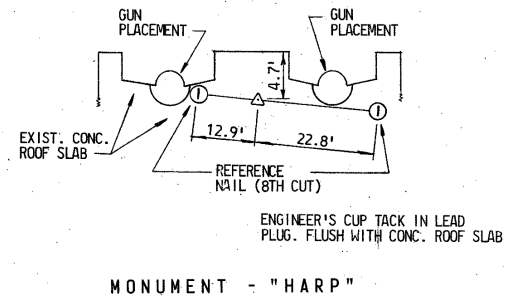
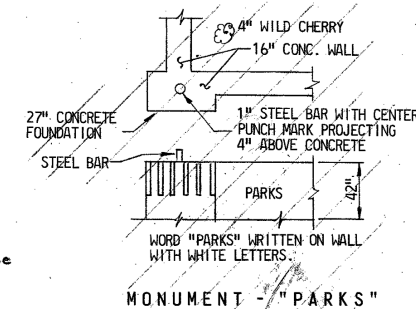
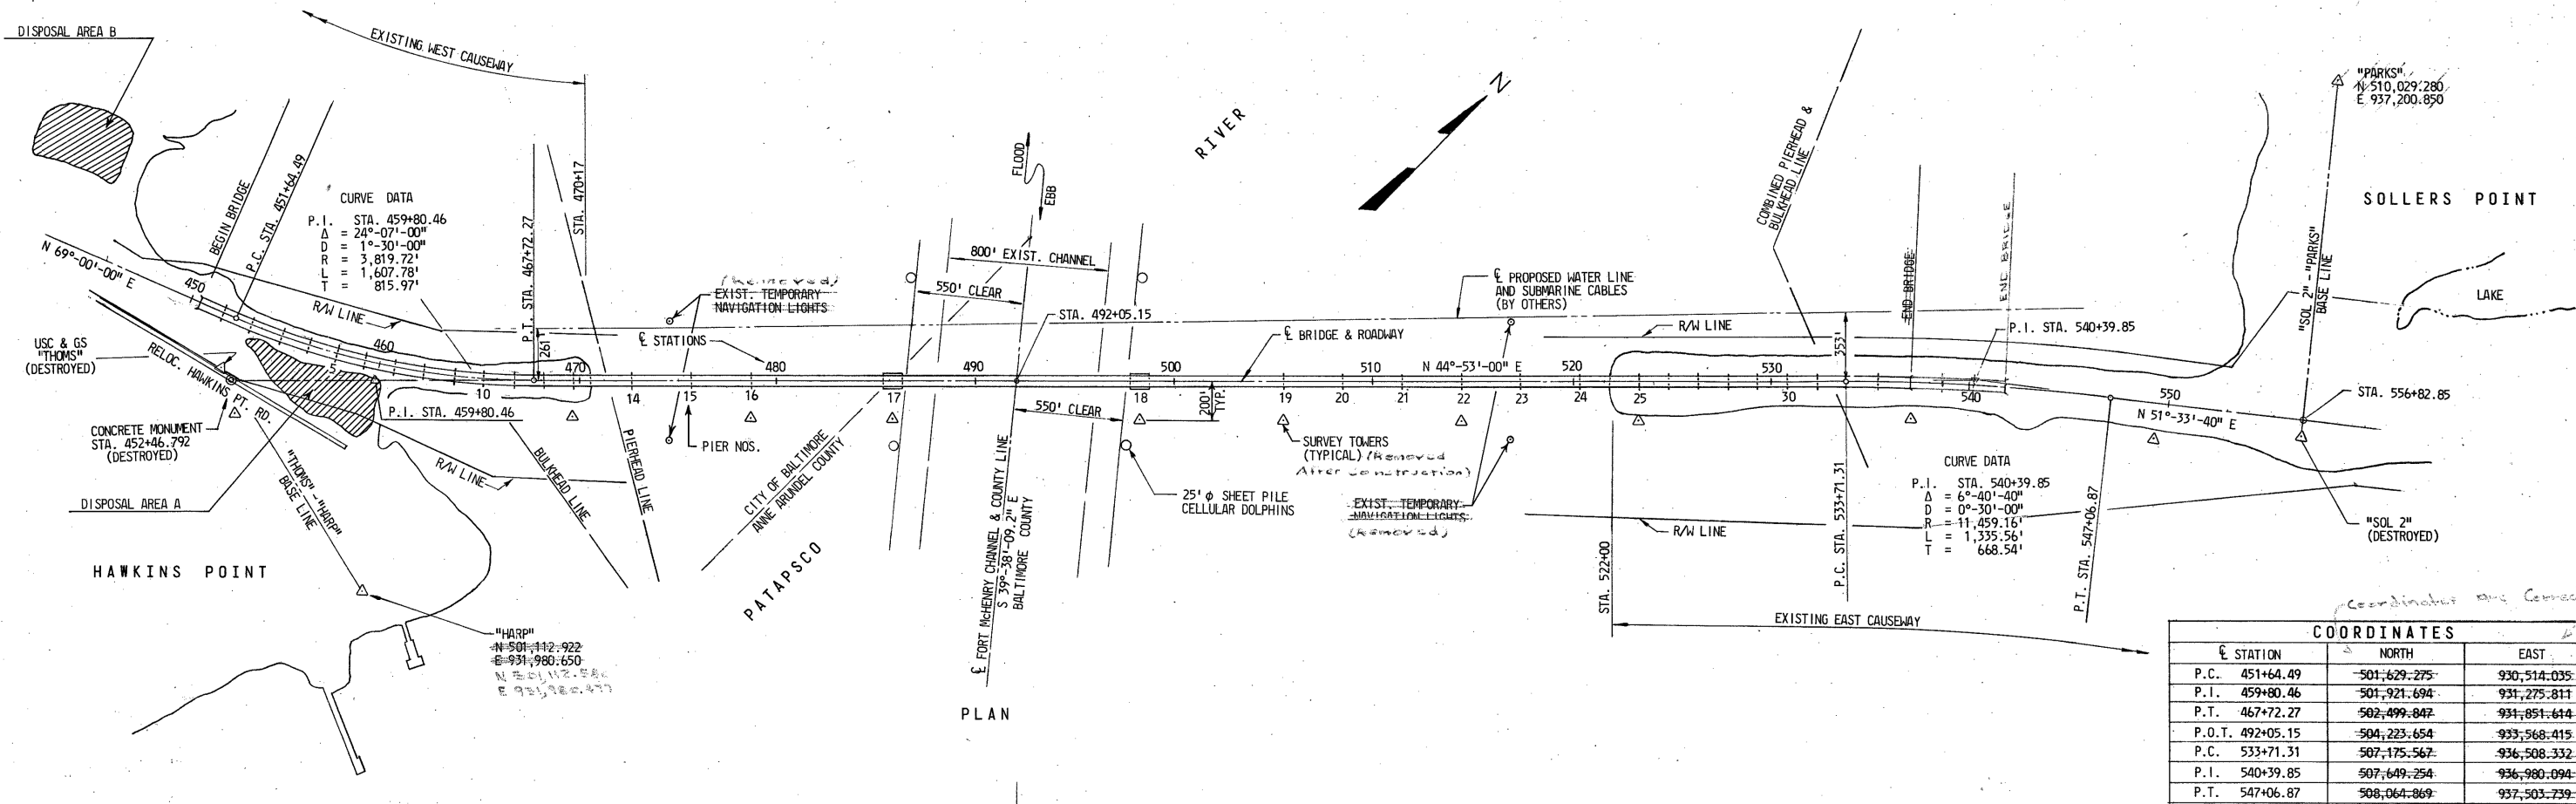
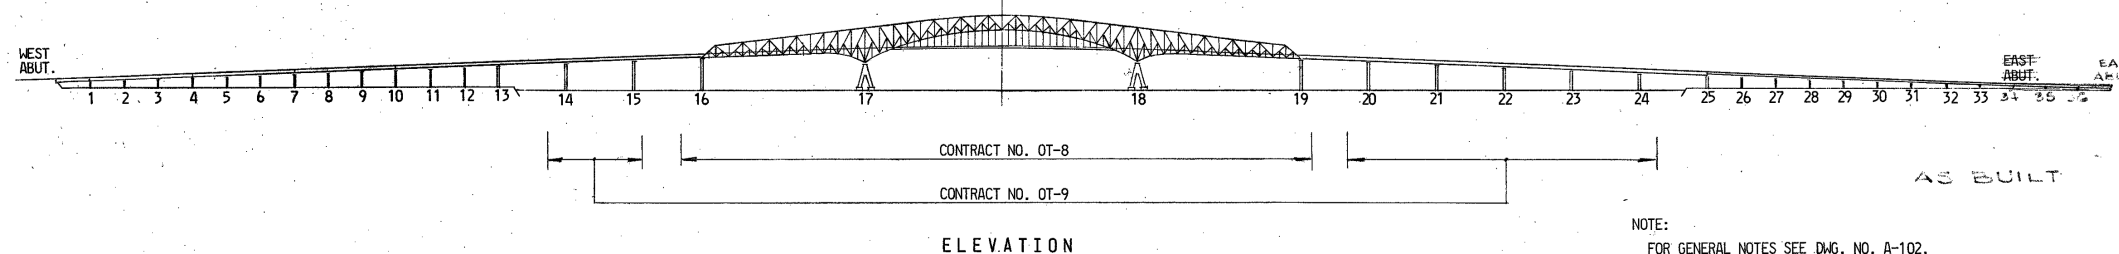
NOTE:
FOR GENERAL NOTES SEE DWG. NO. A-102.
Δ DENOTES SURVEY TOWERS. FINAL LOCATION WILL BE DETERMINED BY THE ENGINEER.

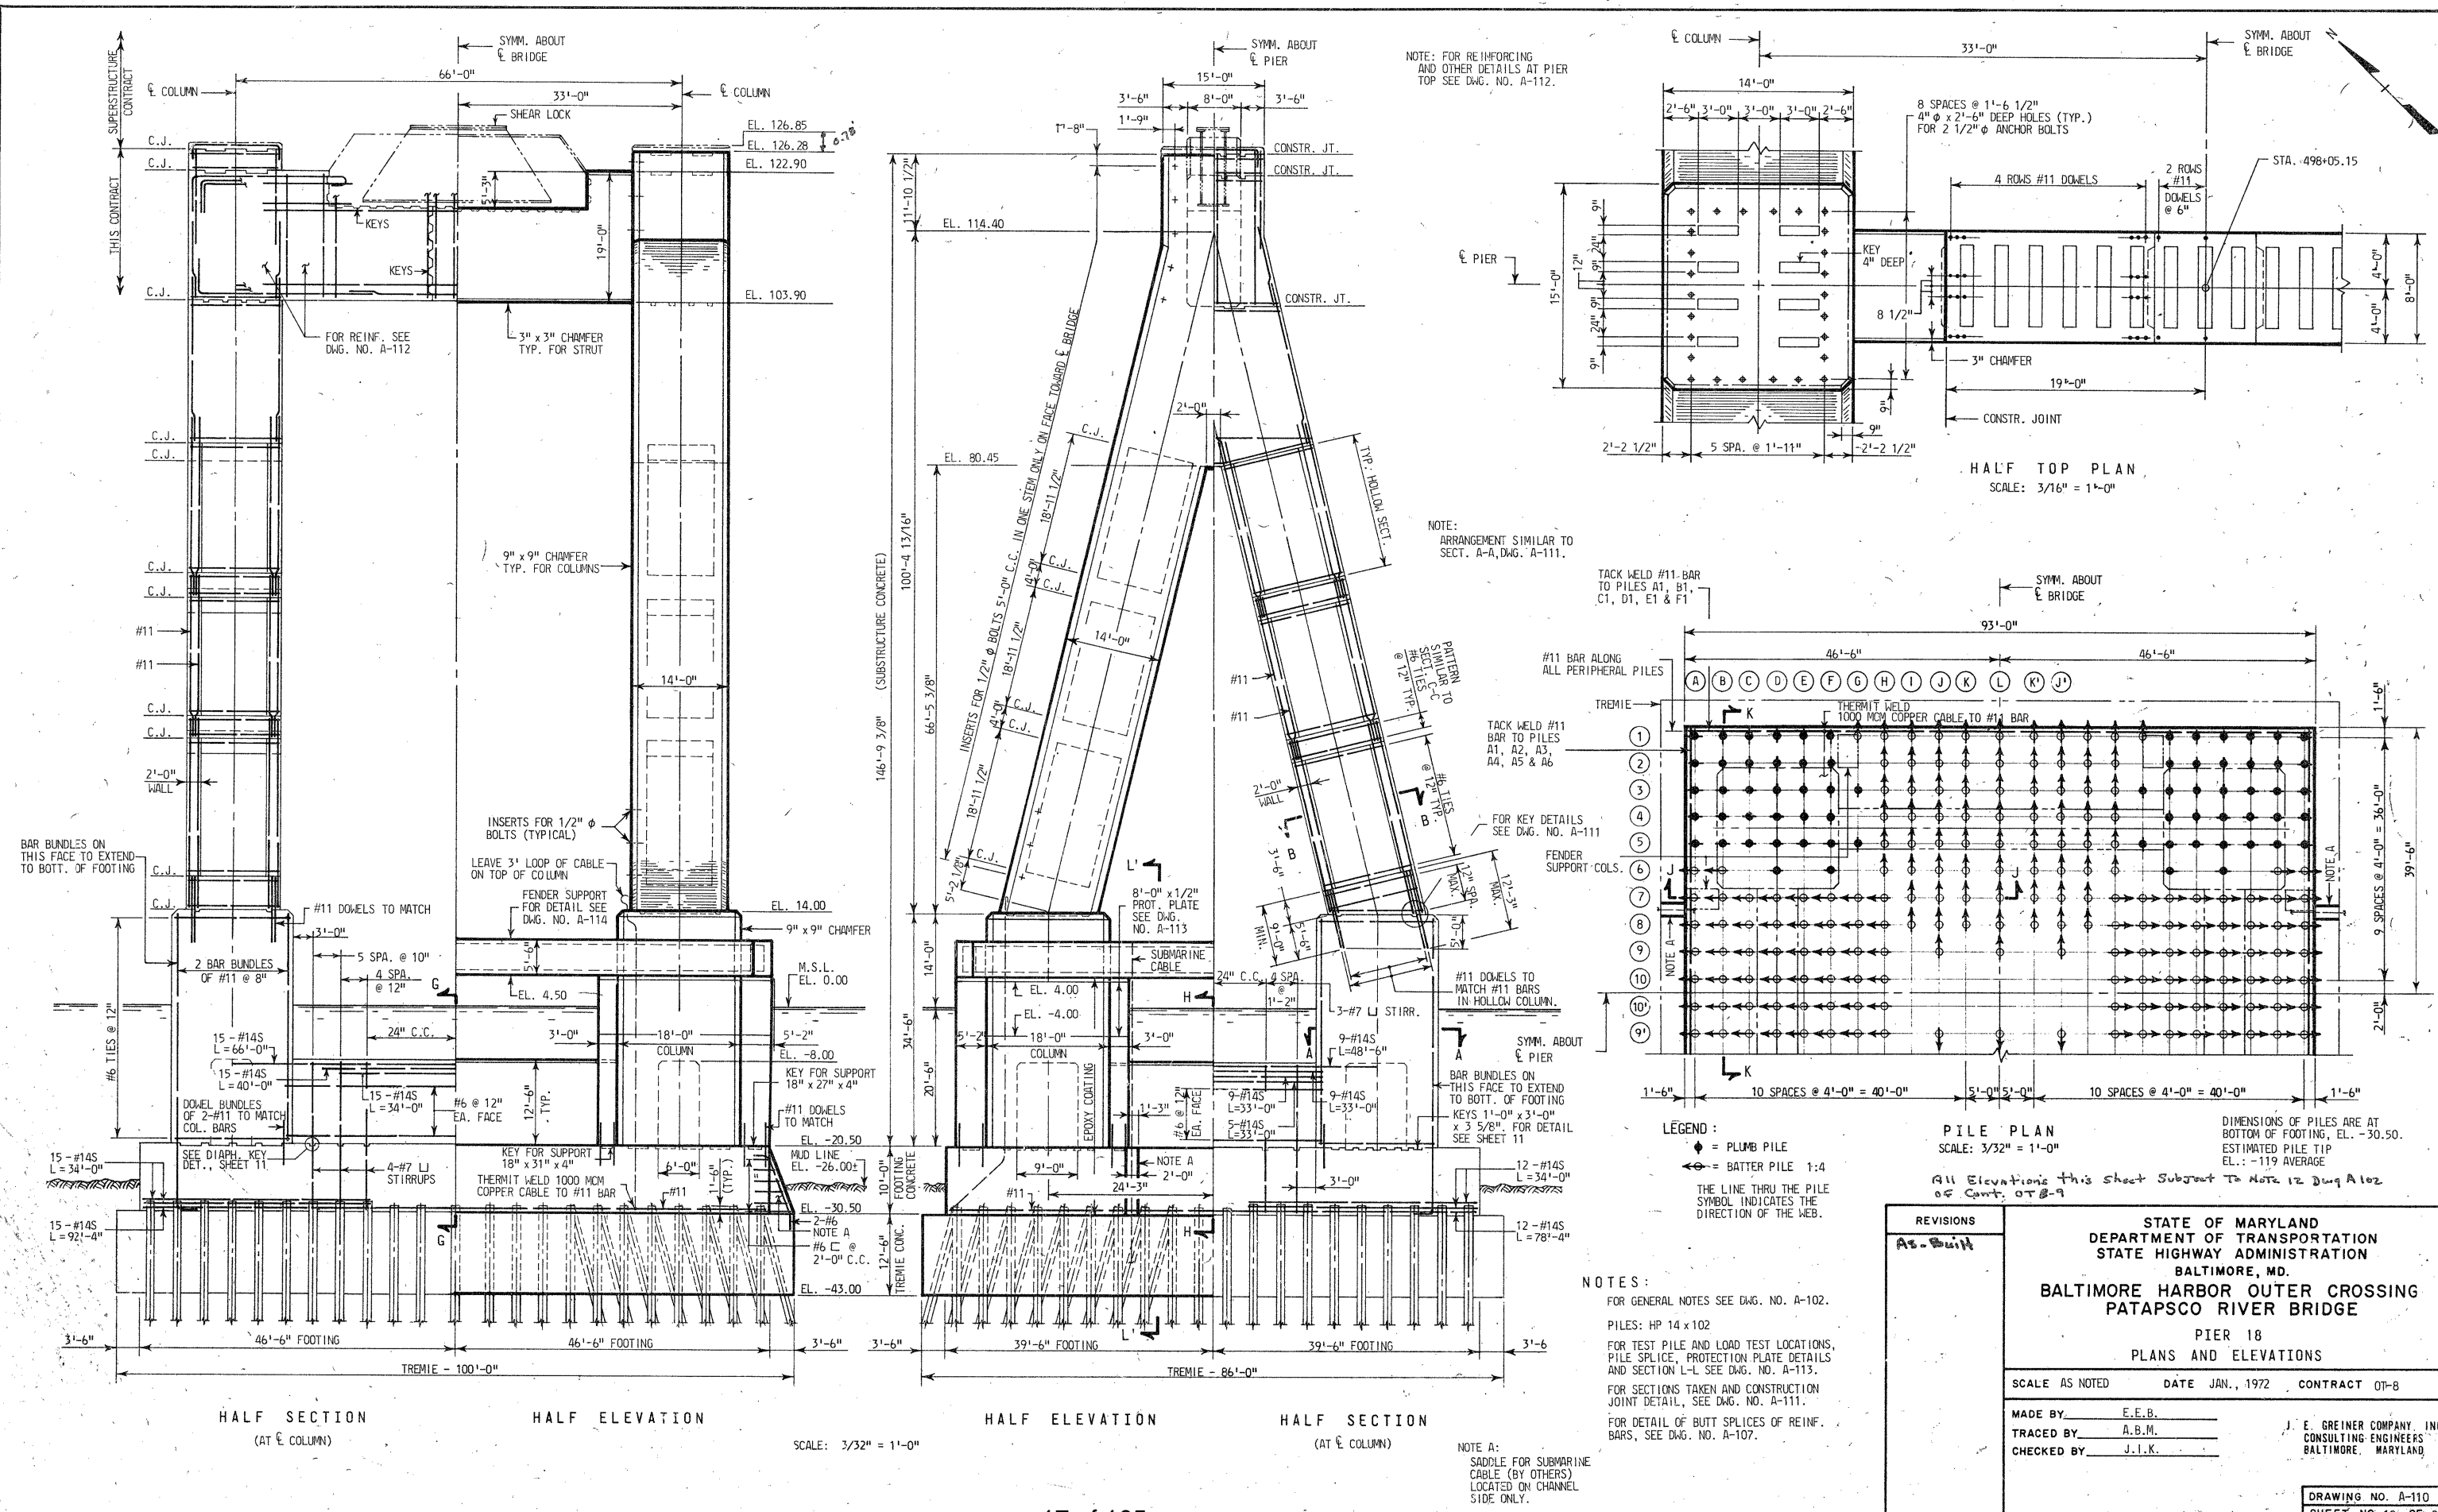
REVISIONS As-Built	STATE OF MARYLAND DEPARTMENT OF TRANSPORTATION STATE HIGHWAY ADMINISTRATION BALTIMORE, MD. BALTIMORE HARBOR OUTER CROSSING PATAPSCO RIVER BRIDGE PIER 18 PLANS AND ELEVATIONS		
	SCALE AS NOTED	DATE JAN., 1972	CONTRACT OT-8
	MADE BY E.E.B. TRACED BY A.B.M. CHECKED BY J.I.K.	J. E. GREINER COMPANY, INC. CONSULTING ENGINEERS BALTIMORE, MARYLAND

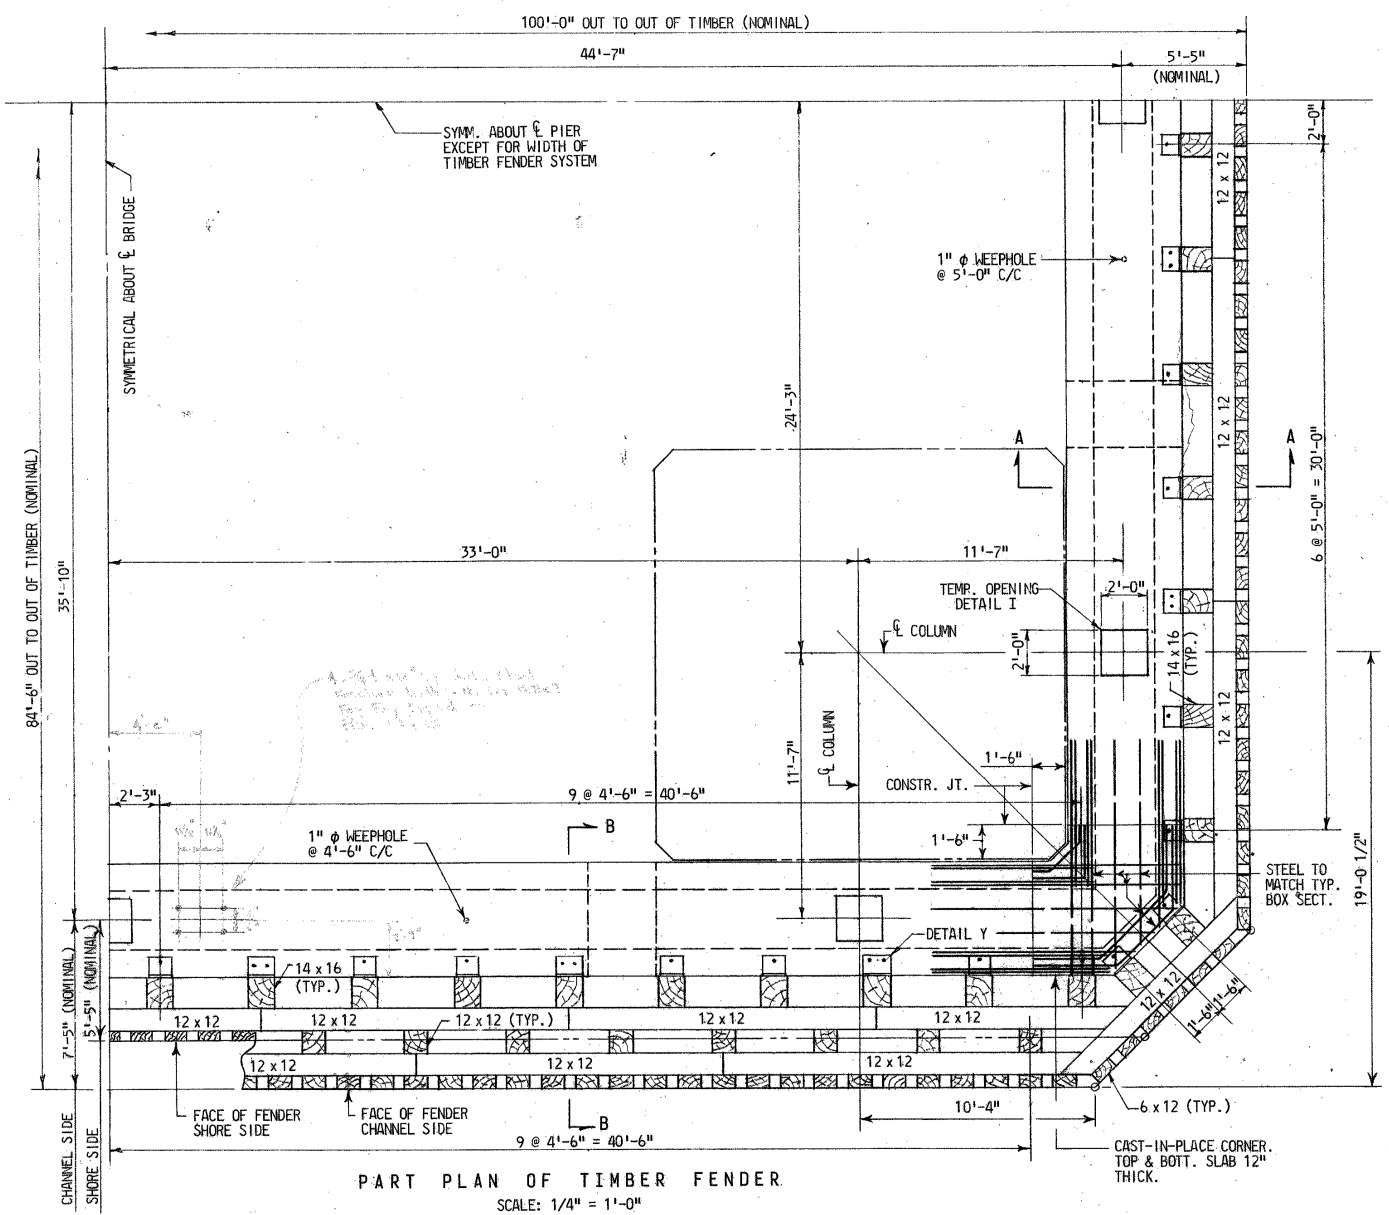
PART PLAN OF TIMBER FENDER
SCALE: 1/4" = 1'-0"

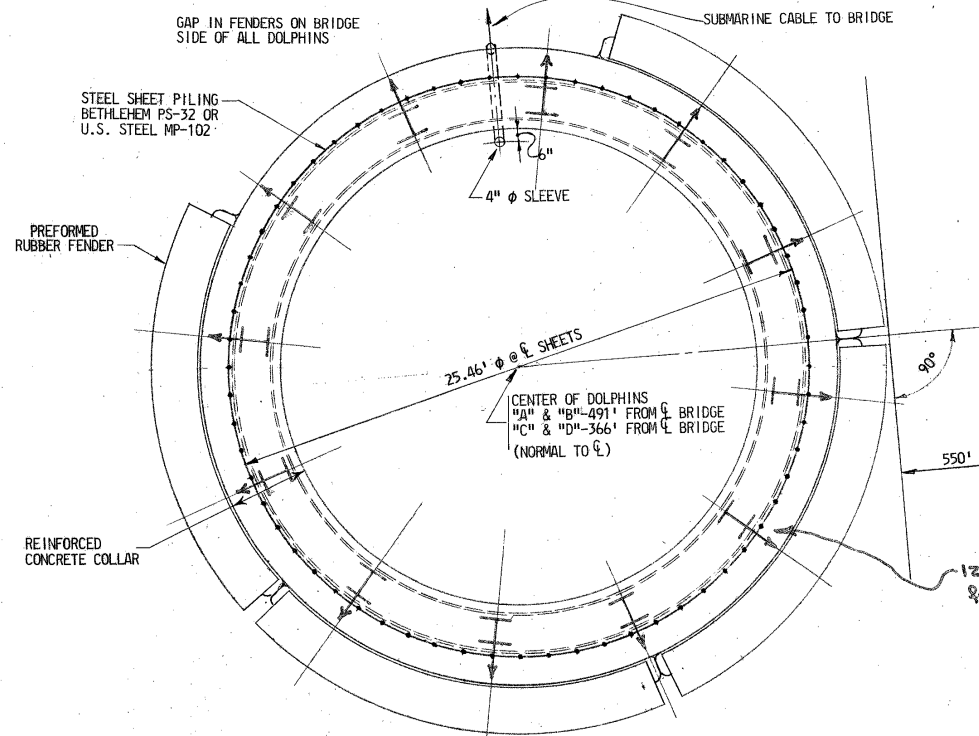
PLAN OF DOLPHIN
SCALE: 1/4" = 1'-0"

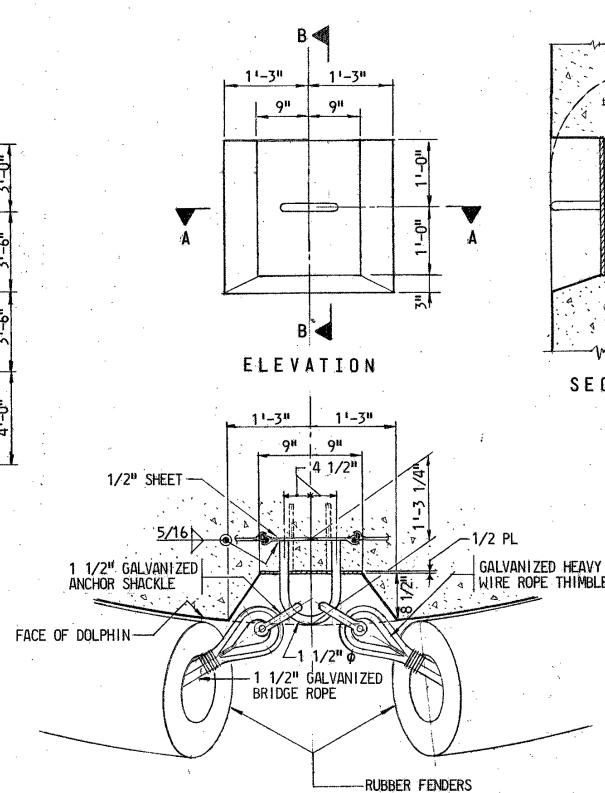
SECTION A-A
FENDER SUPPORT DETAILS
TYPICAL EXCEPT AS NOTED
SCALE: 3/4" = 1'-0"

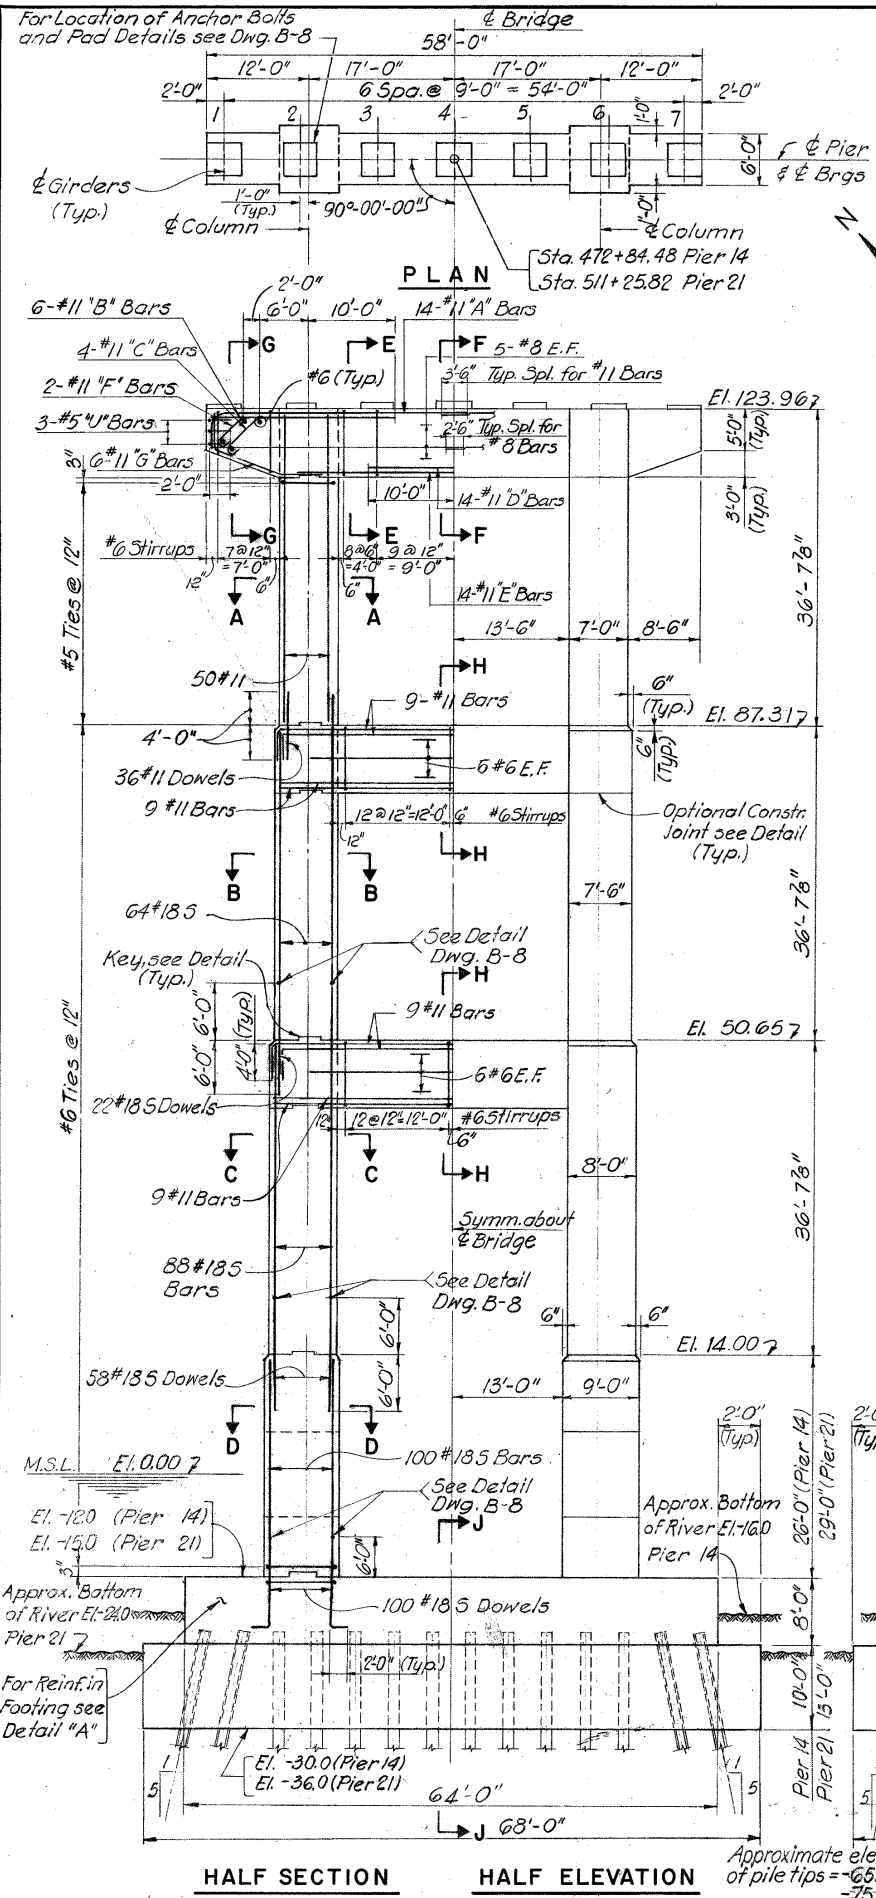
GIRDER No.	PAD ELEVATION SCHEDULE						
	1	2	3	4	5	6	7
PIER 14	124.29	124.43	124.57	124.71	124.57	124.43	124.29
PIER 21	124.29	124.43	124.57	124.71	124.57	124.43	124.29

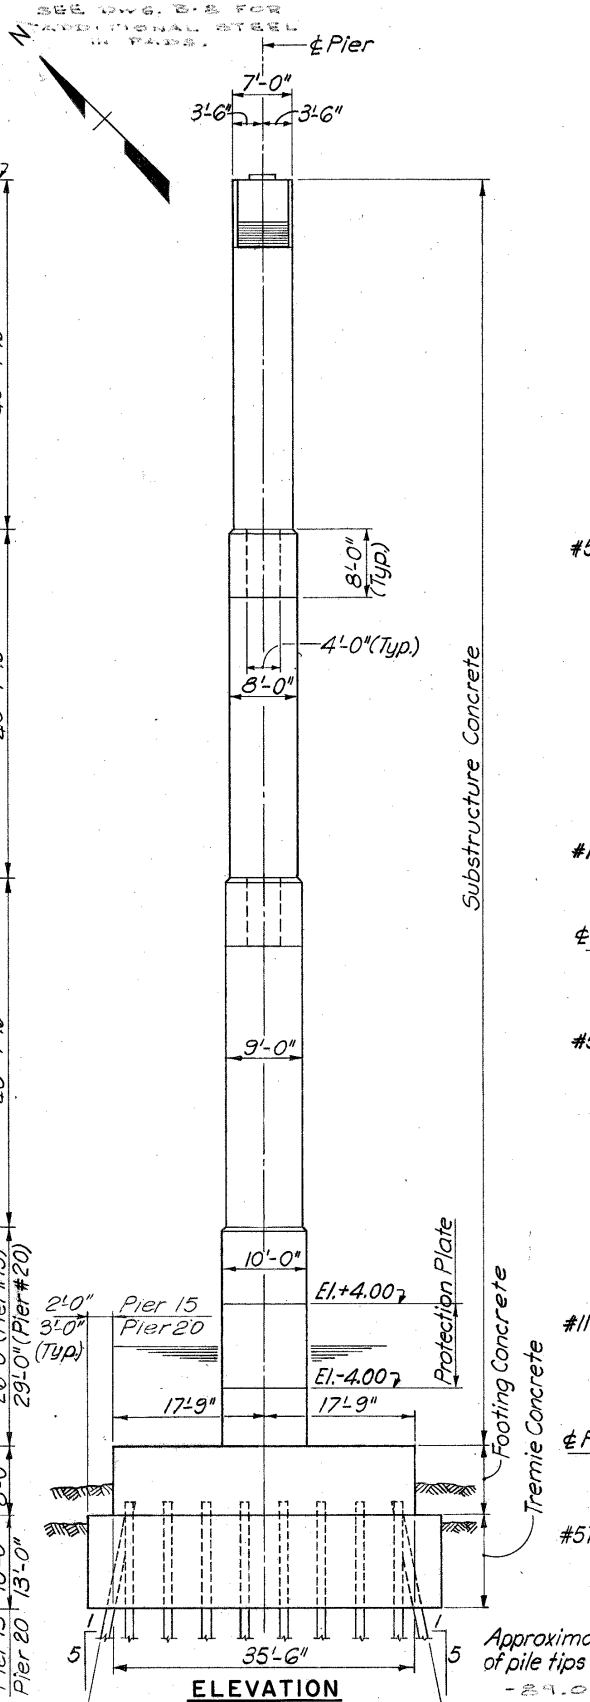
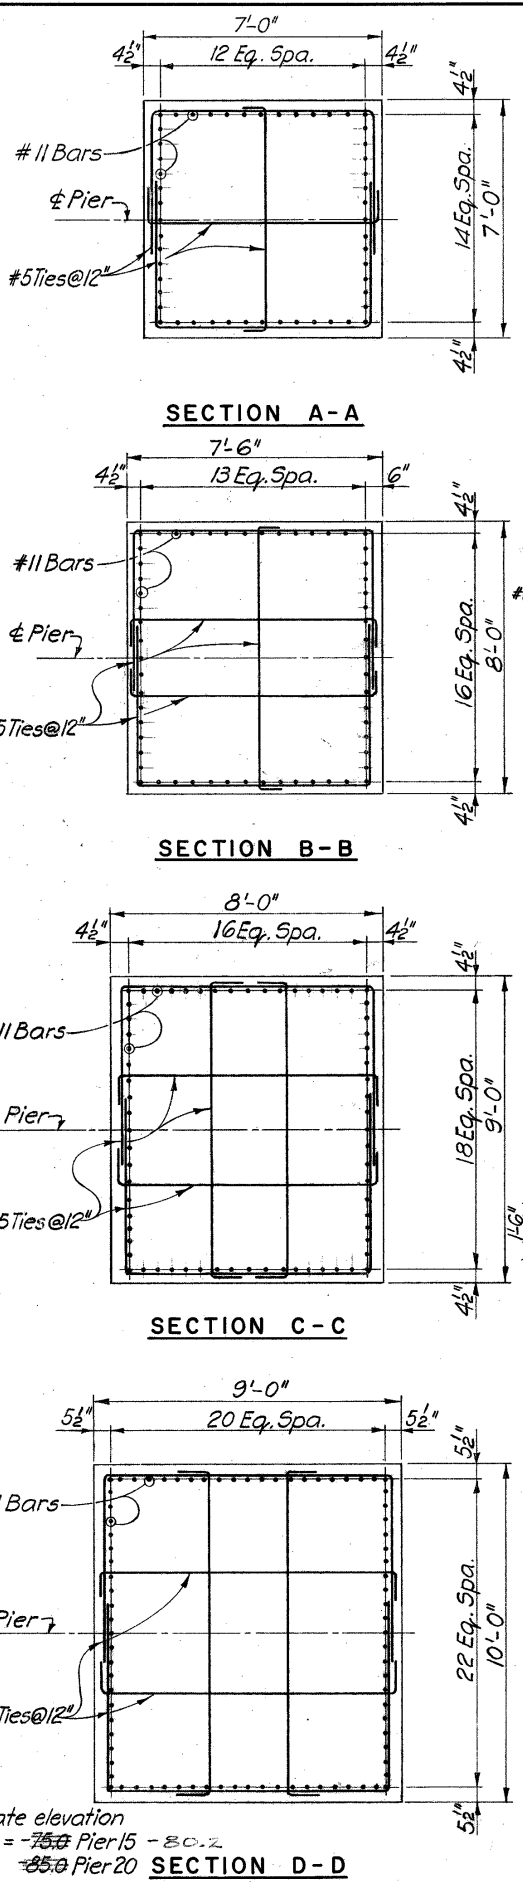
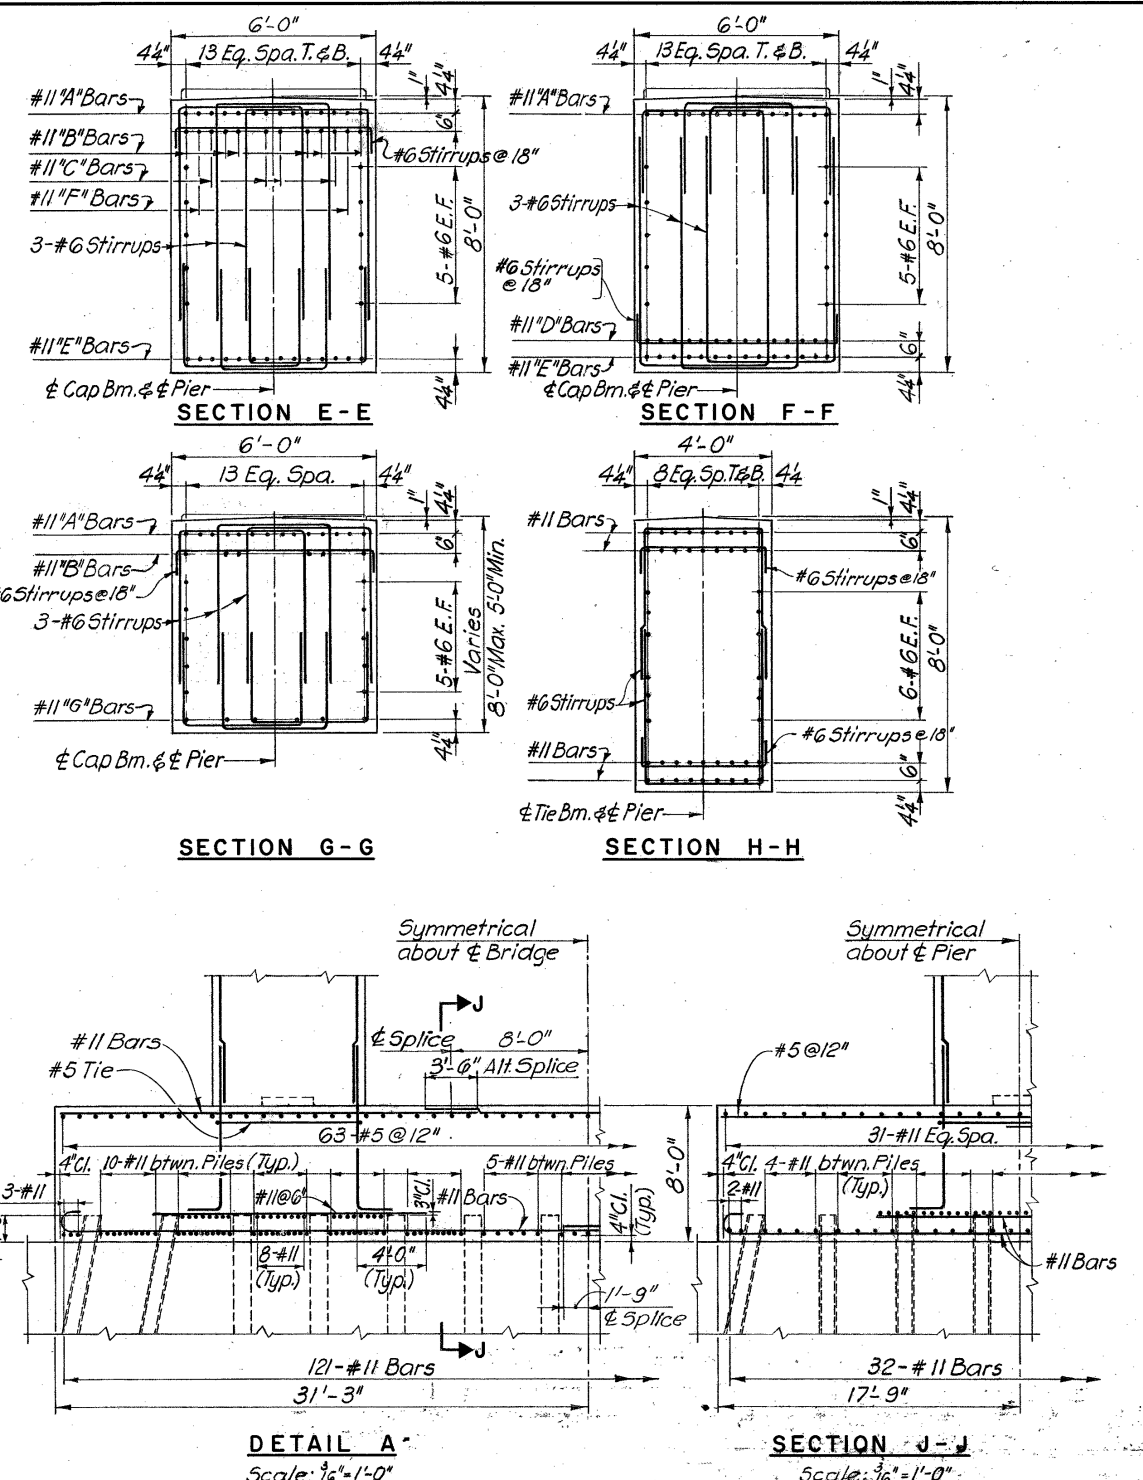
- NOTES:**
- For General Notes see Dwg. A-102
 - For Pile Plan see Dwg. B-6
 - For Typical Construction Joint and Key Detail see Dwg. B-3
 - For method of cofferdam construction see Dwg. I-1
 - For Protection Plate Details see Dwg. B-8
 - All elevations in this sheet subject to Note 12 Dwg. A-102 Contract DC-869

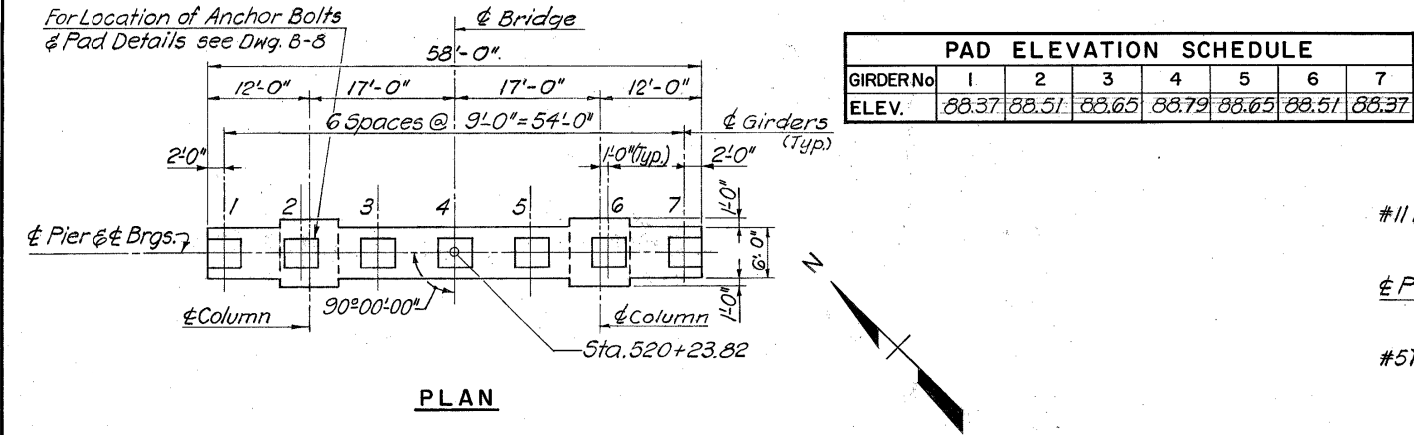
PAD ELEVATION SCHEDULE							
GIRDER NO.	1	2	3	4	5	6	7
ELEV.	88.37	88.51	88.65	88.79	88.65	88.51	88.37

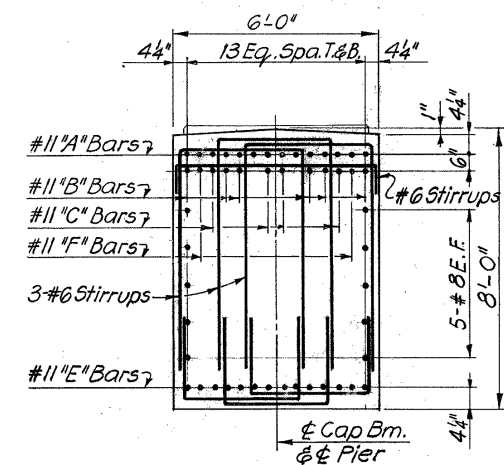
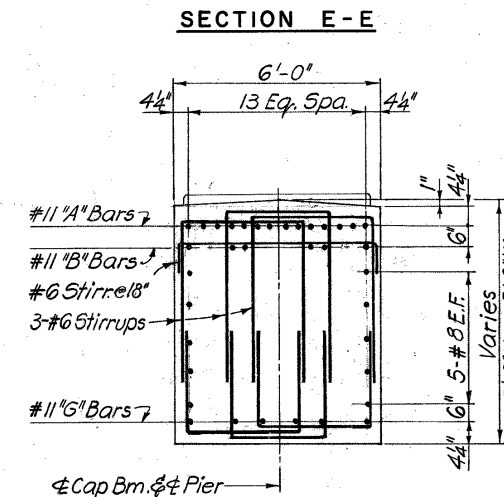
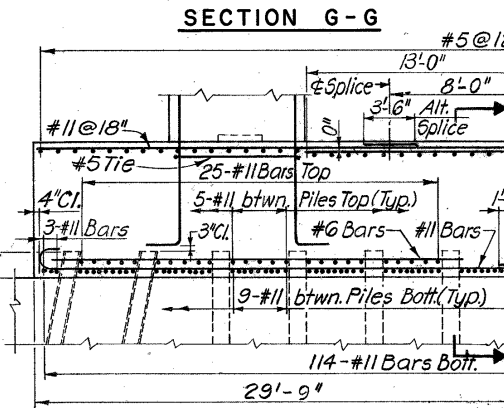
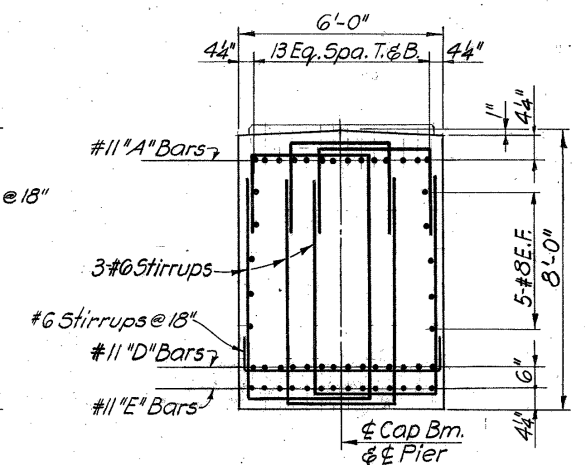
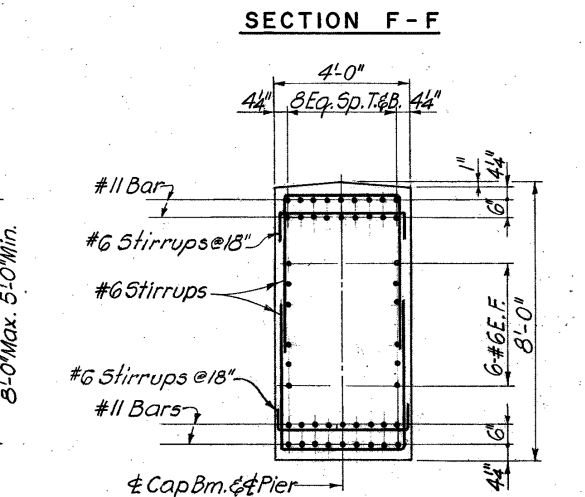
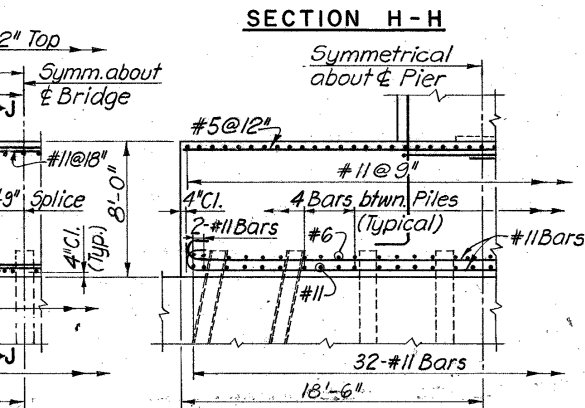
AS BUILT		STATE OF MARYLAND DEPARTMENT OF TRANSPORTATION STATE HIGHWAY ADMINISTRATION BALTIMORE, MD.	
BALTIMORE HARBOR OUTER CROSSING PATAPSCO RIVER BRIDGE			
PIER 24			
SCALE 3/32"=1'-0" & As Noted	DATE Jan. 1972	CONTRACT OT 99	
MADE BY O.S.	TRACED BY O.S.	CHECKED BY C.C.Y.	ZOLLMAN ASSOC. INC. AND SINGSTAD, KEHART NOVEMBER AND HURKA A JOINT VENTURE Baltimore, Md.
DRAWING NO. B-5			INDEXED
SHEET NO. 20 OF 24

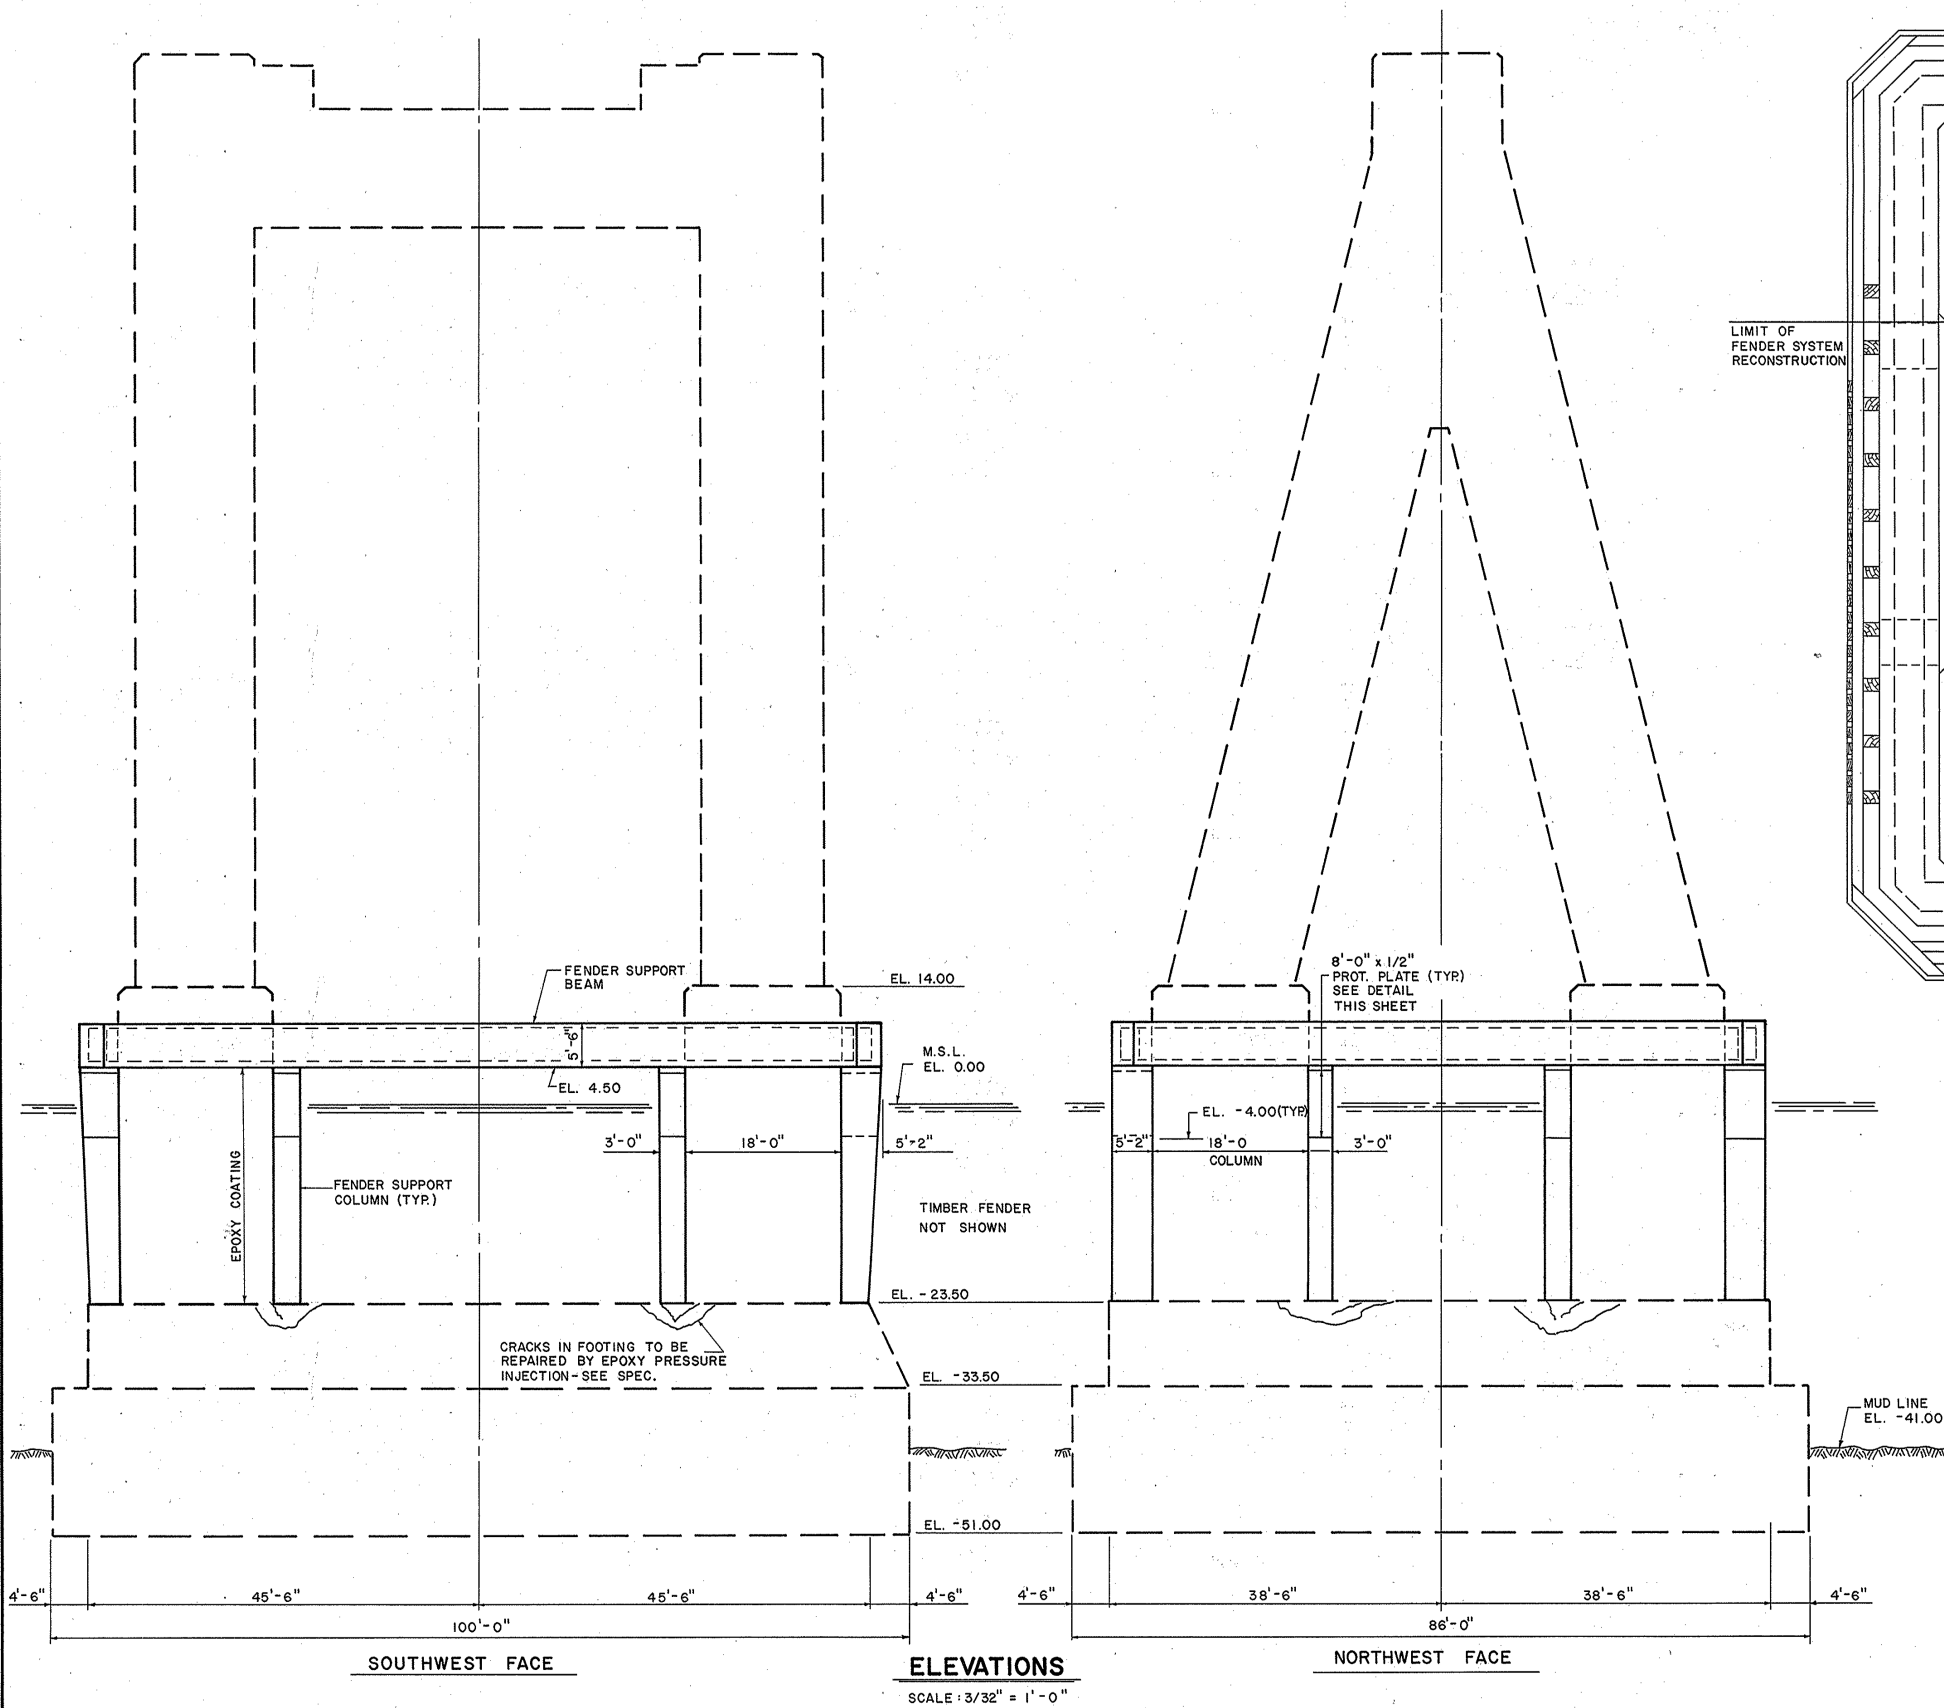
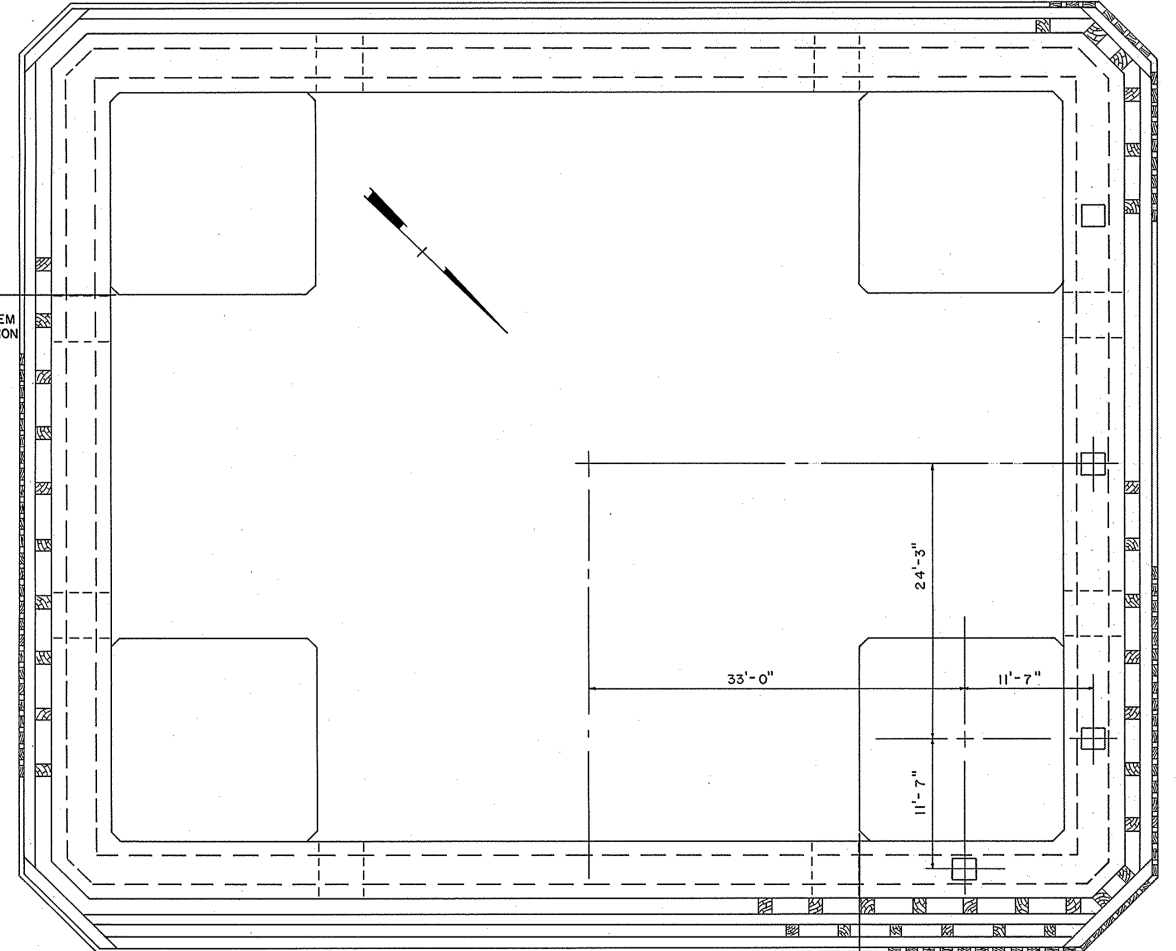
PLAN VIEW
SCALE: 1/8" = 1'-0"

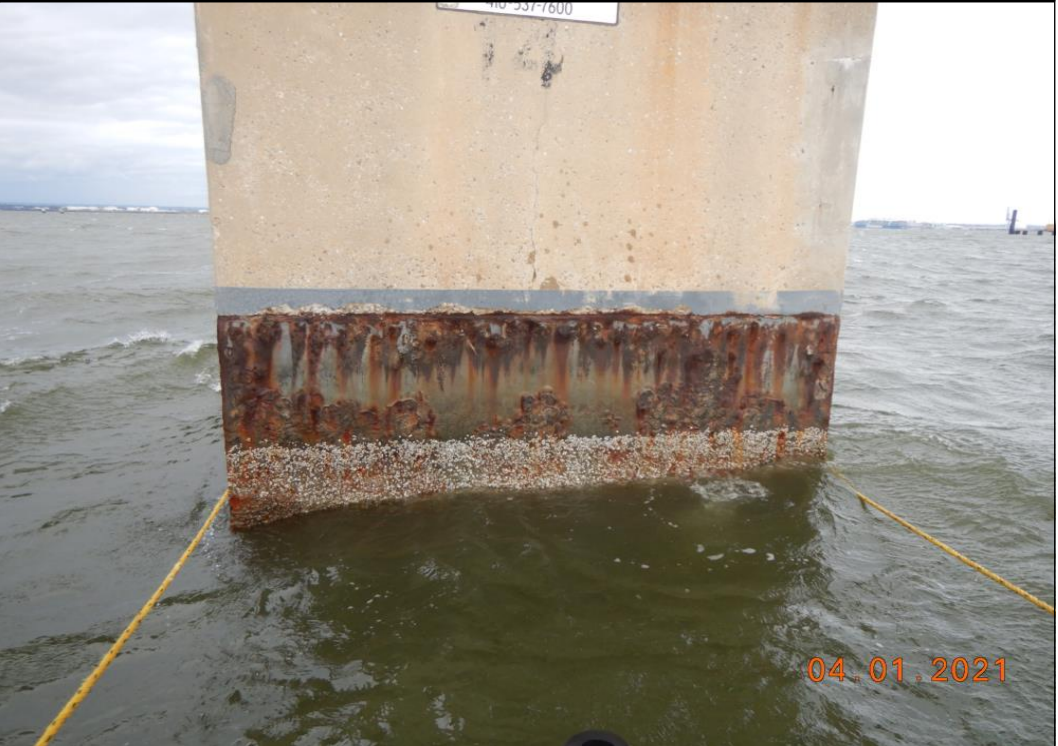
<p>PHOTO NO.: 2</p> <p>Location: Pier 14, South Column</p> <p>Direction: North</p> <p>Description: New epoxy paint on concrete column below the protection plate</p> <p>Element #: 60.04 - Columns</p> <p>Condition State Rating: 7</p> <p>MDTA Repair: 3 Repair Id: 2013-BCZ472001-00034</p>
