BRIDGE PROTECTION SYSTEMS ATTACHMENT

MDTA 2021 Underwater Inspection Report

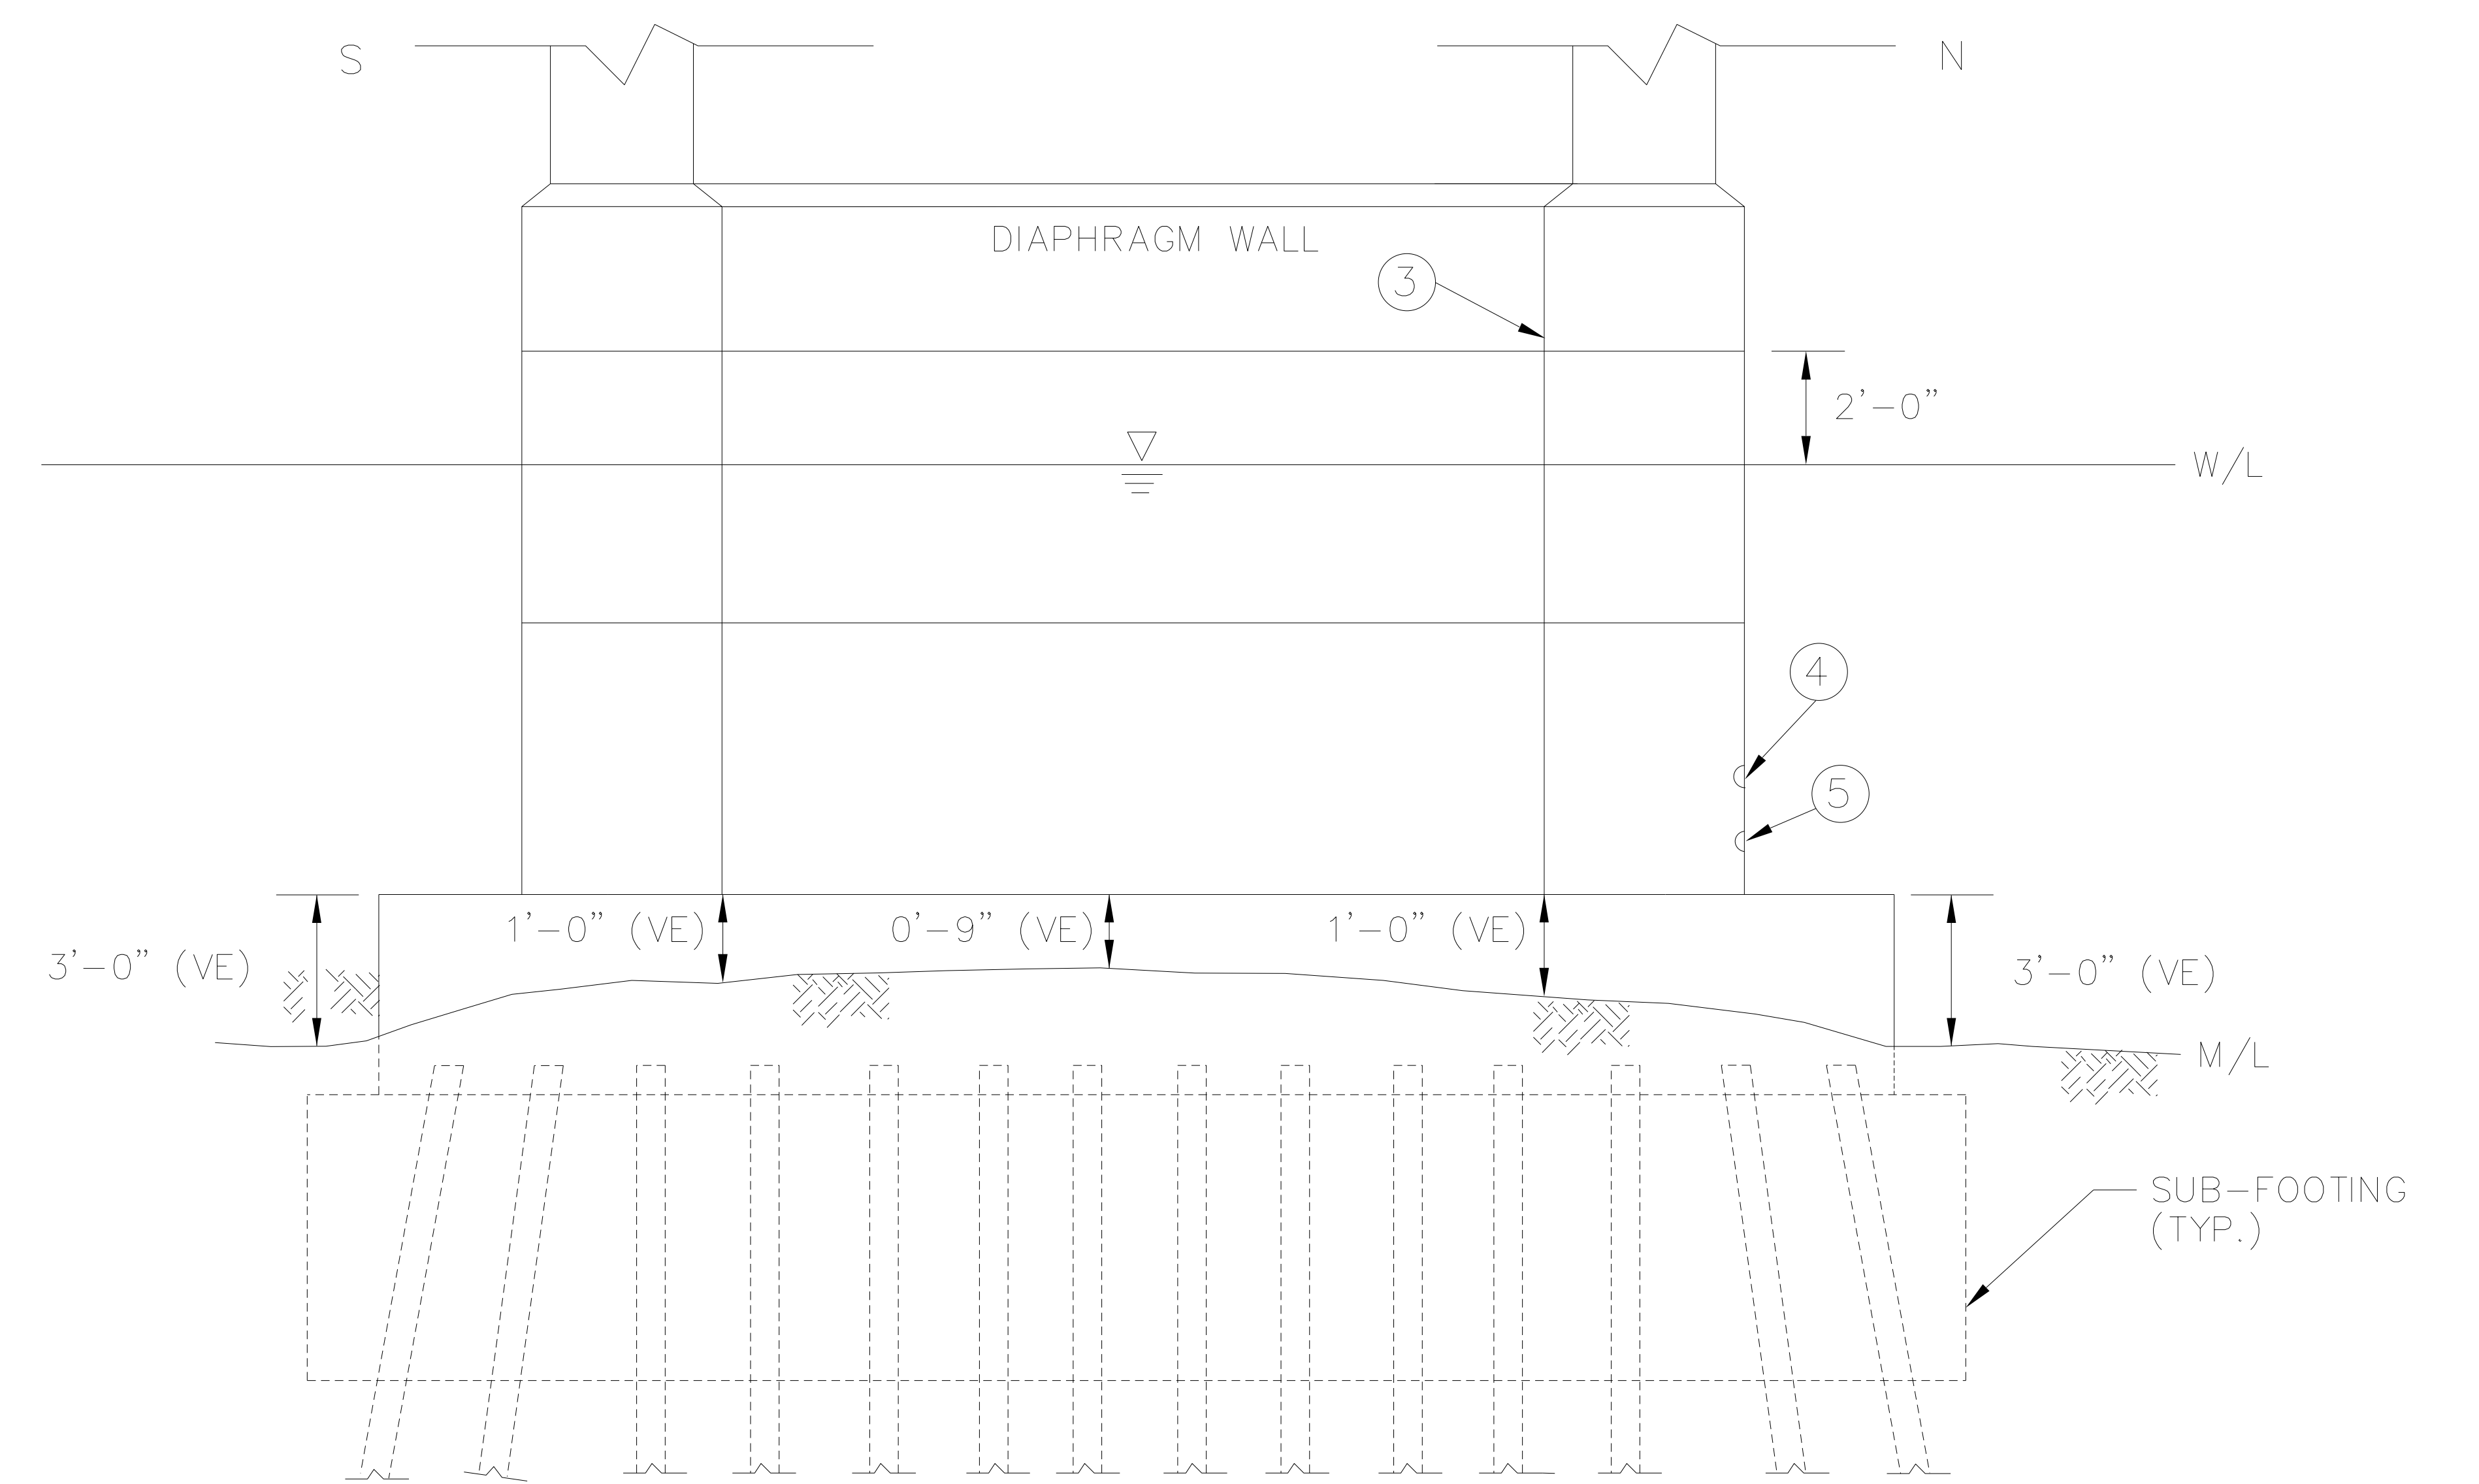
- ① NORTH COLUMN, NORTHWEST CHAMFER, 1'-1" ABOVE FOOTING - 1'-0" L x 2" H x 1" D VOID ALONG HORIZONTAL CONSTRUCTION JOINT.
- ② NORTH COLUMN, NORTHWEST CHAMFER, 2'-10" ABOVE FOOTING - 5" L x 1" H x 1/2" D VOID ALONG HORIZONTAL CONSTRUCTION JOINT.

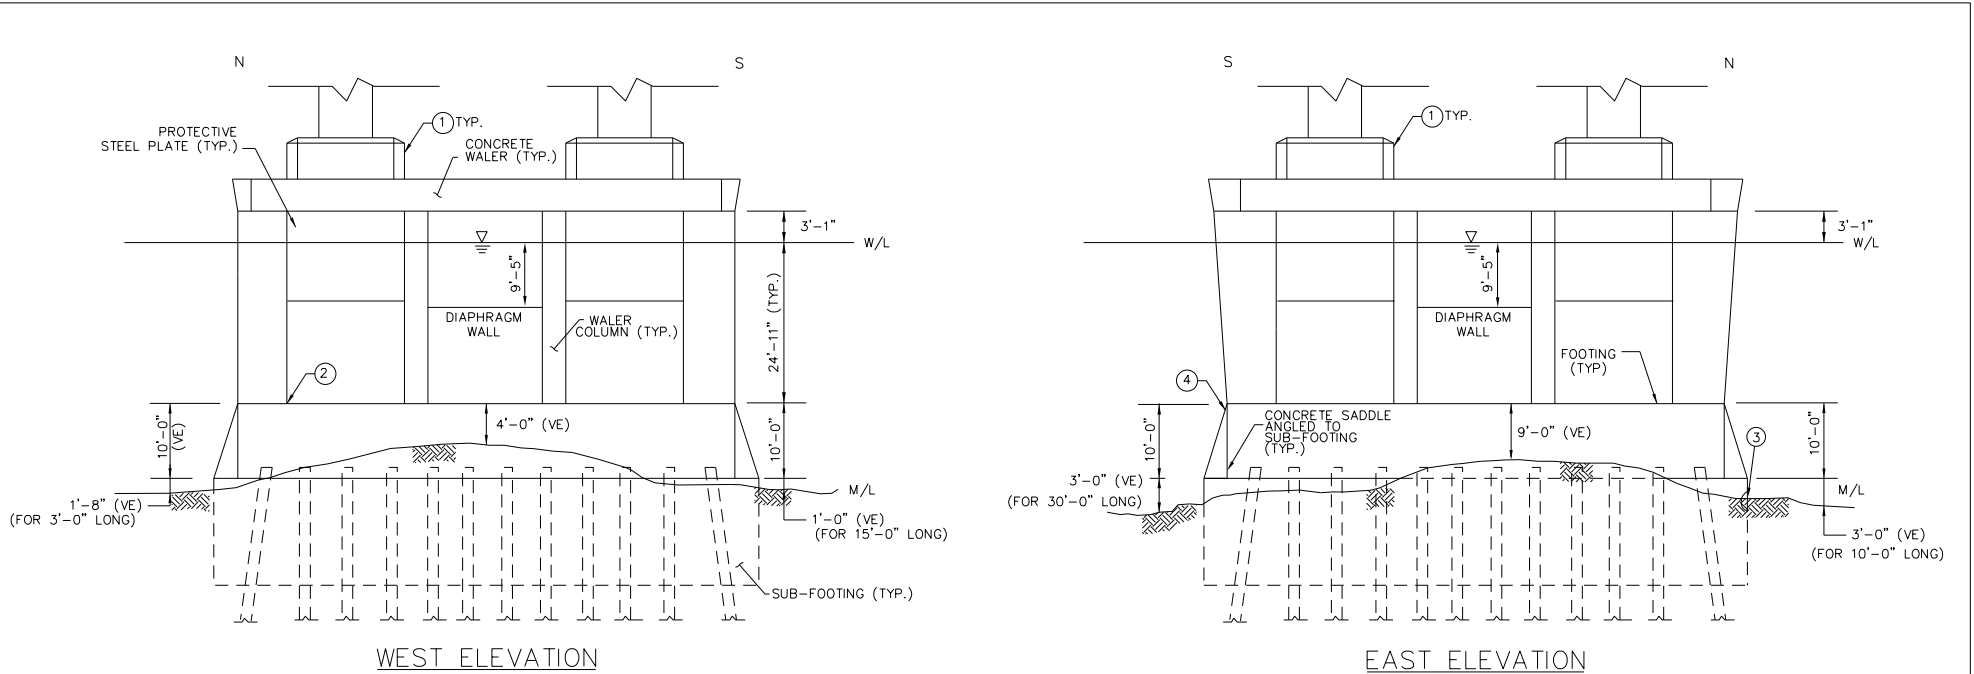
- ① TYPICAL COLUMN, ABOVE CONCRETE WALER – RANDOM MAP CRACKING UP TO 1/8" WIDE.
- ② FOOTING, 3'-0" FROM NORTHWEST CORNER – 4" H x 7" W x 1 1/2" D SPALL.

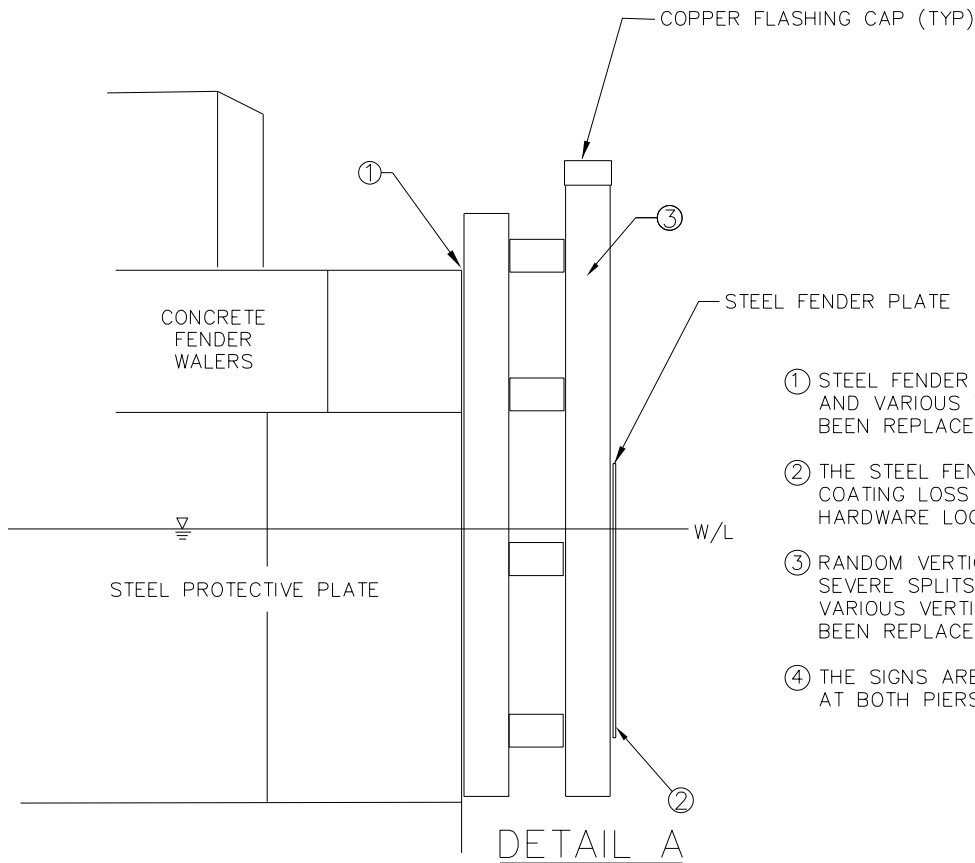
- ① STEEL FENDER PLATE, ASSOCIATED HARDWARE, AND VARIOUS VERTICAL TIMBER MEMBERS HAVE BEEN REPLACED OR REHABILITATED.
- ② THE STEEL FENDER PLATE HAS ISOLATED COATING LOSS AND LIGHT CORROSION OF THE HARDWARE LOCATED THROUGHOUT.
- ③ RANDOM VERTICAL TIMBER MEMBERS HAVE SEVERE SPLITS, CHECKS, OR IMPACT DAMAGE. VARIOUS VERTICAL TIMBER MEMBERS HAVE BEEN REPLACED.
- ④ THE SIGNS ARE TYPICALLY DAMAGED AND FADED AT BOTH PIERS.

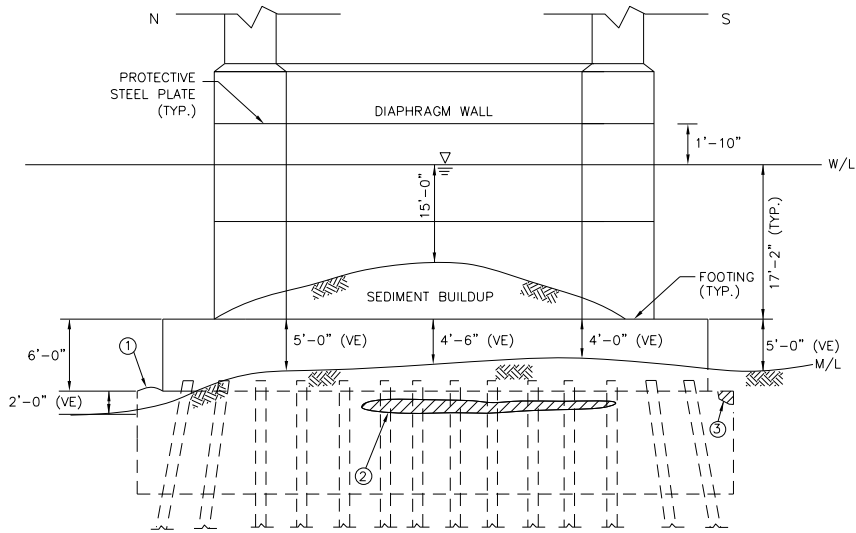
CONTRACT NO.
 AE-3016-000-001
 DRAWING NO.

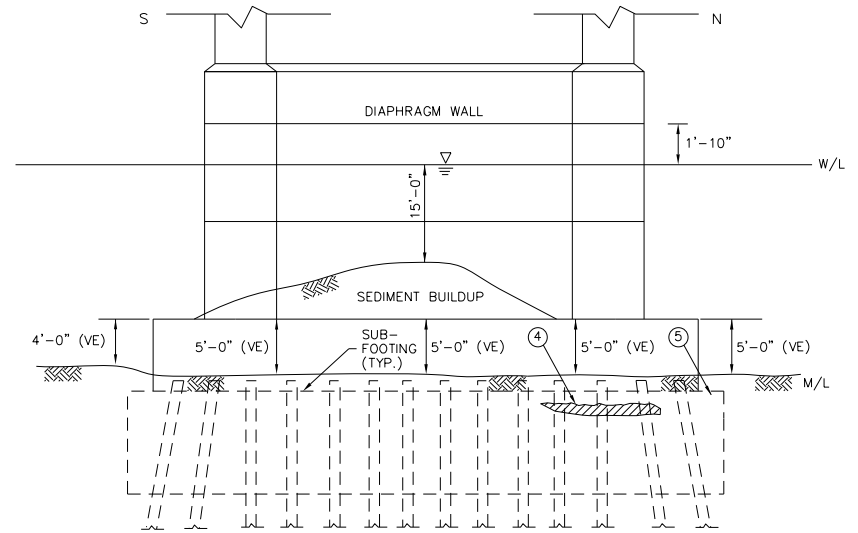
- ① SUB-FOOTING, NORTHWEST CORNER - CONCRETE OVERPOUR ON TOP 1'-6" HIGH.
- ② SUB-FOOTING, 26'-0" FROM NORTHWEST CORNER, 6" BELOW TOP - 6" H x 15'-0" L x 10" D VOID. (BURRIED DURING 2017 & 2021 INSPECTION)
- ③ SUB-FOOTING, SOUTHWEST CORNER - 6" DIA. x 3" D CORNER SPALL. (BURRIED DURING 2017 & 2021 INSPECTION)

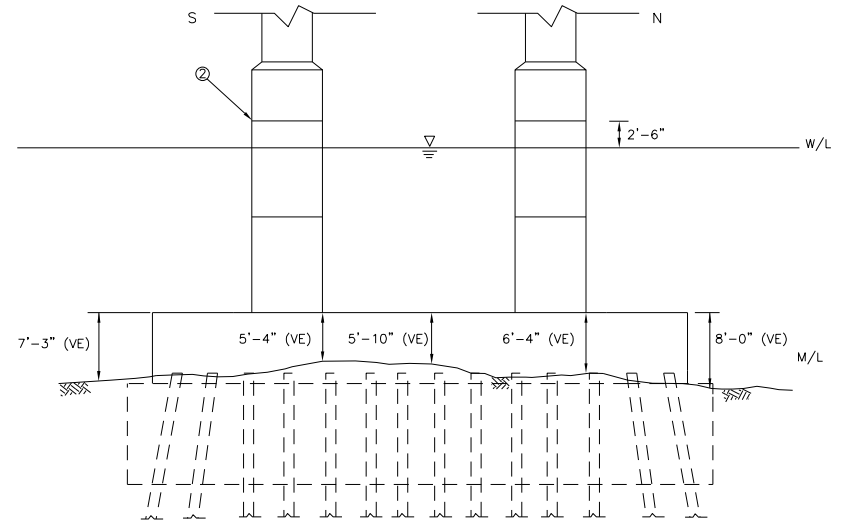
① BETWEEN COLUMNS, UP TO 2'-0" OF SEDIMENT ON TOP OF FOOTING.

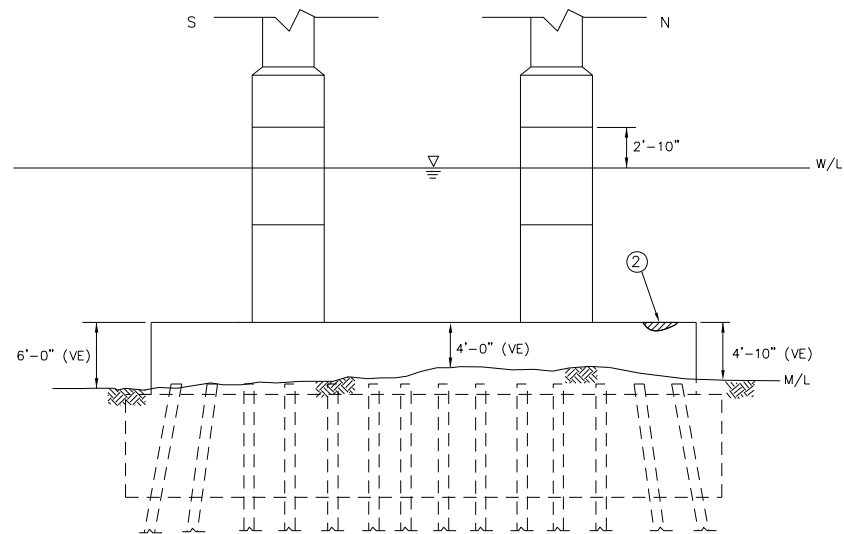
① FOOTING, NORTH FACE, 12'-0" FROM NORTHWEST CORNER - 1'-0" H x 10" W x 1/2" D EDGE SPALL.
