National Transportation Safety Board

CEN23LA088

WRECKAGE EXAMINATION SUMMARY

Location: Tomball, Texas
Date: January 22, 2023
Time: 1127 central standard time (1727 UTC)
Airplane: Beech M35; Registration No. N9306Y

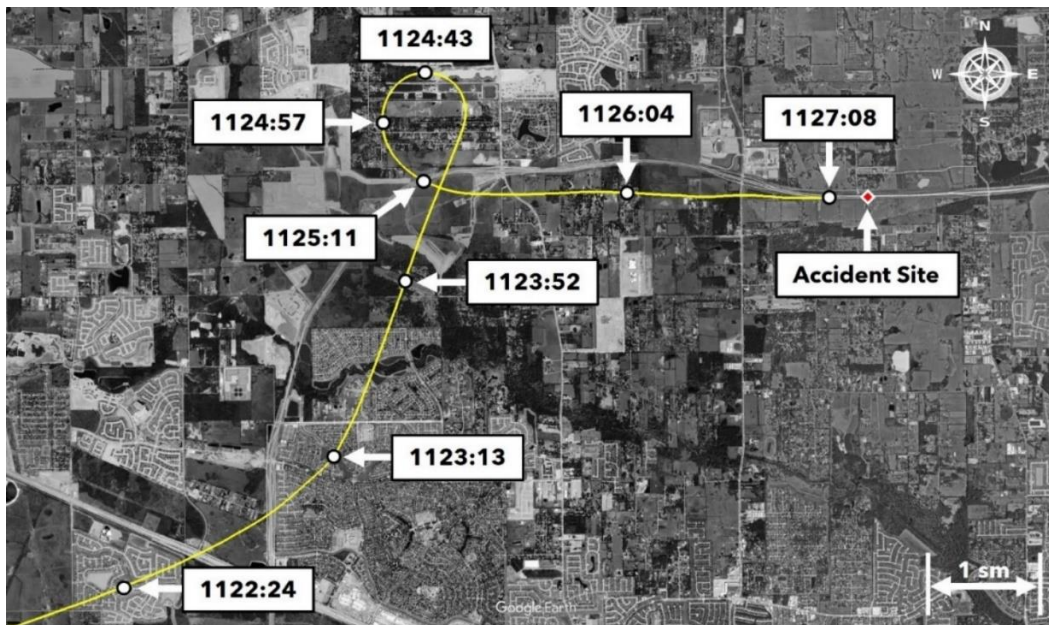
Based on a review of ADS-B flight track data and the pilot's statement, about 1 hour 16 minutes into the flight, the pilot entered a left 270° turn to avoid another airplane before

flying to the east toward David Wayne Hooks Memorial Airport (DWH), as shown in Figure 1. The pilot reported that the airplane had a total loss of engine power shortly after he completed the left turn and was heading east. The ADS-B track data showed the airplane about 11 miles west of DWH at 2,000 ft mean sea level before it entered a sustained descent, as depicted in Figure 2.

Figure 1 – Plot of airplane ground track.

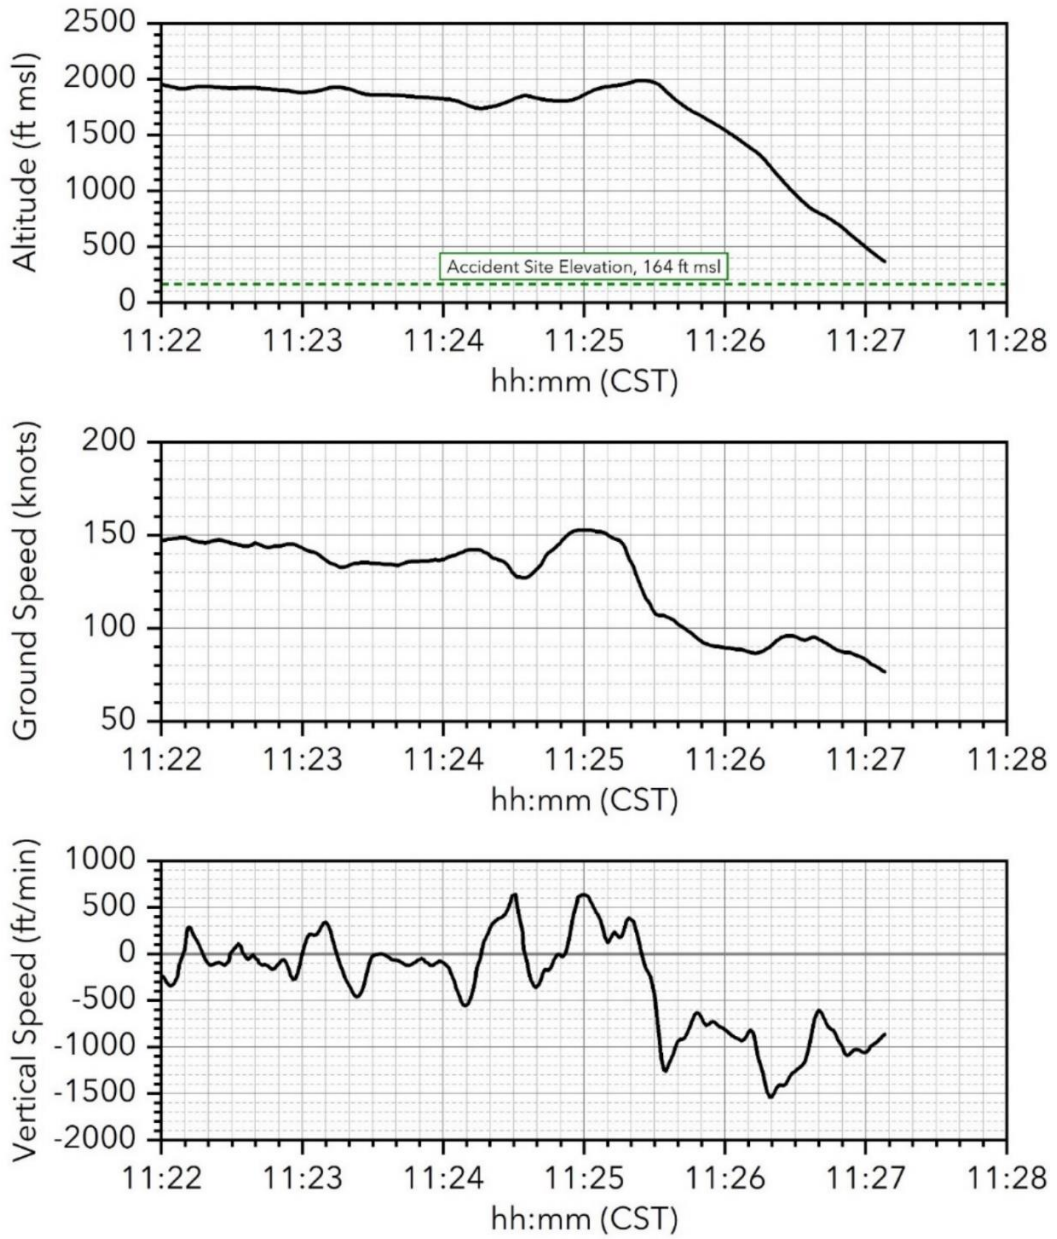
Figure 2 – Plot of altitude, ground speed, and vertical speed.

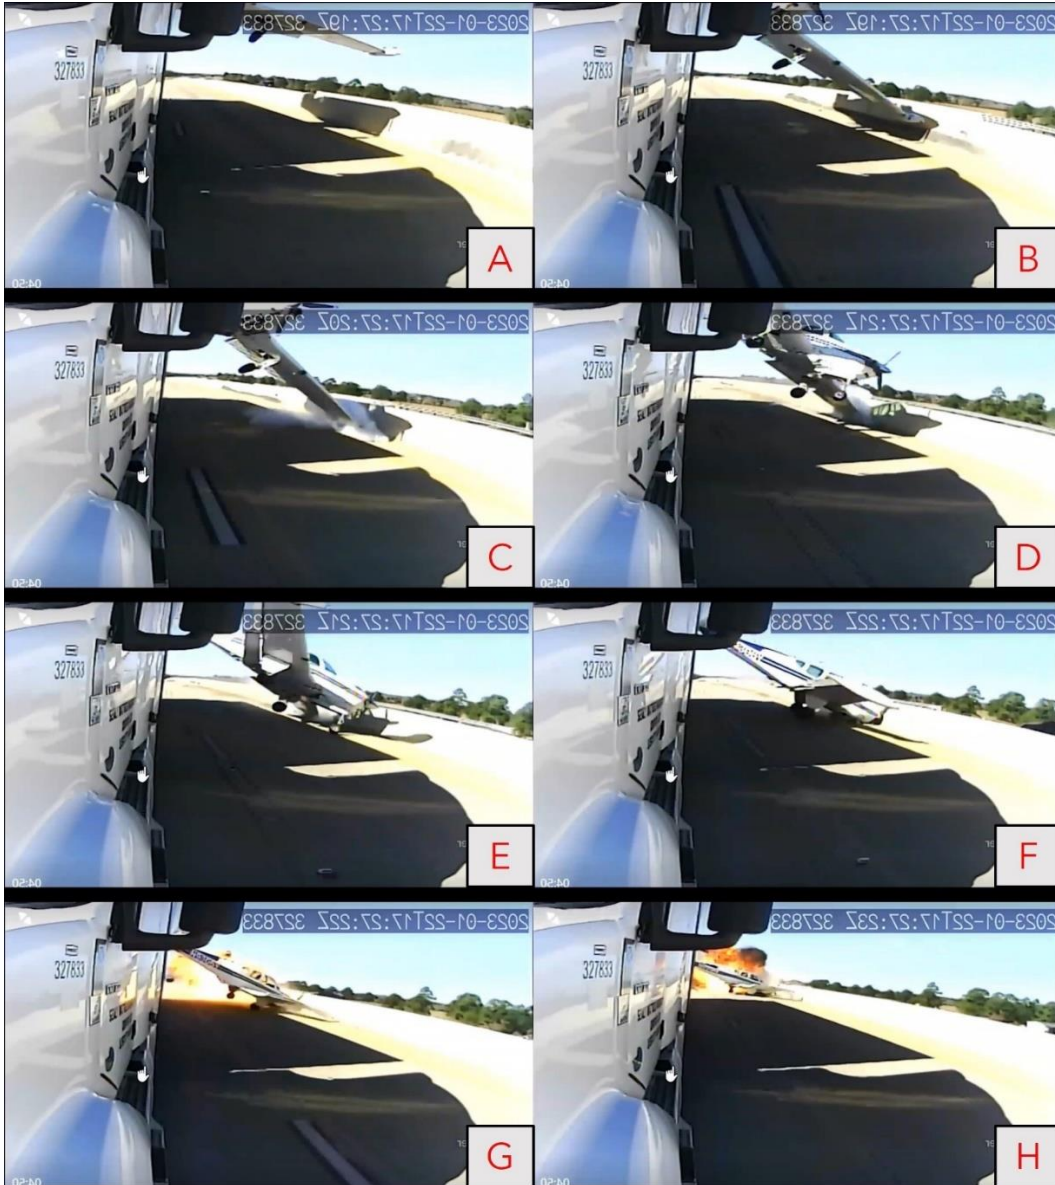
During the forced landing the airplane's right main landing gear impacted the roof of a semi-trailer before the airplane rolled left wing down and descended into a concrete highway median, as shown in Figure 3. The airplane was immediately engulfed in fire after it came to rest on the highway. After the accident, the pilot unbuckled his restraints and exited the airplane.

Figure 3 – Selected screenshots from the semi-trailer truck camera footage.

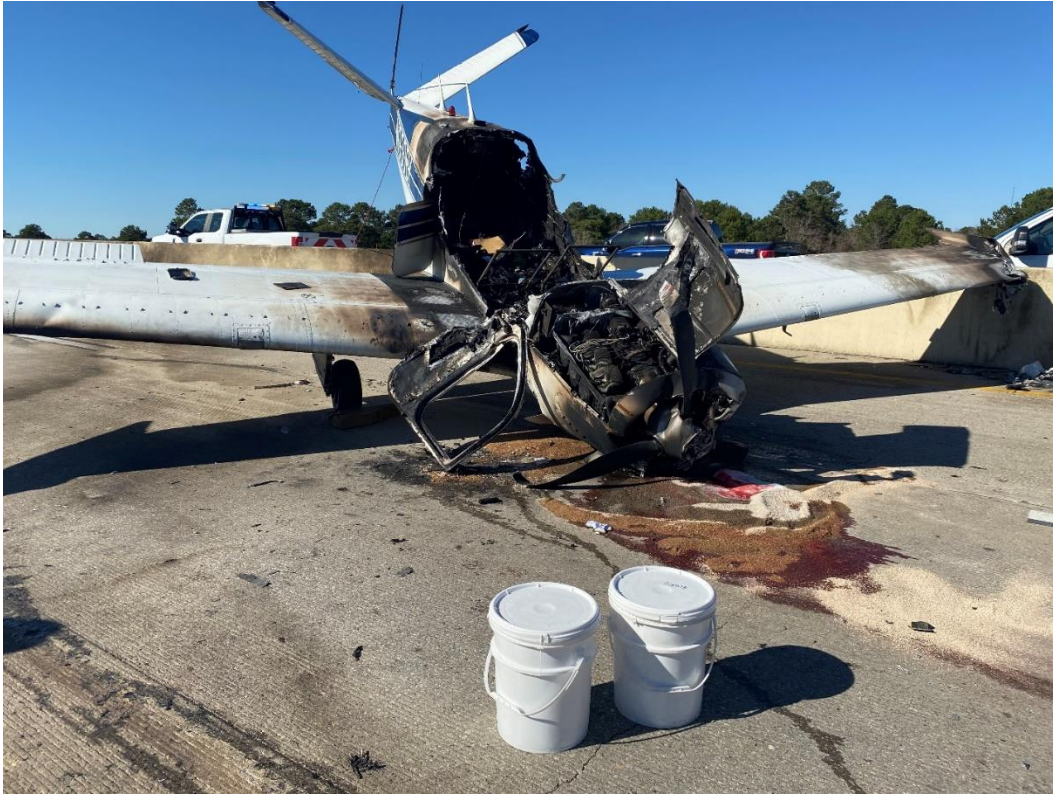
According to the Federal Aviation Administration (FAA) inspectors who responded onsite, the airplane descended onto the eastbound lanes of Highway 99 about 1 mile west of the Telge Road exit. The landing gear and flaps were found extended. The postaccident fire destroyed most of the fuselage, cabin, and cockpit, as shown in Figure 4 and Figure 5. Both wing roots exhibited various degrees of thermal damage near the main fuel tanks. The filler caps for the two main fuel tanks and the two auxiliary fuel tanks were found properly installed. According to the FAA Inspectors, the tow truck operator reportedly drained about 25 gallons of fuel from the fuel tanks before the airplane was moved, but the amount of fuel recovered from each fuel tank was not individually documented. The tow truck operator also added an absorbent granular substance (oil dry) to the fuel tanks to prevent further fuel leaks while the airplane was transported from the accident site. The left wingtip fuel tank exhibited extensive impact and thermal damage, and there was no residual fuel within the tank. The right wingtip fuel tank exhibited extensive thermal damage, and there was no residual fuel within the tank.

Figure 4 – Airplane at the accident site. (Photo courtesy of FAA)

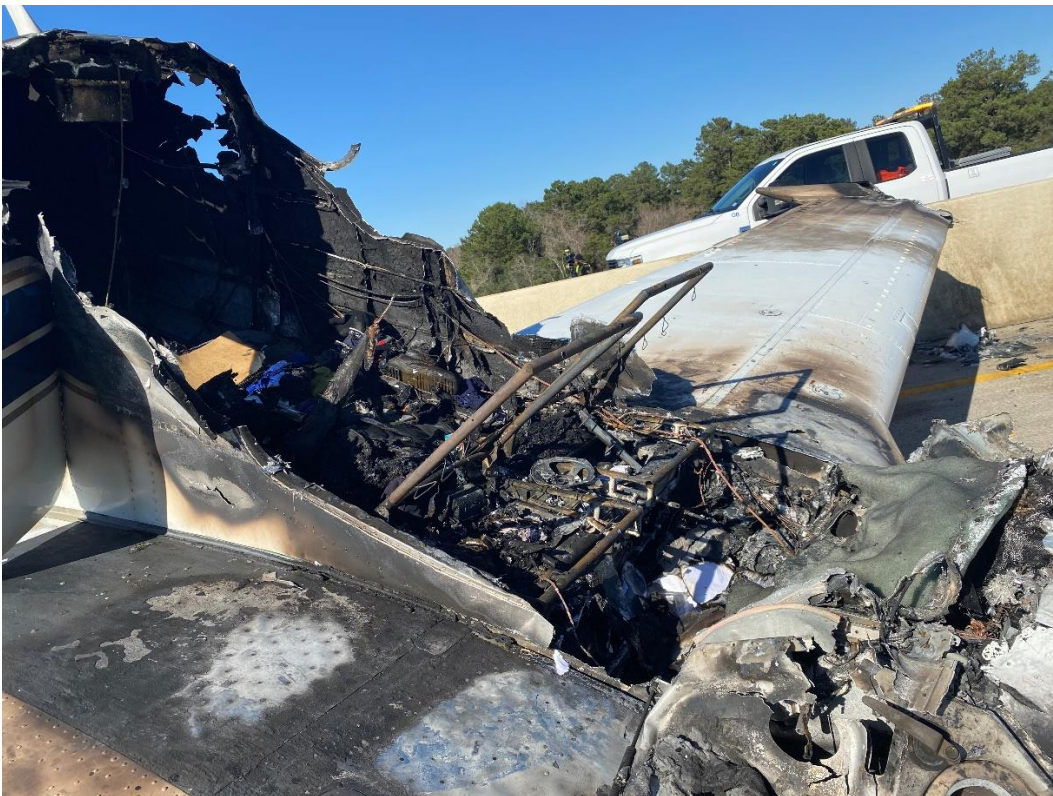
Figure 5 – Airplane cabin and cockpit at accident site. (Photo courtesy of FAA)

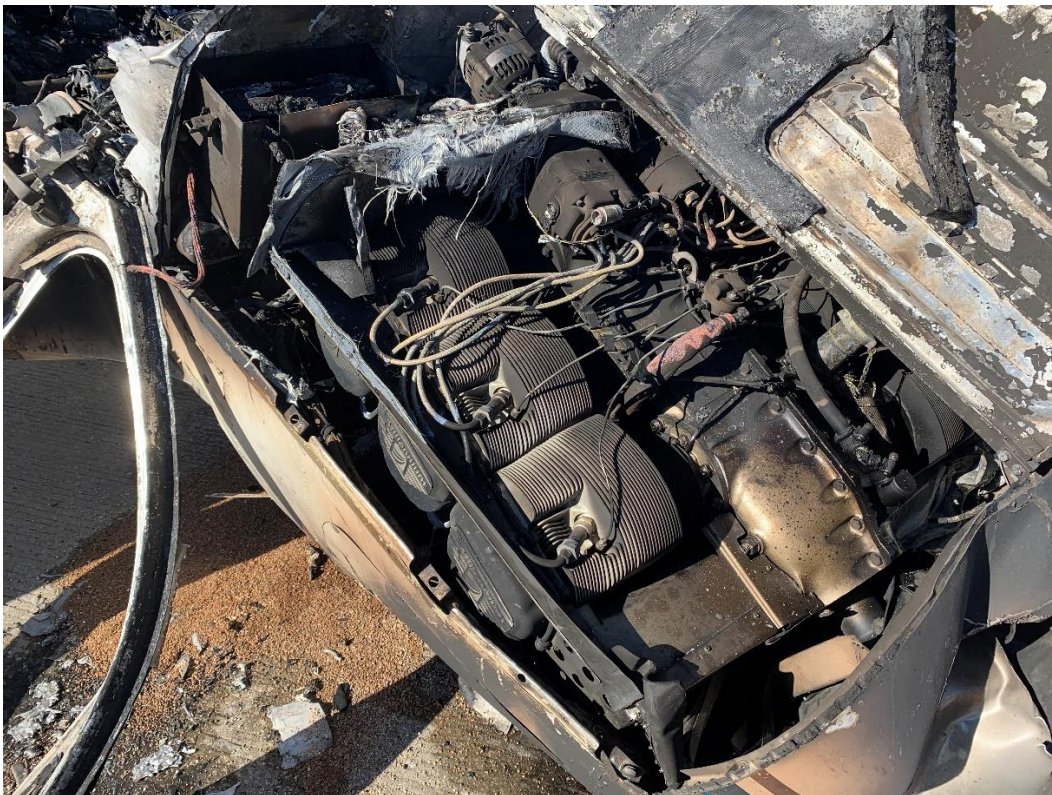
The engine remained partially attached to its engine mounts. The forward engine mounts exhibited impact-related damage. The engine crankcase exhibited various degrees of thermal damage but was otherwise intact, as shown in Figure 6. The aft portion of the engine and the rear-mounted engine components exhibited extensive thermal damage. There was no evidence of cracks or holes in the crankcase or cylinders. The exterior of the engine did not exhibit any evidence of an oil or fuel leak. The engine oil sump contained ample oil. The oil lines remained intact and attached to their respective components. The oil filter exhibited thermal damage. The oil filter element did not exhibit any evidence of metal contamination. The intake tubes and exhaust were found unobstructed.

Figure 6 – Engine at accident site. (Photo courtesy of FAA)

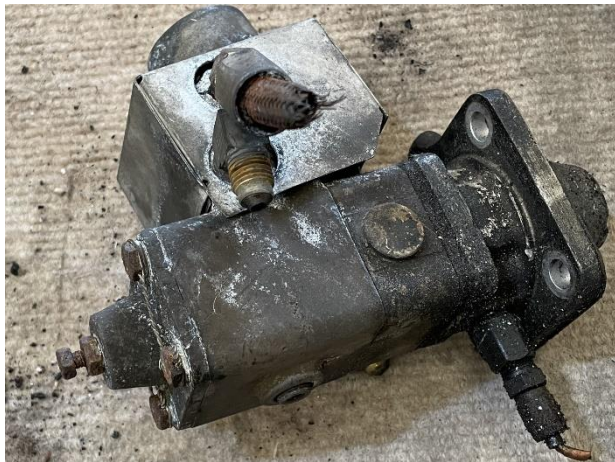
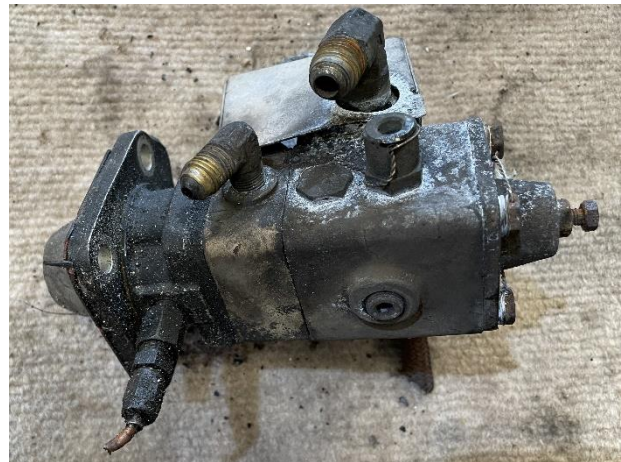
The engine-driven fuel pump exhibited extensive thermal damage associated with the postaccident fire, as shown in Figure 7 and Figure 8. The drive coupling was found sheared, but there was no evidence of rotational damage that is typically associated with an operational failure of the pump. Additionally, disassembly of the pump revealed thermal damage to the internal components of the pump, as shown in Figure 9 and Figure 10. The rotating shaft and its associated carbon vanes remained intact but exhibited thermal damage. A dark-black resolidified material was observed within the pump chamber. Based on the thermal damage to the engine-driven fuel pump components, the drive coupling likely sheared when the propeller/crankshaft was rotated postaccident.

Figure 7 – Engine-driven fuel pump

Figure 8 – Engine-driven fuel pump

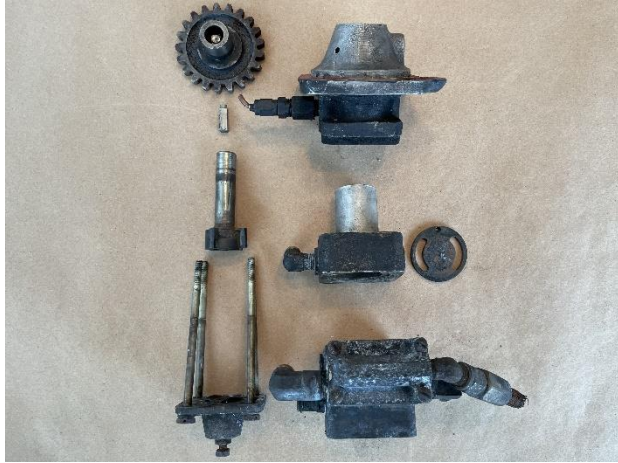
Figure 9 – Disassembled fuel pump

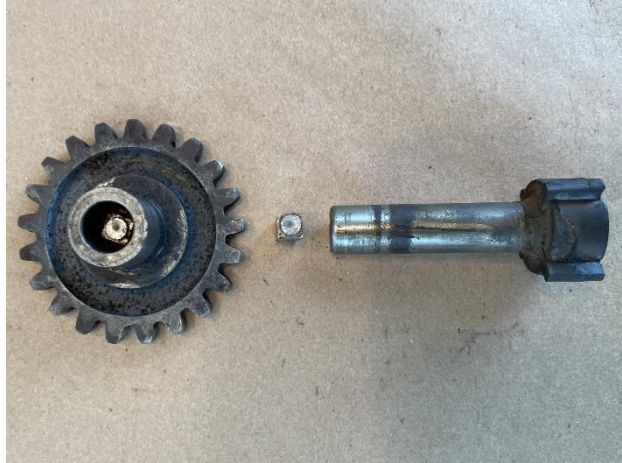
Figure 10 – Pump drive components

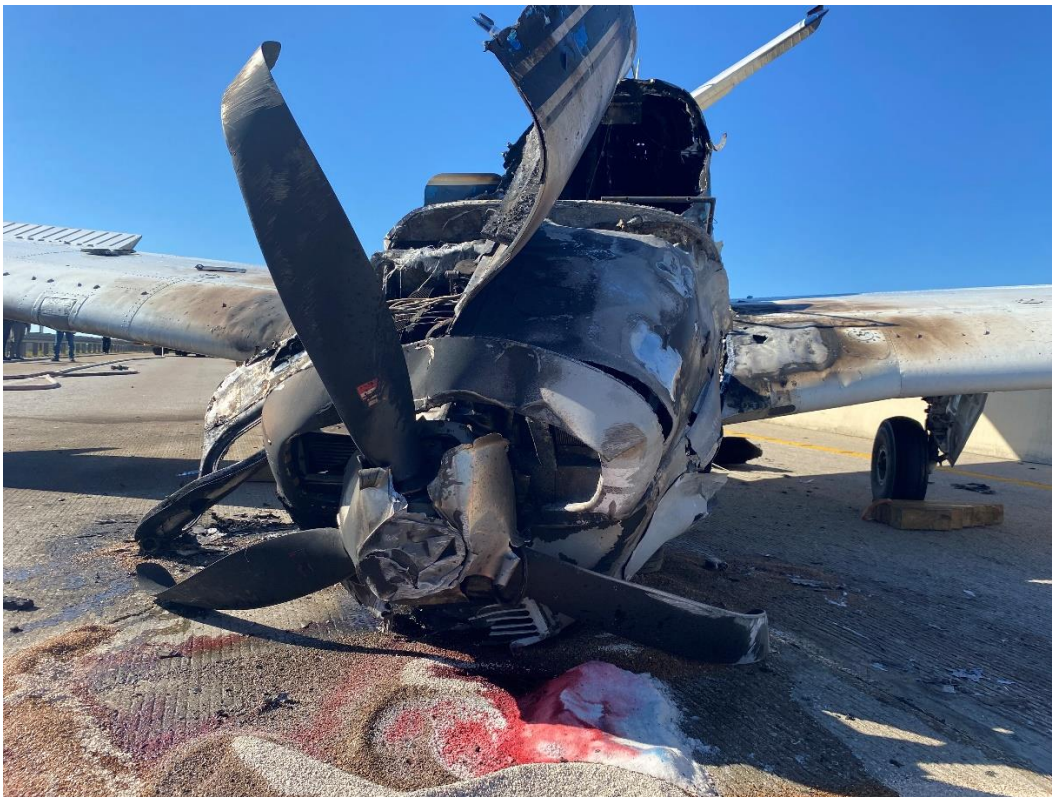
The propeller remained attached to the crankshaft flange. All three propeller blades exhibited aft bending, twisting toward low pitch, and chordwise scratching, as shown in Figure 11.

Figure 11 – Propeller at accident site. (Photo courtesy of FAA)

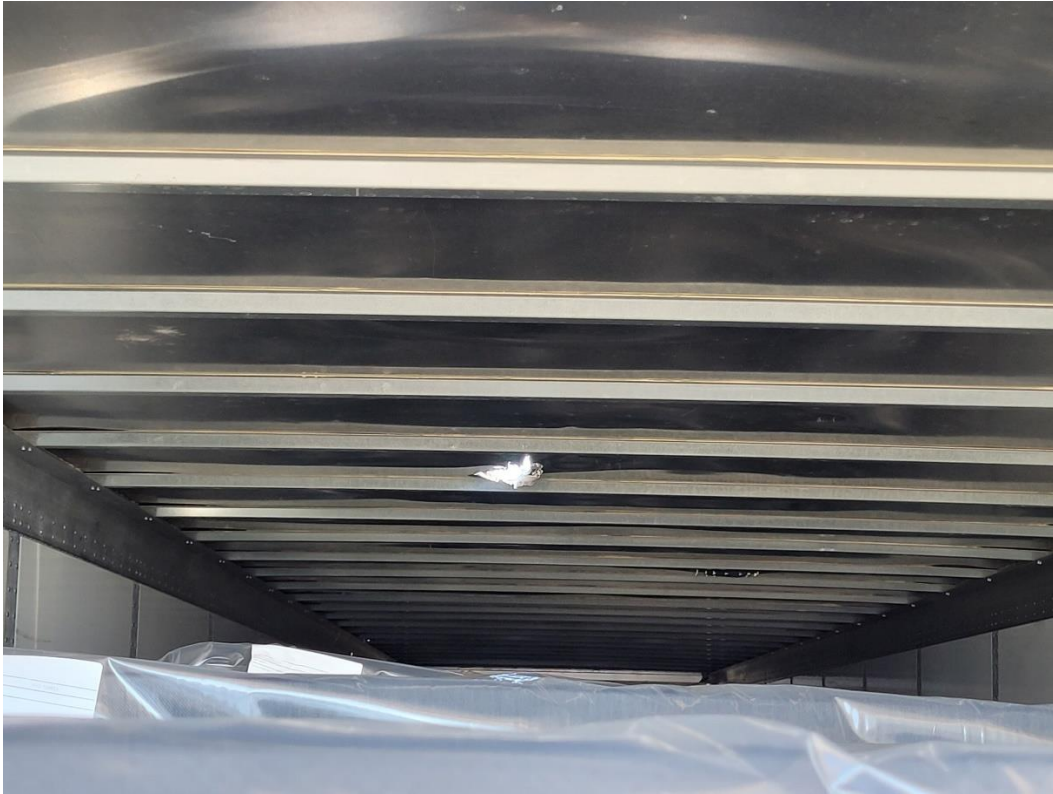
The semi-trailer truck sustained a minor puncture to the roof of the trailer but was otherwise undamaged, as shown in Figure 12.

Figure 12 – Puncture to the roof of the semi-trailer. (Photo courtesy of FAA)
