## MEMORANDUM FOR RECORD

**Subject:** NTSB investigation ERA19FA249, N303TL, Cessna T303, Lagrangeville, New York, August 17, 2019. Airframe and Engine Examination

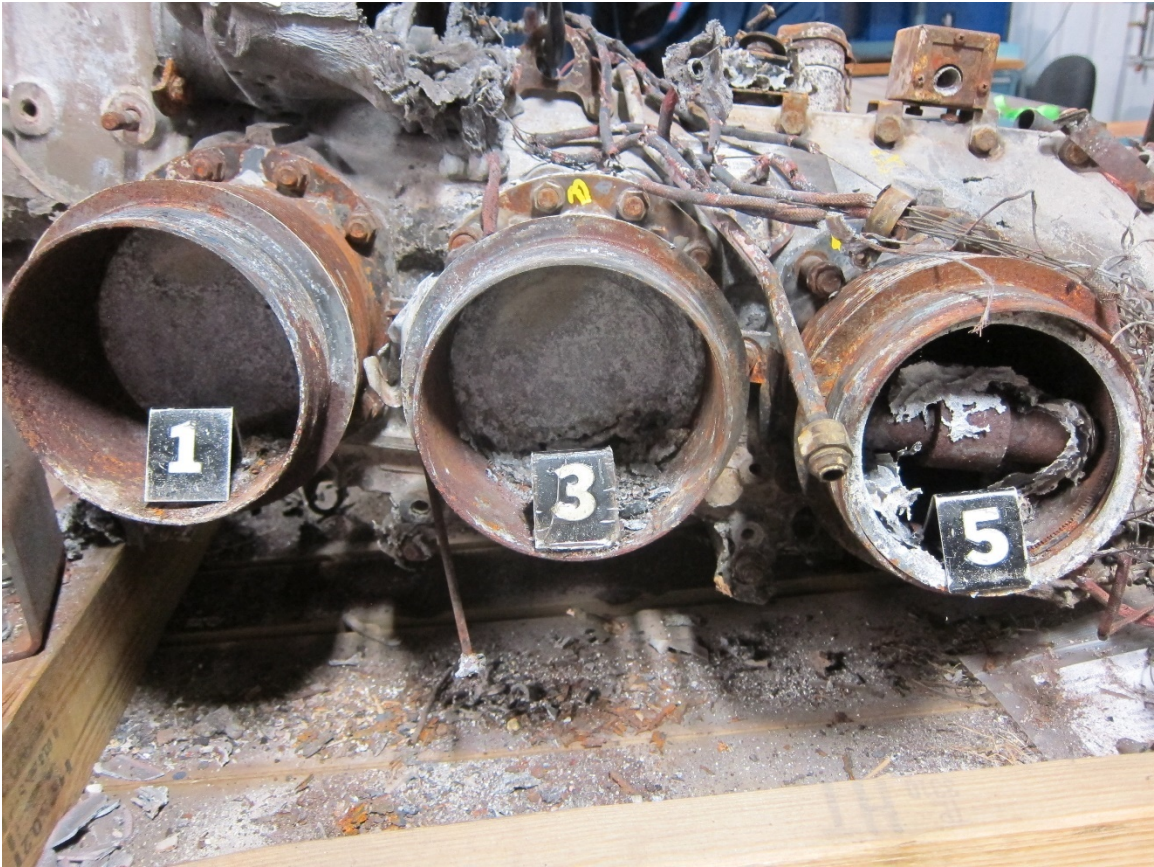
*Figure 1 Left Engine Cylinders 1, 3, 5*

The No. 5 piston was almost entirely melted

The No. 3 piston top was partially melted at its lower edge

The No. 1 piston top was partially melted

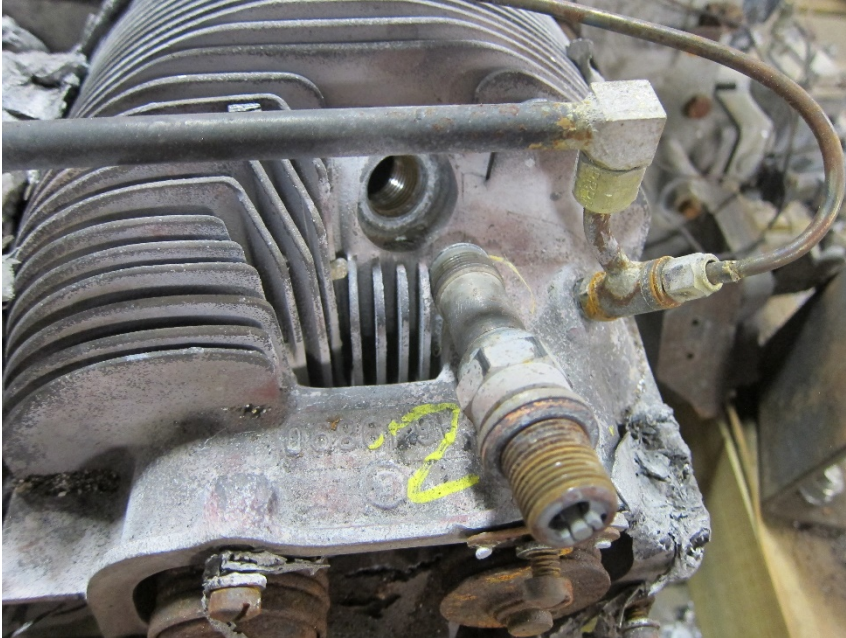
Figure 2 Left Engine No. 2 Spark Plug

The Nos. 2 and 4 piston tops (examined via borescope) had some melting material on their lower edge, there was no melted piston material found on the spark plugs.  
The No. 6 piston was almost entirely melted

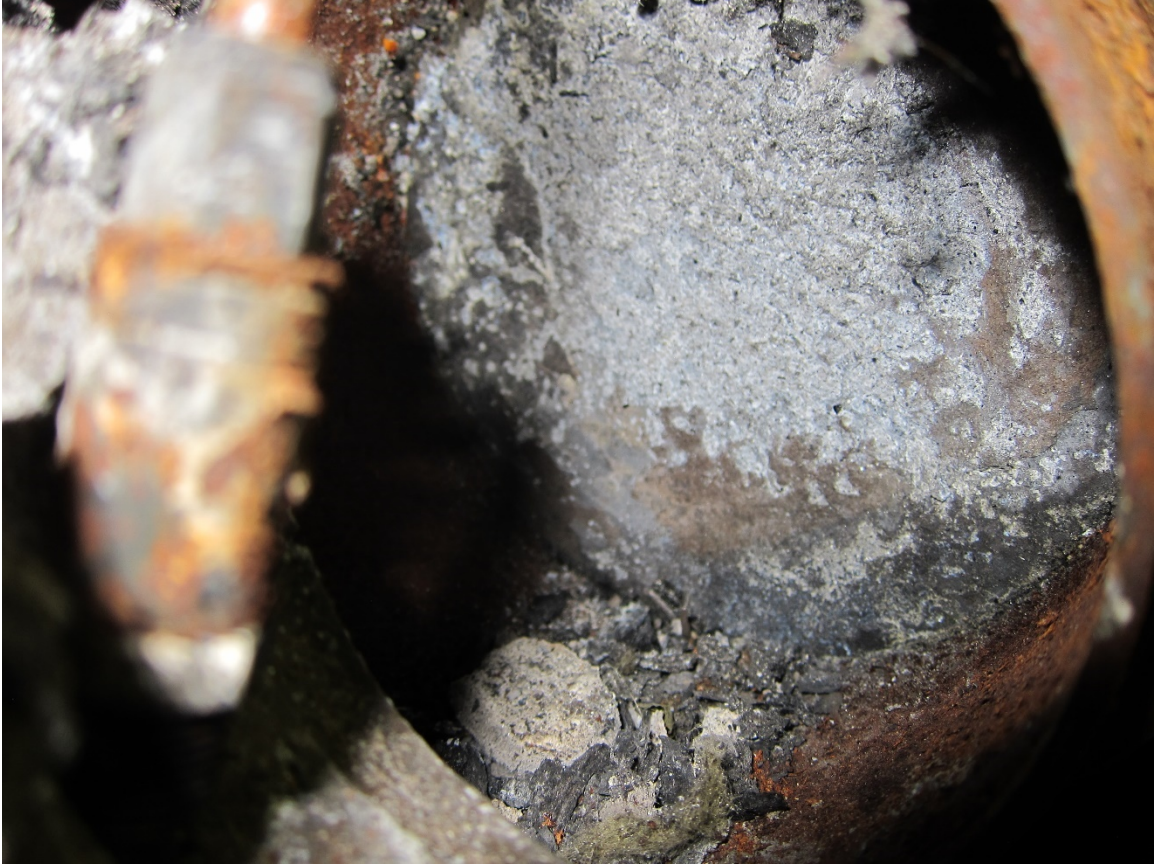
*Figure 5 Right Engine No. 5 Piston Top*

The No. 5 piston top had some melting on the piston top

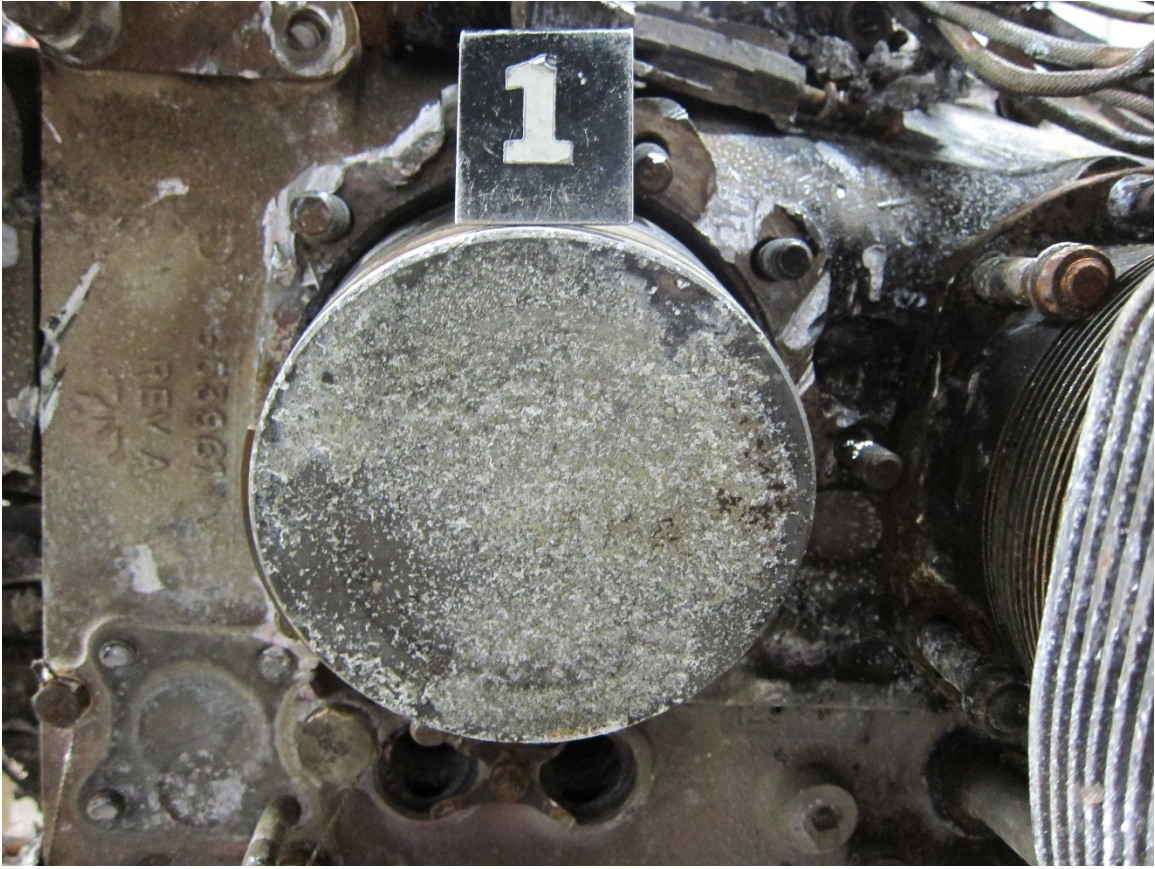
*Figure 6 Right Engine No. 1 Piston Top*

The No. 1 piston top did not appear to have any melting or damage, there was no melted piston material on the spark plug.

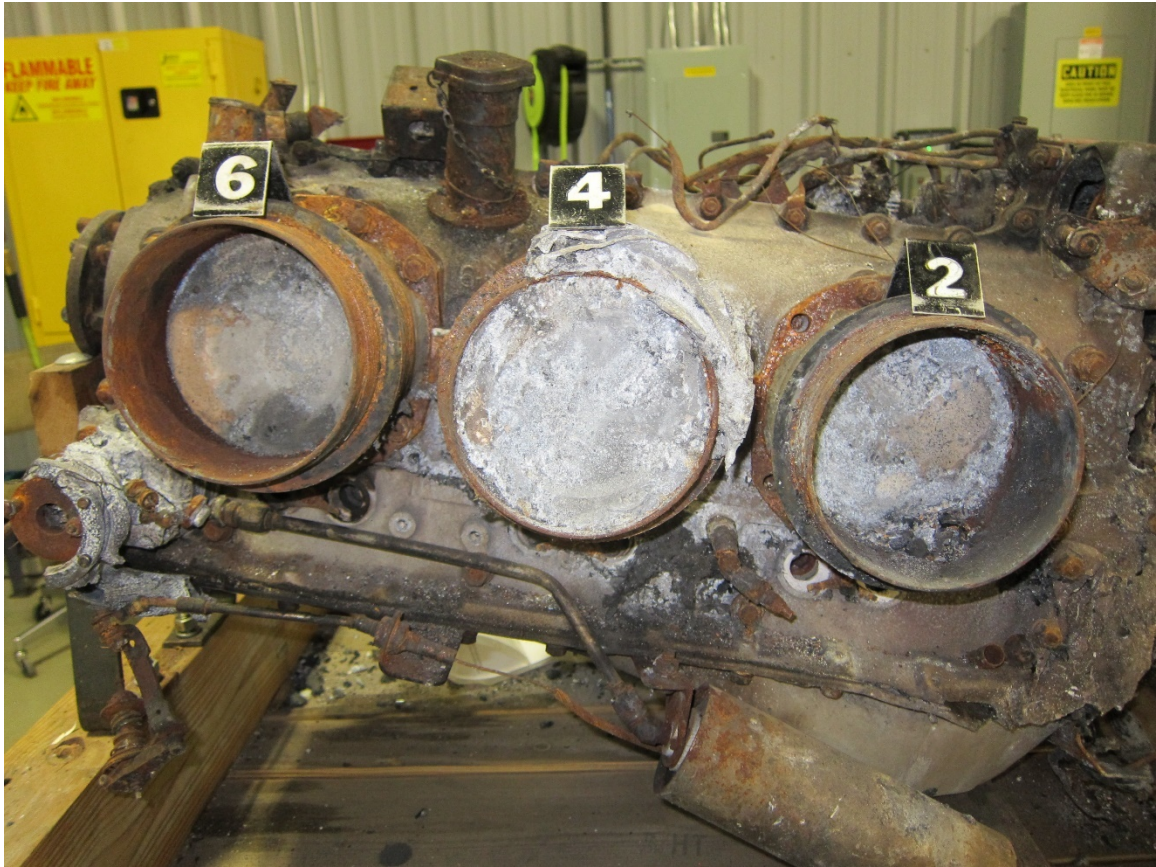
The Nos. 6, 4 and 2 piston tops had some melting/ thermal damage
