National Transportation Safety Board

ERA22FA261

WRECKAGE EXAMINATION SUMMARY

Location: Panama City, Florida
Date: June 6, 2022
Time: 1610 CDT
2110 UTC
Airplane: Piper PA-28RT-201

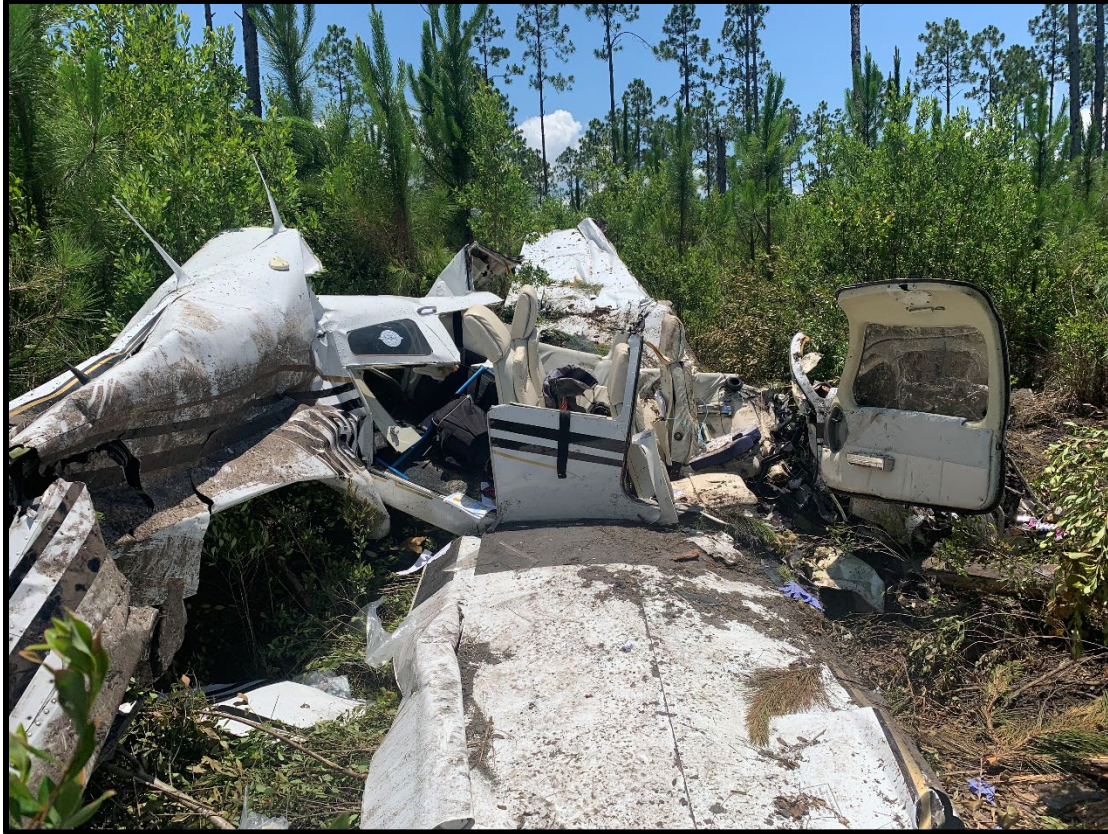
Figure 2 - Main Accident Site

The airplane came to rest in a dense brush area, at an elevation of 25 ft, upright, on a 200° heading. All major components of the airplane were located in the vicinity of the main wreckage. The airplane struck three trees prior to impacting the ground. The first tree was about 100 ft from the main wreckage. There was an odor of fuel at the accident site.

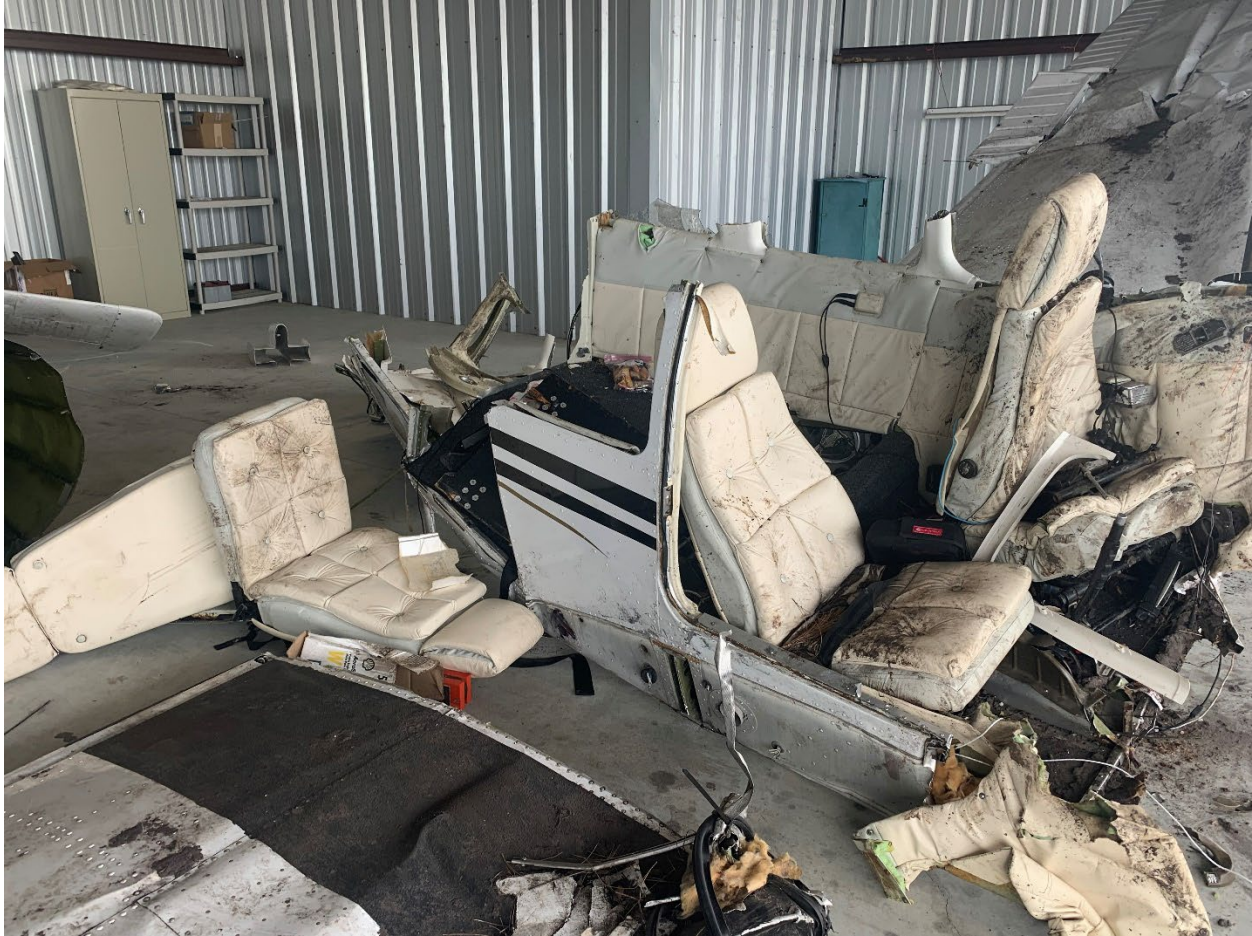
Figure 3. View of fuselage.

The forward section of the cabin was impact crushed aft. The four seats remained attached to the cabin floor. The top of the cabin was cut by first responders. The yokes remained attached to the control columns. Flight control continuity was established from the flight control surfaces to the flight controls through cuts made by recovery personnel.

The right underside of the fuselage was coated in oil.

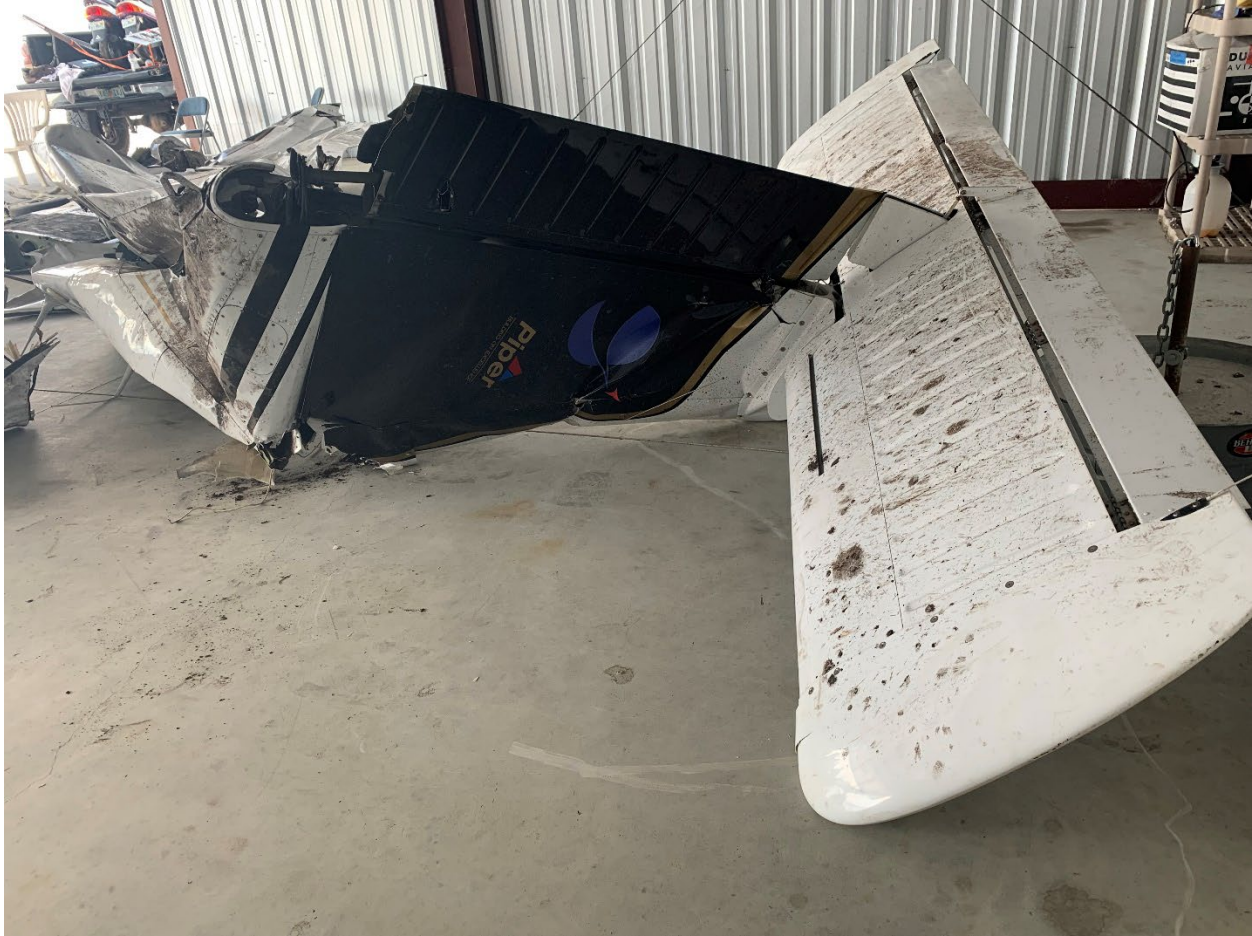
Figure 4. View of right side of empennage.

The empennage was partially impact separated but remained attached to the fuselage on the right side. The empennage was separated to facilitate recovery. The vertical stabilizer remained attached to the empennage. The rudder remained attached to the vertical stabilizer, but the bottom 8-inch section was impact separated. The horizontal stabilator remained attached to the vertical stabilizer. The stabilator trim tab remained attached to the horizontal stabilator. The trim drum was measured and corresponded to partial nose down trim.

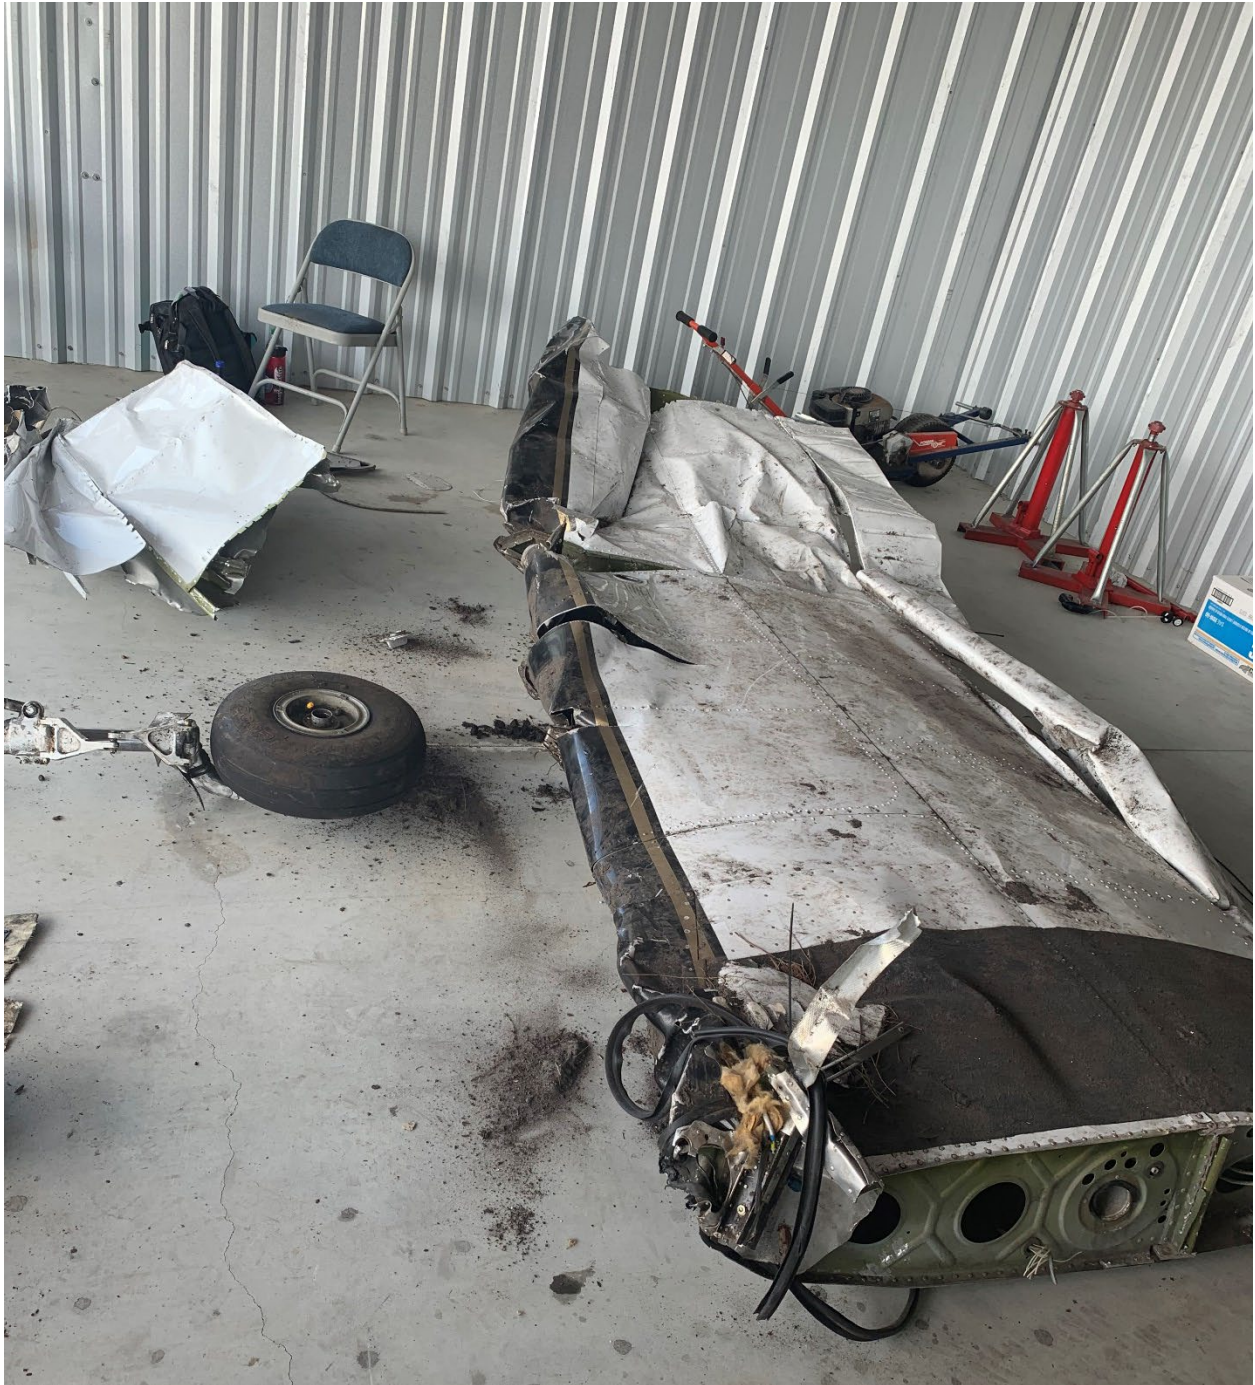
Figure 5. View of right wing.

The right wing remained attached to the fuselage and the leading edge exhibited impact damage. The outboard 4 ft section of the right wing was impact separated and located along the debris path. The inboard section of the right aileron remained attached to the right wing and was impact damaged. The right inboard section of the aileron remained attached to the right wing and the outboard section was impact separated and located along the debris path. The balance weight was not located. The right flap was extended to the 40° position and remained partially attached to the right wing. The right wing fuel cap remained seated and the right fuel tank was breached. The right fuel pickup screen was free of debris.

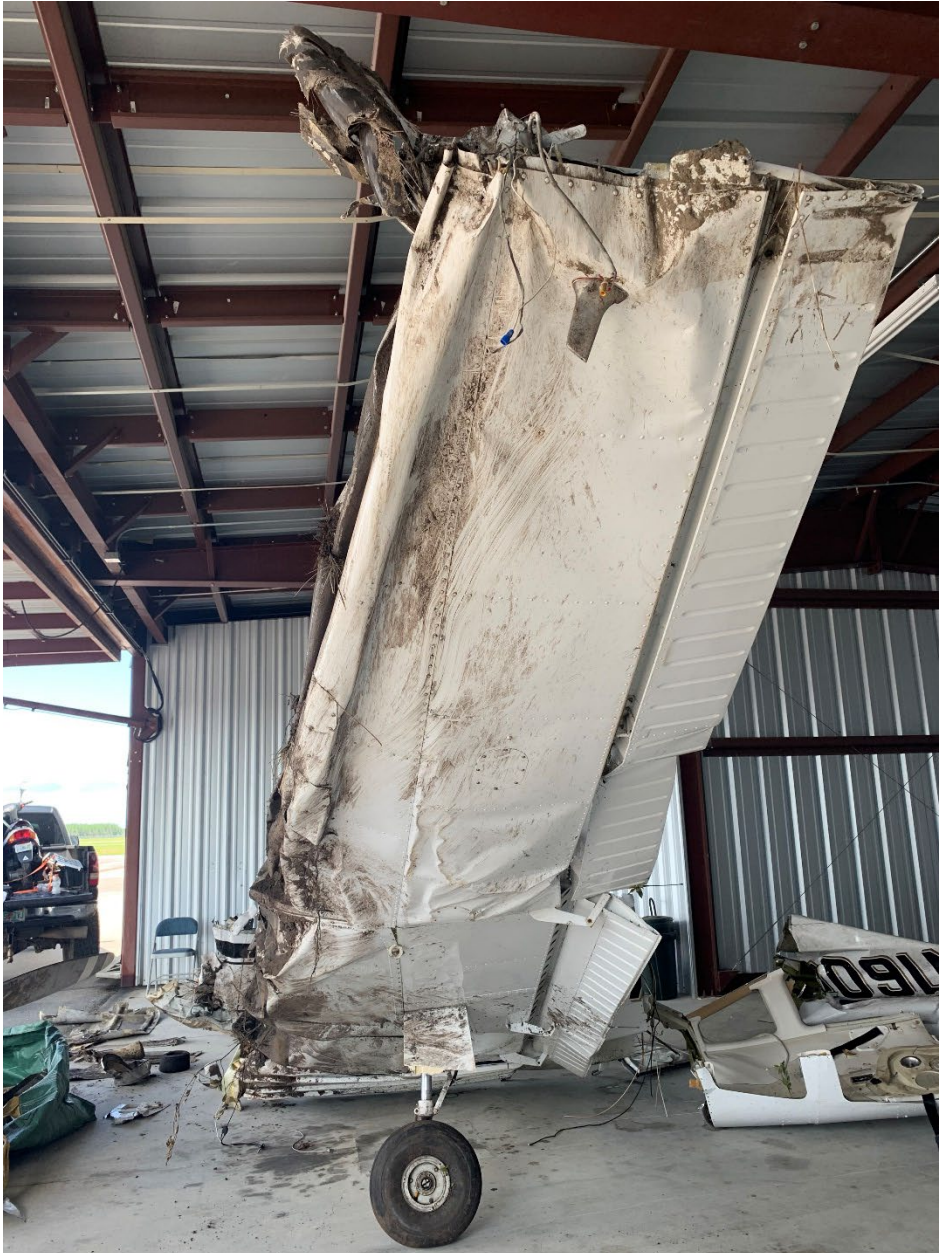
Figure 6. View of left wing.

The left wing remained attached to the fuselage. The leading edge exhibited impact damage the entire span. The left wing tip was impact separated and located in the vicinity of the left wing. The left flap was extended to the 40° position and remained attached to the left wing. The left aileron remained attached to the left wing and exhibited impact damage. The left fuel cap remained

seated and the left fuel tank was breached. The left fuel pickup screen was free of debris.

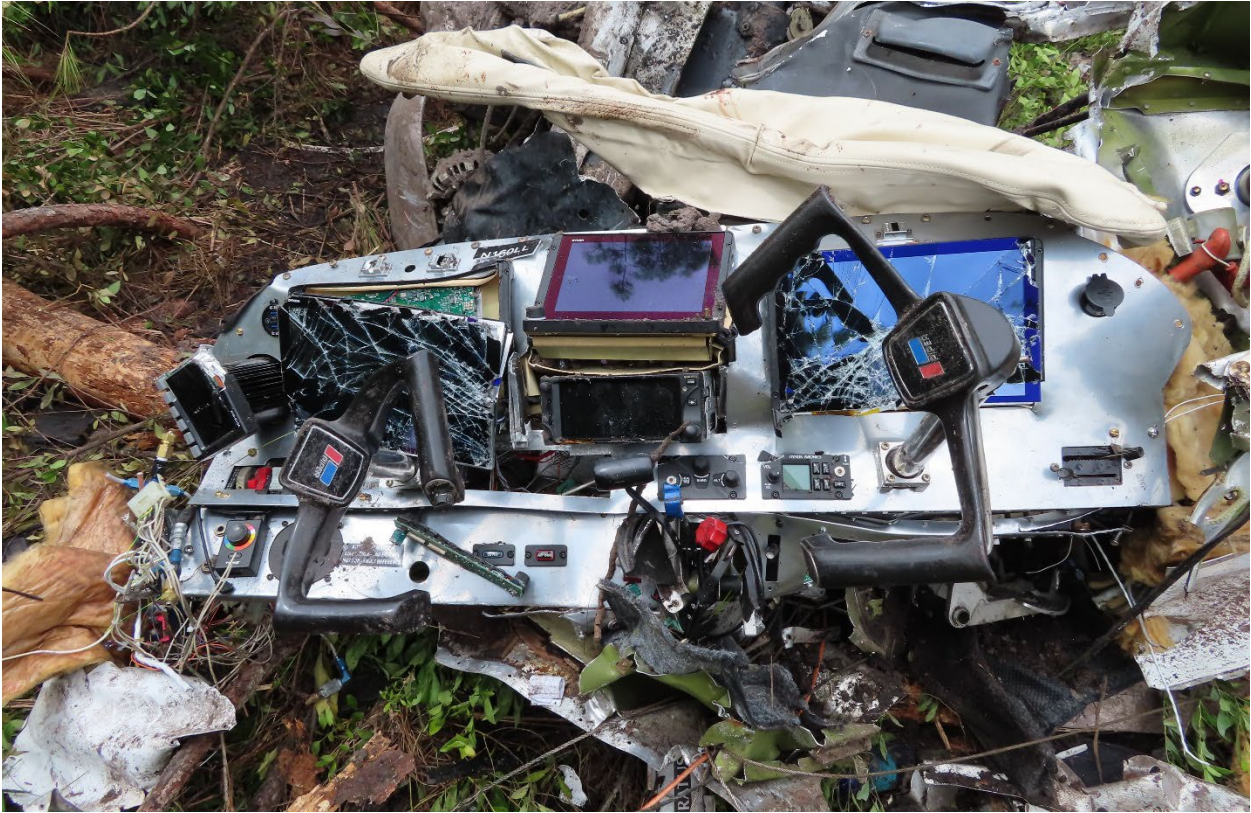
Figure 7. View of instrument panel.

The flap handle was in the 40° flaps extended position. The landing gear handle was in the down position.

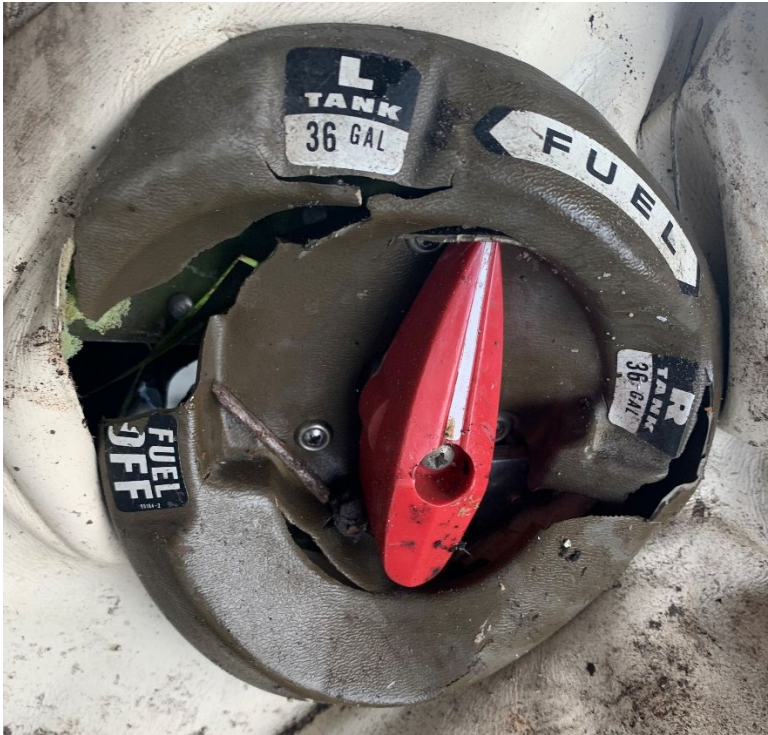
Figure 8. View of fuel selector as found.

The fuel selector was in the left tank position. When low pressure air was applied to the fuel line going from the fuel selector back to left and right tank

inlet, air came out of the line going into each tank. There was no debris noted on the fuel screens inside the fuel tanks. The gascolator was disassembled and the fuel screen did not contain debris.

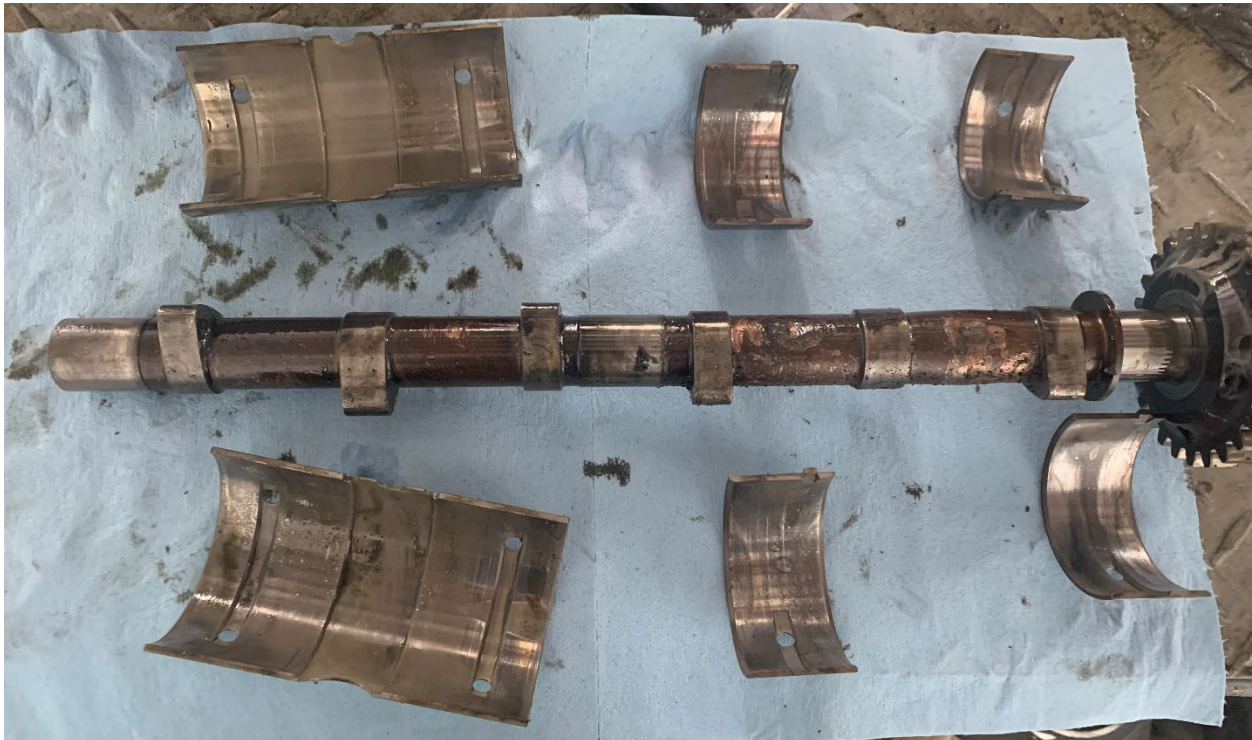
The camshaft was removed and examined. The No. 4 camshaft lobe exhibited impact damage and thermal damage was noted on the aft section of the camshaft.

Figure 13. View of camshaft and main journal bearings. From left to right - front main bearing, center main bearing, rear main bearing.

The front main bearing exhibited no anomalies. The center main bearing exhibited no anomalies. The rear main bearing exhibited minor smearing.

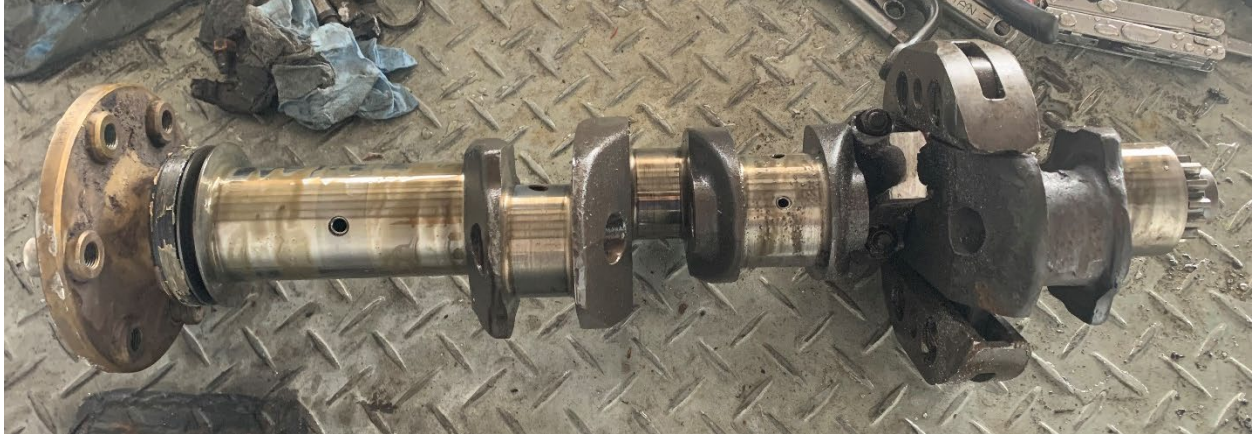
Figure 14. Crankshaft.

The crankshaft was removed from the engine and examined. No anomalies were noted on the main journals. The Nos. 1 & 2 connecting rod journals exhibited no anomalies. The No. 3 connecting rod journal could not be examined because the No. 3 connecting rod remained attached to the crankshaft. The No. 4 connecting rod journal exhibited thermal damage and bearing material was noted welded to the crankshaft.

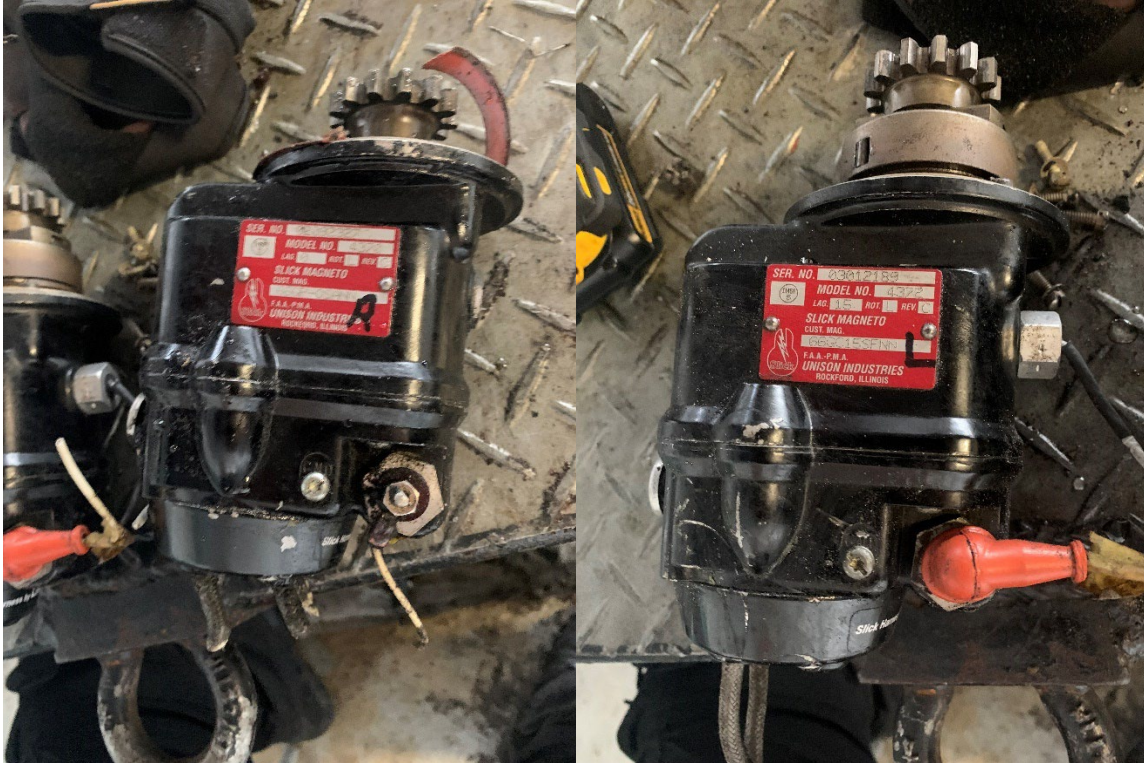
Figure 15. View of magnetos

The left and right magnetos remained attached to the engine. The magnetos were turned by hand and sparked on all towers.

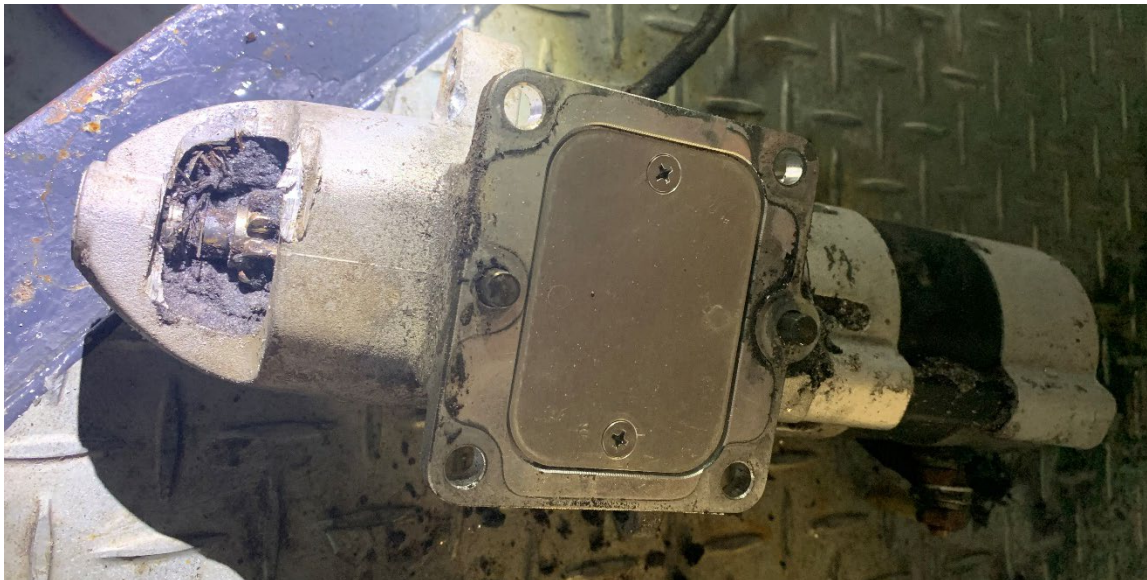
Figure 17. View of starter.

The starter remained attached to the engine. Rotational scoring was noted on the starter gear.

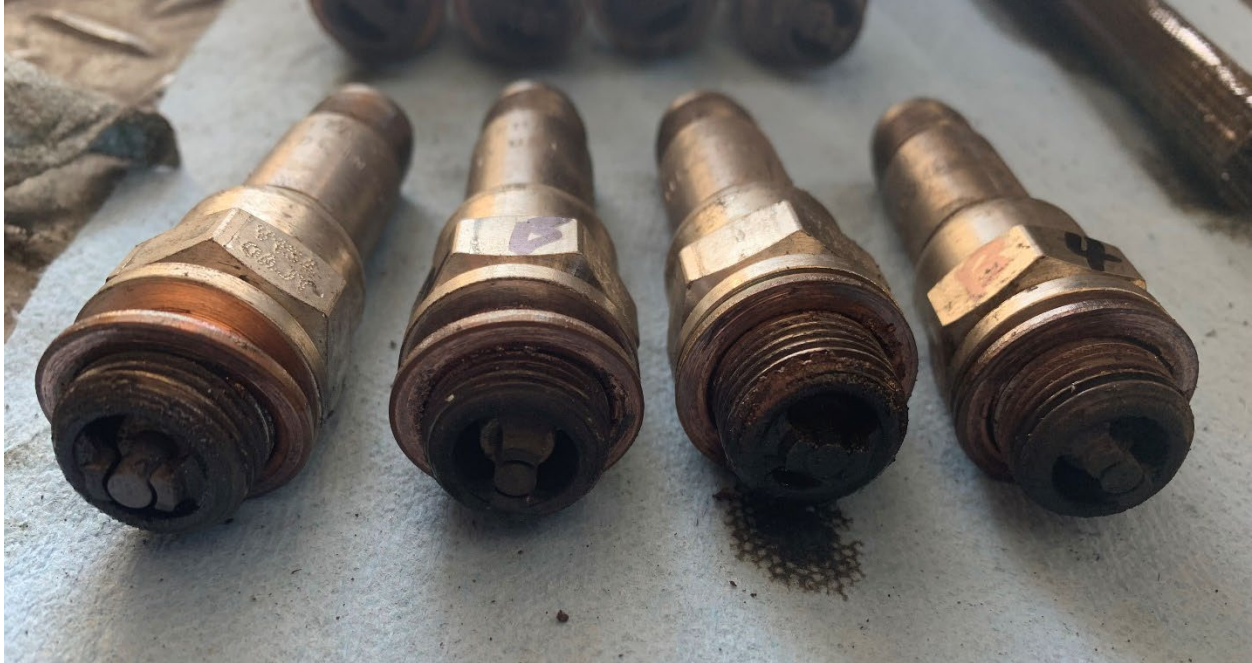
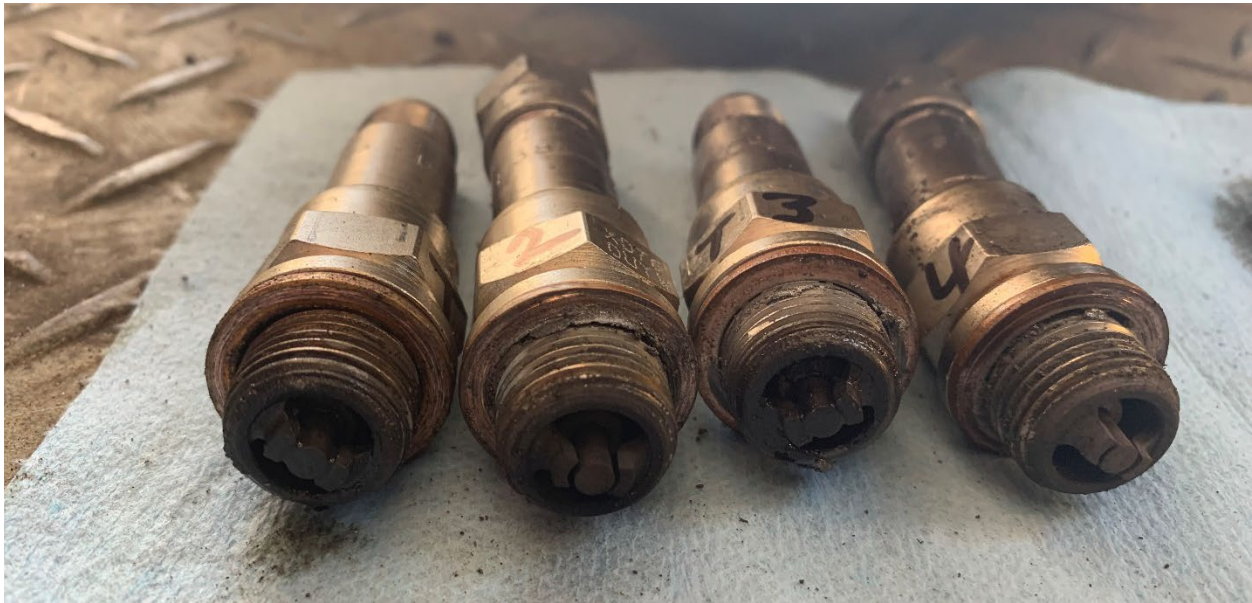
All spark plugs were removed from the cylinders and examined. The Nos. 1 and 3 top and No. 3 bottom spark plug was oil soaked. All other spark plugs were dark grey in color and exhibited normal wear when compared to the Champion Check-A-Plug Chart.

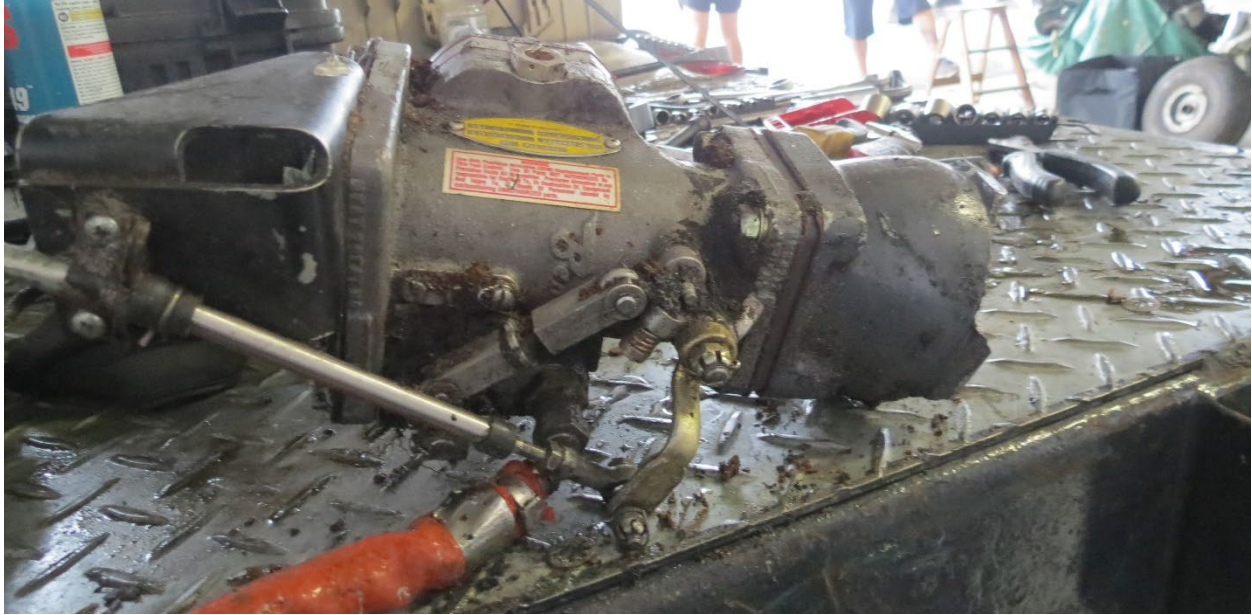
Figure 21. Fuel Servo

The fuel servo was impact separated from the engine. When it was examined, 100LL aviation fuel drained out of the inlet hose. Dirt was noted inside the throttle body. Both control cables were impact damaged, therefore, their position could not be determined. The control cables remained attached to their respective control arms. The fuel line to the servo was unobstructed. The throttle valve could be moved by hand. The fuel screen was removed from the throttle body and no debris was noted in the screen. The mixture control arm could be moved by hand. The servo regulator diaphragm was intact, and no anomalies were noted.

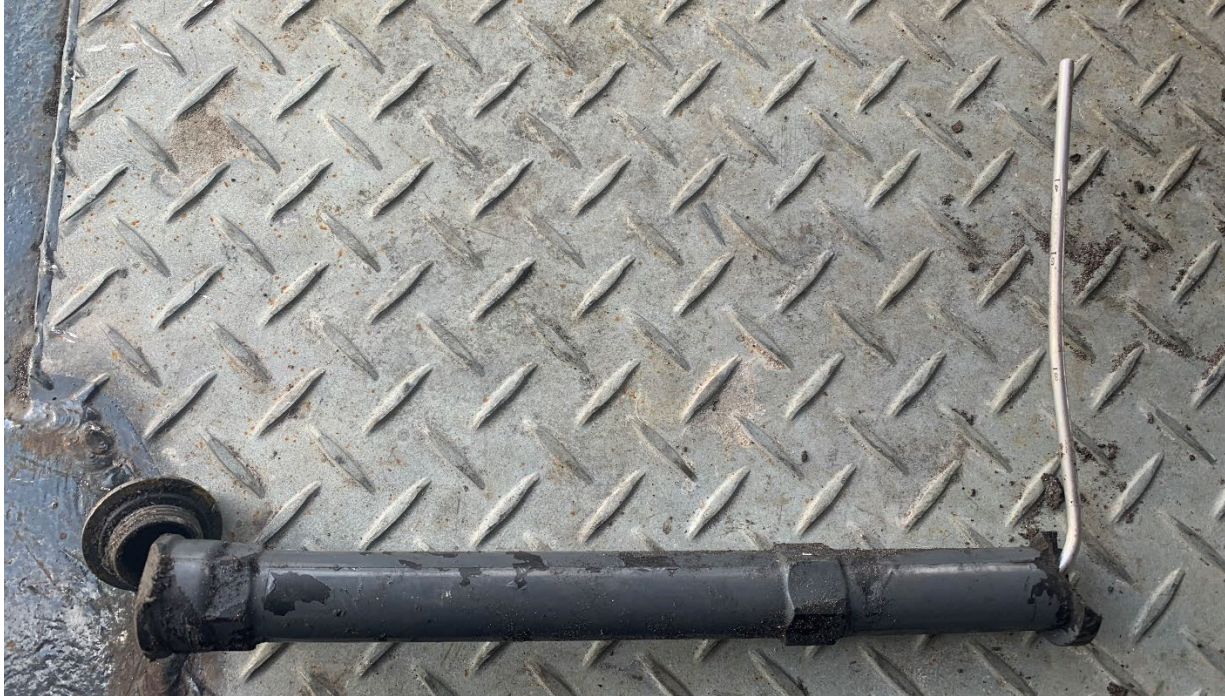
Figure 22. View of oil filler neck and oil dipstick.

The oil filler neck and dip stick were impact separated from the engine. The oil dip stick threads were undamaged but covered in oil and dirt. The threads of the filler neck were undamaged but were covered in oil and dirt.

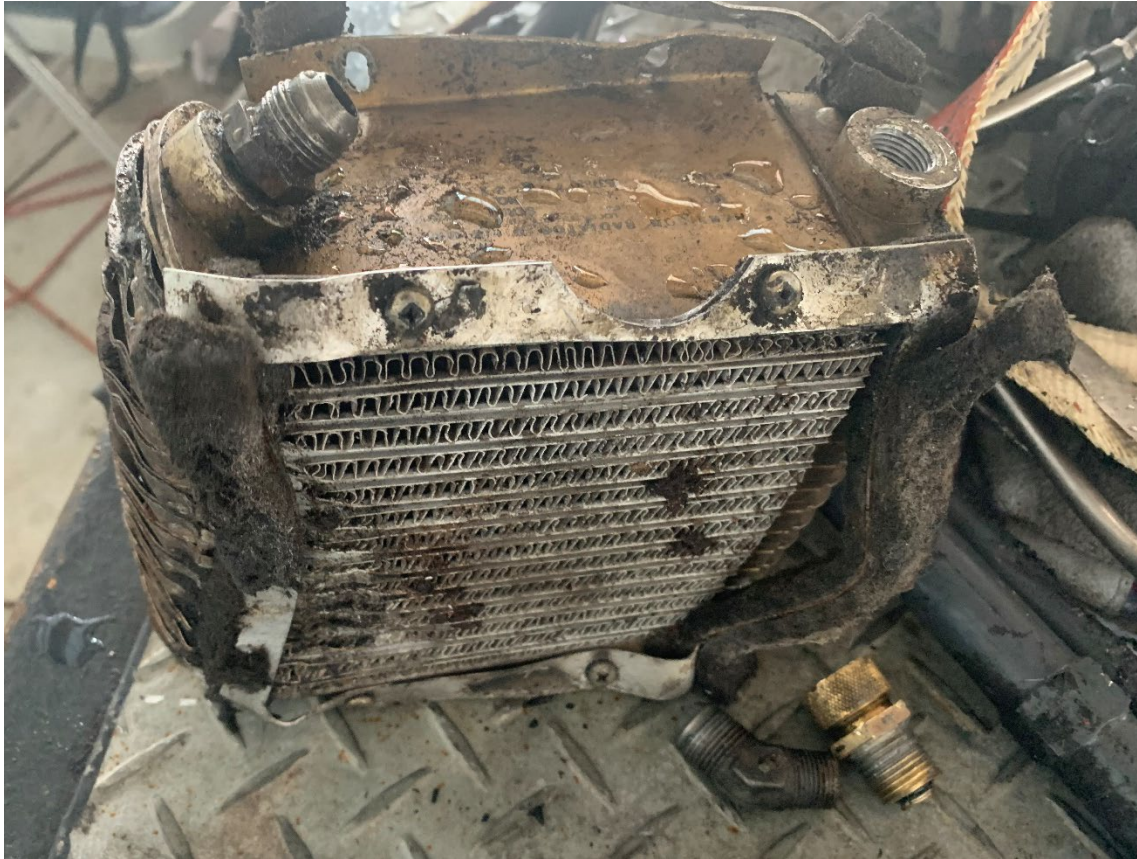
Figure 23. View of oil cooler.

The oil cooler was removed and exhibited impact damage. The oil lines to and from the oil cooler were pressure tested and no leaks were noted.

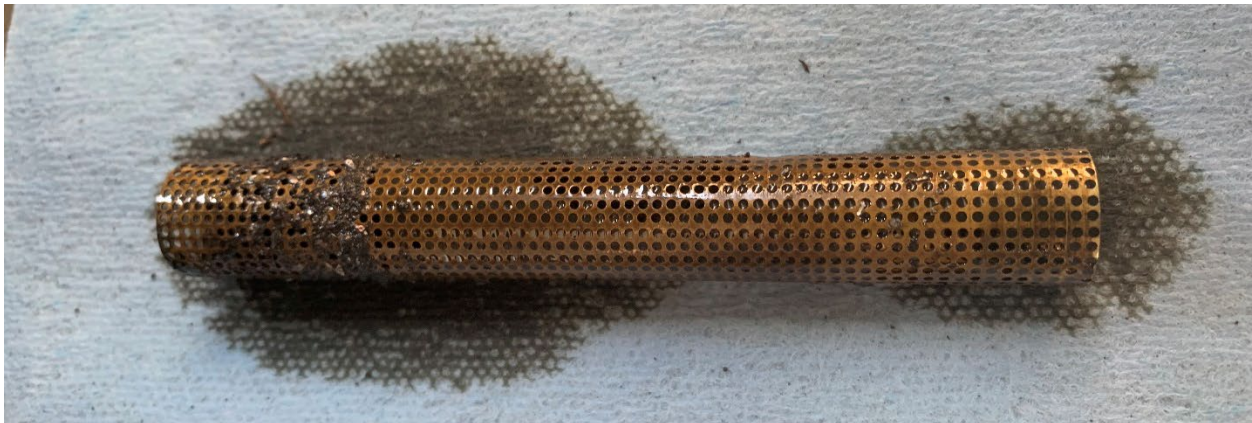
Figure 24. Side view of oil suction screen.

The oil suction screen was removed from the sump and it was filled about $\frac{1}{4}$ with metallic and carbon debris. About a $\frac{1}{2}$ teaspoon of the debris was metallic.

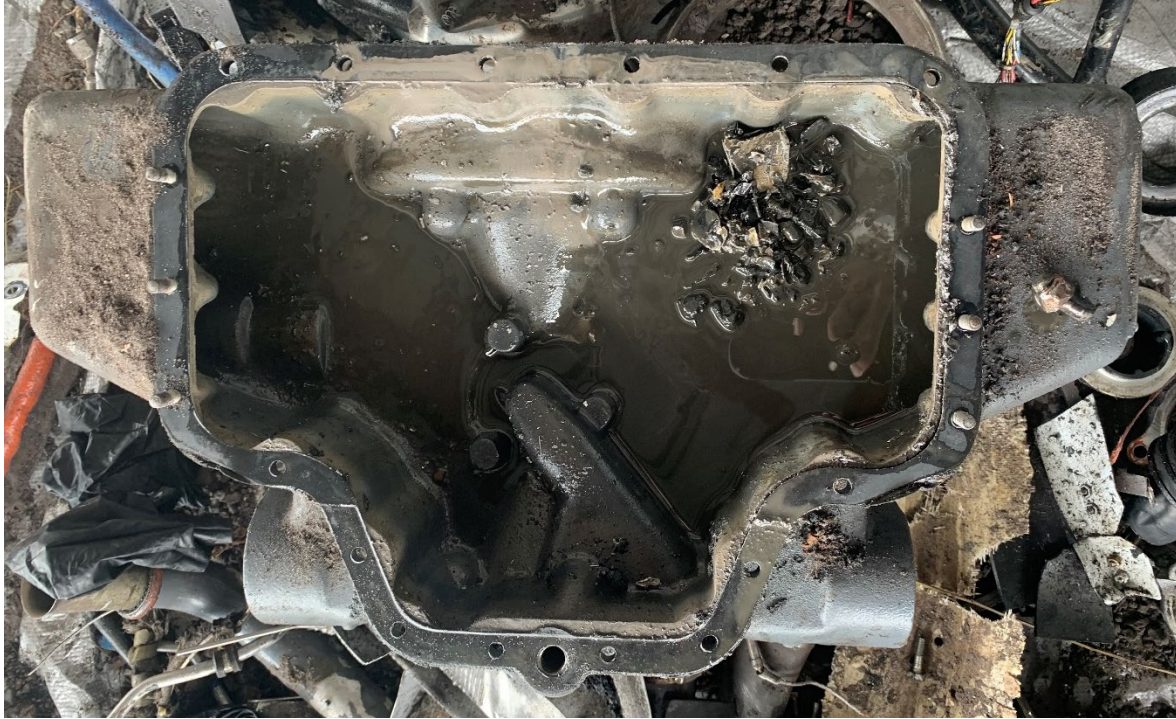
The No. 4 cylinder remained attached to the crankcase. The No. 4 piston remained in the cylinder and could not be removed. The No. 4 connecting rod remained attached to the piston but was impact damaged and separated from the crankshaft. The No. 4 connecting rod bearing was smeared and located in the oil sump.

The oil sump was removed and the No. 4 connecting rod cap, connecting rod bolt and bearing pieces were noted in the sump along with other metallic debris.

Figure 27. View of oil sump and debris in the sump.

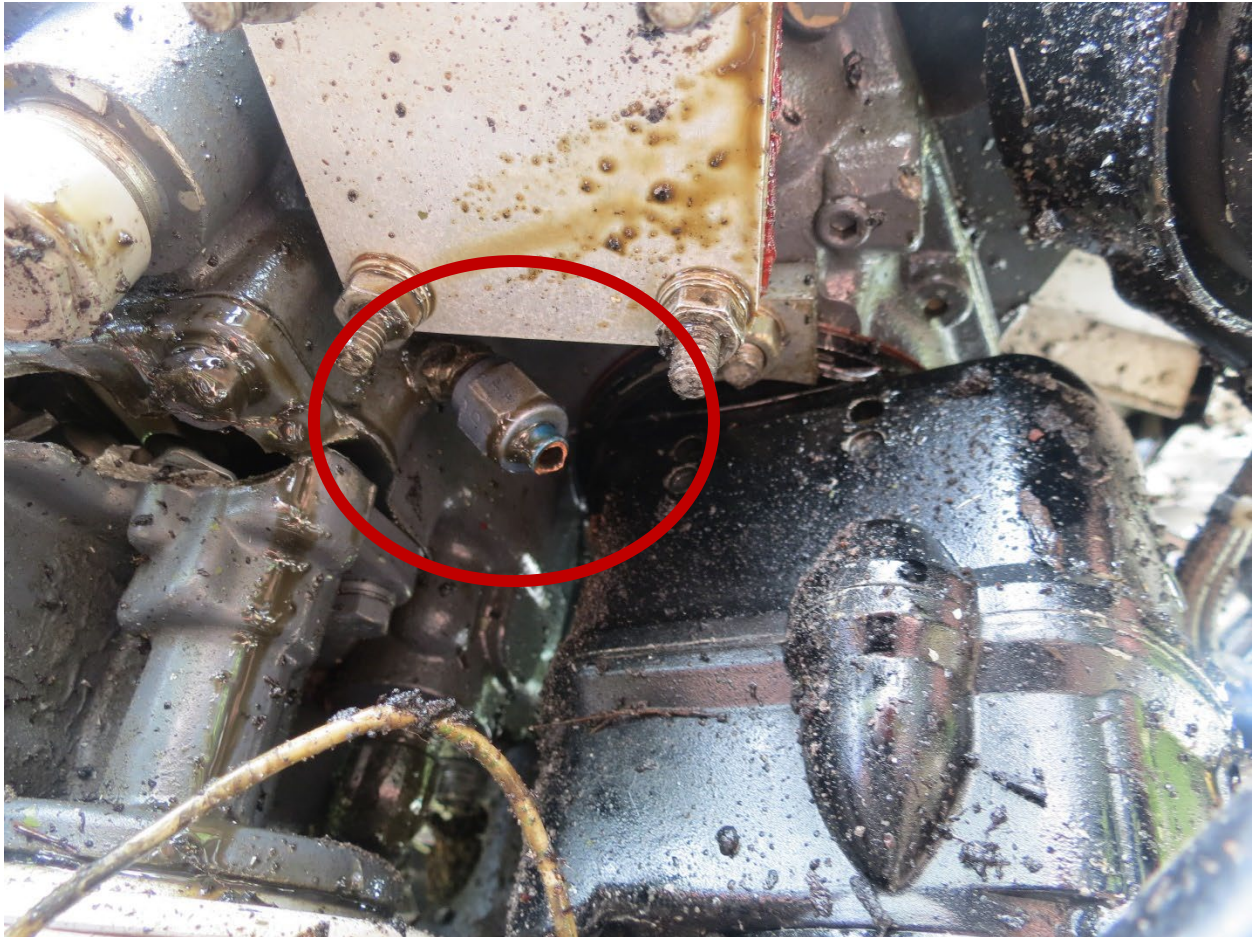
The oil pressure sensor was separated from the engine. The copper line was fractured at the fitting to the accessory section of the crankcase. The copper line and oil pressure sensor were retained for further examination. According to the STC and installation instructions, "Always mount the sensor to the airframe structure and connect it with flexible hose to minimize vibration effects." Furthermore, the oil pressure sensor did utilize a restrictor fitting.

Figure 29. View of broken copper line installed on the accessory section of the engine.

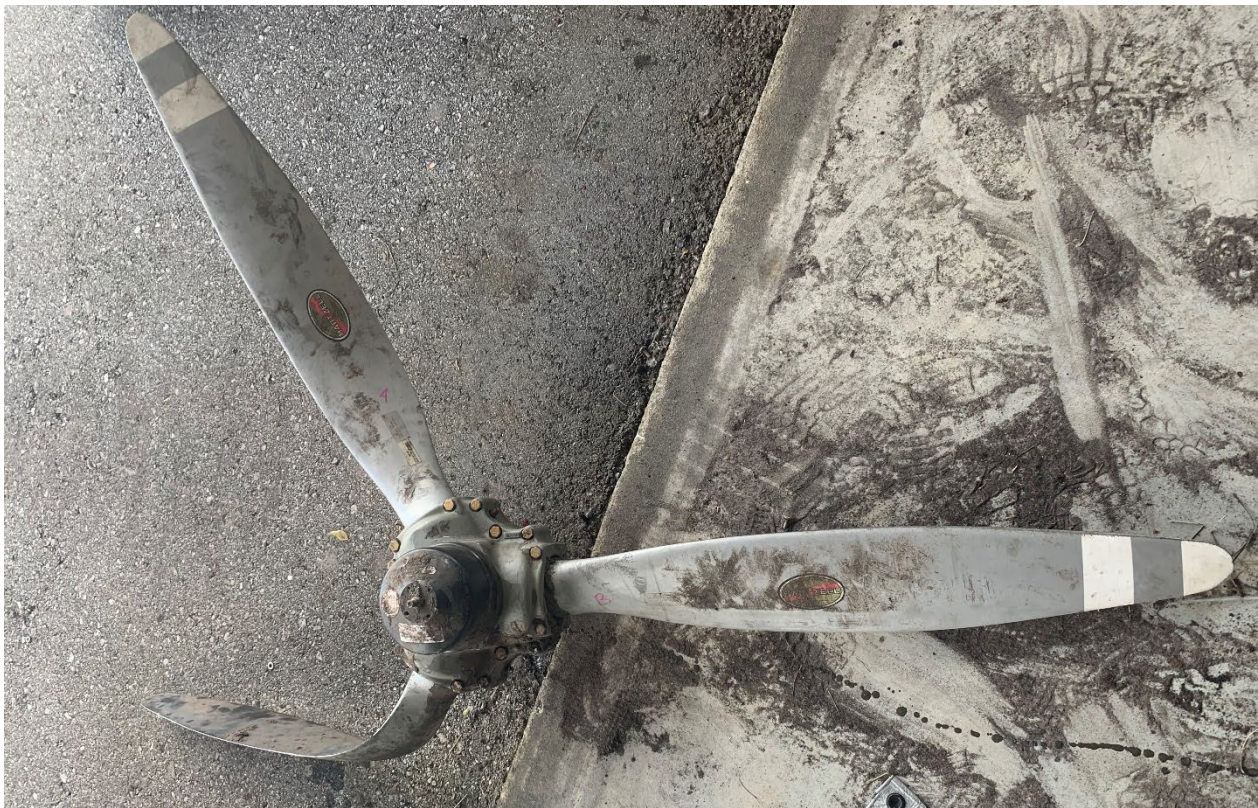
Figure 31. Propeller.

The three-blade propeller remained attached to the engine. The spinner was impact damaged and all blades remained attached to the hub. Blade A was bent forward about 30°. Blade B remained straight and exhibited chordwise scratching. Blade C was bent aft about 90°.

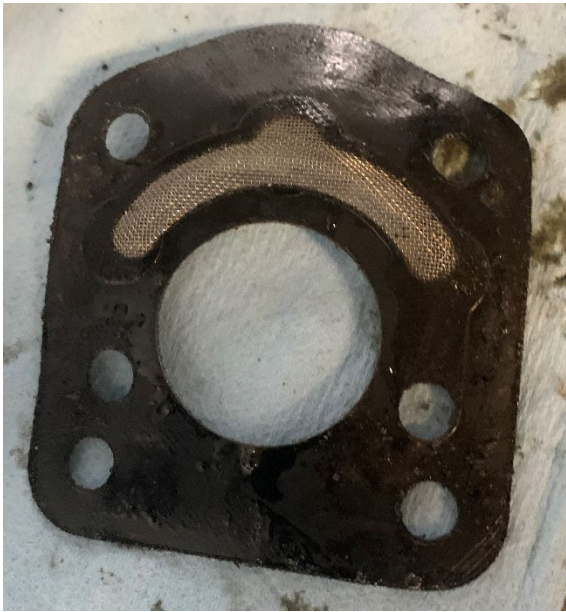
Figure 32. View of propeller governor screen.

The propeller governor was removed and the control rod end remained attached to the control arm. The governor could not be rotated by hand. The

propeller governor screen was removed, and small particles were noted in the screen, but it was not obstructed. (Hartzell F-2-7A, S/N NK58665E)

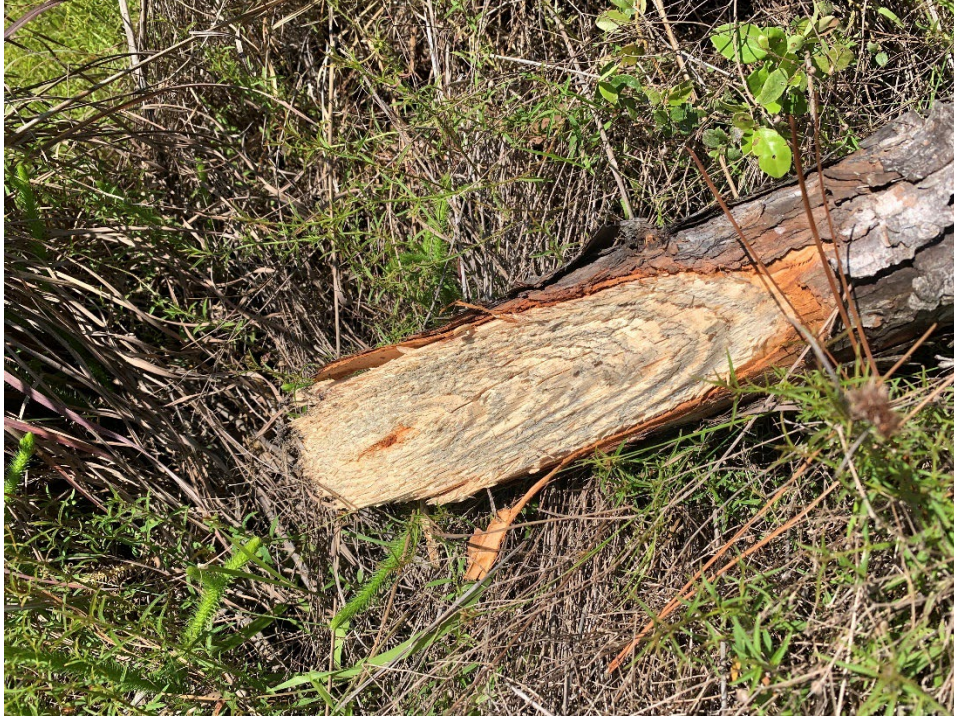
There were multiple branches located along the debris path that exhibited black paint transfer and were cut at 45° angles.

Figure 33. View of branch with 45° angle cut and black paint transfer.
