**NATIONAL TRANSPORTATION SAFETY BOARD
OFFICE OF HIGHWAY SAFETY
WASHINGTON, D.C.**

**TECHNICAL RECONSTRUCTION GROUP CHAIRMAN'S
FACTUAL REPORT**

1. Introduction, Collision Site Description and Data Sources

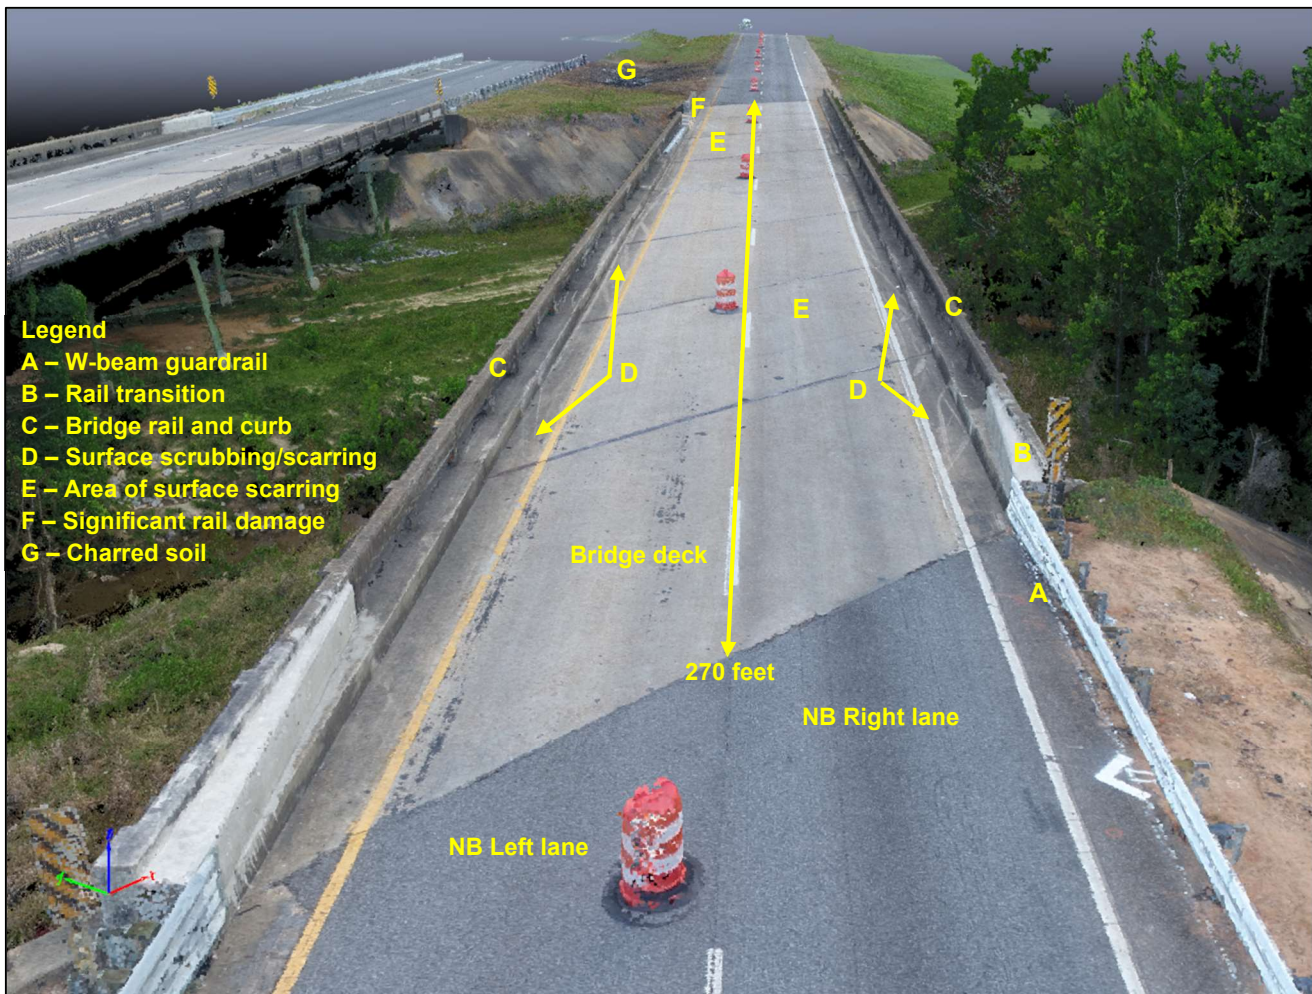
Pavement surface scrub marks, scuffing and scarring were observed in both travel lanes and shoulders on the bridge. As noted, the bridge deck shoulder widths decrease to about 2.5 feet with contiguous raised concrete curbing and railing along the outside of the shoulder. Pavement scarring exhibited characteristics of linear scrapes and surface scrubbing or cleaning. Surface scarring along the shoulder areas frequently angled toward the raised curbing that likewise exhibited additional evidence of scarring and scrubbing.

Along the right half of the roadway, the onset of pavement surface evidence was observed about 11 feet from the south end of the bridge deck. The onset of contact evidence to the bridge rail began about 30 feet from the south end of the parapet.³ While some evidence of scrubbing to the raised curbing was observed along almost the entire length of the bridge, the most prominent evidence of bridge rail contact was observed about 164 feet from the south end of the rail. Within the right travel lane, surface scratches were observed near the middle of the lane about 62.5 and 148 feet from the south end of the bridge deck. These surface scratches were light and individually measured no more than about 3.8 feet in length.

Significant displacement of the bridge rail was observed about 222 feet from the south end of the rail.⁴ In total, about 24 feet of bridge rail was removed for repair. Evidence of contact with the left side ridge rail continued to the north end terminus.

Within the left travel lane, surface scarring in the form of multiple scrapes and scratches was observed beginning about 209 feet from the south end of the bridge deck. The scarring covered a distance of about 60 feet from about the middle of the lane and outward toward the left shoulder. Additional surface scarring was observed about 16 feet further north and continued to end of bridge deck. Some asphalt pavement gouging north of the bridge deck was also observed but its age could not be discerned.

Figure 4: Screen capture of photogrammetric 3D point cloud depicting northbound roadway bridge over Pigeon Creek with areas of evidentiary interest marked.

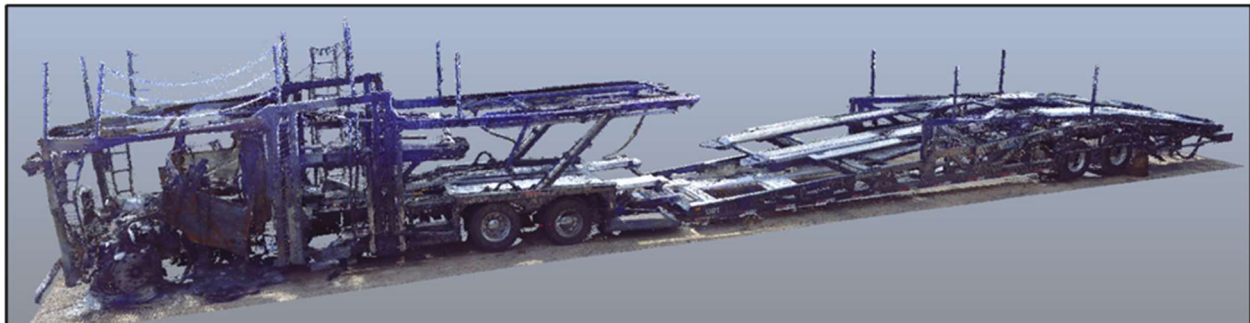
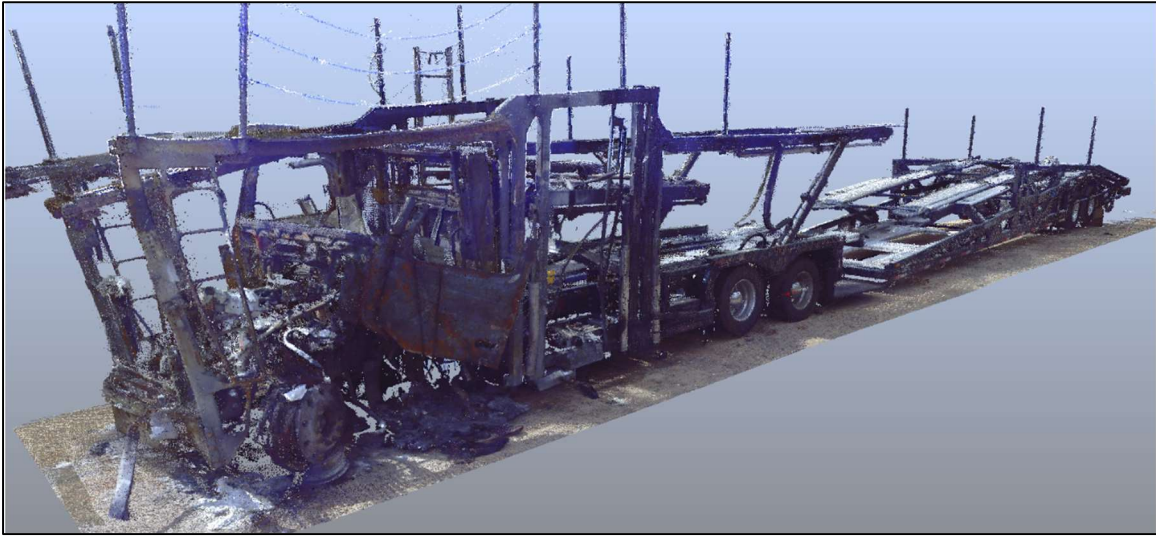
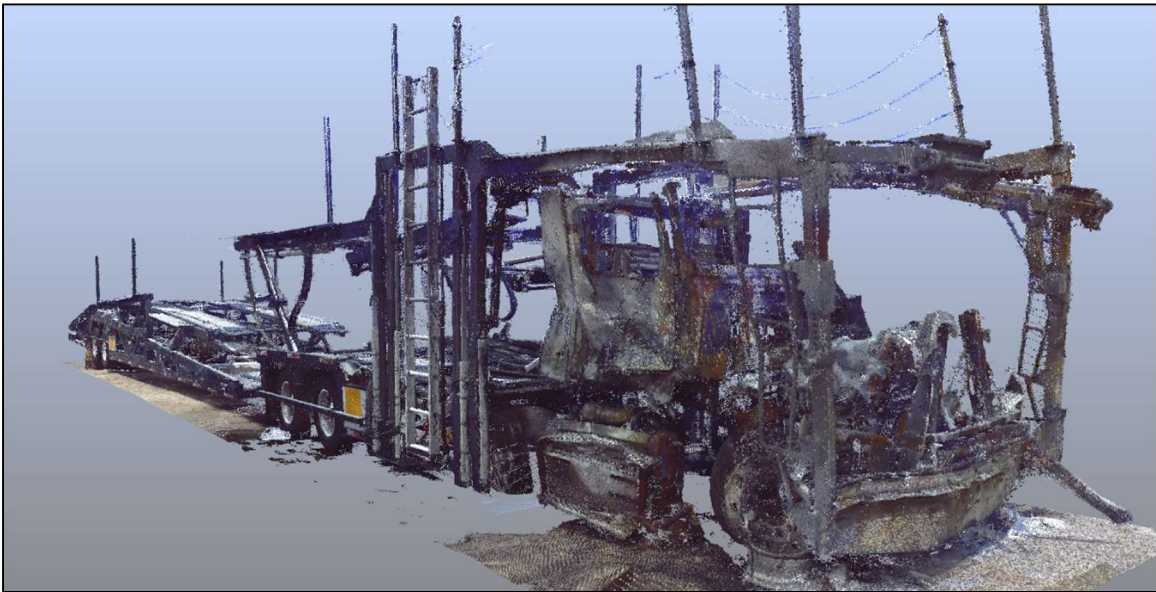
The left (driver's) side fuel tank had been consumed by fire while the right-side tank was found intact. **Figures 6-8** depict a screen captures of the colorized three-dimensional scan point cloud from different perspectives. **Figure 9** is a photograph depicting the damage along the right (passenger) side of the Cottrell trailer.

Figure 6: Screen capture of the 3D scan project point cloud depicting the left side of the Volvo combination.

Figure 7: Screen capture of the 3D scan project point cloud depicting the left side of the Volvo combination.

Figure 8: Screen capture of the 3D scan project point cloud depicting the right side of the Volvo combination.

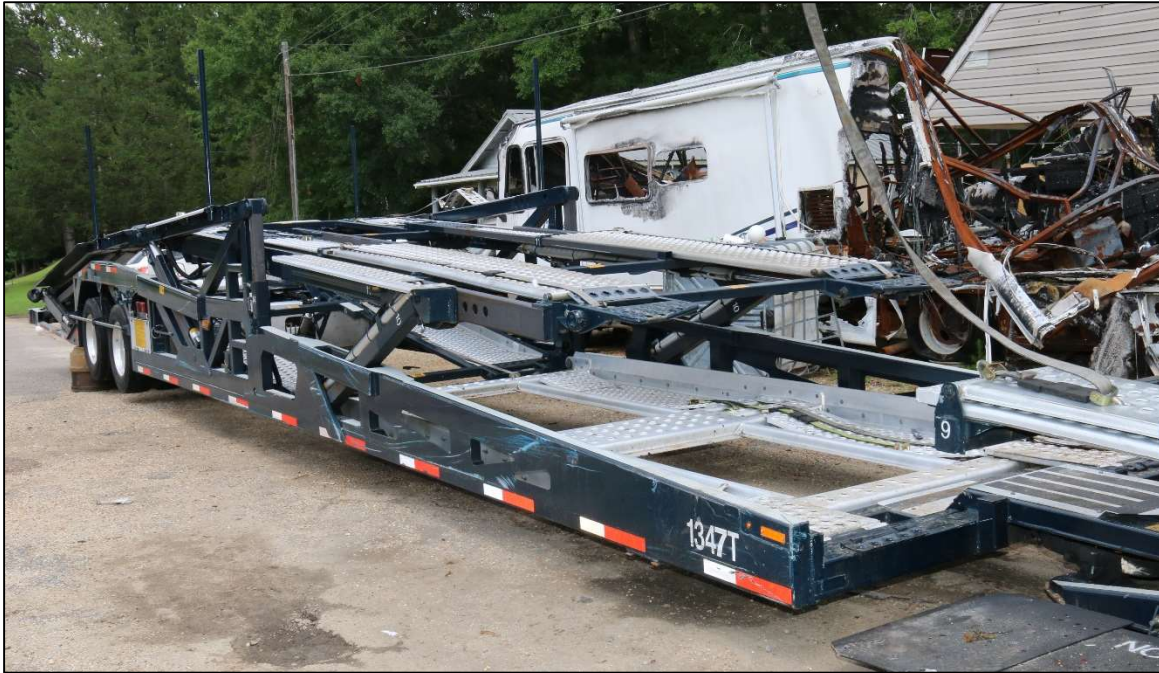
Figure 9: Photograph depicting paint damage along the right side of the Cottrell semitrailer.

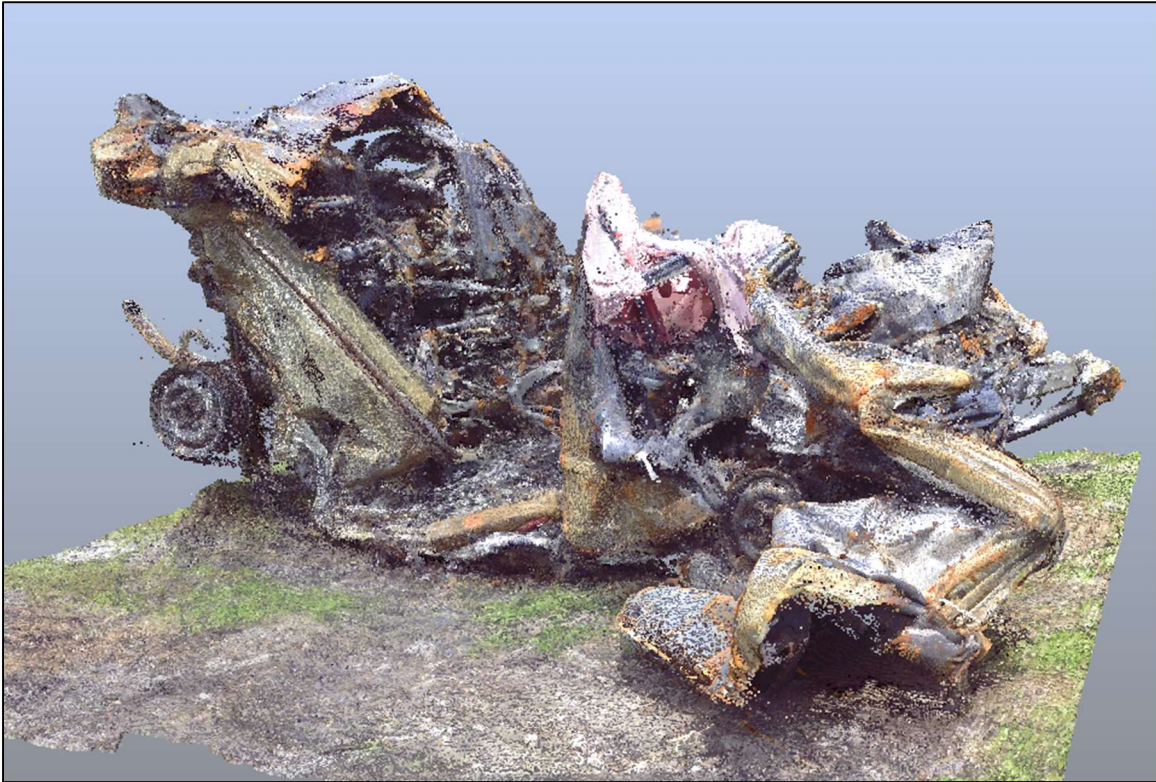
The vehicle was identified as a full-size van configured for multiple passenger transport. When examined at the storage facility the vehicle exhibited extensive deformation and the complete consumption of nonmetallic components by fire. Evidence of multiple impacts was observed at the front and rear that included an upward displacement of the vehicle structure at the rear just forward of the rear axle. The vehicle was so heavily damaged that additional evidence of contact was indiscernible. Displacement of some body structure was due to recovery operations. **Figures 10** and **11** depict screen captures of the colorized three-dimensional scan point cloud.

Figure 10: Screen capture of 3D scan point cloud depicting the right side of the Ford Transit van.

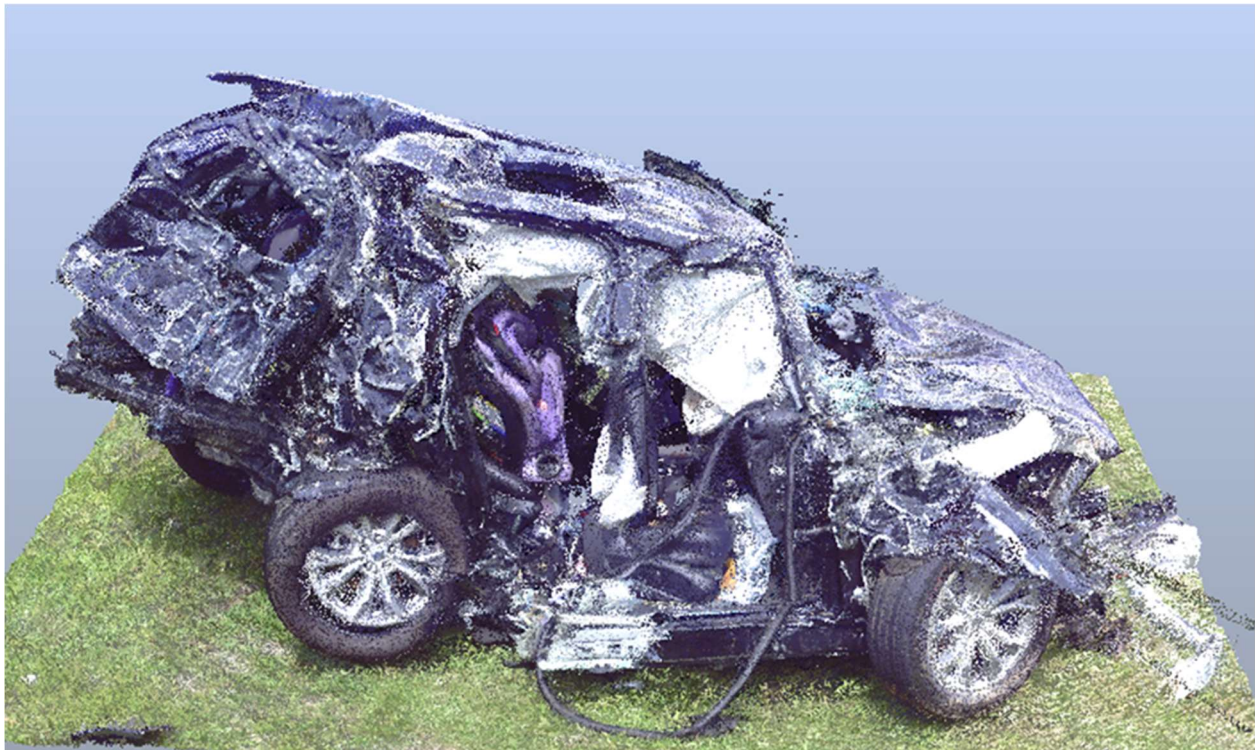
The vehicle was identified as a sport utility vehicle (SUV). When examined at the storage facility the vehicle exhibited extensive body deformation and occupant compartment displacement. While evidence of contact damage extended across the entire rear of the vehicle, the area of initial contact was at the right rear that resulted in greater displacement of the vehicle body structure along the right (passenger) side. The left front similarly exhibited evidence of contact damage that also resulted in the detachment of the left front wheel. The roof exhibited gouging and scraping to the painted surface that was consistent with the vehicle having overturned. **Figure 12** depicts a screen capture of the colorized three-dimensional scan point cloud.

Figure 12: Screen capture of 3D scan point cloud depicting the right side of the Ford Explorer.

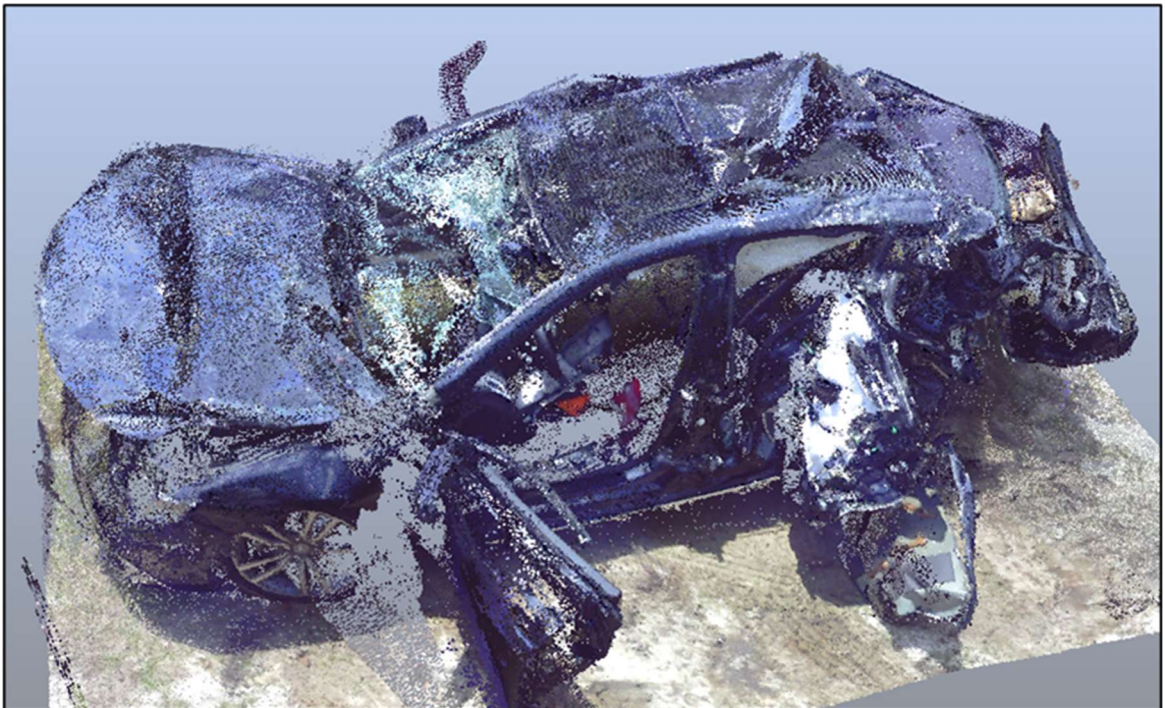
The vehicle was identified as a four-door sedan. When examined at the towing storage facility the vehicle exhibited extensive body deformation at the front, rear and along the right (passenger) side. The left rear exhibited evidence of a significant impact that also resulted in displacement of the axle. Contact damage at the right front was indicative of contact damage. The entire right (passenger) side exhibited damage and blue color material transfer consistent with a sideswipe contact. **Figure 13** depicts a screen capture of the colorized three-dimensional scan point cloud.

Figure 13: Screen capture of 3D scan point cloud depicting the left side of the Acura TLX.

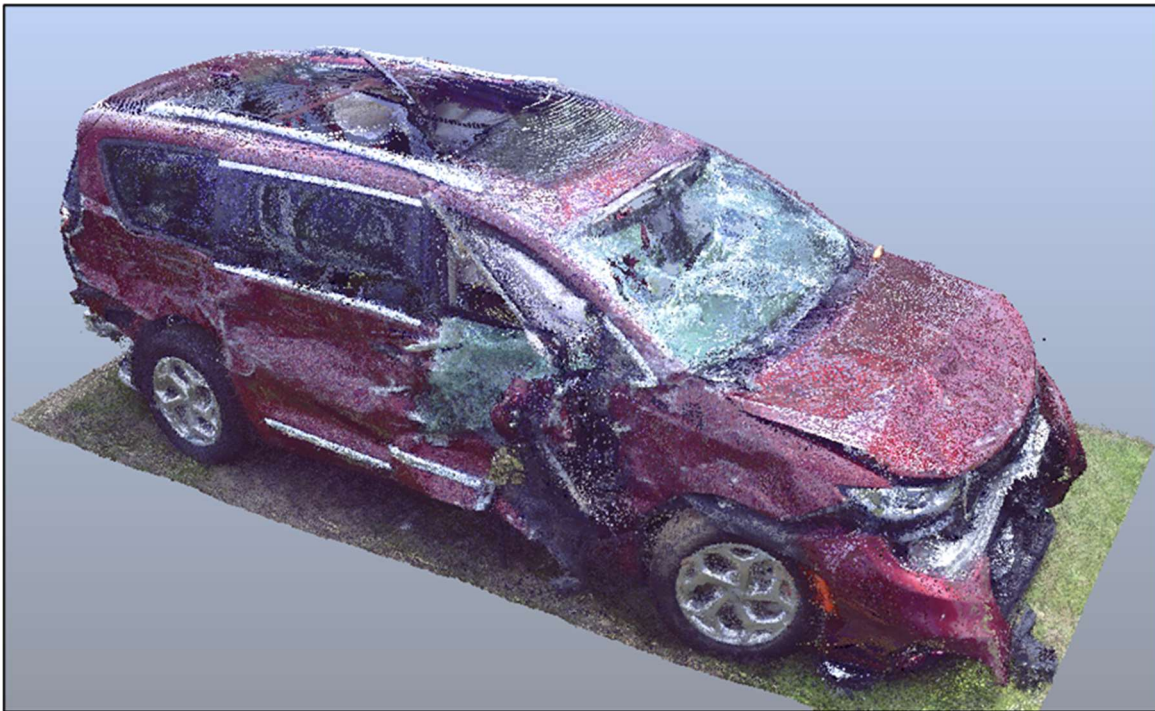
The vehicle was identified as a sport utility vehicle crossover. When examined at the storage facility the vehicle exhibited extensive body deformation at the front, rear and along both sides. Damage at the front of the vehicle was characteristic of a colinear impact with some indication of underride. Damage to both sides of the vehicle was characteristic of sideswipe contact. Entrapped within the damage at the right-side front door was dark colored fiberglass body panel that was consistent with the left rear lower fender skirt from the Buick. The rear exhibited impact damage at the bumper level that resulted in some forward displacement of the body and loss of the rear bumper cover. **Figure 15** depicts a screen capture of the colorized three-dimensional scan point cloud.

Figure 15: Screen capture of 3D scan point cloud depicting the right side of the Chrysler Pacifica.

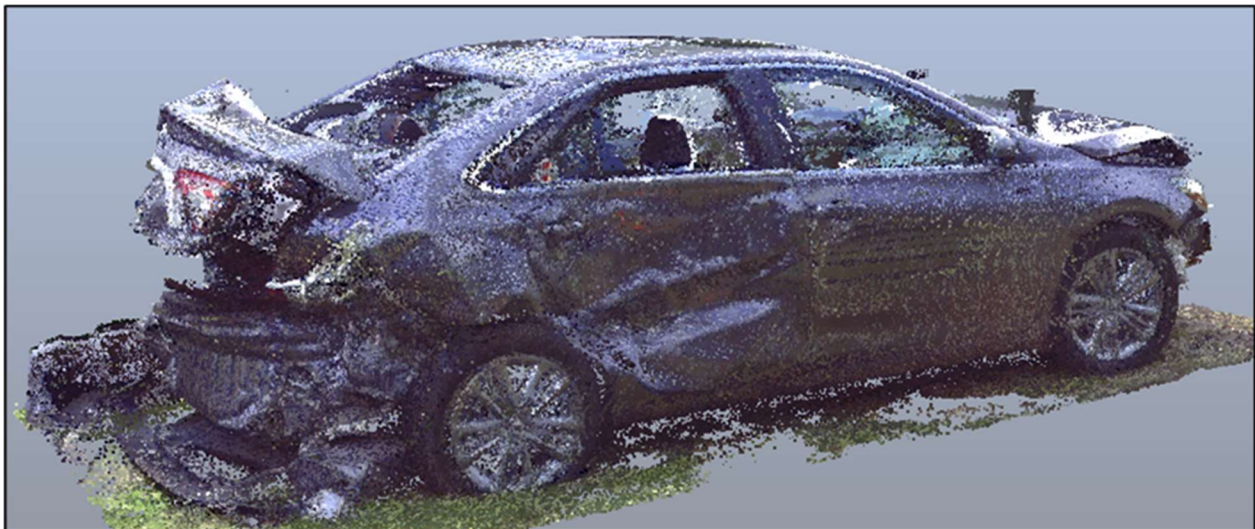
The vehicle was identified as a four-door sedan. When examined at the storage facility the vehicle exhibited contact damage at the front, rear and to both sides. Impact damage at the rear extended across the full width of the vehicle but exhibited greater displacement at the left rear. The left (driver) side exhibited evidence of contact at the left front fender and both side doors. The frontal impact damage appeared concentrated slightly to the left (driver) side of the vehicle centerline and generally appeared to be colinear. The right (passenger) side rear door exhibited contact damage that included inward displacement of the exterior door panel and some tearing to the sheet metal. **Figure 16** depicts a screen capture of the colorized three-dimensional scan point cloud.

Figure 17: Screen capture of 3D scan point cloud depicting the right side of the Toyota Camry.

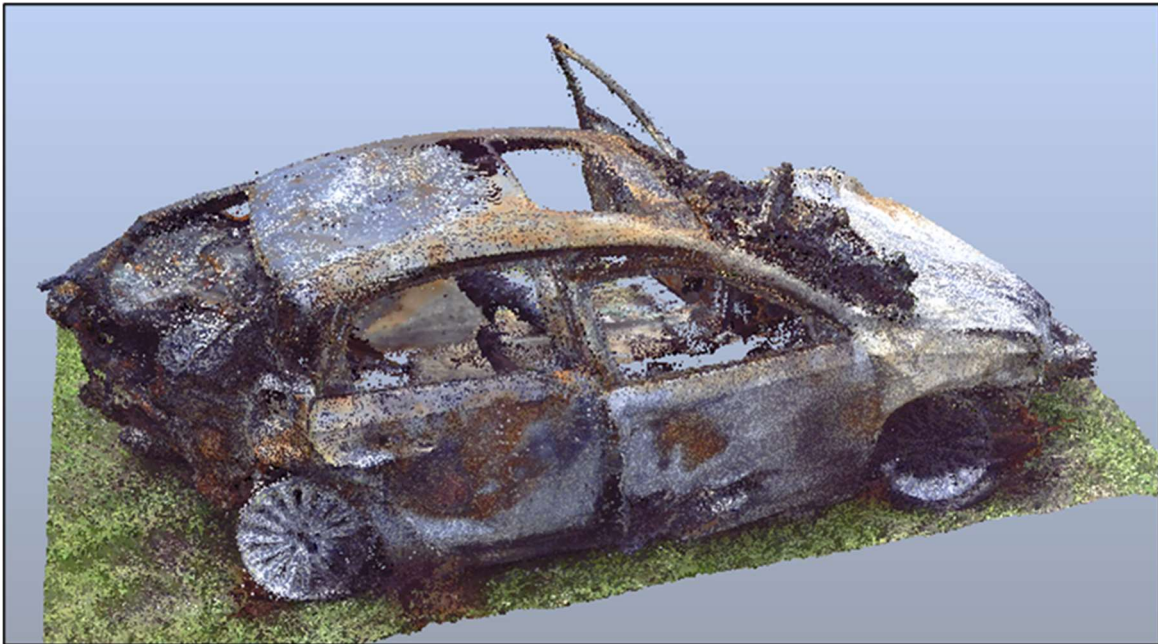
The vehicle was identified as a four-door sedan. When examined at the storage facility the vehicle exhibited evidence that it had been entirely engulfed in fire. It also exhibited extensive body deformation consistent with an impact at the rear with lesser contact deformation at the front. Both sides of the vehicle likewise exhibited contact evidence. Contact damage at the rear appeared to originate at the right (passenger) side rear. Frontal damage exhibited evidence of underride with apparent contact at both the left and right side of the hood. While the left side front door exhibited little deformation, the trailing end of the left side rear door exhibited inward deformation and longitudinal scarring of the sheet metal. Tearing of the exterior door sheet metal to both right side doors was observed. **Figure 18** depicts a screen capture of the colorized three-dimensional scan point cloud.

Figure 18: Screen capture of 3D scan point cloud depicting the right side of the VW Passat.

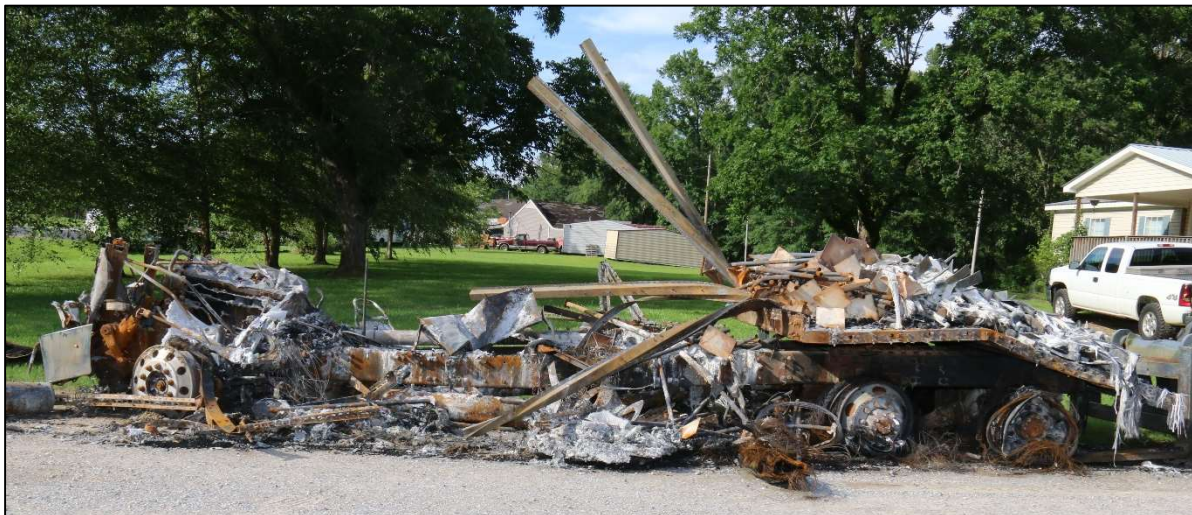
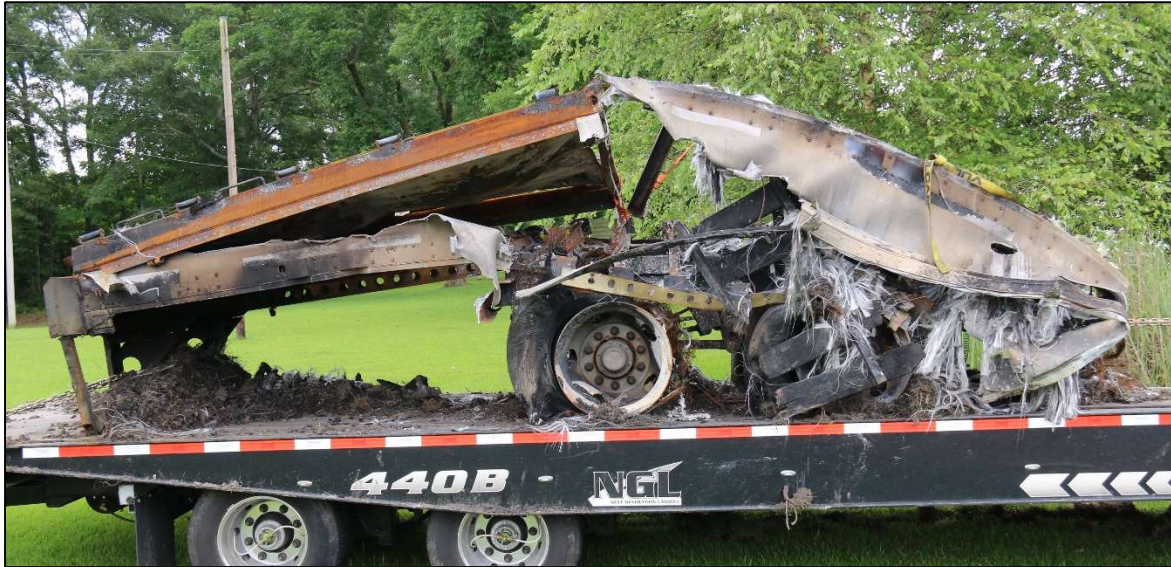
The vehicle was identified as a combination vehicle that had consisted of a three-axle truck tractor coupled to a two-axle van body semitrailer. When examined at the storage facility both the tractor and semitrailer had been substantially consumed and structurally compromised by the post-crash fire. Generally, only the vehicle frame and metallic components at or below the frame level remained. It is estimated that approximately the forward one-third of the semitrailer remained attached to the tractor. The fifth wheel coupler remained connected with the trailer's king pin plate with portions of the frame normally above the tractor drive axles attached. The aft section of the trailer frame that included the axles and trailing frame to the rear of the vehicle were separate from the tractor. **Figures 19 and 20** depict photographs of the truck tractor and semitrailer remnants.

Figure 19: Photograph depicting remnants of the 2005 Freightliner truck tractor as viewed from the left side.

Figure 20: Photograph depicting remnants of the 2009 Wabash semitrailer from the axles rearward as viewed from the right side

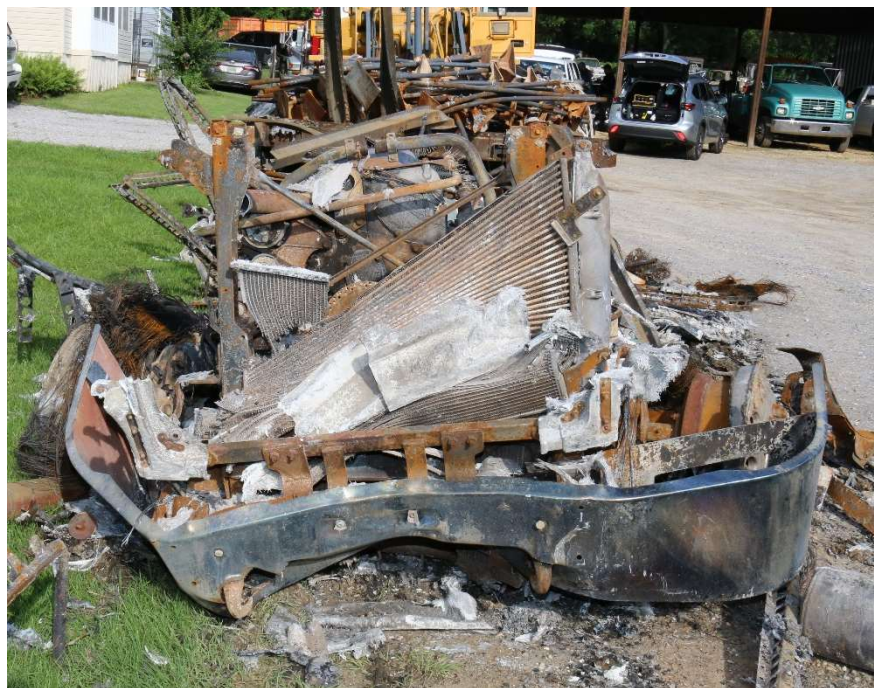
While there were insufficient remains of the Freightliner-Wabash combination to discern all potential areas of contact between this and other vehicles, the front bumper and right side of the tractor did exhibit evidence consistent with contact damage. The right end of the bumper outboard of the frame rail connection was bent inward and the lower portion between the frame rails was displaced rearward. The left end outboard of the frame rail appeared undamaged. Limited scene photographs depicting a portion of the right side of the tractor depicts displacement of structures between the cab and front of the trailer including the area likely to have included right-side fuel tank. **Figure 21** is a photograph depicting the front of the Freightliner.

Figure 21: Photograph depicting the front bumper of the Freightliner truck tractor.

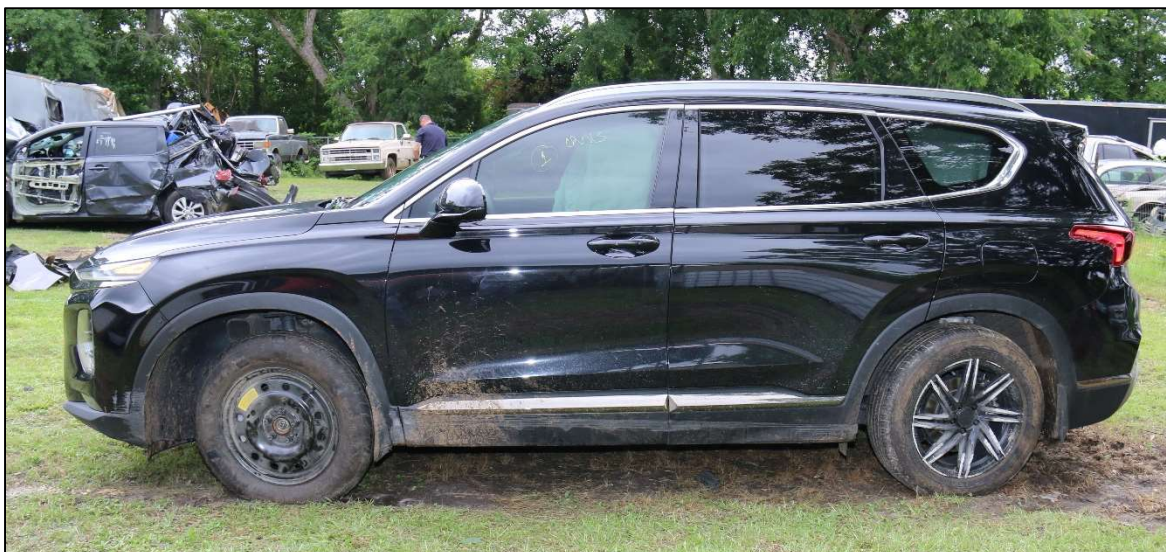
Figure 22: Photograph depicting the left side of Hyundai Santa Fe. The left front wheel has been replaced.

Replacement of the left front tire near the crash site was corroborated by law enforcement investigators who prepared a report stating that the vehicle had sustained wheel damage after the left side wheels made contact with the raised curb adjacent to the left lane on the Pigeon Creek bridge. Video data acquired from a HUB Group truck depicted the Hyundai as having been stopped along the left shoulder about 170 feet north of the bridge rail when the significant collision events began. The video depicts the vehicle's right-side wheels centered within the left shoulder area or slightly closer to the left lane edge line. The left side of the vehicle was in the median. Another passenger vehicle was similarly stopped on the left shoulder and median several vehicle lengths further north of the Hyundai.

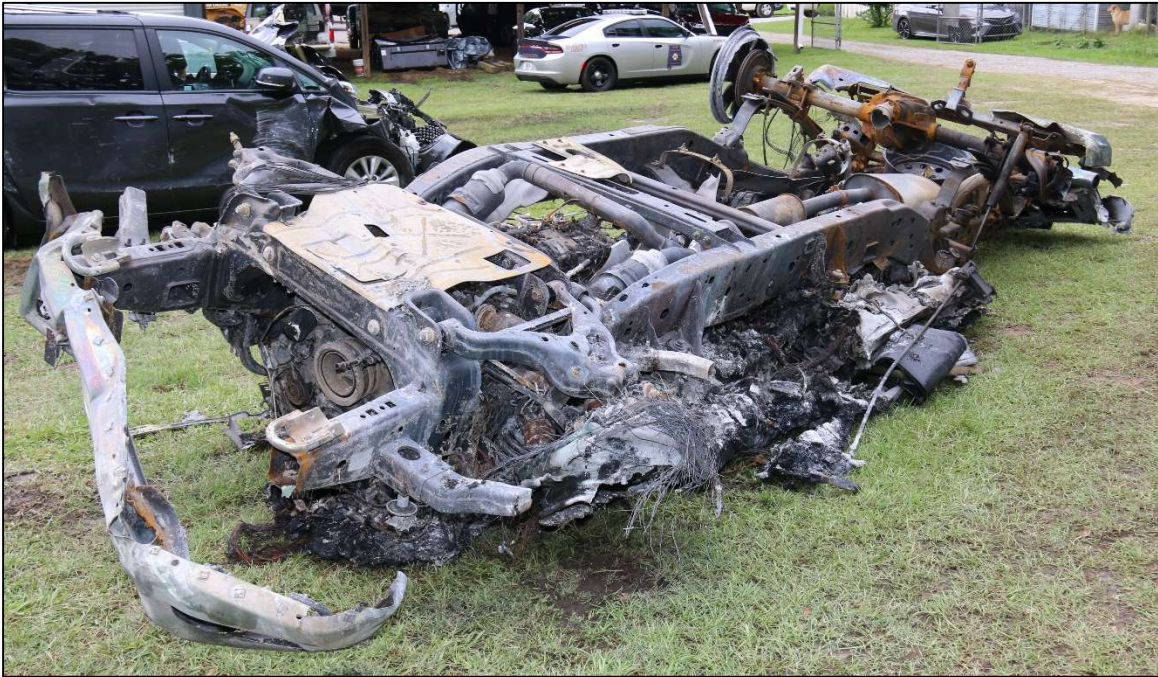
Remnants of the Ford F-150 were recovered from the crash scene and impounded by law enforcement investigators. Examination of the vehicle at the storage facility revealed the vehicle to be inverted and near fully consumed by the post-crash fire. What remained of the front bumper exhibited some deformation damage consistent with direct contact. The aft portion of the longitudinal frame rails behind the rear axle exhibited a vertically downward displacement.

Figure 23: Photograph depicting the remnants of the Ford F-150 after recovery from the crash site.

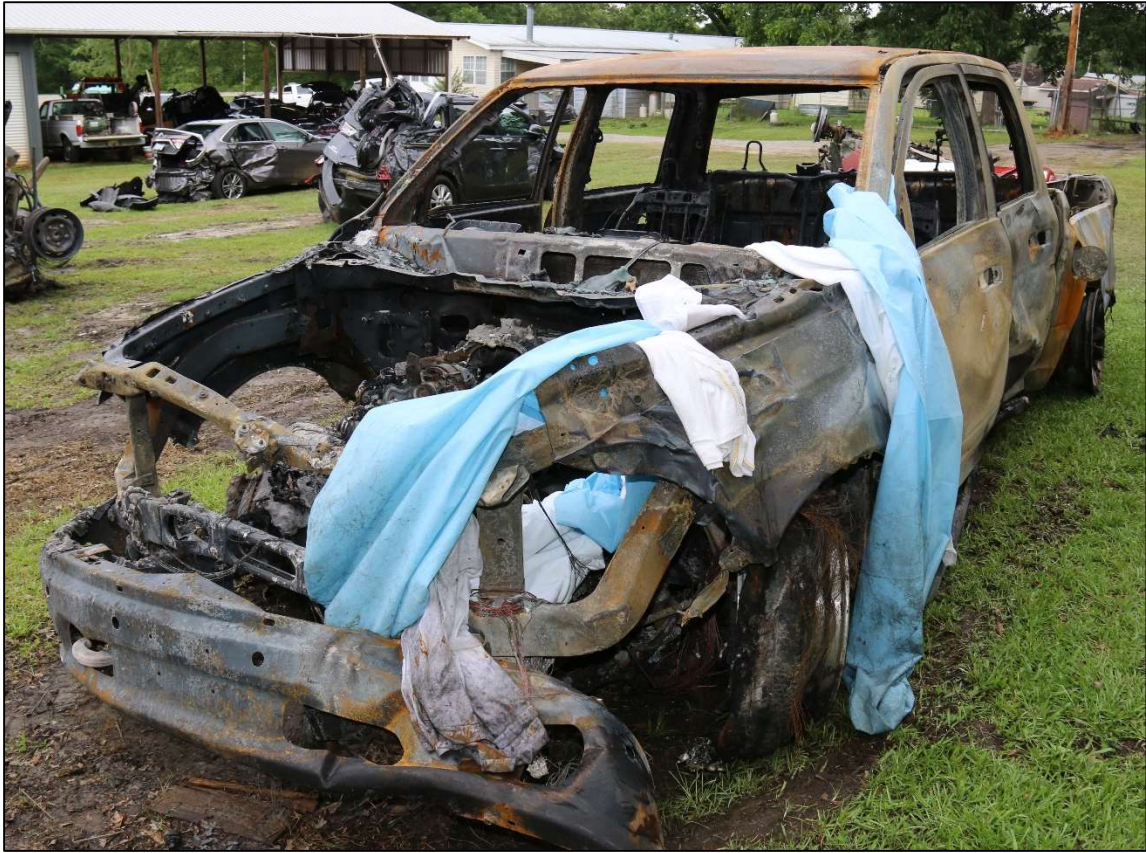
Remnants of the Ram 1500, a four-door pickup truck, were recovered from the crash scene and impounded by law enforcement investigators. Examination of the vehicle at the towing storage facility revealed the vehicle to be upright but near fully consumed by the post-crash fire. While much of the body sheet metal was intact, evidence of contact damage was apparent at several locations. Contact deformation was visible to the right rear panel rearward of the wheel well. The vehicle front end and both left, and right front fenders exhibited displacement that trended rearward. Similarly, the left-side cab doors exhibited deformation that trended rearward. There was some tearing to the lower section of the left rear cab door and likely displacement of the rear axle.

Figure 24: Photograph depicting the 2016 Ram pickup after recovery as viewed from the left front.

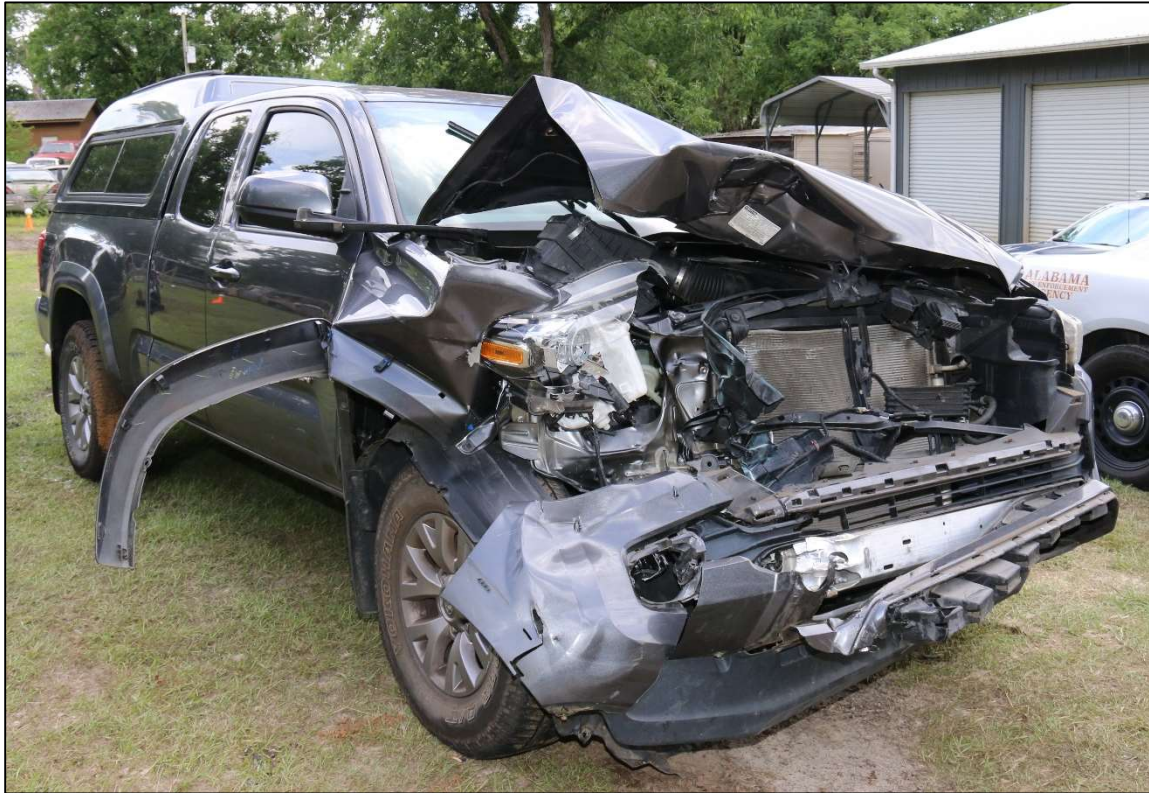
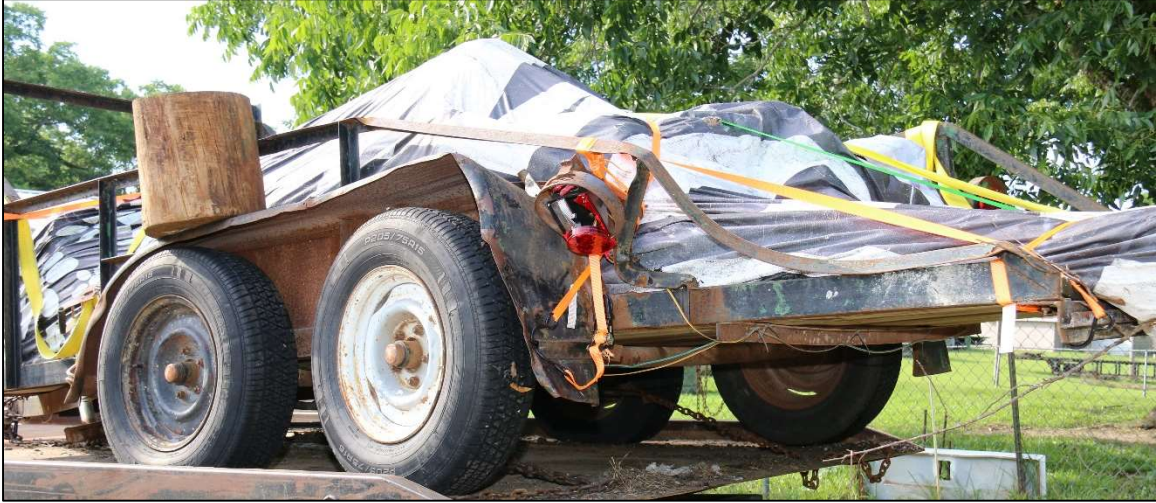
The vehicle was identified as an extended cab SR-5 model pickup truck. When examined at the storage facility the vehicle exhibited contact damage to the right front end consistent with an impact. The damage was concentrated outboard of the approximate longitudinal centerline of the vehicle. The vehicle was outfitted with a typical frame mounted trailer hitch receiver and ball mount (drawbar). Examination revealed that the hitch ball and drawbar had been displaced forward and slightly upward, indicative of a rear-end impact.

As depicted in scene photographs, the Tacoma had been towing an unidentified light duty trailer that was laden with material covered by a tarp. The trailer had been impounded and was briefly examined while stored atop the deck of a rollback tow truck. The trailer was a tandem axle flat deck trailer with low steel perimeter railing and a steel mesh headwall. The trailer exhibited contact damage at the left rear that was indicative of an impact. The A-frame exhibited some deformation rearward of the coupler and some of the cargo had displaced the mesh headwall forward. **Figures 25 and 26** are photographs of the Tacoma and the towed trailer respectively.

Figure 25: Photograph depicting the 2016 Tacoma pickup as viewed from the right front.

Figure 26: Photograph depicting the light duty utility trailer towed by the Tacoma as viewed from the left rear.

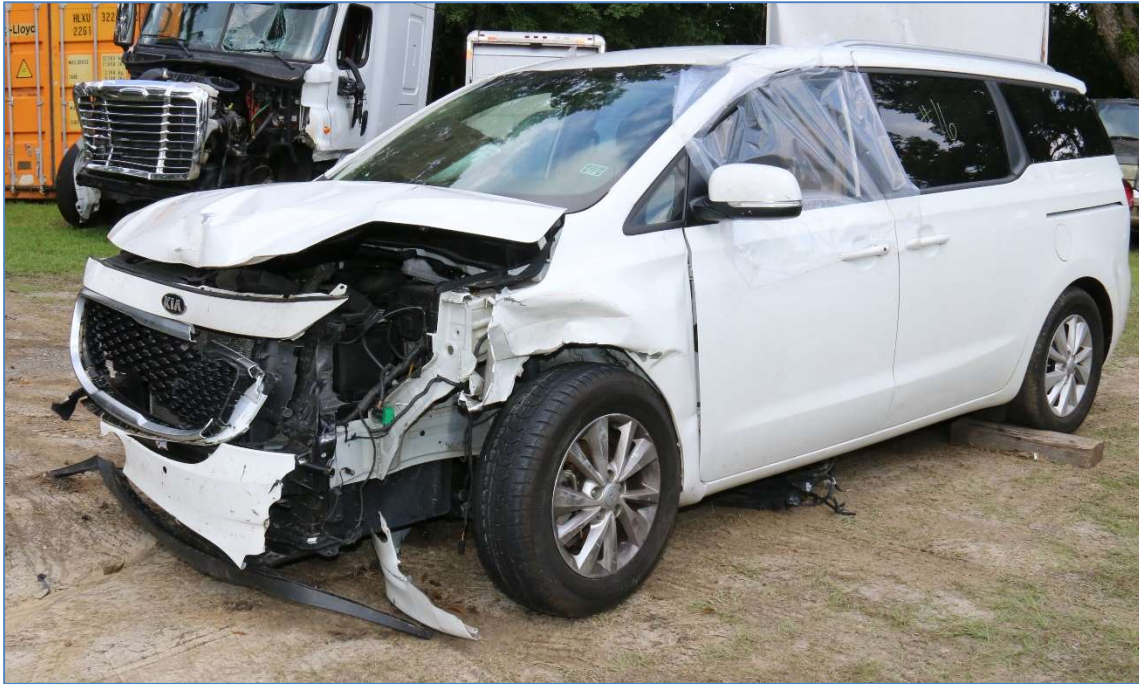
The vehicle was identified as a minivan that was towed and stored by law enforcement investigators. Examination of the vehicle revealed evidence of contact across the full width of the vehicle front end that appeared to be more concentrated to the left side. Along the right of the vehicle there was evidence consistent with a sideswipe contact that extended rearward from the front door to the rear fender. Blue colored material transfer was observed about the middle of the frontal damage.

Figure 27: Photograph depicting the left front of the 2017 Kia Sedona.

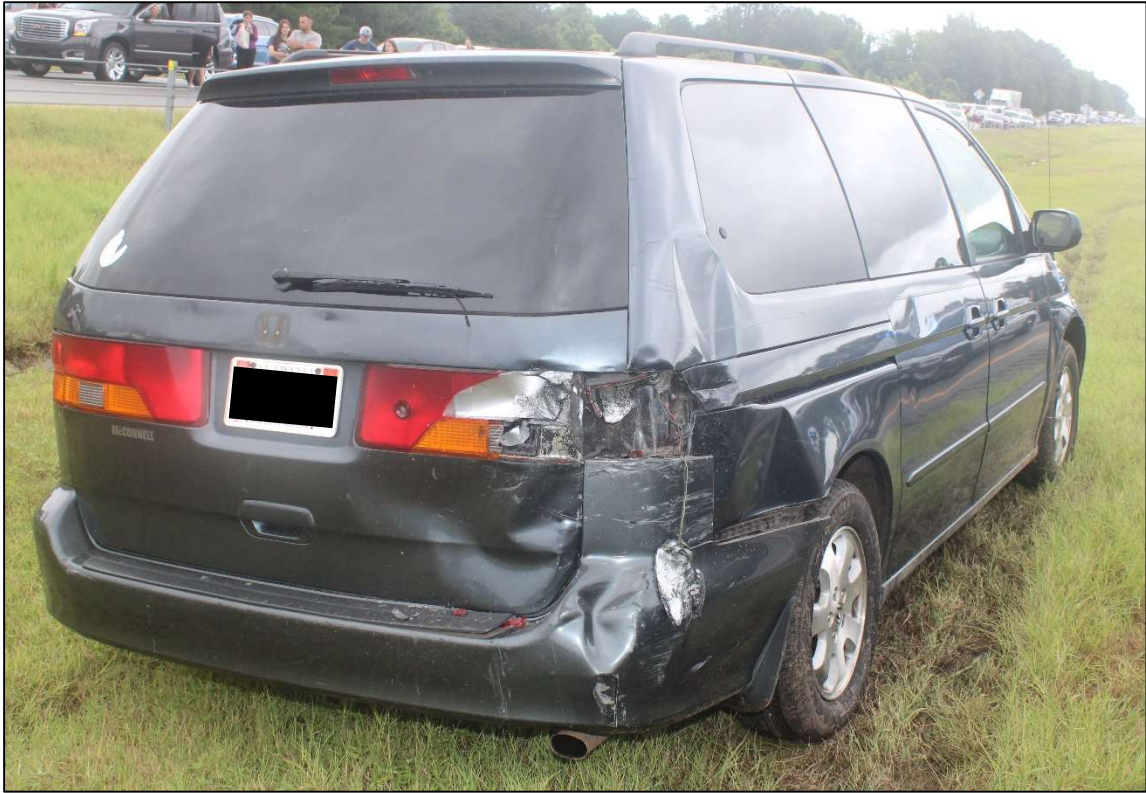
The photographs depict contact damage at the right rear of the vehicle. **Figure 28** is a law enforcement photograph of the vehicle.

Figure 28: Photograph of Honda Odyssey, 2004 vintage, stopped in median and exhibiting damage to the right rear. Photograph was provided by ALEA (law enforcement) investigators.
