FACTUAL REPORT OF INVESTIGATION ATTACHMENT

Crash Reconstruction Mechanical Inspection

Excelsior, Wisconsin

HWY23FH012

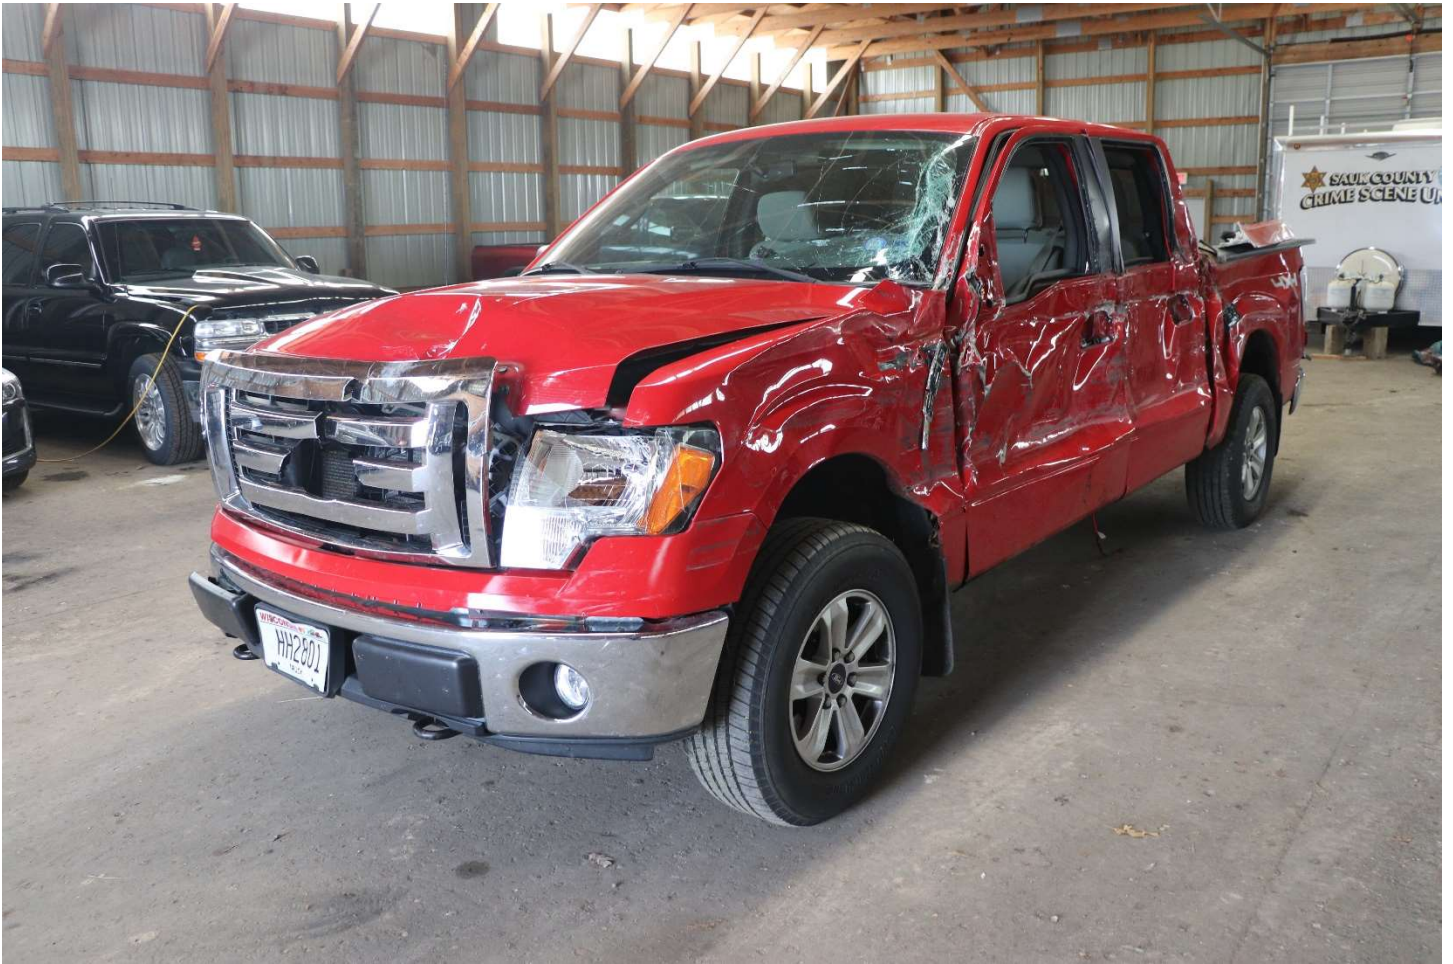
Figure 1 Insp. Schultz_jpeg-3255

On June 19, 2023, I went to the Sauk County Sheriff's Office (SASO) impound in reference to a mechanical inspection 2010 Ford F150 pickup (Figure 1). The F150 had been involved in a fatal crash on State Highway 33 involving a pedestrian and a school bus. The F150 had been stored inside the SASO impound facility. I was able to complete a full mechanical inspection, and test drive of the F150.

I began my inspection with a walk around examination of the F150. I was unable to access the Federal Certification Label inside of the driver's door due to body damage. The F150 was a body on frame construction. The F150 had sustained moderate body damage to the cab, box, and body panels in the incident. I did not observe any functional damage.
