VEHICLE FACTORS ATTACHMENT

Vehicle Examination Photographs

Williamsburg, VA

HWY23MH004

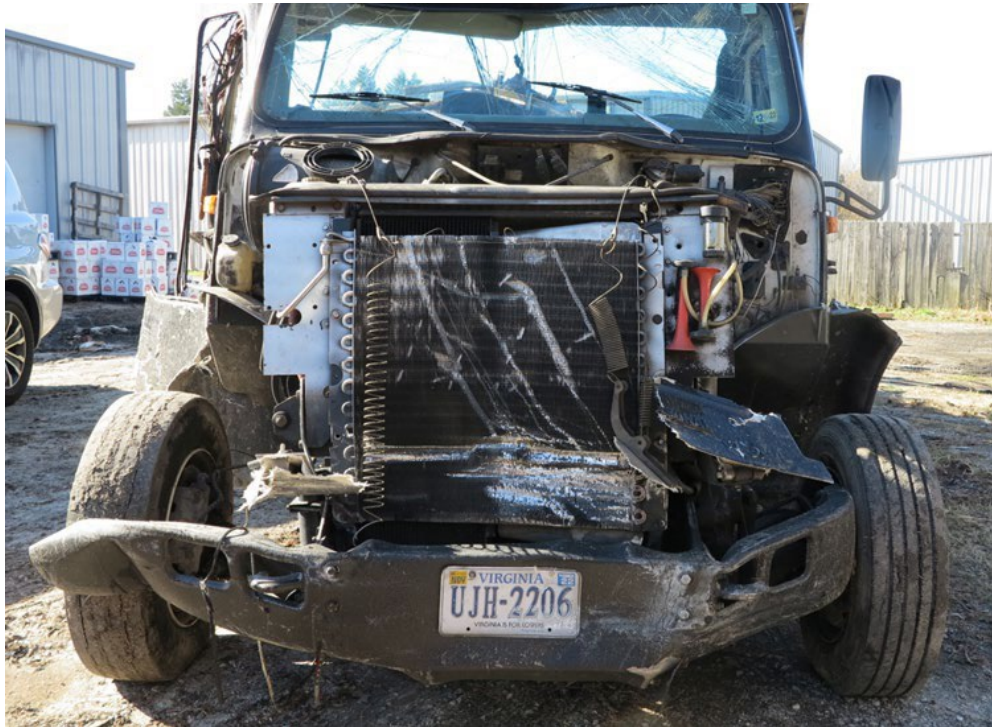
Photo1. The front of the Eldorado Bus.

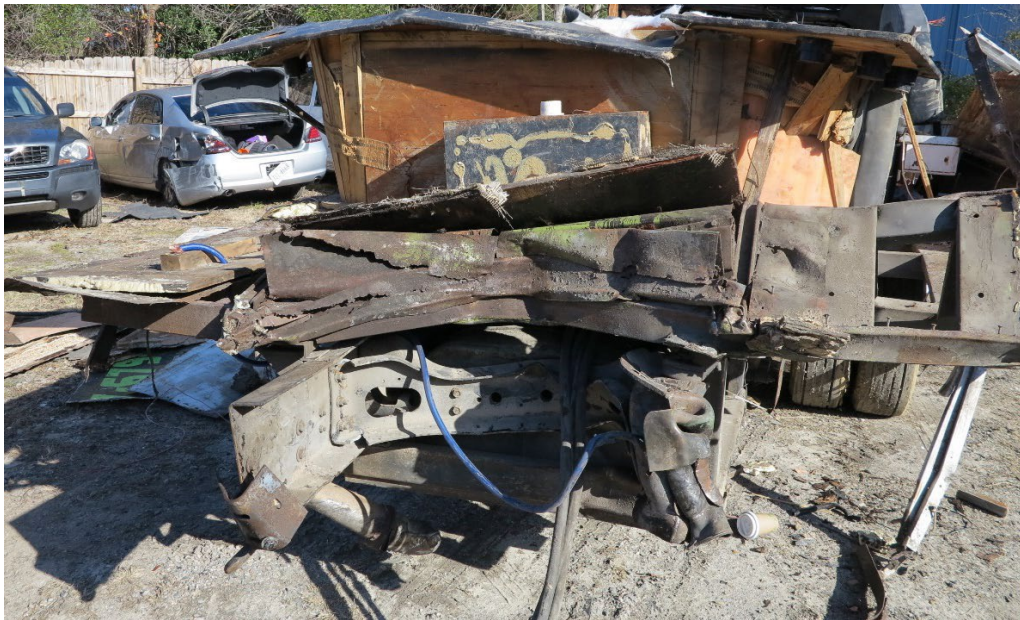
Photo 2. The damage sustained to the rear of the bus.

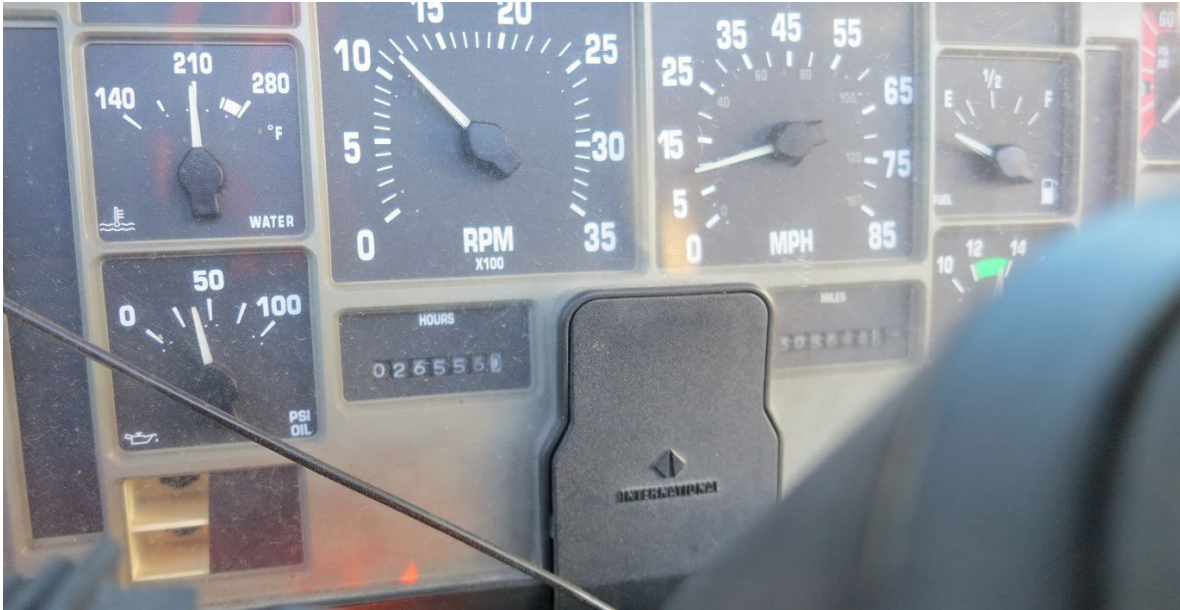
Photo 3. The instrument cluster for the bus.

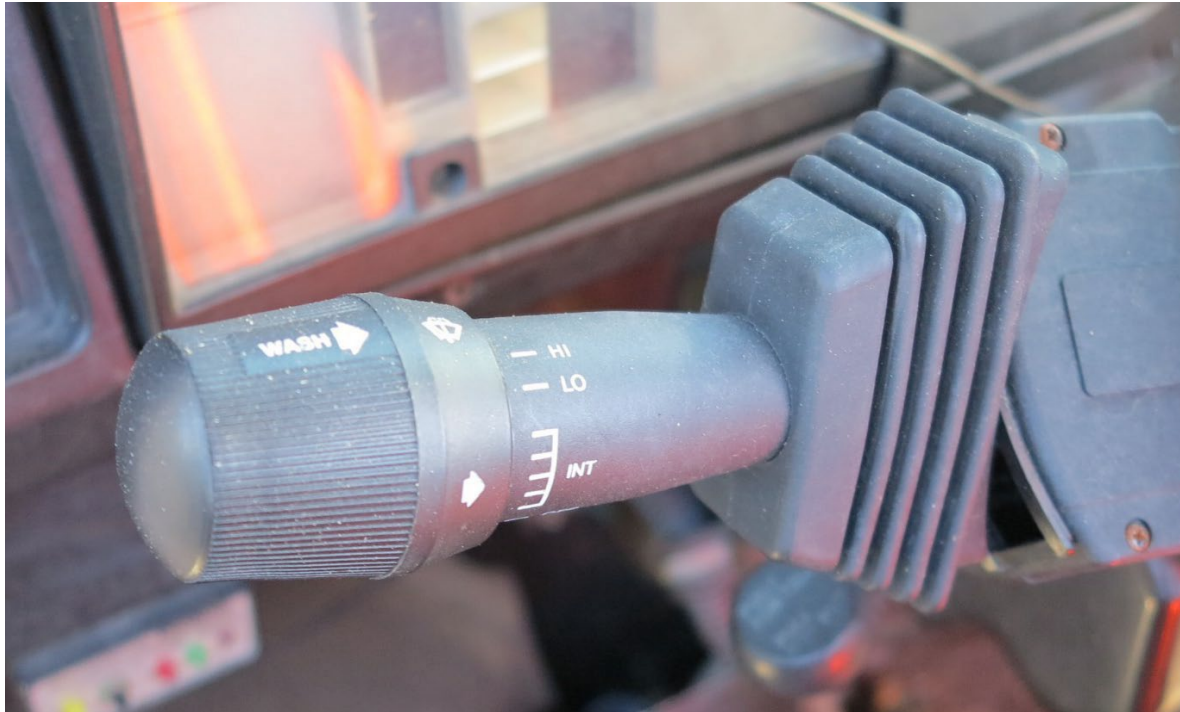
Photo 4. The windshield wipers setting for the bus.

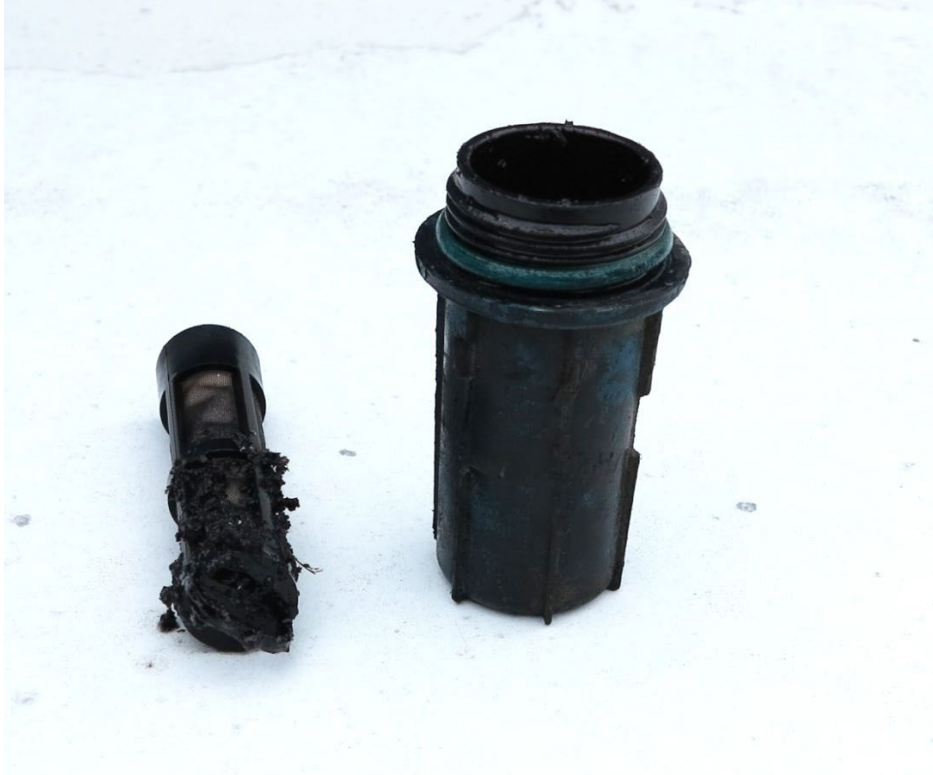
Photo 5. The partially blocked prescreen fuel filter from the bus.

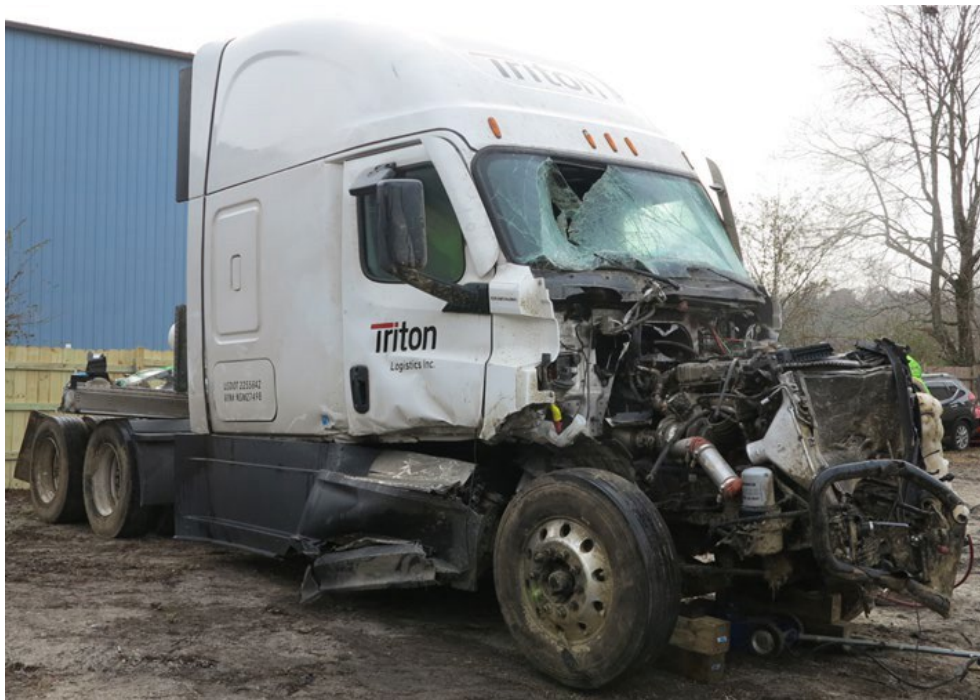
Photo 6. The damage sustained to the right side of the truck-tractor.

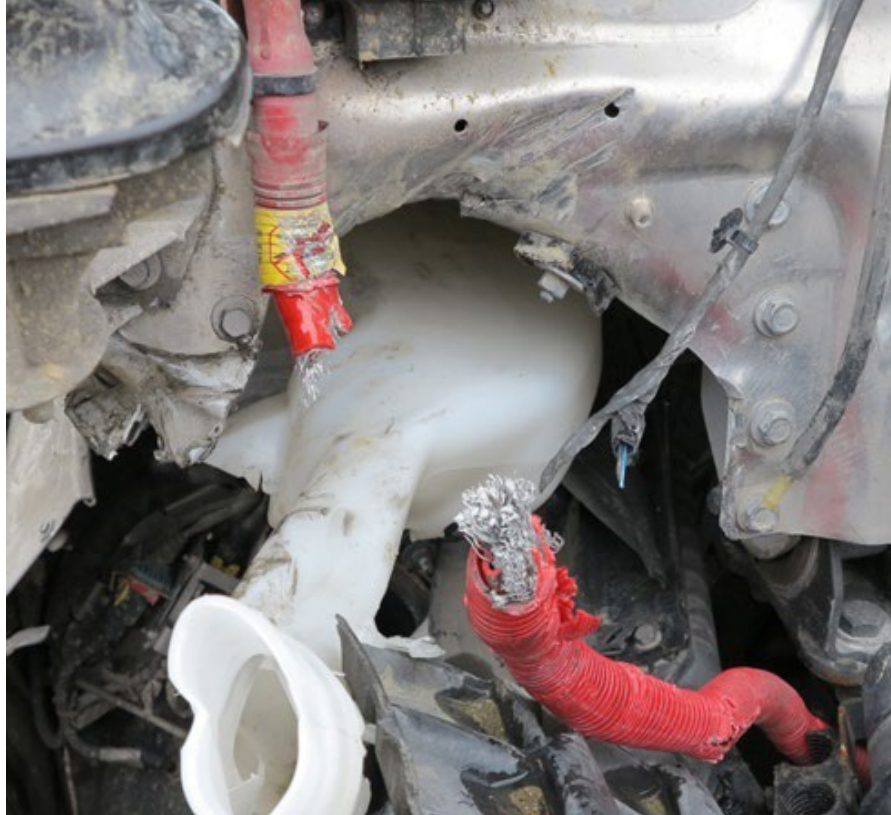
Photo 7. The severed power cable to the vehicle control modules.

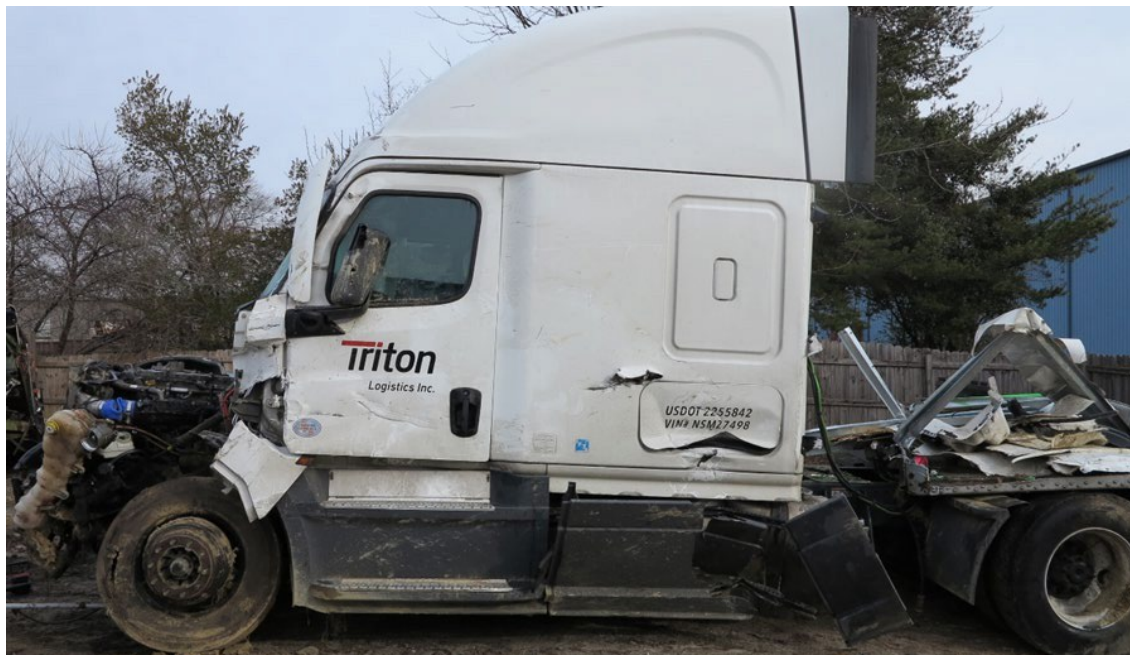
Photo 8. The damage sustained to the left side of the truck-tractor.

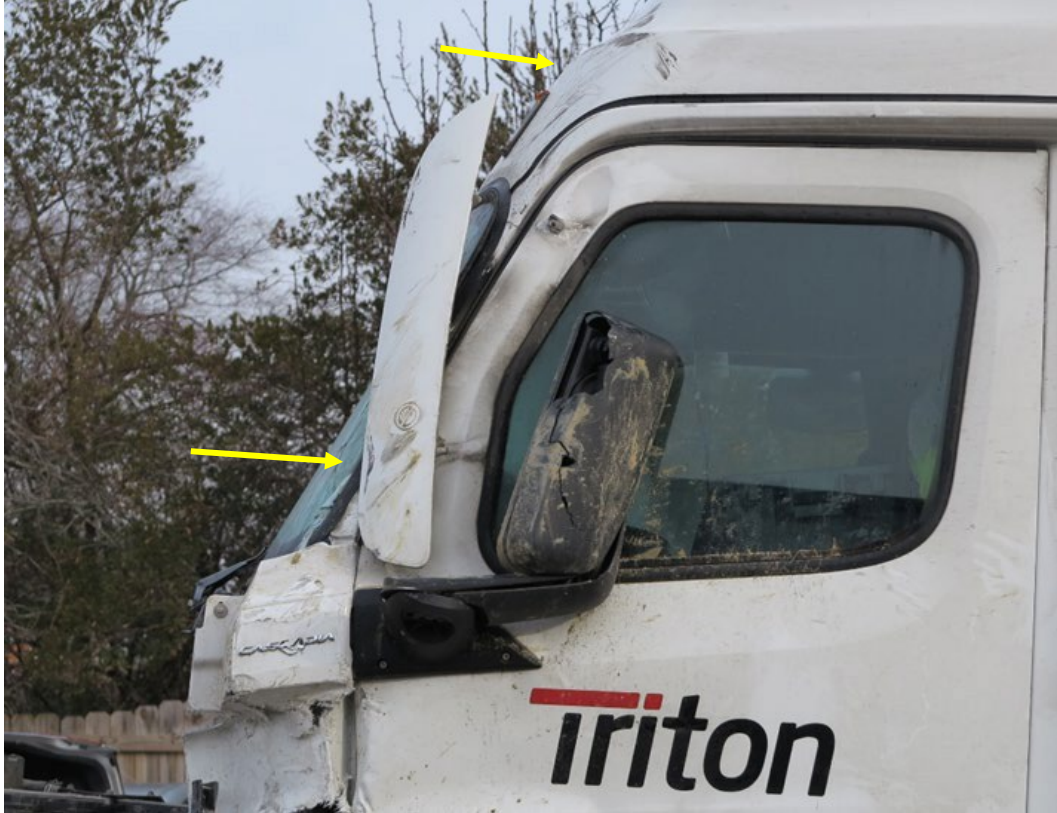
Photo 9. The arrows are pointing to some paint transfer from the bus.

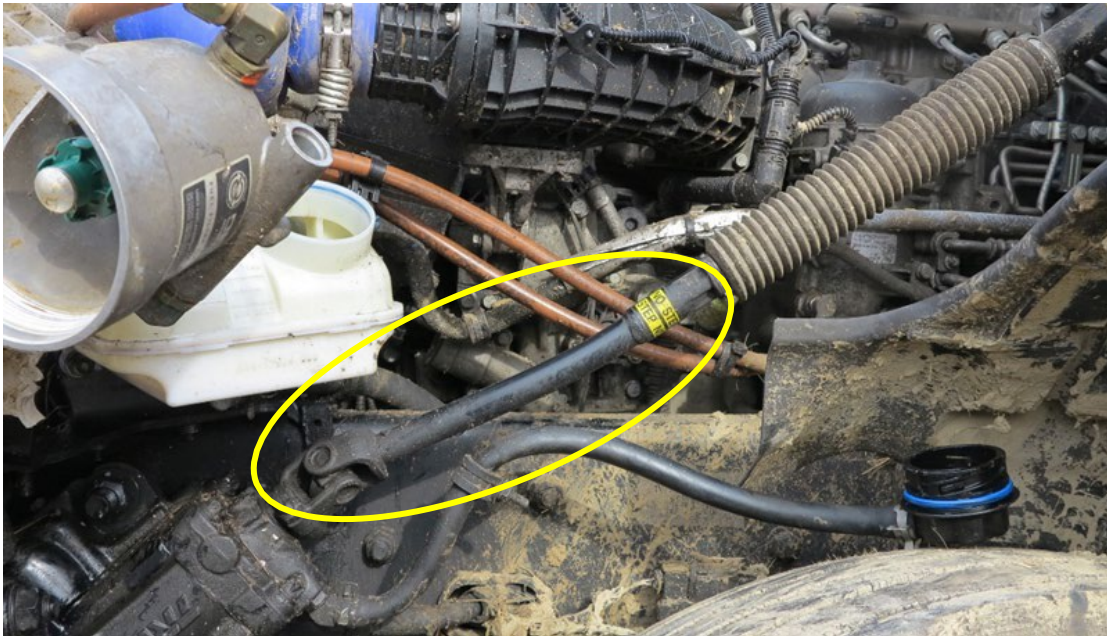
Photo 10. The bent lower steering arm.

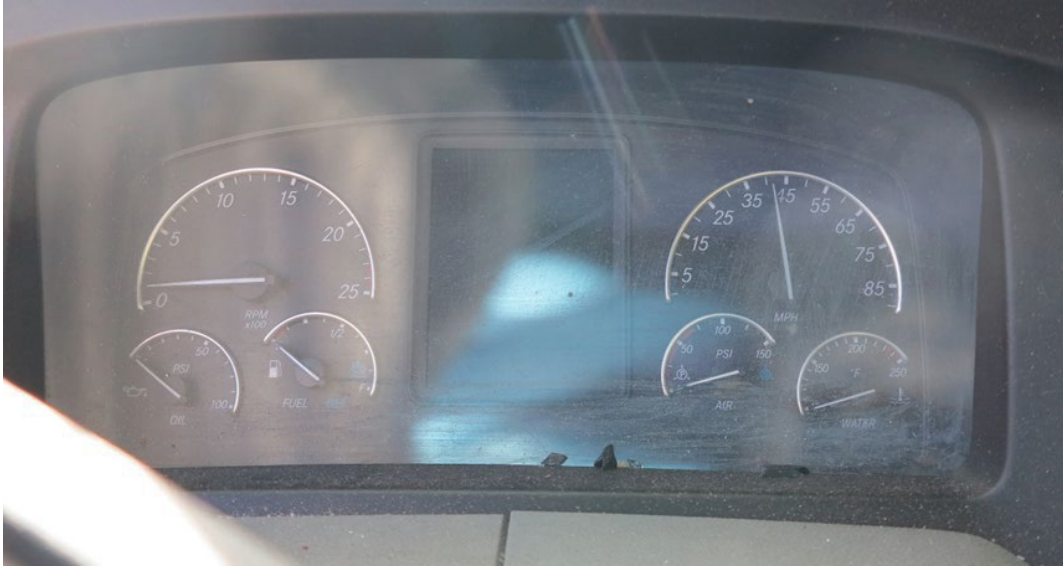
Photo 11. The center gauge cluster of the truck-tractor.

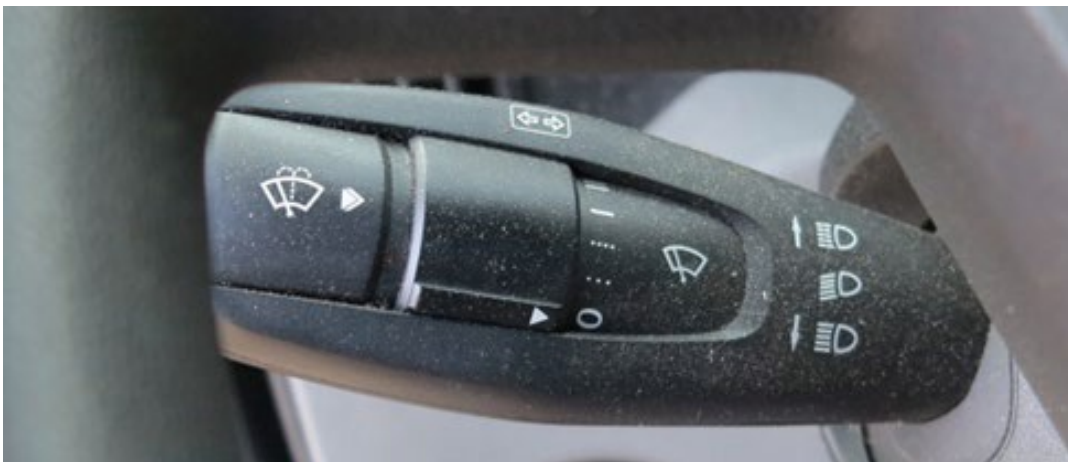
Photo 12. The windshield wipers setting for the truck-tractor.

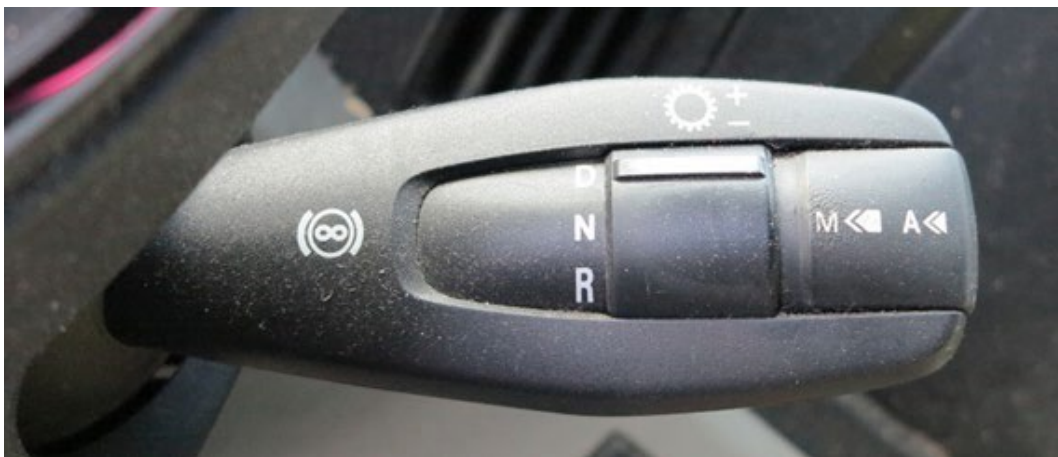
Photo 13. The transmission gear selector for the truck.
