**NATIONAL TRANSPORTATION SAFETY BOARD
OFFICE OF HIGHWAY SAFETY
WASHINGTON, D.C.**

**VEHICLE FACTORS GROUP CHAIRMAN'S
FACTUAL REPORT**

GREENVILLE, ALABAMA – HWY21MH009

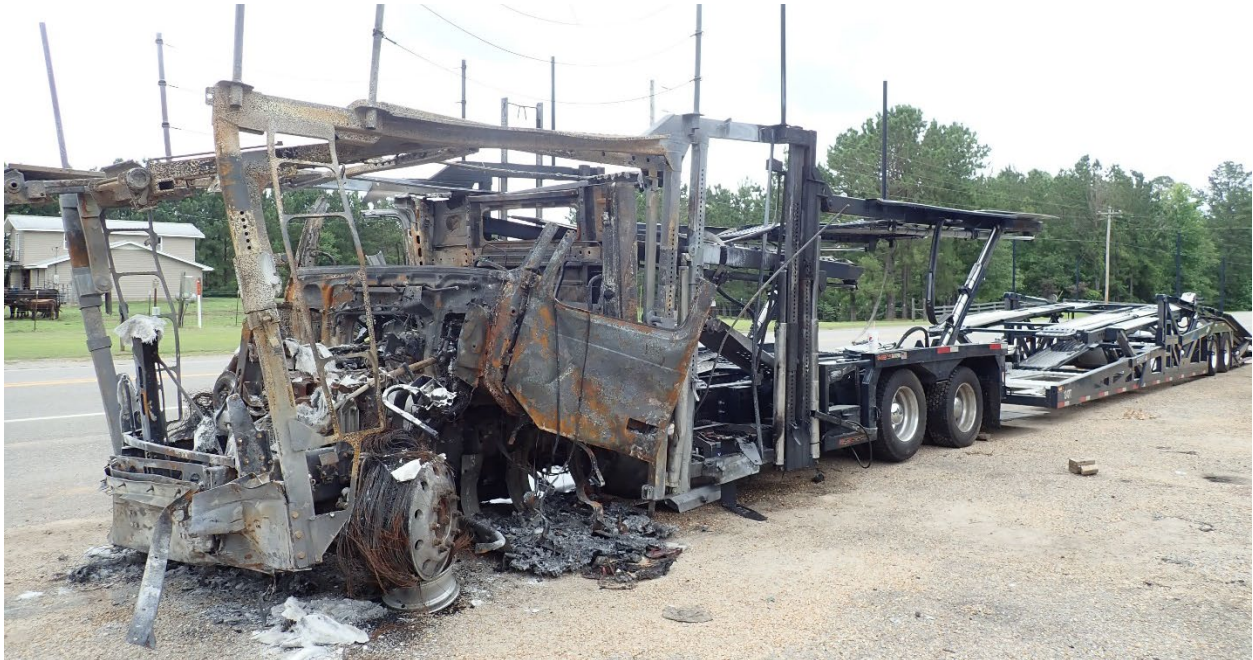
Figure 1: The damaged Volvo combination viewed from the left front corner

The entire cab and engine were severely fire damaged. The portion of the Volvo truck-tractor to the rear of the cab did not sustain severe fire damage. The entire left side fuel tank located under the driver's door was consumed by fire, with only the mounting straps remaining. The fuel tank located on the right side behind the passenger door had an approximate 3-inch by 3-inch hole in the forward portion of the tank. The diesel exhaust fluid tank behind the cab on the left side was damaged and deformed by heat.

There was contact damage to the left front bumper. The right front frame rail was shifted left approximately 2-inches. The left side of the front bumper was torn away from the left frame rail. Attached to the front bumper on the left and right ends were 2-inch by 4-inch steel box support beams for the car hauler structure over the cab. The beams on the left side were shifted right approximately 11-inches. There were deep contact striations in the metal on the left outside corner of the box beams located approximately 18-inches and 40-inches high as measured from the ground. Both left and right ladders leading to the upper rack of the car carrier were warped.

The right-side door had an 8-inch by 6-inch tear in the sheet metal. There was also a fold in the door's sheet metal. The door was still in the frame. Just aft of the right door was a fold in the top of the frame rail.

The left-side door was still attached to the "A" pillar, which was shifted rearward approximately 12-inches. The top portion of the pillar had been cut and was missing. The car hauler trailer had an aluminum tread on the left side which was folded approximately 10-inches upward. There was also a tear in the aluminum bracket at the rear of the trailer.

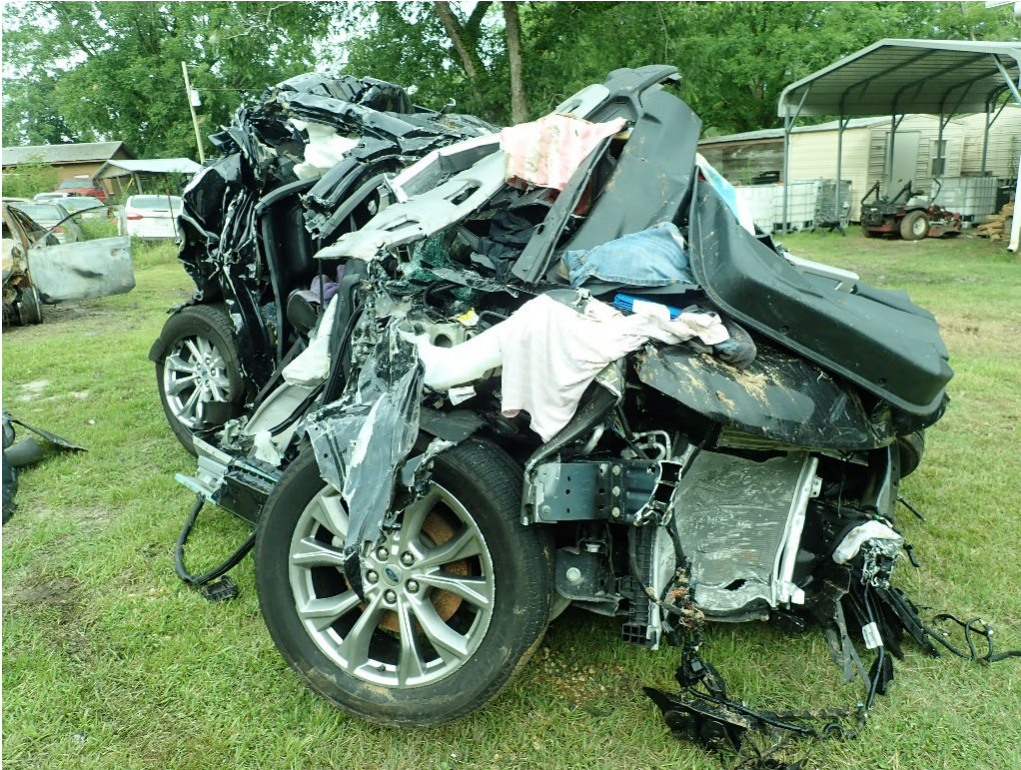
Figure 2: The damaged Ford Explorer viewed from the right front corner

The front bumper was torn away from the frame rail and deformed. The left front frame rail was displaced downward. The radiator was displaced rearward. The hood was scratched, deformed, and folded. The windshield was shattered and partially missing. The left front wheel was detached from the vehicle but present. The tire was detached from the wheel and the wheel was fractured laterally. The left A pillar was displaced to the left. The left front door frame was displaced down and to the left at the top. The glass in the door was shattered but in place. The left rear door sustained slight damage. The left rear wheel was damaged. The rear of the vehicle was displaced upward, and the roof folded. The right rear door glass was intact. The rear bumper fascia was detached and missing. The rear bumper was displaced forward on the right side to the rear axle. The rear hatch was displaced forward and to the left. The hatch frame was deformed. The right rear tire was torn from the wheel and the wheel was folded and chipped. Both right side doors were missing with the B pillar cut. The right front wheel flange was scuffed around its

circumference and the tire was flat. The right front quarter panel was displaced to the left and the right-side A pillar also shifted left.

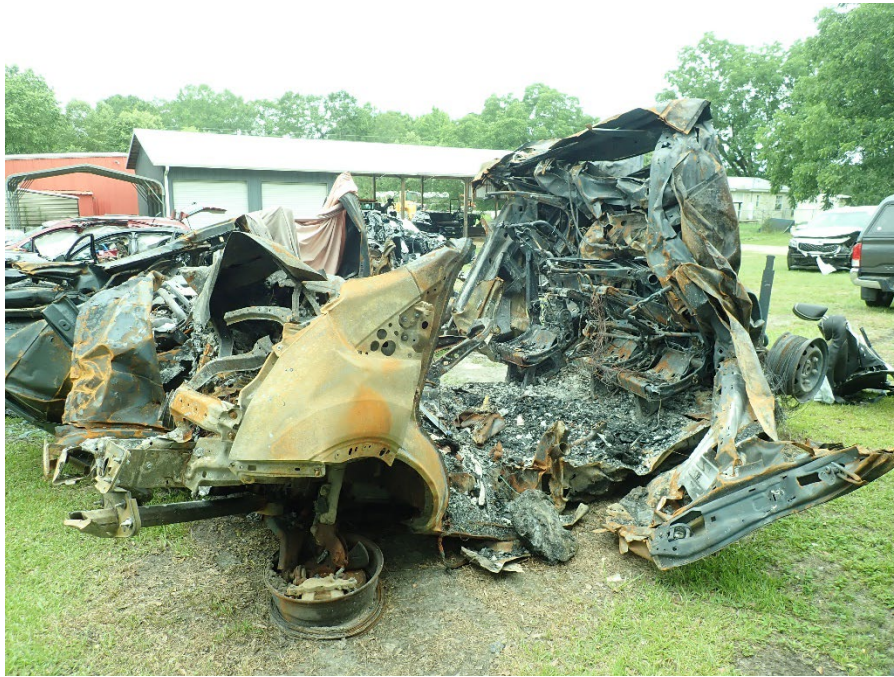
Figure 3: The damaged Ford Transit Van as viewed from the left front corner

Nearly the entire vehicle was consumed by fire. All passenger controls and interior features were burned, leaving only the frames of the seats. All doors had been removed from the van and the A, B, and C support pillars cut during extrication. The rear axle was displaced forward and upward. The bottom of the rear bumper was approximately 72-inches from the ground. The rear leaf spring suspension was deformed and both sides were detached from their respective hangers.

The front frame rails were deformed. The left rail was shifted left approximately 10-inches and the right rail shifted right approximately 40-inches. The driveline was detached at the rear differential.

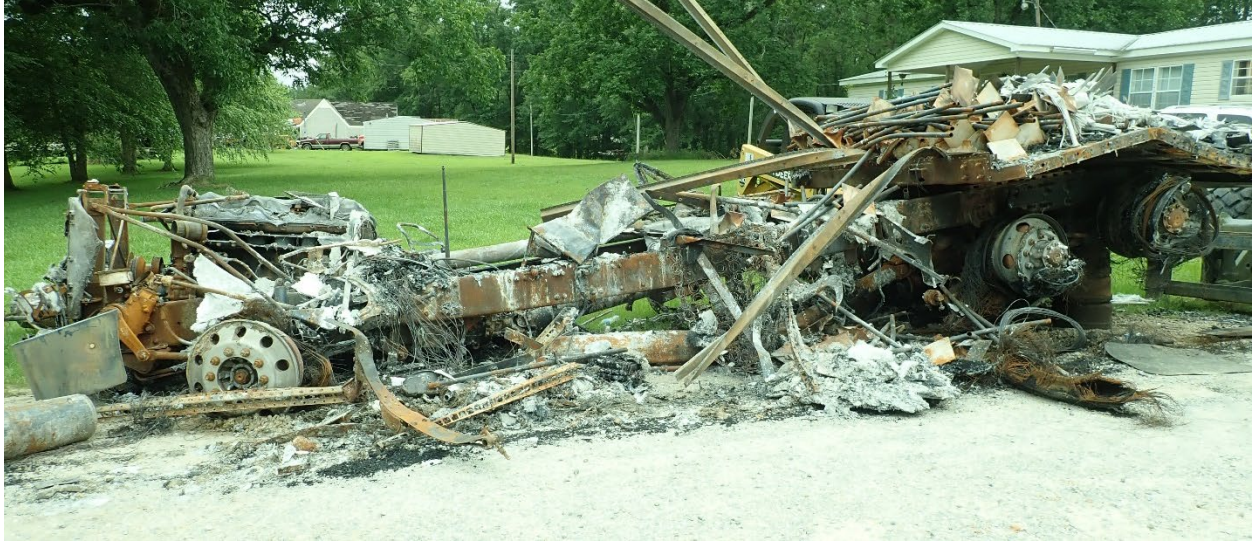
Figure 4: The damaged Freightliner Truck-Tractor viewed from the left side

The Freightliner truck-tractor sustained severe fire damage to all areas, affecting all major mechanical systems. The Freightliner sustained contact damage to the right front bumper, which was displaced rearward approximately 18-inches. Both left and right saddle fuel tanks were consumed by the fire.¹²

The entire van trailer also sustained severe fire damage. Both sides of the trailer were consumed in the fire. The front panel and rear trailer doors were mostly consumed, with the remaining structure folded down and inward. A portion of the bottom of the trailer had disengaged from the upper structure and remained connected to the truck-tractor at the fifth wheel.

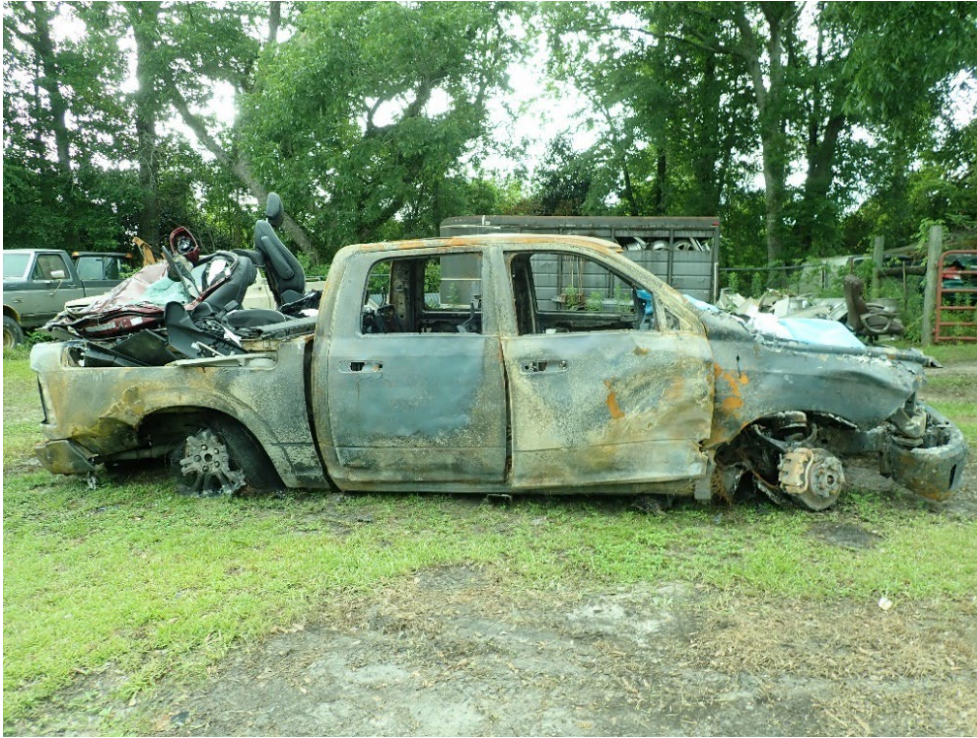
Figure 5: The damaged Ram 1500 viewed from the right side

The entire vehicle had extensive fire damage. All tires were consumed by fire and all windows were missing. All passenger controls and interior features were burned, leaving only the frames of the seats. The front bumper was detached on the left side, deformed and the left bumper horn was shifted right approximately 8-inches. The radiator was missing, consumed by fire. The left front quarter panel was displaced rearward. The hood brace was fractured and deformed. The right front alloy wheel was totally consumed by fire and the left front, right rear and left rear were mostly consumed. The left rear door panel was dented as was the right front door, which was still mounted in the frame, but warped and unable to close.

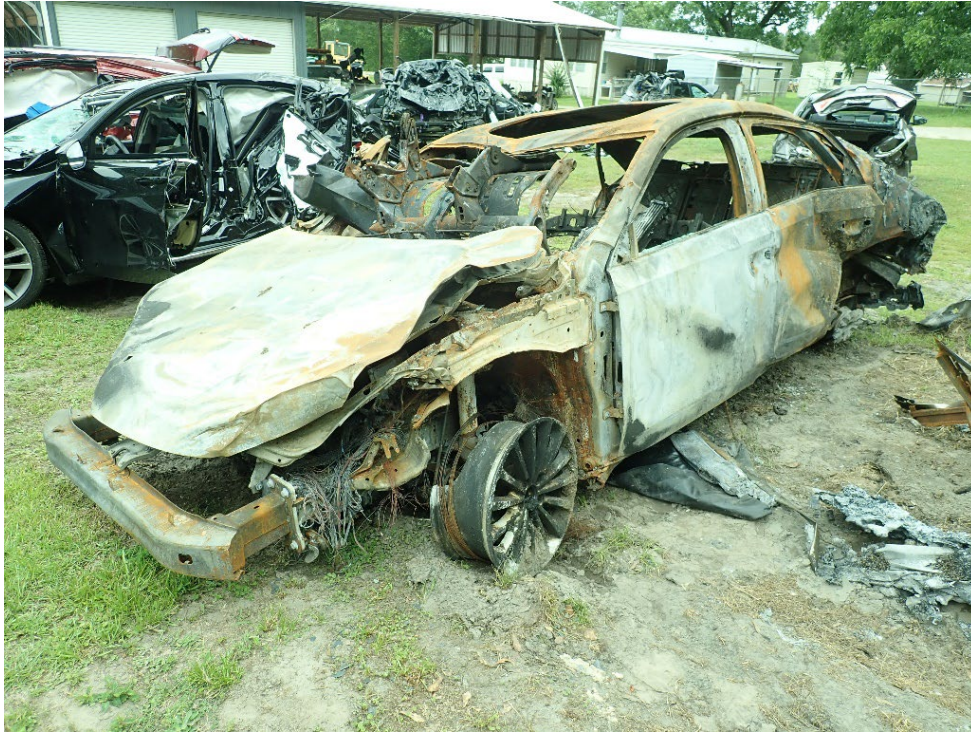
Figure 6: The damaged Volkswagen Passat viewed from the left front corner

Nearly the entire vehicle was consumed by fire. All passenger controls and interior features were burned, leaving only the frames of the seats. The front bumper fascia was consumed but the bumper was in place with no damage. The hood was displaced downward and deformed. The left front quarter panel was missing, and the right front quarter panel was displaced to the rear. All tires were consumed by the fire. The left and right front wheels were partially consumed with evidence of contact damage and grinding around the circumference of the outer wheel flange. All glass was missing. The right front door had an approximately 24-inch wide by 8-inch hole in the bottom of the door panel. The right rear door was damaged at connection with the “C” pillar. The roof was displaced downward near the sunroof. The right rear bumper and quarter panel were displaced forward to the rear axle and shifted to the left approximately 16-inches. The left rear quarter panel did not have as much contact damage but was shifted to the left. The right rear wheel was partially consumed by fire and the left rear was totally consumed. The left rear door was deformed inward between 17 to 25-inches from the bottom of the panel. All door latches were consumed.

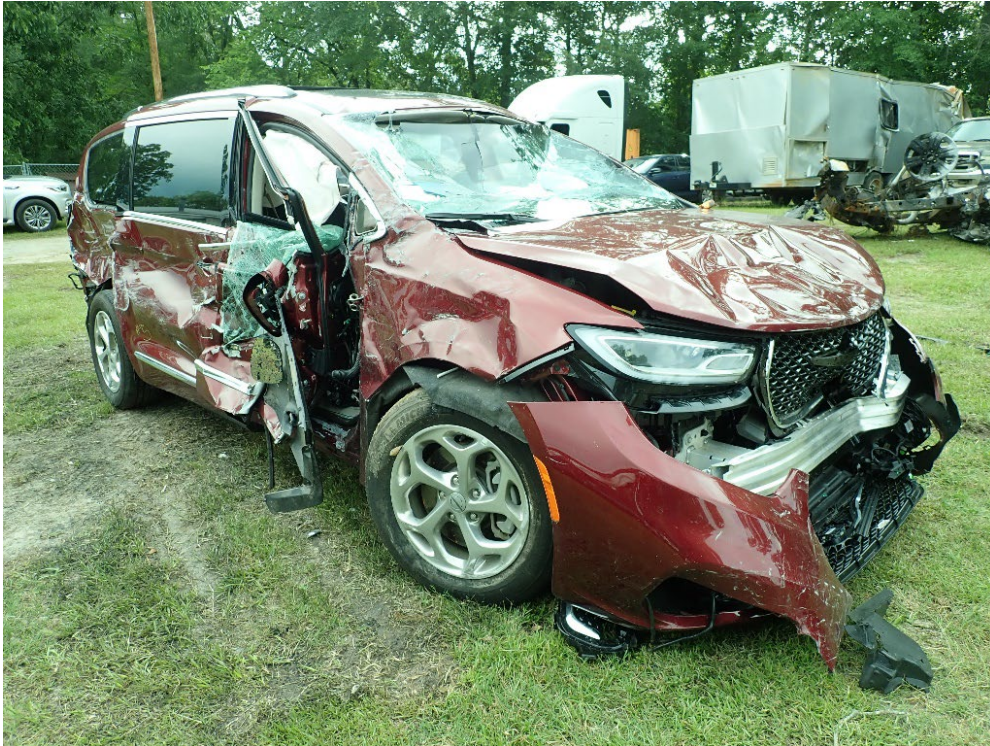
Figure 7: The damaged Chrysler Pacifica viewed from the right front corner

The front bumper fascia and grill were displaced, torn away from the vehicle but present. The front bumper was displaced rearward on its left side. The hood was displaced rearward and deformed. The left headlight was missing from its mount. The windshield was still present in its frame but shattered and partially displaced rearward. The left front door was missing and the left side sliding door was hanging from its rear mount. The B pillar on the left side was missing. The left front tire was flat, but the wheel was undamaged. The left rear tire was also flat, and the wheel was scratched. The rear bumper fascia was missing, and the bumper was damaged on its right side. The right front tire was inflated but the wheel was scuffed. The right rear tire was inflated but had scuff marks and blue paint transfer on it. The right front door was displaced to the left and the glass was missing. There were scratches down the entire right side with blue paint transfer near the right rear corner. The glass was still in place on the right-side sliding door and the far rear window. The right-side sliding door and quarter panel were displaced to the left.

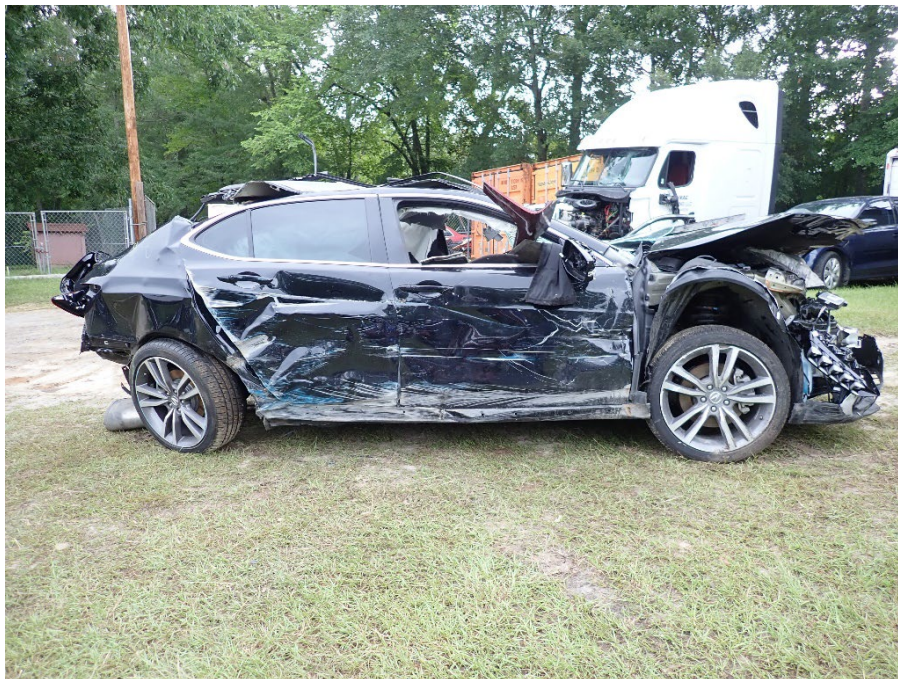
Figure 8: The damaged Acura TLX viewed from the right side

The front bumper fascia was detached on the right side. The front bumper was displaced approximately 2-inches rearward at the midpoint. The hood was displaced to the rear and was deformed. The windshield was partially in its frame and shattered. The left front tire was intact and undamaged. The left front door was damaged at the B pillar, which was cut. The left rear door was folded toward the rear. The left rear wheel and tire were displaced forward under the rear seat of the vehicle. The rear bumper was displaced forward and folded at its midpoint. The left side glass was missing, the right front door glass was also missing, but the right rear door glass was intact. The back window was missing. The trunk was detached from its mounting brackets. The

rear of the vehicle was displaced forward and to the left. There was blue paint transfer down the entire right side. The right front quarter panel was missing. There was a scrape along the bottom of the right side and a tear in the right front door near the handle. There was a gouge beginning at the right front door handle extending rearward to the right rear door handle. The right rear tire was displaced and canted away from the vehicle. The right front outside wheel flange was partially ground away, and the entire flange was scraped around the circumference.

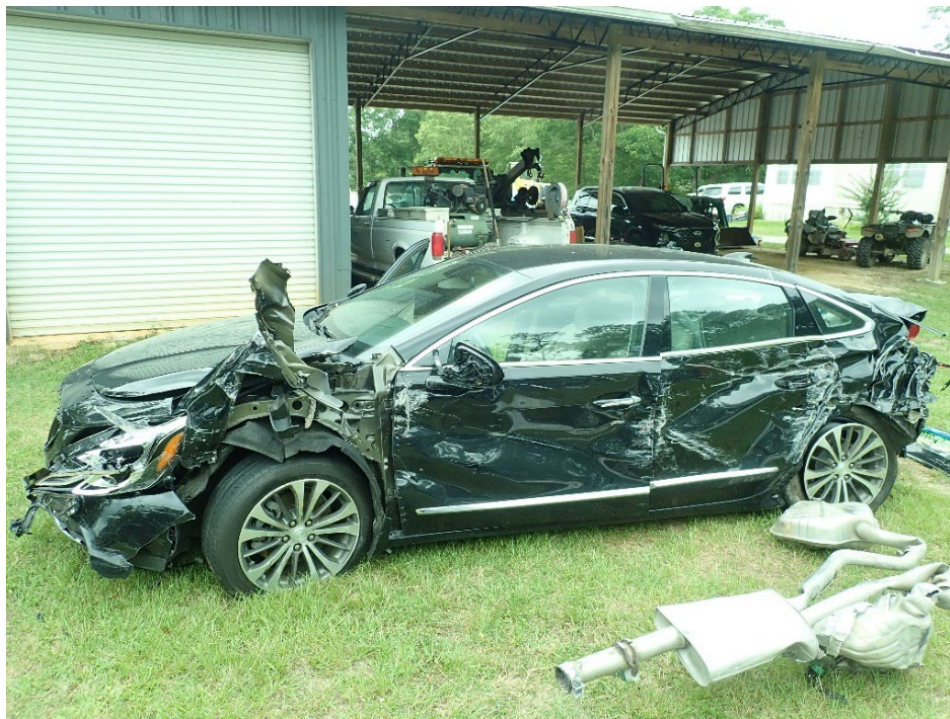
Figure 9: The damaged Buick Lacrosse viewed from the left front corner

There was damage to the front bumper fascia on both the right and left side. The left front quarter panel was displaced to the left and deformed. The windshield was still in its mount but cracked. The left front tire was flat, but the wheel was undamaged. The left rear tire was also flat and there was wheel damage. There were scratches down the left side, more severe on the left rear door, with red paint transfer present. The left side glass was intact. The left rear quarter panel was displaced forward. The rear bumper fascia and bumper were displaced forward. The rear window was missing. The bottom portion of the right rear quarter panel was displaced and hanging from its mount. The right-side glass was intact. The right rear and right front tires were flat and the wheel both were scuffed around the entire outside flange.

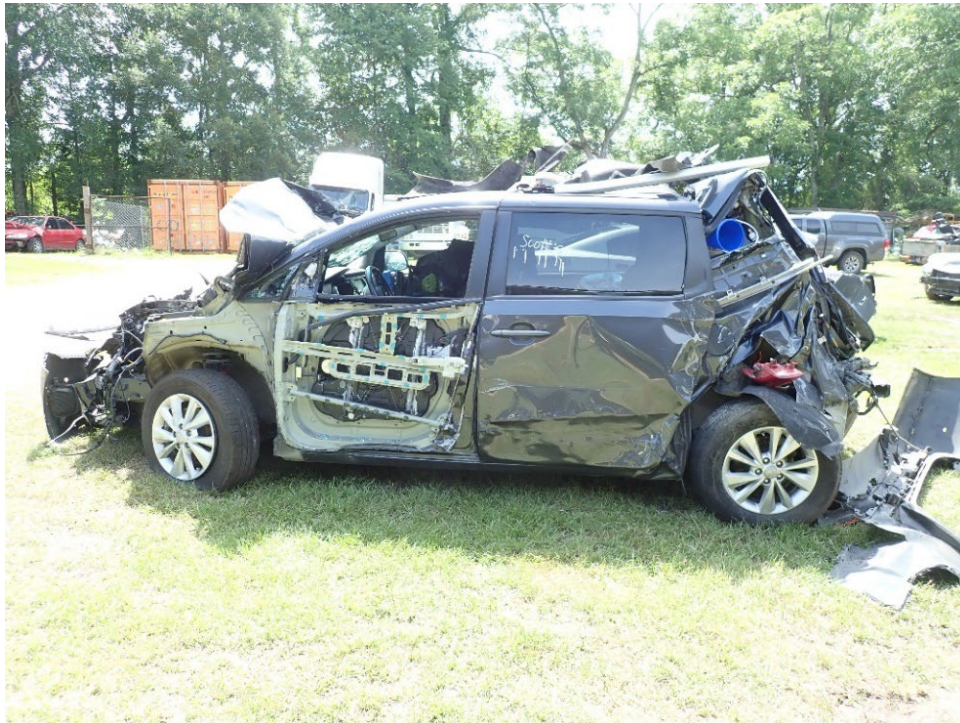
Figure 10: The damaged Kia Sedona viewed from the left side

The front bumper fascia was detached, but present. The front bumper was intact. The radiator was displaced rearward. The hood was deformed, folded, and displaced rearward. The windshield was shattered but present in its frame. The left front quarter panel was missing. The left front sheet metal door skin was missing and was the glass from the door frame. The left rear door had a lateral scrape at its midpoint. The left rear quarter panel was displaced forward to the rear wheel well. The left front tire was flat, and the wheel was scuffed near the lug nuts. The left rear tire was inflated but there was heavy scuffing on the wheel flange. The rear bumper was displaced forward, with more displacement on the left. The bumper was torn just to the left of the left frame rail. The rear hatchback was displaced forward to the rear seatbacks and the glass was missing. The rear bumper fascia was detached but present. The bottom portion of the right rear quarter panel was missing, and the top portion of the panel was scratched and displaced to the left. The roof was folded and displaced downward between the C and D pillars. The right rear glass was missing. The right rear tire was flat with minor wheel flange scratches. The right-side sliding door and right front door glass was intact, but there were scratches throughout. There was a dent in the sheet metal below the right-side mirror. The right front tire was flat and the outside wheel flange was scraped around its circumference. The right front quarter panel was displaced rearward.

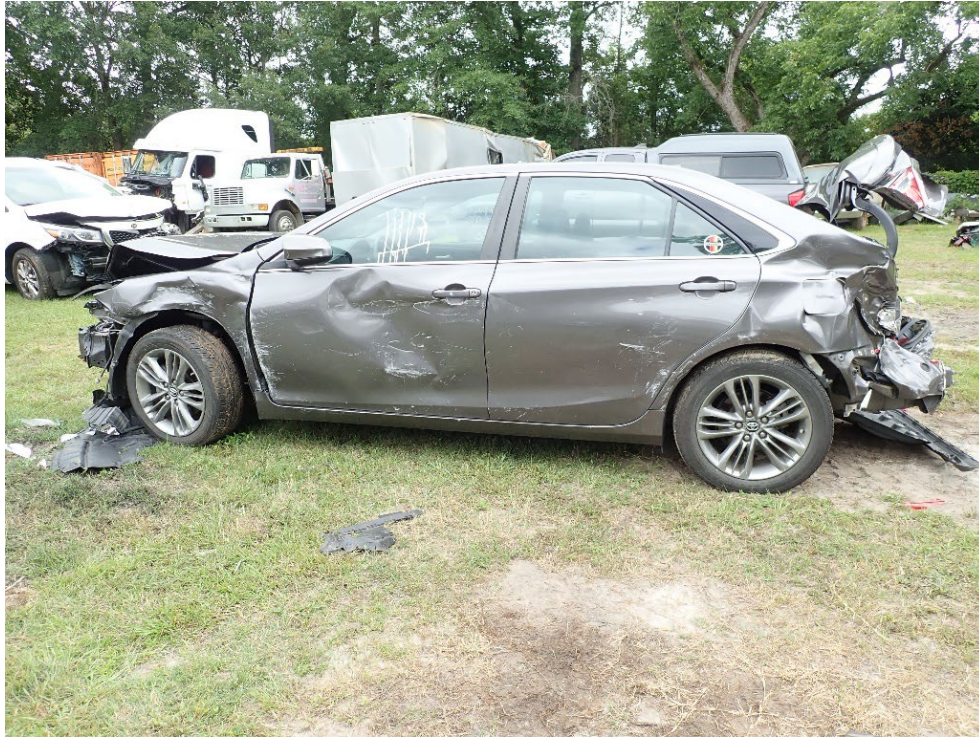
Figure 11: The damaged Toyota Camry viewed from the left side

The front bumper fascia was missing but the bumper was in place and undamaged. The hood was displaced rearward and folded. The left front quarter panel was displaced rearward to the wheel well. There were scratches down the entire left side of the vehicle. The left front door had a dent in the sheet metal at the midpoint. The left front tire was inflated but the wheel flange was scuffed around its lug nuts. The left rear tire and wheel were intact and undamaged. All glass but the right rear door and rear windows was intact. The rear bumper fascia was detached but present. The rear bumper was torn from its frame mounts and missing. The right-side frame rail was displaced forward to the rear tire. Both right rear and left rear quarter panels were displaced forward to the rear tires. The trunk was displaced forward and to the right. The right rear tire was flat, but the wheel was undamaged. The right front tire and wheel were undamaged. The right rear door was displaced to the left with a 5-inch high and 10-inch-long tear in the sheet metal.

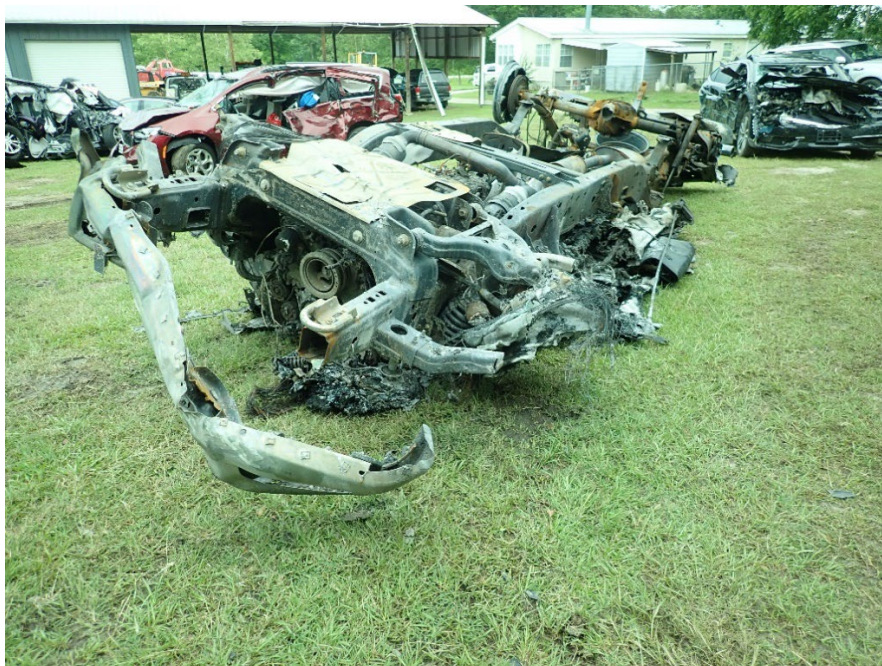
Figure 12: The damaged overturned Ford F-150 viewed from the left front corner

The Ford pick-up was on its roof and nearly entirely consumed by fire. All passenger controls and interior features were burned, leaving only the frames of the seats. The front bumper was detached from its mounts on the right side of the frame rail. One left side door frame was visible, but all other doors were missing or consumed. The left tow hook mounted to the frame rail was deformed. The drivetrain was melted at the rear differential. The rear leaf springs and shocks of the suspension system were warped away from the frame with the rear axle still attached. All
