# NATIONAL TRANSPORTATION SAFETY BOARD

MATERIALS LABORATORY FACTUAL REPORT

Report No. 18-003

Place : Millersville, Pennsylvania  
Date : July 2, 2017  
Vehicle : Natural gas mechanical tapping tee assembly  
NTSB No. : DCA17FP006  
Investigator : Roger Evans (RPH)

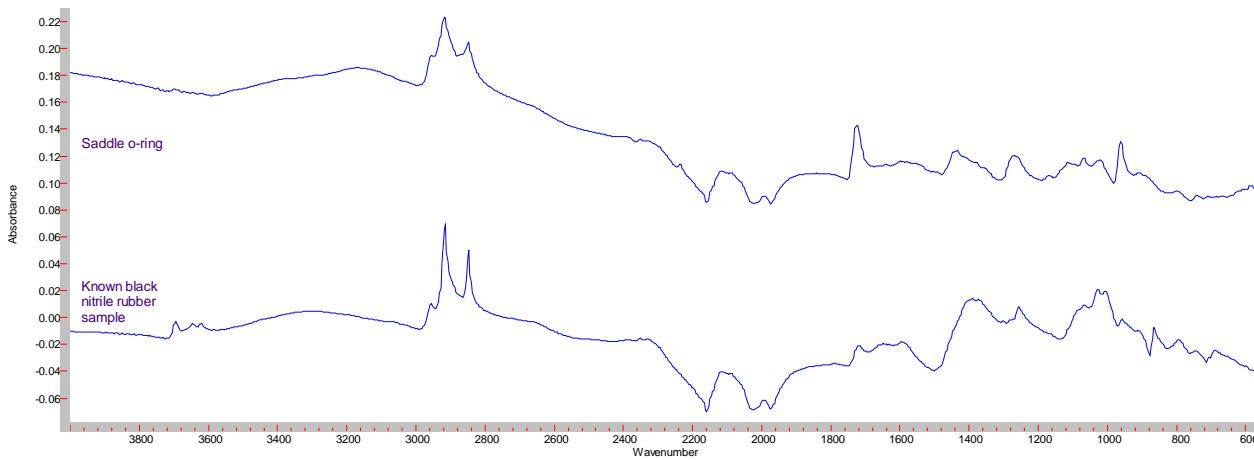
Appendix A9. FTIR spectrum for the saddle O-ring from dwelling 206 (top spectrum) is consistent with that of a known sample of black nitrile rubber (bottom spectrum).

In the spectrum for the SADDLE O-RING sample, one peak was found that was not found in the CUTTER TOOL O-RING sample or the known sample. The presence of a single peak  $\sim 1700\text{ cm}^{-1}$  is indicative of double bonded carbon=carbon (C=C) group. The presence of the a carboxy (C=O) group could indicate the presence of a foreign material on the surface of the O-ring. Carboxy groups are common in a wide variety of materials including materials containing carboxylic acids, esters and carboxylates (a class of surfactants).

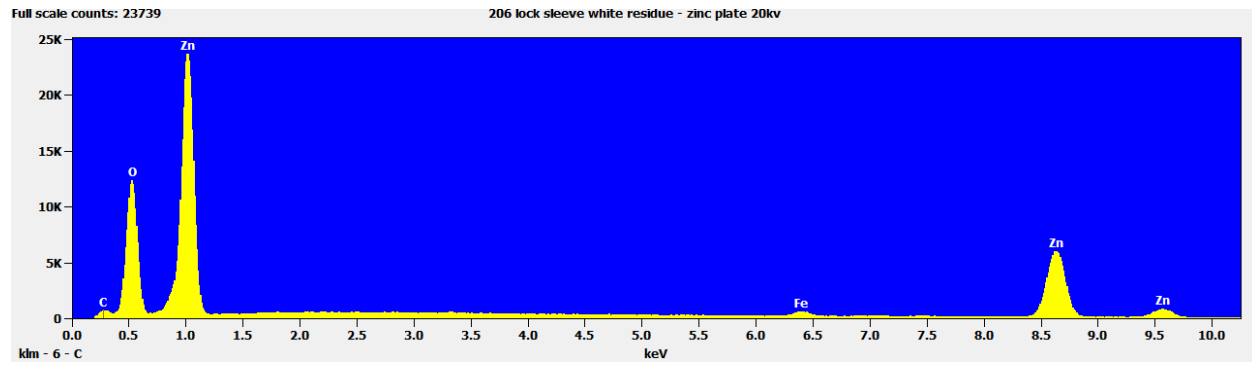
Appendix D4. EDS spectrum of the locking sleeve outer threads from dwelling 206 in an area that contained white deposits showing major elemental peaks of zinc and oxygen and minor elemental peaks of carbon, and iron. The major peak of zinc is consistent with the galvanized coating that was specified for the locking sleeve.

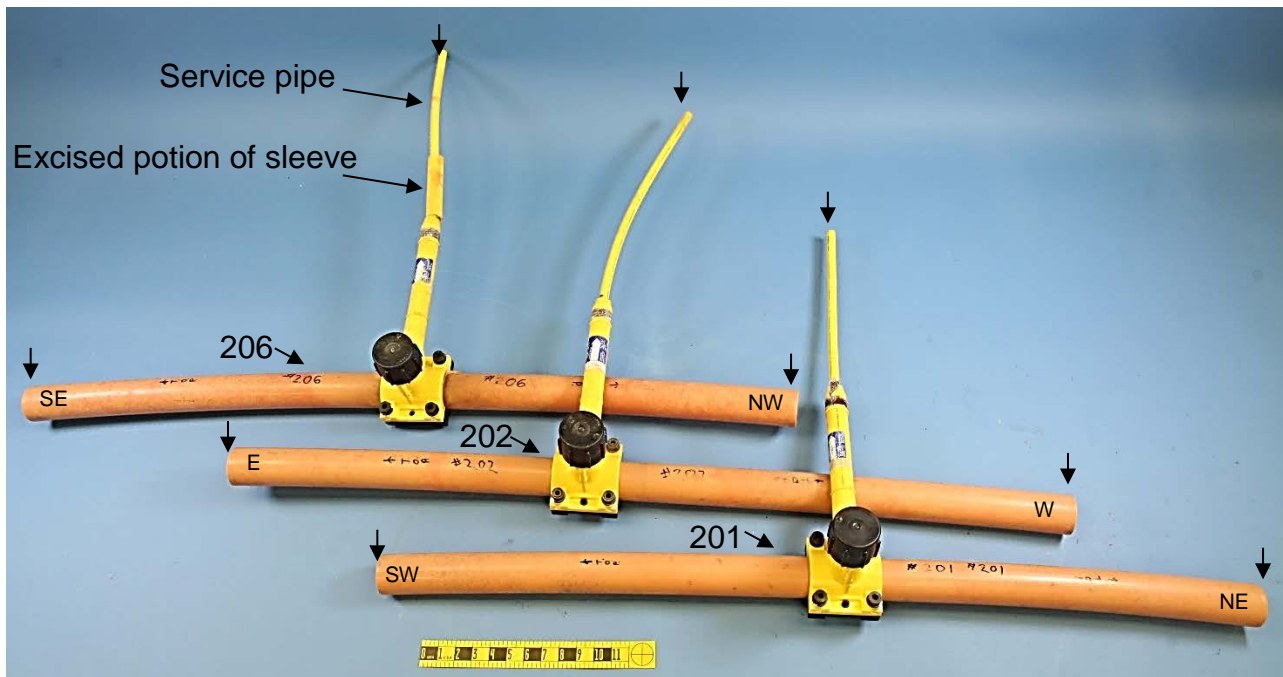
Figure 1. As-received Permalock® mechanical tapping tee assemblies from dwellings 201, 202, and 206, shown after brush cleaning with water. Arrows indicate cut portions of the pipes to facilitate transportation and handling. The position of the sleeve does not represent the sleeve's location as-found on the service pipe at the time of the accident.

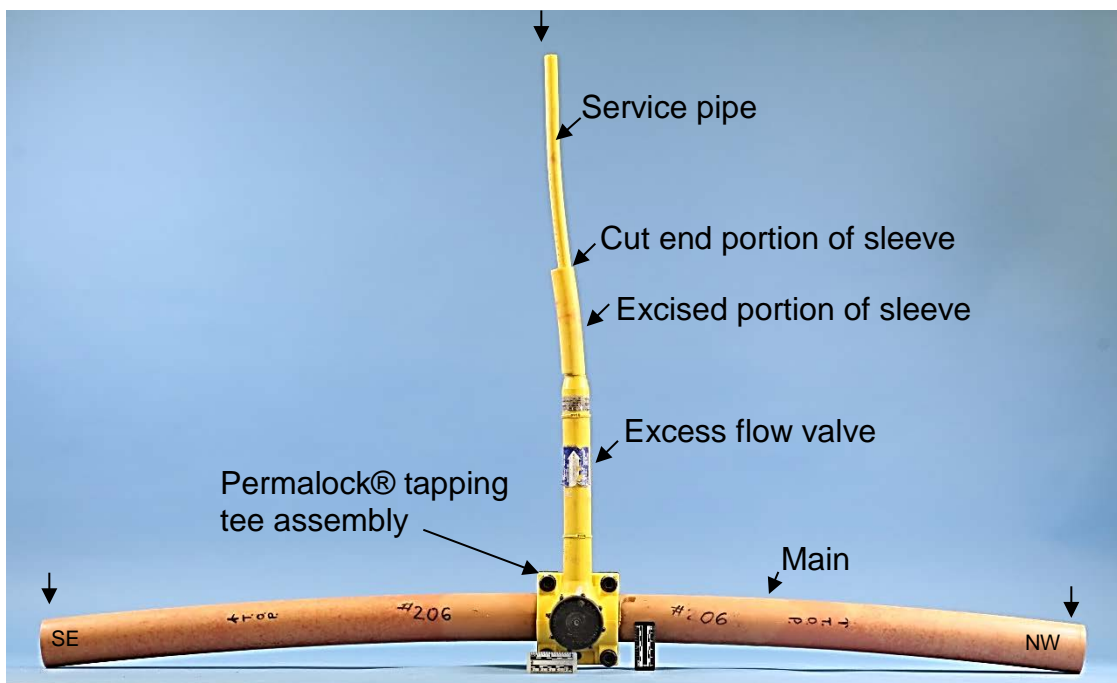
Figure 2. Close-up photograph of the Permalock® mechanical tapping tee assembly from dwelling 206. Arrows indicate cut portions of the pipes to facilitate transportation and handling.

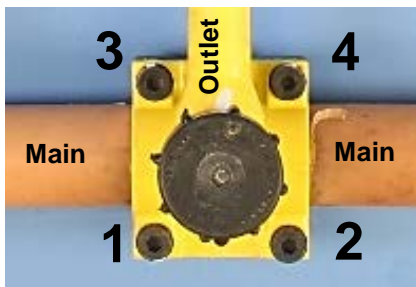
The Nylon bolts were arbitrarily assigned a number between "1" and "4", orientation as shown in figure 5. The length of a Nylon bolt measured approximately 2.5 inches. The combined length of the shank and threaded portions measured approximately 2 inches. The diameter of the non-threaded shank portion measured approximately 0.5 inch. Figure 10 shows a side view of the upper half portions of the fractured bolts. The mating thread fragments remained in the base. The two fractured bolts were located on the non-outlet side, corresponded to numbers "1" and "2". The mating fractured portion of the bolts remained attached to the base. The intact bolts were located on the outlet side, corresponded to numbers "3" and "4". The head portion of each bolt contained hexagonal recessed slots. The hexagonal slots of the four bolts showed evidence of vertical contact lines consistent with hexagonal slots that were in contact with an Allen key/wrench, and no evidence of slot deformation.

Figure 5. Photograph of the tee assembly from dwelling 206 that was involved the accident showing the top view, and identification numbers that were arbitrarily assigned to the Nylon bolts, "1" through "4". The same bolt numbering system was used for each tee.

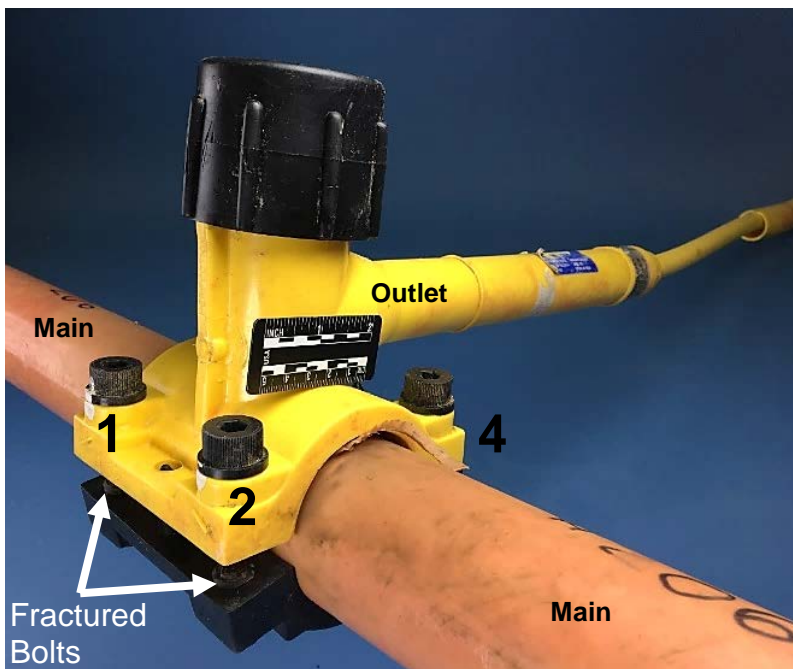
Figures 5 through 8 show photographs of the tee assembly involved in the accident (also referred in this report as tee assembly from dwelling 206). Visual examination of the tee assembly involved in the accident revealed two of the four Nylon bolts fractured at the first full thread adjacent to the non-threaded shank portion. The fracture in each bolt corresponded to an area between 0.13 and 0.16 inch above the mating halves of the tee assembly, on the non-outlet side. The outlet side was facing the house. A gap was noted between the mating halves of the tee assembly on the non-outlet side (side that contained the fractured bolts). The gap measured in the vertical direction approximately 0.5 inch. The mating halves of the tee assembly on the side that contained the two intact bolts (outlet side) showed no evidence of a gap.

Figure 6. Photograph of the tee assembly from dwelling 206 showing fractured bolts "1" and "2".

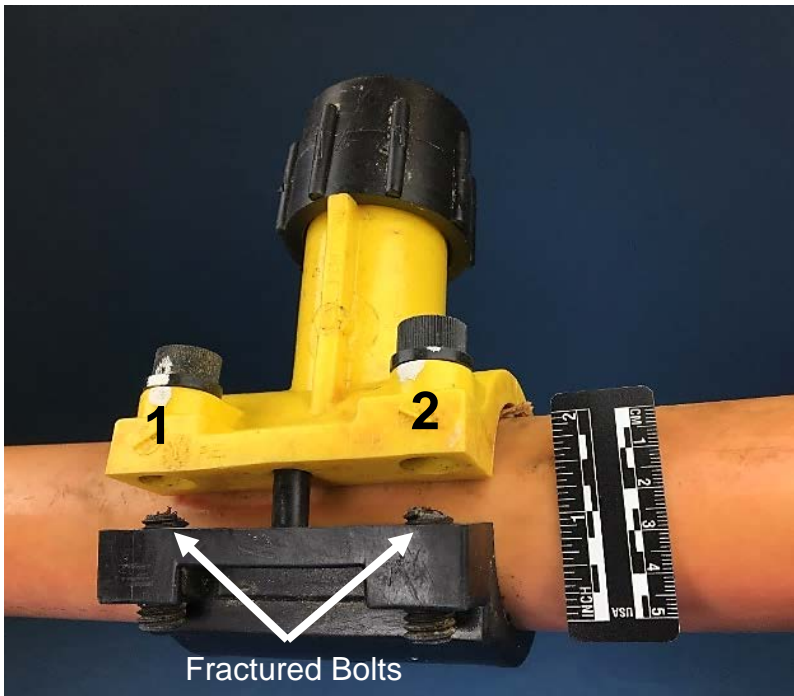
Figure 7. Another view of the tee assembly from dwelling 206 showing fractured bolts “1” and “2”.

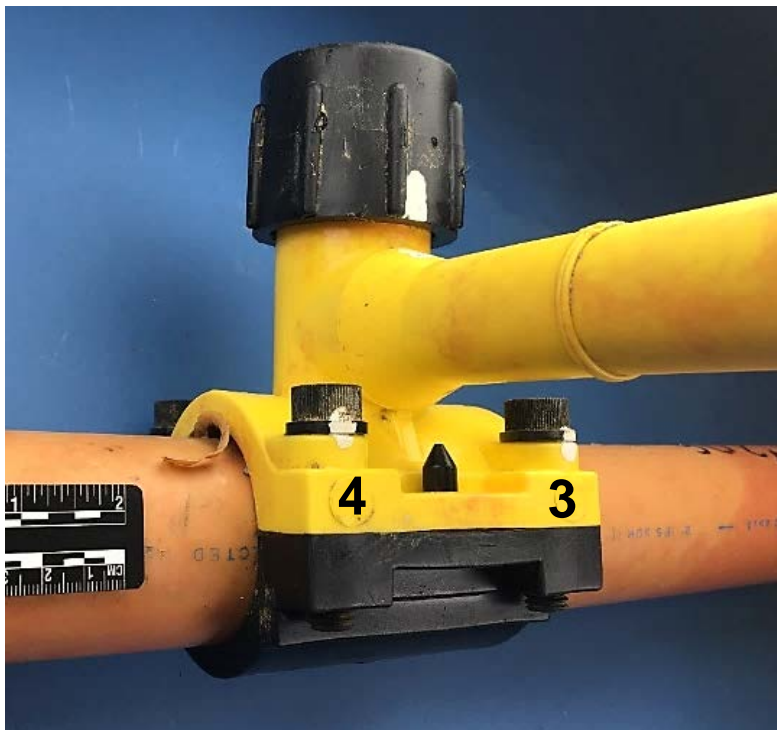
Figure 8. Photograph of the tee assembly from dwelling 206 showing intact bolts “3” and “4”.

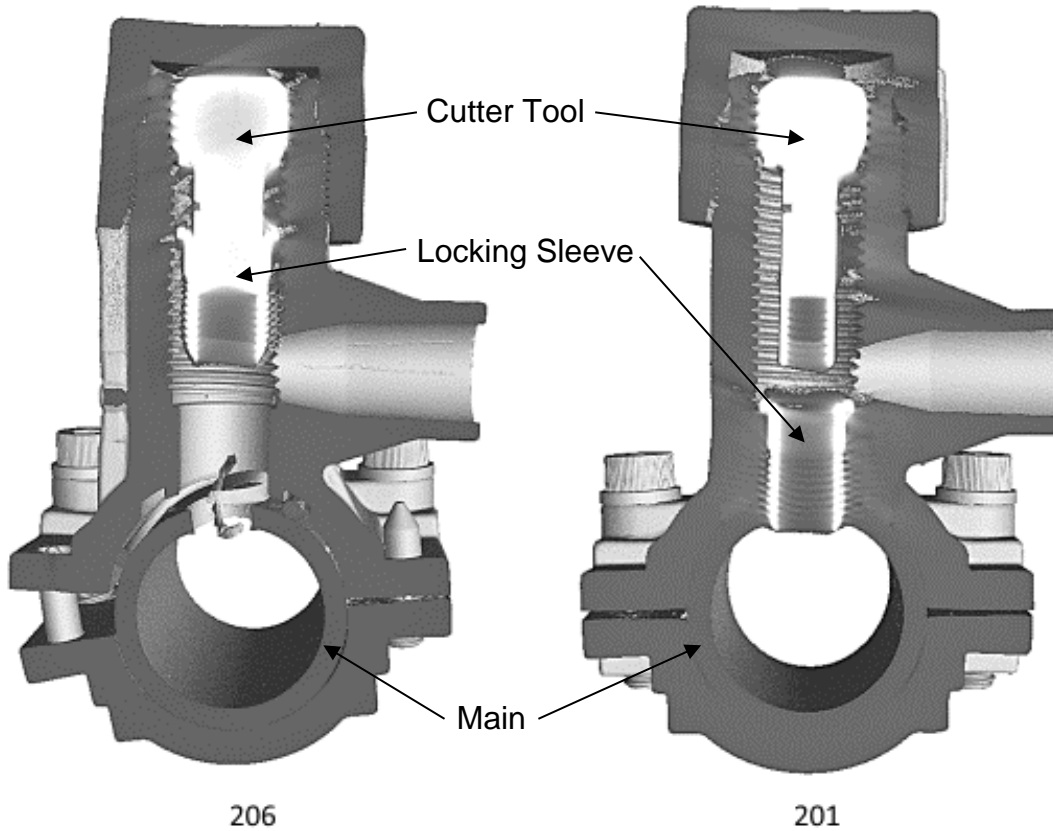
Figure 9. Reconstructed X-ray CT image of the tee assembly from dwelling 206 involved in the accident showing a locking sleeve that was not installed on the main (left side of page) and image of tee from dwelling 201 showing a locking sleeve that was attached to the main (right side of page). The locking sleeve in the dwelling 206 tee assembly remained attached to the cutter tool.

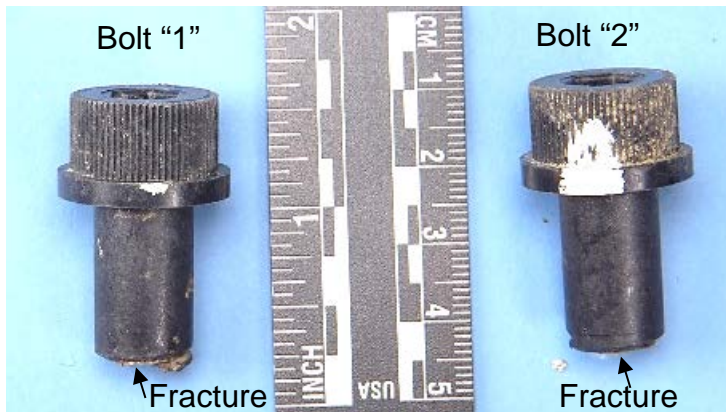
The two fractured bolts "1" and "2" were removed by hand from the tee assembly, with ease and no resistance. Both fractured bolts went through ultrasonic cleaning bath using a solution of dishwashing soap and water. The shank and thread portions of the fractured bolts "1" and "2" showed no visible evidence of elongation deformation (reduction in diameter cross section) in the general area of the fracture. On both bolts, the fracture occurred at the first full root of the thread, in an area adjacent to the non-threaded shank portion, and on a slight spiral plane that followed the root of the thread. On both bolts, the fracture extended around one complete revolution of the root portion of the spiral thread. The fracture face in the center portion of the bolt on one side of the fracture face extended approximately the length of one thread above the fracture plane, and appeared similar to a round cone. Figure 11 shows a photograph of the fracture face from bolt "2". The fracture face of bolt "2" showed no evidence of a fracture origin or general direction of fracture propagation. The fracture face of bolt "1" showed fracture features that were similar to those of bolt "2".

Figure 10. Photograph of fractured Nylon bolts "1" and "2" that were disassembled from the tee assembly involved in the accident (dwelling 206).

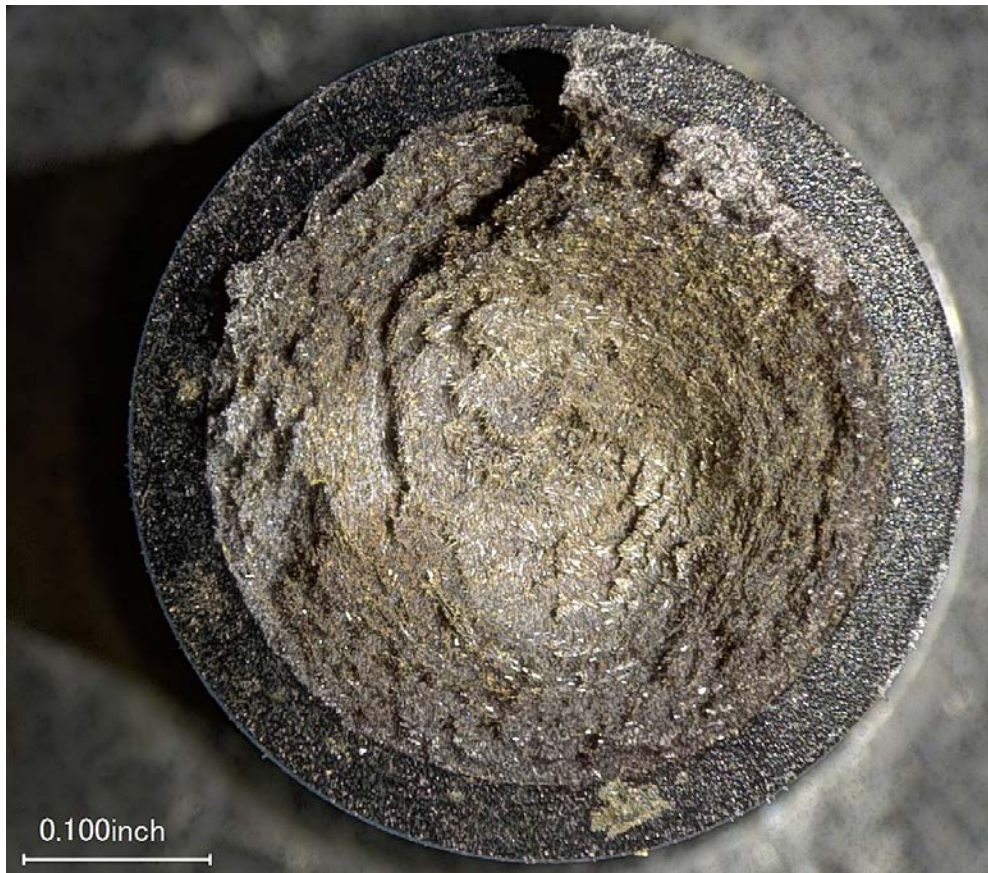
Figure 11. Fracture face of Nylon bolt "2" after ultrasonic cleaning.

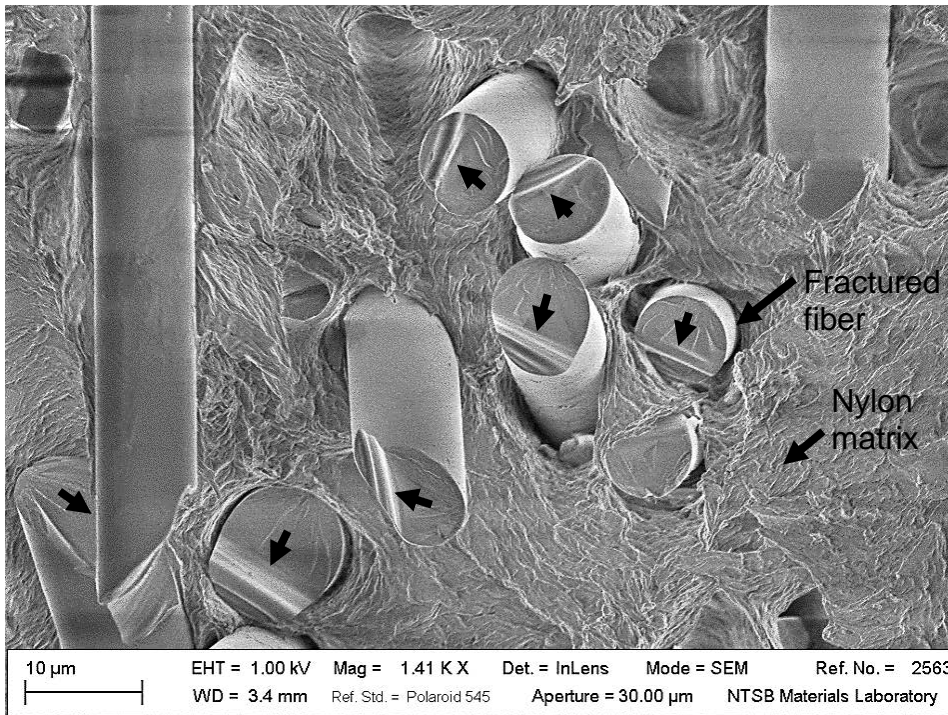
Scanning electron microscope (SEM) examination of bolt “2” revealed the fracture face contained evidence of fracture features on the polymer matrix (Nylon) and fiber portions (see figure 12). The Nylon matrix portion of the bolt exhibited evidence of fibrils that exhibited minor elongation. Many of the glass-fiber fracture faces showed evidence of a fracture propagation direction, but the direction of fracture propagation varied from fiber to fiber. The fracture face on the Nylon matrix and individual fibers showed no evidence of a pattern that identified a general direction of fracture propagation in the bolt. The origin of the bolt fracture could not be determined, because fracture patterns varied randomly within the Nylon matrix and direction of fracture propagation varied from fiber to fiber.

Figure 12. Scanning electron microscope (SEM) photograph of a portion of the fracture face from Nylon bolt "2" showing the matrix (Nylon) and the end of several fractured fibers. Arrows indicate general direction of fracture propagation on each fractured fiber.

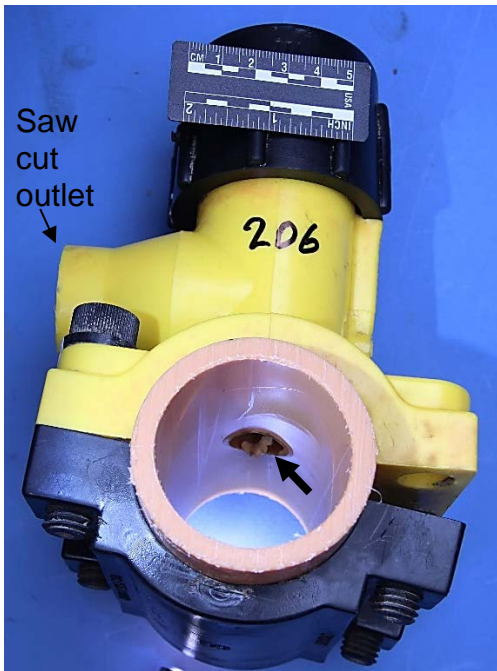
Figure 13. Photograph of the tee assembly from dwelling 206 showing the exposed inner wall of the main in the area where the cutter tool made a hole in the wall of the main. A curled fragment is sticking out of the pierced hole in the area indicated by an unmarked arrow. The wall of the pierced hole was bare and showed no evidence of a locking sleeve.

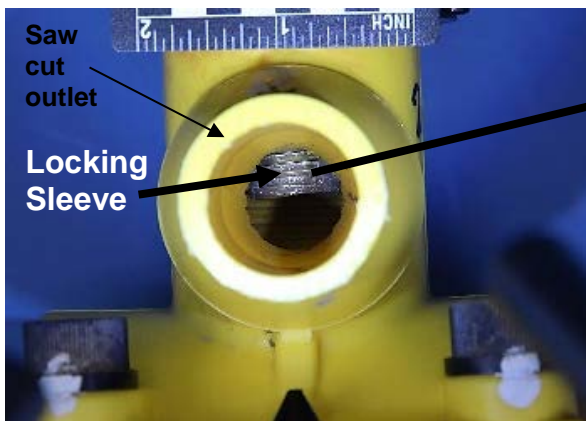
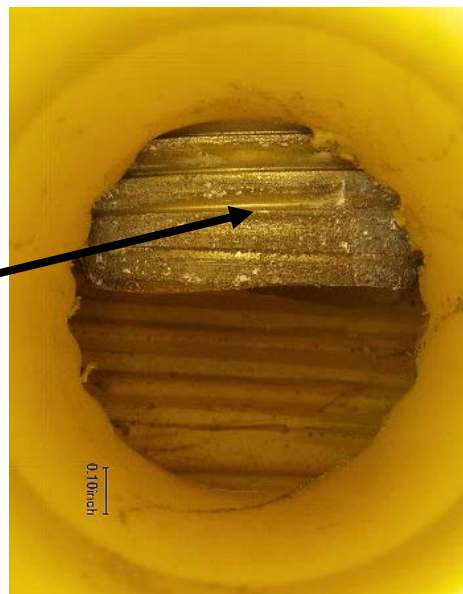
Figure 14. Photograph of a portion of the tapping tee assembly from dwelling 206 looking in the outlet port showing the bottom end of the locking sleeve that was in an area near the upper side of the outlet port (left side of page) and a close-up photograph of the same locking sleeve (right side of page).

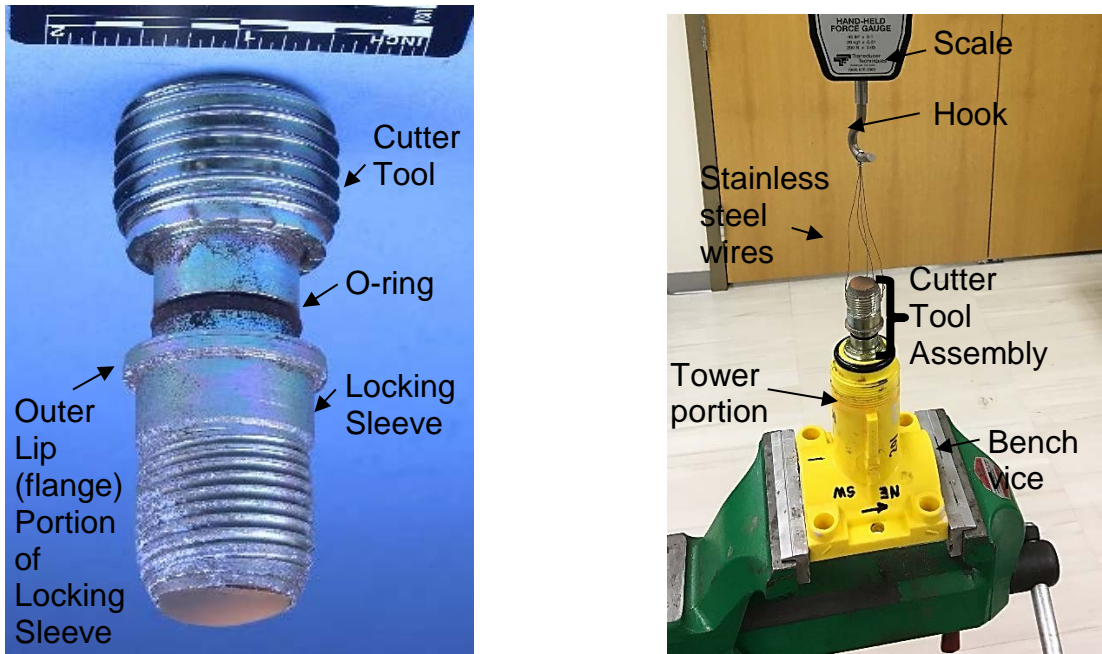
Figure 15. Photograph of the cutter tool assembly that was disassembled from the tapping tee assembly from dwelling 206 (left side of page). The locking sleeve remained attached to the cutter tool. Set-up used for attempting to separate the cutter tool from the locking sleeve (right side of page). The threaded-head portion of the cutter tool was inverted and installed into the tower portion, and the tee was secured to the bench vice.

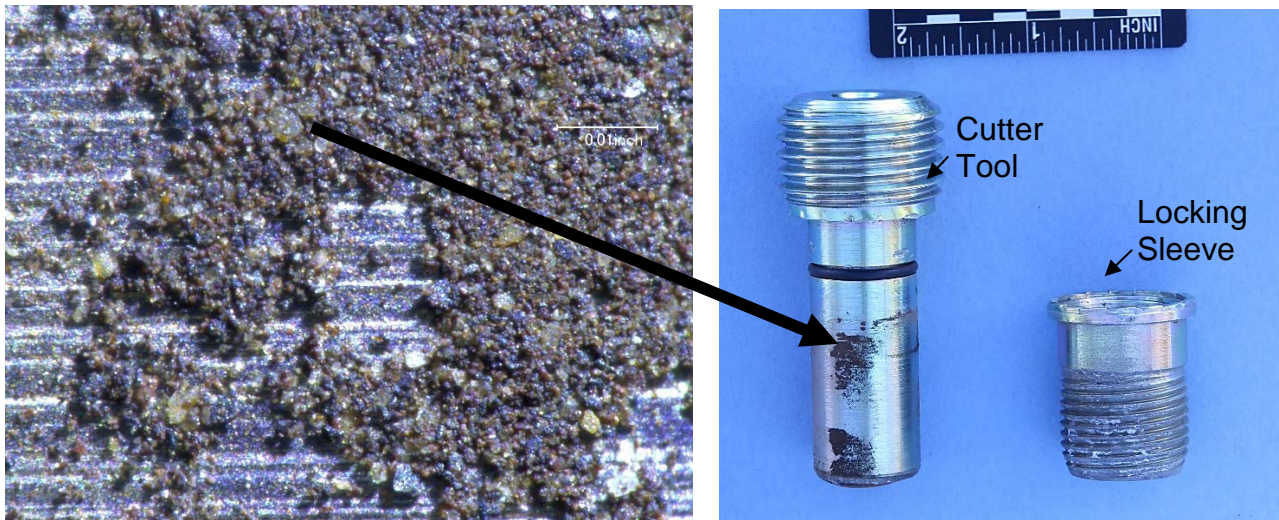
Figure 16. Photograph of the cutter tool from dwelling 206 after it was disassembled from the locking sleeve (right side of page), and photograph of soil particles that were found on the shank portion of the cutter tool (left side of page).

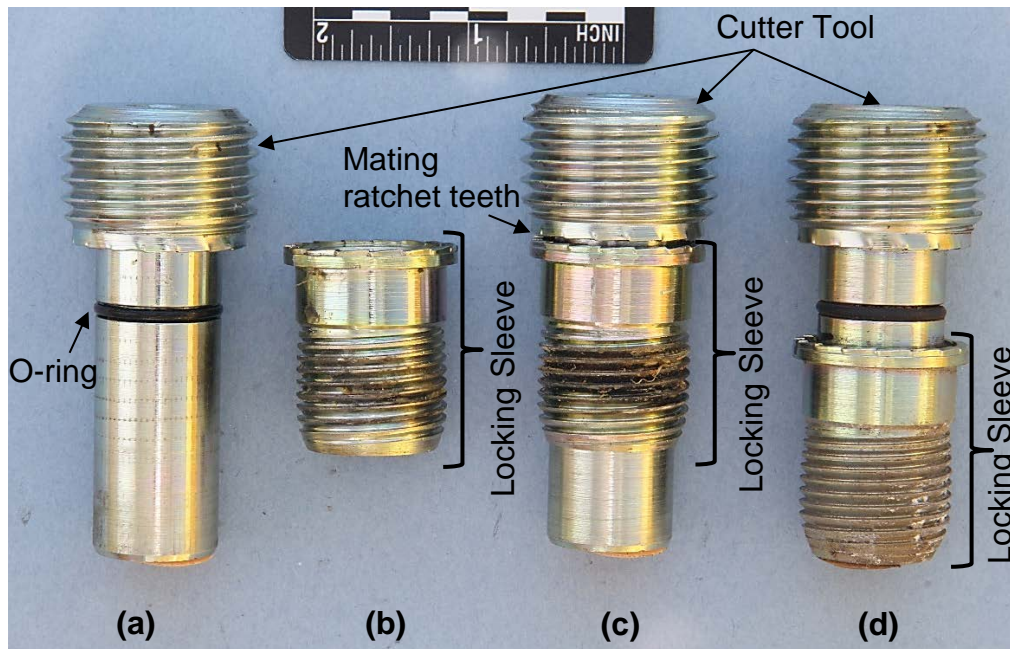
Figure 17. Photograph of cutter assemblies in different conditions of assembly showing (a) disassembled cutter tool from dwelling 201; (b) disassembled locking sleeve from dwelling 201; (c) cutter tool and locking sleeve from dwelling 202 that were re-assembled to simulate the unit prior to driving the cutter assembly into the main; and (d) cutter assembly (locking sleeve and cutter tool) in the condition when removed from the tee assembly associated with dwelling 206.

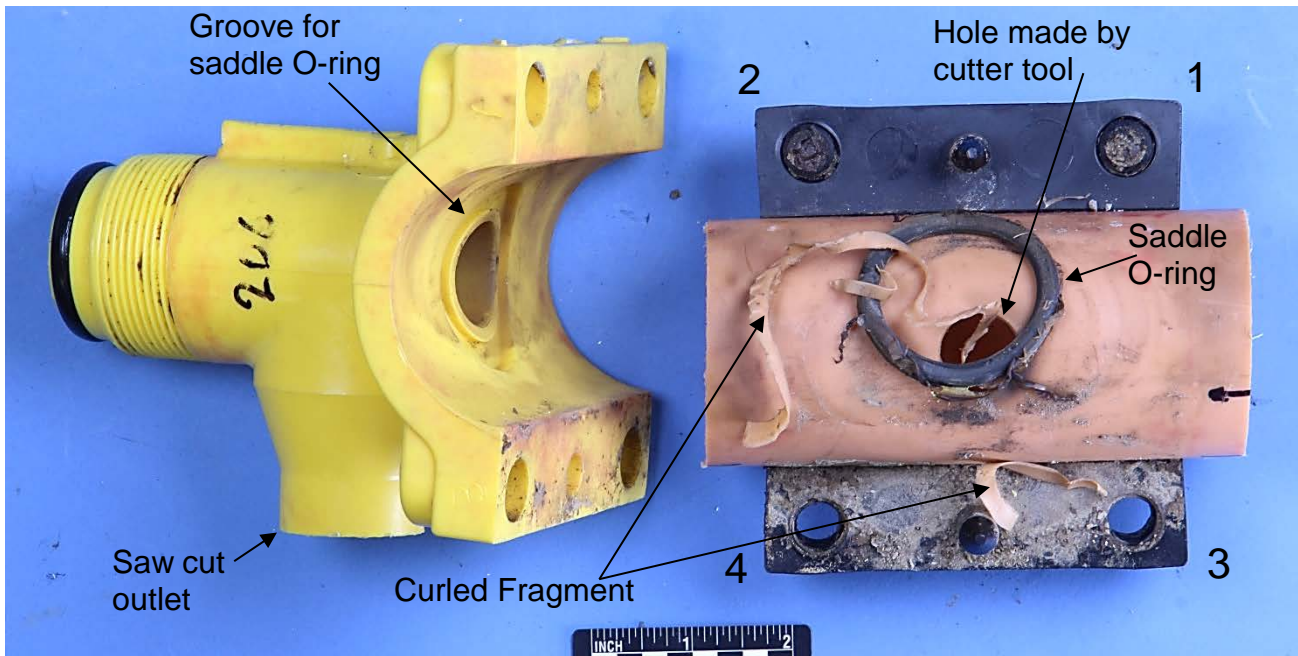
The tee assembly was disassembled from the pipe (see figure 18). The tee assembly showed no evidence of cracking. Two long curled fragments were found on the surface of the main. The longer curled fragment extended between the pierced hole made by the cutter tool and the outer face of the tee assembly. The shorter curled fragment was located near the base. The two curled fragments exhibited an orange-like color and texture that were similar to those of the main. The width of the curled fragments measured between 0.16 inch and 0.24 inch. The greatest width was nearly as large as the specified wall thickness of the main (0.216 inch - 0.242 inch). The length of the longer curled fragment measured approximately 6 inches, whereas, the length of the shorter curled fragment measured approximately 2.8 inches. The thickness of the curled fragments measured between 0.01 inch and 0.02 inch. The surface of both fragments exhibited a continuous longitudinal texture, as if the fragment was shaved from the wall of the main. FTIR testing of a sample from the main in the tee assembly at the Safety Board Materials Laboratory produced a spectrum that was consistent with polyethylene

The saddle O-ring was found on top of the main (see figure 18). The saddle O-ring is specified as BUNA-N (Nitrile). According to manufacturer written installation instructions supplied with each tee assembly shipment, the main surface and saddle O-ring are to be lubricated with a silicone grease or leak test soap solution prior to installing the tower on to the main. The size of the saddle O-ring is specified in Perfection Corporation engineering drawing number 53942, Revision B, titled 'Contoured O-ring 2" IPS PMTT'. The measured size of the saddle O-ring is shown in table 6. The inside diameter of the saddle O-ring was within the size specified by the manufacturer (see table 6). Although only a thickness is specified for the saddle O-ring, the height and width of the O-ring were measured. The height of the saddle O-ring was slightly less than the specified thickness and the width of the saddle O-ring was slightly greater than the specified thickness. FTIR analysis of the saddle O-ring produced a spectrum consistent with nitrile, and two peaks associated with a molecular functional group often found in a class of surfactants (such as a detergent), see Appendices A8 and A9.

Figure 18. Photograph of the disassembled tee from dwelling 206 showing the top exposed surface of the main and pierced hole (made by the cutter tool).

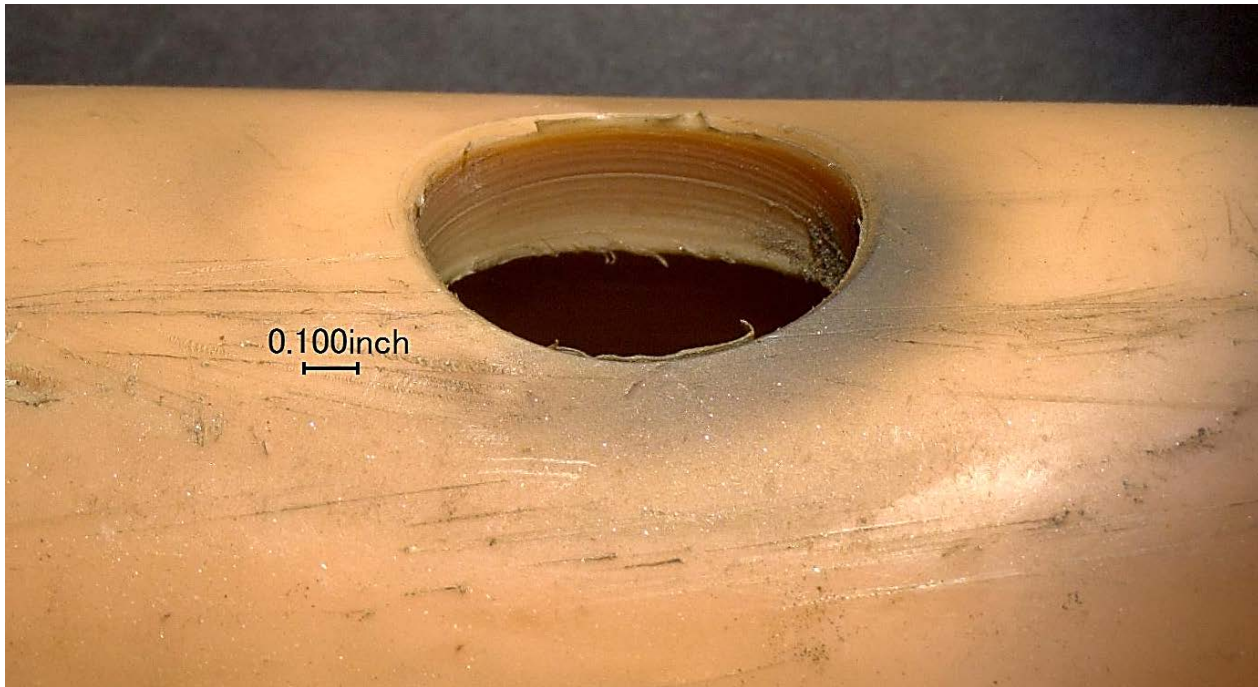
Figure 19. Photograph of the exposed outer top surface of the main after disassembly of the tee from dwelling 206 showing the pierced hole made by the cutter tool. Note the fine circular cut marks within the pierced hole and the absence of threads.

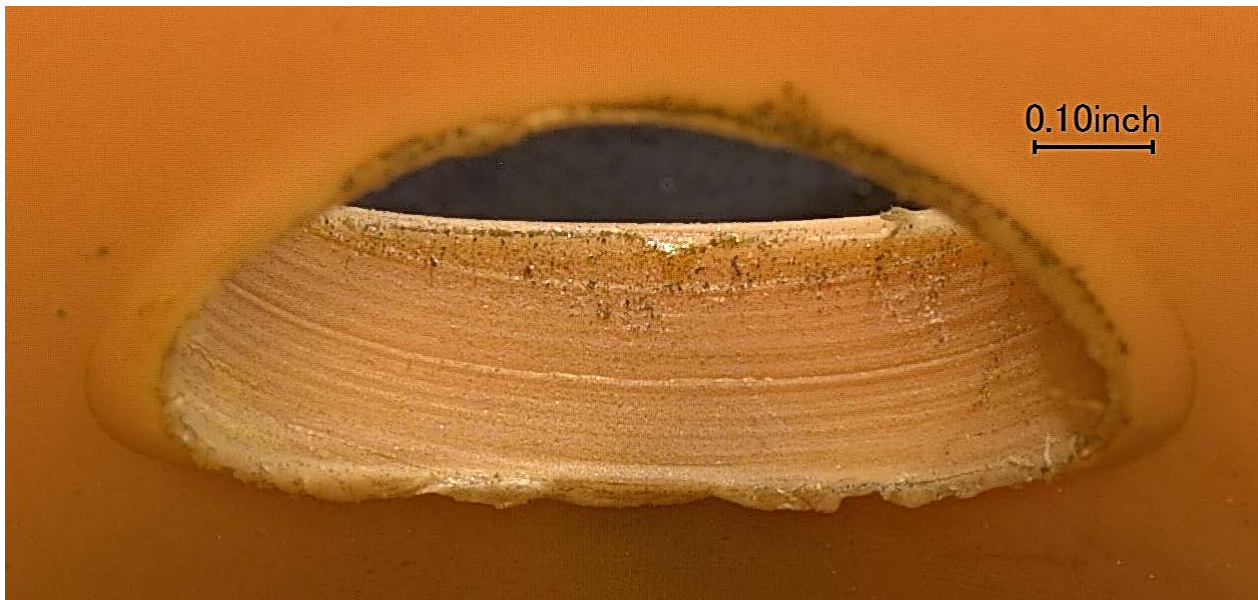
Figure 20. Photograph of the exposed inner surface of the main after disassembly of the tee from dwelling 206 showing the pierced hole made by the cutter tool. Note the fine circular cut marks within the pierced hole and the absence of threads.

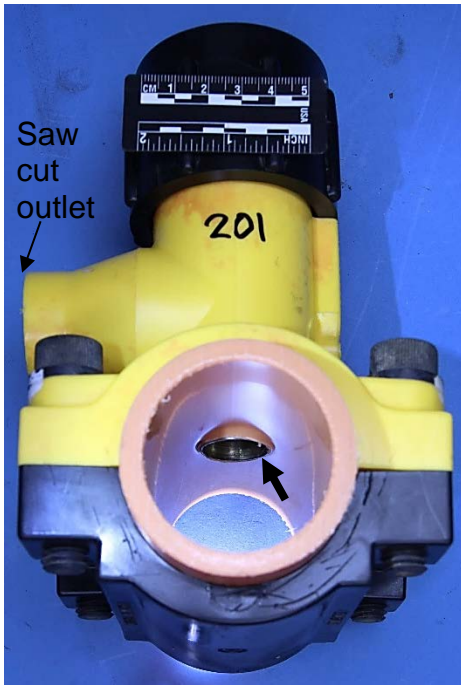
Figure 24. Photograph of the tee assembly from dwelling 201 showing the exposed inner wall of the main in the area where the cutter tool pierced the wall of the main. The bottom portion of the locking sleeve is visible in the pierced hole, in the area indicated by an unmarked arrow.

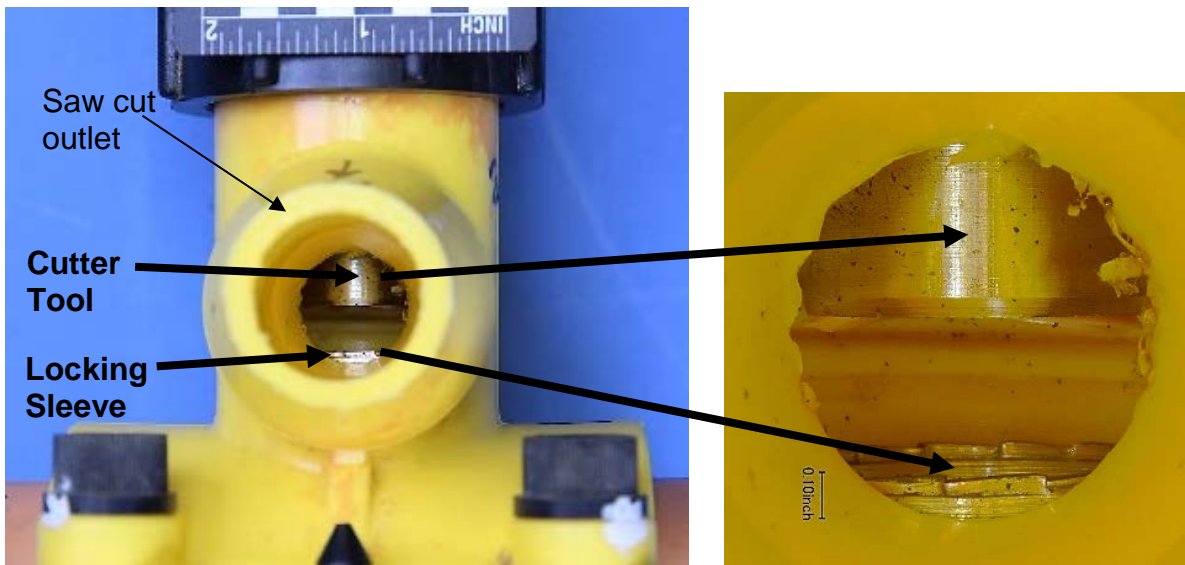
Figure 25. Photograph of a portion of the tapping tee assembly from dwelling 201 looking in the outlet port showing a portion of the cutter tool in the area near the upper side of the outlet port and upper portion of the locking sleeve at the lower side of the outlet port (left side of page); and a close-up photograph of the cutter tool and locking sleeve (right side of page).

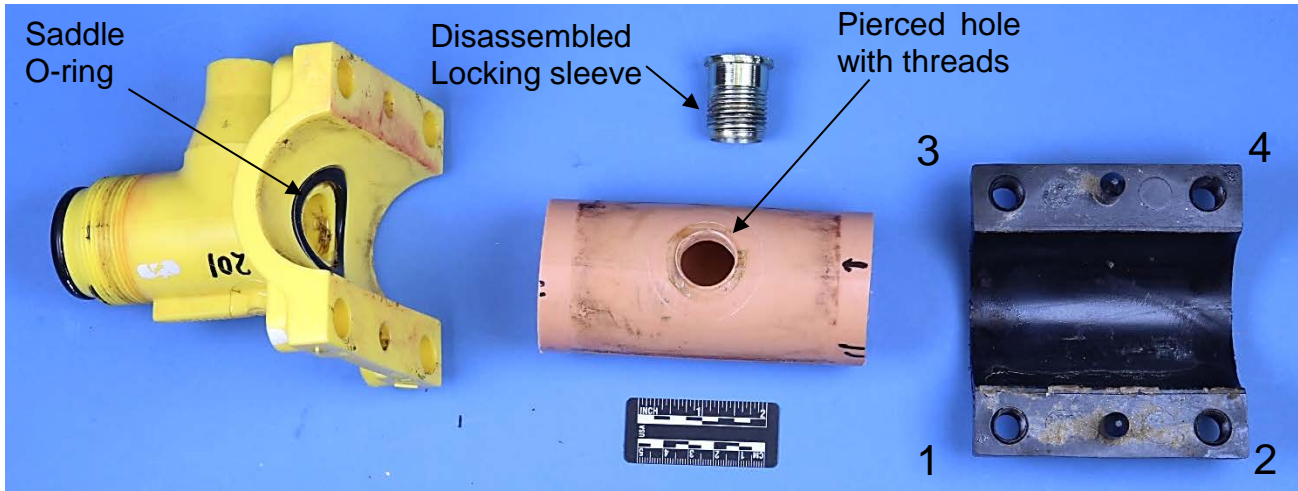
Figure 26. Photograph of the disassembled tee from dwelling 201 showing the top exposed surface of the main and pierced hole with threads (after removal of the locking sleeve).

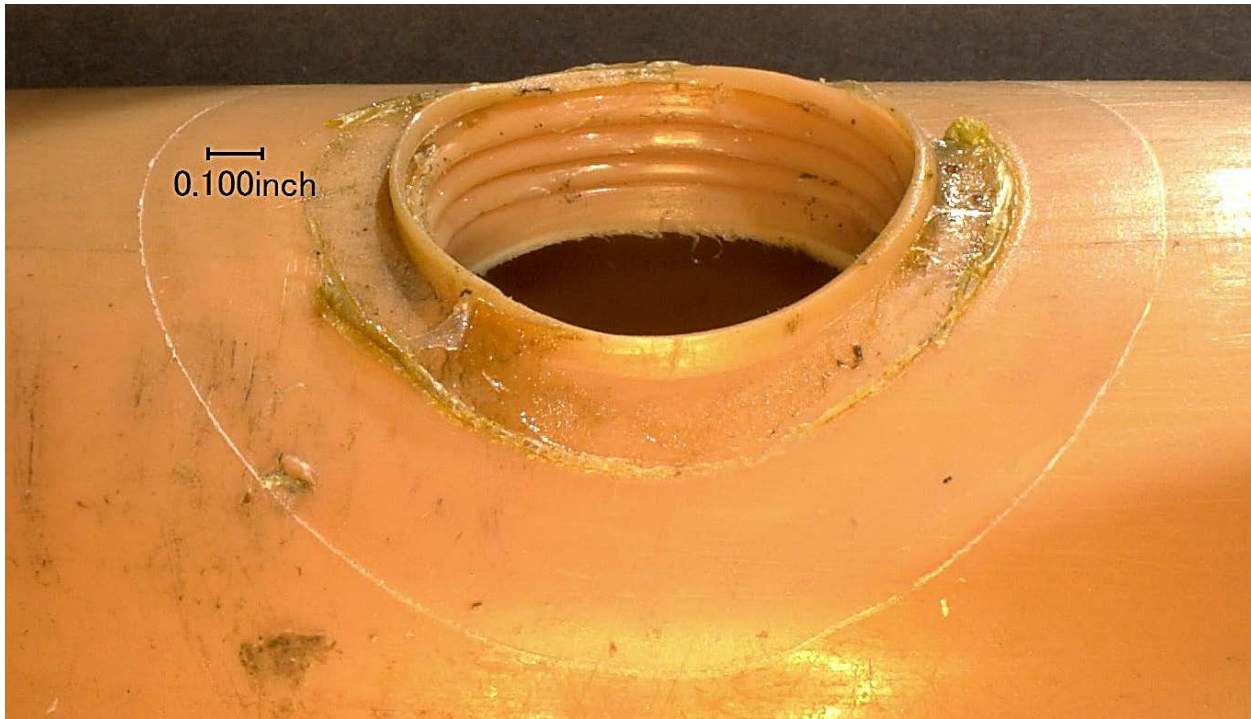
Figure 27. Photograph of the exposed outer top surface of the main after disassembly of the tee from dwelling 201 showing the pierced hole with threads (after removal of the locking sleeve).

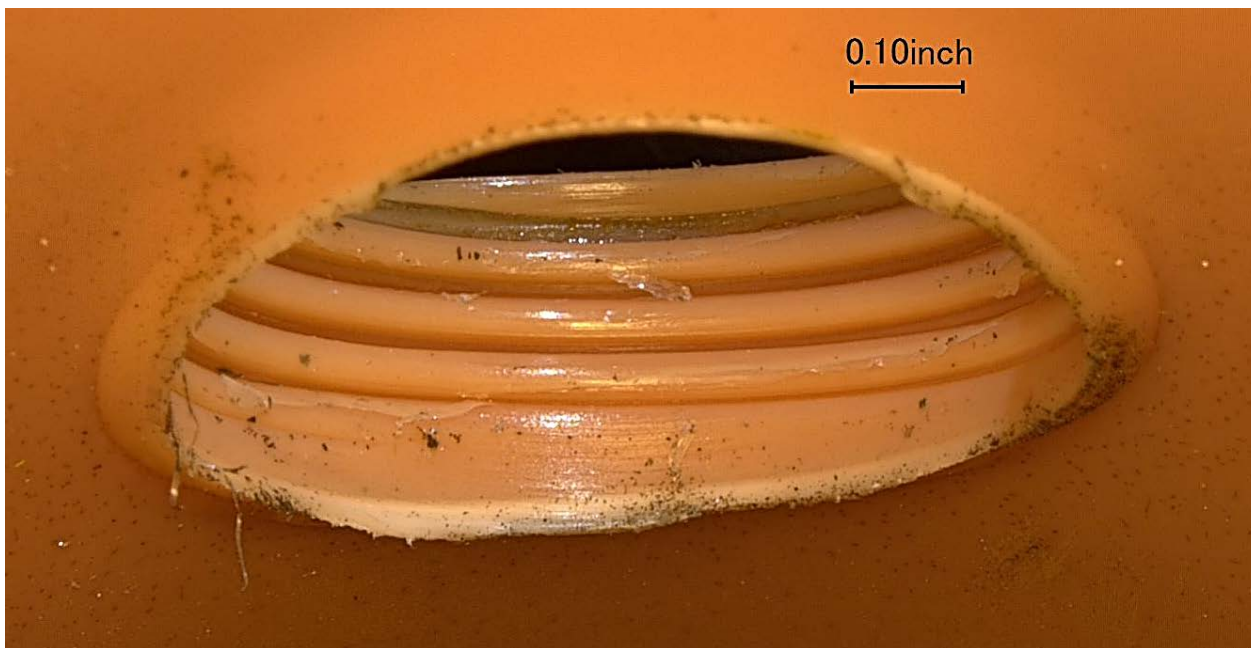
Figure 28. Photograph of the exposed inner surface of the main after disassembly of the tee from dwelling 201 showing the pierced hole with threads (after removal of the locking sleeve).
