# NATIONAL TRANSPORTATION SAFETY BOARD

MATERIALS LABORATORY FACTUAL REPORT

Report No. 18-010

Place : Hertford, North Carolina  
Date : September 8, 2017  
Vehicle : Eurocopter MBB-BK 117C2 (N146DU)  
NTSB No. : ERA17MA316  
Investigator : Douglas Brazy

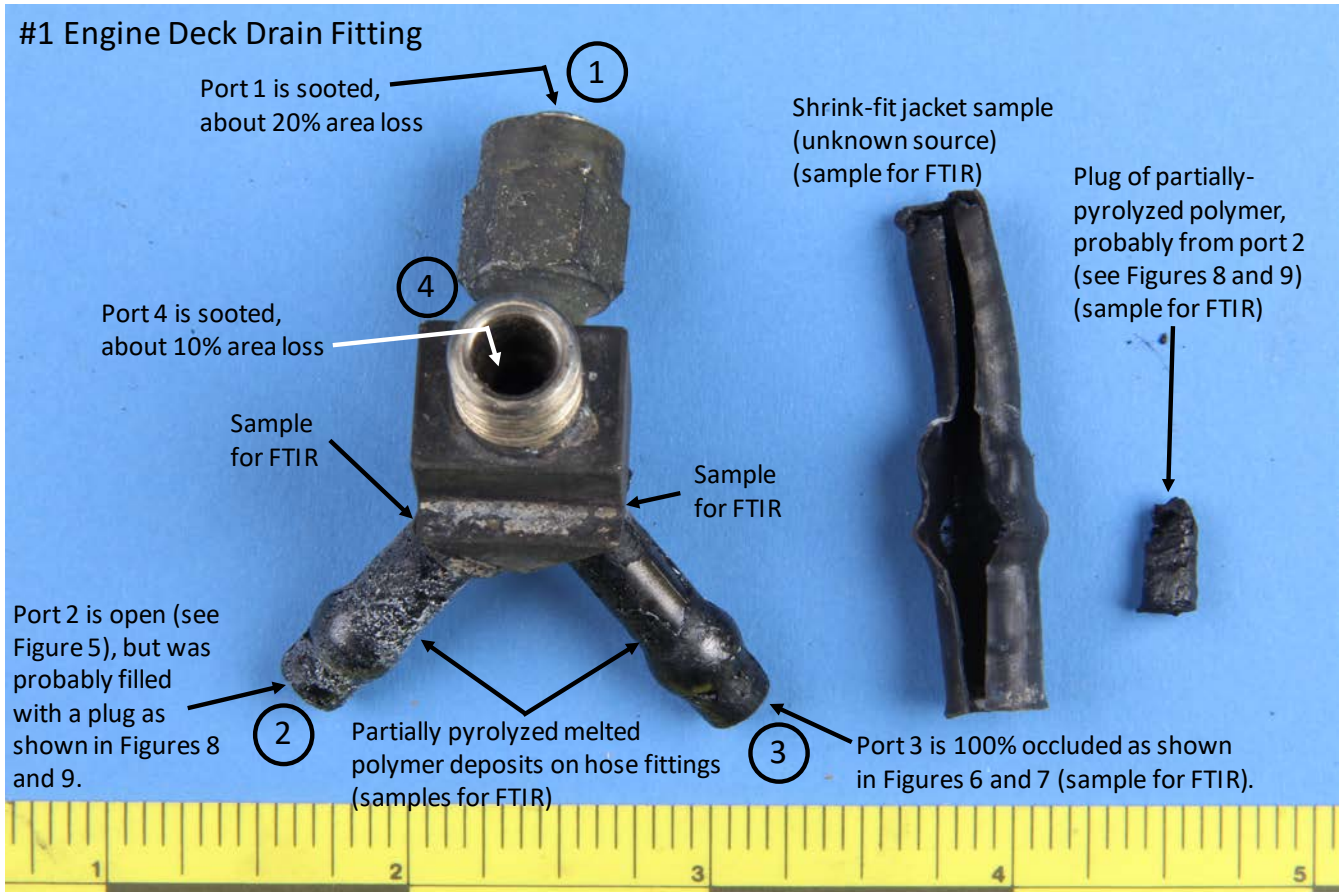
The #1 engine deck drain fitting exhibited surface oxidation, rust, soot, and deposits of partially pyrolyzed polymer or organic matter as shown in Figure 4 with each port numbered consistent with Figure 2. Using a 5X to 50X stereo-zoom microscope and a 0.033 inch diameter stainless steel wire, each port was inspected for the presence of sludge, coking deposits, or other occlusions. The observations for each port are summarized in Figure 4 and closer details for occlusions are documented in Figures 5-8. As indicated in Figure 9, samples were removed locations labelled D through I and were evaluated by Fourier transform infrared spectroscopy (FTIR)<sup>1</sup>. The spectra were compared with reference spectra from exemplar hoses (see Figure 2, hoses 2 and 3) and shrink jacket tubing used over the hose connectors.

Figure 4 Image of the #1 engine deck drain fitting. Each port is identified relative to Figure 3. The

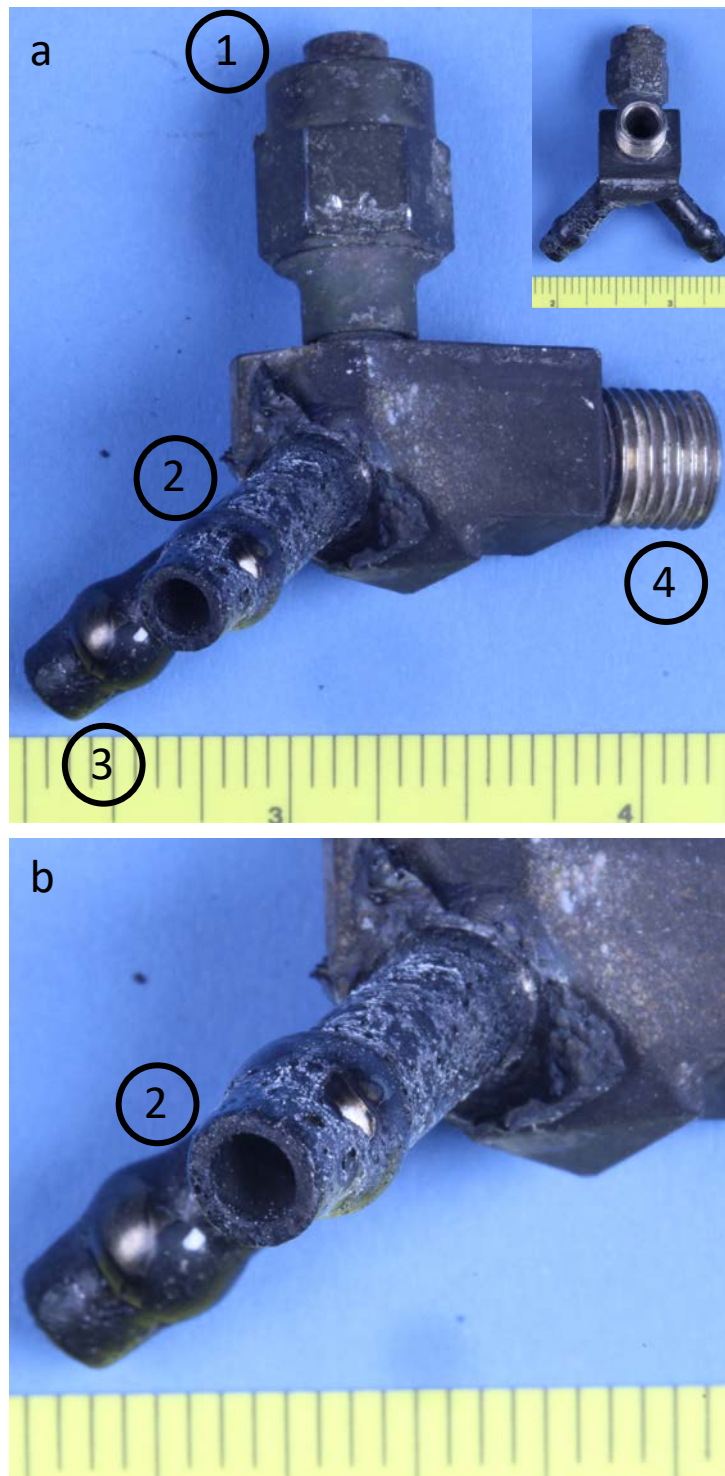
Figure 5 Images of port 2 of the #1 engine deck drain fitting.

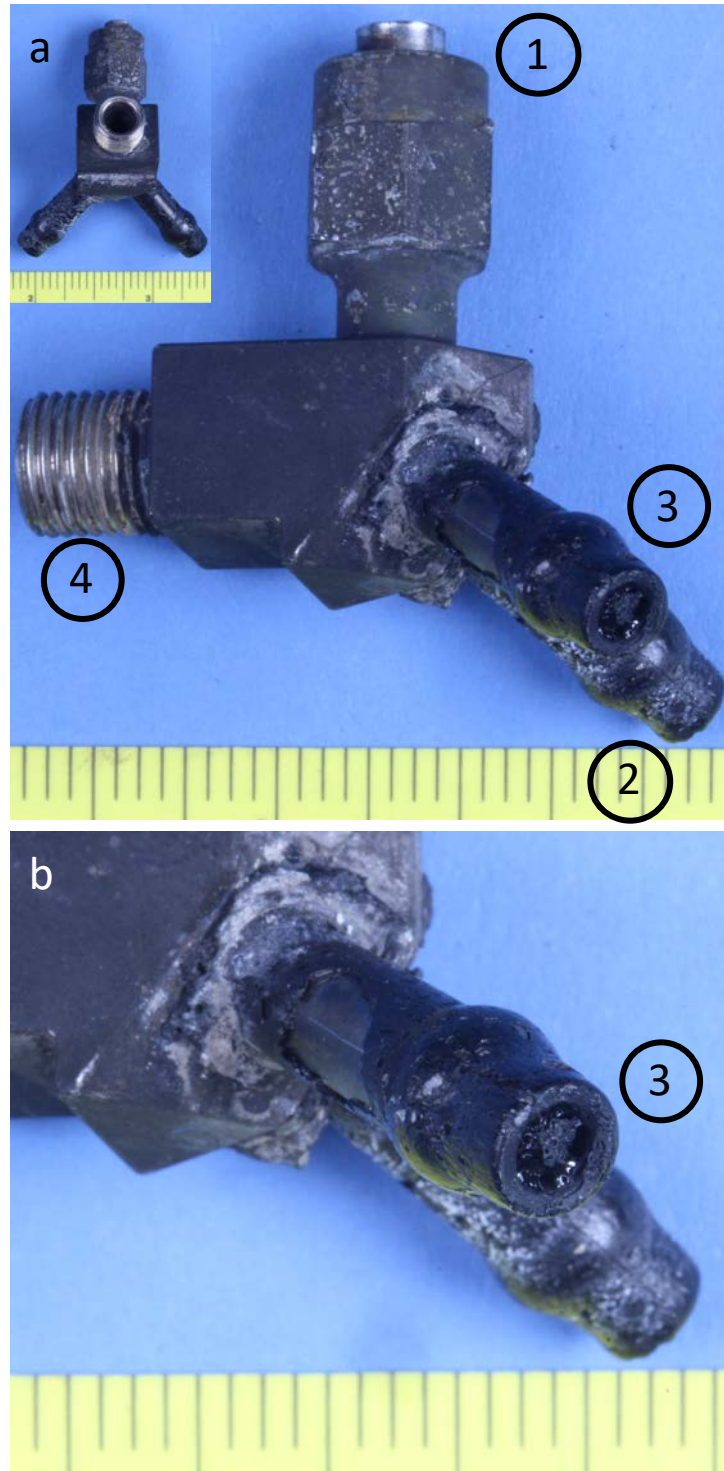
Figure 6 Images of the occlusion in port 3 of the #1 engine deck drain fitting.

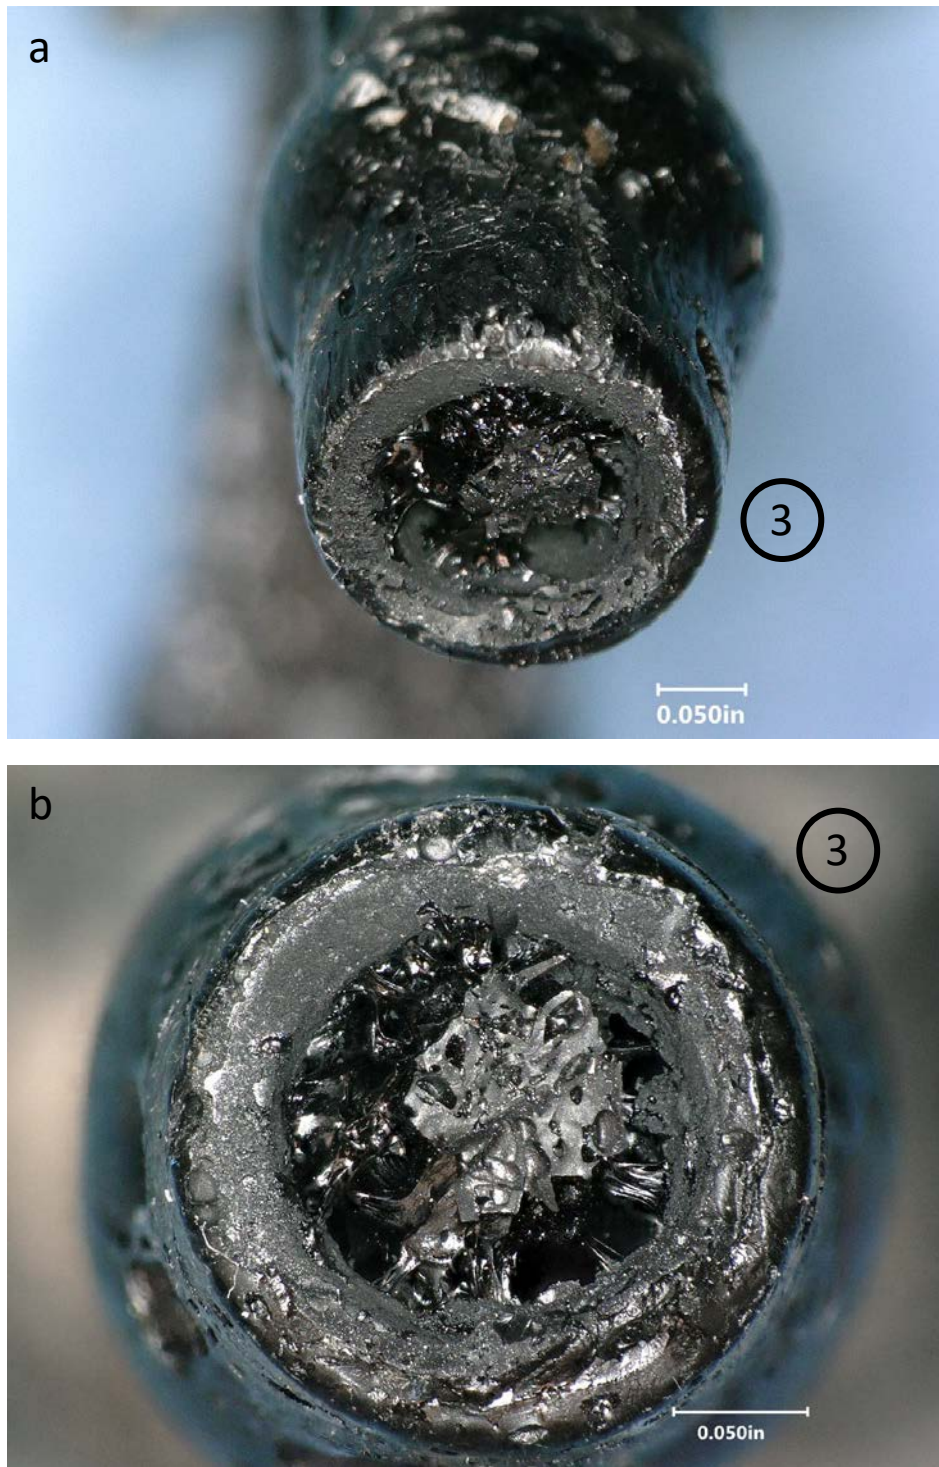
Figure 7 Closer images of the occlusion in port 3 of the #1 engine deck drain fitting shown in Figure 6. A sample was removed for FTIR analysis (see Figure 9 and Table 1).

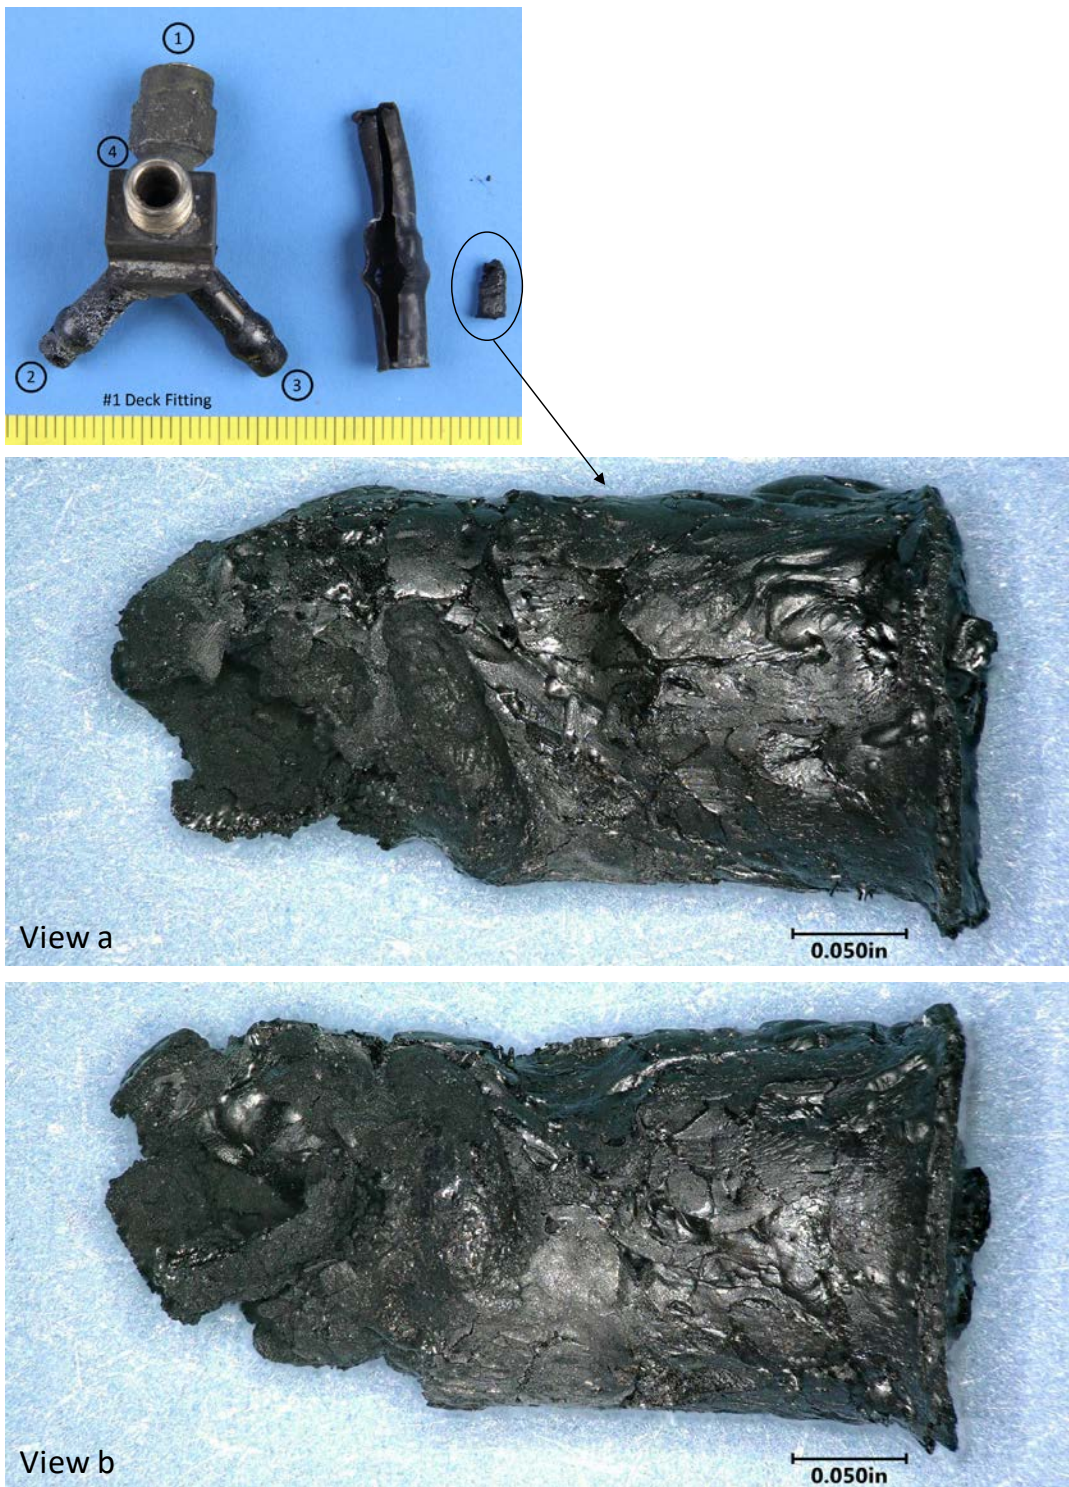
Figure 8 Images of the plug submitted with the #1 deck drain fitting. Most likely this plug was removed from port 2 as indicated in Figure 4.

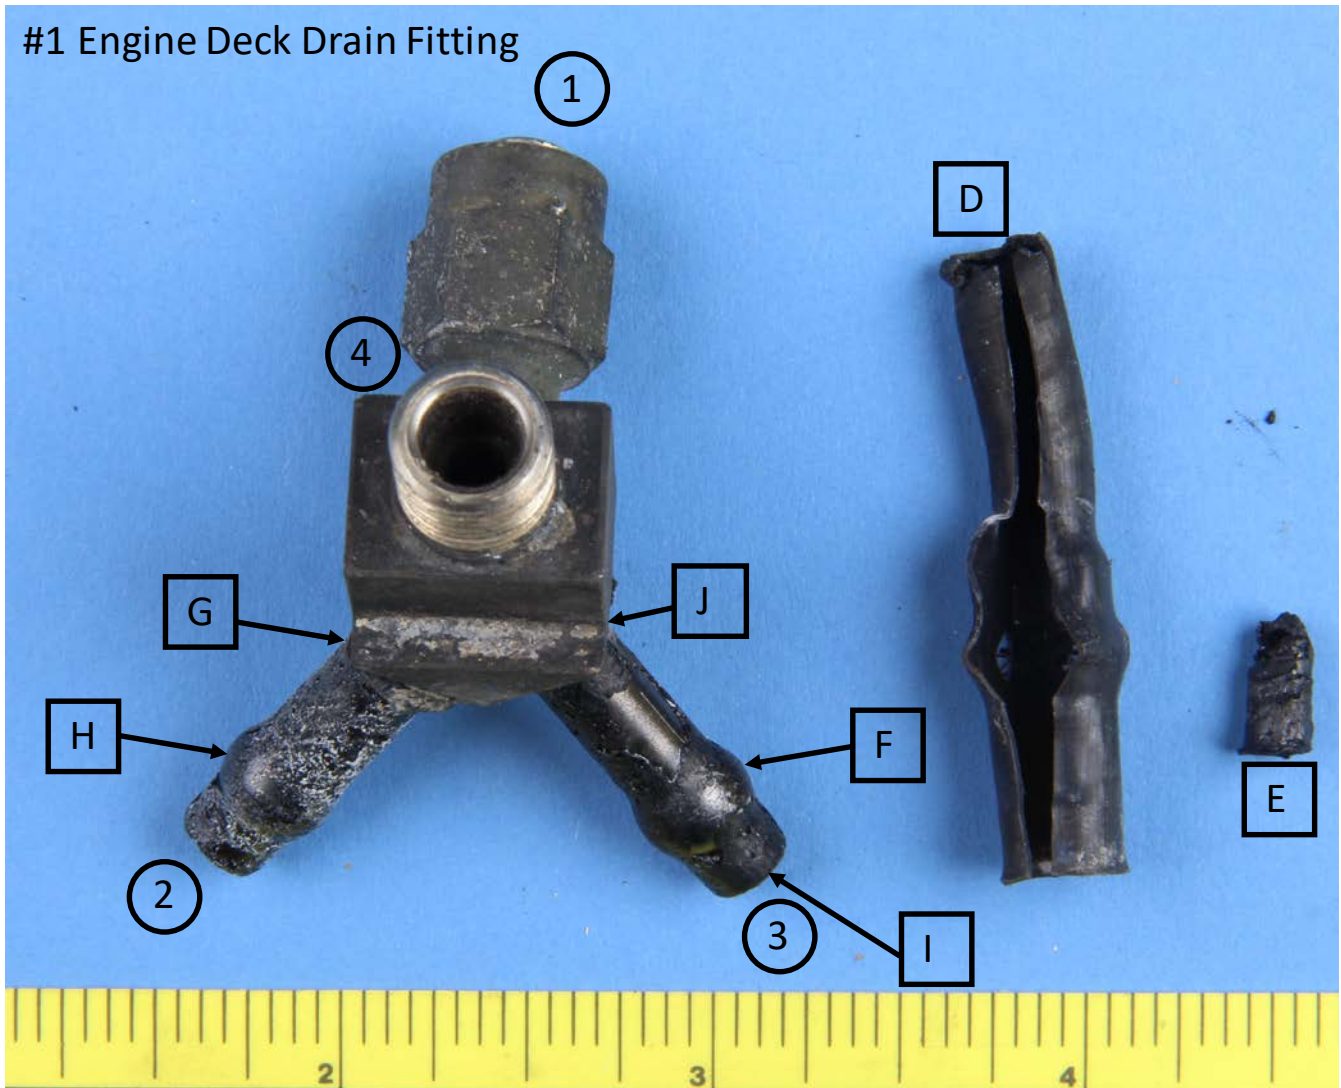
Location	Sample	FTIR spectra interpretation	Identified material (or closest spectral match)
A	Exemplar hose, corrugated, 117-600381.105 (oil supply line deflector, port 2, Figure 3)	Direct library match	PTFE
B	Exemplar hose, corrugated, 117-600381.104 (rear bearing vent line, port 3, Figure 3)	Direct library match	PTFE
C	Exemplar shrink jacket tubing, Raychem ¼ DR-25 (Figure 4)	No strong library match; Doublet at ~2920 and 2852; Strong peak at 1716; Peaks at 2360, 1434, 1268, 1102, 874 and 728	May be based on polyethylene and olefin copolymers, fluoropolymers, polyamides and polyesters
D	Shrink jacket submitted with #1 deck fitting (Figure 4)	Doublet at ~2922 and 2851; Strong peak at 1713; Peaks at 2593, 1371 and 1242	Shrink jacket tubing
E	#1 deck fitting, loose plug from port 2 (Figures 4 and 8)	Doublet at ~2922 and 2851; Strong peak at 1713; Peaks at 2389, 1371 and 1242	Shrink jacket tubing

F	#1 deck fitting, hose fitting exterior deposit, port 3 (Figure 4)	Peaks at 1688, 1265, 1099 and 728	Shrink jacket tubing
G	#1 deck fitting, A side corner, port 2 (Figure 4)	Peaks at 1688, 1265, 1099 and 728	Shrink jacket tubing
H	#1 deck fitting, hose fitting exterior deposit, port 2 (Figure 4)	Doublet at ~2924 and 2853; Strong peak at 1696; Peaks at 1418, 1268, 1160, 873 and 728	Shrink jacket tubing
I	#1 deck fitting, plug deposit, port 3 (Figures 4 and 7)	Doublet at ~2923 and 2854; Strong peak at 1719; Peaks at 2359, 1416, 1096, 873, 721	Shrink jacket tubing
J	#1 deck fitting, B side corner, port 3 (Figure 4)	Doublet at ~2922 and 2852; Strong peak at 1715; Peaks at 2081, 1580, 1420, 1240, 1095, 873, and 728	Shrink jacket tubing

Figure 9 Image of the #1 deck drain fitting annotated to indicate all of the samples and sampling locations for Fourier transform infrared spectroscopic analysis (results are listed in Table 1).

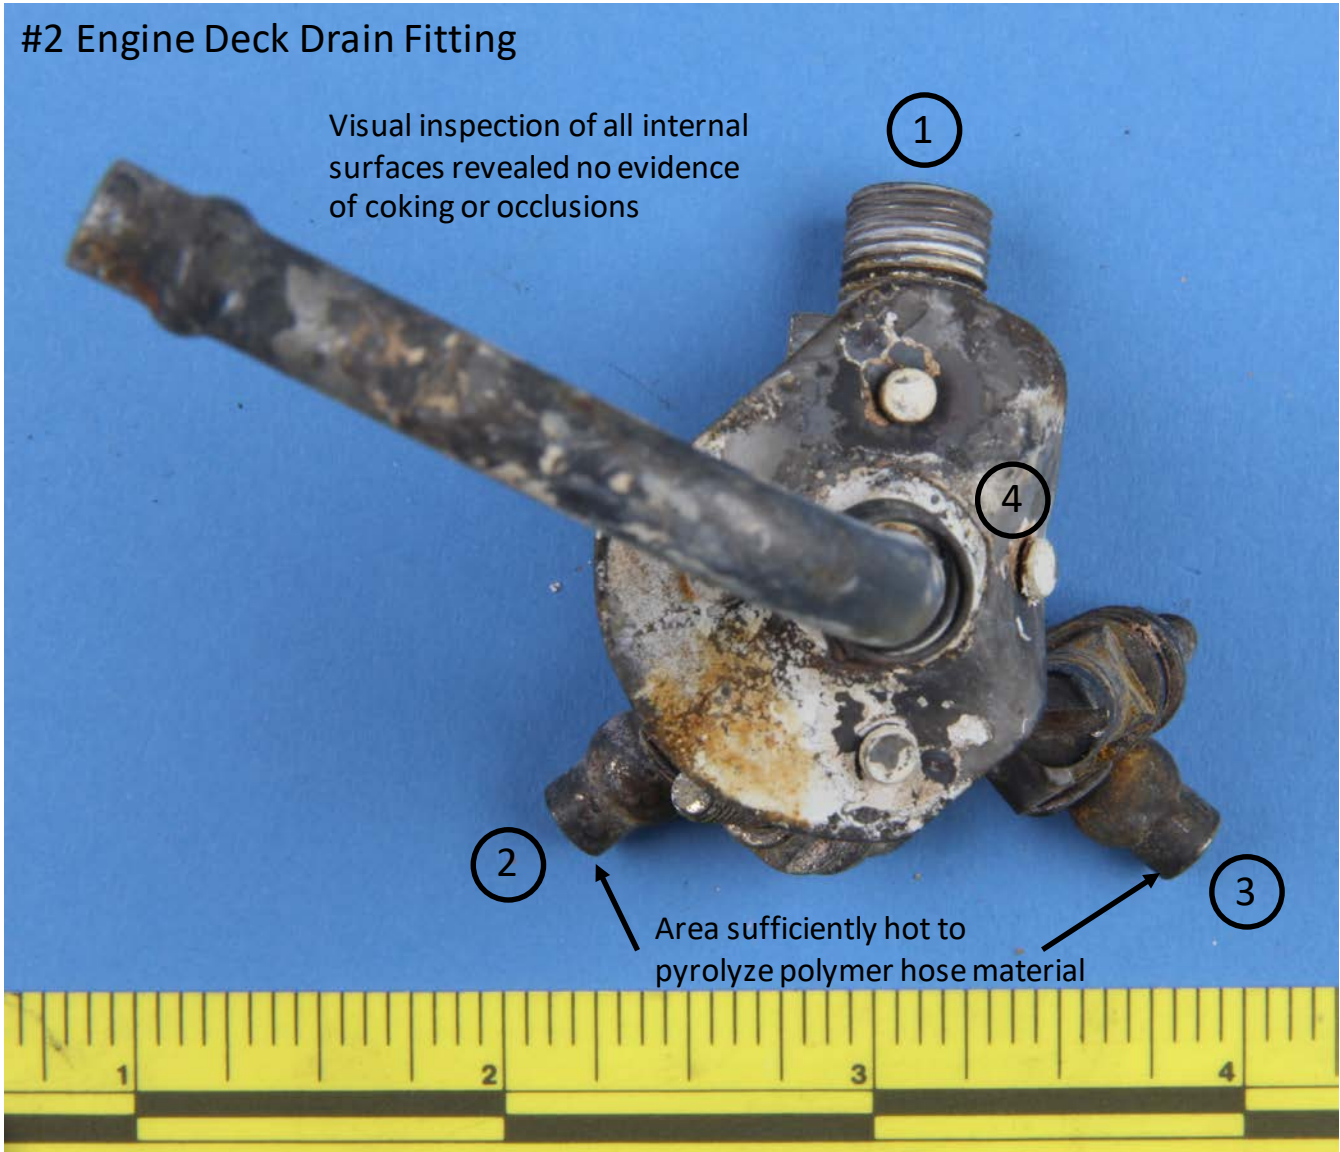
The #2 engine deck drain fitting exhibited surface oxidation, rust, and salt deposits consistent with exposure to temperature and time conditions enough to fully pyrolyze organic matter such as polytetrafluoroethylene (PTFE) hoses and shrink tubing (see Figure 10). Using a 5X to 50X stereo-zoom microscope and a 0.033-inch diameter stainless steel wire, each port was inspected for the presence of sludge, coking deposits, or other occlusions—no occlusions were observed.

Figure 10 Image of the #2 engine deck drain fitting.

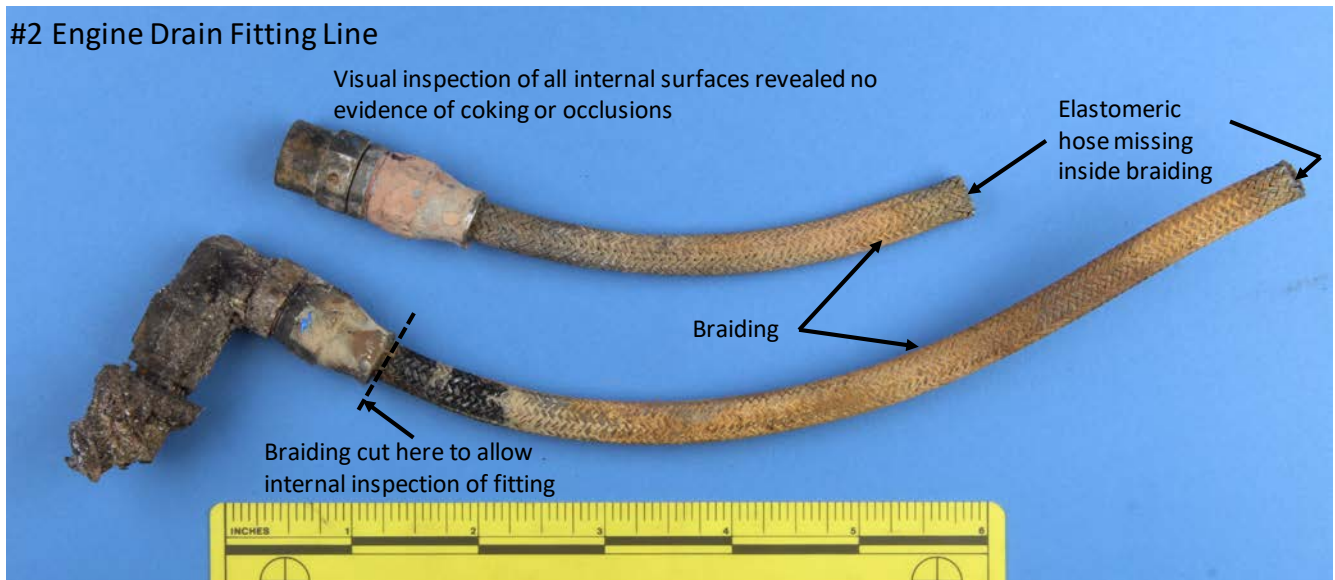
The #2 engine drain fitting line exhibited surface oxidation, rust, and salt deposits consistent with exposure to temperature and time conditions enough to fully pyrolyze organic matter such as the elastomeric hose inside the braiding (see Figure 11). Using a 5X to 50X stereo-zoom microscope and a 0.033 inch diameter stainless steel wire, each port was inspected for the presence of sludge, coking deposits, or other occlusions—no occlusions were observed.

Figure 11 Image of pieces of the #2 engine drain fitting line.
