National Transportation Safety Board

Accident Site and Wreckage Examination Summary

NTSB Accident No: CEN20FA001
Accident Date/Time: Thursday, 3 October 2019, at 0858 EDT
Accident Location: Lansing, Michigan
42°46'48.6"N
84°36'22.32"W
846 ft mean sea level

Aircraft Make/Model: Socata TBM 700 C2
Aircraft Registration: N700AQ
Aircraft Serial No: 252
Engine Make/Model: Pratt & Whitney PT6A-64
Engine Serial No: PCE-PM-0140
Propeller Make/Model: Hartzell HC-E4N-3/E9083SK
Propeller Serial No: HH1456
Airworthiness Date: 12 May 2003
Airplane Time: 3,550.6 hours since new
Engine Time: 3,550.6 hours since new
Propeller Time: 3,550.6 hours since new

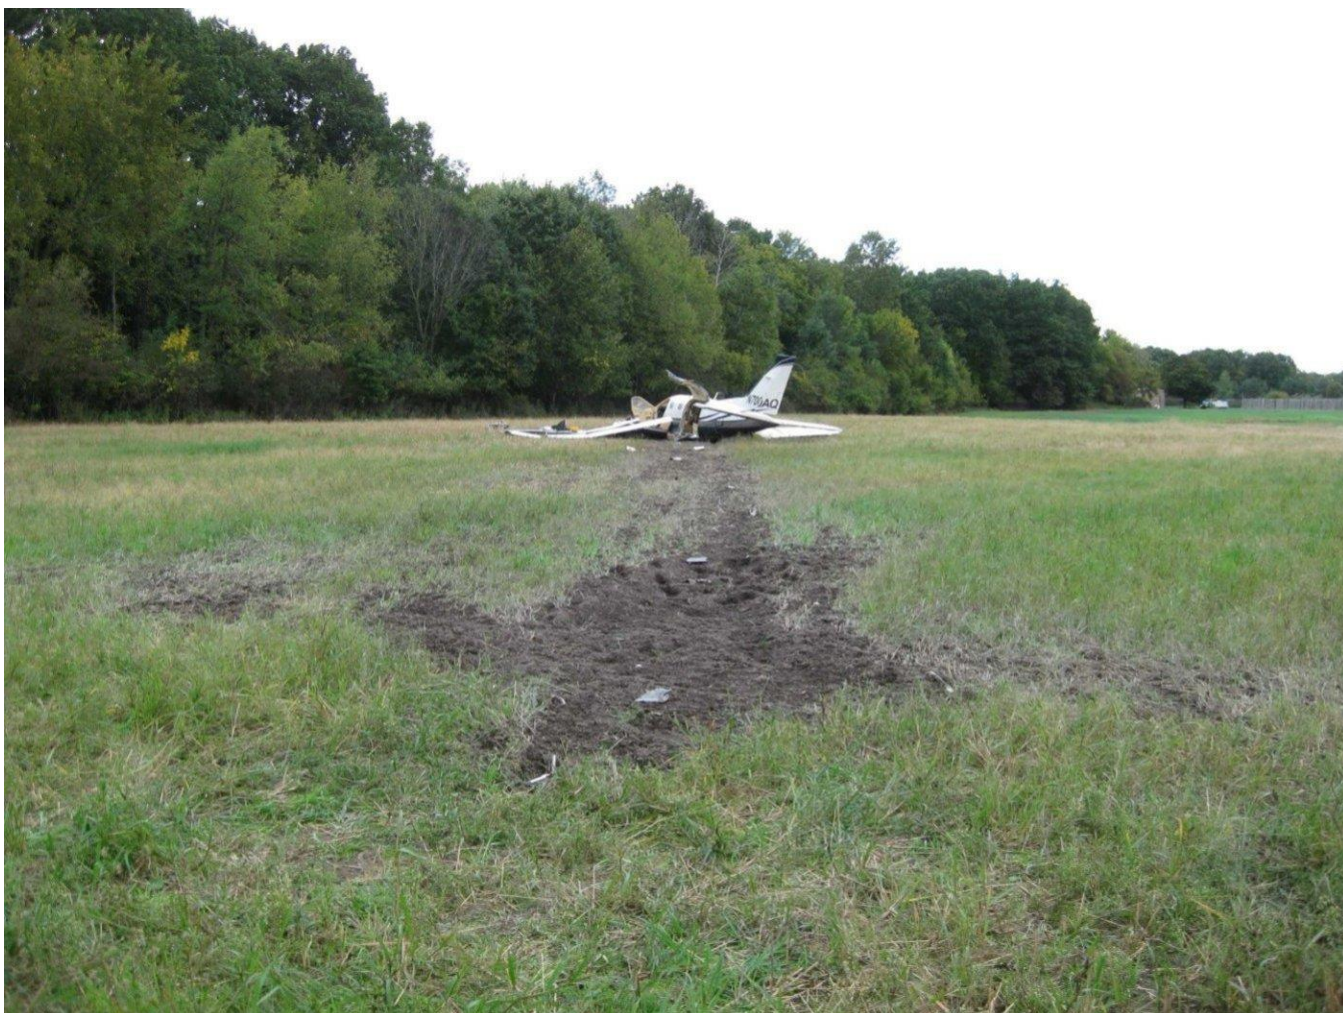
The accident site was in an open grass field located about 0.3 miles west-northwest of the runway 10R threshold. The initial impact point was in a large, depressed grass area that preceded a 135 ft long ground scar oriented on a 060° bearing. The initial impact area measured 42 ft wide, consistent with the wingspan of the airplane (Figure 1). The lower VHF antenna, the left main landing gear door, and several flap track fairings were located along the wreckage debris path.

Figure 1. Overview Photo of the Initial Impact Point and Ground Scar

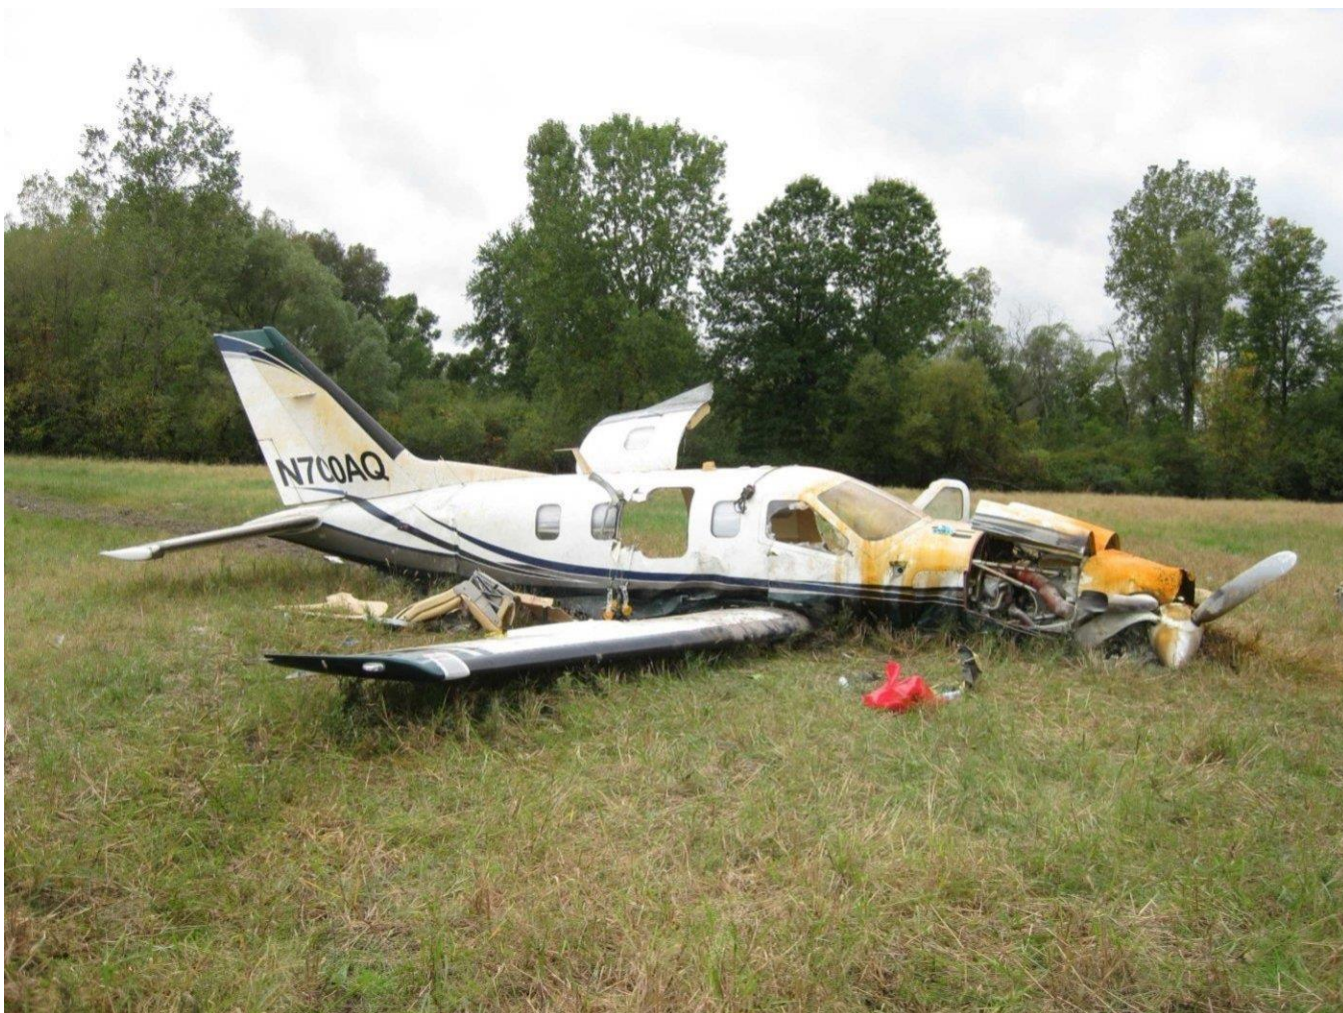
The main wreckage consisted of the entire airplane (Figure 2). Both wings and the empennage remained attached to the fuselage. All flight control surfaces remained attached to their respective hinges. Flight control continuity for the elevator, rudder, and right aileron were confirmed from each flight control surface to the forward cabin. Flight control continuity to the left aileron could not be established due to impact damage; however, the observed cable separations near the left wing root were consistent with overstress. Both spoilers were retracted and remained connected to their respective ailerons. Both the rudder and elevator trim surfaces were found in a neutral position.

The flap selector was found in the up-and-locked position. The wing flap actuator jack screws were found about halfway between the takeoff and landing positions. The landing gear selector switch was found in the gear-up position. The left main landing gear and nose gear were fully retracted and on their respective actuator uplocks. The right main landing gear was retracted into its wheel well; however, the right gear was not secured by its respective actuator uplock.

Figure 2. Overview Photo of Main Wreckage at Accident Site

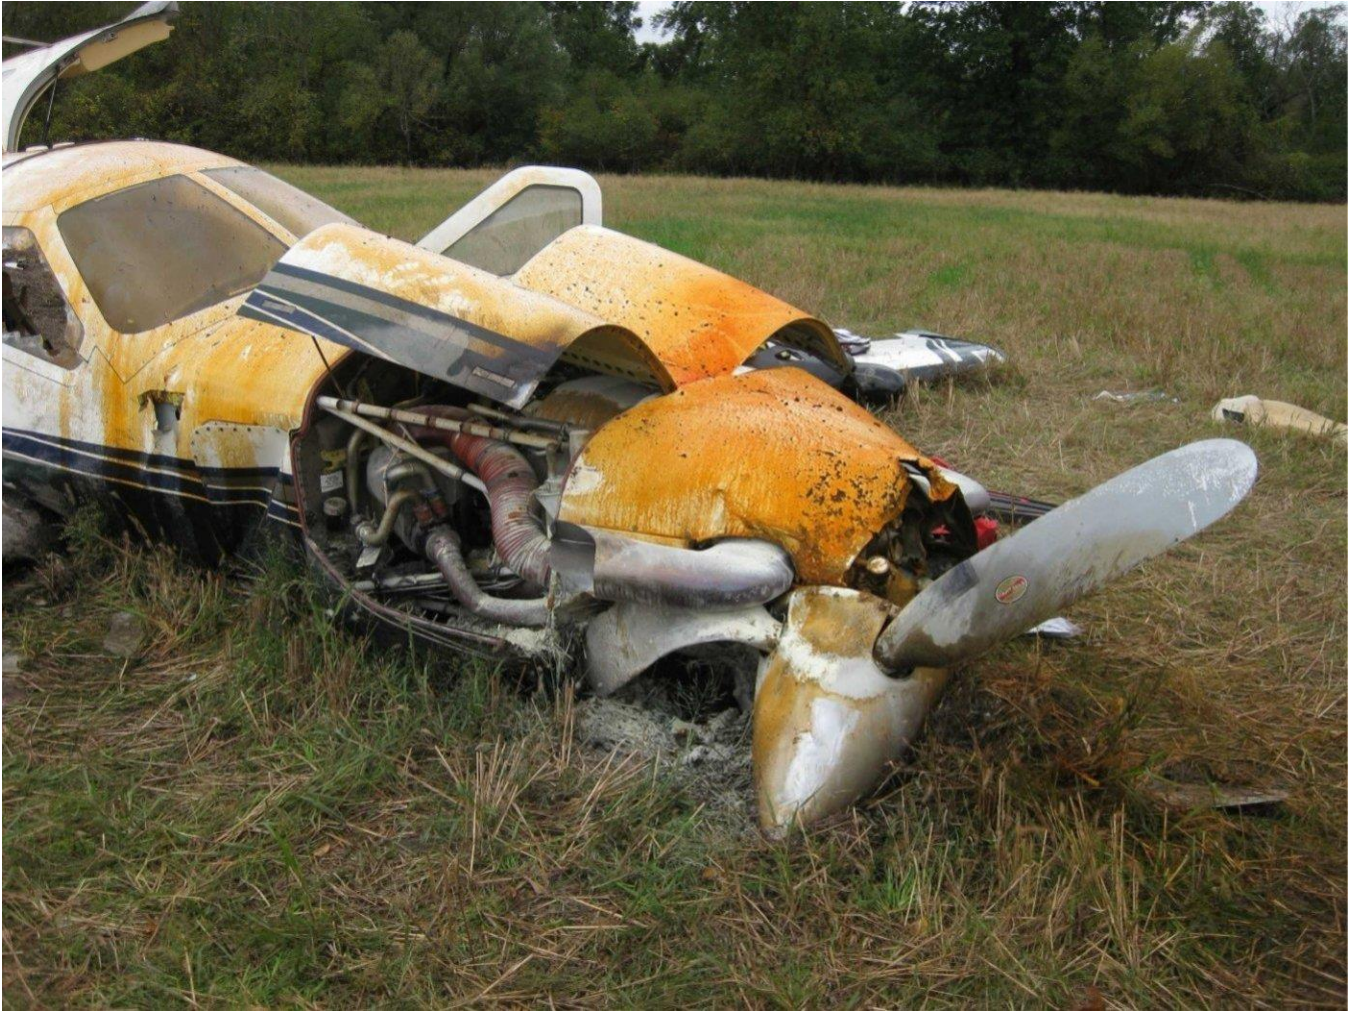
The engine remained attached to its respective engine mounts. There was a complete fracture of the propeller shaft and reduction gearbox housing forward of the 2nd stage reduction gears. There was evidence that engine oil was discharged out of the engine after impact; engine oil was found on the outside of the engine cowling, windscreen, and extending 20 ft in front of the engine (Figure 3). There was compressive impact damage to the exhaust case at the 6 o'clock position. Engine control continuity was established from the cockpit to the fuel control unit. The propeller speed setting lever and reset cables were found separated from the propeller governor; however, these cables moved freely when the associated cockpit levers were moved by hand. The compressor rotor turned freely with no anomalies and had continuity with the accessory gearbox. Fuel discharged from hoses when the fuel pump was rotated. The fuel filter bowl was about half full, and the fuel appeared clear with no significant debris or phase separation. Both magnetic chip detectors were free of any metallic particles. There was some minor foreign object debris found on the leading edge of several 1st stage compressor blades and vegetation debris in the inlet screen. The compressor turbine (CT) and power turbine (PT) were intact with all blades present. There were rotational contact signatures observed on the CT blades downstream platforms from contact with the inner shroud of the upstream side of the 1st stage PT vane ring. The 1st stage PT blade tips displayed rubbing, with corresponding rubbing observed on the shroud at the 6 and 12

o'clock positions. Some of the upstream blade platforms displayed rubbing with the inner shroud of the downstream side of the 1st stage PT vane ring.

Figure 3. Overview Photo of the Engine and Propeller at Accident Site

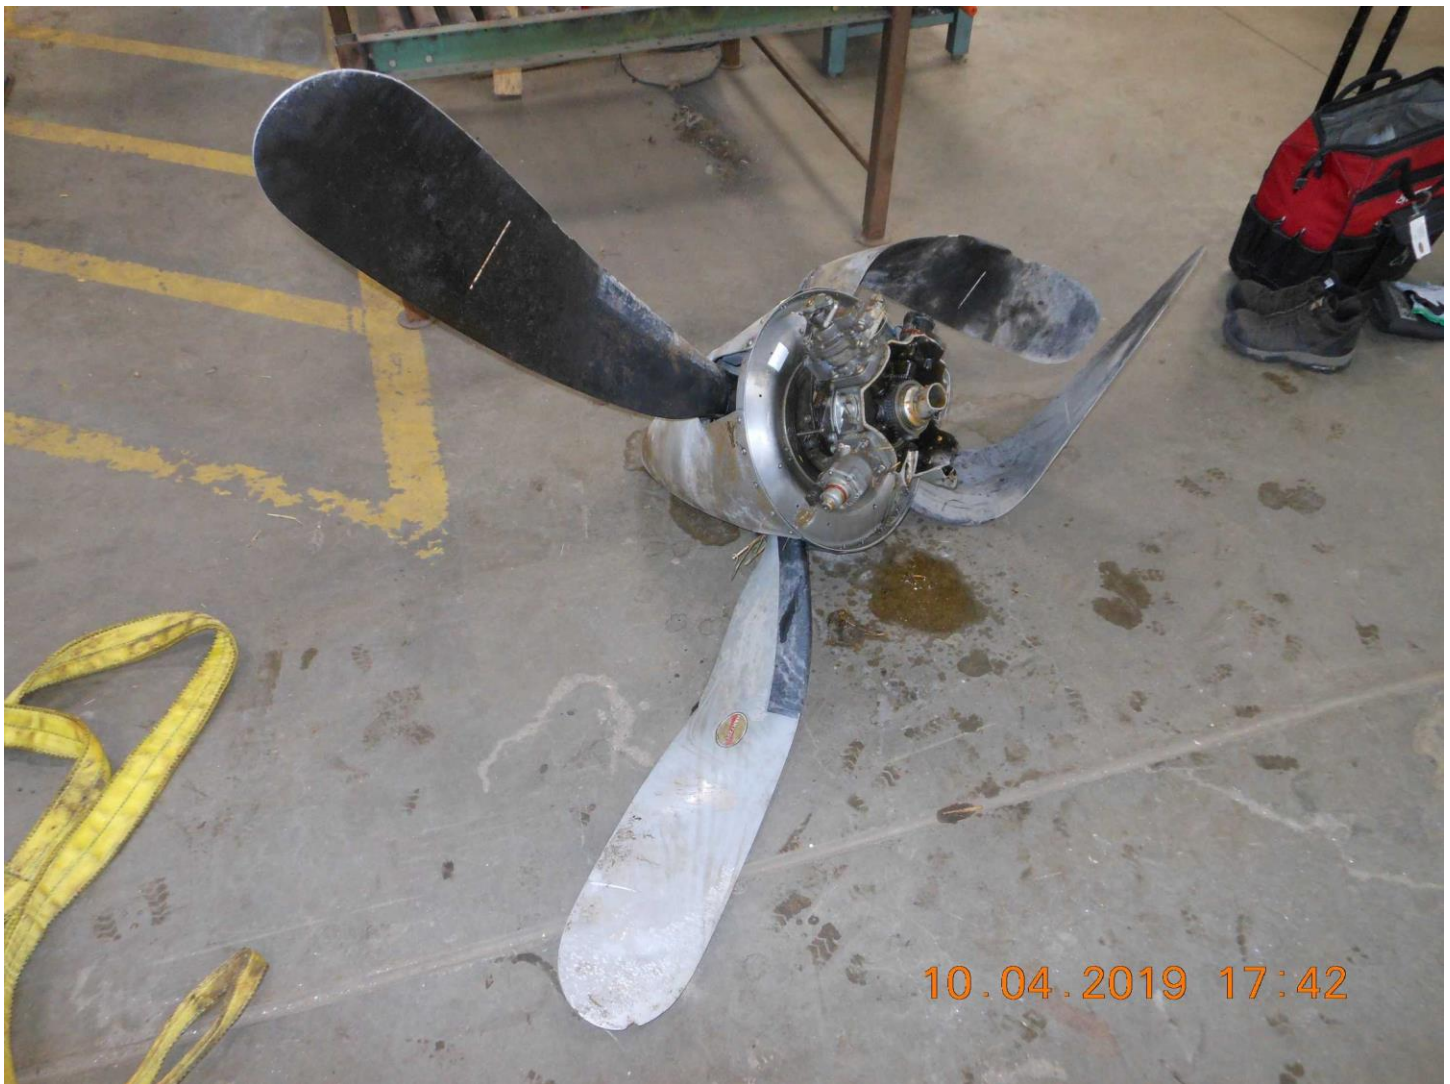
The propeller assembly remained attached to the engine propeller shaft that fractured from the engine reduction gear box during impact (Figure 4). One propeller blade was bent in the forward/thrust direction. The remaining three propeller blades were bent in the aft direction. All four propeller blades exhibited chordwise/rotational scoring on the camber side with paint discoloration from the tip to the outboard end of the deice boot. Three blades exhibited chordwise/rotational scoring on the face side. The spinner dome was dented adjacent to one propeller blade with a counterweight impression area with the center/average angle of about 44°. The pitch change rod was in the feathered position. Three propeller blades could be rotated by hand force due to fractured pitch change mechanisms. One propeller blade had been forcefully rotated beyond the reverse stop position, two blades were in an approximate low pitch position, and one blade was in an approximate feathered position. The beta ring appeared intact and undamaged with the carbon block and beta arm in position. The beta arm and valve moved freely.

Figure 4. Overview Photo of Propeller Before Disassembly
