Highway Factors Photographs 1 through 9

Williamsburg, VA

HWY23MH004

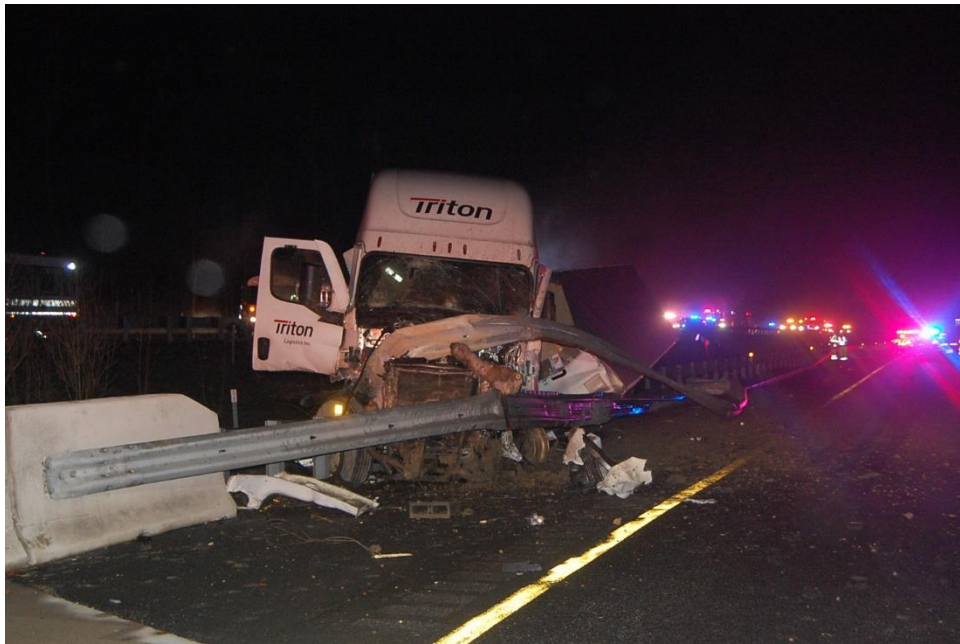
Highway Factors Photo 1 – View of strong post blocked-out W-beam guardrail that contained the Freightliner combination vehicle within the median standing in the leftmost travel lane in the westbound direction looking to the northwest (Source: Virginia State Police)

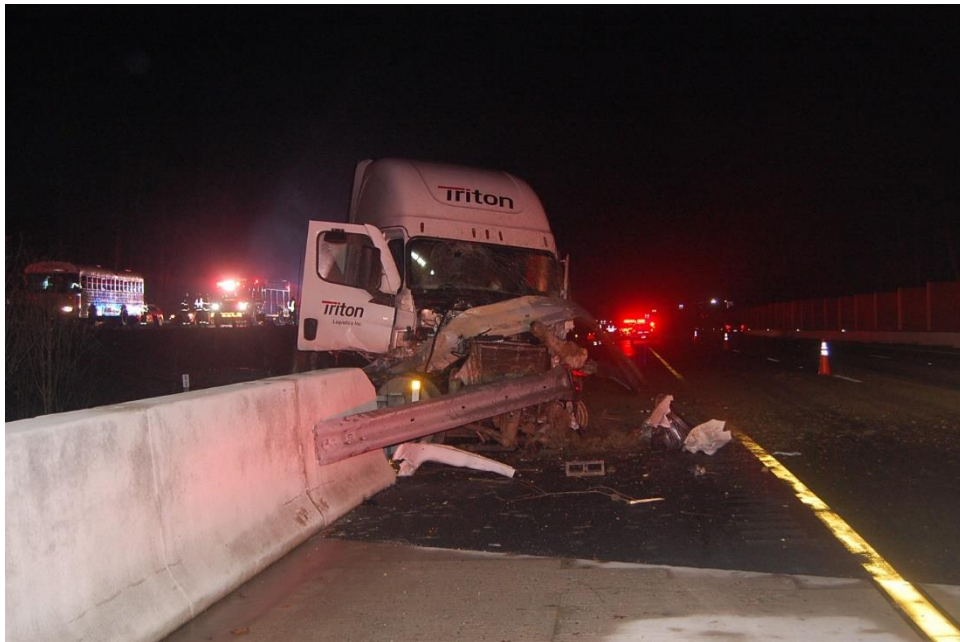
Highway Factors Photo 2 – View of strong post blocked-out W-beam guardrail that contained the Freightliner combination vehicle within the median standing in the paved shoulder adjacent to the leftmost travel lane in the westbound direction looking to the northwest (Source: Virginia State Police)

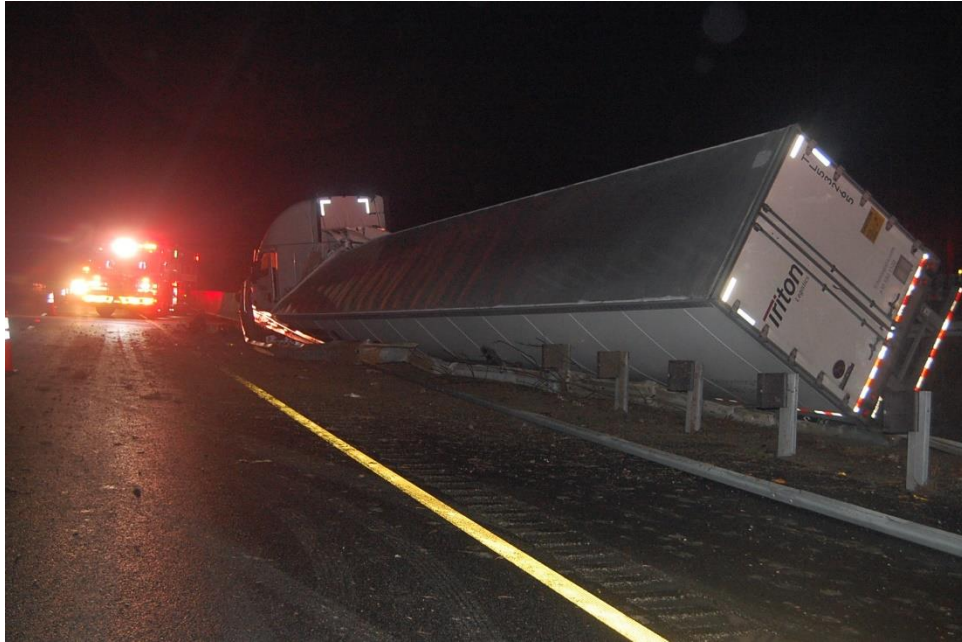
Highway Factors Photo 3 – View of strong post blocked-out W-beam guardrail that contained the Freightliner combination vehicle within the median standing in the leftmost travel lane in the westbound direction looking to the southeast (Source: Virginia State Police)

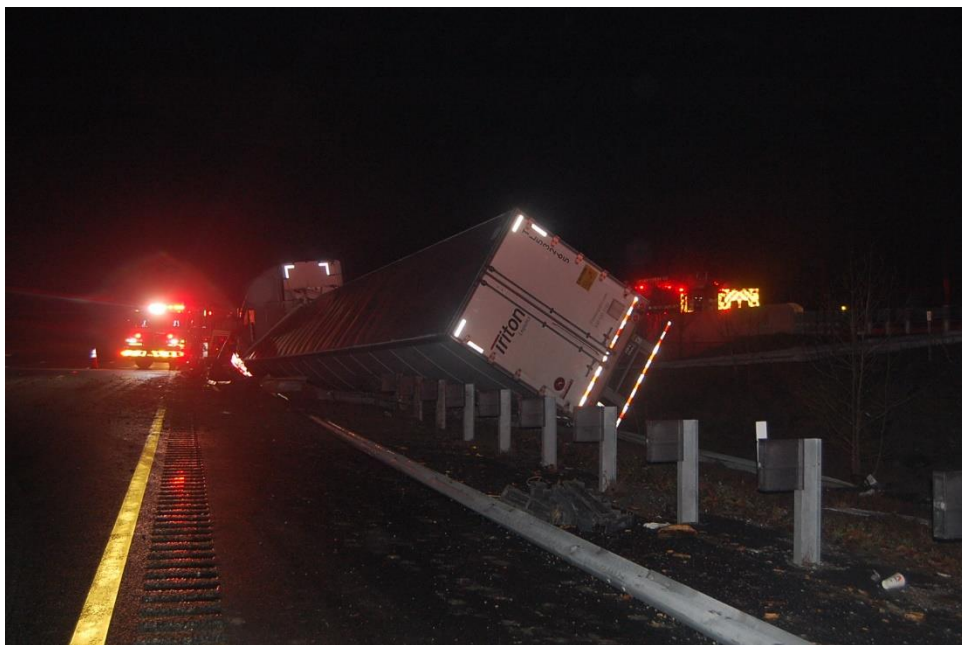
Highway Factors Photo 4 – View of strong post blocked-out W-beam guardrail that contained the Freightliner combination vehicle within the median standing in the paved shoulder adjacent to the leftmost travel lane in the westbound direction looking to the southeast (Source: Virginia State Police)

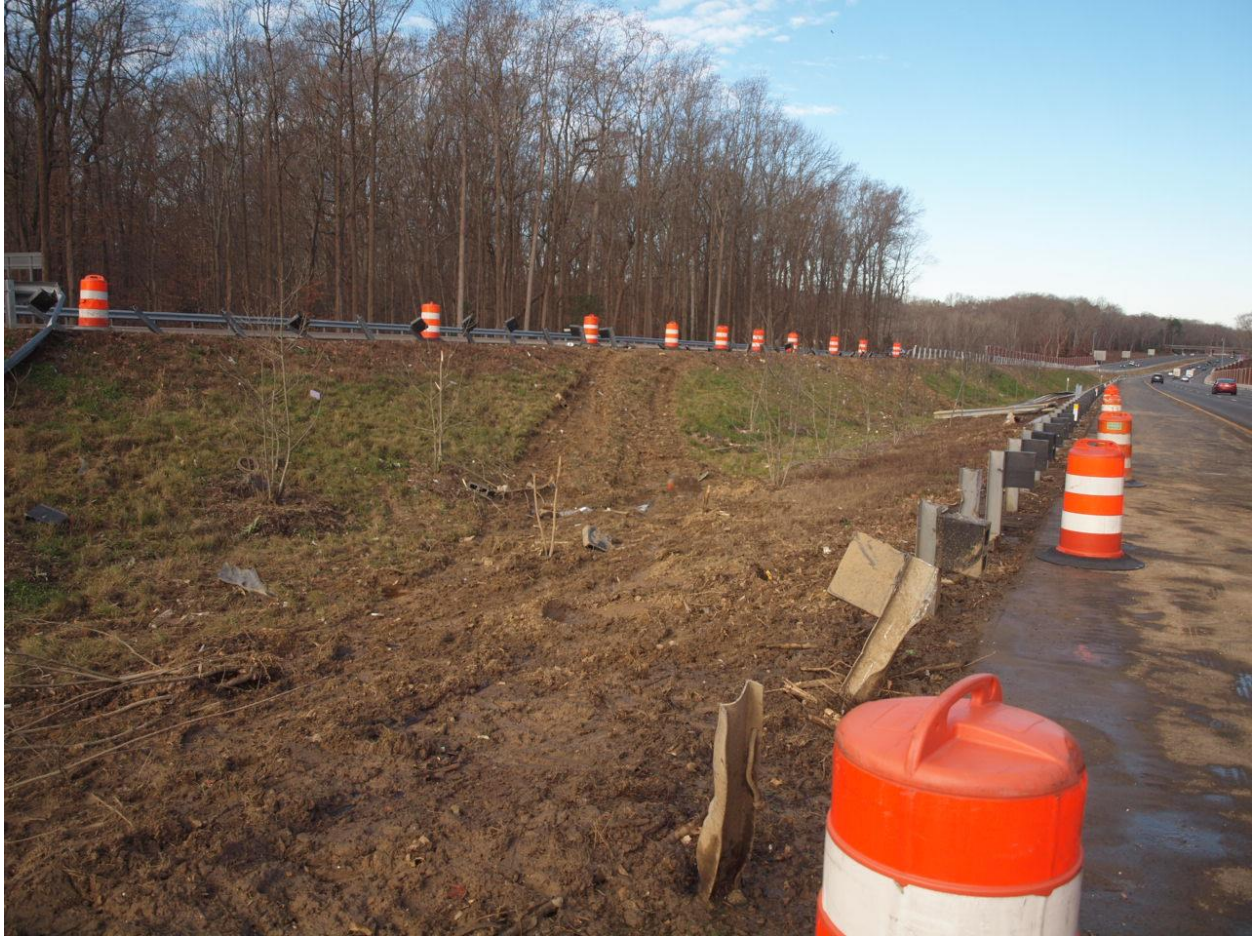
Highway Factors Photo 5 – View of tire marks left in the median by the Freightliner combination vehicle standing in the paved shoulder adjacent to the leftmost travel lane in the westbound direction looking to the northwest

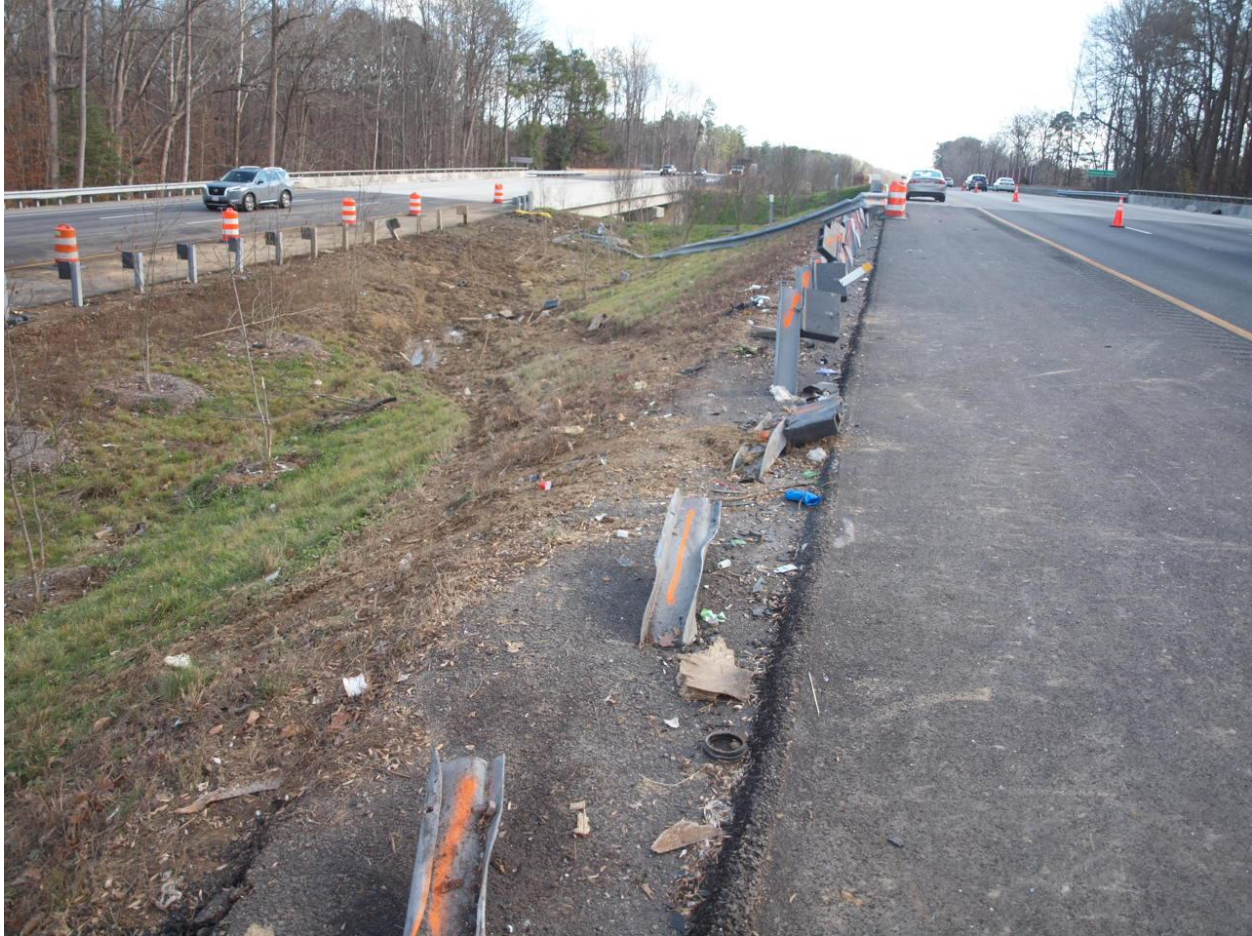
Highway Factors Photo 6 – View of tire marks left in the median by the Freightliner combination vehicle standing in the paved shoulder adjacent to the leftmost travel lane in the eastbound direction looking to the southeast

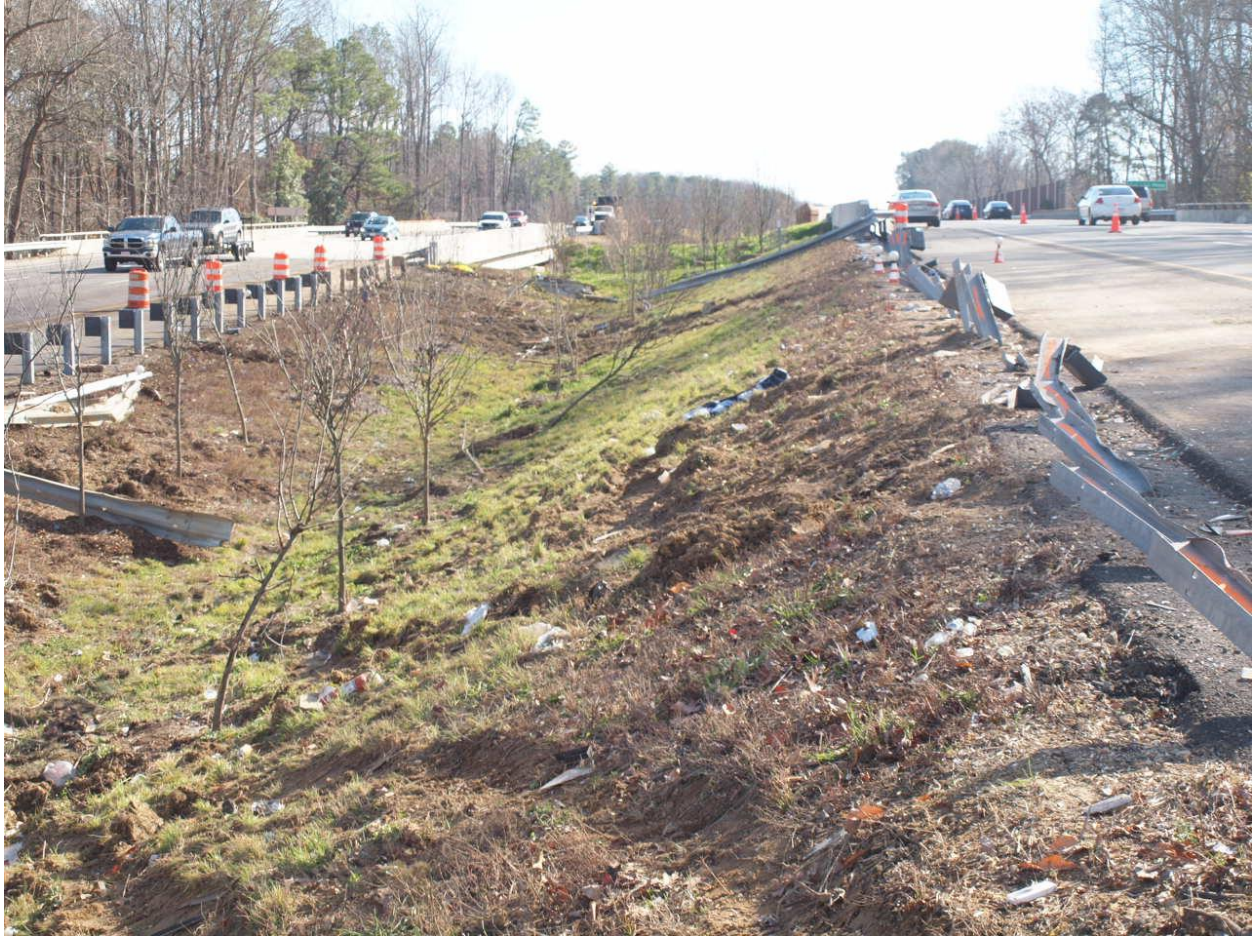
Highway Factors Photo 7 – View of median separating the eastbound travel lanes from the westbound travel lanes looking to the southeast

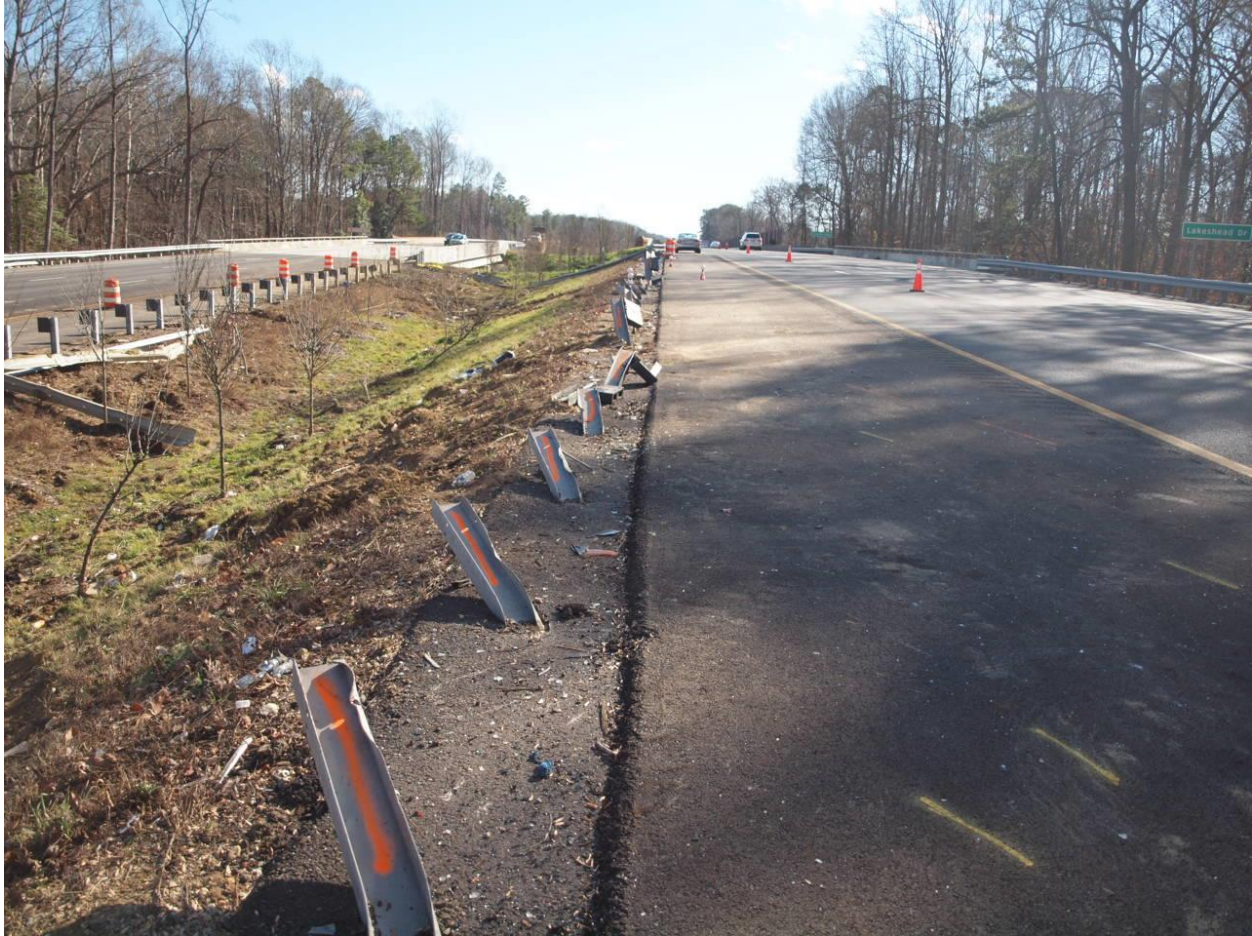
Highway Factors Photo 8 – View of deformed W 6 x 9 steel I-beam posts standing in the paved shoulder adjacent to the leftmost travel lane in the eastbound direction looking to the southeast

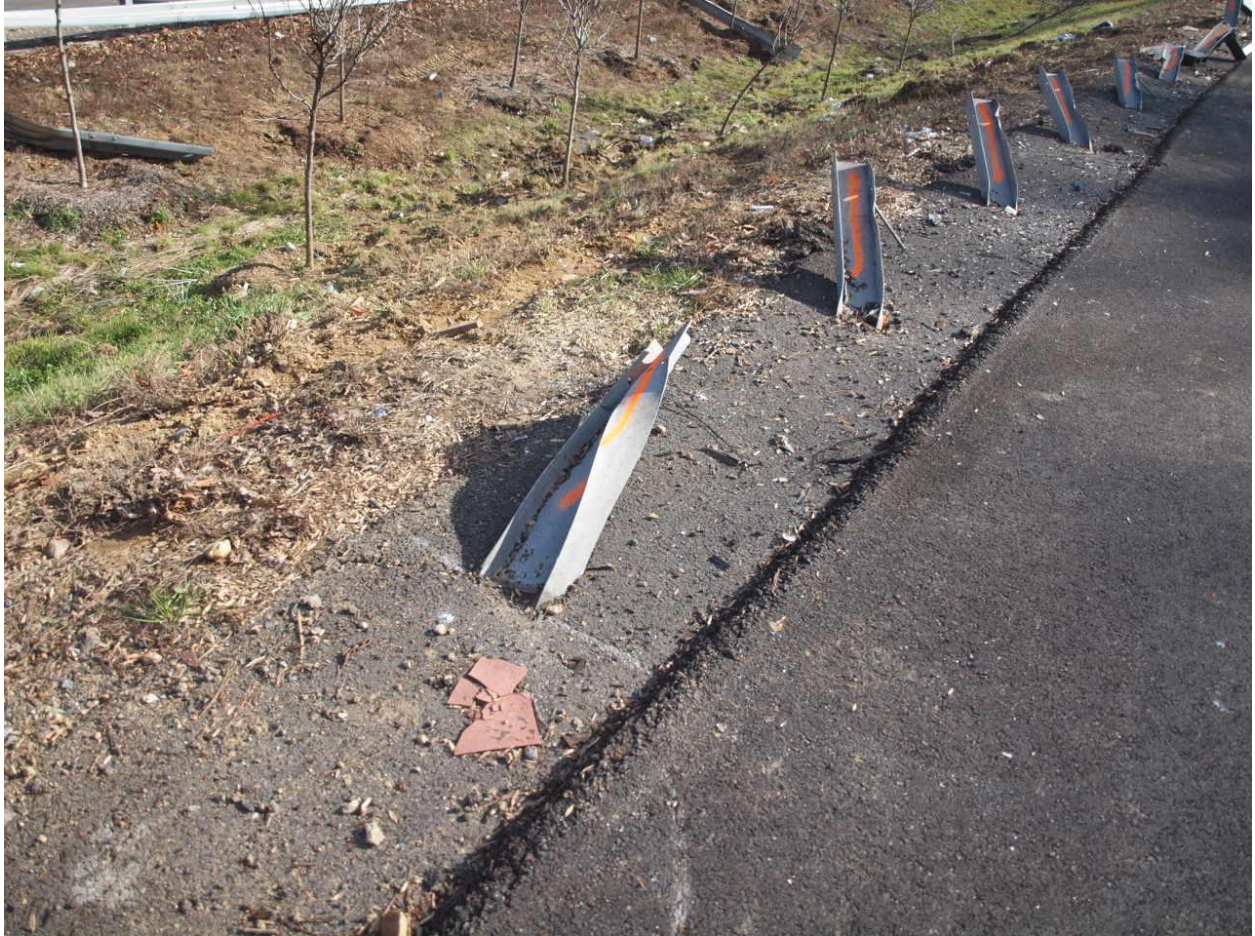
Highway Factors Photo 9 – Close up view of deformed W 6 x 9 steel I-beam posts standing in the paved shoulder adjacent to the leftmost travel lane in the eastbound direction looking to the southeast
