NTSB

RRD21LR007

Mechanical Working Group

Union Pacific Track Maintenance Machine (TMT) TMT-1602 Inspection Protocol

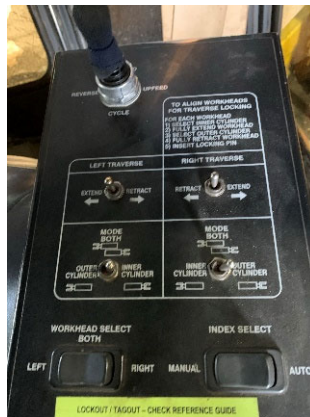
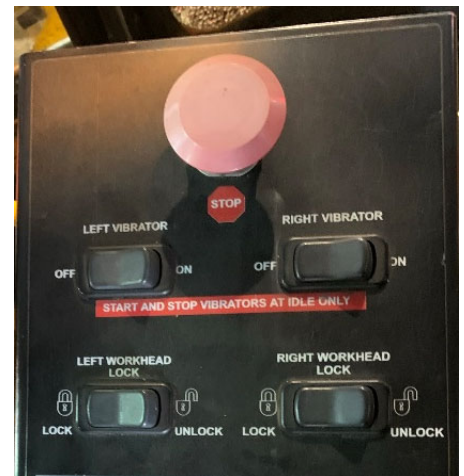
- Right control panel
 - Joystick – Neutral
 - Left Traverse – Extend
 - Mode – Inner Cylinder
 - Right Traverse – Extend
 - Mode – Outer Cylinder
 - Workhead Select – Both
 - Index Select – Manual

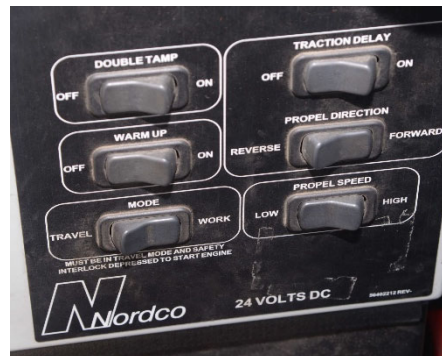
- Main panel
 - Double tamp – off
 - Warm up – off
 - Mode – Work
 - Traction Delay – Off
 - Propel Direction – Forward
 - Propel Speed – Low

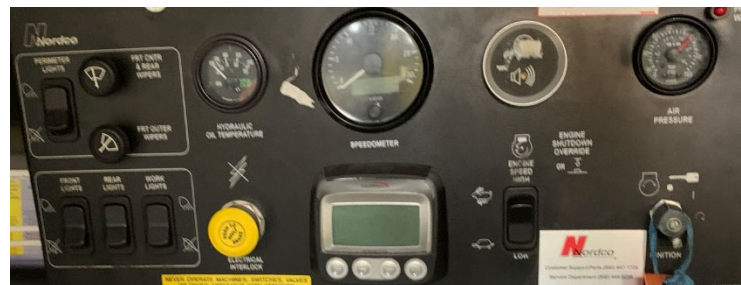
- Overhead panel
 - Perimeter lights – on(up)
 - Front lights – on (up)
 - Rear lights – off (down)
 - Work lights – on (up)
 - Engine speed – low
 - Ignition – off

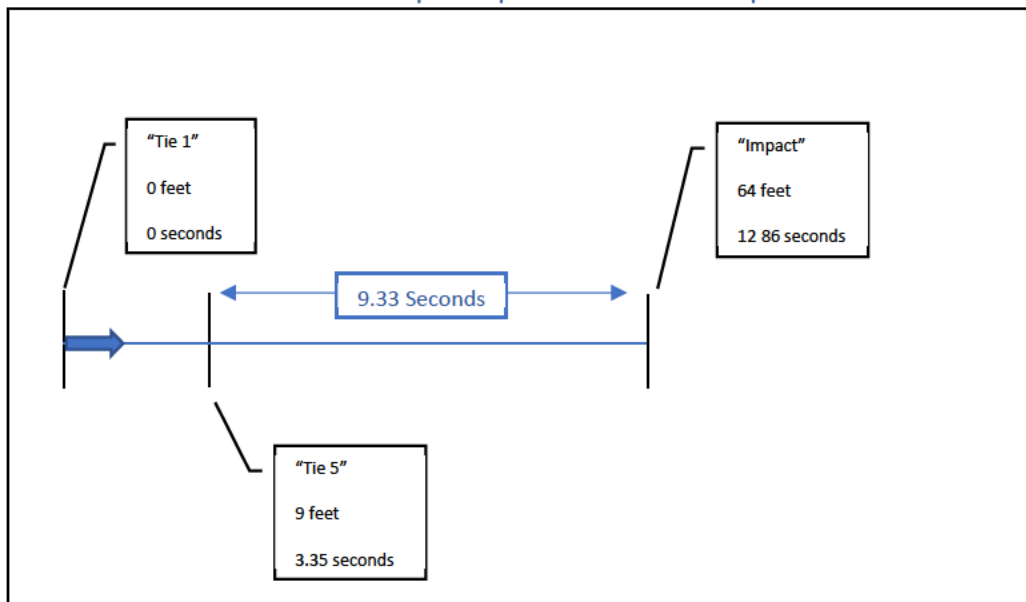
- The machine was operated from a stand-still at "Tie 1", representing the location of the last tie worked by the operator.
 - The machine reached "Tie 5" in 3.53 seconds

- The machine continued to the "impact" spot and reached this point in 12.86 seconds from the start.

- The "impact" location was determined by evidence collected at the accident site and was approximately 17 feet west of the injured employee's post-accident location.
- The test was repeated with an emergency stop application at "Tie 5". The machine stopped 11 feet past "Tie 5"
