Re: Beta's Proposed Findings, Probable Cause Statement, and Safety Recommendations regarding January 2021 Anchor Drags and October 2021 Oil Spill in San Pedro Bay

Beta Operating Company, LLC ("Beta") writes pursuant to 49 C.F.R. § 831.14(a) to submit proposed findings, probable cause statement, and safety recommendations regarding the January 2021 anchor-dragging incident and October 2021 oil spill in San Pedro Bay.

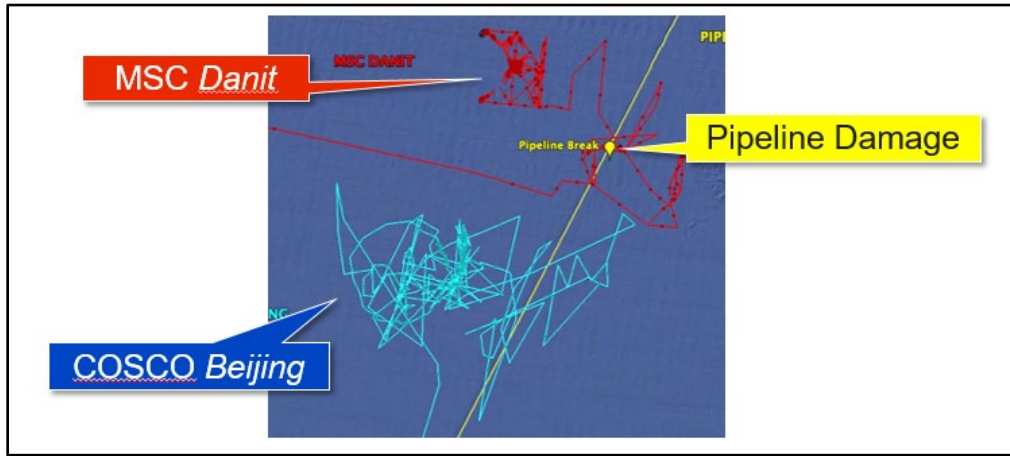
As detailed in Part I(G), on January 25, 2021, the MSC *Danit* and the M/V *Beijing* dragged their anchors outside of their designated anchorages and into a “no-anchor” zone across the Pipeline. Both vessels had been warned of an approaching storm, and authorities had instituted “heavy weather protocols.” Many other vessels left their anchorages to ride out the storm in deeper waters, but the *Danit* and *Beijing* remained anchored near the Pipeline. The storm arrived, and both vessels struggled to control their movements in the high waves and winds. They began dragging their anchors across the seafloor. Data from the vessels’ transponders show that they repeatedly zig-zagged across the Pipeline:

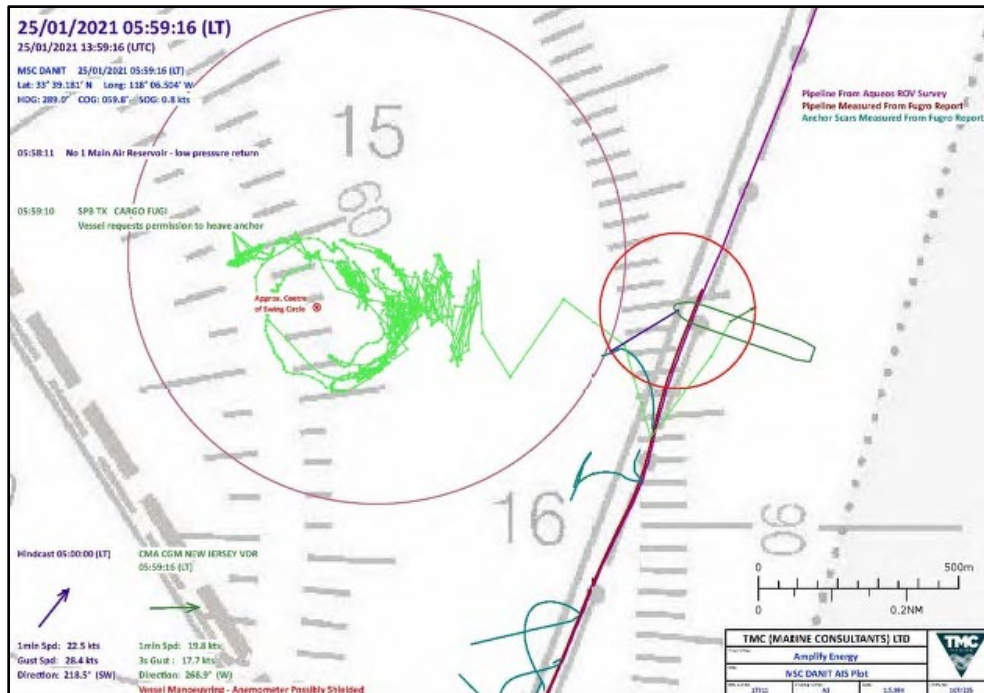
A reconstruction of the *Danit*’s AIS data confirmed the vessel’s location directly over the Pipeline with its anchor down:

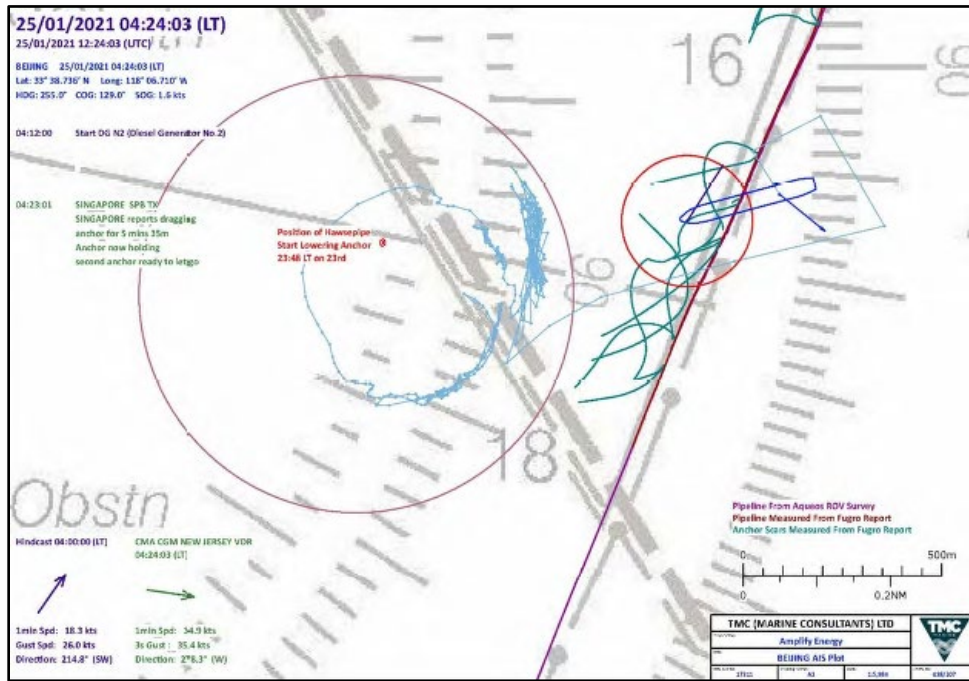
As did a reconstruction of the AIS data for the *Beijing*:

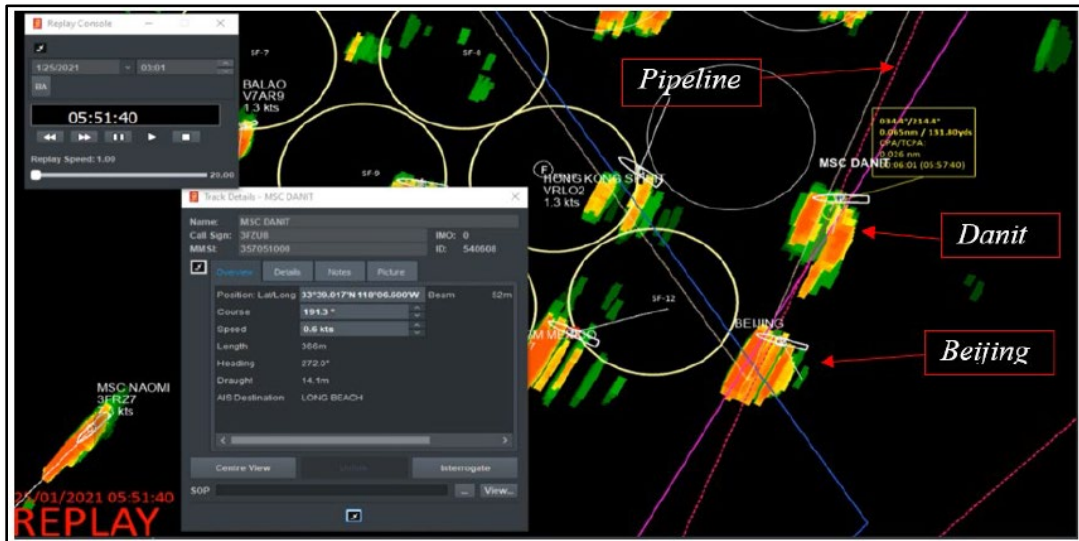
Video provided by the Marine Exchange (which was responsible for monitoring vessel traffic) demonstrated that Marine Exchange also knew, or should have known, of the anchor drags over the Pipeline on January 25:

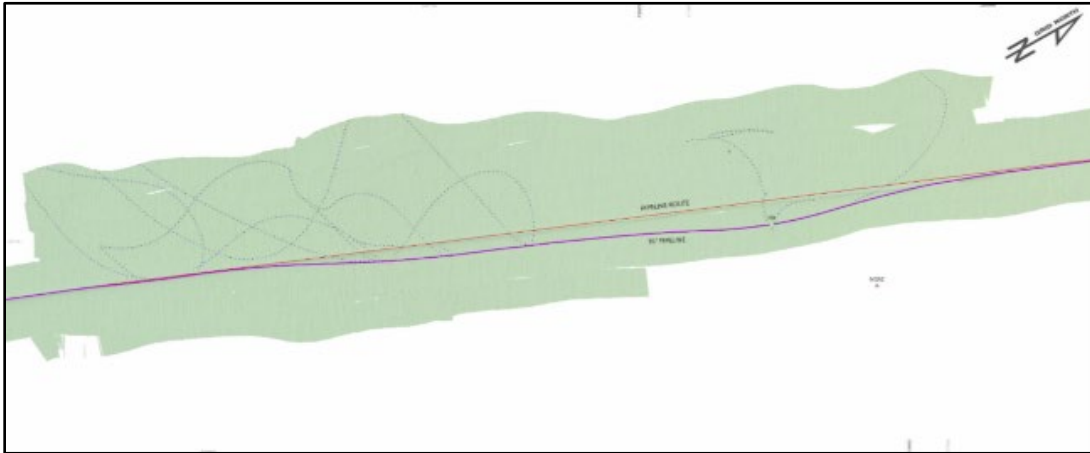
As detailed in Dr. Krishnamurthy's report, when the vessels' anchors dragged along the seafloor, they hooked the Pipeline and bent a 4,000-foot section of it. The anchors damaged and

displaced the Pipeline by up to 105 feet. This chart shows both the anchor drags in the sand, the Pipeline's plotted location, and the Pipeline's displaced location:¹⁰⁴

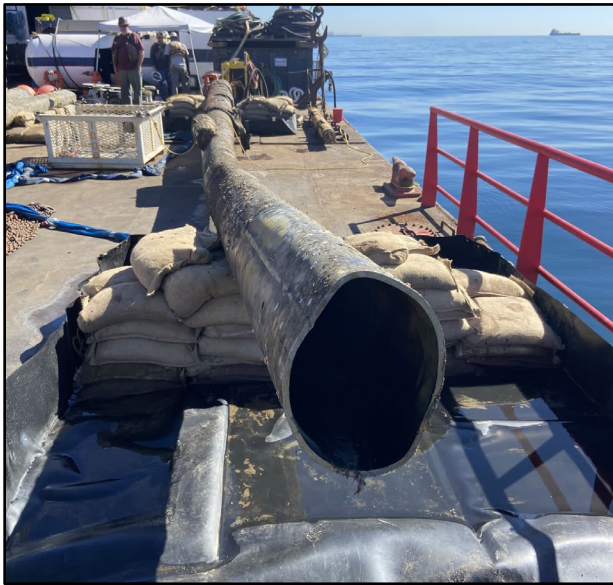
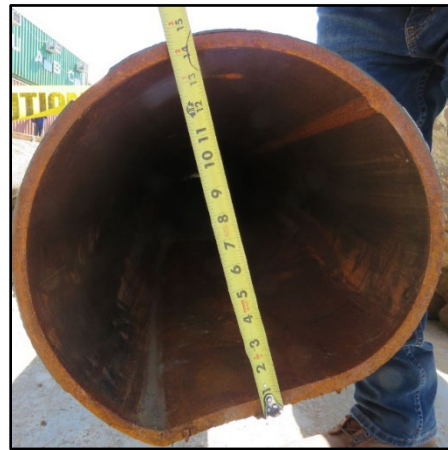
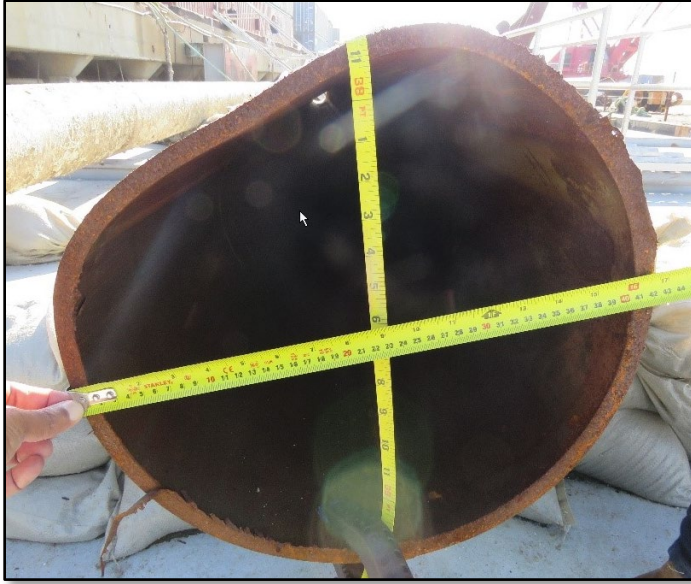
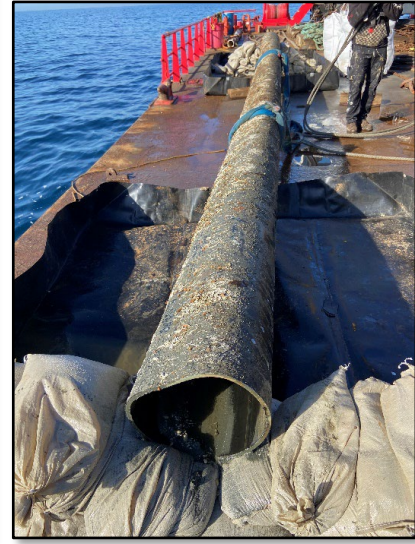
Although the Beta crew did not know it on the night of October 1, 2021, the anchors had caused significant damage and displacement to the Pipeline. The following photographs show the bent, deformed, and crushed Pipeline (first at the northern, or *Danit*, anchor contact site, followed by the southern, or *Beijing*, anchor contact site):

After an extensive fact and expert discovery process in federal court, the owner of the *Beijing* was forced to admit that “the BEIJING’s anchor likely contacted the Pipeline during an anchor dragging incident.”¹⁰⁵ Metallurgical experts, including one retained by the *Beijing*, determined that a fatigue mechanism through cyclic loading caused the initial, *Danit*-caused crack to grow to a through-wall crack and leak on October 1, 2021. Specifically, as Dr. Krishnamurthy’s report shows, the *Danit* laterally displaced the Pipeline 100 feet. (The *Danit*’s anchor had an unbuoyed weight of about 21.5 tons.) The *Danit*’s anchor caused a global axial strain of 1.12% along the Pipeline axis above the acceptable standards for safe transport of hazardous liquids. The stresses on the Pipeline, along with the in-line pressure, significantly exceeded the yield strength of the material. Local crushing and deformation also generated significantly high local stresses and strains (39.74%) that could initiate micro-cracking. And the local deformation, gouges, and denting occurred adjacent to the weld, which contributed to rupture or cracking at the weld-pipe intersection. This crack grew through fatigue to failure following the initial encounter with the ships. Dr. Krishnamurthy’s conclusions are consistent with the Board’s analysis of the cracked section. The *Danit*-caused damage had to be—and was—repaired.

The damage to the southern, or *Beijing*, section was also substantial. Dr. Krishnamurthy’s report shows that the *Beijing*’s anchor had an unbuoyed weight of about 16.5 tons and initially laterally displaced the Pipeline by about 60 feet prior to the *Danit* encounter. This resulted in a global strain of about 0.95%. It similarly caused a global bend along the Pipeline axis above the acceptable codes and standards for safe transport of hazardous liquids. The stresses and in-line pressure also significantly exceeded the yield strength at this location. The *Beijing*-caused damage had to be—and was—repaired.
