V.SHIPS GREECE LTD.
1, Piliou & Ermoupoleos str.
Piraeus, 185 41 - Greece
Tel: +030 (210) 410 2210
www.vships.com
hellas@vships.com

Re: NTSB No. DCA22FM001, Proposed Findings, Probable Causes, and Safety Recommendations of V.Ships Greece Ltd.

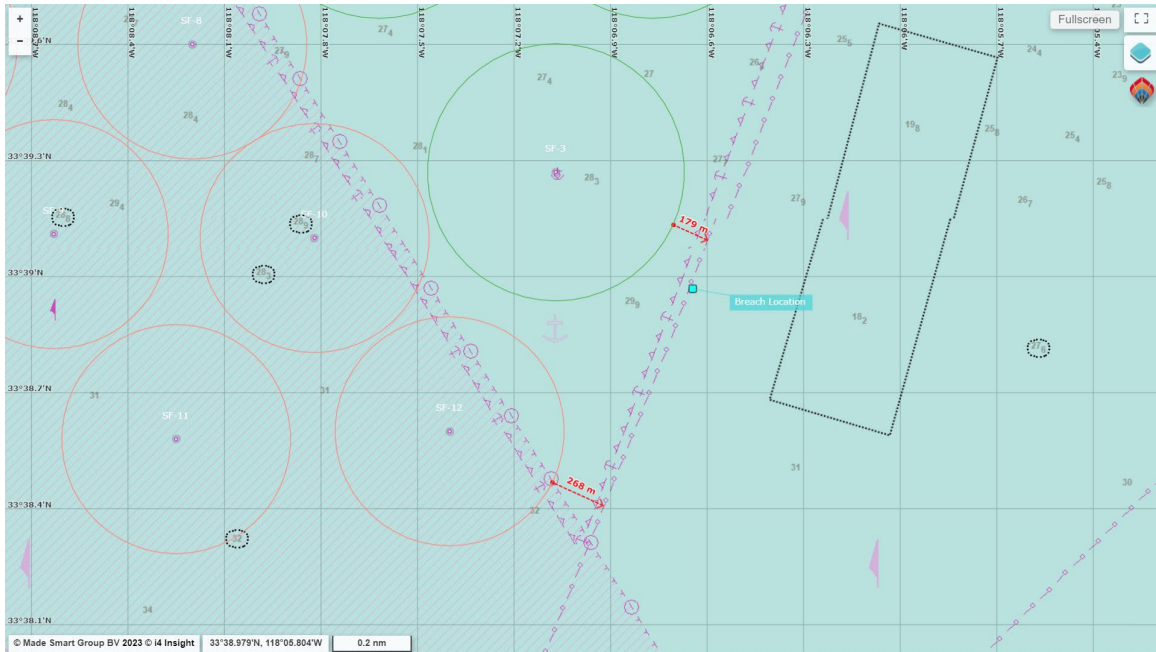
A. The BEIJING did not contact the Pipeline at the breach point.

AIS data showing GPS coordinates of the BEIJING, together with scour marks reflected on the seabed floor in bathymetric surveys, make clear that the BEIJING’s anchor did not make contact with the Pipeline where it later cracked.¹ The closest likely contact between the BEIJING’s anchor and the Pipeline was located approximately at 33°38’46.76”N, 118°6’45.77”W.² The point at which the likely BEIJING anchor scour marks intersect with the Pipeline at this northernmost likely contact point —*i.e.*, the one closest to the breach point—is between 1,184 feet and 1,297 feet away from where the Pipeline ultimately leaked.³ As shown in the figure below,⁴ the BEIJING’s anchorage, SF-12, abutted the Pipeline—but not at the breach point. During the course of extensive litigation that arose out of the Oil Spill, no party ever contended that the BEIJING contacted the Pipeline at the breach point.

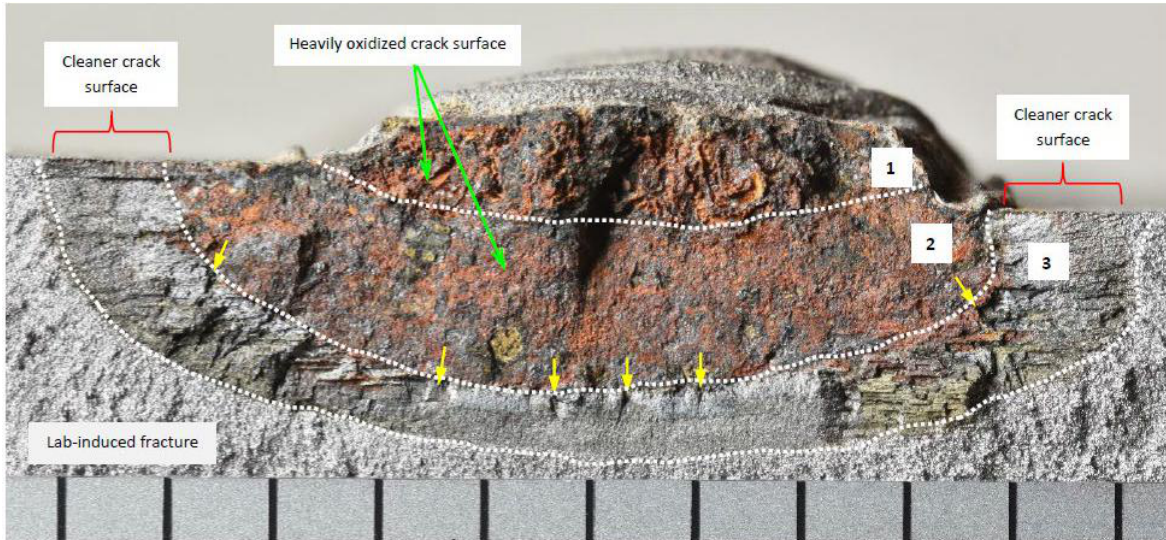
after the Oil Spill.⁸ The most severe deformation—and the greatest changes in radius—corresponded with the pipe sections abutting the section of which the NTSB took possession.⁹

C. The dented and gouged area where the DANIT contacted the Pipeline was subjected to cyclic loading caused by pumping oil, which caused the gouge to extend and cause the Oil Spill.

The appearance and circumstances of the longitudinal crack suggest fatigue as the most likely cracking mechanism.¹⁰ Dents result in abnormal stresses in the pipe wall as the internal pressure tries to push the dent out.¹¹ Relative to round, undented pipe, deformed pipe is therefore much more susceptible to fatigue.¹² Moreover, the mechanical damage and gouge coincide with an additional stress concentration—the longitudinal seam weld.¹³ The progressive characteristics of fatigue are consistent with the time that elapsed between the impact damage and the Oil Spill.¹⁴ In addition, a recent fatigue crack, oriented in the same direction as the leak, was observed in a girth weld just north of the leak site, as shown below.¹⁵ The crack was approximately 31 feet north of the NTSB cut and was in the same manufactured joint of pipe.¹⁶ This crack exhibited signs of recent fatigue cracking that initiated from a much older, dormant, heavily oxidized crack that formed around the time the Pipeline was originally constructed.¹⁷ The presence of the fatigue crack further suggests the Pipeline was subject to fatigue (cyclic) loading.¹⁸

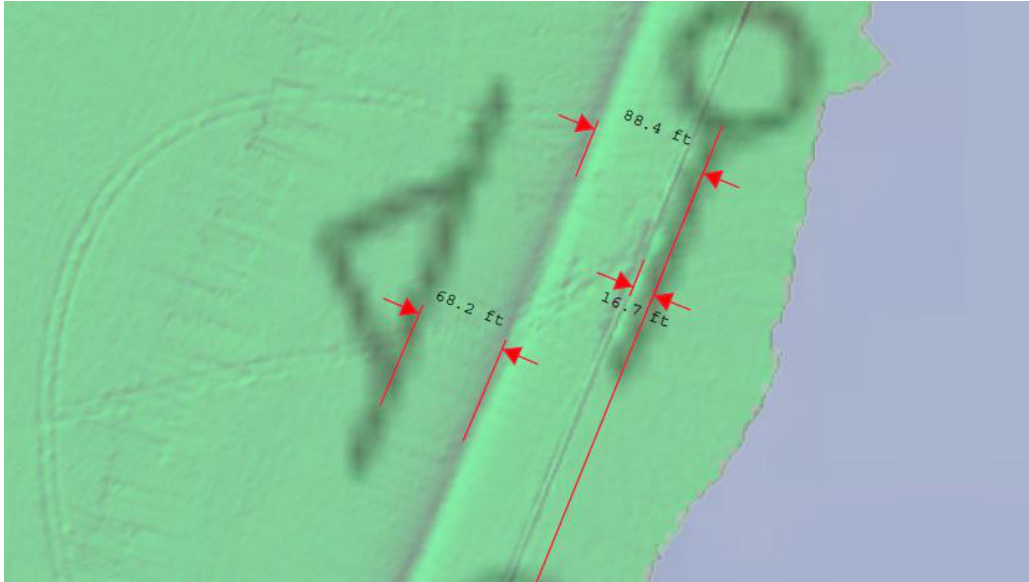
it.²³ The Pipeline's final displaced position near the points at which the BEIJING's anchor likely contacted it was between 16.7 feet and 32.8 feet west of the Pipeline's charted location.²⁴

There is no dispute that the bathymetric surveys conducted after the Oil Spill by both the BEIJING's experts and Amplify demonstrate that the chart displayed on the BEIJING's navigational display showed the Pipeline was nearly 100 feet further from the vessel than it really was.²⁵

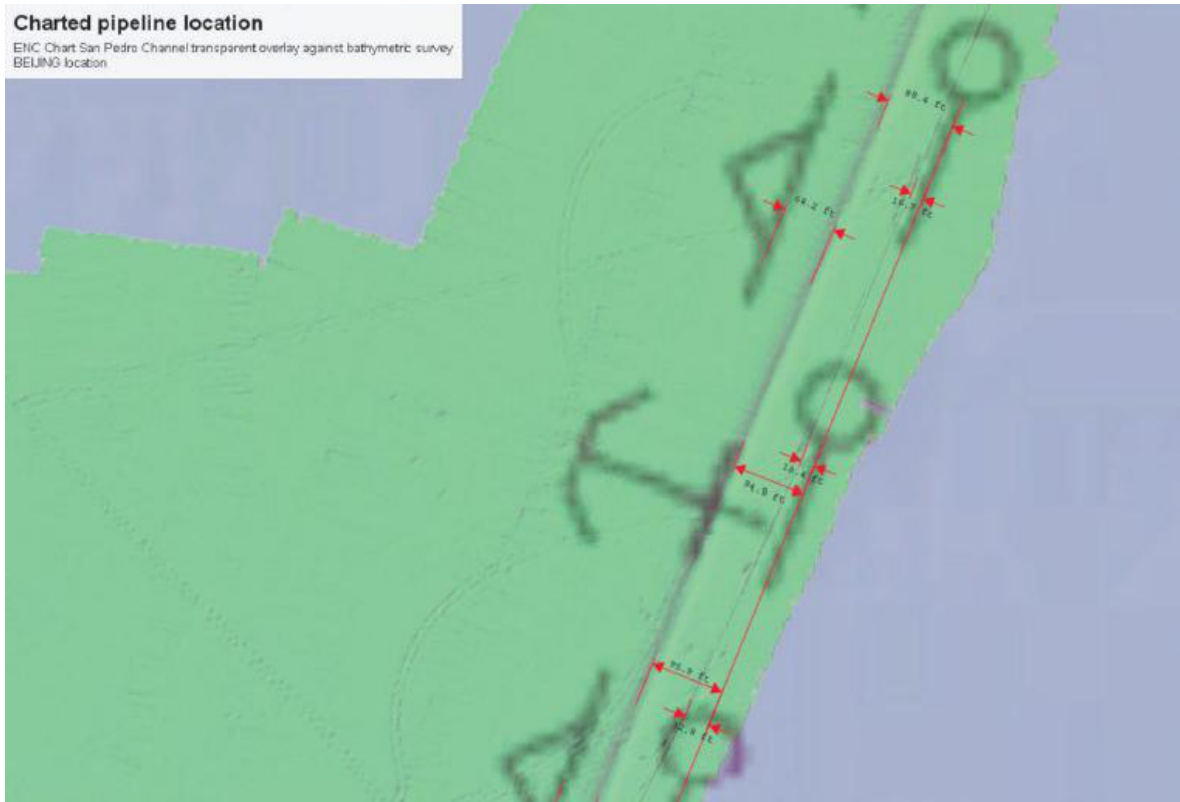
E. The BEIJING's anchor never reached the charted location of the Pipeline.

The BEIJING's anchor never would have contacted the Pipeline had it been located where it was charted. The BEIJING's anchor left scour marks on the seabed that have been recorded by bathymetric surveys conducted after the Oil Spill.²⁶ As illustrated by the image below, those scour marks do not reach, and instead are all closer to the anchorage area than, the charted location of the Pipeline.²⁷ The fact that the BEIJING's anchor did not cross the Pipeline's charted location demonstrates that the BEIJING's Captain reasonably believed that the

Beijing's anchor did not contact the Pipeline. While the hull of the BEIJING crossed over, the scour marks that are likely attributable to the BEIJING's anchor dragging do not extend to the charted location of the Pipeline. Were the Pipeline in its charted location, the BEIJING's anchor accordingly would not have contacted it.
