FILE 17-026765 CONDITION AND VALUE SURVEY REPORT

April 27, 2017

**VESSEL:** fv MISTY BLUE

**OWNER / OPERATOR:** International Sea Harvester (ISH) dba F/V MISTY BLUE LLC

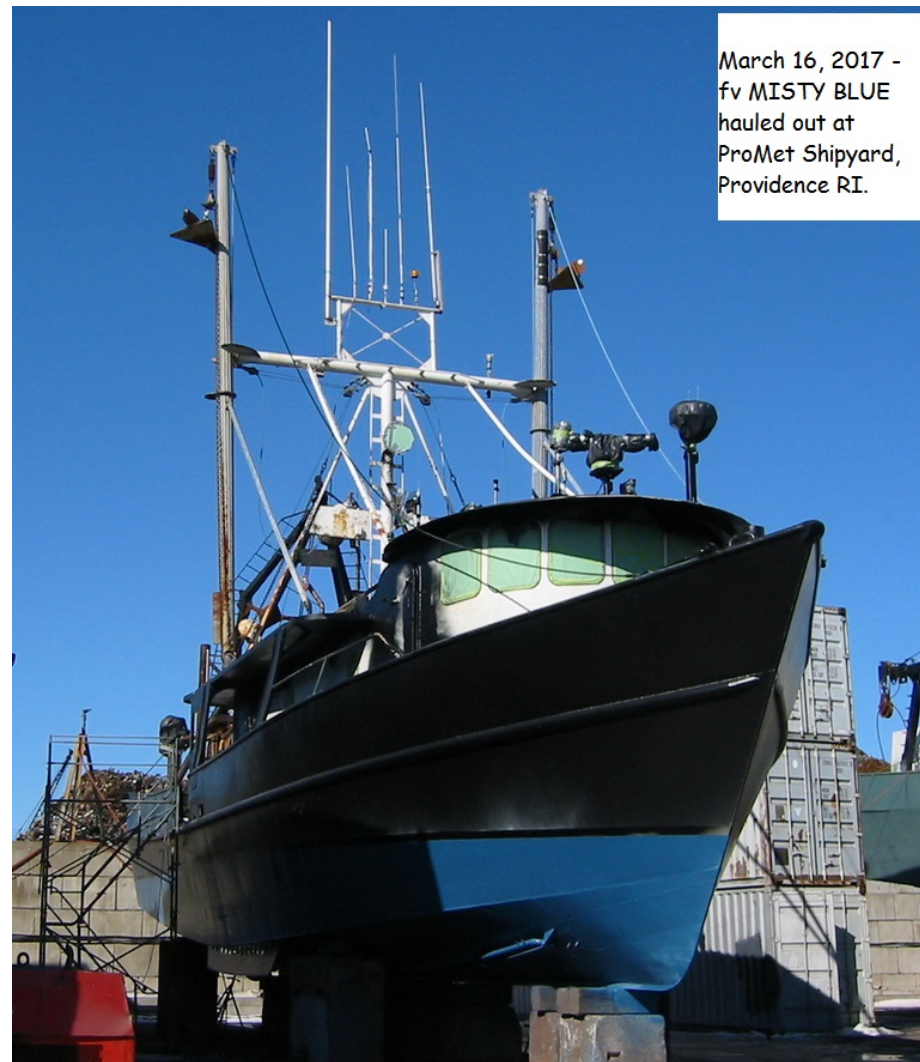
March 16, 2017 -  
fv MISTY BLUE  
hauled out at  
ProMet Shipyard,  
Providence RI.

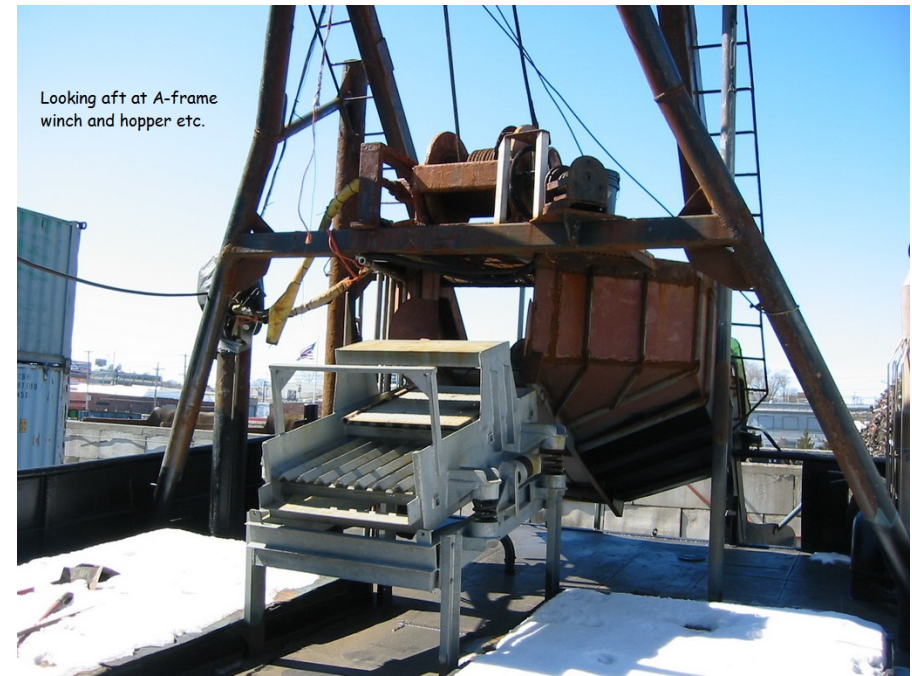
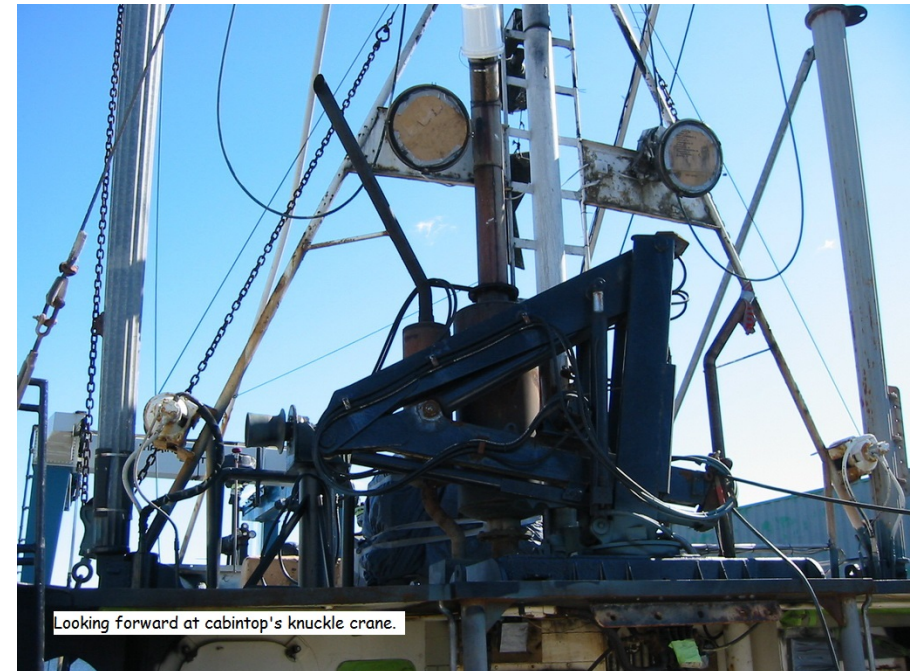
- A 72" clam dredge and 300ft. of 8" clam hose (not on board at time of survey).
- An 8" steel pipe A-frame spanning the stern.
- One Gearmatic Haulback Winch mounted mid-height center on the A-frame.
- Dredge hopper and stainless steel cleaner/sorter mounted in way of the A-frame's base.
- One stainless steel conveyer (not on board at time of survey).
- Part worn wooden hatch covers (**See Recommendations**) in place over each clam tank.
- One 4-ton capacity hydraulic knuckle crane mounted on cabintop's aft end and reportedly seeing service transferring clam cages on and off the vessel.
- Cabintop mid-span carries a T-shaped main mast and twin 30ft. Fluted Outriggers with Pullmaster winches.
- All winch controls are set up at the pilothouse's starboard aft corner control station.

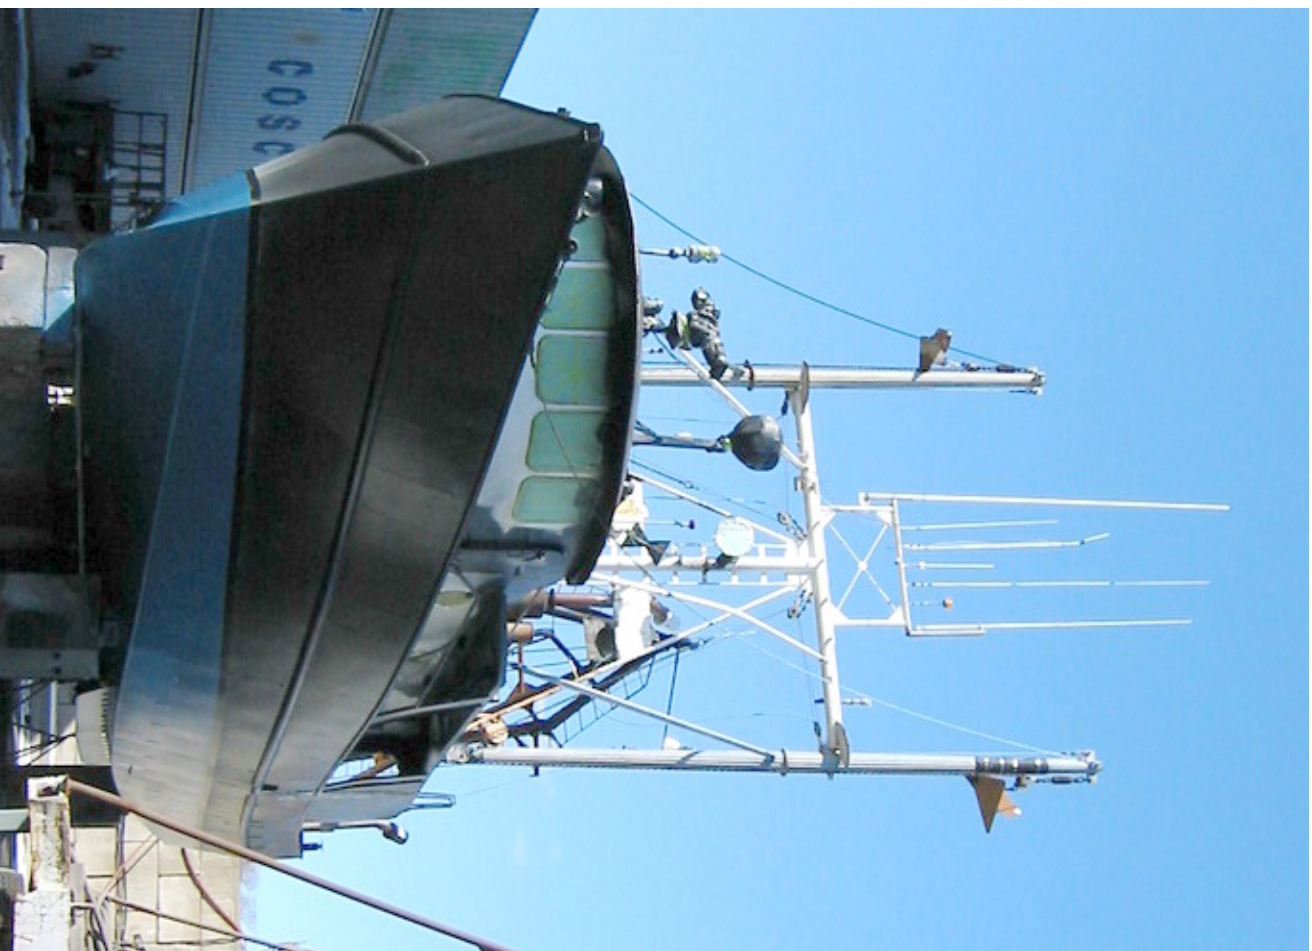
- The clam tanks' wooden hatch covers were weathered and worn (See Recommendations).
- The deck paint was blistered immediately in way of the lazarette hatch (See Rec's).
- All remaining topside clammimg gear machinery and attachments appeared to be intact and in apparent good operating order for a vessel this age and type service. There were no other significant exceptions or discrepancies noted

- The port forward quarter bulwarks appeared to be lightly and broadly set in. Otherwise it did not appear as if there were any significant damages or significant deterioration noted in any of the topside or upper hullside surfaces.

- Replace the clam tanks' worn wooden hatch covers with new wooden weathertight hatch covers.
- Chip and grind blistered paint in way of lazarette's deck hatch back to sound material. Recoat the affected area with preservative and finish coats as necessary to blend in with the remainder of the topsides.
