16710/P021482  
Serial: H2-1801014  
17 Jul 2018

Subj: POST-SINKING STABILITY ANALYSIS OF F/V MISTY BLUE, O.N. 1043789

**POST-SINKING STABILITY ANALYSIS OF F/V MISTY BLUE**

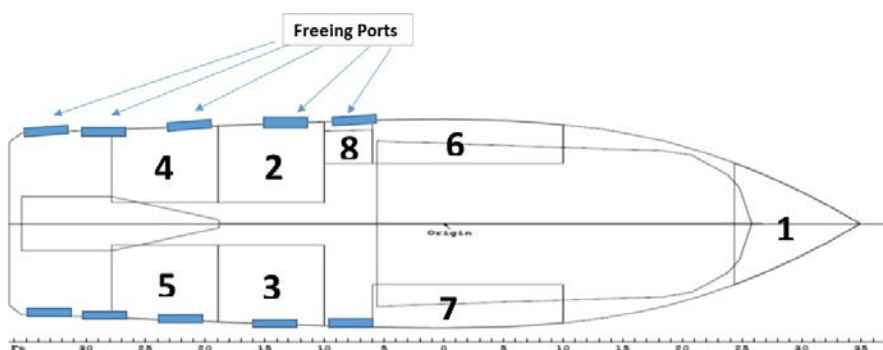
**Figure 4: Plan View of the MISTY BLUE GHS Model**

Figure 4 depicts the tank layout used in our analysis and includes freeing port arrangements. The tank layout was included with the NMD GHS model while the freeing port locations were estimated by MSC based on photos received from the IO.

Figure 4 also shows four clam tanks: tanks 2 and 4 are marked on the port and tanks 3 and 5 on starboard. A partition separates the forward and aft clam tanks vertically up to one foot below the main deck. Water can flow between forward and aft tanks above this partition. The watertight integrity of the partition is not known. In the GHS model and our analysis, all clam tanks were modeled individually.

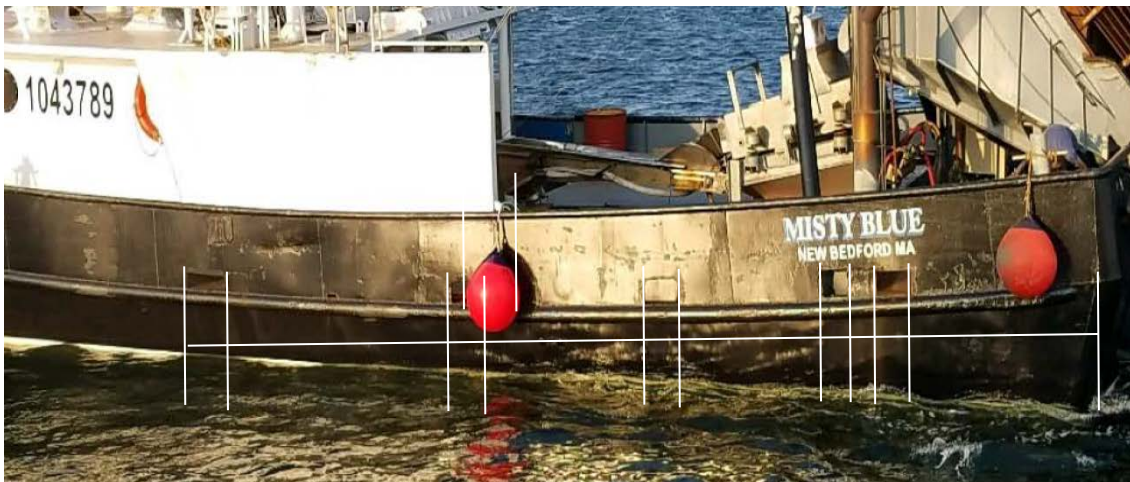
**Figure 5: Freeing Ports**

According to marine survey reports, MISTY BLUE's "working deck" had four freeing ports, which measured 8" x 15" on each side of the vessel. However, in reviewing photos of the vessel, we observed five freeing ports configured along the open deck area aft of the house. We conservatively included this fifth freeing port area in our evaluation of the vessel. If five freeing ports were available with the same dimensions of 8"x15", the actual available freeing ports area on each side would be 4.13 ft<sup>2</sup>. The freeing ports can be observed in Figure 5.

If required to meet a freeing port criteria, a suitable standard is in 46 CFR 28.555 and would require a freeing port area of 15.5 ft<sup>2</sup> on each side. The actual freeing ports area for MISTY BLUE was only estimated to be 4.13ft<sup>2</sup>, which is 27% of the required freeing ports area on similarly sized vessels.

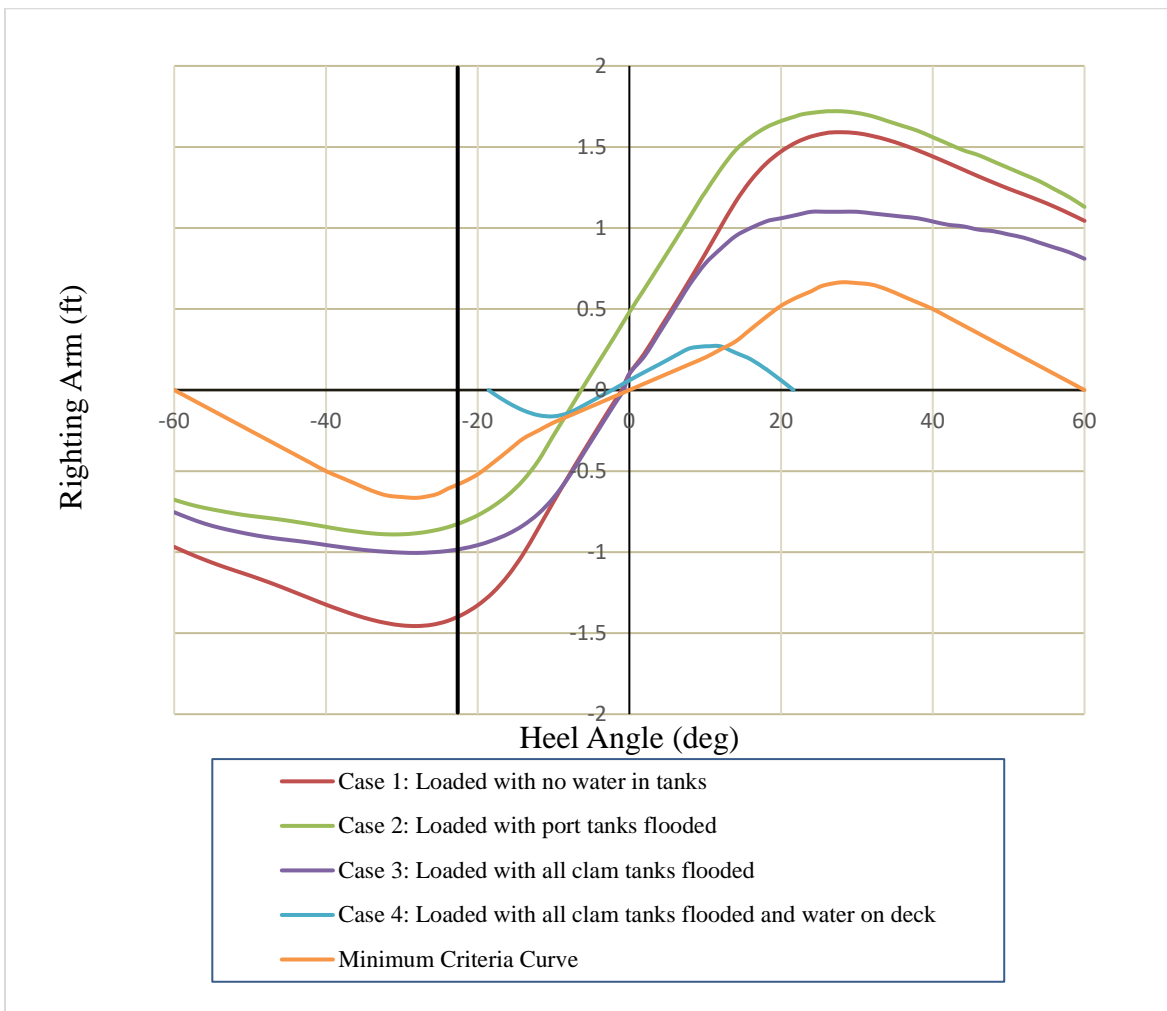
**Figure 6: Righting Arm Curve Comparison for Incident Loading Cases**

While there is significant uncertainty in the estimated initial lightship values as well as the assumed loading condition for the MISTY BLUE on the day of the incident, Figure 6 can nonetheless be used to demonstrate the relative impact on stability of the various evaluated Loading Cases. In Figure 6, heel angles to port and righting arm are assigned a negative value and can be seen on the left hand side of the figure. This is the convention used to distinguish between port and starboard. Our calculated angle of downflooding ( $22^{\circ}$  to port) is represented as a black vertical line.

To demonstrate the relative impact of the various loading conditions, MSC developed the Minimum Criteria Curve, shown as orange, as a visual representation of the minimum limits required to satisfy intact stability found in 46 CFR 28.570. Figure 6 demonstrates that Cases 1-3 exceed these intact stability limits.

Figure 6 demonstrates the negative impact of the off-center flooding at the time of sinking. The righting arm curve for Case 2 is shifted to the left and crosses the x-axis at  $-6.4$  degrees; this crossing location represents the vessel at static equilibrium with a  $6.4$  degree list to port. MSC has calculated that at a heel angle of  $22^{\circ}$  the vessel will downflood into the lazarette vent. This means that the off-center flooding of the port clam tanks decreases the range to down flooding by over 5 degrees. In addition the area under the righting arm curve from static equilibrium to the point of downflooding is significantly decreased due to the port list. The area for Case 2 is approximately 50% less than the area from equilibrium to downflooding for Case 1.

Case 4 places approximately 7 inches of water on deck above the assumed vertical center of gravity. The righting arm curve for this scenario demonstrates significant negative impact on righting energy, one that is particularly difficult to recover from. The weight of the water added was approximately 1LT, the approximate weight of one loaded clam cage.

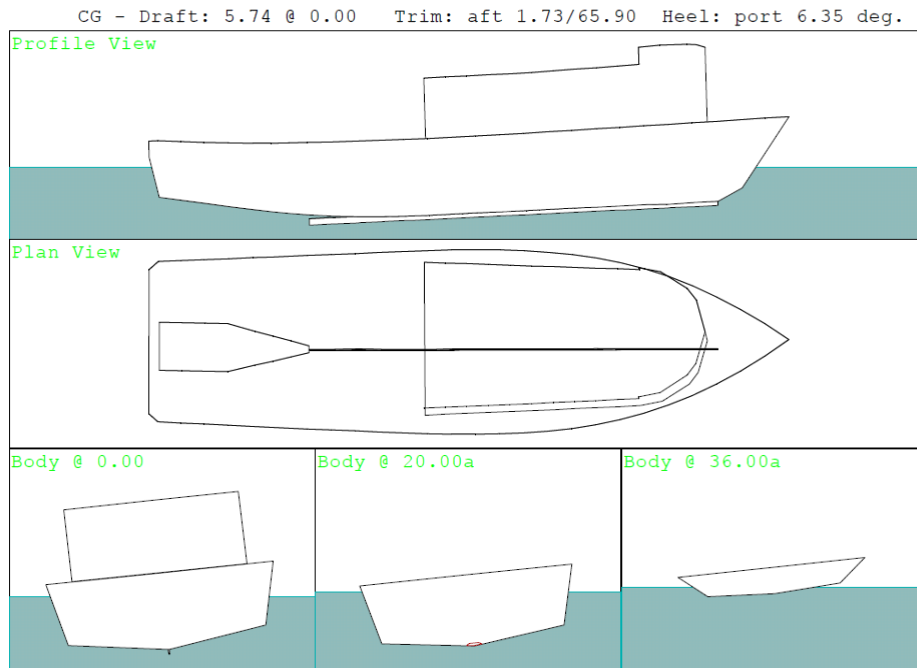
**Figure 7: Floating Condition of the Vessel Loaded as Estimated At Time of Sinking**

Figure 7 presents the static condition of the vessel as loaded in Case 2, with an estimated port list of  $6.4^{\circ}$ . When the vessel was loaded as estimated at the time of sinking, with the port tanks

flooded, the freeing ports would be very near the water's edge. This aligns with witness testimony presented in reference (b), and indicates that the flooding in the port tanks alone would be sufficient to induce the reported list. Given the sea state at the time of the incident and the relatively small freeing port areas, it is likely that water accumulated quickly on deck and settled to the port side.
