## **NATIONAL TRANSPORTATION SAFETY BOARD**

# **ONSITE EXAMINATION NOTES**

**WPR19FA124**

Location: Ridgefield, WA  
Date: Apr 29, 2019  
Aircraft: N90LK  
NTSB IIC: Michael Huhn

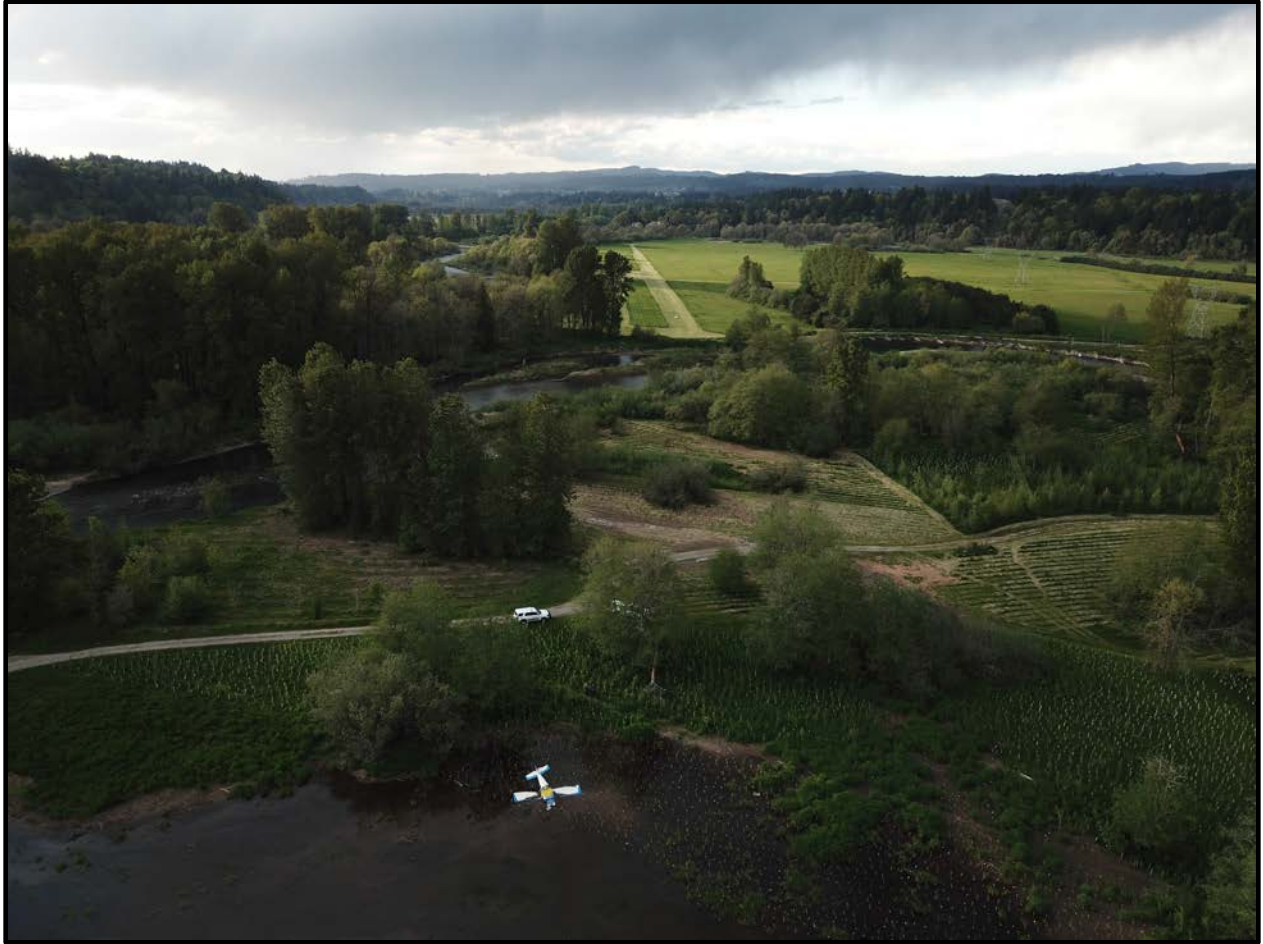
Examination of the accident site revealed that the airplane impacted into shallow water about 1.5 ft deep in the Zimmerman Greenway on the East Fork of Lewis River, in Clark County, flood overflow area. The marsh was surrounded by bunches of large trees (about 75-90 ft in height) Additionally, a high-tension power line ran from the north to south, and was about located about 200 ft east of the accident site. No trees or power lines were observed to be damaged. The site was located about 1200 ft south southeast from the departure end of runway 31, at the Daybreak Airport (WA46), La Center, Washington. The elevation was about 28 ft. The water was swampy, murky, and in an area where new seedling trees have been planted for restoration of the wetland. About 23.5 acres of restoration was taking place in the area.

**Figure 1: Airplane wreckage in reference to the Daybreak Airport.**

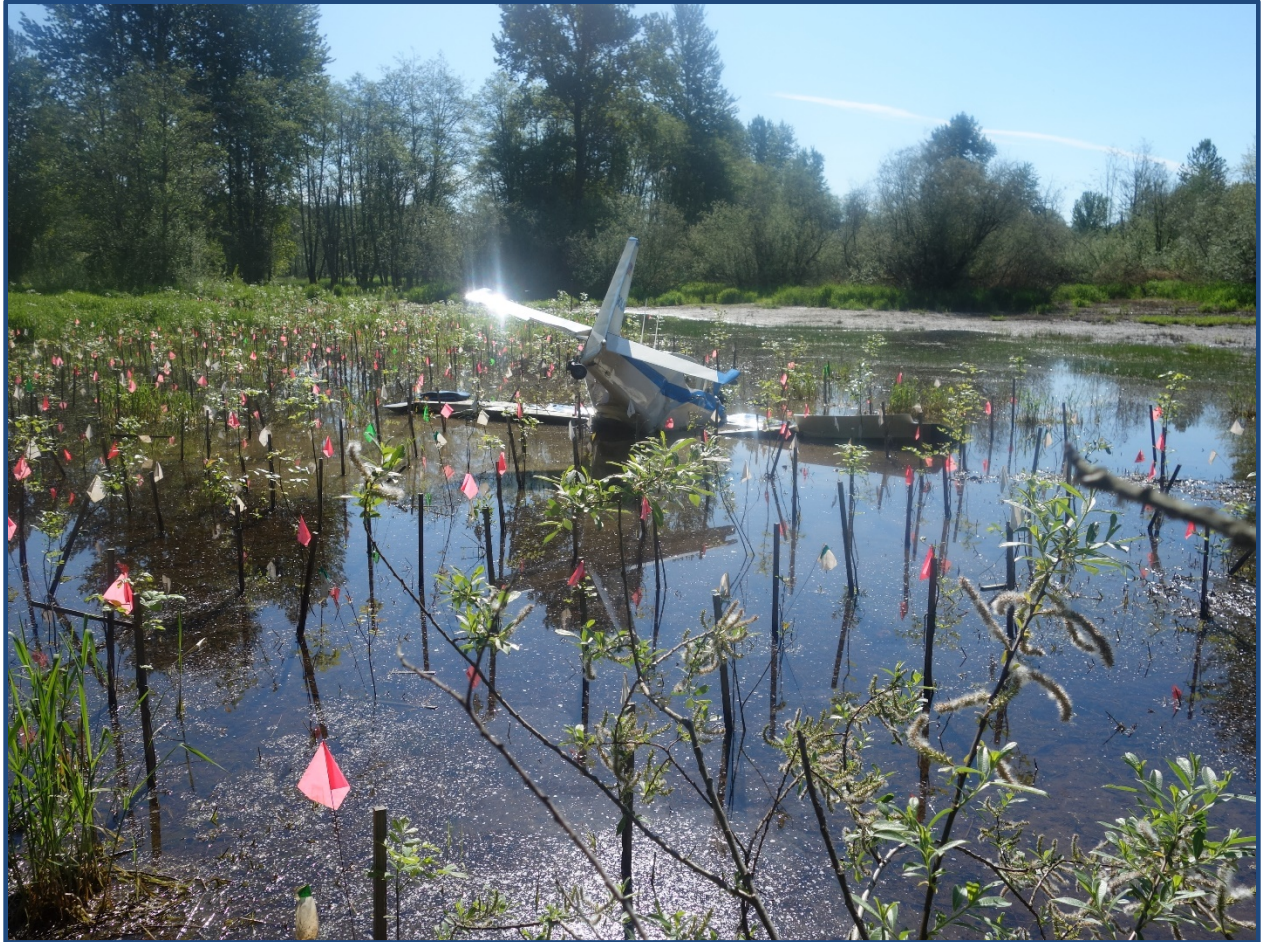
All major components of the airplane were contained within the main wreckage site. The airplane's fuselage came to rest upright on a heading of about 090° magnetic and was positioned about 25° nose low. The empennage was totally out of the water. The wreckage was located about 30 ft from the nearest shore line. There was no postimpact fire.

Figure 2: Airplane wreckage viewed from the aft.

Visibility in the water and mud was very limited but the wings appeared to be attached to the fuselage. The empennage was attached and intact. The fuselage was bent right just aft of the cabin. Flight control continuity was unable to be established from the individual flight controls surfaces to the flight control sticks, because of impact damage to the bottom of the airplane, with the exception of the right aileron, which continuity with the cockpit controls was established. The flaps were in the retracted position.

The empennage was relatively intact. The vertical stabilizer and rudder were attached to their respective attachment points. The left and right horizontal stabilizer and elevator were attached and were relatively undamaged. The elevator trim tab was observed in the full [tab trailing edge] up position. Both the tail wheel and the rear position light were attached and intact.

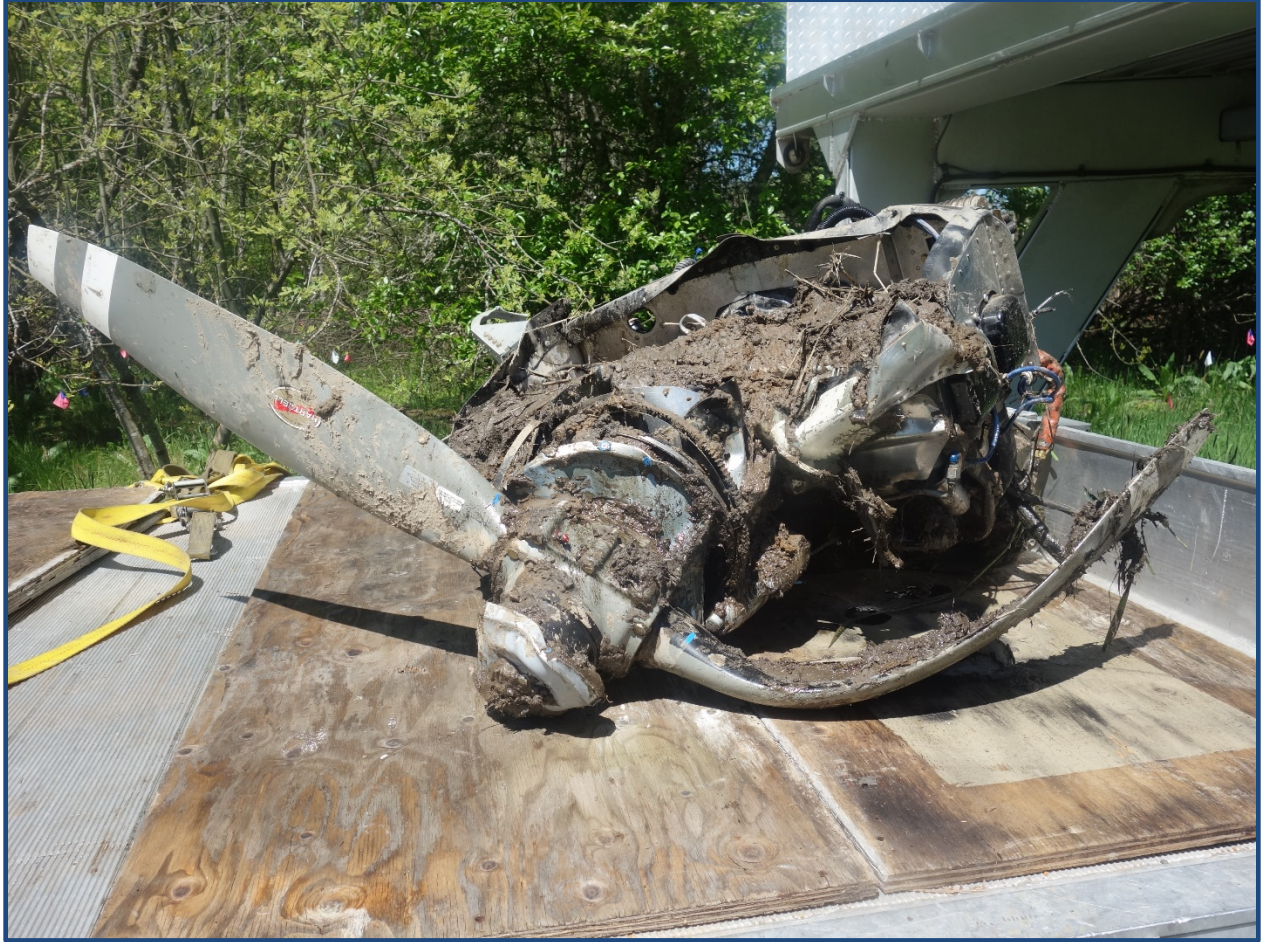
The engine was covered with mud and all the engine accessories appeared to be attached. Oil was observed leaking from the oil sump. The oil quantity dipstick indicated about 4 on the scale of 1-6. The propeller remained attached. One blade was bent aft about mid-span and the other blade was relatively intact.

**Figure 3: The engine as viewed from the front after removal from the fuselage.**
