## **SURVIVAL FACTORS ATTACHMENT**

**WSP Limited Reconstruction Analysis and Interviews**

**HWY20FH006**

## LIMITED RECONSTRUCTION ANALYSIS

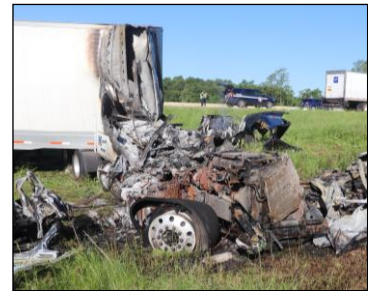
*Figure 3-Damaged K. Express Semi Unit (IMG\_7846.JPG)*

The K. Express semi unit was a 2013 Freightliner, white in color, displayed an Illinois apportion registration plate of P926191, and Vehicle Identification Number (VIN) 1FUJGLDR4DSBV4582. **Figure 3** shows the damaged and burned semi-tractor and trailer unit. The attached trailer displayed an Illinois registration plate of 607010ST, VIN of 1UYVS2538H7178208, and sustained damage during the collision sequence. A post-crash inspection of this semi unit was completed by Inspector Creighton Schwark. His report is attached to this reconstruction package.

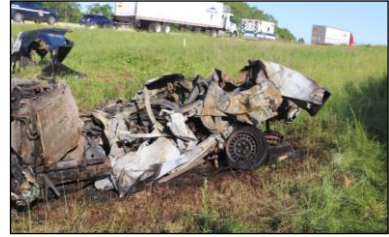
*Figure 6-Damaged Chevrolet  
(IMG\_7847.JPG)*

The 1999 Chevrolet Malibu was tan in color, displayed a Wisconsin registration plate of [REDACTED], and a VIN of 1G1ND52M3X6[REDACTED]. As shown in **Figure 6**, the Chevrolet sustained heavy damage during the collision sequence and ensuing fire.

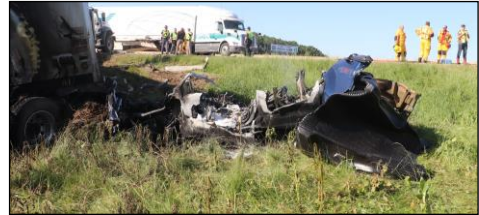
*Figure 7-Damaged Ford (IMG\_7895.JPG)*

The 2018 Ford F150 was blue in color, displayed a Wisconsin registration plate of [REDACTED], and a VIN of 1FTEW1EP2JKG[REDACTED]. As shown in **Figure 7**, the Ford sustained heavy front and rear end damage during the collision sequence and totaling damage from the ensuing fire. The hood of the Ford was found embedded in the rear-end of the Mack dump truck.

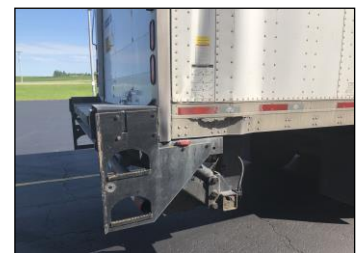
*Figure 10-Damaged Med Trans  
Semi Unit (IMG\_0928.JPG)*

The Med Trans semi unit was a 2020 Volvo, white in color, displayed an Illinois apportioned plate of P1039831, and a VIN of 4V4W19EG1LN244334. The semi-trailer was white in color, displayed an Illinois registration plate of 639995ST, and a VIN of 1UYVS24277G284009. As shown in **Figure 10**, the semi-trailer sustained to its rear during the collision sequence. A post-crash inspection of this unit was completed by Inspector Teresa Burchard. Her report is attached to this reconstruction package.

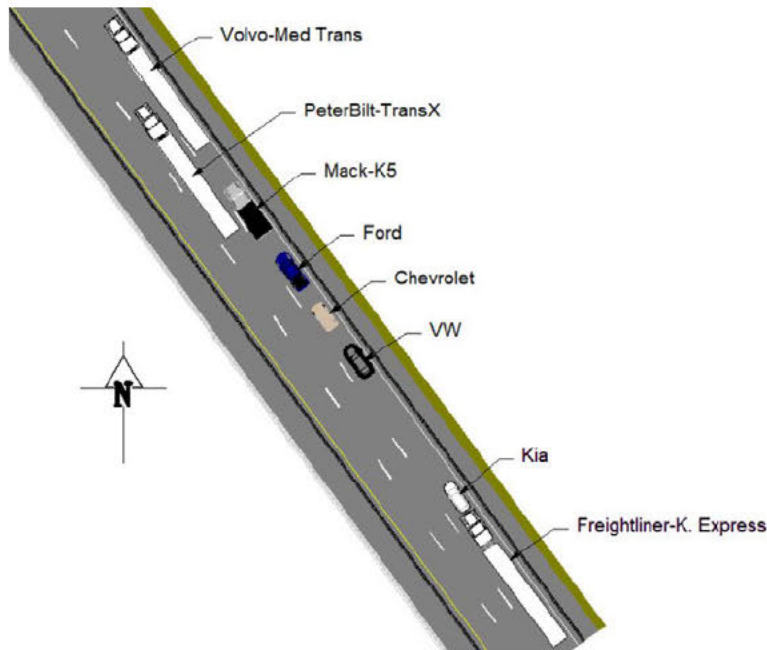
*Figure 11-Pre-Crash Sequence*

**Figure 11** shows the involved vehicles in their approximate pre-crash order and alignment. The pre-crash order and alignments were determined by video and physical scene evidence
