National Transportation Safety Board

Investigator-in-Charge's Accident Summary

NTSB Accident #PLD21FR002

Natural Gas-Fueled Explosion During Routine Maintenance

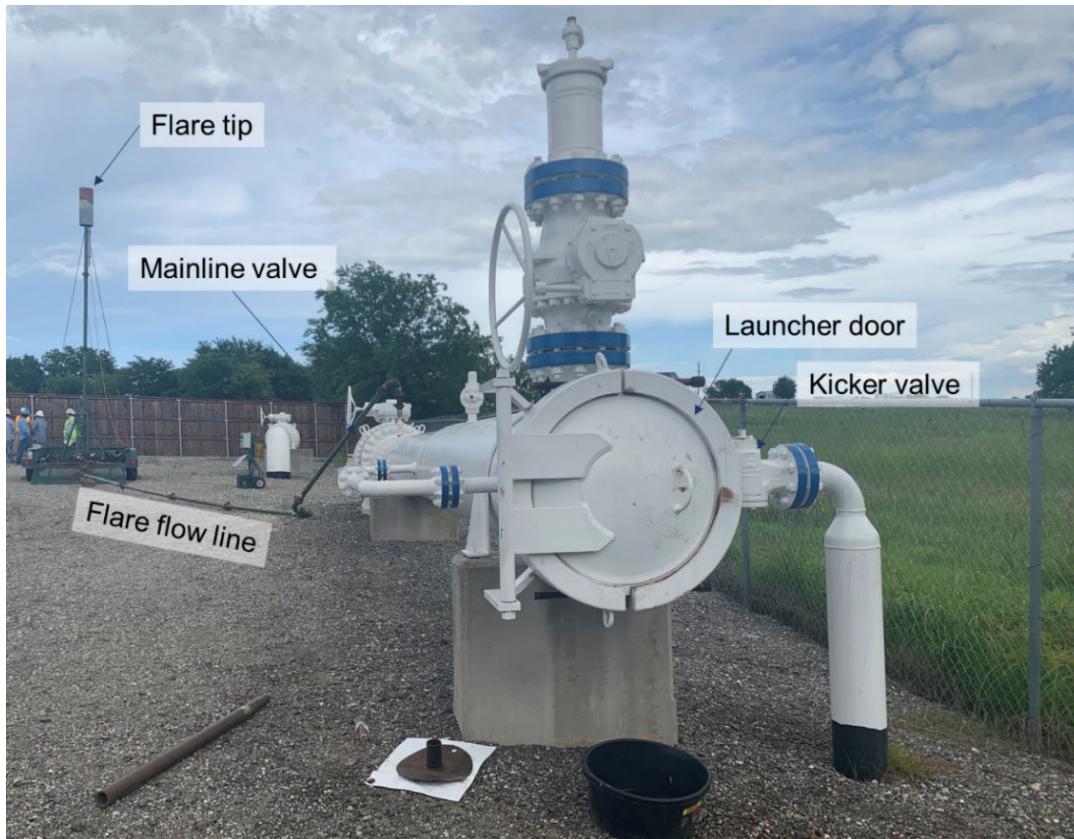
On June 28, 2021, at about 3:35 p.m. central daylight time, natural gas ignited causing an explosion during routine maintenance activities involving the insertion of an in-line inspection tool (pig) into a launcher, near Farmersville, Texas (Figure 1).¹ The pig was ejected from the pipeline shortly after it had been inserted into the launcher, while employees were manually removing the insertion tool.² Before the insertion tool was completely removed, employees at the site heard a loud sound and one employee observed a flash near the open launcher door. Employees from Atmos Energy Corporation (Atmos), FESCO, Ltd. (FESCO), and Bobcat Contracting, L.L.C. (Bobcat) were onsite at the time of the accident performing work for Atmos. The explosion was directed toward four employees, injuring all of them, two fatally. Three other employees who were working nearby on the same project were not injured.

Figure 1. Front View of Pig Launcher Involved in the Accident
