**Vehicle Attachment – Vehicle Factors Photographs**

**Clarendon Hills, IL**

**HWY22MH009**

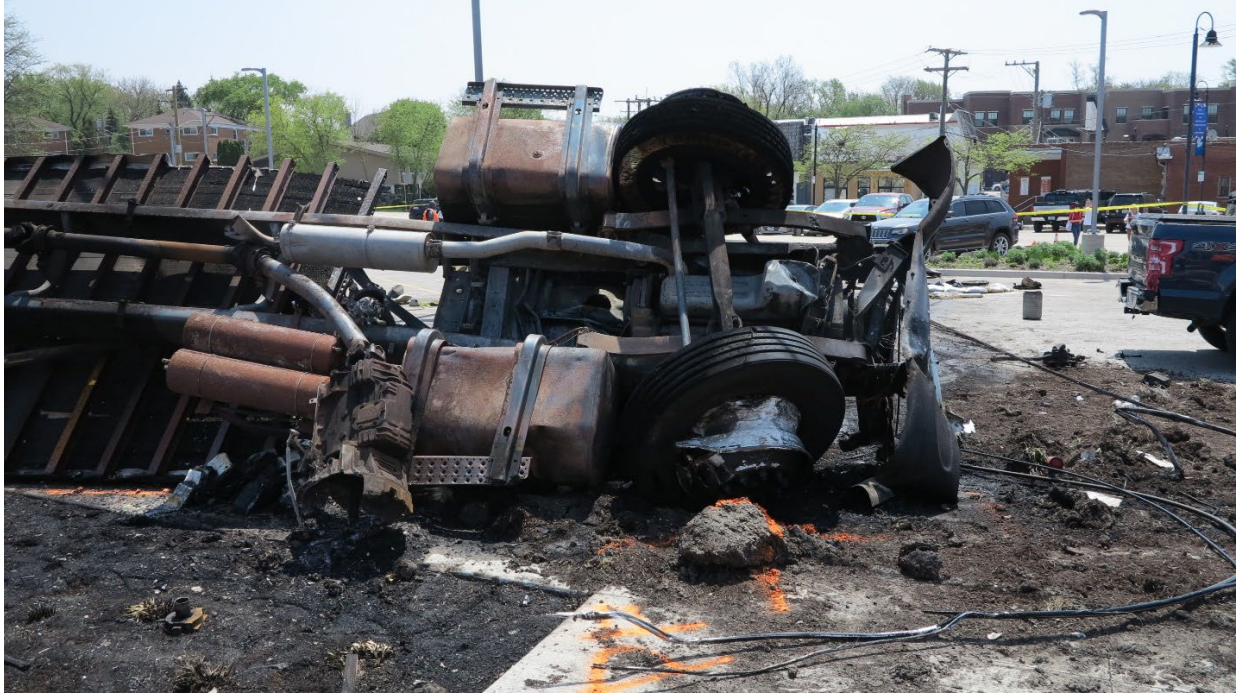
**Photograph 1:** An image of the bottom of the engine compartment and displaced transmission.

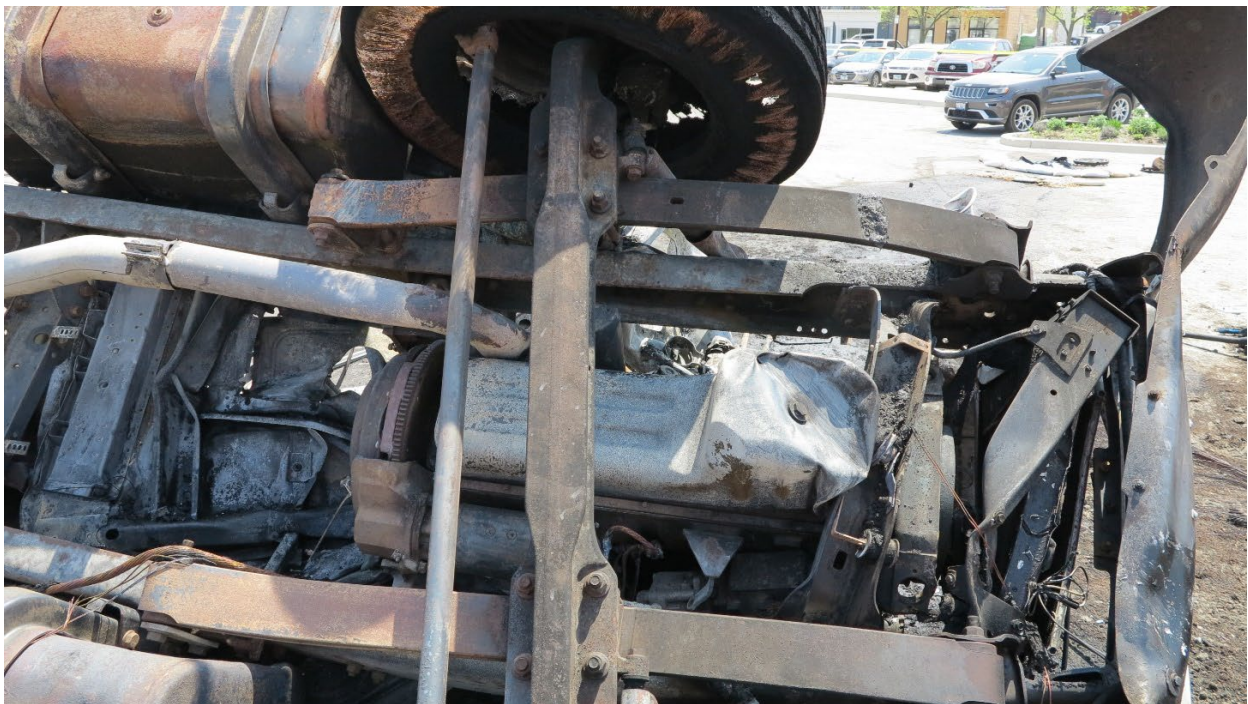
**Photograph 2:** An image of the damaged oil pan and rearward displacement of the steering axle.

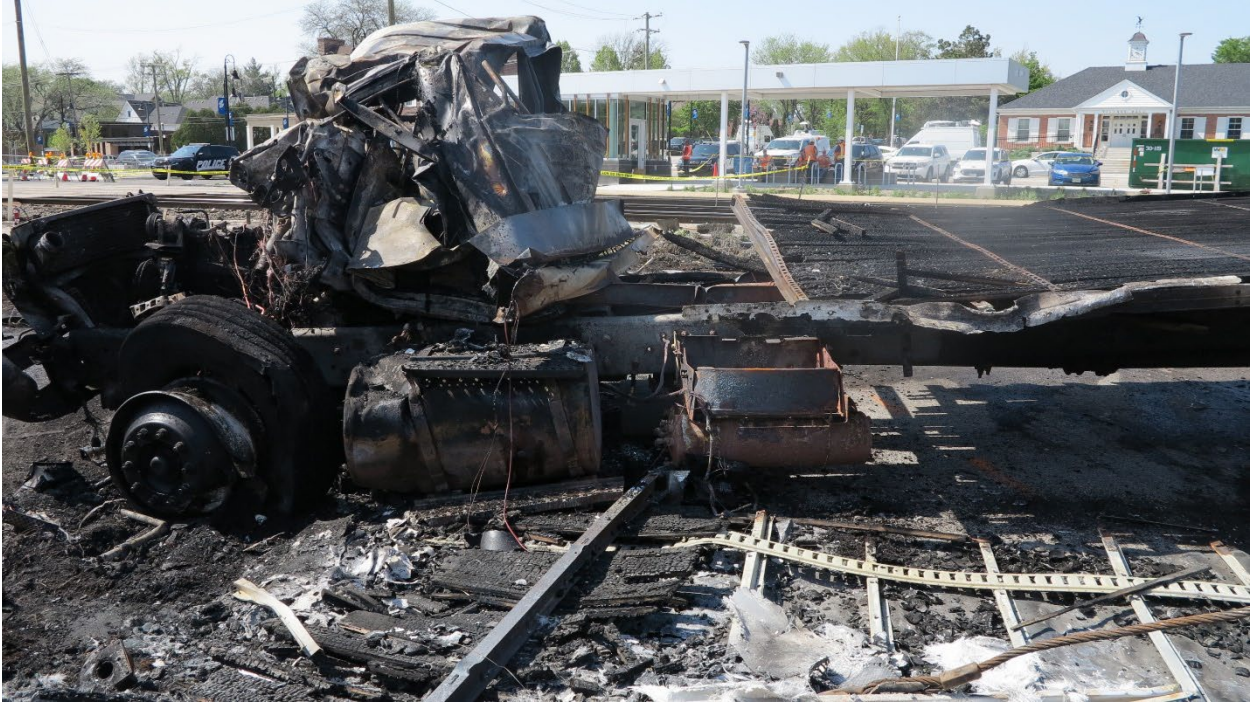
**Photograph 3:** An image of the left side of the cab after the truck up righted.

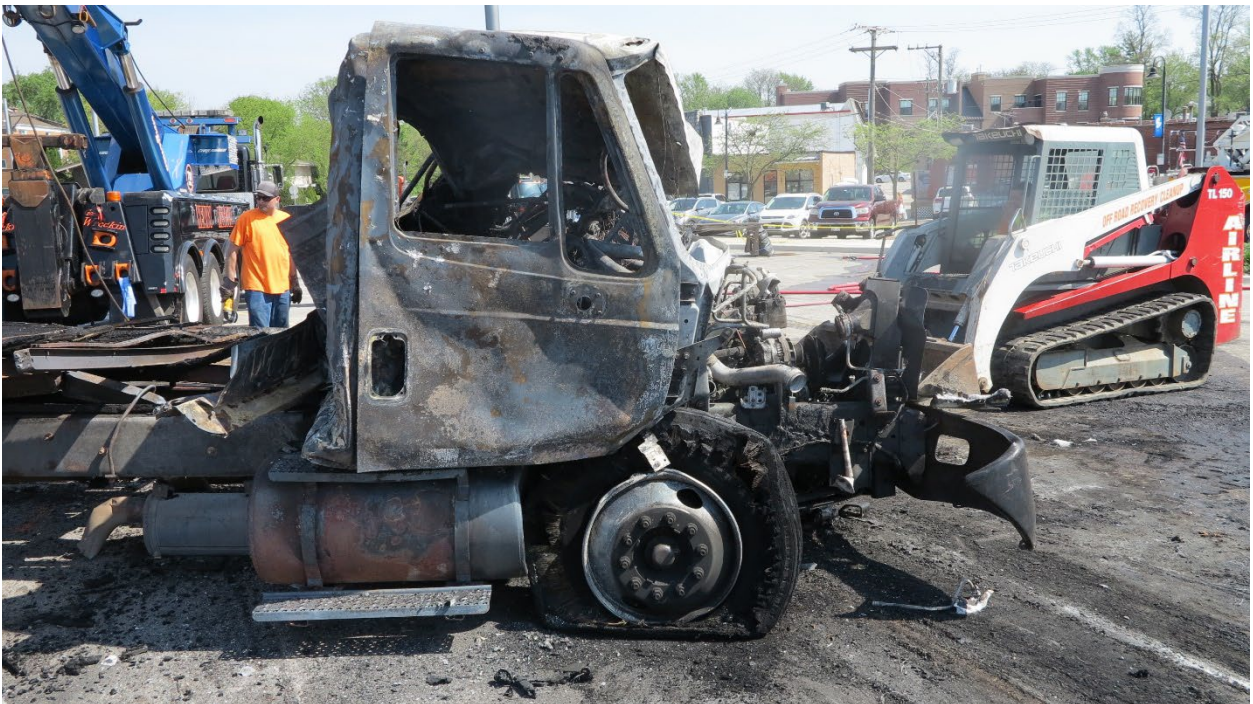
**Photograph 4:** An image of the right side of the cab after the truck was up righted.

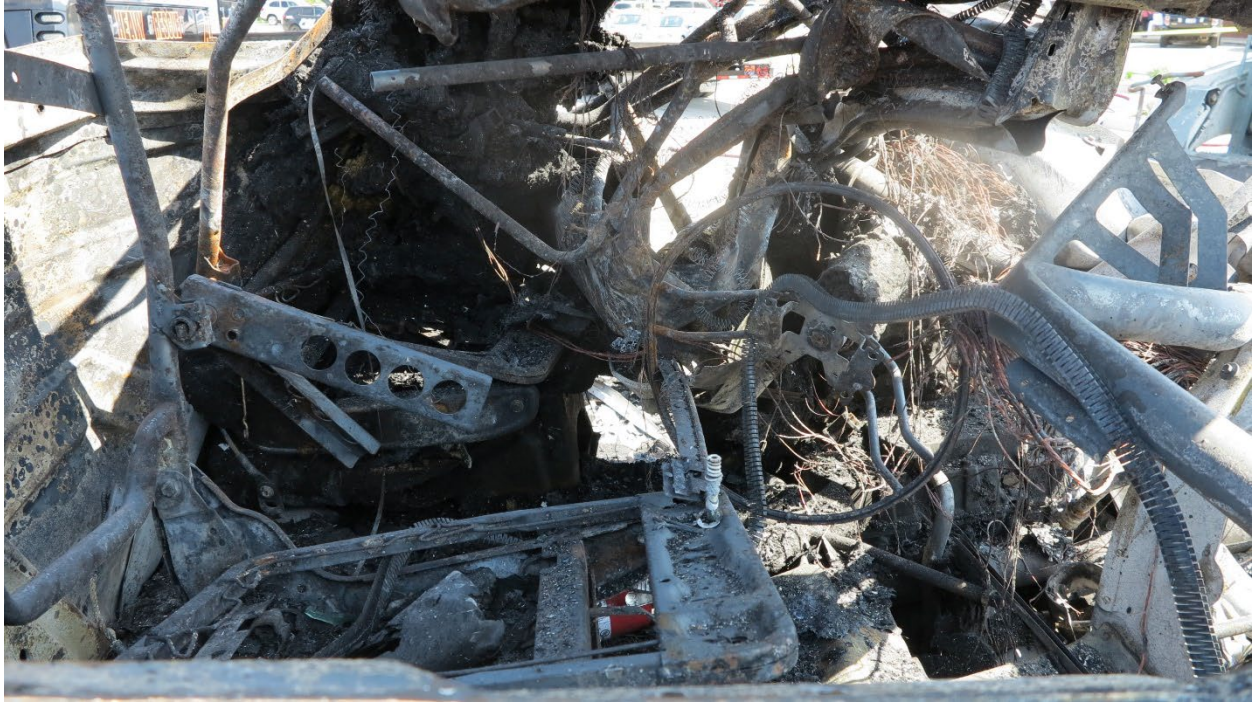
**Photograph 5:** An image (looking from the right side toward the left side) of the cab interior.

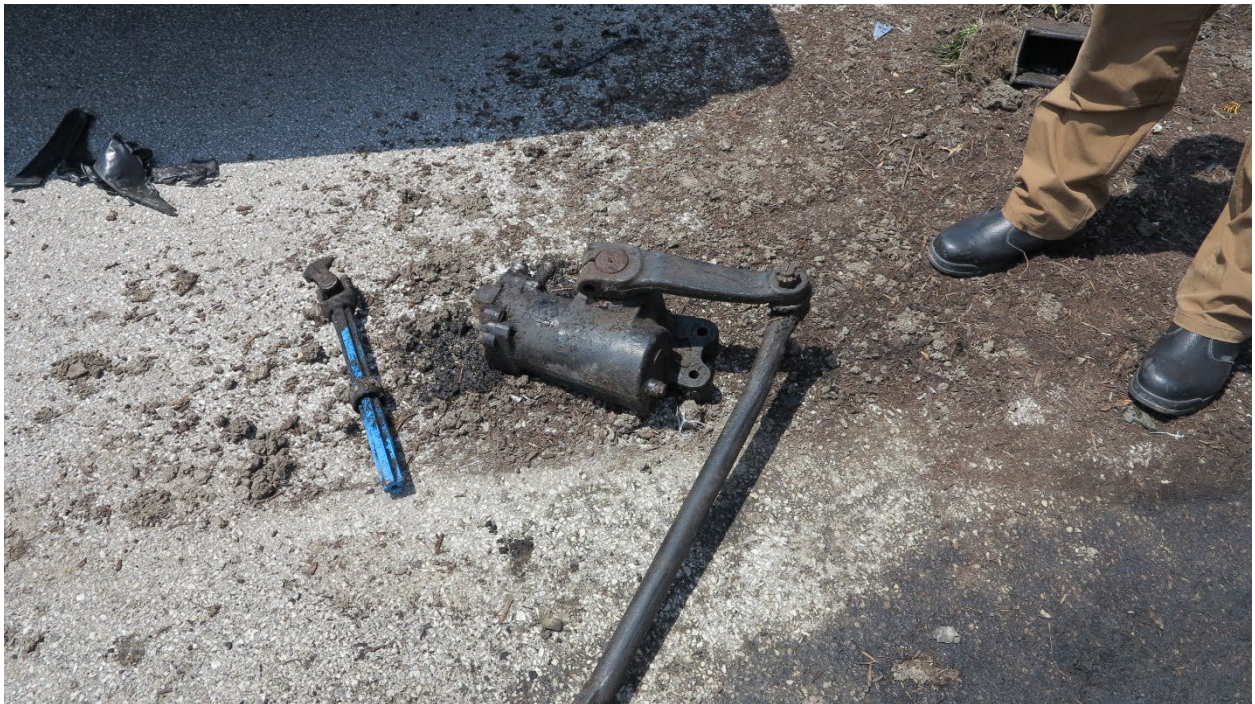
**Photograph 6:** An image of the displaced steering gear at the crash scene.
