**Enbridge (formerly Spectra) 70130.01 Hardspot Reanalysis – Letter of Intent**

# **LINALOG<sup>®</sup> Hard Spot Inspection Report**

**Enbridge**  
**75.5 mi. x 30" TOMP-DANV Line 15**  
**Tompkinsville – Danville**  
**Run Date: 05 Apr 2011**  
**Job #: 70130.01**  
**Run 1**

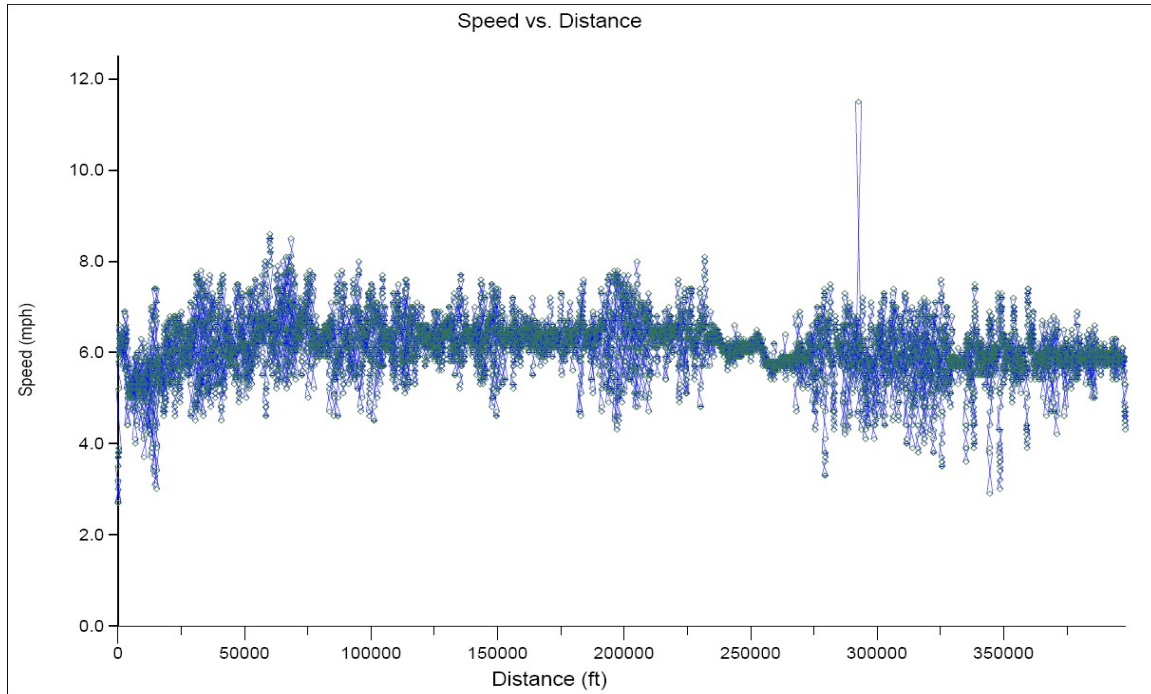
##### 2011 Inspection – Tool Speed vs. Distance

An inspection survey was performed on 05 Apr 2011. The Linalog Max-LF tool was launched at 7:29 a.m. and trapped at 7:55 p.m. Natural gas propelled the tool for 12 hours and 26 minutes at an average speed of 6.07 mph. There was no debris reported. Of the 76 AGMs deployed, 2 were not detected.

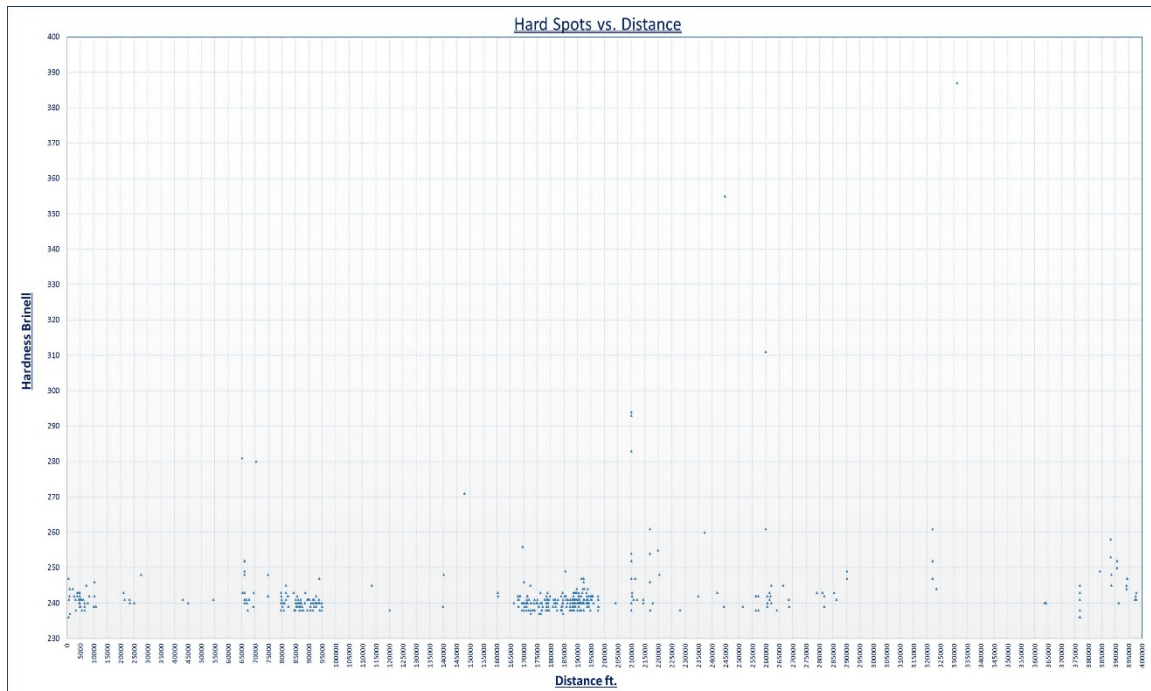
##### 2019 Re-analysis - Hard Spot vs. Distance

During the 2019 re-analysis of the same dataset, our analysts reported **438** indications of hard spots that met the 200 – 300 Brinell criteria and **3** indications of hard spots that met the 301 – 400 Brinell criteria.

The number of hard spots found in this most recent 2019 analysis has increased, which is due to the significant improvements in hardware and software made available to our analysis team today versus the technology available in 2011.
