## Pipe and Coating Inspection Report: 8162

### Pipe and Coating Inspection Report: 8393

## Pipe and Coating Inspection Report: 8163

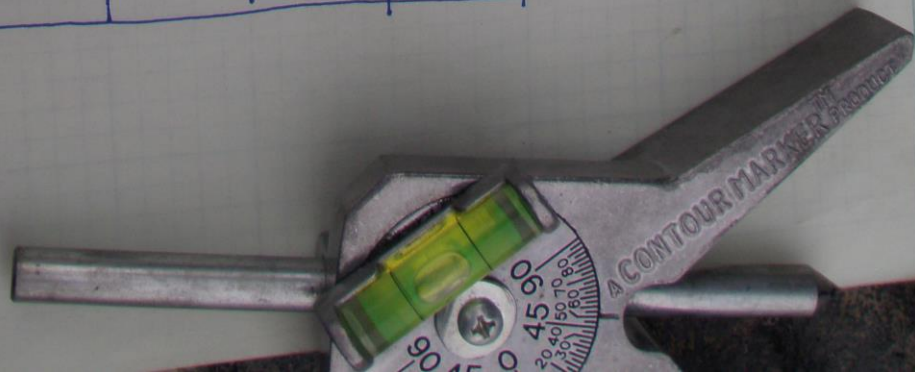
UT WT

WC 244877.883

1:30

1	367	372	376	377	375	368	364
2	369	372	377	375	369	366	366
3	366	373	378	375	372	368	366
4	367	374	379	<u>Hard spot</u> 374	372	370	363
5	369	375	379	374	371	366	363
6	365	375	377	374	369	369	364
7	366	373	373	375	372	370	362

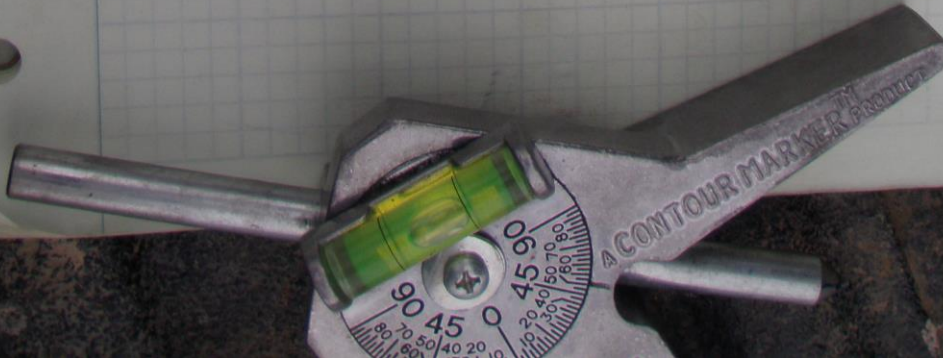
WC 244877.883 1:30

Maximum Hardness Rockwell 89 HRB (Brinell 160)
