DAMAGE SURVEY REPORT

CAPT. KIRBY DUPUIS

Report Number: 66-11-29-2021-A

Inland Towing Vessel

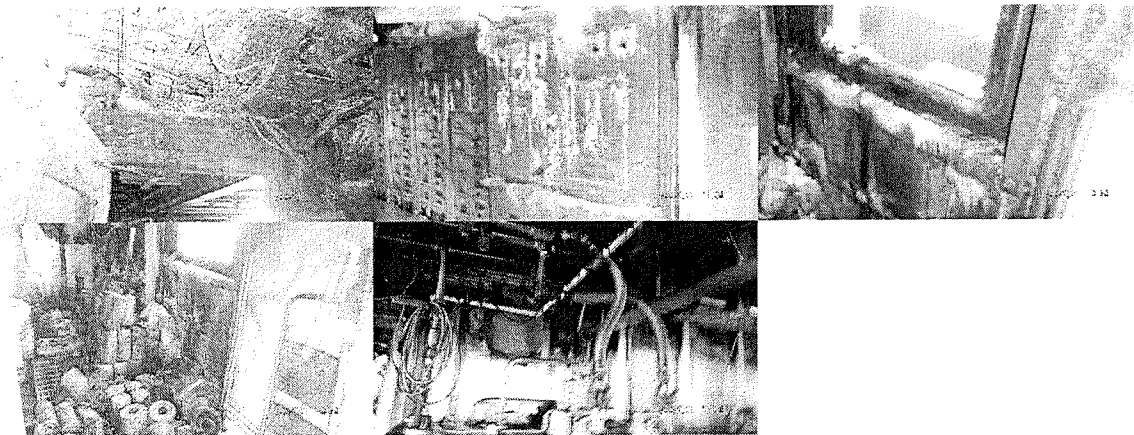
The upper and lower engine was found to be heavily burned in way of ceilings, wall board, equipment, tools, and supplies. Engine monitors, alarm system, electrical switch gear, and motor starter controllers were burned and melted. Fire damage was also sighted in the steering room compartment and bulkhead. Engine room, steering space, and machinery maybe considered a Total Loss except for the main engines' pending inspections.

Main deck house cabin floors, walls, ceilings, and ventilation system were found to contain heavy soot on the 1st deck and light soot on the 2nd, 3rd, and wheel house levels. There was a heavy presence of the smell of smoke throughout the vessel.

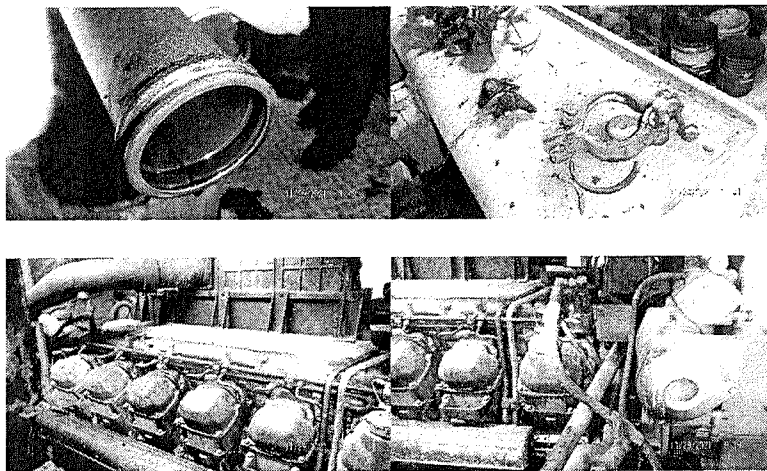
Port Main Engine/Missing Support Bracket

After inspection/survey of the port main engine, it was discovered by LA Cat that the oil cooler piping that supplies the filter housing O-ring failed and sprayed oil on the exhaust manifold causing the fire. The inner retainer and piping support bracket was found missing which allowed the piping to move and caused the O-ring to fail. Brian Young, with NTSB, was also on the vessel on 11/30/2021 reviewing the damages. Port engine was also found to be low on oil.

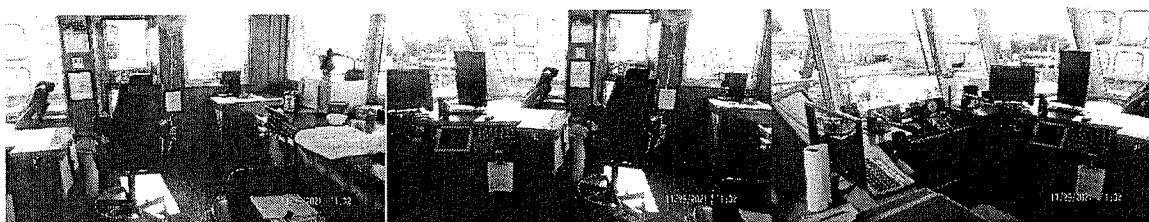
Pilothouse/Pilothouse - Deck Level

No Damage sighted in pilot house at time of survey. See recommendation for repairs.

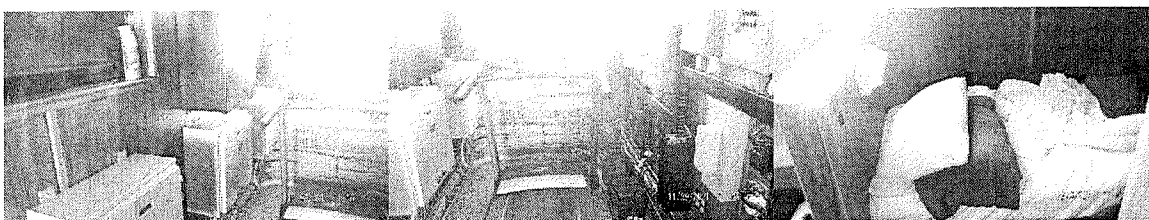
Electronics Room - Third Deck Level

No damage sighted in electronics room at time of survey. See recommendation for repairs.

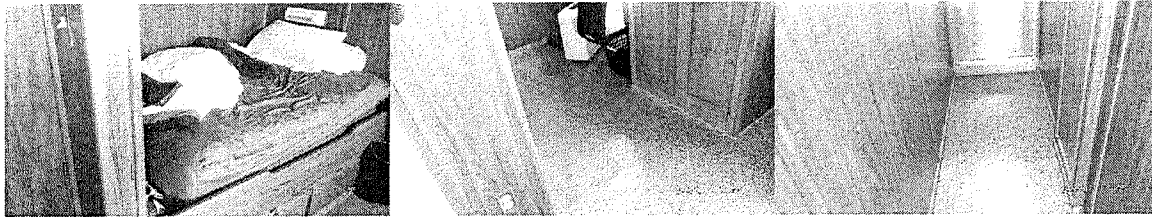
Second Deck Level

No damage sighted on the second deck level at time of survey, other than light soot. See recommendation for repairs.

- Vessel's interior spaces to be protected with dehumidifiers to stop any moisture issues.
- Retain a fire cleaning service to professionally clean/disinfect all interior surfaces and A/C duct to remove any odors and dust.
- Remove main deck aft living quarters wall board for inspection. If damage is found, it may require future removals. The exterior surface of this bulkhead did have a lot of heat from the engine room.

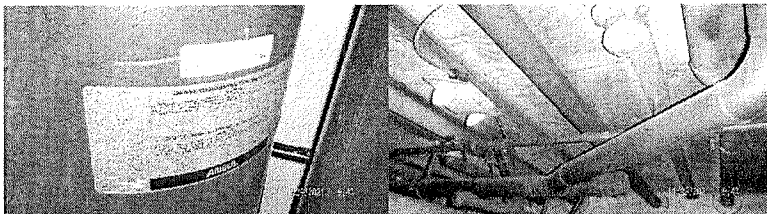
Fwd. Machinery Space

No damage sighted at time of survey, other than heavy soot. See recommendations for repairs later in this report.

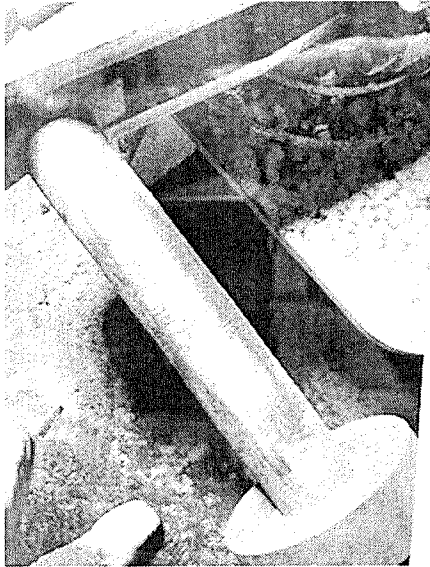
Steering Equipment

Steering rams looked to have gotten hot or contaminated.

- Port and starboard main engines and gears are to be removed for inspection by authorized dealer.
- Cat Generators to be replaced as original.
- Remove/Repair/Replace steering rams.
- Clean all tanks that supply machinery & equipment, such as day tanks and oil reservoir.
