Alaska Airlines Flight 1282

Boeing 737-9, N704AL

Left Mid Exit Door Plug Separation in Portland, OR

# **Manufacturing Records and Human Performance Factual Report**

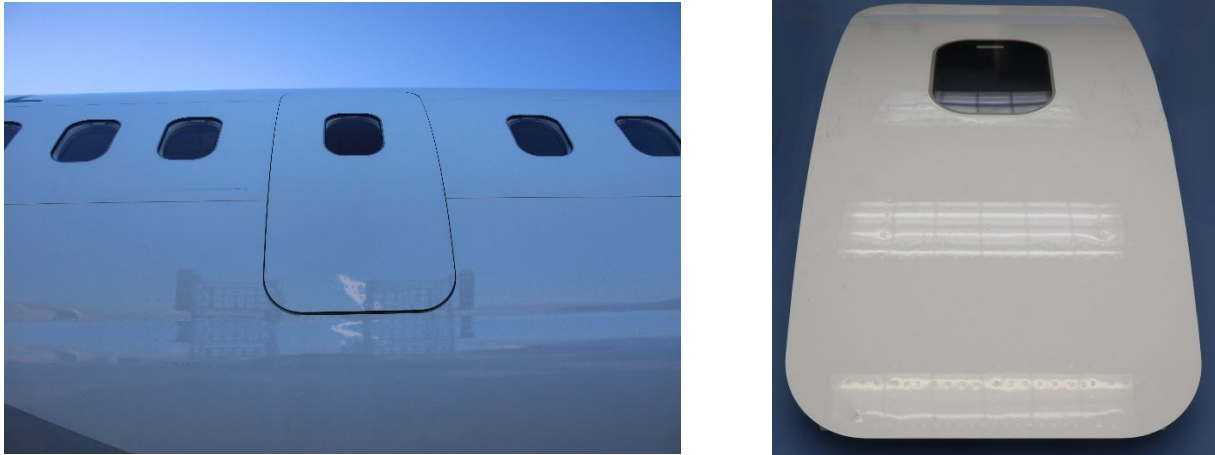
**Figure 4.** Left photo: Exemplar MED Plug installed on airplane. Right photo: Recovered LH MED Plug. [NTSB Photos]

Spirit AeroSystems had design responsibility for the MED plug. This included the build standards and Engineering Drawings. The LH MED plug installed on the accident airplane was built per applicable engineering drawings.

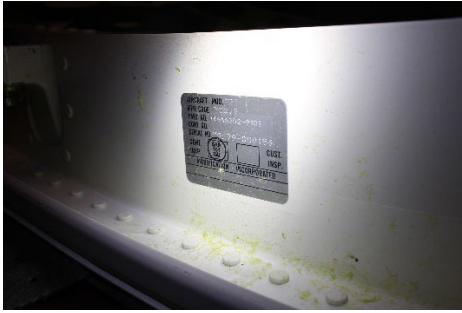
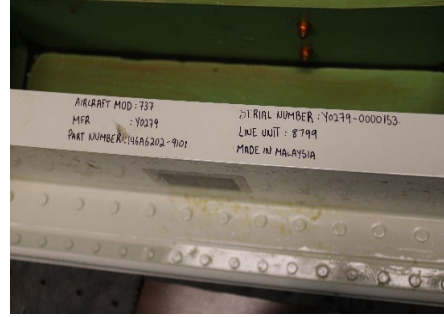
**Figure 5.** Left photo: LH MED plug Data Plate. Right photo: Markings on accident airplane [NTSB Photos]

According to Manufacturing Records, the LH MED plug installed on the accident airplane was manufactured by Spirit AeroSystems Malaysia on March 24, 2023, and received by Spirit AeroSystems Wichita on May 10, 2023.

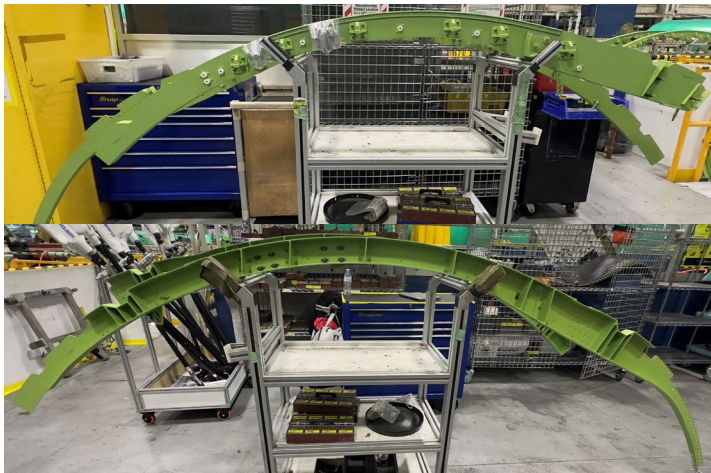
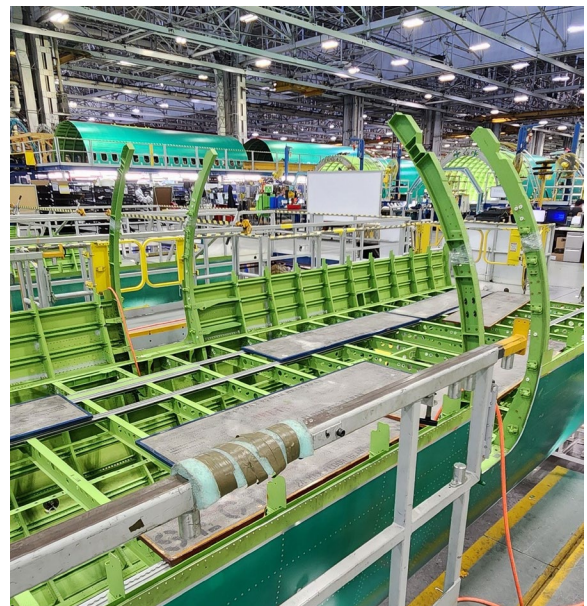
**Figure 6.** Left photo: MED Plug Edge Frame components. Right photo: Edge Frame Installation on Fuselage [Source: Spirit AeroSystems. Reproduced with permission]

Both the LH and Right-Hand (RH) MED plug edge frames components installed on the fuselages during production were manufactured by a Spirit AeroSystems supplier, Quik Tek. The edge frame components were delivered to Spirit AeroSystems, placed in inventory, and stored in the factory.

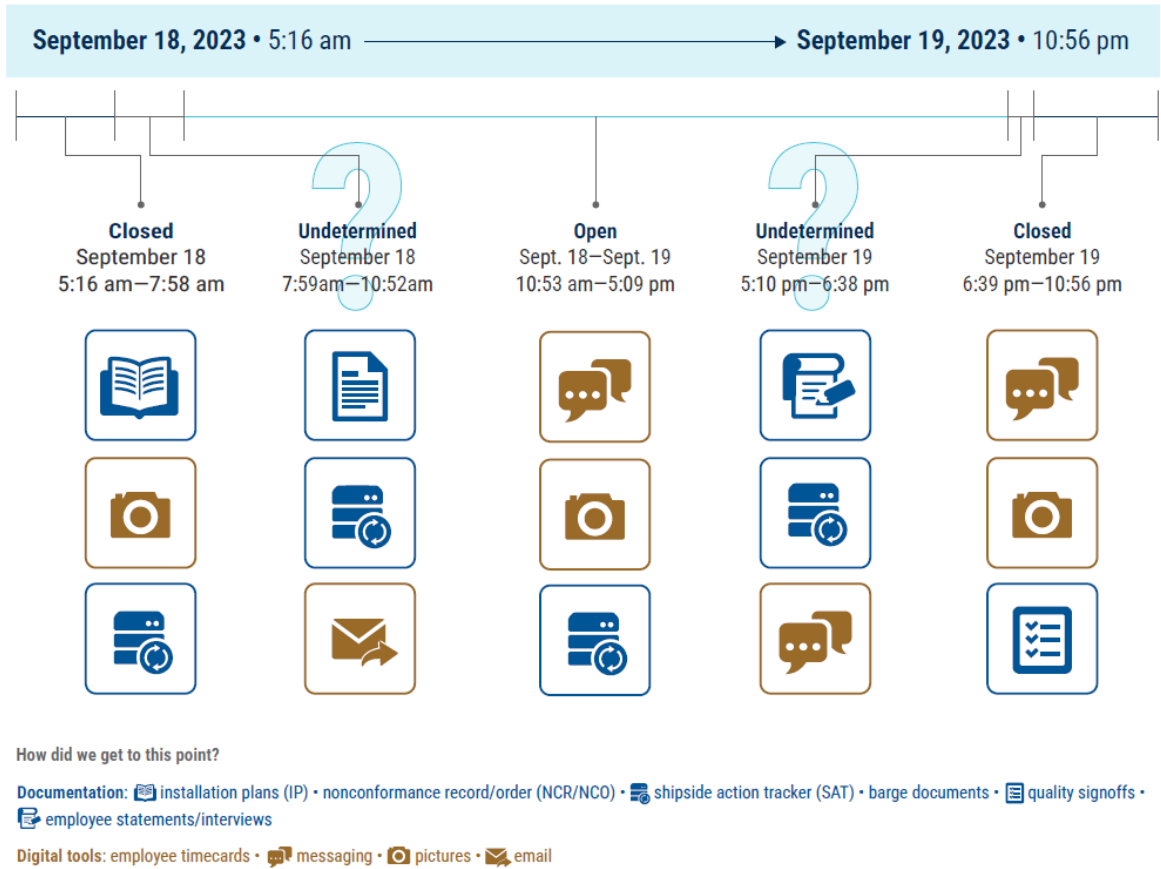
To provide access for Spirit AeroSystems personnel to replace the five discrepant rivets, Boeing manufacturing personnel were responsible for the opening and closure of the completed MED plug installation. Opening of the MED plug required the removal of the four bolts that prevent upward movement of the MED plug. Per the Boeing process *Perform a Part or Assembly Removal*, removal of the bolts would have required a removal record to be initiated.

**Figure 8.** Approximate Timeline of opening and closing of LH MED Plug on Line 8789 [Source: NTSB]
