Human Performance Attachment – New York State Police Collision

Reconstruction Findings Report

HWY23FH005

**Two-Vehicle
Fatal Collision**

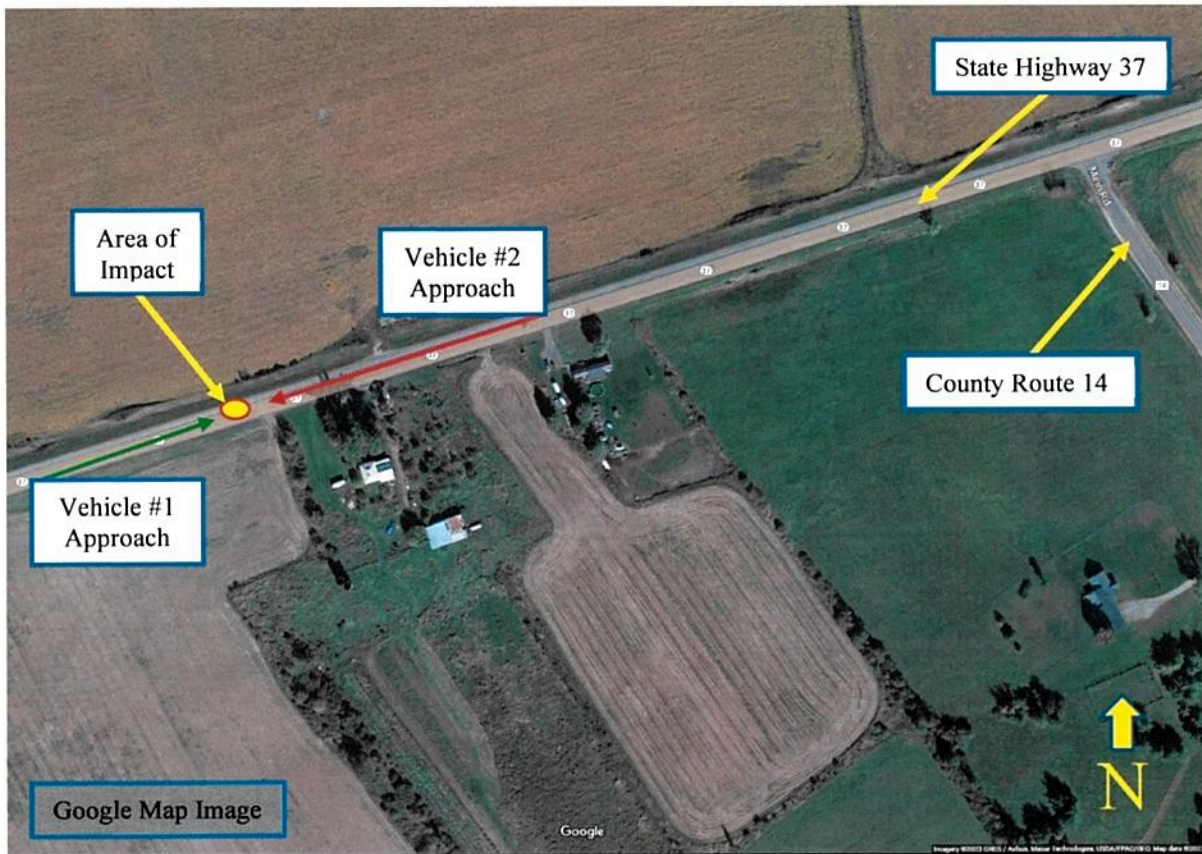
In the area of the collision, State Highway 37 was a relatively straight, flat, two-lane, two-way roadway constructed of asphalt with paved shoulders. In the portion of the roadway containing the collision, the roadway progressed in a general northeast/southwest direction. For report clarity, all descriptions of vehicle headings and motion will follow the east/west directional convention. The roadway was marked with a dashed yellow center line indicating passing was permitted for both lanes of travel. The north and south shoulders of the roadway were flanked by a relatively steeply sloped, snow covered, downward embankment and banked snow was observed along the outward most edges of the asphalt surface of both shoulders of the roadway. The traveled portion of the asphalt surface was noted to be wet, with no significant accumulation of snow or water within either lane of travel. First responding Troopers confirmed the roadway condition was consistent with the conditions observed when they arrived on scene. A Milled In Auditory Roadway Delineator (MIARD) was present along the center line portion of the roadway and the roadway had an unposted speed limit of 55 miles per hour.

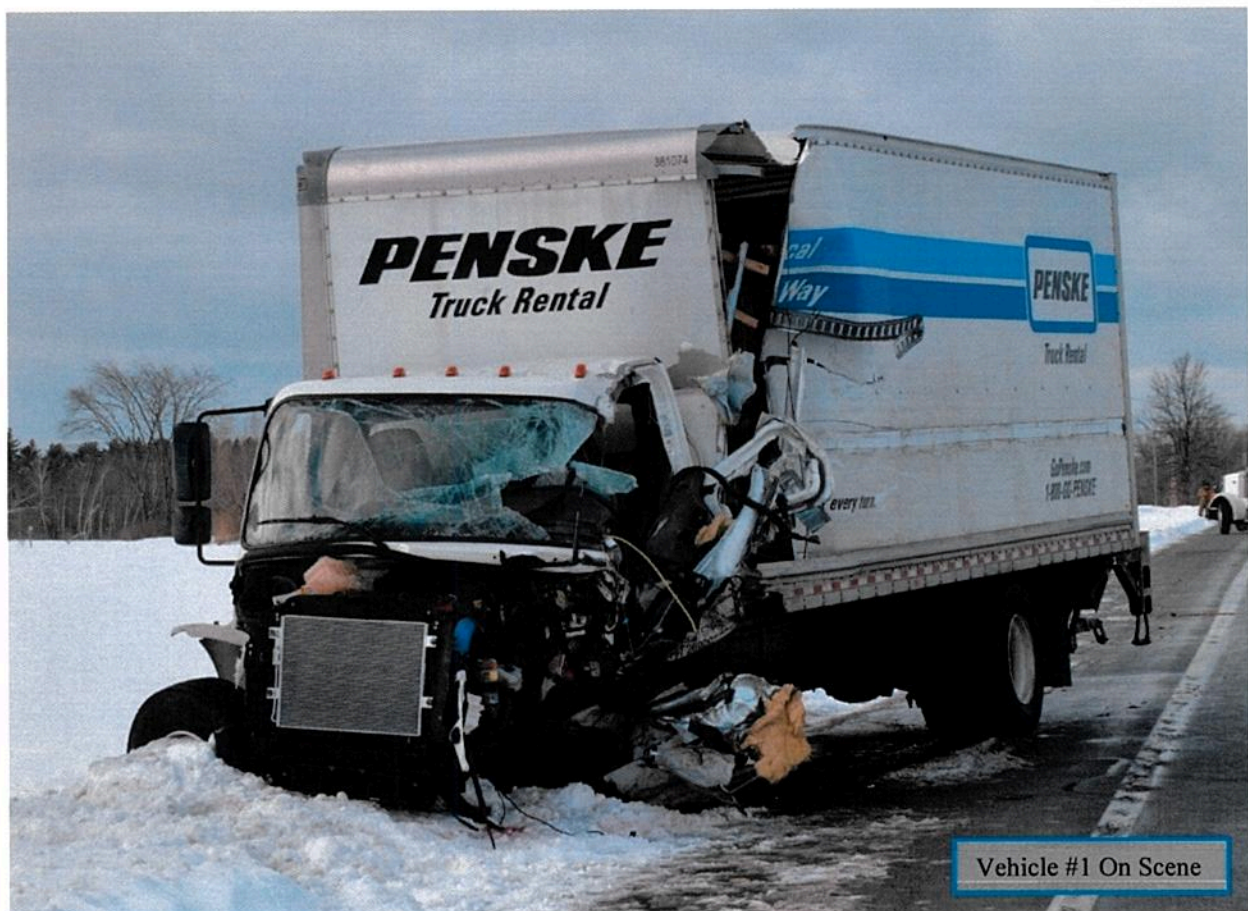
Evidence at the scene consisted of the two involved vehicles, gouging and scratching of the asphalt surface of the roadway, vehicle debris, fluid patterns, furrowing and disturbance of the banked snow, biological matter, and the deceased victims. The Area of Impact (AOI) was located within the westbound lane and was identified by a series

of scratches in the asphalt surface, light and heavy gouges in the asphalt surface as well as small fragments of red plastic lens material, which was determined to have originated from the outboard left red signal originally located at the top left corner of Vehicle #2. Vehicular debris, fluid patterns and a continuous linear scratch of the asphalt surface led from the AOI to the final rest location of Vehicle #1. A series of scratches and gouges of the asphalt surface, vehicular debris, furrowing of the snow on the north shoulder of the roadway and biological matter led from the AOI to the final rest location of Vehicle #2. No pre-impact tire marks for either involved vehicle were observed at the time of investigation.

The observed evidence indicated that Vehicle #1 exited the area of impact and continued in an easterly direction, eventually coming to rest facing east, against the banked snow, off the south shoulder of the roadway with a portion of the rear of the vehicle still within the paved portion of the south shoulder. Vehicle #2 rotated approximately 160 degrees in a counterclockwise manner as it exited the AOI and continued in a westerly direction before coming to an uncontrolled final rest off the north shoulder of the roadway, facing an easterly direction.

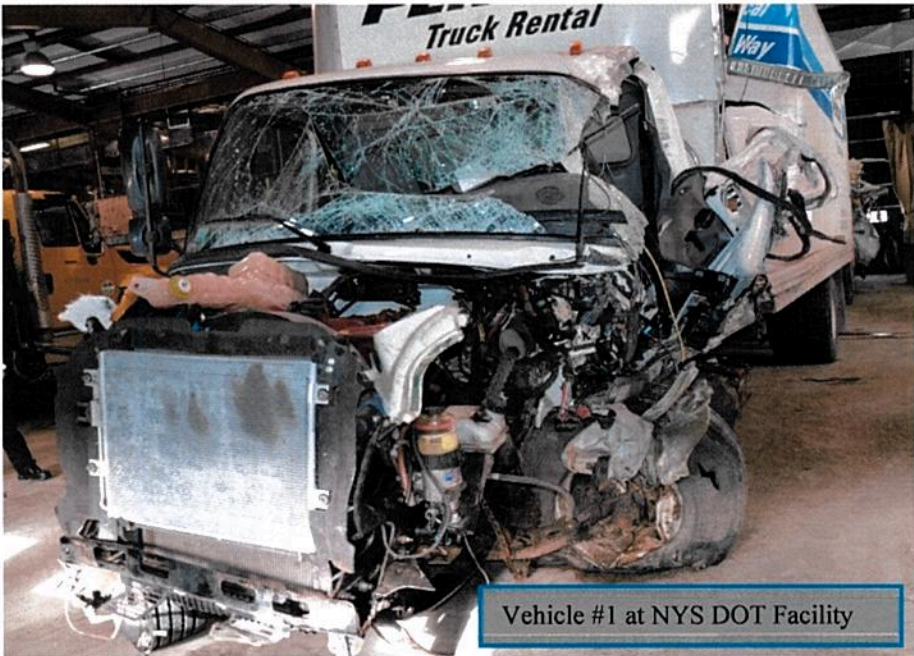
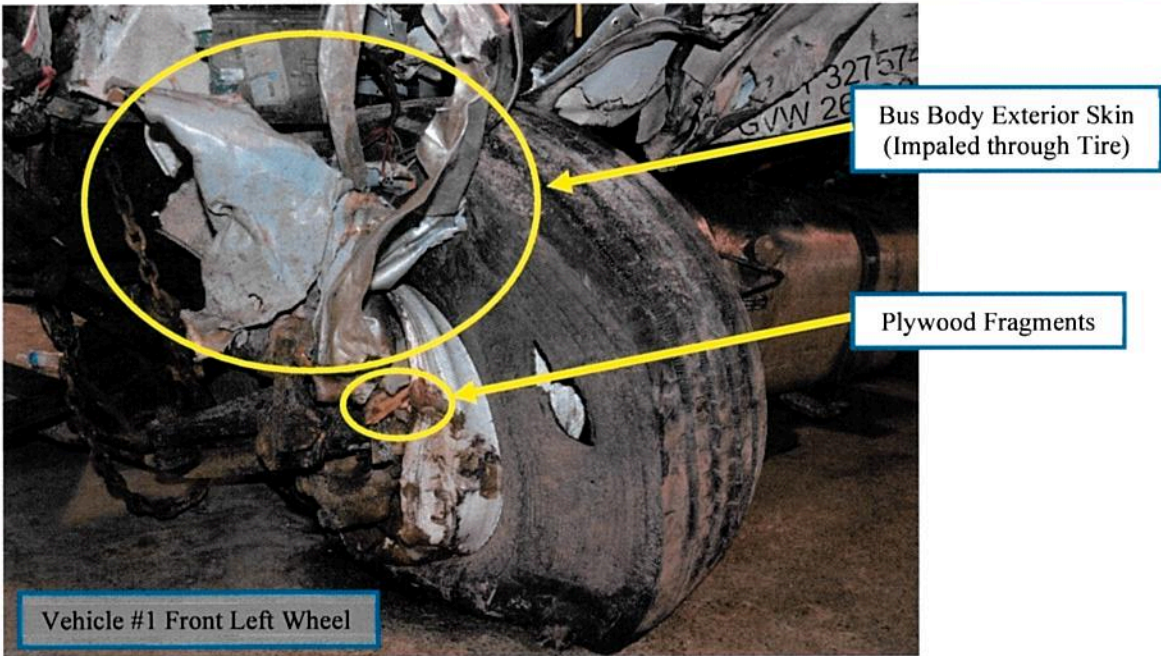
Vehicle #1 sustained significant contact and induced damage as a result of striking Vehicle #2. The contact damage observed on Vehicle #1 was focused about the front and driver's side of the vehicle. The front left wheel and its accompanying suspension and steering structures were displaced toward the rear of the vehicle and/or broken, with the wheel being positioned in such a manner that the inward facing sidewall of the tire was facing a 'forward' direction. A piece of debris from the bus body of Vehicle #2 was impaled through the tire, entering from the now forward-facing sidewall and penetrating out through the now rearward facing sidewall. Further, fragments of plywood were located on the now forward facing side of the left front wheel rim, entrapped within a crushed portion of the rim. These

plywood fragments were found to have originated from the subflooring installed on the bus body portion of Vehicle #2. Inspection of the front axle at the right side of the vehicle revealed a broken U-bolt where the axle and suspension leaf springs are joined, and the axle, front right wheel and accompanying structures were visibly shifted forward of their normal position. Further contact damage was observed at the front left corner of the cargo box and rearward along the left exterior portion of the cargo box. At the scene, a portion of the exterior sheet metal and fiberglass skin from the bus body of Vehicle #2 was observed to be present in the area of the front left corner of the cargo box of Vehicle #1, approximately adjacent to the top of the passenger cabin. The driver's door and A pillar of Vehicle #1 were partially sheared from the cabin structure and displaced rearward.

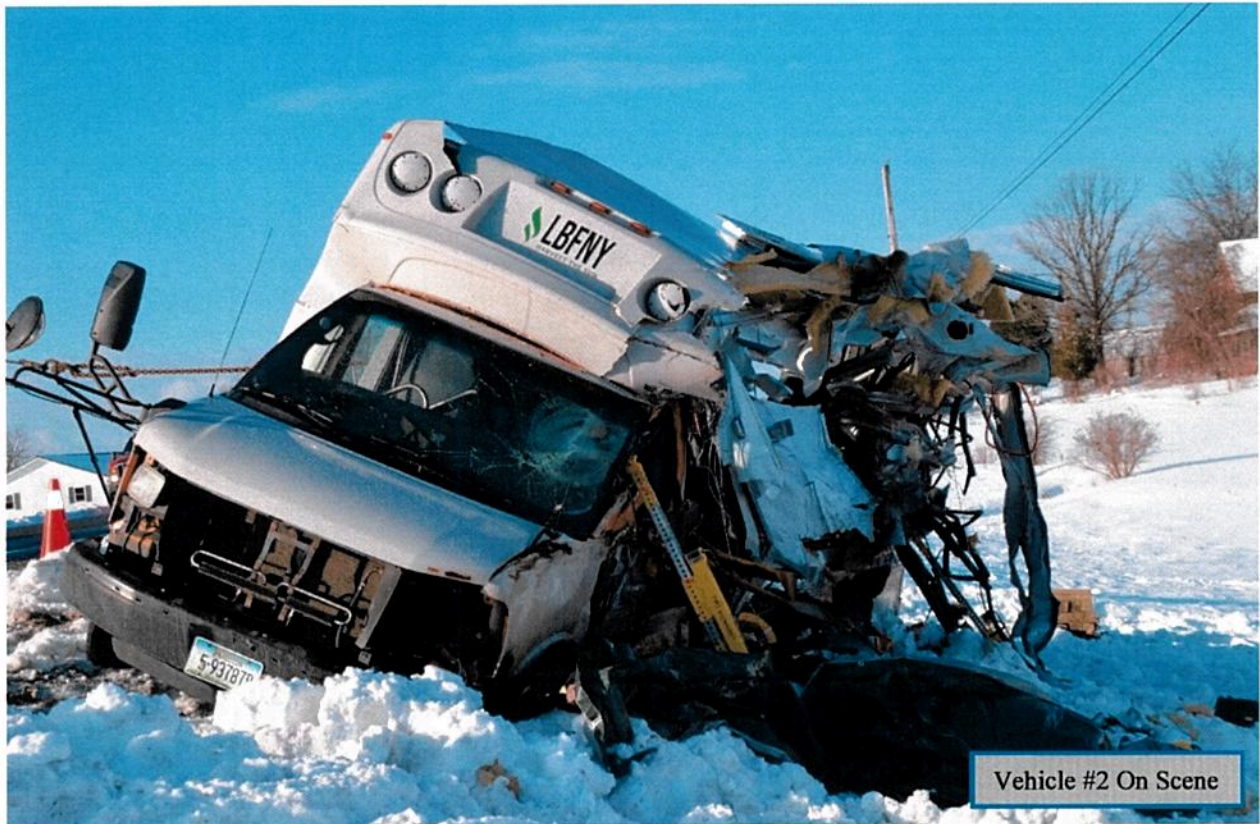
Vehicle #2 sustained ruinous damage, both contact and induced, as a result of being struck by Vehicle #1. The contact damage was focused on the left side of the bus’s passenger cabin structure. As the two vehicles collided and interacted with each other, a significant portion of the bus body’s left side structure was sheared and displaced rearward, resulting in the integrity of the occupant cabin of the bus being compromised. With the occupant cabin compromised, three of the bus passengers were ejected from the vehicle, all of whom suffered fatal injuries. Three

more of the bus passengers remained within the vehicle structure and suffered fatal injuries, two of which remained in their seats and the third being located in the center isle of the bus compartment. Examination of the bus seatbelts found that all seating positions had available and fully functioning seatbelts, with the exception of two ‘aftermarket’ seats that had been installed by the owner of Vehicle #2 in the right rear section of the bus and were not part of the original manufactures build. However, none of the passenger seat belts within Vehicle #2 were utilized and were observed hanging below the seats. The driver’s seatbelt was examined and exhibited evidence that the belt was in use at the time of the collision. This is supported by information discussed later in this report.

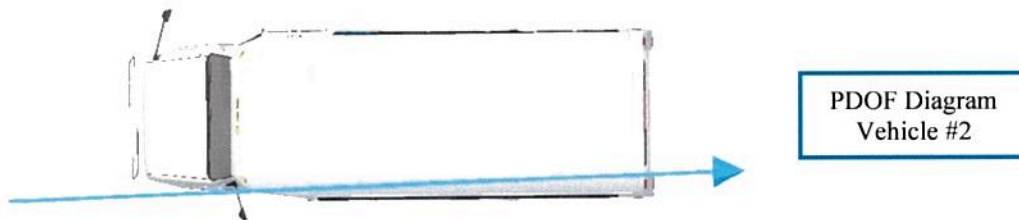
Data contained within the CDR report indicated that Vehicle #2 was traveling approximately 53-54 miles per hour for the two and a half seconds leading to the collisions with Vehicle #1, with the vehicle's operator applying a moderate amount of accelerator input to maintain the vehicle's speed. Of further note, within the last second leading to the crash, the accelerator pedal is released, going from 27 % to 0% input. No application of the service brake is detected within the pre-crash data. This data can be illustrative of the operator of Vehicle #2 perceiving the approach of Vehicle #1 and beginning to react to the impending collision. The report also contained data confirming the driver's seat belt status as "BUCKLED", corroborating evidence observed during the vehicle exam as stated earlier in this report. Utilizing recorded data for changes in velocity experienced by Vehicle #2 during the collision, a diagram depicting the Principal Direction of Force (PDOF) was generated and is depicted below.

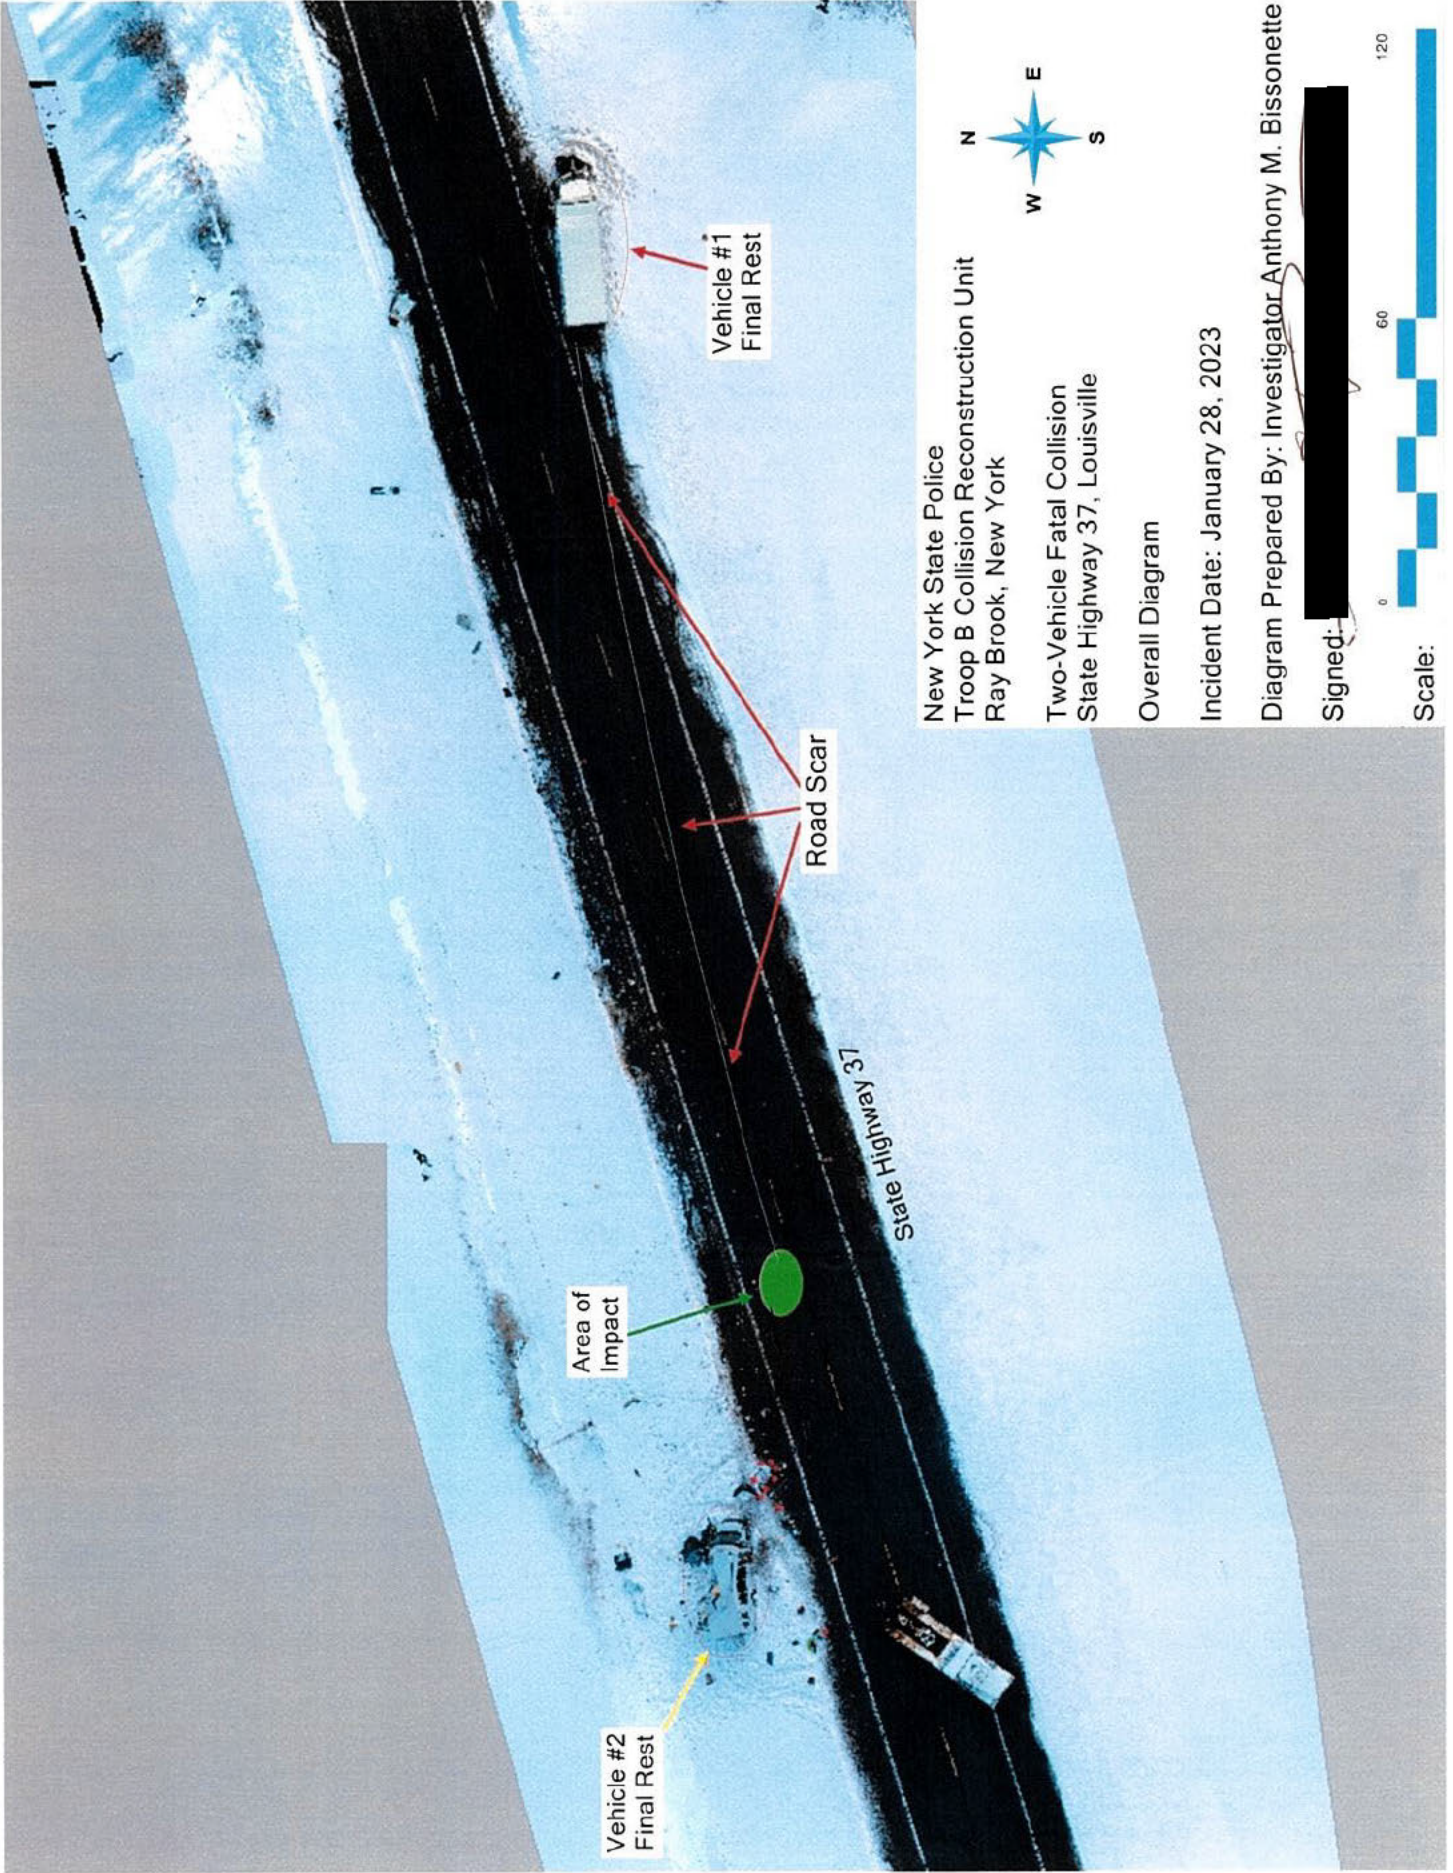
Overall Diagram

Vehicle #2
Final Rest

Area of
Impact

Road Scar

Vehicle #1
Final Rest
