# National Transportation Safety Board

HWY23FH010

## **TECHNICAL RECONSTRUCTION**

Group Chair's FACTUAL REPORT

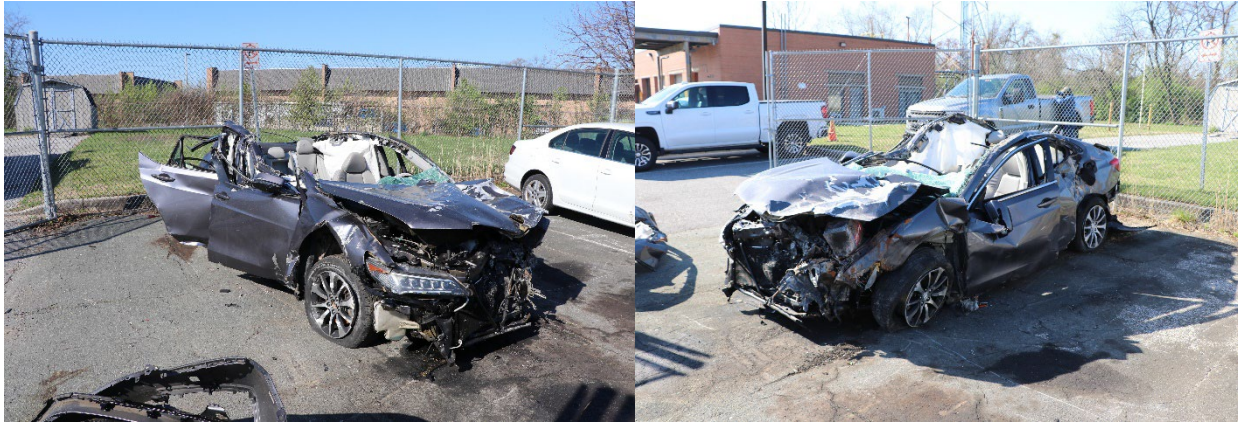
**Figure 2. Images showing the damage to the Acura TLX. The image on the right shows the damage to the front left and left side. The image on the left shows the damage to the front right and right side.**

The Acura sustained contact at areas around the entire vehicle. Beginning at the front of the vehicle, the front bumper cover and grille were torn off the vehicle. The radiator had been pushed rearward into the engine along with the lower radiator support bar. The upper radiator support bar had been bent down and inward. The hood was detached from the latch and buckled in a couple areas. The front of the left fender was bent downward raising the rear of the fender upwards. The left front tire separated from the bead and lost all its air. The driver's door was buckled inward around the driver's side view mirror and was slightly open. The area around the rear of the driver side passenger door, the right rear quarter panel, and the gas cap had been buckled inward causing the rear of the door to push outward. Lateral scrapes and scratches were observed throughout the damage. The left rear tire had also separated from the bead and had several cuts along the sidewall.

The right rear of the Acura had been displaced downward along with the right rear quarter-panel. The rear bumper cover had been torn off the vehicle and the right rear taillight assembly was broken and missing. Longitudinal and lateral scrapes were observed along the trunk lid and upper area of the quarter-panel. The "C" Pillar was pushed inward, and the right rear passenger door was partially open with the outer panel separated from the door. The right front passenger door was also partially open, and the "A" pillar had separated about midway up from the front of the vehicle. The

"A" pillar and door window frame were pushed downward and displaced rearward towards the "B" pillar. The right fender had buckled outward and was offset from where it met the front passenger door.

The roof had been torn from the vehicle and all the glass was shattered. The driver's front, side airbag, knee bolster, and side curtain airbags were deployed along with the passenger side curtain airbags. The seatbelt was observed in a latched condition, with the seatbelt tongue connected to the buckle. The seatbelt retractor was locked leaving the seatbelt extended. The webbing had been cut and was pulled out of the ring at the seatbelt tongue and was lying across the driver's seat and center console.

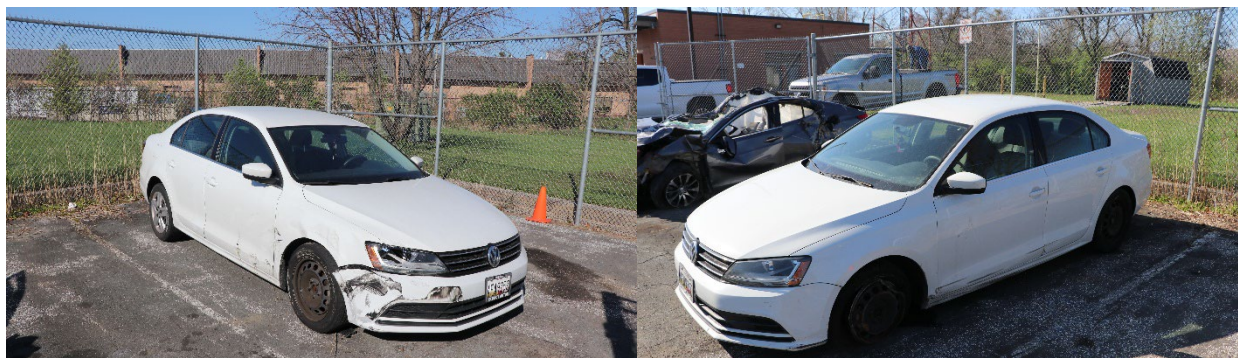
**Figure 3. Images of the Volkswagen Jetta. Image on the left shows the damage to the front right and the image on the right shows the damage to the left side.**

The Volkswagen sustained contact damage along the driver's and passenger's side. Black colored tire transfer marks were observed on the lower area of the front passenger side door. The marks began approximately in the middle of the door. There were three circumferential marks, the marks were dark at the bottom and became lighter as they traveled up the door. The marks continued onto the right fender and the two forward marks left black colored tire transfer marks. The right fender was slightly buckled, and the right front tire sidewall was scuffed encompassing the circumference of the tire.

The right side of the front bumper cover was pulled away from the vehicle and there were black colored tire transfer marks that continued around to the front of the bumper for the length of the headlight. The left front headlight lens was broken.

There was a black colored mark along the bottom left side of the front bumper cover. The marks continued aft of the left front tire along the bottom of the driver's door and onto the left rear passenger door. The left front rim was severely damaged and bent in two locations. The tire had separated from the bead and scuff marks were observed around the circumference of the tire sidewall. The left rear tire also had scuff marks observed on the sidewall.

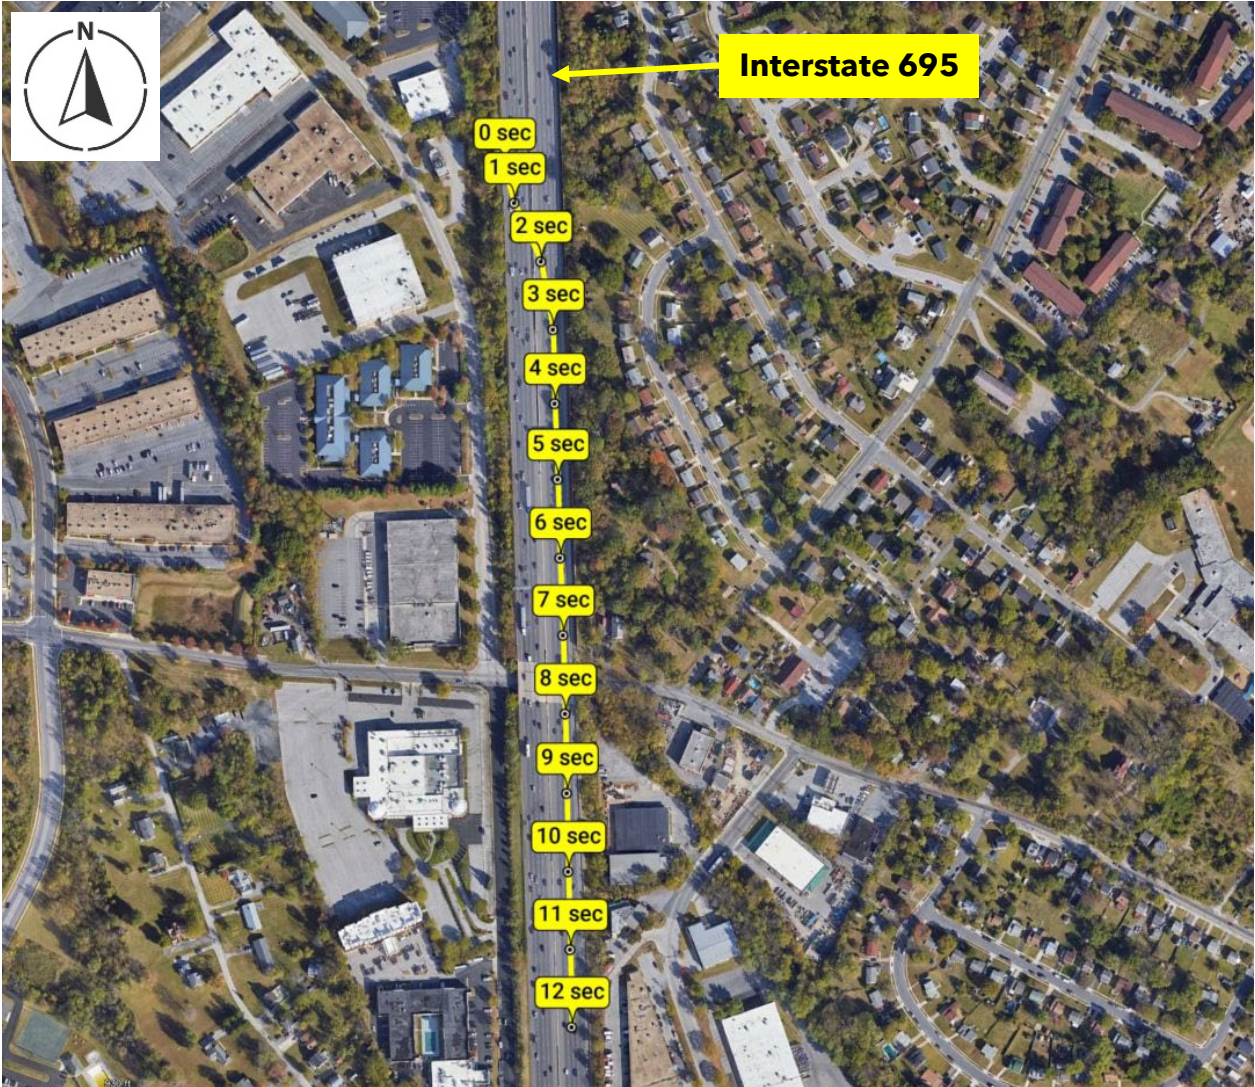
Figure 7 is an image obtained from Google Earth of the area of Interstate 695 leading up to and including the area of the crash. The image is overlaid with the data from Table 3.

**Figure 7. Image of northbound I-695 leading up to an including the area of the collision. Overlaid on the image is the positioning data associated with the Acura. (Source: Google Earth edited by NTSB)**

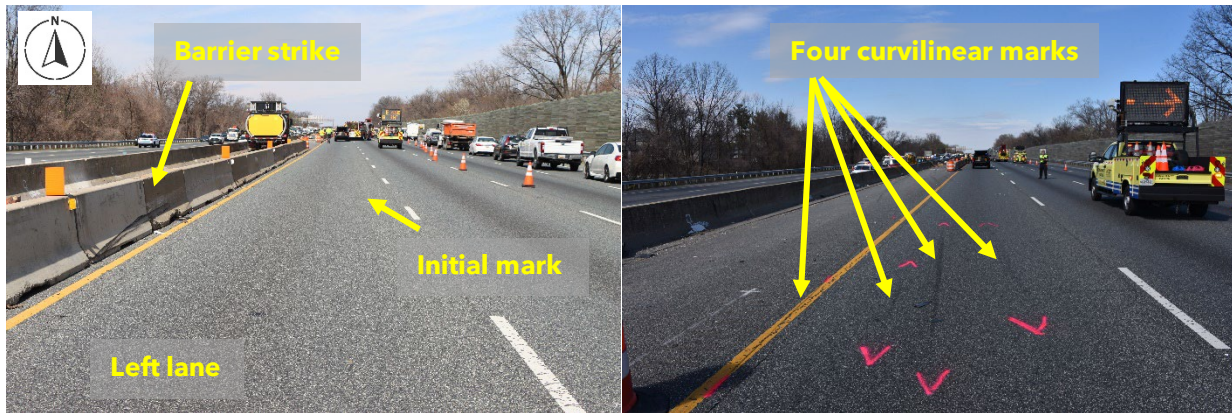
Tire friction marks, road surface scrapes, and marking paint applied by MSP investigators were observed in the photographs provided. Scrape and scratch marks were also observed along the concrete jersey wall that bordered the left lane as well as the median barrier. The roadway evidence appeared to originate within the left lane. As previously described, there was a concrete barrier that bordered the left lane along the yellow edge line. The concrete barrier was in place for an active construction zone along the left shoulder. There was an opening within the barrier that measured about 149-feet. There were two friction marks which began approximately 158-feet south of the beginning of the opening. The first tire friction mark that was observed within the left lane, associated with the Acura, measured about 8.5-feet in length and was offset into the left lane from the concrete barrier about 10-feet. The second tire friction mark was identified approximately 55-feet north of the first tire mark, in the left lane, measured approximately 38-feet in length and was offset from the concrete barrier about 8-feet. Adjacent to the first friction mark, in the region of the Volkswagen striking the concrete barrier, was a tire friction mark coupled with scrape and scratch marks. The tire friction mark evidence continued northwest. Approximately 58-feet north of the second friction mark began a series of four curvilinear friction marks beginning in the left lane, approximately 5.0-feet from the yellow edge line, and traveling onto the left shoulder, through the opening in the barrier. The four curvilinear friction marks arced to the left, extending for about 122-feet, terminating on the left shoulder. Adjacent the end of the curvilinear friction marks along the concrete median barrier about 126-feet north of the beginning of the opening, were scrape and scratch marks that extended north for approximately 37-feet.

The friction mark evidence on the roadway surface and median barrier was consistent with the post impact travel of the Acura while the evidence along the concrete barrier wall was consistent with the Volkswagen post impact. Figure 10 is two photographic images taken by MSP investigators depicting the roadway evidence that extended northwestward from the apparent area of impact.

**Figure 10. Images taken by MSP investigators depicting the roadway evidence. Image on the left shows the initial tire friction mark. The image on the right shows the four curvilinear friction marks. (Source: MSP modified by NTSB)**

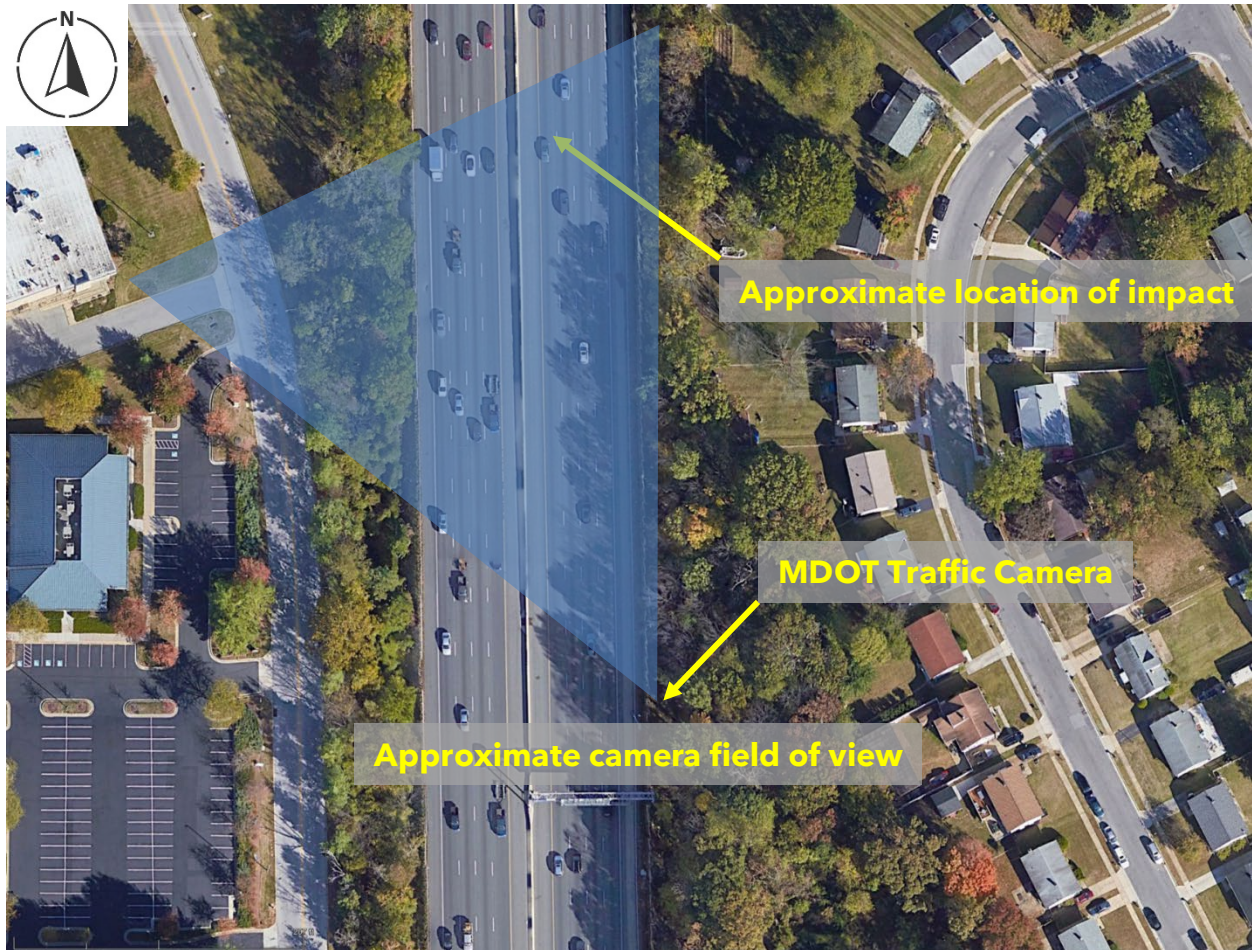
The camera was pole mounted and positioned adjacent the right edge of the paved road and was approximately 434 feet south of the area of the crash. Figure 11 is an overhead image from Google Earth modified by NTSB. The image depicts the location of the MDOT camera, the crash, and the approximate field of view from the camera. The field of view was approximated from the video.

**Figure 11. Overhead image of I-695. The location of the MDOT traffic camera, the approximate location of the crash is identified. Also identified is the approximate field of view of the camera. (Source: Google Earth modified by NTSB)**

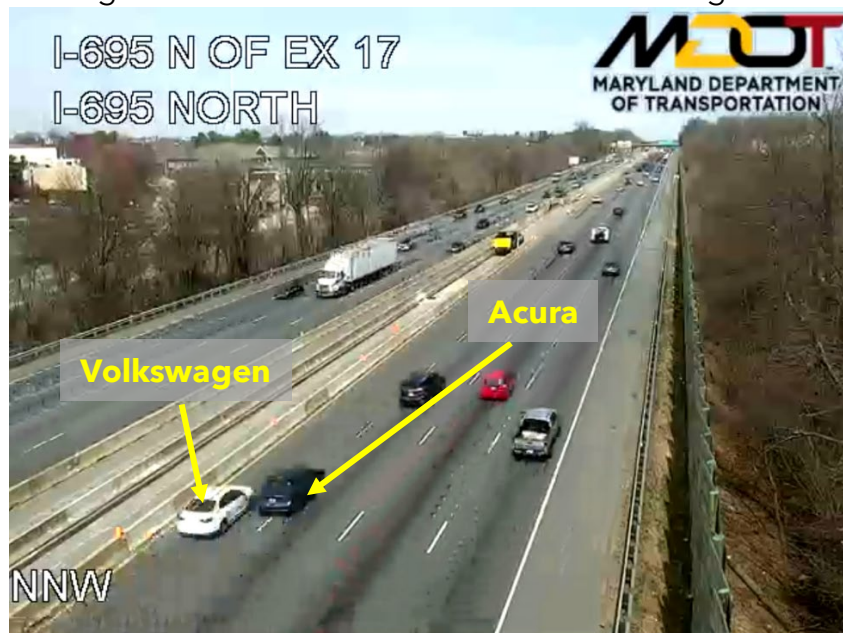
Figure 12 below is an image captured from the MDOT traffic camera. The image depicts the Volkswagen in lane one and the Acura encroaching on the Volkswagen.

**Figure 12. Image capture from MDOT camera depicting the Acura and Volkswagen just prior to contact. (modified by NTSB)**

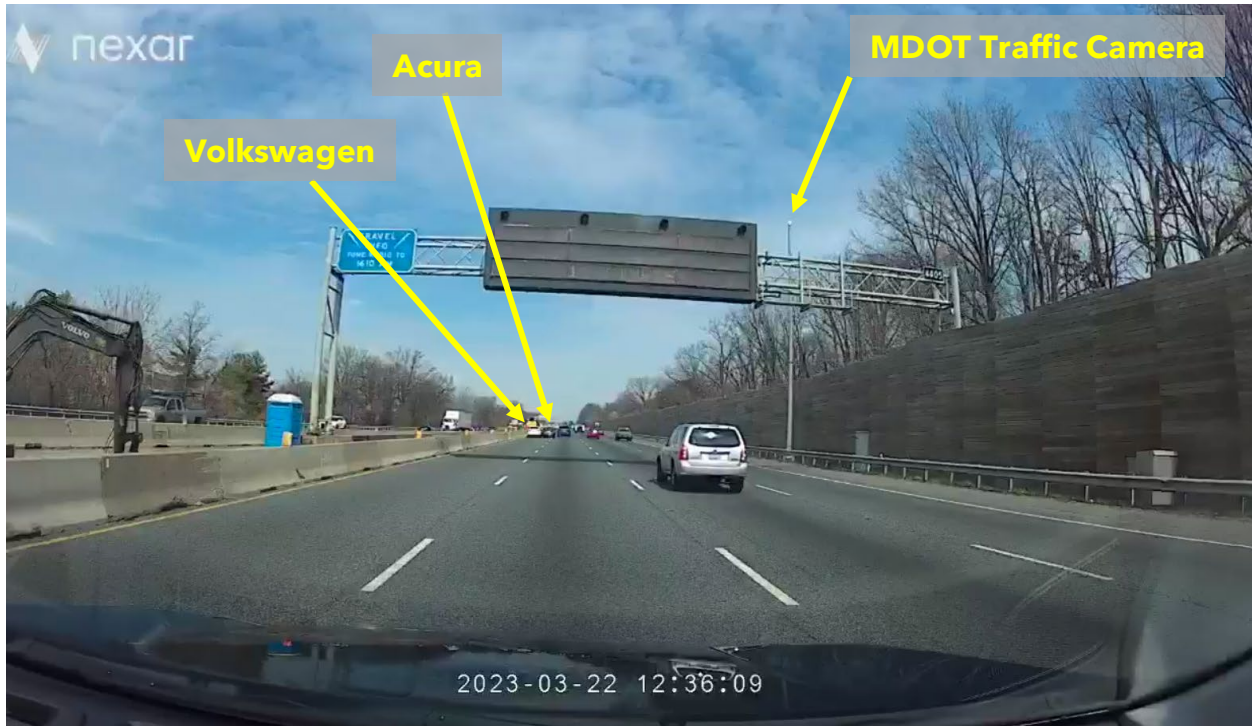
Figure 13 below is an image captured from the dash camera video. In lane 1 (left lane) the Volkswagen and the Acura can be seen. The Acura had transitioned from lane 4 (right lane) to lane 1. Impact between the two vehicles can be seen. Also visible is the MDOT traffic camera discussed above in Section 6.1.

**Figure 13. Image captured from the dash camera depicting the impact between the Acura and the Volkswagen. (modified by NTSB)**
