**Forbes Avenue Over Fern Hollow Bridge Collapse Investigation:
Assessment of Bridge Inspection and Load Rating**

National Transportation Safety Board

NTSB Accident ID: HWY22MH003

September 14, 2023

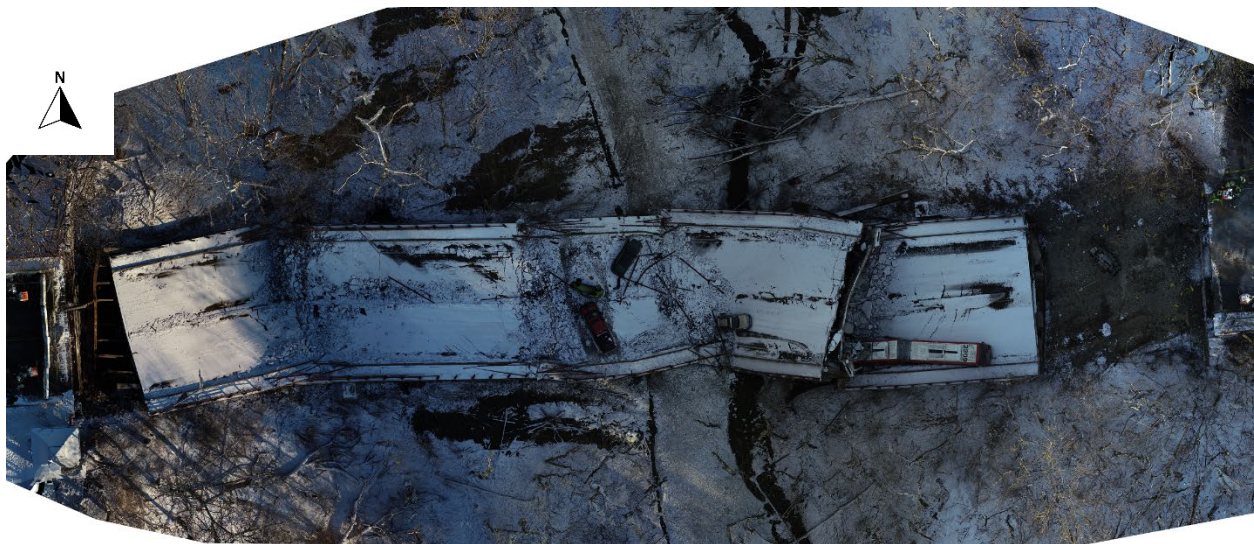
Figure 6. Drone image of collapse site.

Investigators on-site shortly after the collapse did not find any primary fractures in the floor system or girders of the K-frames. Evidence indicated the frame legs as the initiators of the collapse sequence, in particular the Bent 1, right (i.e. southwest) leg. Figures 7 through 10 are photos of the bottom of the frame legs taken after other bridge components had been removed. As seen in those figures, the bottom of the two left legs (Figures 7 and 8) were mostly intact, but the two right legs (Figures 9 and 10) were more distressed. The Bent 1 right leg was kinked in the I-shape's strong axis at the shoe with the far-face flange completely missing. The Bent 2 right leg shoe was intact, but the first web panel over the shoe had fractured along one of the web-to-flange welds and one flange had buckled into the web. It was also observed that the loss of section due to corrosion in the web plates of all four legs was severe to the point where there were holes in numerous locations.

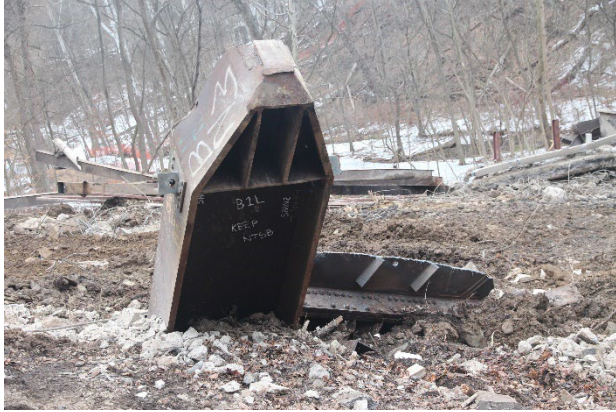
Figure 7. Bent 1 left leg.

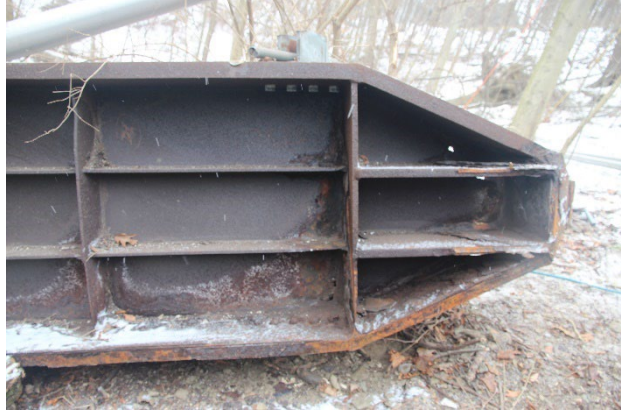
Figure 8. Bent 2 left leg.

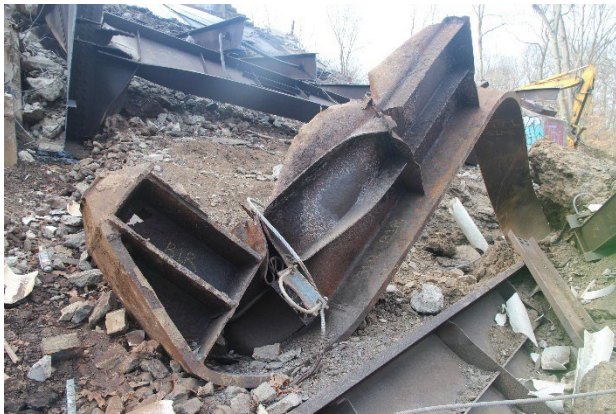
The distress observed in the Bent 1 frame legs, in addition to the commuter bus video, led FHWA investigators to consider the Bent 1, right, shoe as being principally involved in the collapse sequence. Thus, FHWA's evaluation of bridge inspection and load rating records for the Fern Hollow Bridge focused on the treatment of the frame legs in bridge inspection and load rating.

Figure 9. Bent 1 right leg.

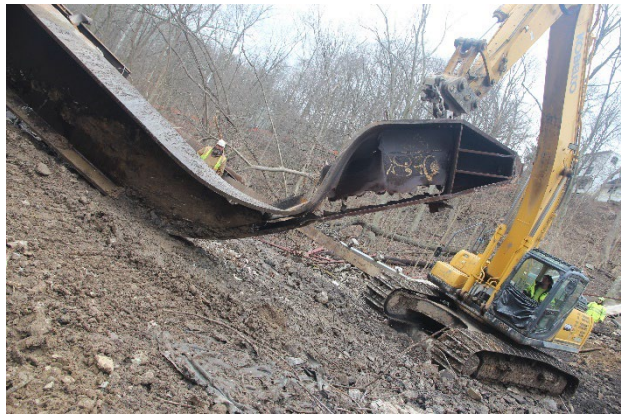
Figure 10. Bent 2 right leg.

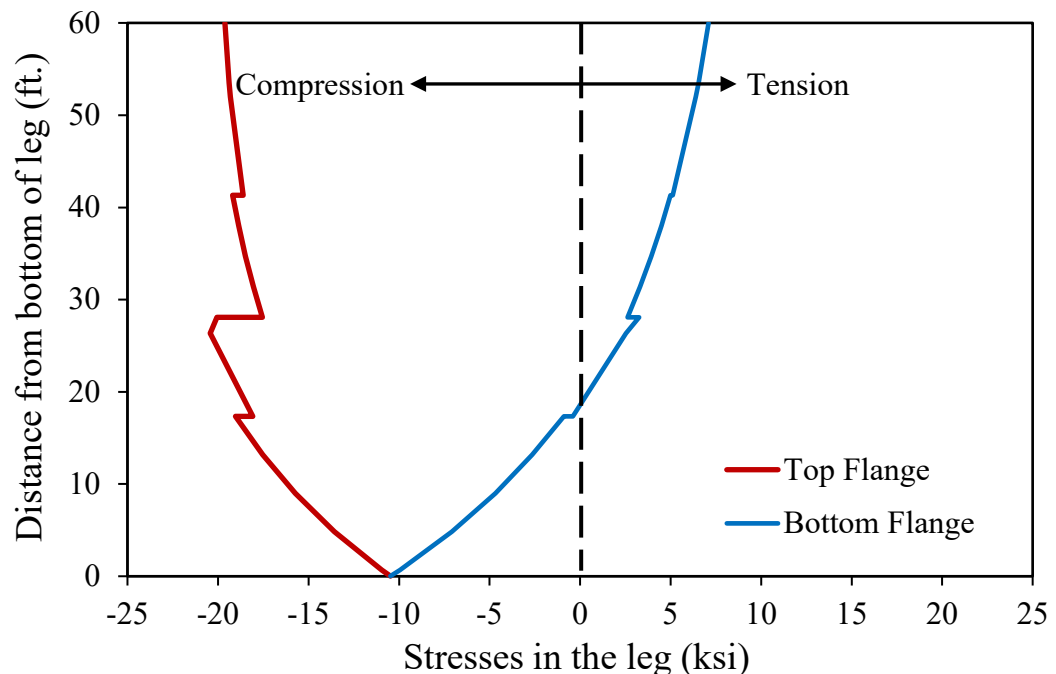
- A “Frame Thrust & Moment Stress Table” included on sheet 12 of the original construction plans indicates that this was the case near the top of the legs. That table reports design axial stresses in the legs of 7.3 kips per square inch (ksi) and bending stresses of ± 14.4 ksi. Structural analysis performed by FHWA after the collapse (Figure 11) confirmed these values and found that the top two-thirds of the frame leg would experience tension under design loads.

Figure 11. Dead Load and Live Load stress in the frame legs.

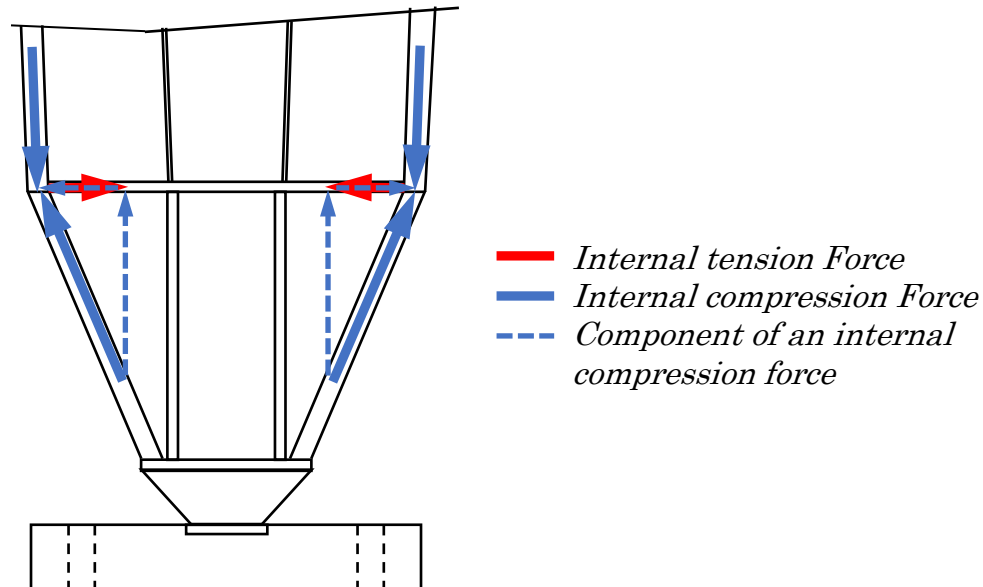
- A free body diagram of the change in direction of the leg flanges at the top of the shoe (Figure 12) shows that a tension force must be resisted at this location to

counteract the compression forces in the flange through its change of direction. At 11¾” wide by ¾” thick, the shoe tension tie (labeled a transverse stiffener on the design drawings) in this location was larger than the other stiffeners in this region of the leg, indicating a design function beyond just stiffening the web plate. As this element is required to maintain equilibrium in the shoe region, the result is a tension element in a component typically considered to be in full compression.

Figure 12. Detailing of leg shoe region with free body diagram of flange node at top of shoe.

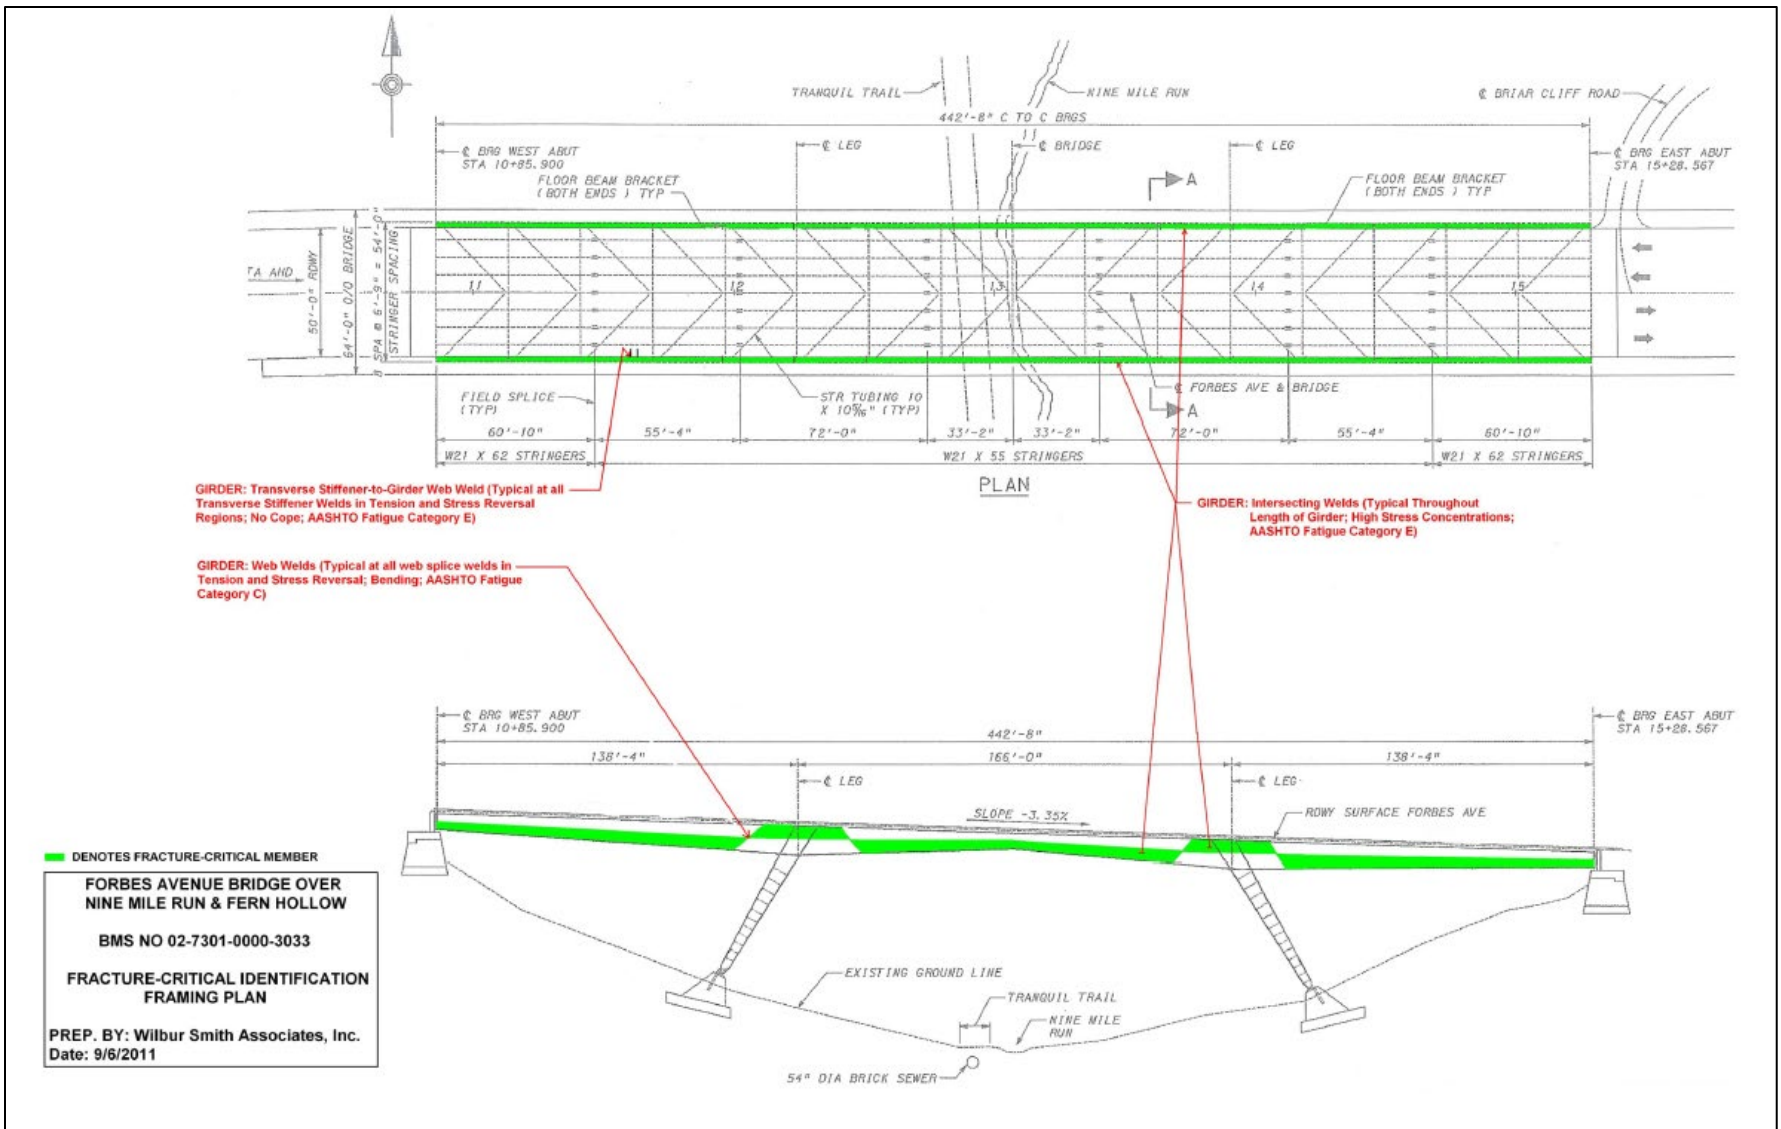
- However, it was unclear whether the frame legs were consistently considered FCMs and subjected to hands-on FCM inspections.
 - Starting in 2011, the inspection reports included a “Fracture-Critical Identification Framing Plan” (Figure 13), prepared by Wilbur Smith Associates, Inc., that identified the floorbeams and portions of the frame girders (those portions likely to be in tension due to flexure) as fracture critical members, but did not similarly identify the frame legs. This diagram was updated in 2015 without changes to the identification of the frame legs. The 2015 diagram was included in inspection reports through the 2021 bridge inspection.

the inspection. In this procedure, only the rigid frame girders and floorbeams are identified as the fracture critical members to be inspected (but not the frame legs), consistent with the identification framing plan developed in 2011. The 2016 inspection plan document is not referenced in any of the subsequent inspection reports, making it unclear whether inspectors referenced the plan when preparing for those inspections.

Figure 13. Fracture Critical Identification Framing Plan developed in 2011 and included in the 2011, 2013, and 2015 inspection reports

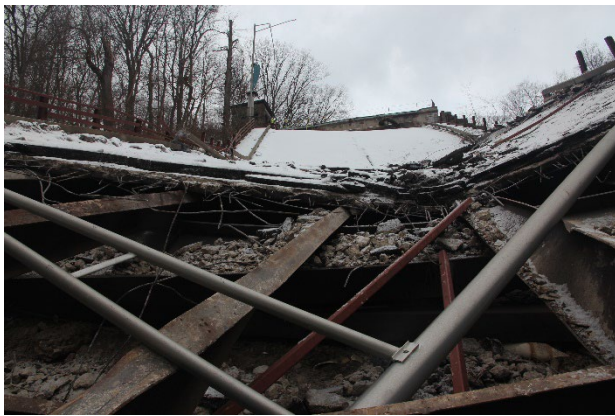
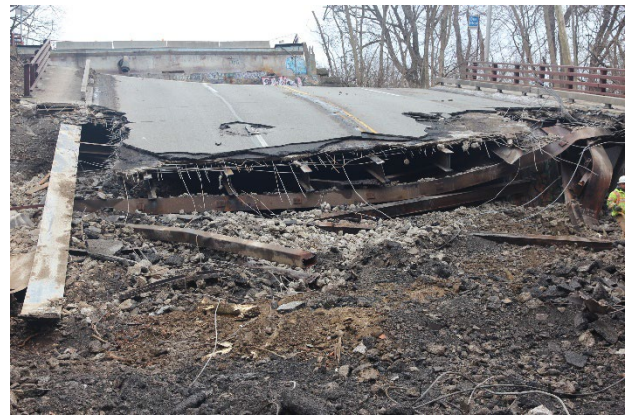
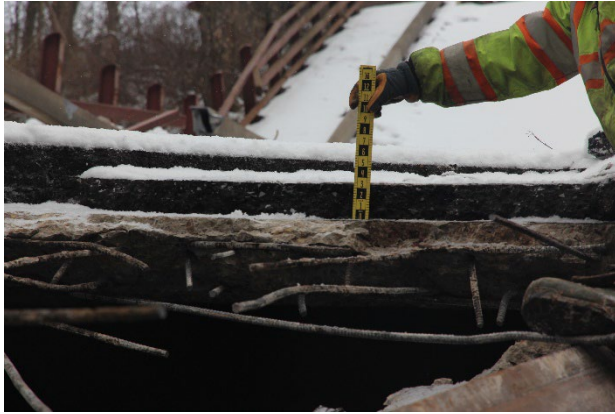
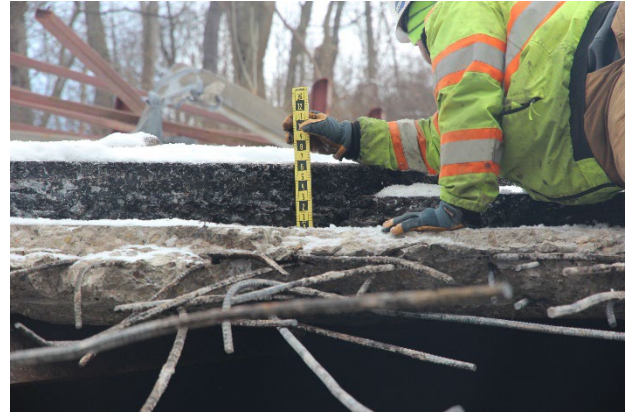
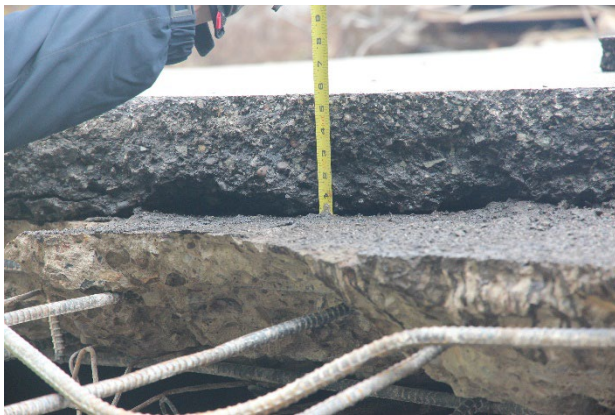
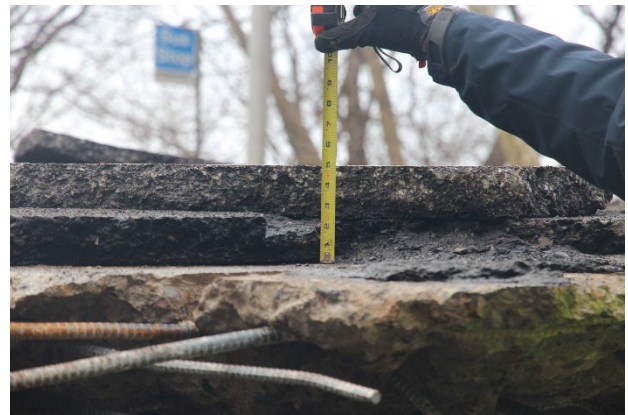
In the recovery of evidence at the collapse site, thickness measurements of the asphalt wearing surface on the bridge deck indicated that it was thicker than assumed in the bridge design and load rating analyses. As the wreckage assumed the shape of the ravine, the deck slab would slide relative to the superstructure as wreckage was removed by the demolition contractor exposing the thickness of the wearing surface at various locations, so it was deemed sufficient to take photos of the wearing surface thickness instead of attempting to collect deck cores to verify thickness. Measurements were collected in four locations, two on the west side, and two of the east side of the bridge as shown in Figures 18 through 23.

The bridge was originally designed assuming a 7½” thick concrete deck slab (with 1” thick haunches at the stringers) and a 3” thick bituminous wearing surface. Bridge inventory data recorded in the 2021 routine bridge inspection report²⁷ (PennDOT data items 6A33 and 6A34) indicated that the wearing surface was three inches thick, last recorded on September 6, 2013 (just prior to the most recent load rating analysis). It was unclear from the inspection report if this value was measured in the field or, if so, where it was taken. Field measurements of asphalt thickness can be made by measuring exposed curb or barrier heights (and comparing to design heights) or by coring. On the west side of the bridge, the bituminous wearing surface thickness measured after the collapse varied from 5½” to 6⅝” thick. On the east side of the bridge deck, the thickness ranged from 4¾” to 5½”.

Review of available records to explain the discrepancy between the asphalt wearing surface thickness assumed in the design and reported from bridge inspections (three inches thick), versus the actual asphalt wearing surface thickness measured after the bridge collapse was inconclusive. The City of Pittsburgh provided paving records demonstrating that resurfacing of Forbes Ave. occurred in July 1983, June 2000, July 2005, April and May 2009, and June and July 2017. In each case, the project specifications required that the remaining in-place wearing surface was to be milled away and replaced by three inches of new asphalt. However, because the records were based on pay items considering a range of thicknesses, FHWA could not determine how much was removed and paved back during each resurfacing operation. The photographs in Figures 18 through 23 indicate there were two distinct lifts (layers indicating placement at different times) of asphalt, but could not discern the age of the lifts. Similarly, it cannot be discerned if the original wearing surface at the time of construction was thicker than that shown on the construction plans, or if the thickness grew over time with successive resurfacing projects. Nevertheless, the discrepancy between the measured and reported thicknesses is significant in that additional dead load from the thicker wearing surface reduced the capacity available to carry vehicular live loads.

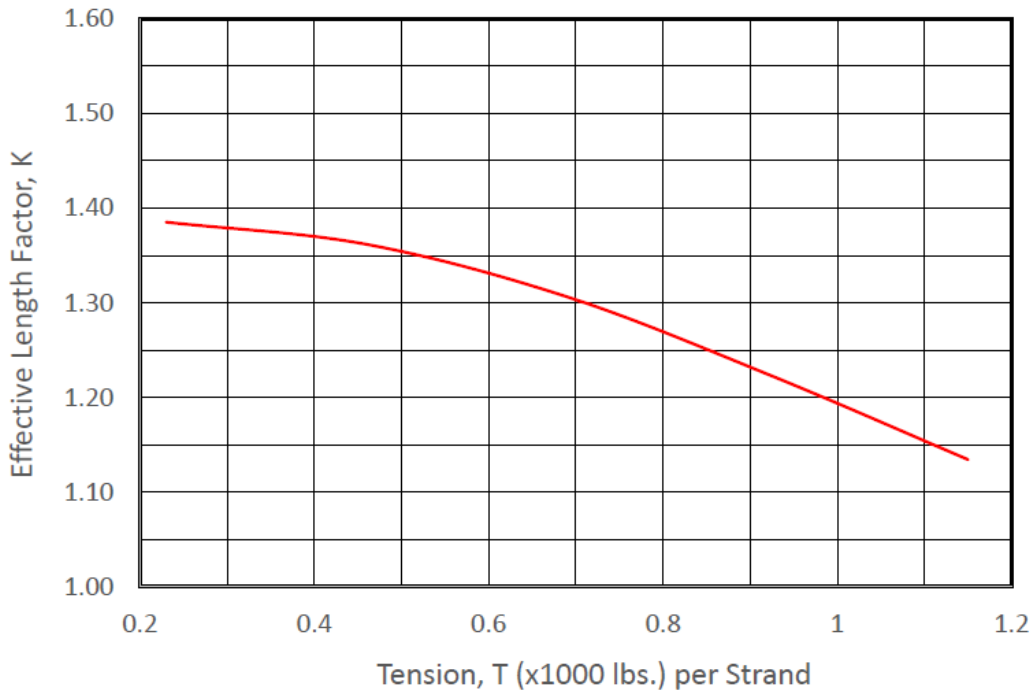
possible values of k as a function of the tension in the cable bracing installed in 2008 and the lateral stiffness of the frame girders and bridge deck (Figure 25). As there was no verification of the tension in the cable bracing other than that they were tight, FHWA assumed that the tension force would be nearer the lower bound of the values in Figure 25 and evaluated the legs assuming a value of k in the weak axis of the leg in the range of 1.2 to 1.4. These values of k reduce the axial compression capacity of the frame legs, based on global buckling, by 45 to 65 percent from that used in the 2014 load rating.

Figure 25: Effective length factor, k , of the frame legs versus bracing cable tension and girder/deck lateral stiffness

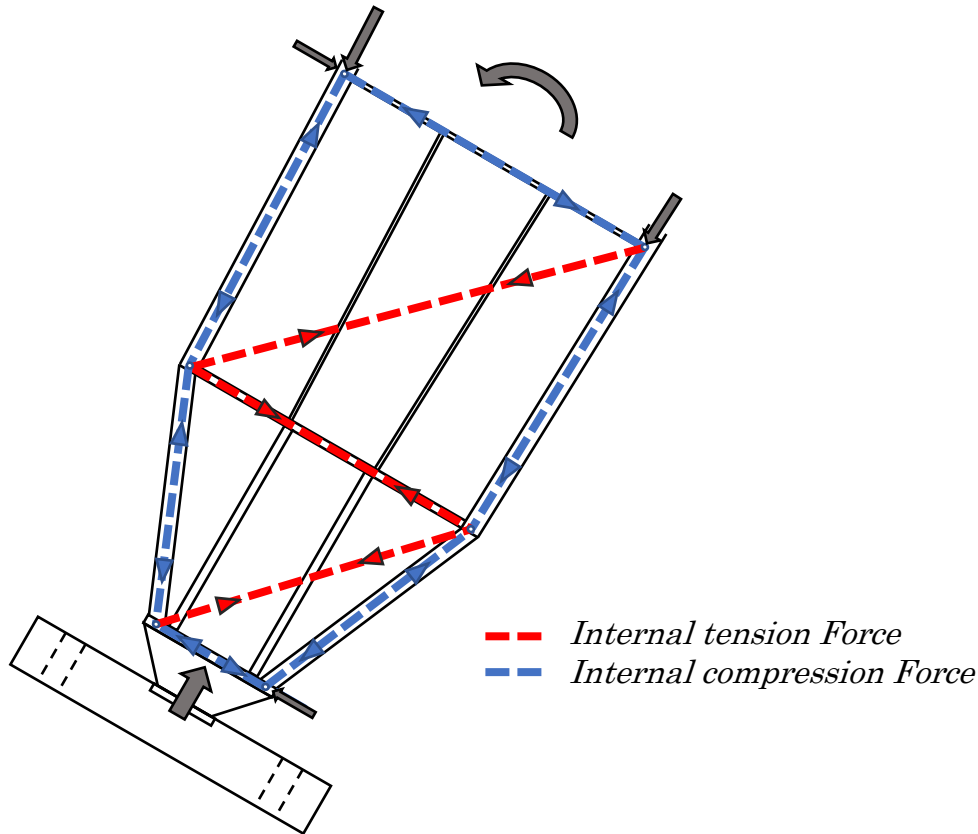
Figure 26: Strut and tie model of the frame leg base and shoe

FHWA’s evaluation using the strut-and-tie model determined that, as-designed, the 23- ½” by ¾” (17.63 in² total area) tension tie plate had sufficient capacity to safely carry legal loads (operating rating factor equal to 8.8), even with the asphalt wearing surface thickness measured after collapse (reducing the operating rating factor to 8.1). Lack of accurate section measurements prior to collapse precluded FHWA from calculating a load rating based on the conditions at collapse. However, FHWA could determine at which point a rating based on strut-and-tie evaluation of measured section loss in the tension tie would have produced a rating factor lower than those shown in Table 5 above:

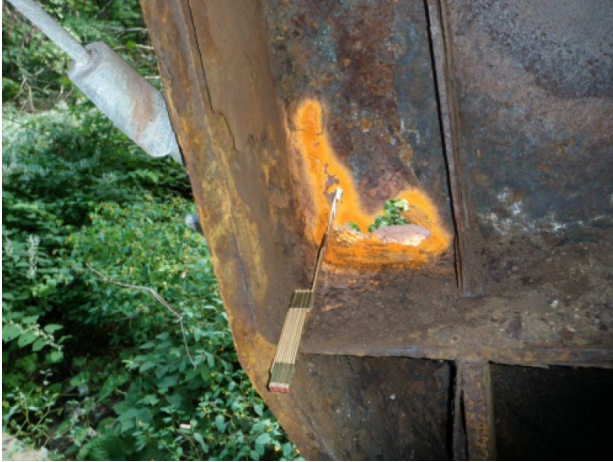
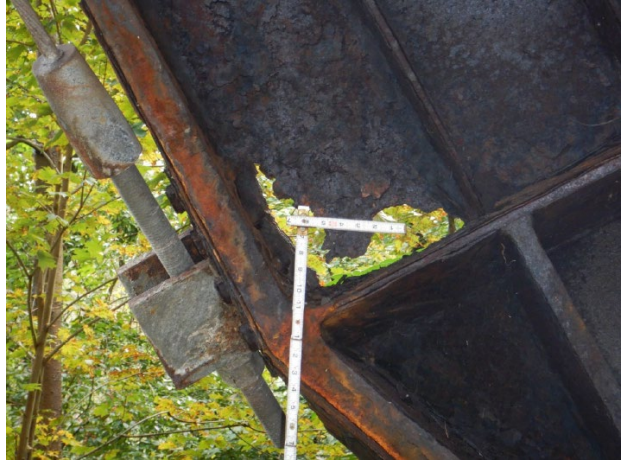
- Side-by-side photos from the 2013 and 2021 inspection reports are provided below. Figure A-1 and Figure A-2 show the through hole in the web above the shoe in B1R leg which has visibly increased in size in eight years. Figure A-3 and Figure A-4 show a view down the B1R leg showing more extensive section loss on the web stiffeners but also more visible light coming through the through-hole above the shoe. Figure A-5 and Figure A-6 show Bent 1 with emphasis of the lower cross-brace not present in the 2021 inspection.

Figure A-1. Bent 1 right leg, inside face, far side, from the September 2013 inspection.

Figure A-2. Bent 1 right leg, inside face, far side, from the September 2021 report.

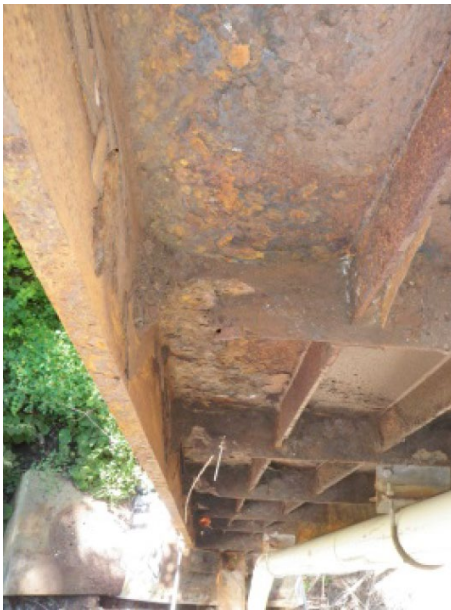
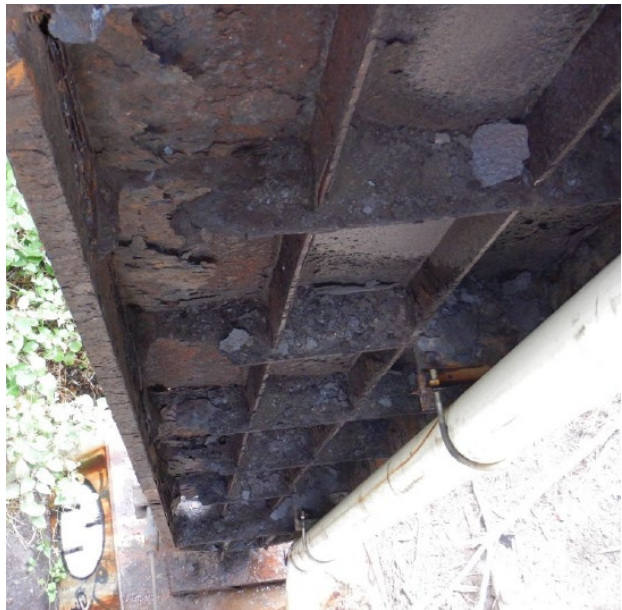
Figure A-3. Looking down Bent 1 right leg, inside face, from the September 2013 report.

Figure A-4. Looking down Bent 1 right leg, inside face, from the September 2021 report.

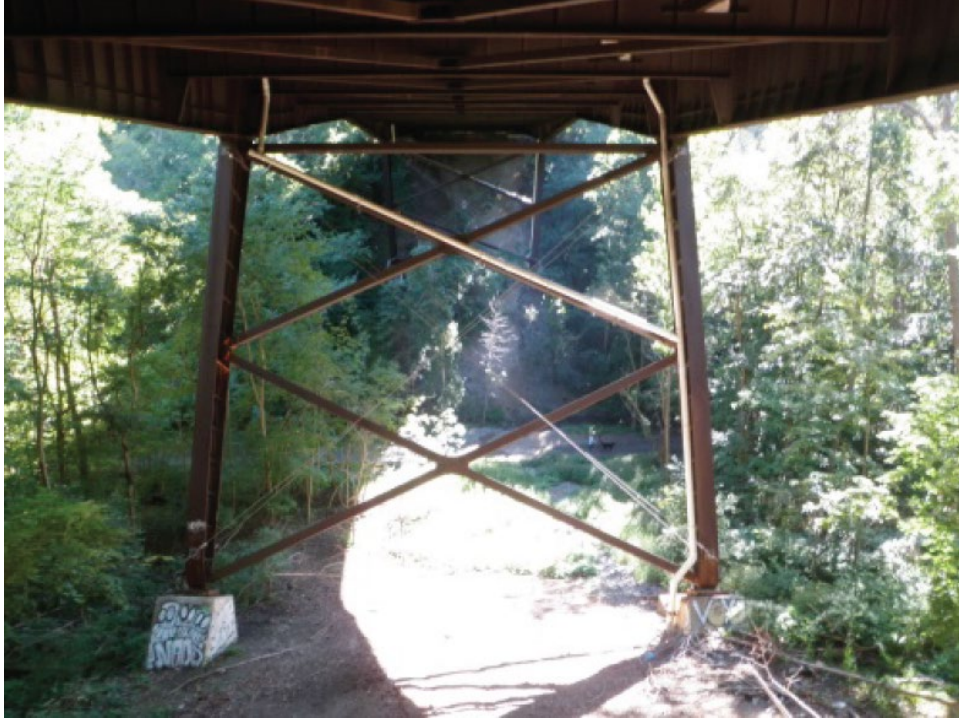
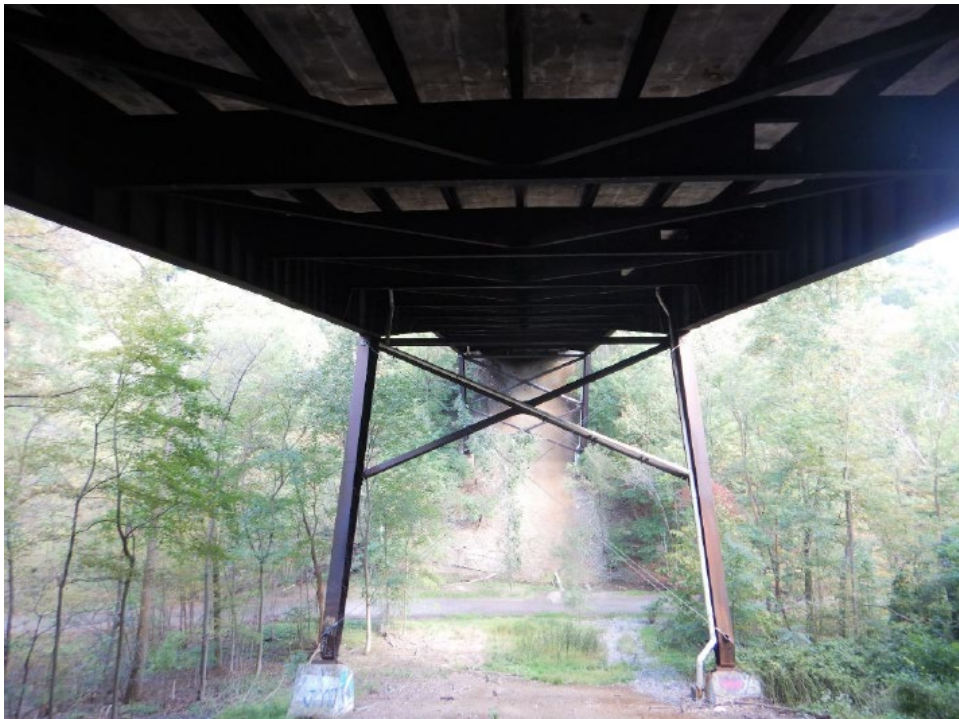
Figure A-5. Bent 1, from the September 2013 report.

Figure A-6. Bent 1, from the September 2021 report
