NATIONAL TRANSPORTATION SAFETY BOARD

MATERIALS LABORATORY FACTUAL REPORT

Report No. 18-004

Place : Millersville, Pennsylvania
Date : July 2, 2017
Vehicle : Natural gas mechanical tapping tee
NTSB No. : DCA17FP006
Investigator : Roger Evans (RPH)

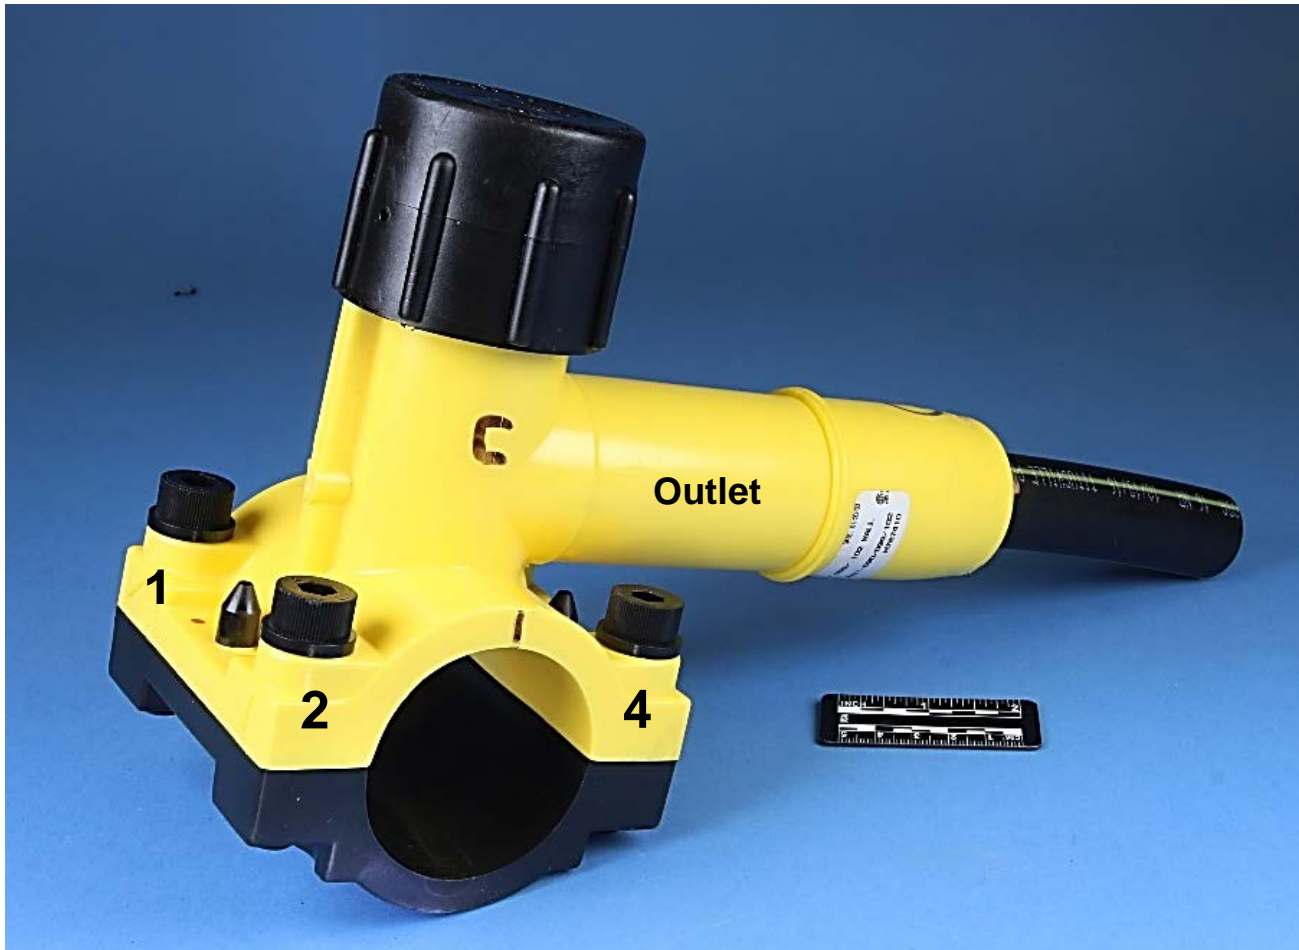
Figure 1. One of the three new Permalock® mechanical tapping tee assemblies that was involved in the laboratory test program, showing bolts arbitrarily designated “1”, “2”, and “4”. The other two tee assemblies were the same model as shown in this photograph. A black tube (service pipe) was installed at the outlet port to facilitate pressure testing of the tee assembly. This is a photograph of tee assembly “C”.

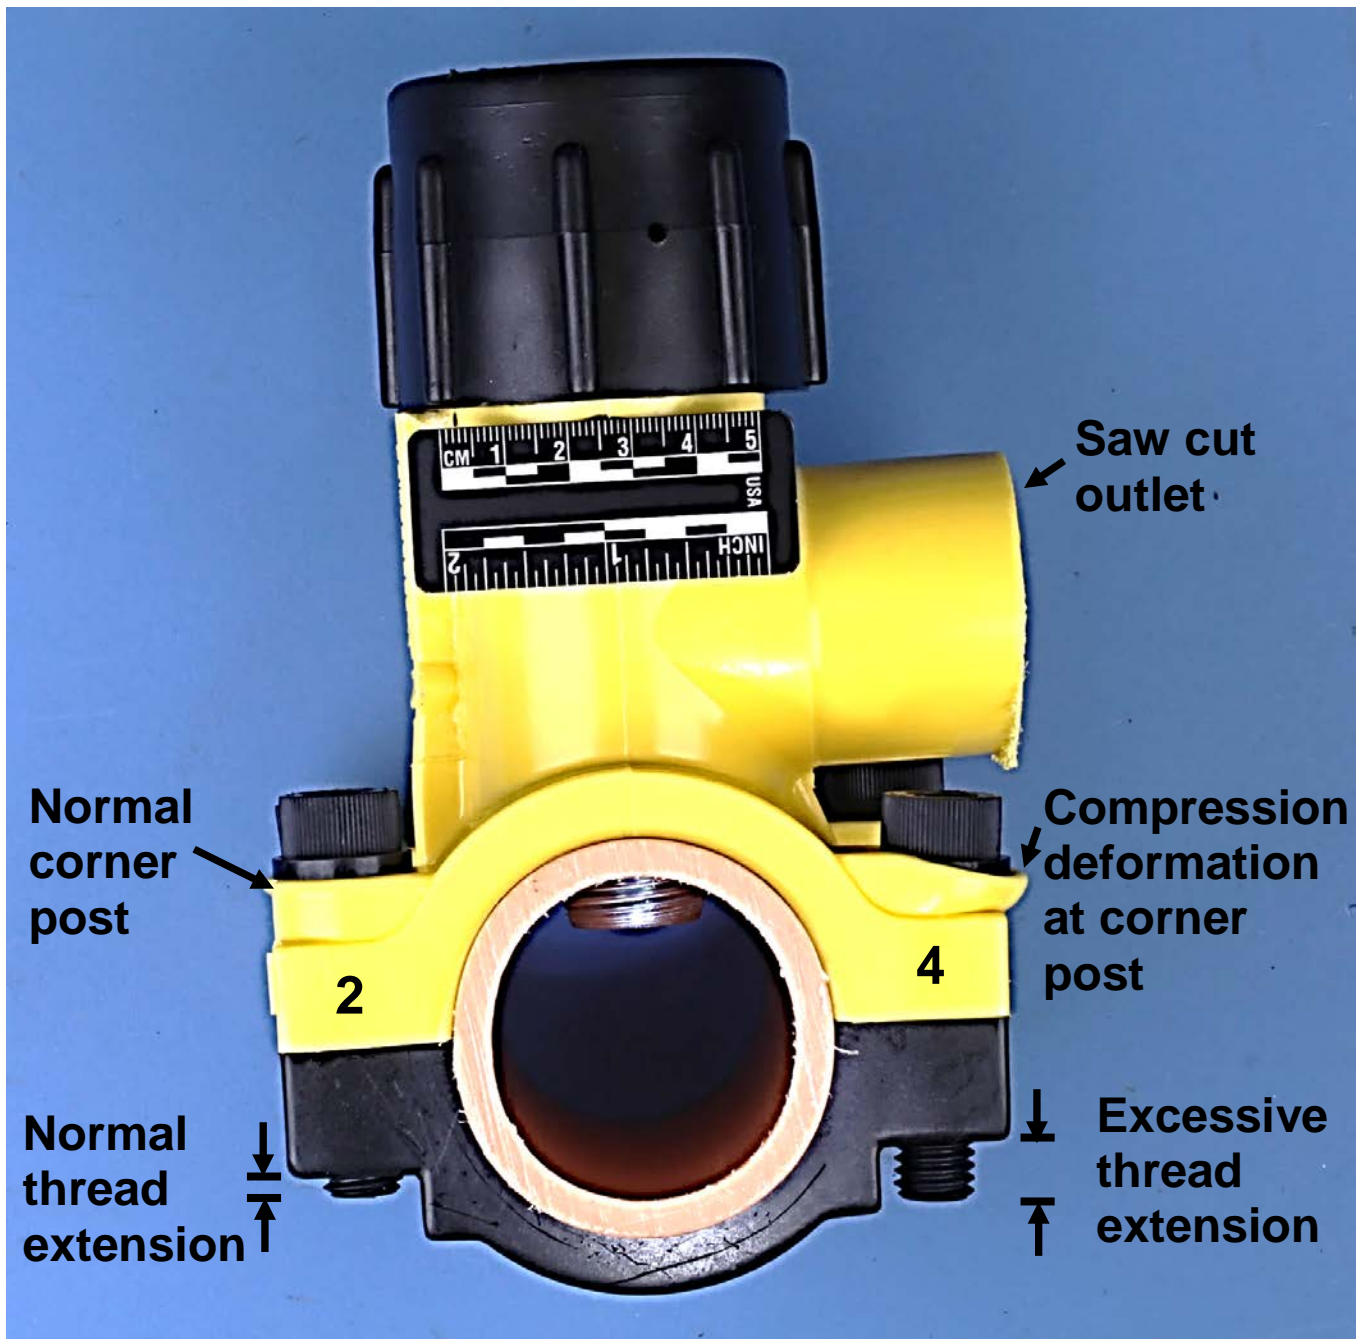
Examination of corner posts that were subjected to application of abusive torque revealed the bottom end of a Nylon bolt extended further from the tee base than Nylon bolts

that were installed per manufacturer's written installation instructions (typically between 0.14 inch and 0.17 inch). The bottom end of the bolt "4" from tee assembly "B" extended as much as 0.38 inch below the base portion of the tee.

Figure 2. Photograph of the tee assembly “B” that was not installed per manufacturer instructions showing the exposed inner wall of the main in the area where the cutter tool pierced the main. The corner post for Nylon bolt “4” exhibits compression damage that resulted from applying intentional and abusive torque application to the Nylon bolt during laboratory experimentation, whereas, the corner post for Nylon bolt “2” shows no evidence of deformation when installed per manufacturer instructions. In areas of the tee assembly where the corner post exhibits compression deformation damage (Nylon bolt “4”), the threaded portion of the attachment bolt extends further down and below the base compared to areas where the corner post retained its original shape (Nylon bolt “2”).

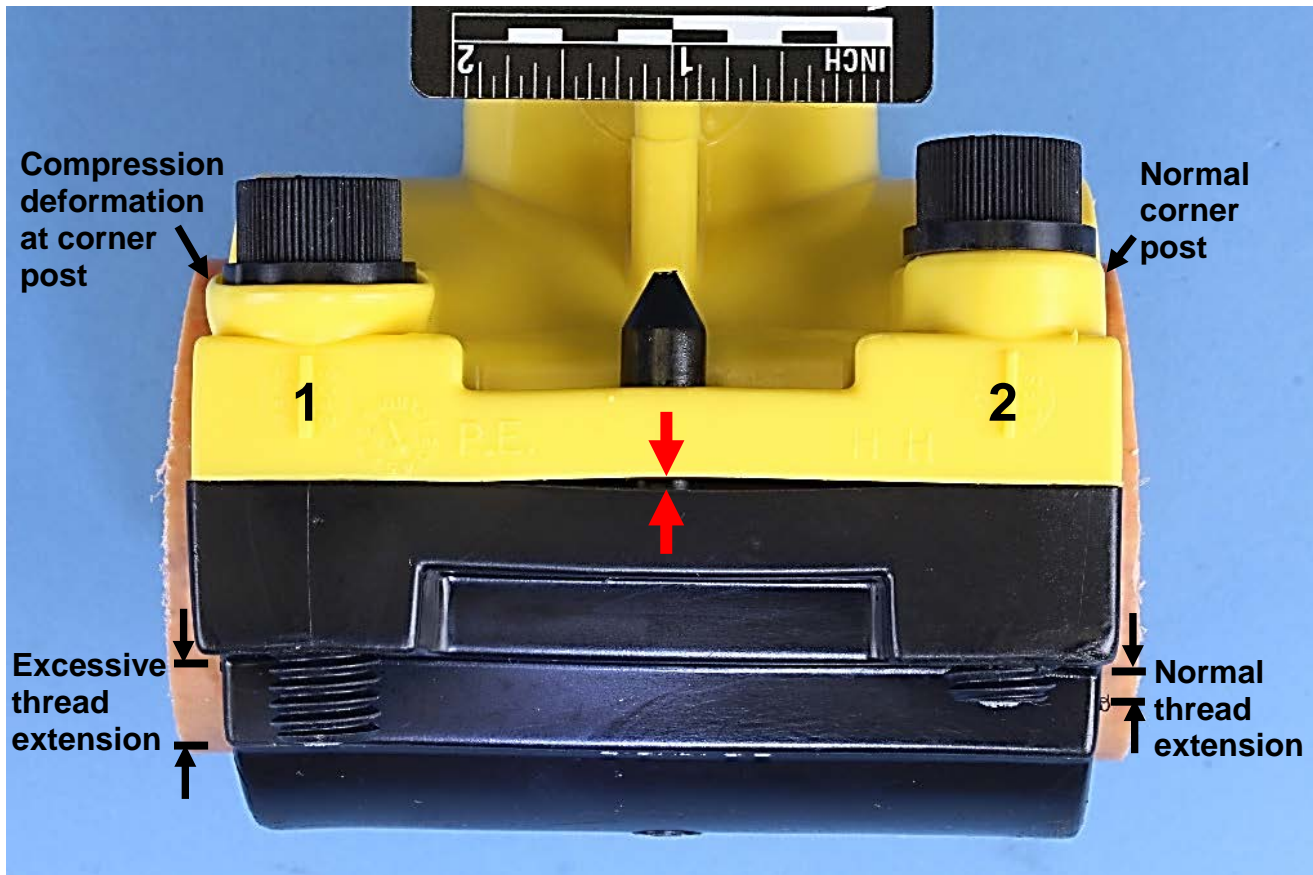
Figure 3. Tee assembly “B” showing Nylon bolts “1” and “2”. Compression damage was intentionally introduced to the corner post for bolt “1” during laboratory experimentation, whereas, the corner post for bolt 2 shows no evidence of deformation when installed per manufacturer instructions. In areas of the tee assembly where the corner post exhibited compression deformation damage (bolt “1”) the threaded portion of the attachment bolt extended further down and below the base compared to areas where the corner post retained its original shape (bolt “2”).

NOTE: The mating halves of the tee in the area of the locating pins contained a slight manufactured bevel, see area between red arrows. The manufacturer’s written installation instructions indicated that a gap between the flanges in the locating pin area is acceptable. All the assembled tee assemblies in this report exhibited evidence of a slight gap in the area of the locating pins, an acceptable condition as indicated in the manufacturer’s written installation instructions.

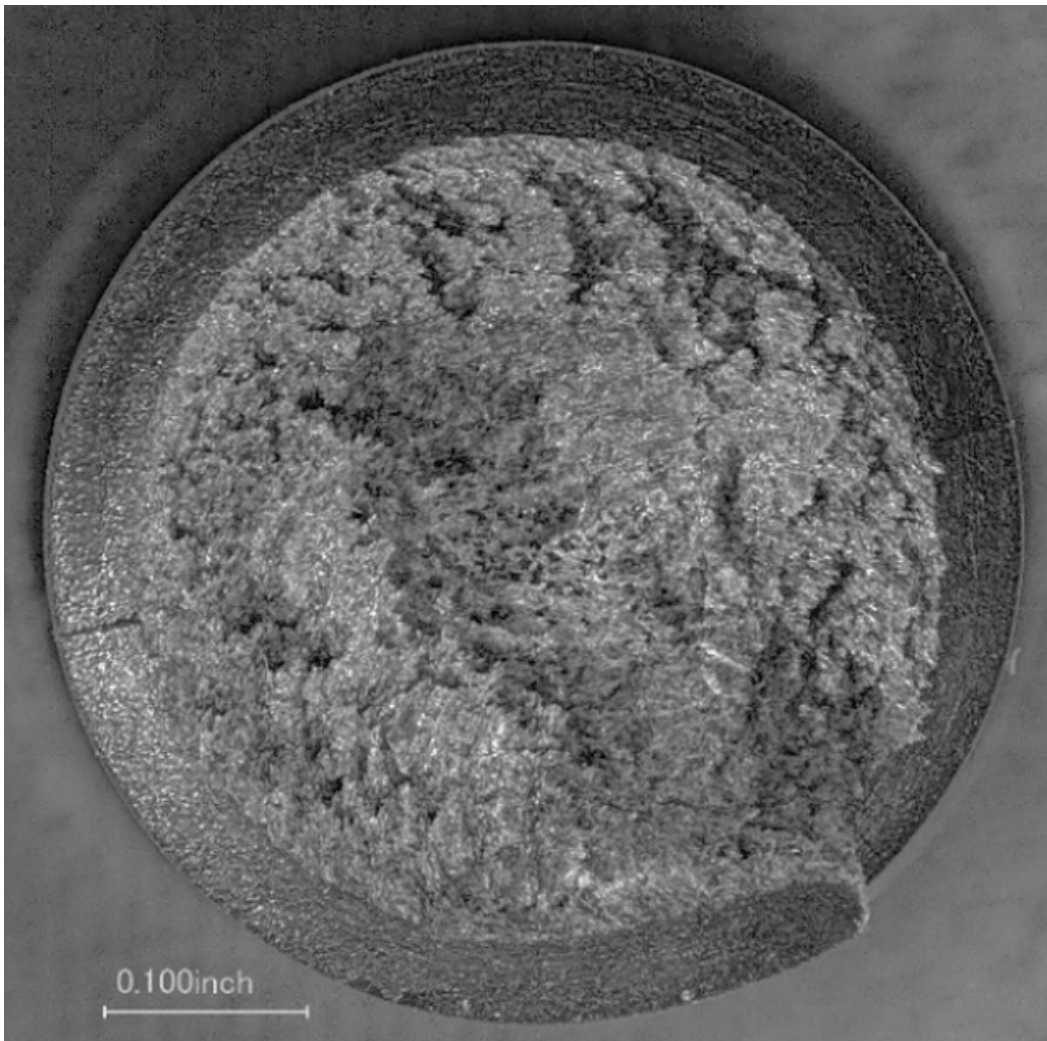
In the second laboratory induced Nylon bolt fracture experiment, the threaded end of a Nylon bolt was secured to the bench vice, similar to the first experiment. The head portion of the Nylon bolt was secured to a channel lock plier. The head portion was turned approximately 90 degrees and the Nylon bolt fractured at the first full thread adjacent to the non-threaded shank by torsional overstress separation. The torque required to cause fracture was not recorded. The fracture was located approximately 0.8 inch below the head portion of the Nylon bolt. Figure 4 shows a photograph of the fracture face. Bench binocular microscope examination of the fracture face revealed evidence of fracture in the polymer matrix (Nylon) and glass fibers portions, but the definition of the fracture features were not clear. SEM examination of the Nylon bolt revealed the Nylon matrix portion showed evidence of fibrils that were elongated laterally relative to the length of the Nylon bolt consistent with shear fracture in torsion mode. The elongated fibrils covered most of the fractured glass fibers (see figure 5 and 6).

Figure 4. Optical photograph of a laboratory induced fracture in torsional overstress mode from a Nylon bolt disassembled from tee assembly "C". The torsional deformation pattern was not obvious when examined visually with the unaided eye.

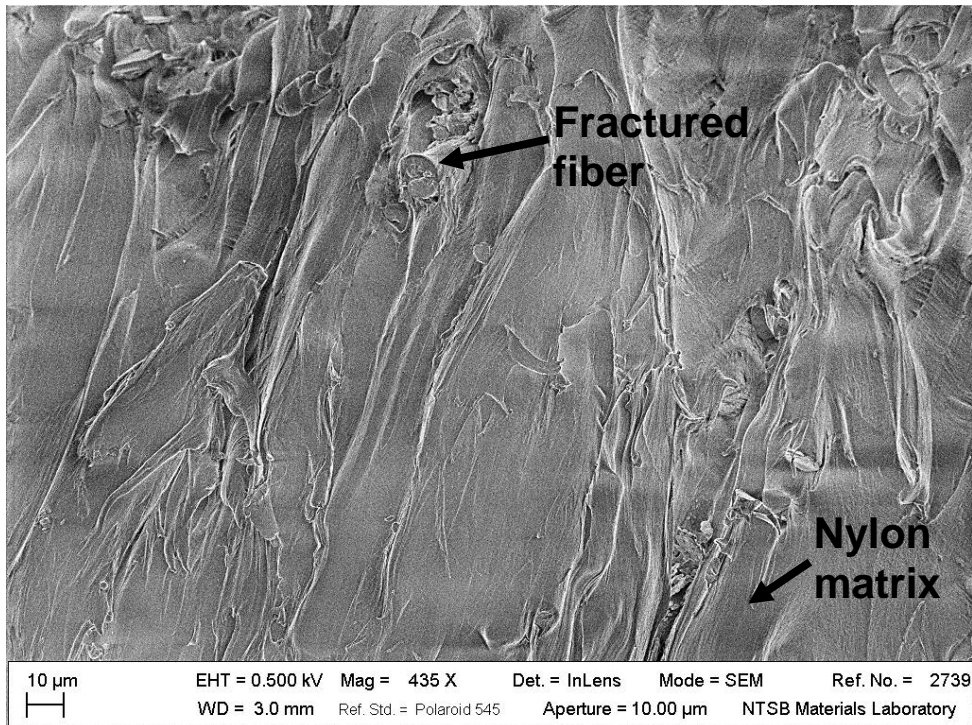
Figure 5. SEM photograph of a fracture showing elongated fibrils in the Nylon matrix that are oriented laterally to the length of the Nylon bolt consistent with an overstress fracture in torsion mode.

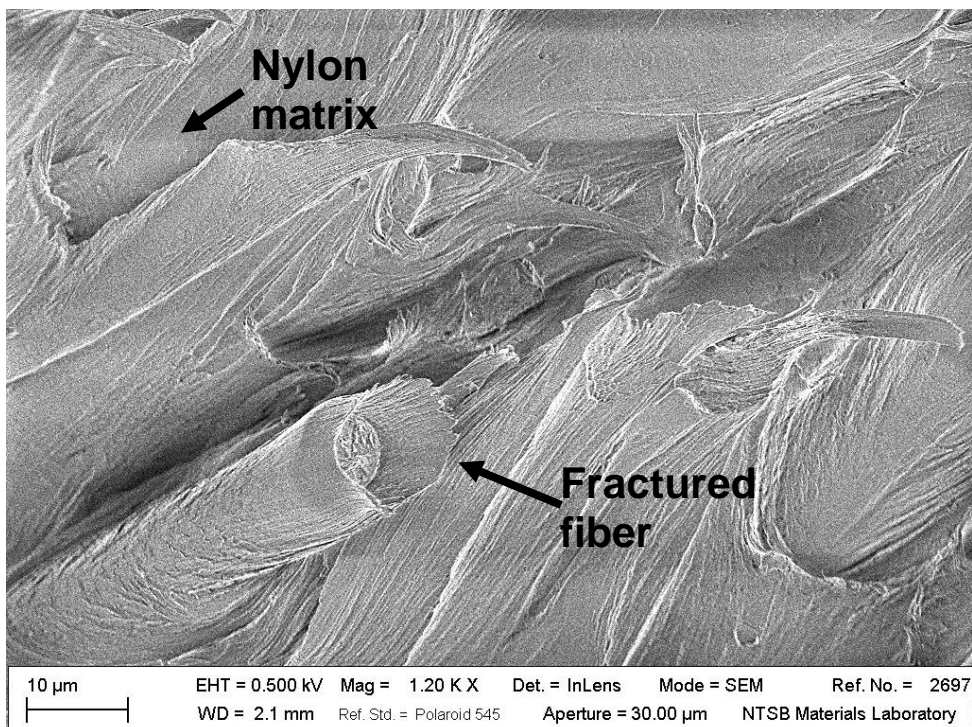
Figure 6. Higher magnification SEM photograph of a fracture showing elongated fibrils in the Nylon matrix that are oriented laterally to the length of the Nylon bolt consistent with an overstress fracture in torsion mode.

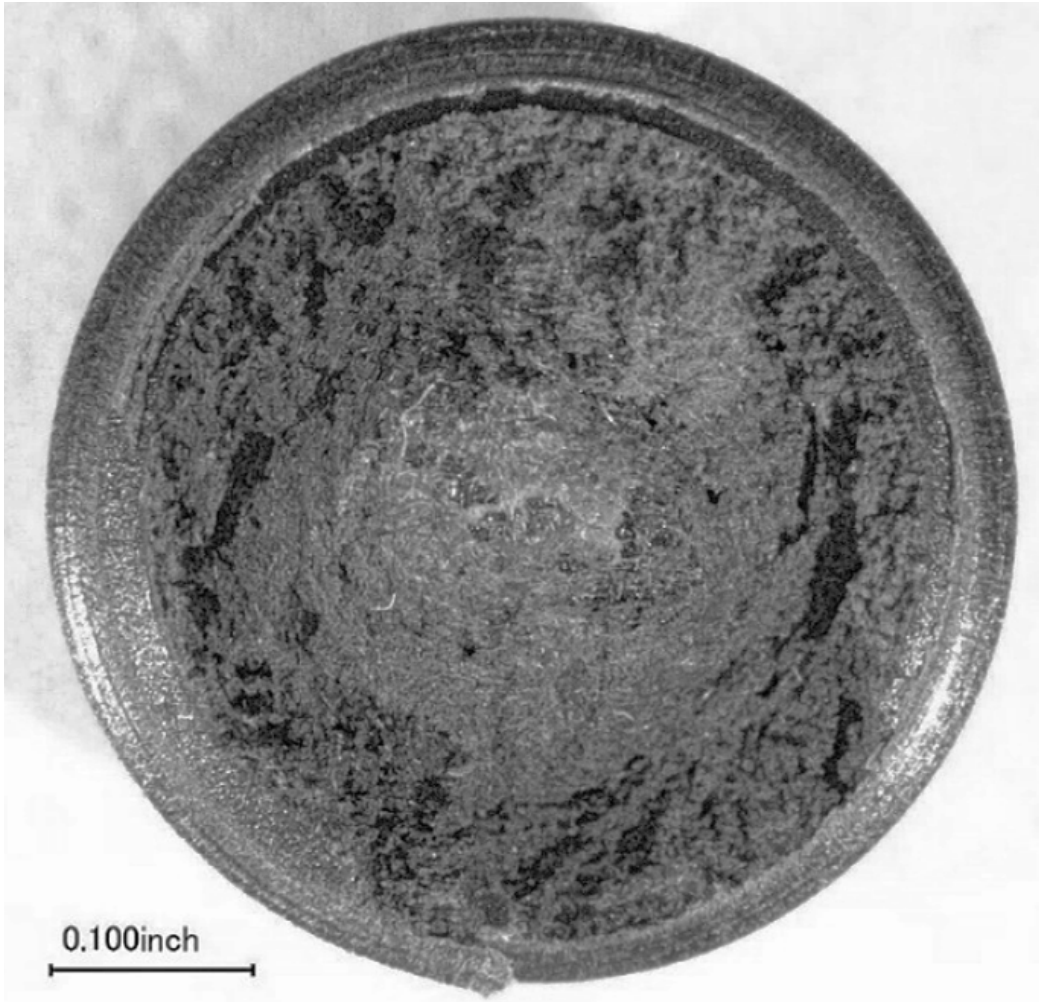
In the third laboratory-induced Nylon bolt fracture experiment, a bolt was inserted through the bore of a total of thirteen steel washers that were stacked against each other (length of approximately 1.6 inches along the axis of bolt) and a steel nut was attached to the threaded end of the Nylon bolt. The nut portion was attached to the grips of the bench vice. The head portion of the bolt was turned clockwise with hand tools using an Allen key. The head was turned multiple times until the Nylon bolt fractured at the 7th root thread (approximately 1.3 inches) from the bottom of the head. The Nylon bolt fractured at an applied torque of approximately 120 in-lbs. The Allen key remained attached to the socket in the bolt head (key did not rotate within the key socket) throughout the turning operation. Figure 7 shows a photograph of the fracture face. Bench binocular microscope examination of one face of the fracture revealed the fracture area at the center portion of the Nylon bolt extended approximately the length of one thread above the fracture plane, and appeared similar to a round cone. The definition of the fracture features was not clear when examined under the bench binocular microscope. SEM examination of the Nylon bolt revealed the Nylon matrix portion showed evidence of fibrils that were elongated parallel to the length of

Figure 7. Optical photograph of a laboratory induced fracture in tensile overstress mode from a Nylon bolt disassembled from tee assembly "C".

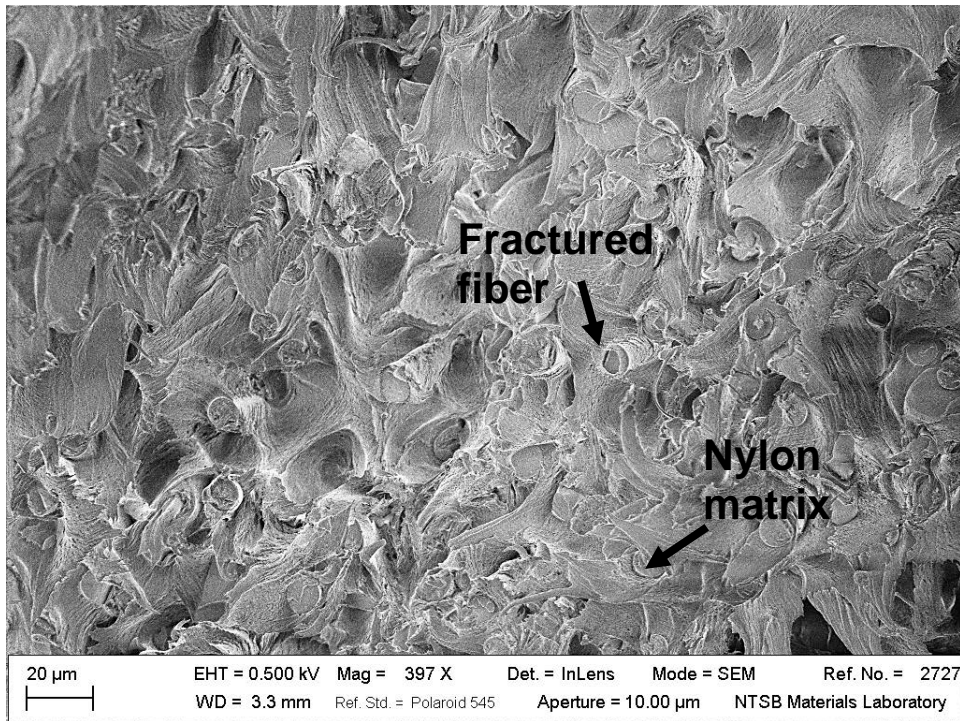
the Nylon bolt consistent with shear fracture in tensile mode (see figures 8 and 9). Many of the glass fiber fracture faces showed evidence of a fracture propagation direction, but the direction of fracture propagation varied from fiber to fiber.

Figure 8. SEM photograph of a fracture showing elongated fibrils that are parallel to the length of the Nylon bolt consistent with an overstress fracture in tensile mode.

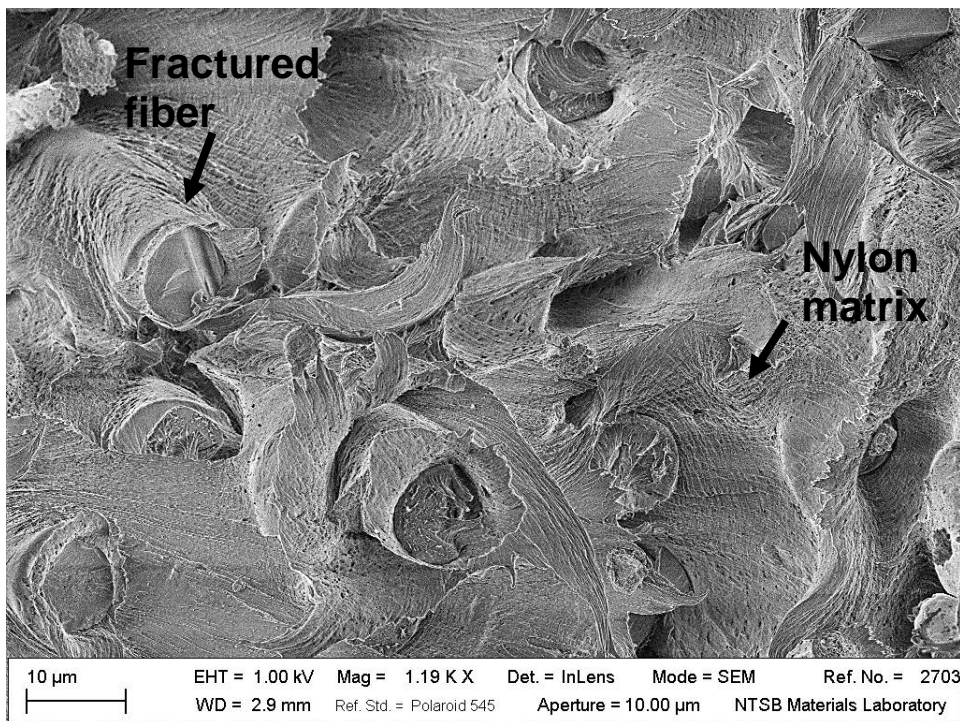
Figure 9. Higher magnification SEM photograph of a fracture showing elongated fibrils in the Nylon matrix that are oriented parallel to the length of the Nylon bolt consistent with an overstress fracture in tensile mode.

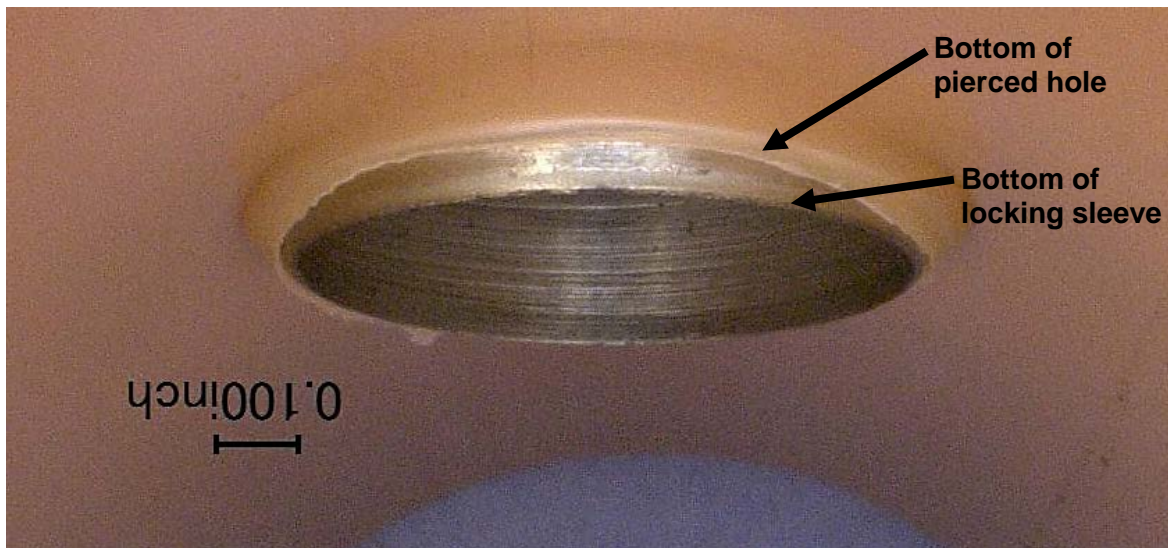
For each completed tee installation, the open end of the main was visually examined to determine the position of the locking sleeve. Examination of the inner walls of a main revealed the locking sleeve for each tee assembly was attached to the main. Figure 10 shows the exposed end of a locking sleeve as it appears inside the main for a tee assembly that was installed per manufacturer's written installation instructions with a depth tube 1/8-inch above the tee tower. The bottom end of the locking sleeve barely extended below the inner wall of the main. Figure 11 shows the threaded portion of the locking sleeve for tee assembly "B" that was not installed per manufacturer's written installation instructions, resulting in a threaded portion of the locking sleeve that extended approximately 0.4 inch below the inner surface of the main. In tee assembly "B", the flange portion of the locking sleeve was driven past and below the stop at the bottom of the tower.

Figure 10. View looking into the inner surface of the main showing a portion of the locking sleeve thread that barely extends out of the pierced hole in the main. This is typical for a locking sleeve that was installed per manufacturer's written installation instructions. Installation of tee assembly "C" with a depth tube at 1/8-inch above the top of the tee tower.

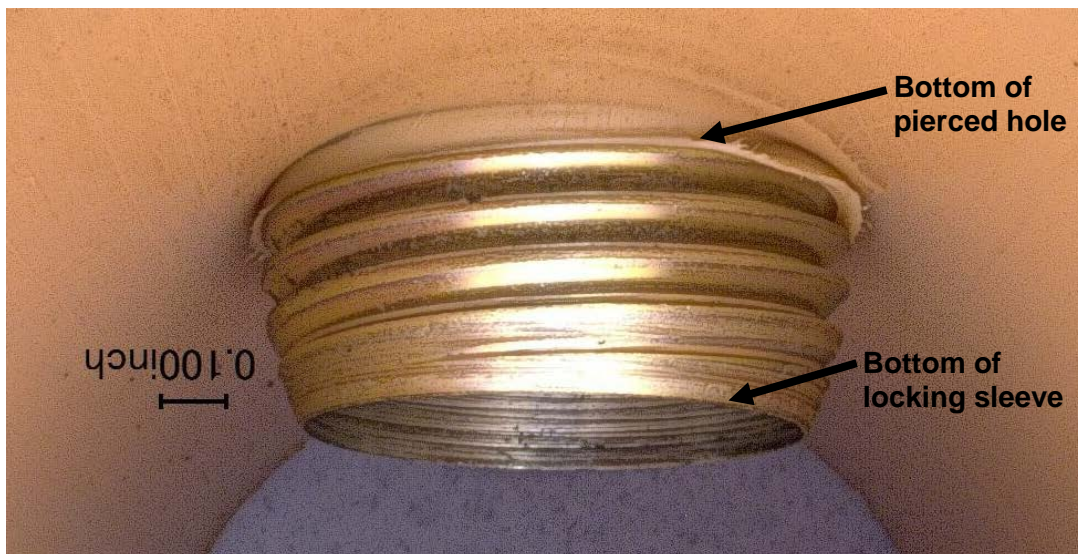
Tee assembly "B" was installed with a 19-inch length torque wrench. Changes in resistance was not felt on the wrench handle during the various phases of the installation. The cutter assembly was driven down the bore with the anticipation that resistance would be felt in the handle of the wrench when the stop was reached. This was not the case. The outer lip (flange) portion of the locking sleeve was driven below and beyond the stop, to the position indicated in table 5. This test demonstrated that the steel locking sleeve can be forced to travel beyond the stop position when using a 19-inch length wrench, and a change in resistance may not be felt in the handle of the wrench.

Figure 11. View looking into the inner surface of the main showing extension of the locking sleeve thread that was installed with a depth tube position at 0.12-inch below the top of the tower. A large portion of the locking sleeve thread extended out of the pierced hole in the main. Installation of tee assembly "B".

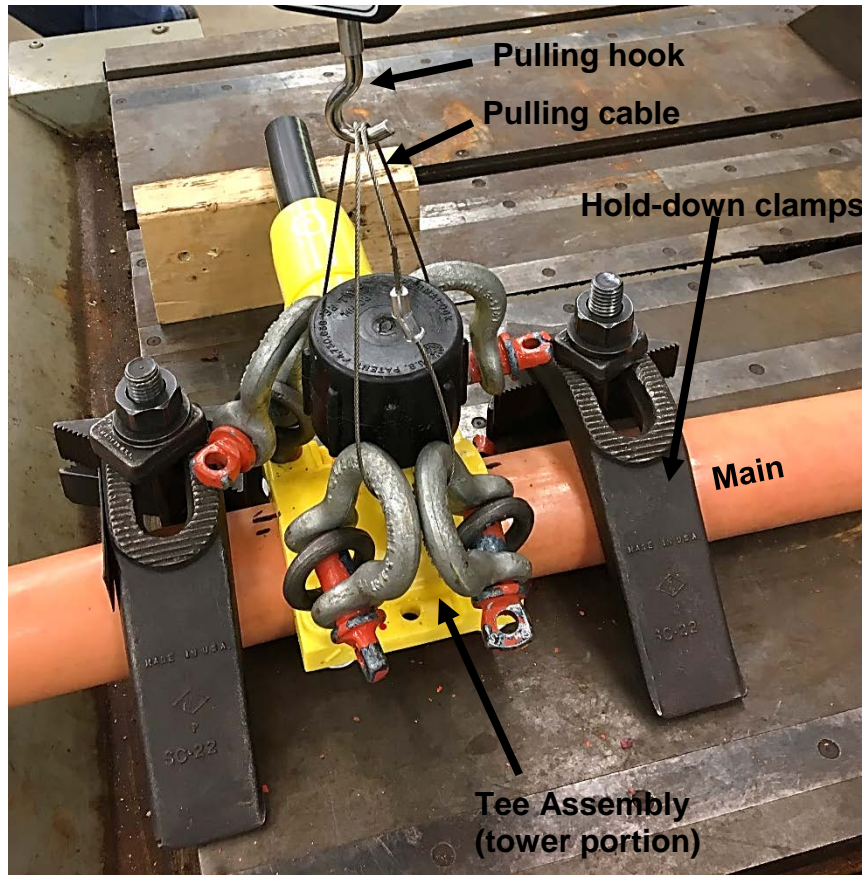
A test was conducted to determine the amount of tensile force that was required to pull out a locking sleeve and tower from a main installed per the manufacturer's written instructions with a tee base and Nylon bolts removed. Figure 12 shows the set-up for the testing. Tee assembly "C" was used in this experiment. Steel attachment bolts, each with a closed loop hook, were attached to the tower portion. A steel cable was passed through the closed loop hook of each steel bolt and, in turn, the other end of the cable was attached to a lifting crane. The force required to pull the locking sleeve and tower from the tee was recorded with an electronic force gage. As a tensile force was applied to the locking sleeve and tower via the cable, one side of the tower started to lift from the main at approximately 280 pounds. The force required to separate the locking sleeve and tower from the main was approximately 380 pounds. Figures 13 and 14 show photographs of the pierced hole in the main after the locking sleeve was intentionally pulled out by force, revealing evidence of thread deformation damage.

Figure 12. Laboratory set-up to intentionally separate the locking sleeve and tower from the main.

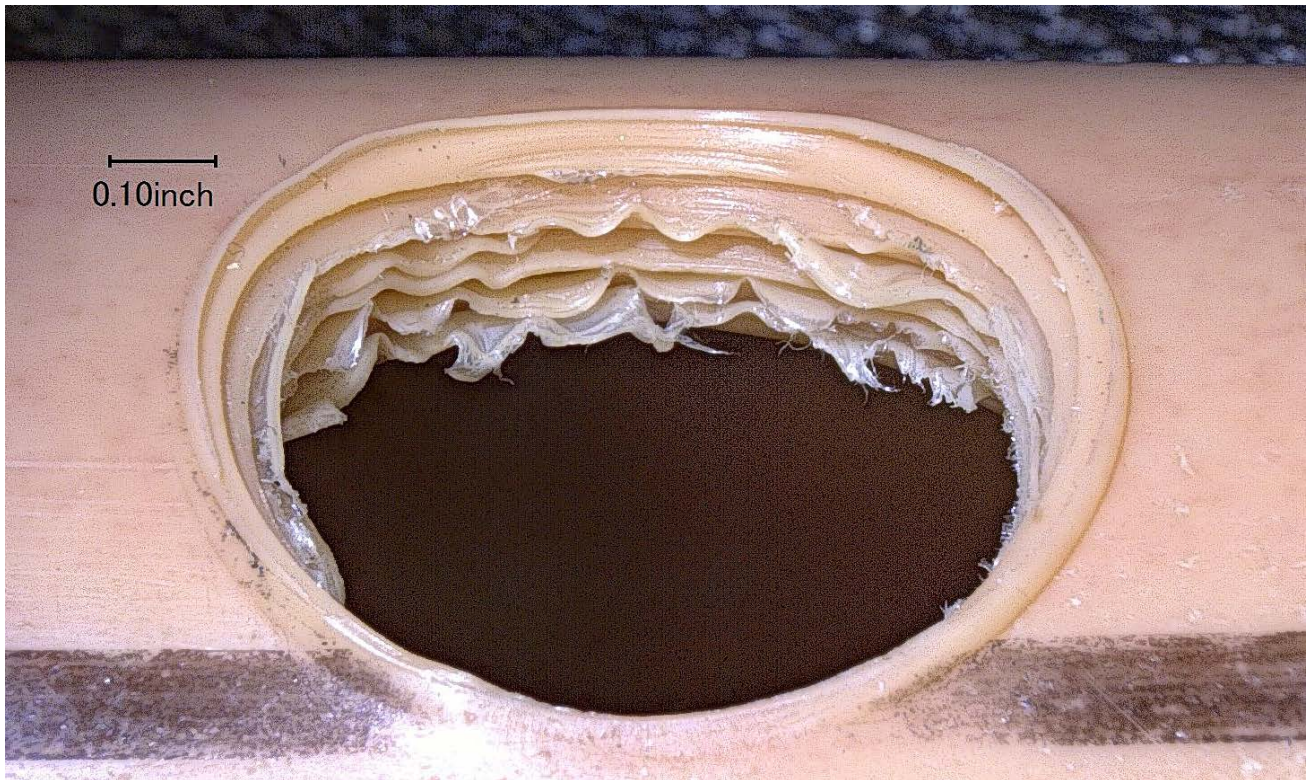
Figure 13. Photograph of the exposed outer top surface of the main after the locking sleeve and tower of tee assembly "C" was forcefully pulled out of the main showing thread damage in the pierced hole.

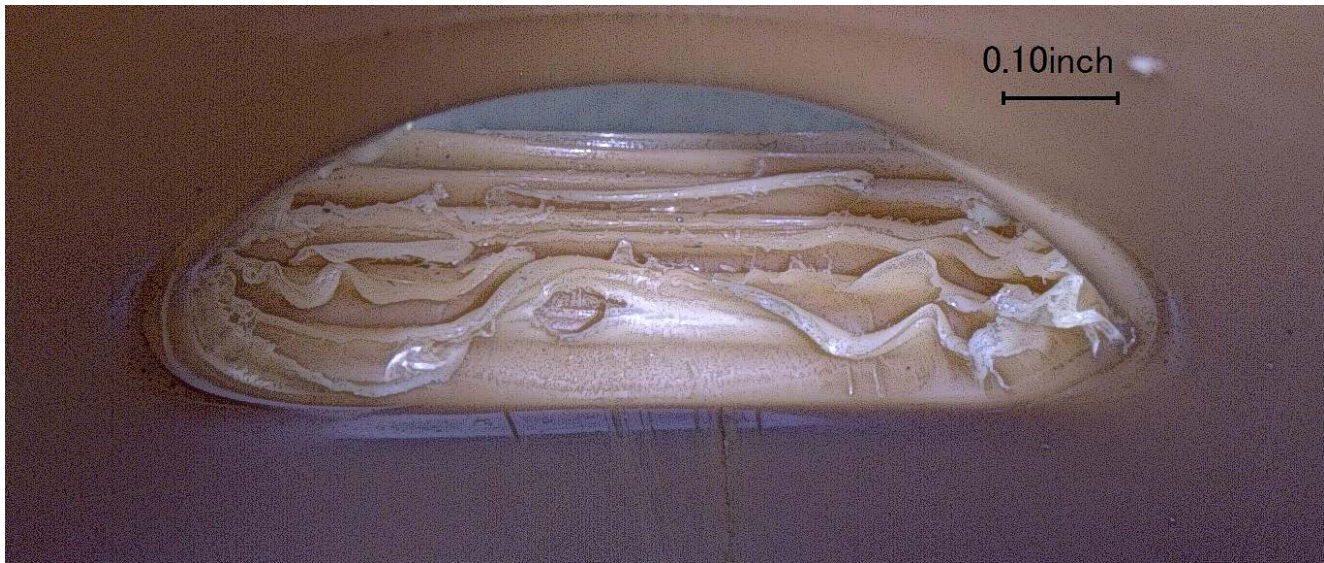
Figure 14. Photograph of the exposed inner surface of the main after the locking sleeve and tower of tee assembly "C" was forcefully pulled out of the main showing thread damage in the pierced hole.
