NATIONAL TRANSPORTATION SAFETY BOARD

MATERIALS LABORATORY FACTUAL REPORT

Report No. 18-005

Place : Millersville, Pennsylvania
Date : July 2, 2017
Vehicle : Natural gas mechanical tapping tee
NTSB No. : DCA17FP006
Investigator : Roger Evans (RPH)

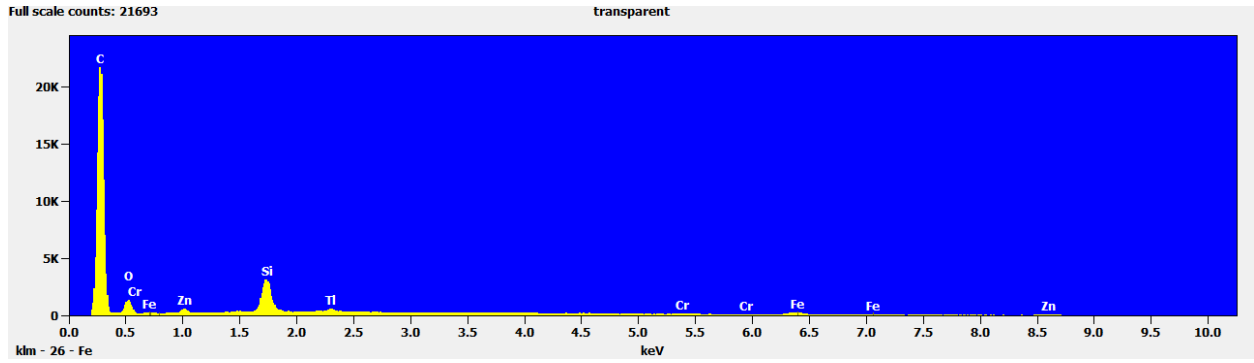
Examination of the cutter tool revealed the outer surface, the slot for the O-ring, and O-ring, were covered with a transparent film, consistent with silicone, and contained no evidence of granular-like particles (such as soil). Portions of the shank was covered with a brown transparent film, similar to a film of silicone (see figure 11). The size of the O-ring for the cutter tool is specified in Perfection Corporation engineering drawing number 53778, Revision D, titled 'Cutter Assembly Ratchet for 2", 3", 4" & 6" PMTT'. The size of the O-ring for the cutter tool was measured and the results are shown in table 5. The size of the cutter tool O-ring was within the specified range. Examination of the locking sleeve revealed the inner surface contained a dry and transparent film that circumferentially oriented relative to the length of the locking sleeve (see figure 12). A sample of the film was removed from the inner surface of the locking sleeve. EDS spectrum of this film contained major elemental peaks of carbon, silicon, oxygen, and minor peaks of zinc, iron, chromium, and titanium (see Appendix B1).

Appendix B1. EDS spectrum of a narrow transparent film that was found on the inner surface of the locking sleeve showing major elemental peaks of carbon, silicon, oxygen, and minor peaks of zinc, iron, chromium, and titanium.

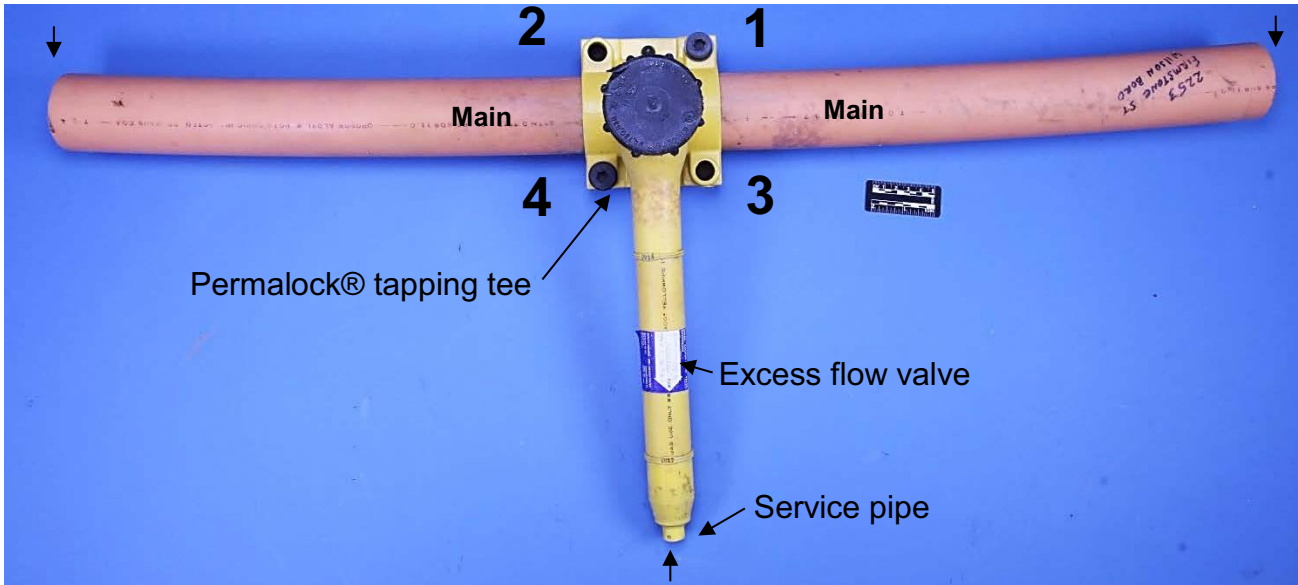
The bolt was specified as Nylon 6/6 with 43% by weight random oriented short glass fiber reinforcement, according to a manufacturer representative for the tee assembly.³ For the purpose of this report, the Nylon bolts were arbitrarily assigned a number between “1” and “4”, orientation as shown in table 2. The fractured bolts, bolts “2” and “3”, were located on diametrically opposite sides of the tower. One fractured Nylon bolt was located on the outlet side and the other was located on the nonoutlet side. The head portion of fractured bolts were not submitted.

The mating halves of the tee at the corners that contained the two fractured Nylon bolts showed evidence of a gap. The gap between the mating halves of the tee at the corner that contained fractured Nylon bolt “2” measured in the vertical direction approximately 0.256 inch, and the gap between the mating halves of the tee at the corner that contained fractured Nylon bolt “3” measured 0.213 inch. The mating halves of the tee at the corners that contained the two intact Nylon bolts showed no evidence of a gap.

Figure 1. Photograph of the mechanical tapping tee, shown after brush cleaning with water, and identification numbers that were arbitrarily assigned to the Nylon bolts, "1" through "4". Bolts "2" and "3" fractured at the thread portion. Arrows indicate cut portions of pipes to facilitate transportation and handling.

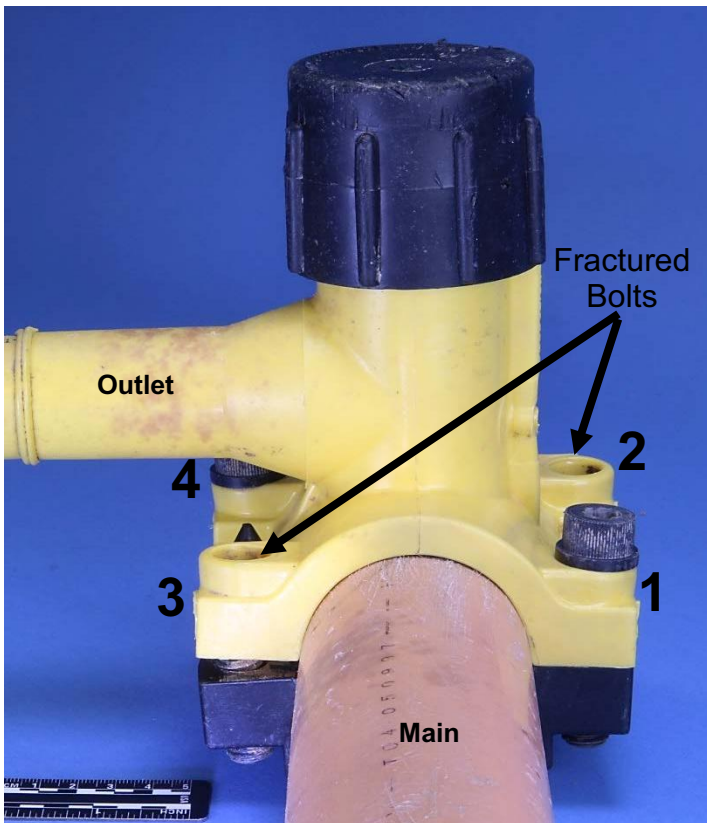
Figure 2. Side view of the tee assembly showing fractured bolts "2" and "3".

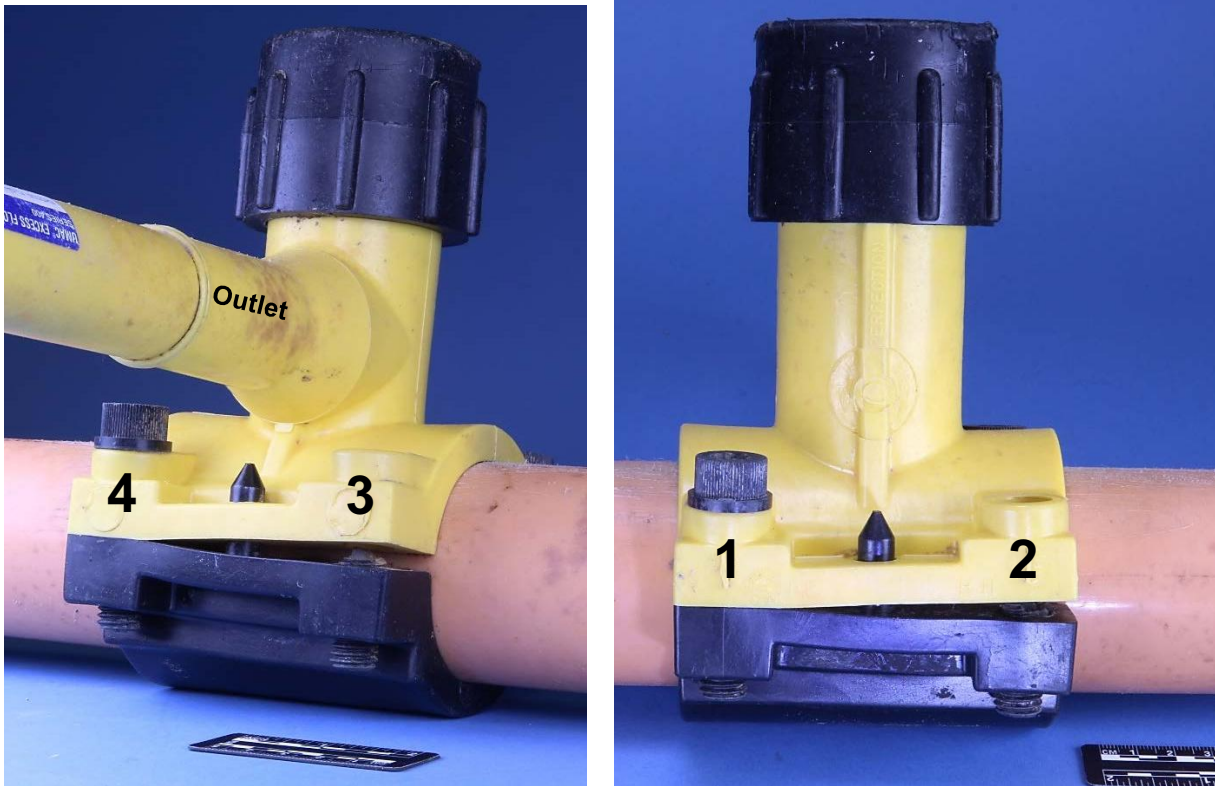
Figure 3. Other views of the tee assembly showing fractured bolts "2" and "3".

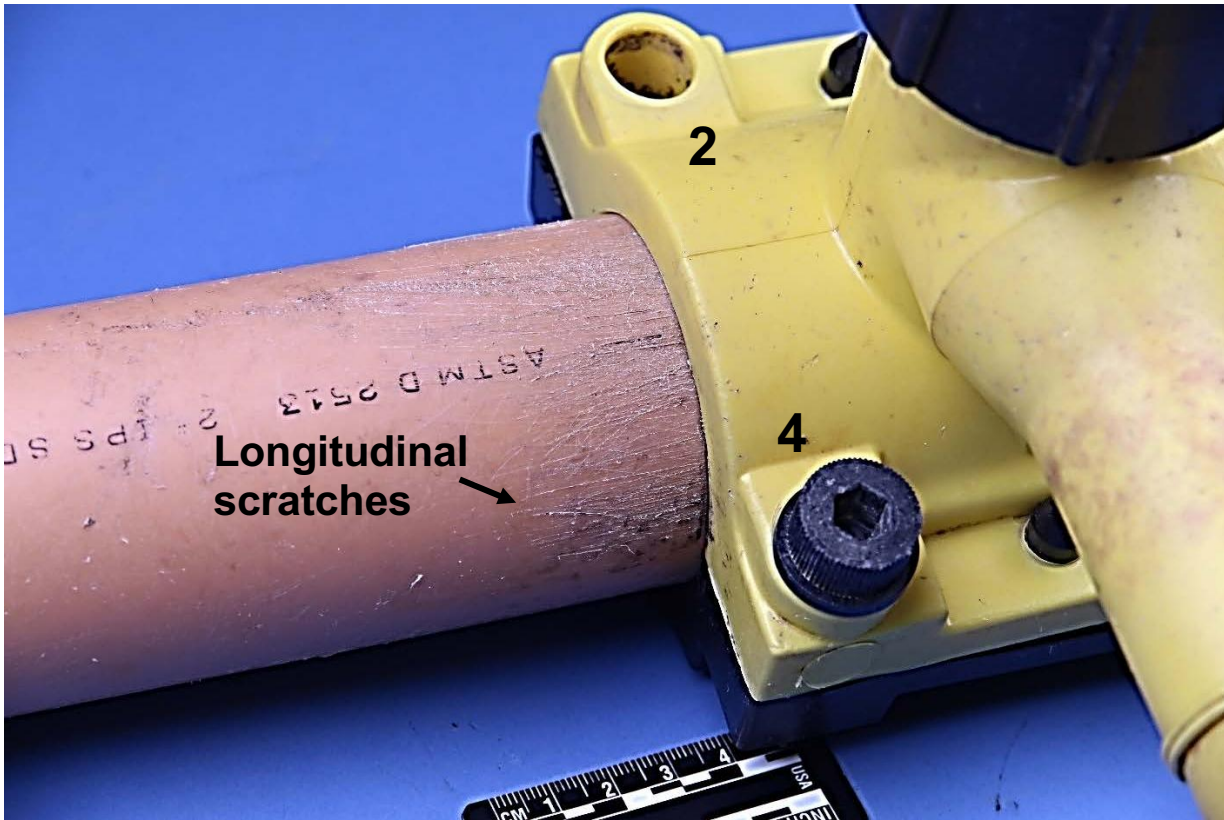
Figure 4. Close-up view of the top portion of the main showing longitudinal scratches that extend out of the tee assembly.

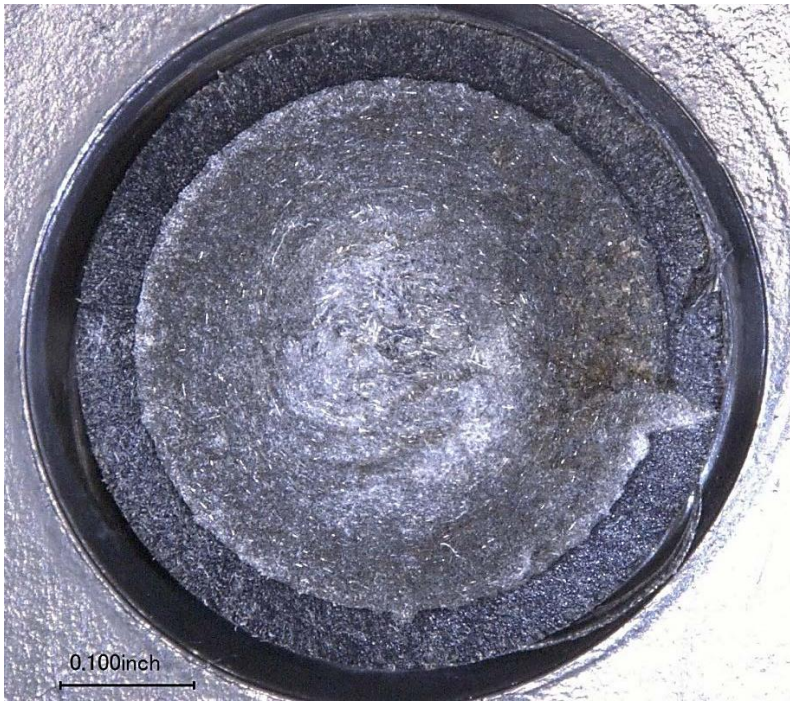
A saw cut was made at the bottom end of both fractured Nylon bolts, so that it intersected the center of each Nylon bolt. A screw driver was inserted into the cut slot at the bottom of each Nylon bolt, and turned until the remnant of the Nylon bolt was unscrewed from the base portion. The fractured Nylon bolt fragments were ultrasonic cleaned in a solution of detergent and water. The shank and thread portions of fractured Nylon bolt “2” showed no visible evidence of elongation (reduction in diameter cross section) in the general area of the fracture face. Figure 5 shows a photograph of the fracture face from Nylon bolt “2”. The fracture face showed no evidence of a fracture origin or general direction of fracture propagation. The fracture face of Nylon bolt “3” showed fracture features that were similar to those of bolt “2”.

Figure 5. Fracture face of bolt "2" after ultrasonic cleaning.

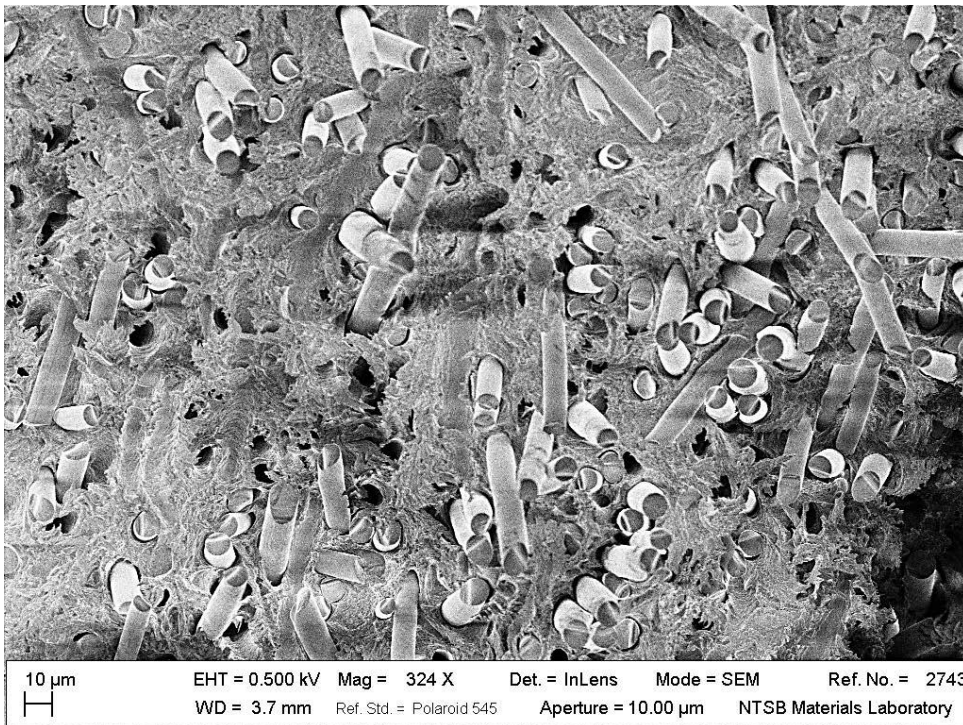
Scanning electron microscope (SEM) examination of Nylon bolt “2” revealed the fracture face contained evidence of fracture features on the polymer matrix (Nylon portion of the bolt) and glass fiber portions (see figure 6 and 7). The fracture face on the Nylon bolt (polymer matrix and individual glass fibers) showed no evidence of a pattern that identified a

Figure 6. Scanning electron microscope (SEM) photograph of a portion of the fracture face from Nylon bolt "2" showing the matrix (Nylon) and the end of several fractured glass fibers.

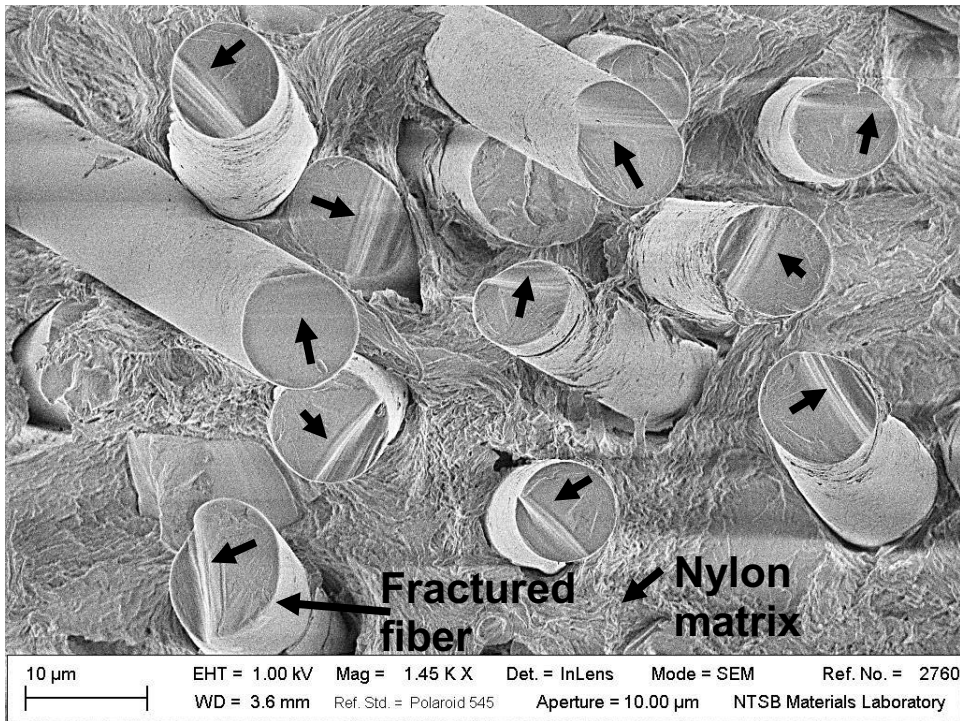
general direction of fracture propagation. The origin of the Nylon bolt fracture could not be determined, based on the fracture pattern on the polymer matrix or the glass fibers.

Figure 7. Scanning electron microscope (SEM) photograph of a portion of the fracture face from Nylon bolt "2" showing the matrix (Nylon) and the end of several fractured glass fibers. Arrows indicate general direction of fracture propagation on each fractured glass fiber.

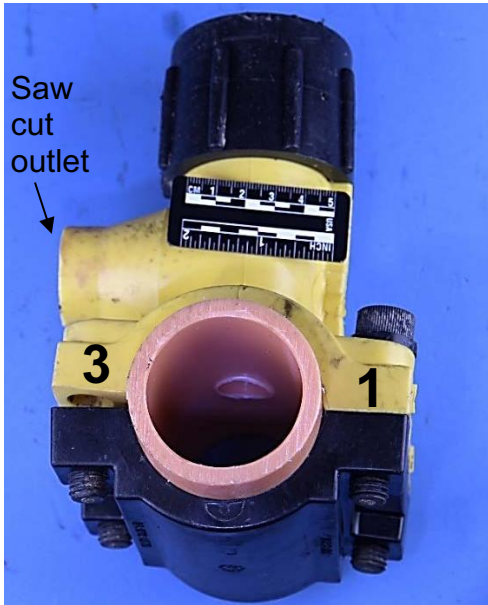
Figure 8 shows a side view of the tee assembly and the exposed inner wall of the main in the area where the cutter tool made pierced a hole in the wall of the main to gasify the service. The cap was removed from the tower of the tee. The distance between the top of the cutter tool and the top of the tower was measured and the results are shown in table 3. The pierced hole in the main showed no evidence of a locking sleeve, and only showed the bare wall of the main. When looking into the saw cut outlet portion of the tee, the cutter tool extended approximately half way down the bore of the outlet. The bottom half portion of the bore showed no evidence of the locking sleeve (see figure 9).

Figure 8. Photograph of the tee assembly showing the exposed inner wall of the main in the area where the cutter tool pierced a hole in the wall of the main to gasify the service. The wall of the pierced hole was bare and showed no evidence of a locking sleeve.

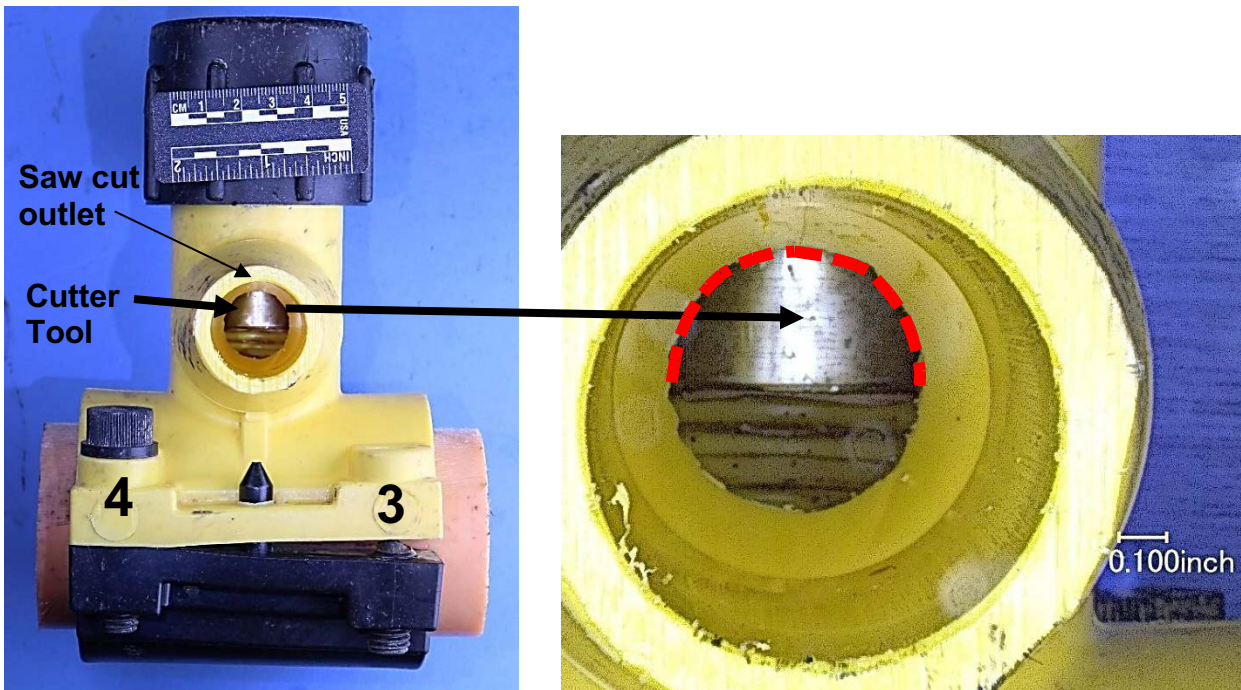
Figure 9. Photograph of a portion of the tapping tee assembly looking in the saw cut outlet showing the bottom end of the cutter tool that extended approximately half way down the outlet (left side of page). A close-up photograph of the same cutter tool (right side of page) shows the portion of the cutter tool that was exposed through to the outlet highlighted by the red dashed line.

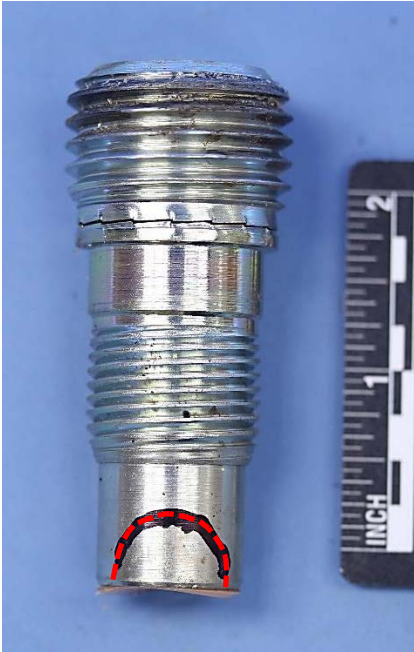
A 5/16-inch hex wrench was inserted into top of the cutter tool and turned counterclockwise. The cutter tool was removed from the tower. The locking sleeve was attached to the cutter tool, see figure 10. The bottom hollow portion of the cutter tool contained a round cut-out coupon from the wall of the main. The cutter tool and locking sleeve were pulled apart from each other by hand with constant and steady force. The two pieces were examined after disassembly. The disassembled cutter tool and locking sleeve showed no evidence of mechanical damage.

Figure 10. Photograph of the extracted cutter assembly. The area enclosed by a red dashed line represents the portion of the cutter tool that was exposed in the outlet (see figure 9).

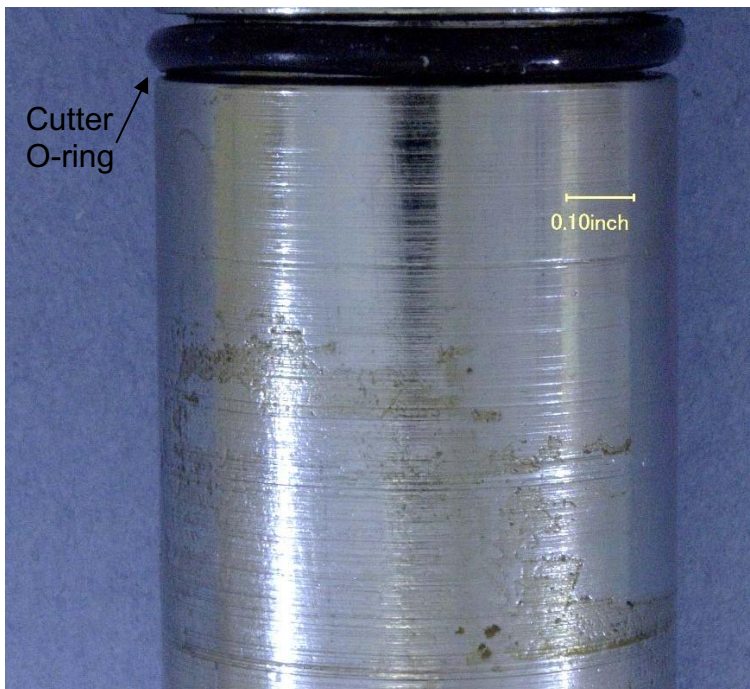
Figure 11. Photograph of a portion of the cutter tool after disassembly showing the outer shank surface adjacent and below the cutter O-ring.

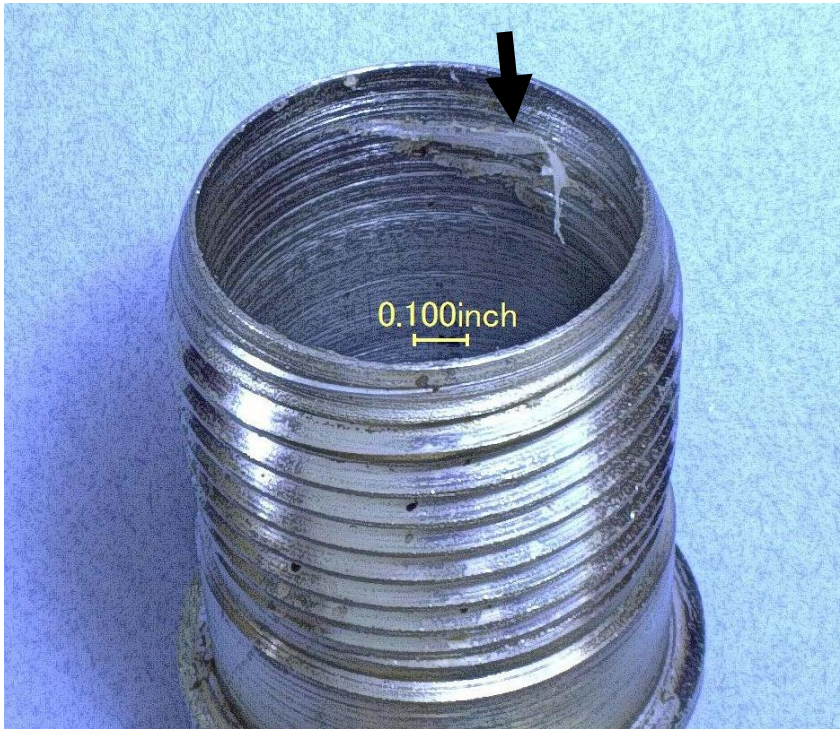
Figure 12. Photograph of the disassembled locking sleeve showing the inner surface and a transparent particle (film) that was circumferentially oriented, indicated by an arrow.

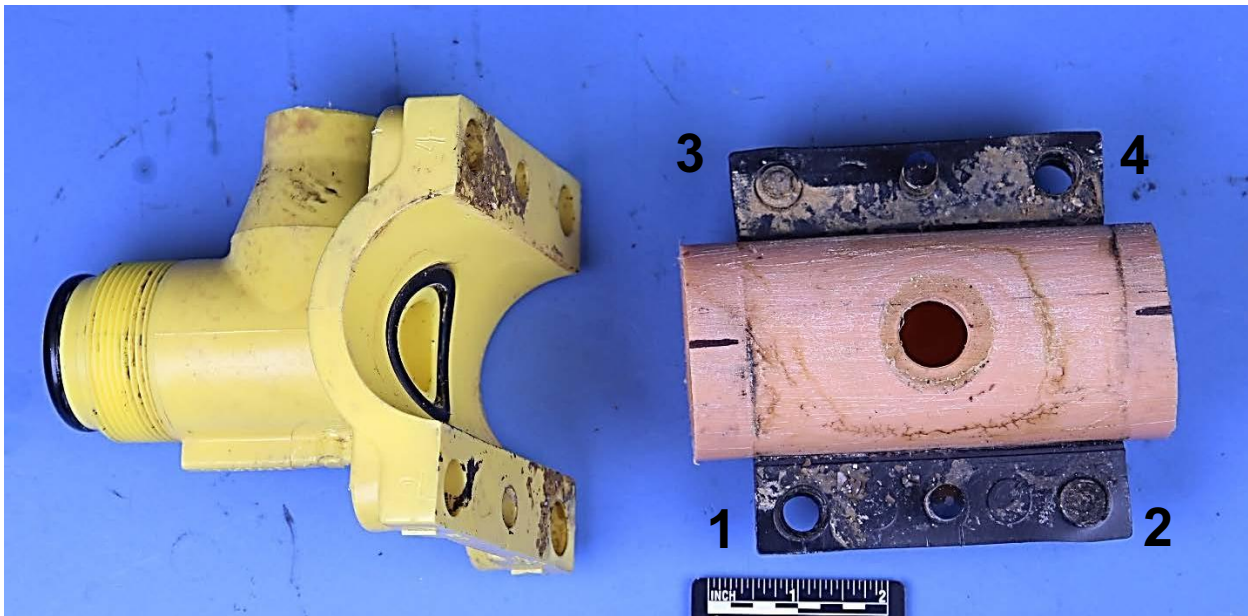
The tee assembly was disassembled from the main (see figure 13). The tee showed no evidence of cracks. The top portion of the main contained longitudinal scratches that intersected the pierced hole in the main. The saddle O-ring was firmly attached to the mating groove that was located at the underside of the tower. The O-ring was peeled off the groove with the assistance of the tip of a screwdriver. The saddle O-ring was found on top of the main. The size of the saddle O-ring is specified in Perfection Corporation engineering drawing number 53942, Revision B, titled 'Contoured O-ring 2" IPS PMTT'. The size of the saddle O-ring was measured with a caliper and the results are shown in table 6. The inside diameter of the saddle O-ring was slightly less than the specified size (see table 6). The saddle O-ring contained evidence of a parting line and minor squeeze-out from the molding process all around the circumference at the inner and outer diameter surface. The inside diameter of the O-ring included the squeeze-out portion. Although only a thickness is specified for the saddle O-ring, the height and width of the O-ring were measured. The measured height of the saddle O-ring was slightly less than the specified thickness and the measured width of the saddle O-ring was slightly greater than the specified thickness.

Figure 13. Photograph of the disassembled tee showing the top exposed surface of the main and pierced hole. The top portion of the main contained longitudinal scratches that intersected the pierced hole in the main.

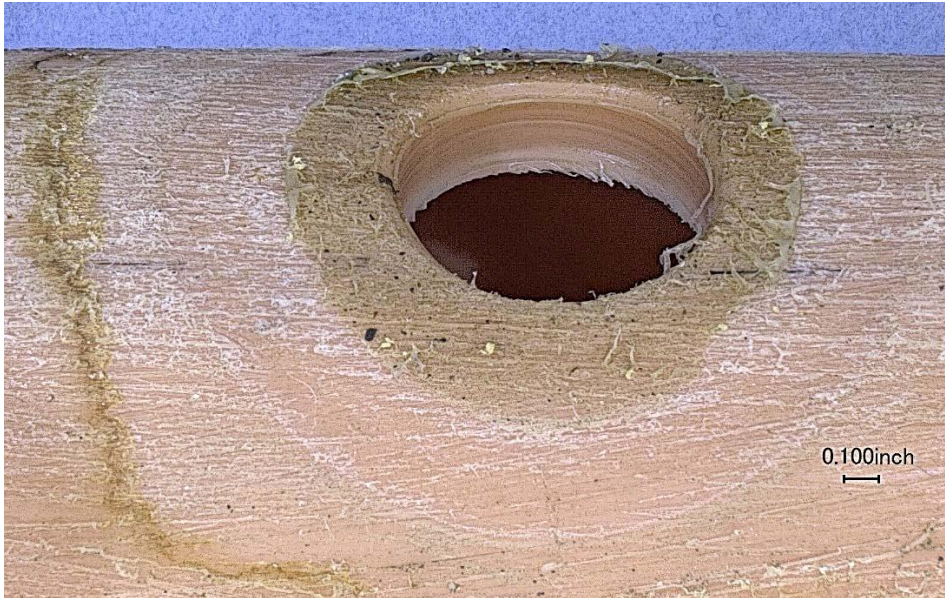
Detailed bench binocular microscope examination of the main revealed the pierced hole contained circumferential fine cut marks with no evidence of threads, see figures 14 and 15. The diameter of the pierced hole measured approximately 0.71 inch (see table 7).

Figure 14. Photograph of the exposed outer top surface of the main after disassembly of the tee showing the pierced hole made by the cutter tool. Note the fine circular cut marks within the pierced hole and the absence of threads.

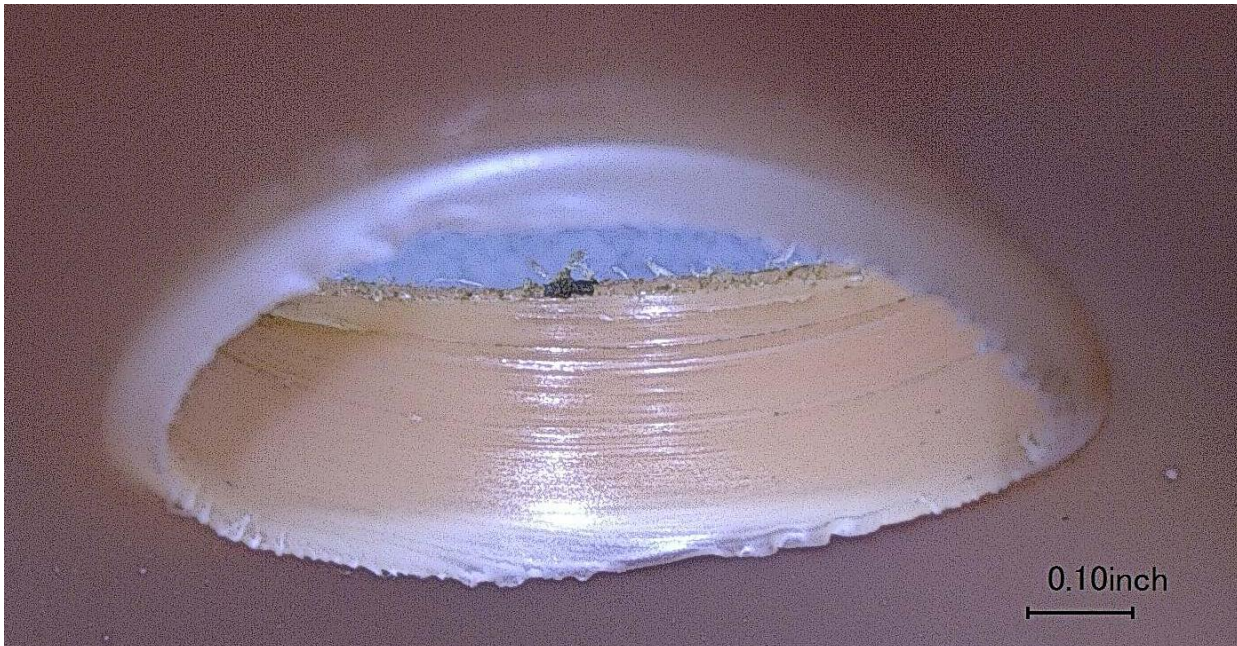
Figure 15. Photograph of the exposed inner surface of the main after disassembly of the tee showing the pierced hole made by the cutter tool. Note the fine circular cut marks within the pierced hole and the absence of threads.
