# NATIONAL TRANSPORTATION SAFETY BOARD

MATERIALS LABORATORY FACTUAL REPORT

Report No. 18-006

Place : Millersville, Pennsylvania  
Date : July 2, 2017  
Vehicle : Natural gas mechanical tapping tee  
NTSB No. : DCA17FP006  
Investigator : Roger Evans (RPH)

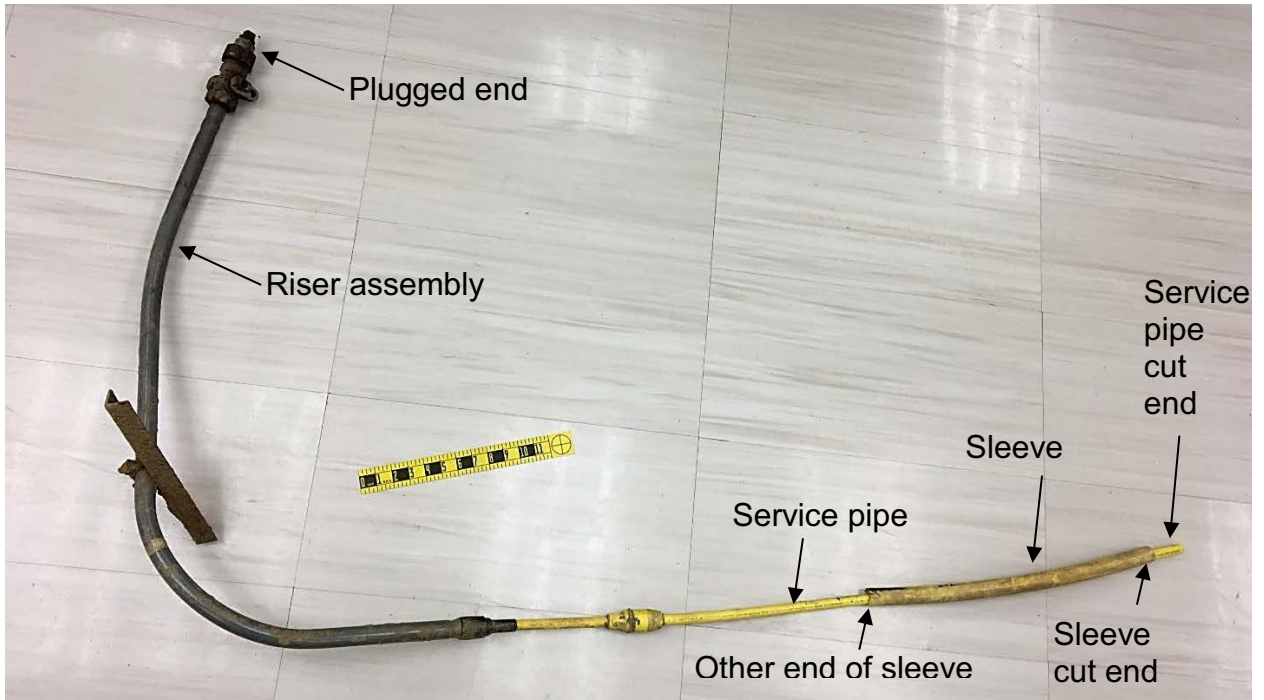
Figure 1. As-received meter riser assembly that was connected to the polyethylene service pipe.

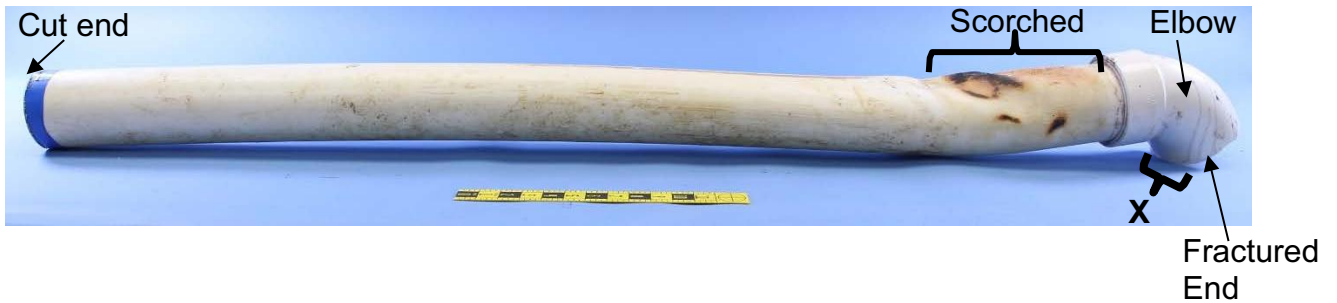
Figure 2. As-received sewer pipe. The fracture in the elbow portion emanated from the outer face in the area indicated by bracket "X". Figure 4 shows another view of the same fracture origin area indicated by bracket "X".

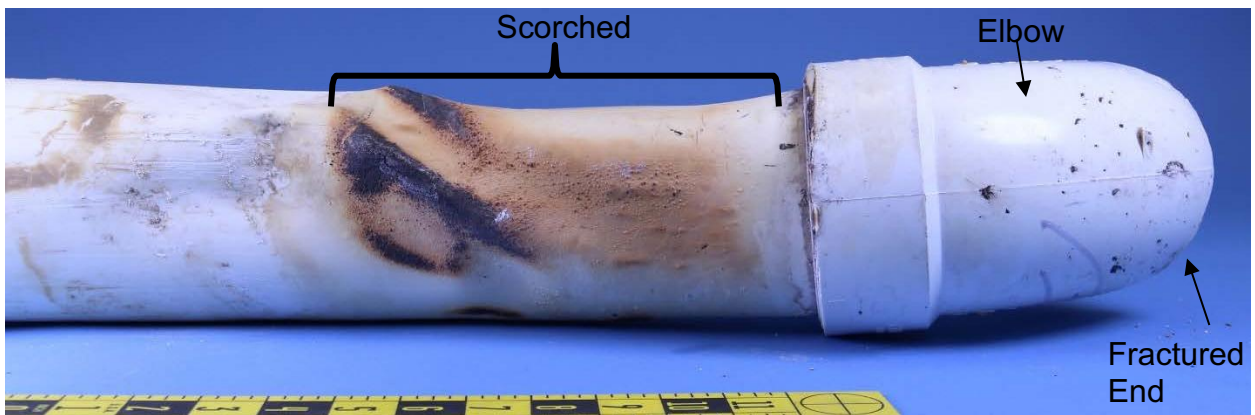
Figure 3. Photograph of a portion of the sewer pipe showing the scorched portion.

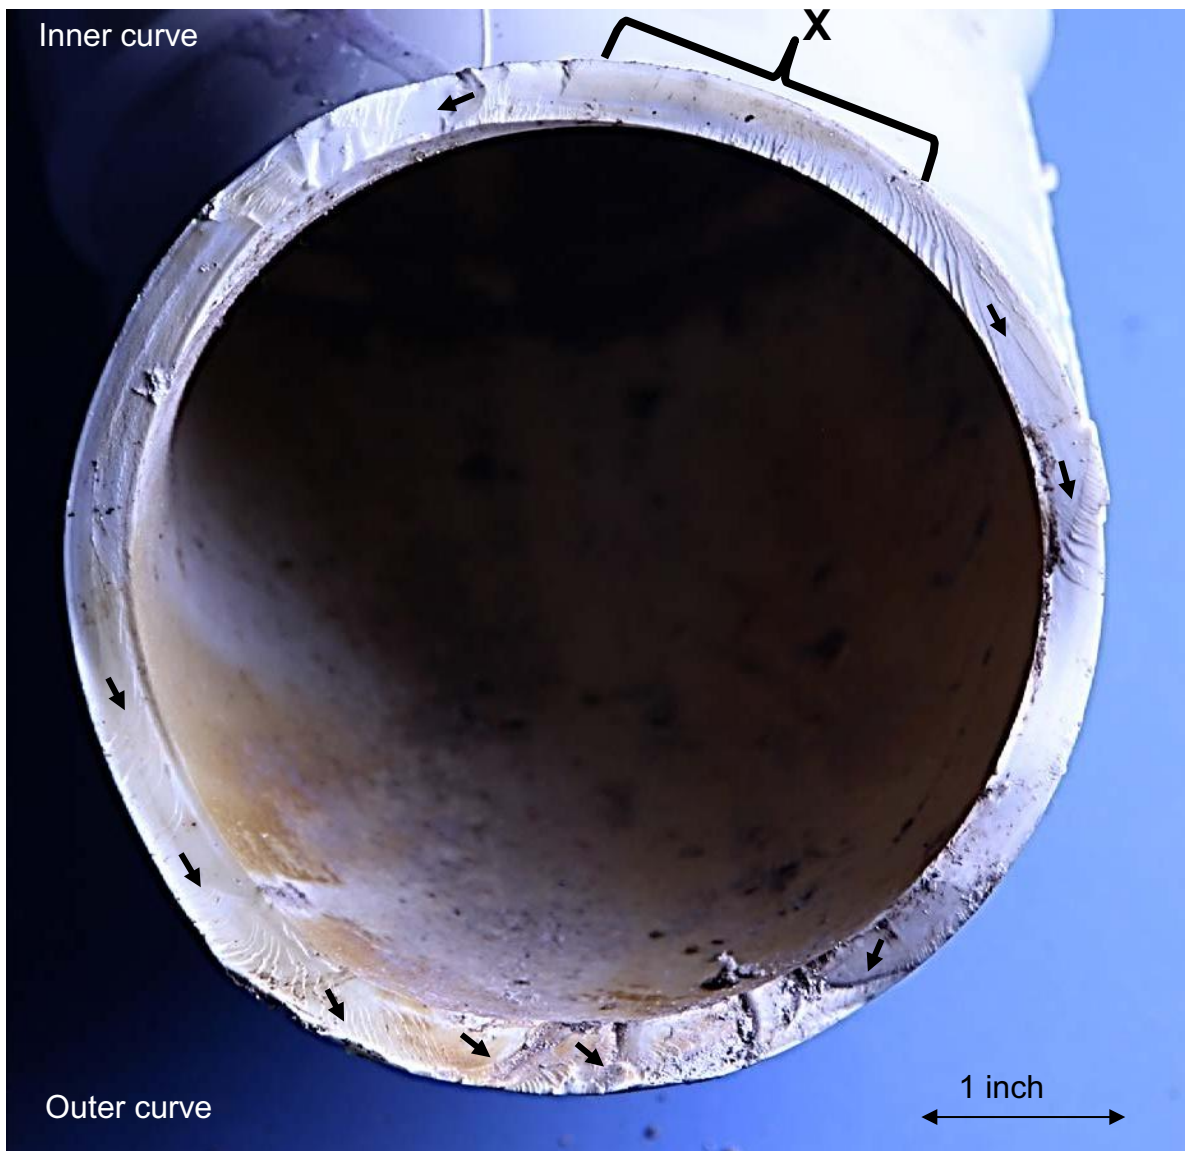
Figure 4. Photograph of the elbow fracture face. The fracture emanated from the outer face in the area indicated by bracket "X". Fracture propagation was in the general direction indicated by arrows.
