NATIONAL TRANSPORTATION SAFETY BOARD

MATERIALS LABORATORY FACTUAL REPORT

Report No. 18-007

Place : Millersville, Pennsylvania
Date : July 2, 2017
Vehicle : Natural gas mechanical tapping tee
NTSB No. : DCA17FP006
Investigator : Roger Evans (RPH)

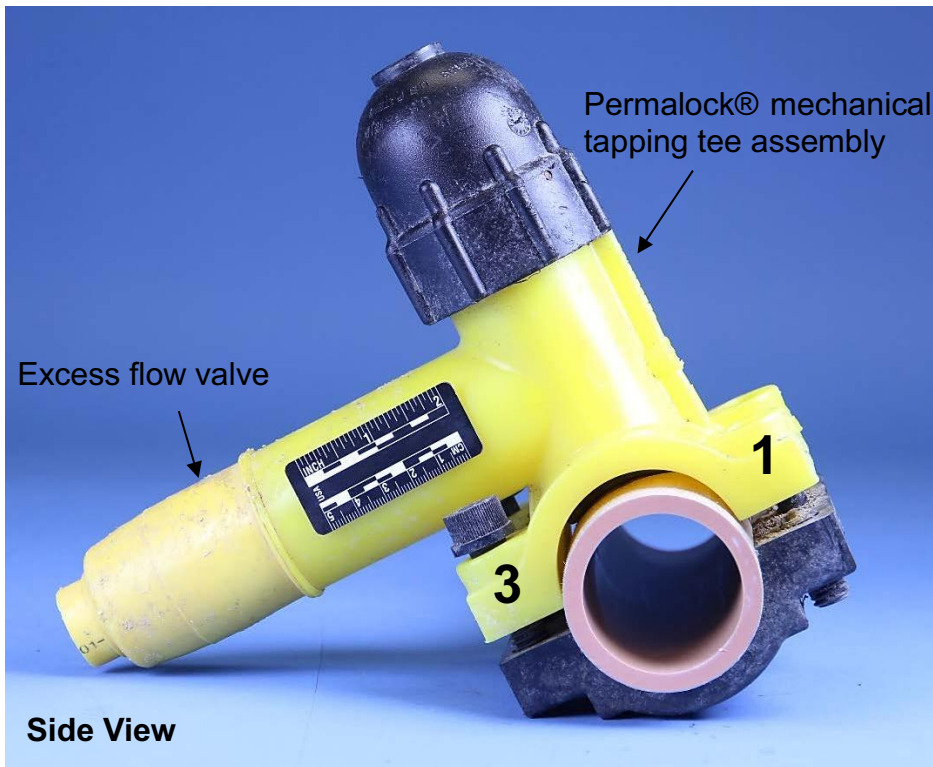
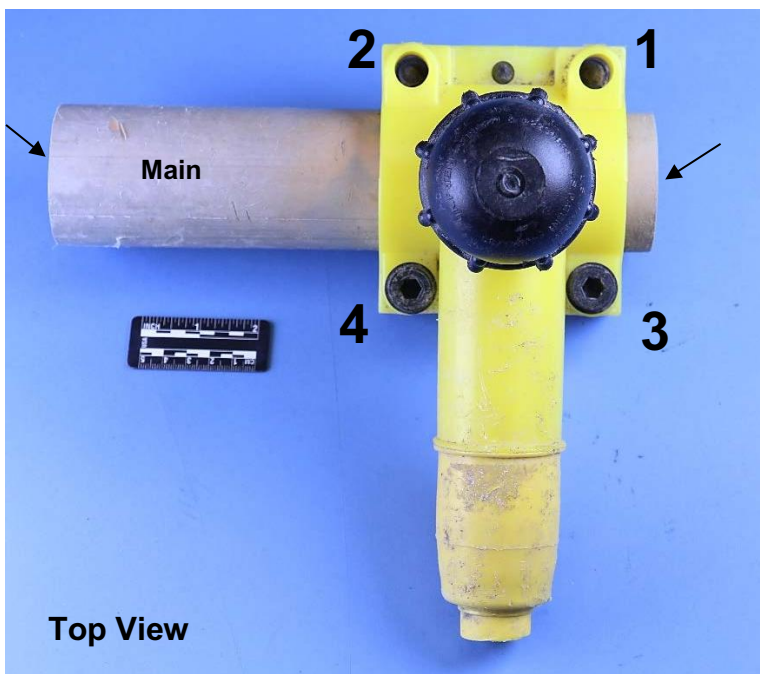
Figure 1. Photographs of the as-received mechanical tapping tee and identification numbers that were arbitrarily assigned to the attachment bolts, "1" through "4". Bolts "1" and "2" fractured at the thread portion. Arrows indicate cut portions of the main.

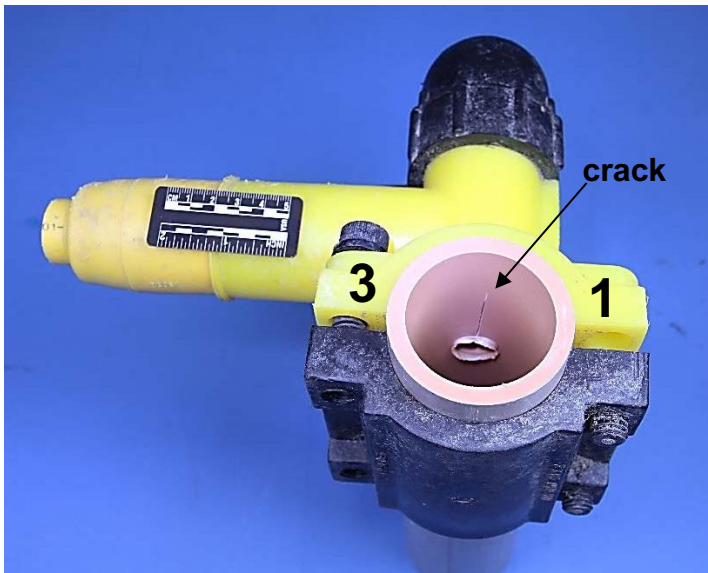
the parts. The main contained a longitudinal crack at the inner wall that intersected the pierced hole in the main (see figures 2 and 3). The length of the longitudinal crack on the inner wall surface measured approximately one inch. The mating faces of the fracture (crack) appeared flat. The tower portion was disassembled from the main and a longitudinal deformation pattern associated with the crack was noted on the outer face of the main. Figure 4 shows a photograph of the pierced hole that was made by the cutter tool. The pierced hole contained fine circular cut marks. The top portion of the main contained scratches that for the most part were circumferentially oriented relative to the length of the main and intersected the pierced hole in the main (see figures 5 and 6). Two of the four attachment bolts fractured at the threaded shank portion. The head portion of the two fractured bolts were not submitted and presumed missing. Figure 7 shows a photograph of the fracture face from bolt "2".

Figure 2. Photograph of the tee assembly showing the exposed inner wall of the main in the area where the cutter tool pierced the main. The wall of the pierced hole was bare.

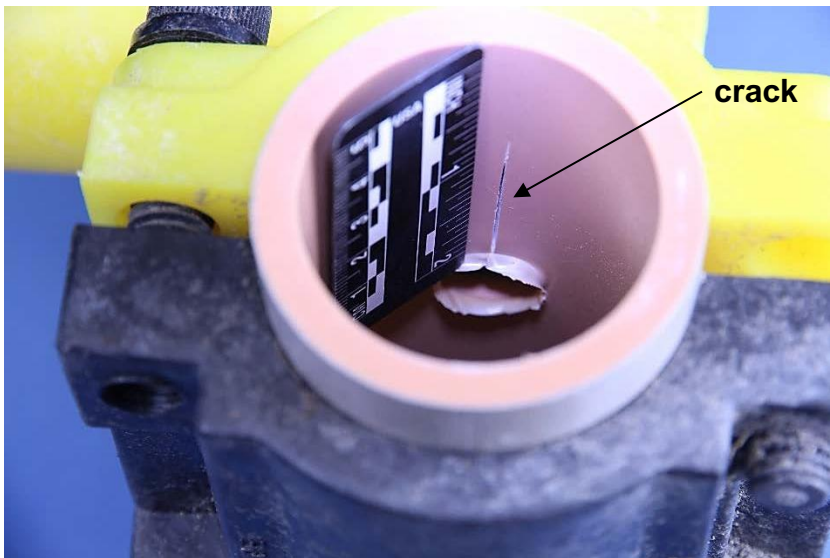
Figure 3. Another view of the inner wall of the main showing the longitudinal crack that intersected the pierced hole in the main.

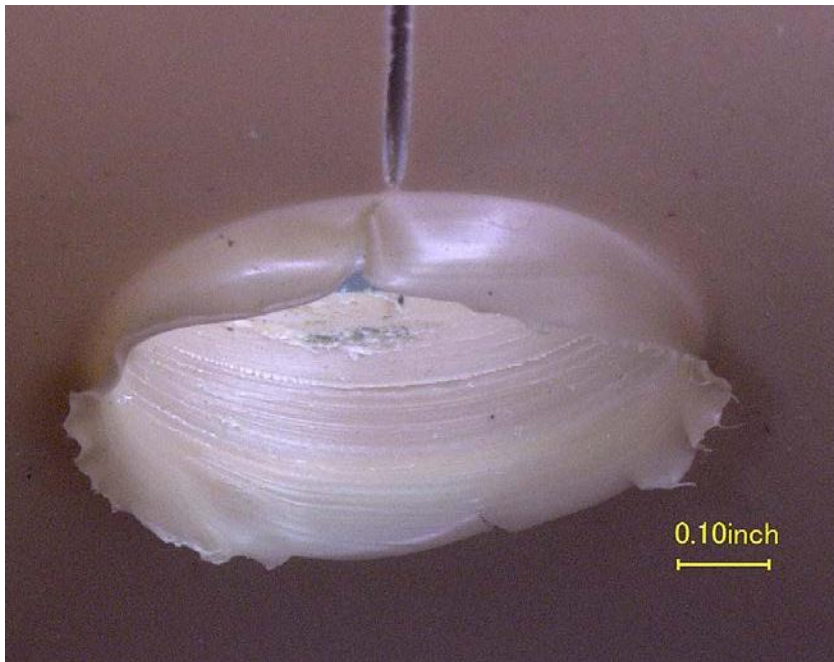
Figure 4. Photograph of the exposed inner surface of the main after disassembly of the tee showing the pierced hole made by the cutter tool. Note the fine circular cut marks within the pierced hole.

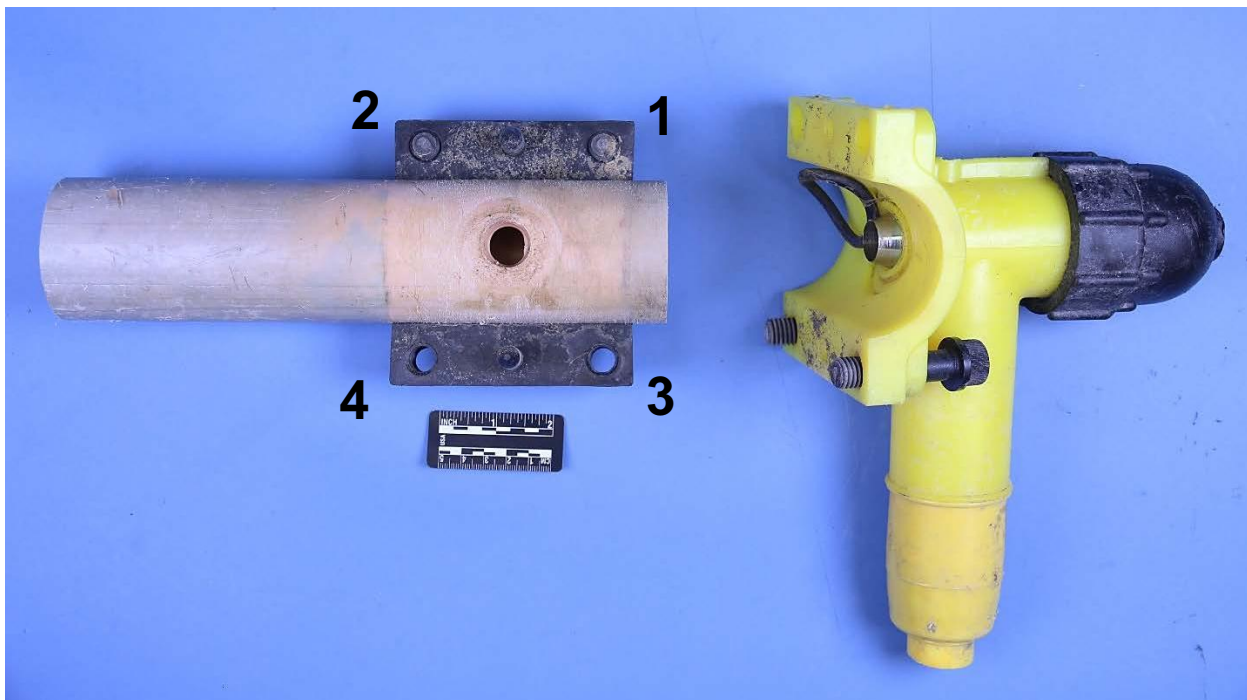
Figure 5. Photograph of the disassembled tee assembly showing the exposed outer top surface of the main and pierced hole (after removal of the tower portion). The top portion of the main contained scratches that for the most part were circumferentially oriented relative to the length of the main and intersected the pierced hole in the main.

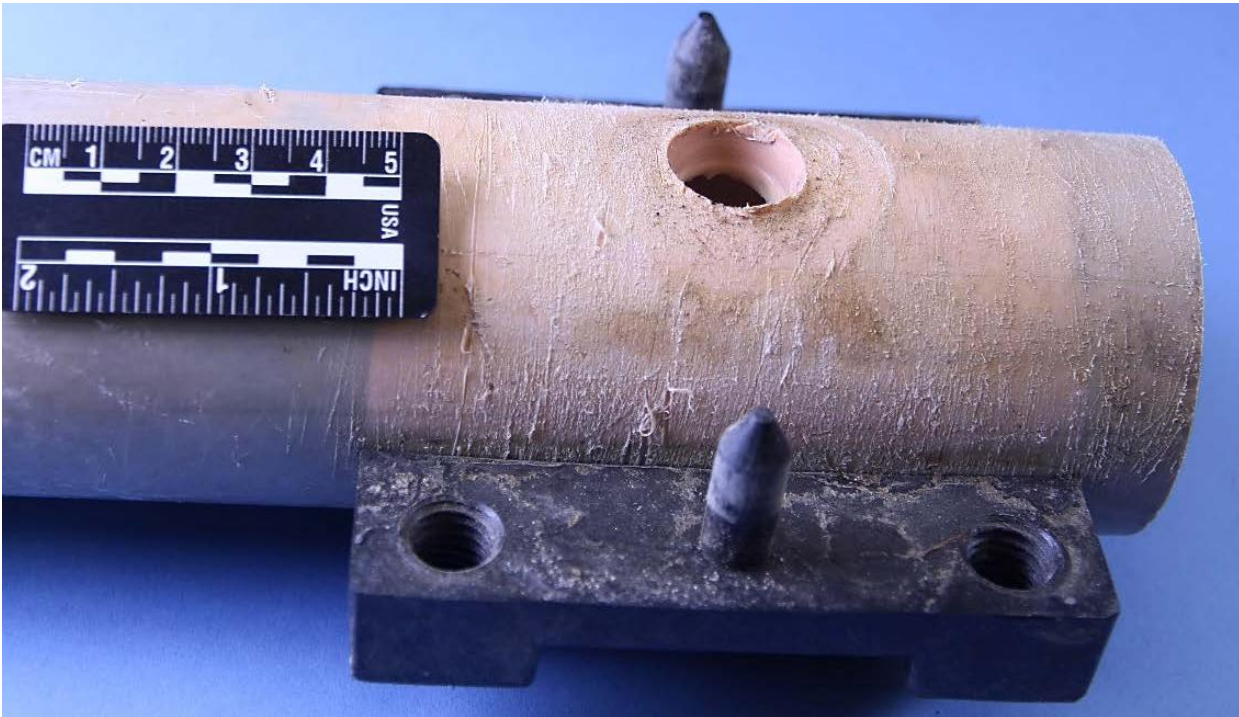
Figure 6. Photograph of the exposed outer top surface of the main after disassembly of the tower portion showing the pierced hole made by the cutter tool. The top portion of the main contained scratches that, for the most part, were circumferentially oriented relative to the length of the main and intersected the pierced hole in the main.

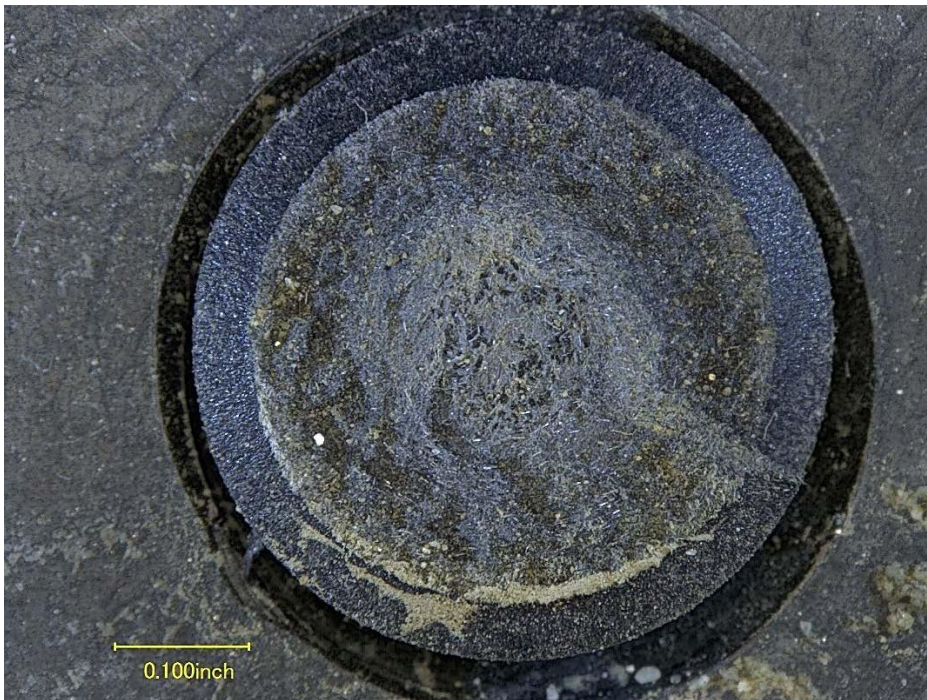
Figure 7. Fracture face of bolt "2".
