# NATIONAL TRANSPORTATION SAFETY BOARD

MATERIALS LABORATORY FACTUAL REPORT

Report No. 18-061

Place : Daytona Beach, Florida  
Date : April 4, 2018  
Vehicle : Piper PA-28R-201, N106ER  
NTSB No. : ERA18FA120  
Investigator : Aaron McCarter, AS-ERA / Clinton R. Crookshanks, AS-40

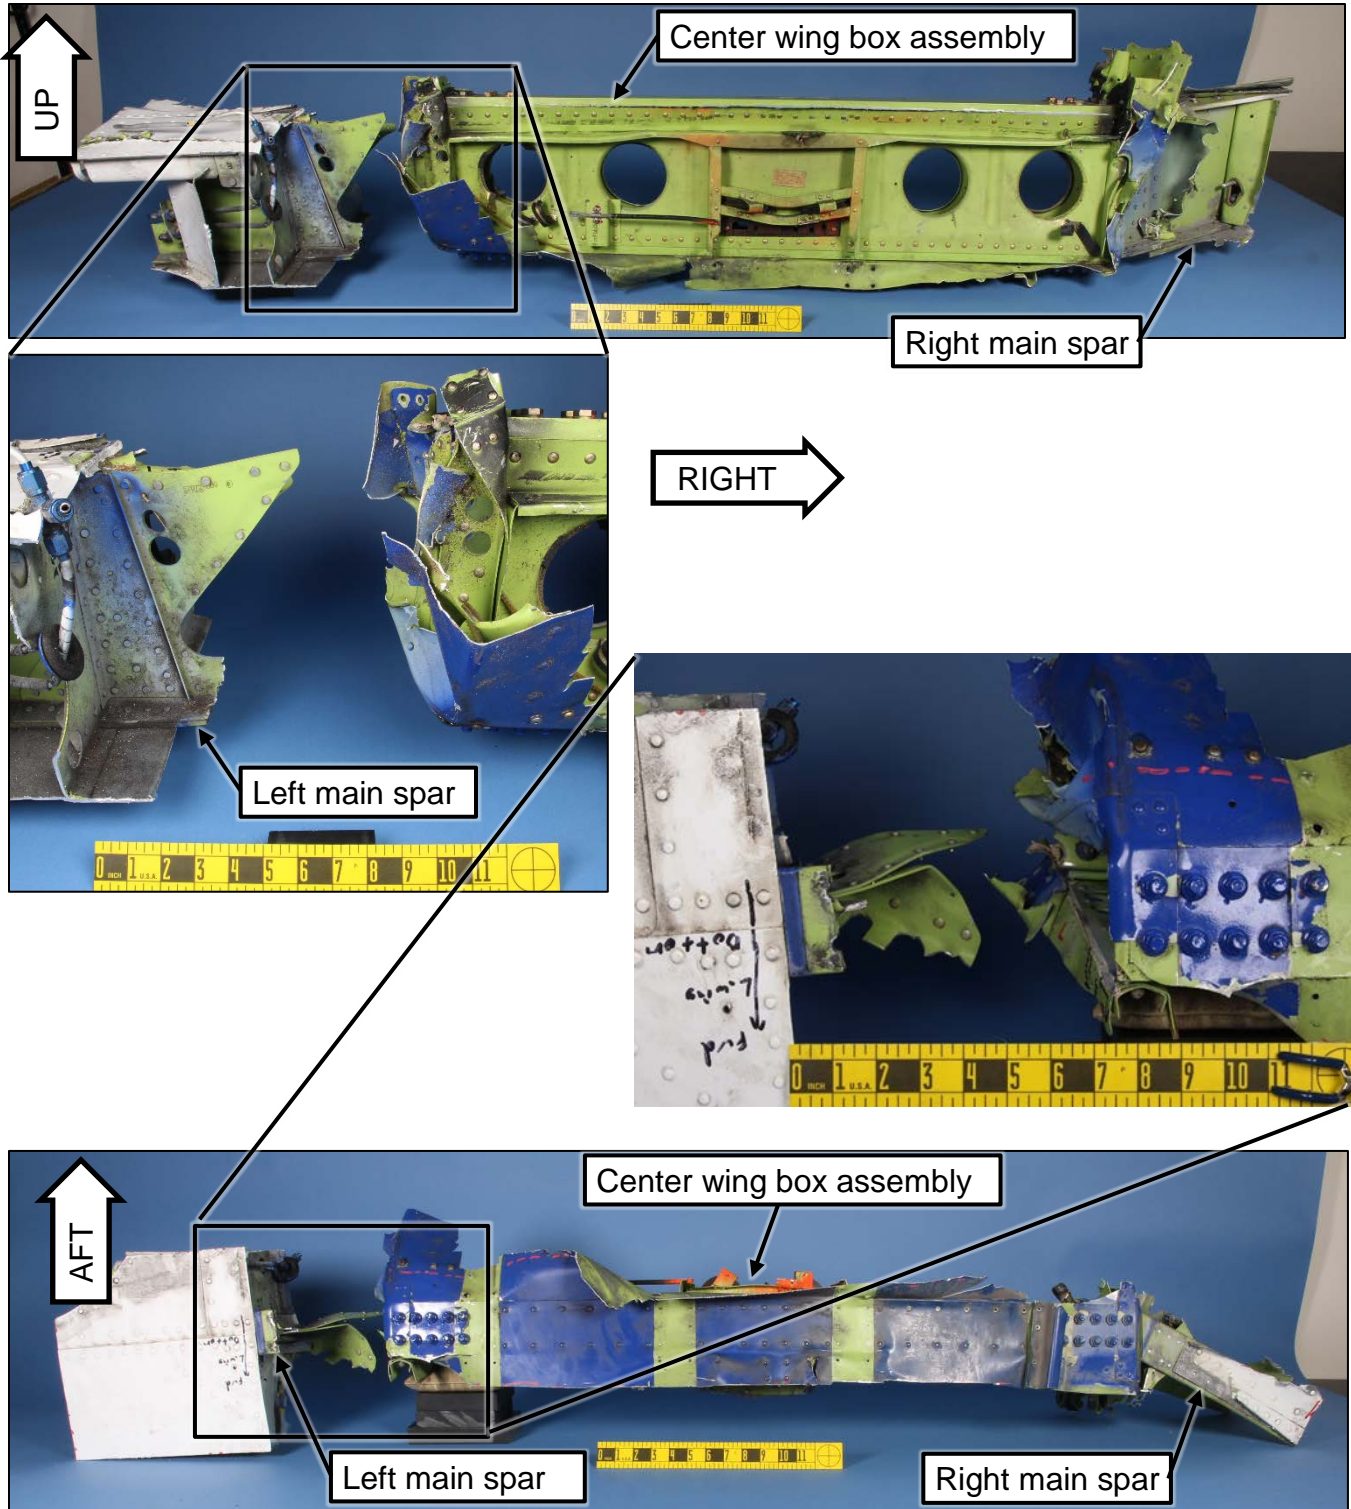
Overall views of the submitted center wing box assembly with attached right wing main spar piece and fractured left wing main spar piece are shown in figure 1. The right main spar was cracked at the inboard attachment location and the outboard end of the piece was deflected forward. The left main spar was fractured at the inboard attachment location. A group examination of the components was conducted on April 10 through 12, 2018 at the NTSB Materials laboratory with Structures Group representatives from the NTSB, Federal Aviation Administration, Piper Aircraft, Inc., and Embry-Riddle Aeronautical University (ERAU) present.

Figure 1. Overall views of the submitted components from the accident airplane showing the aft (upper images) and lower (lower images) surfaces.

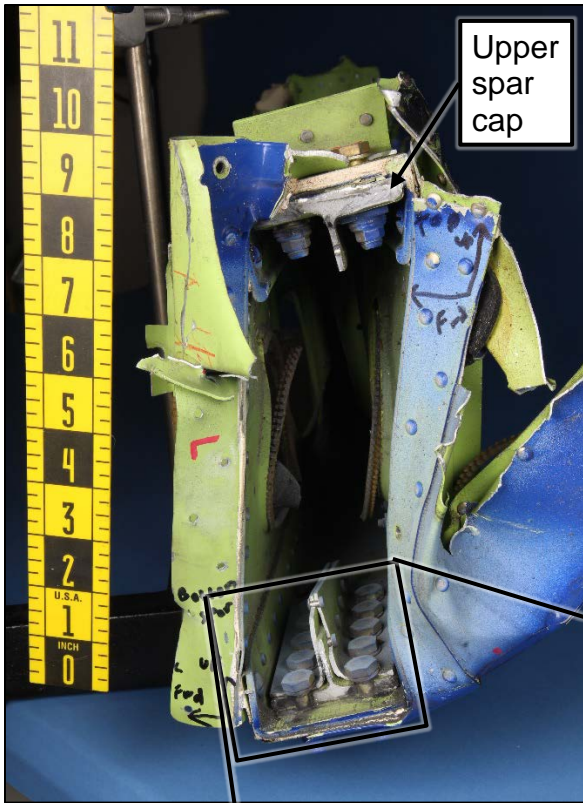
Views of the fracture in the left spar are shown in figures 2 and 3. The lower spar cap shown in figures 2 and 3 had a fracture that intersected holes for attachment bolts LC-1 and LD-1. Portions of the fracture surface had relatively smooth features in a plane perpendicular to the longitudinal axis, features consistent with fatigue fracture. Crack arrest lines were visible on the fracture surfaces of the lower spar cap and the forward and aft doublers, also consistent with fatigue fracture. Some of the fracture features were obscured by black-colored deposits, particularly in the areas near the apparent fatigue origins. The upper spar cap displayed rough matte-gray features consistent with ductile overstress fracture. Deformation associated with the fracture in the upper spar cap was consistent with an upward bending load.

Figure 2. Inboard side of the fracture in the left wing main spar viewed looking toward the center section.

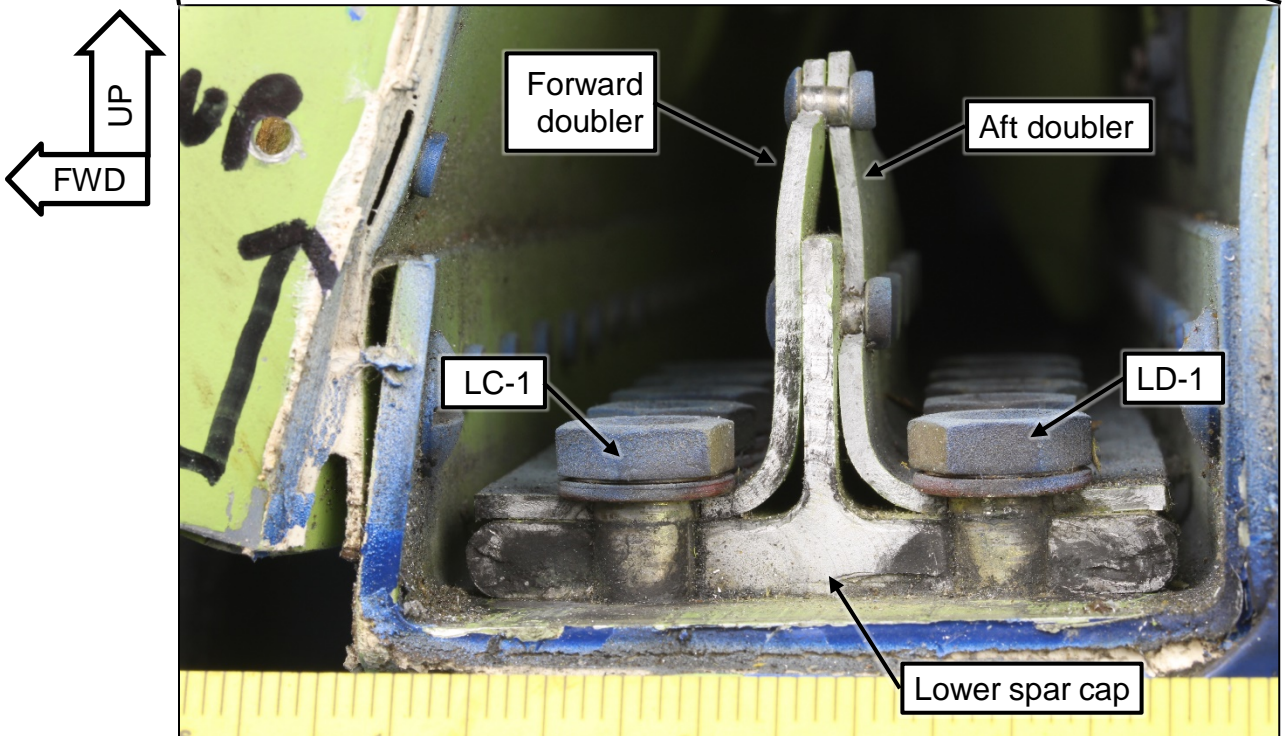
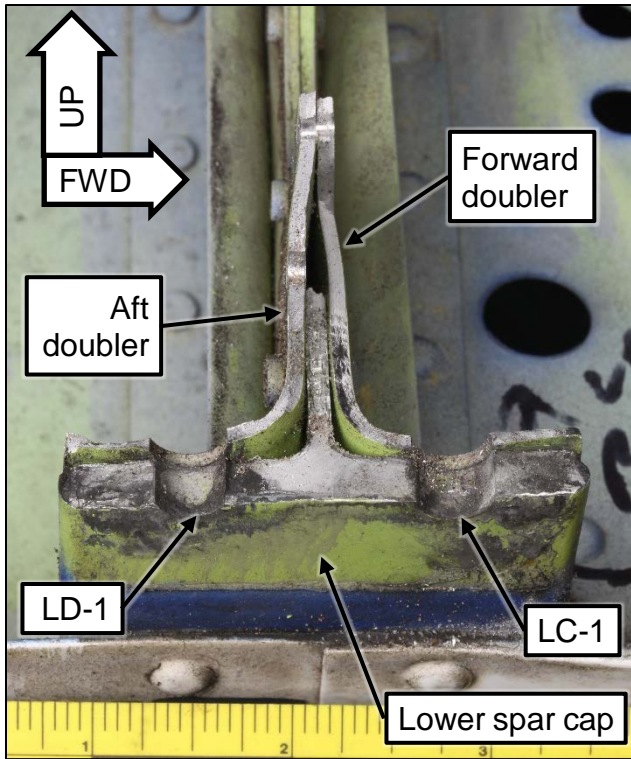
Figure 3. Outboard side of the fracture in the lower spar cap and attached doublers of the left wing main spar.

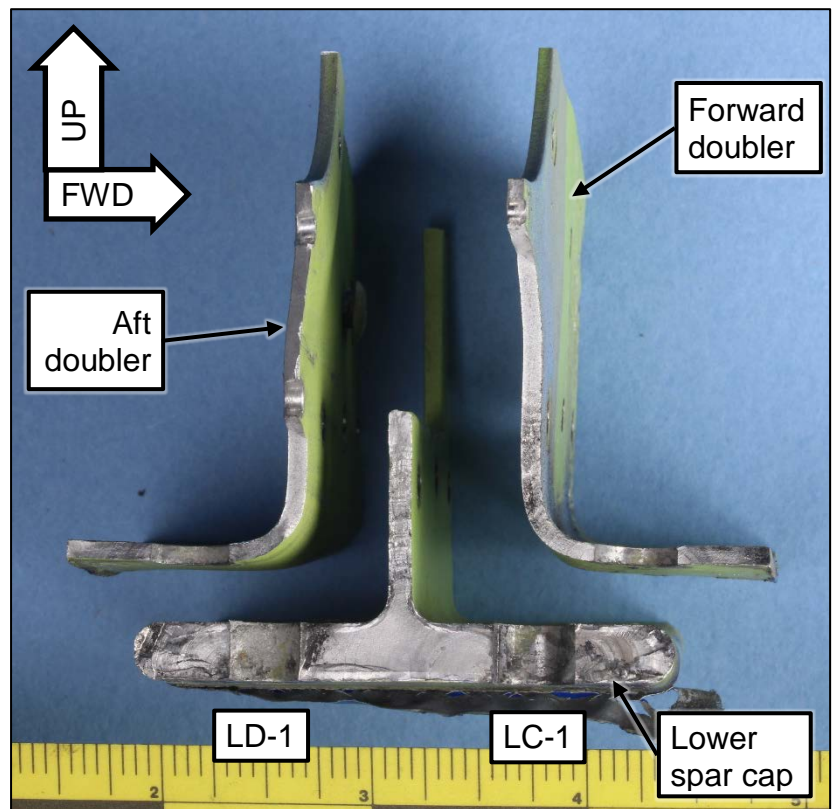
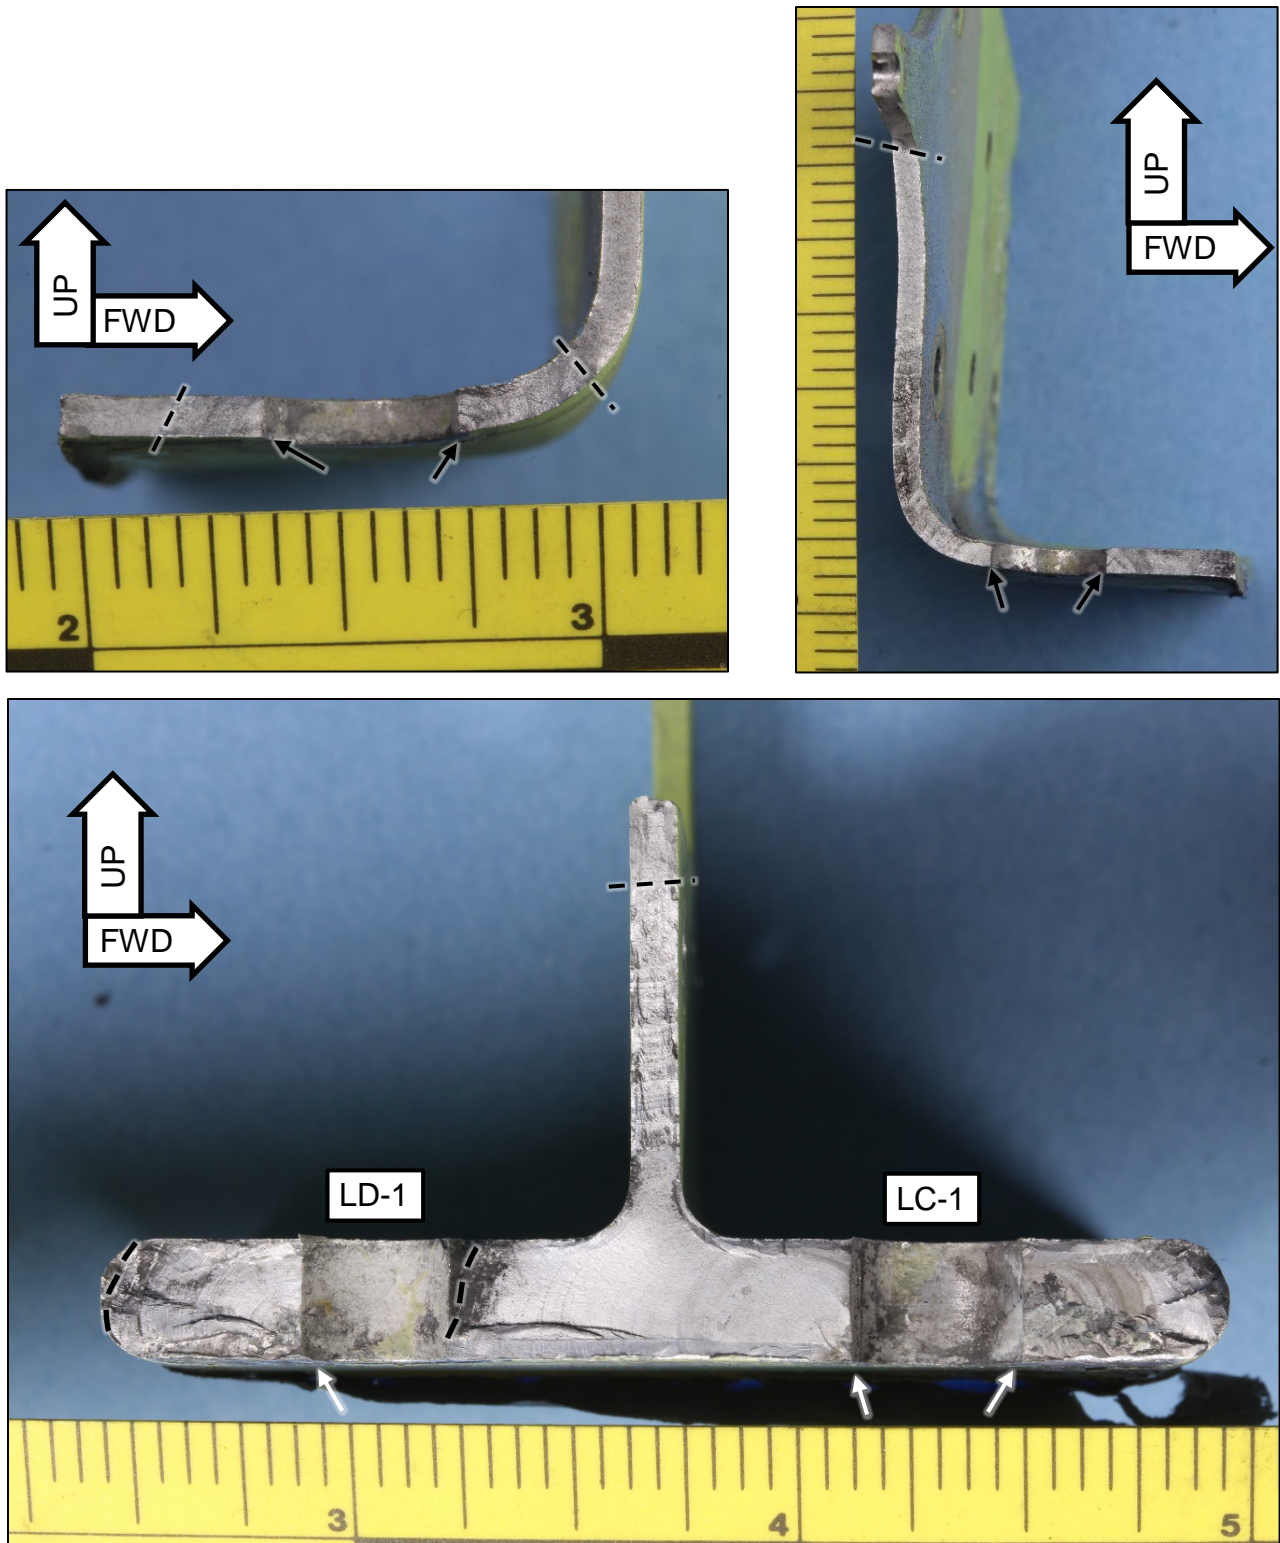
Unlabeled arrows in figure 5 indicate locations of fatigue origins, and dashed lines indicate fatigue boundaries. In the lower spar cap, origins were located at the lower surface both forward and aft of hole LC-1 and at the aft side of hole LD-1. Forward of hole LC-1, fatigue features extended to the forward edge of the lower spar cap as shown in a closer view of the fracture surface in figure 6. Aft of hole LC-1, fatigue features extended aft through the spar cap, intersecting the lower side of hole LD-1, and upward into the web to the boundary located approximately 0.75 inch above the spar cap. From

the aft side of hole LD-1, fatigue features extended to the boundary near the upper aft side of the lower spar cap as shown.

In the doublers, fatigue origins were noted on the lower sides of the doublers both forward and aft of the attachment holes. The fatigue region in the forward doubler was larger, extending forward to the forward edge of the doubler and upward approximately 1.25 inches from the aft side of the hole. In the aft doubler, the fatigue regions extended to the boundaries shown in figure 5 where the boundaries were approximately 7/8 inch apart.

Figure 5. Closer views of the fracture surfaces in the doublers (upper images) and the lower spar cap (lower image) after cleaning. Unlabeled arrows indicate fatigue origin areas, and dashed lines indicate fatigue boundaries.

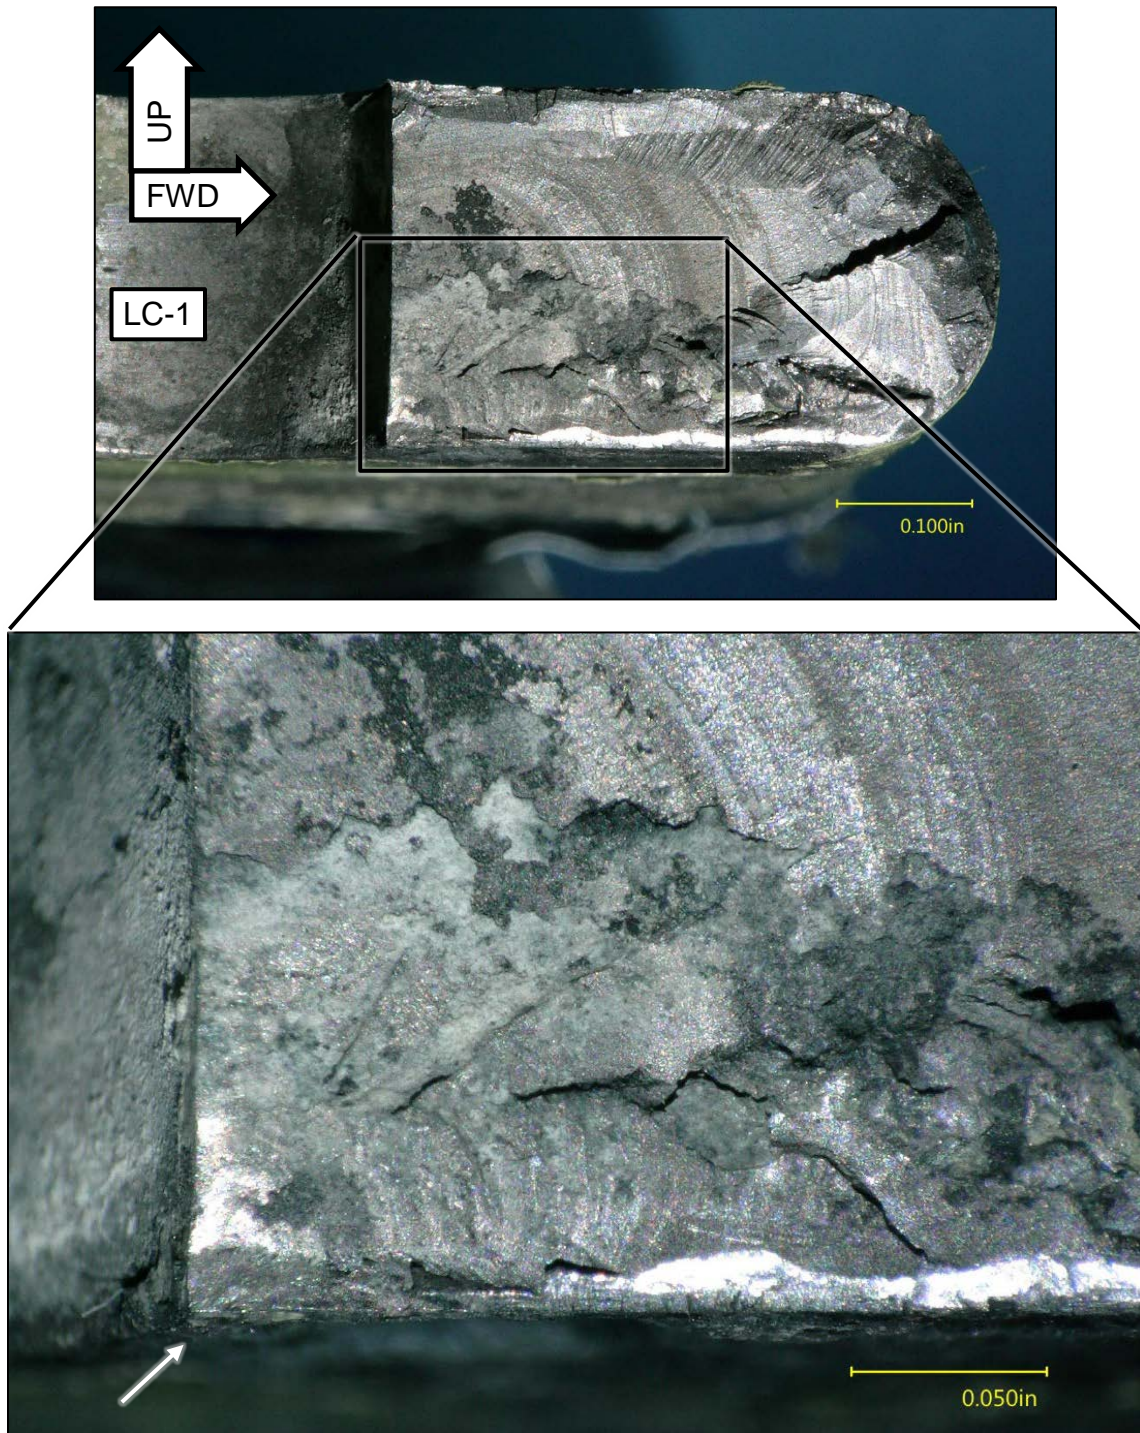
Next, the lower spar cap was examined using a scanning electron microscope (SEM). Parts of the fracture surface remained obscured by light green deposits on the surface visible in the optical image in figure 6. The deposits generally appeared brighter in the SEM due to charging effects associated with SEM imaging of nonconductive materials.

Figure 6. Optical images of the fatigue region forward of hole LC-1 (upper image) with a closer view of the fatigue origin area. An unlabeled arrow indicates the fatigue origin area.

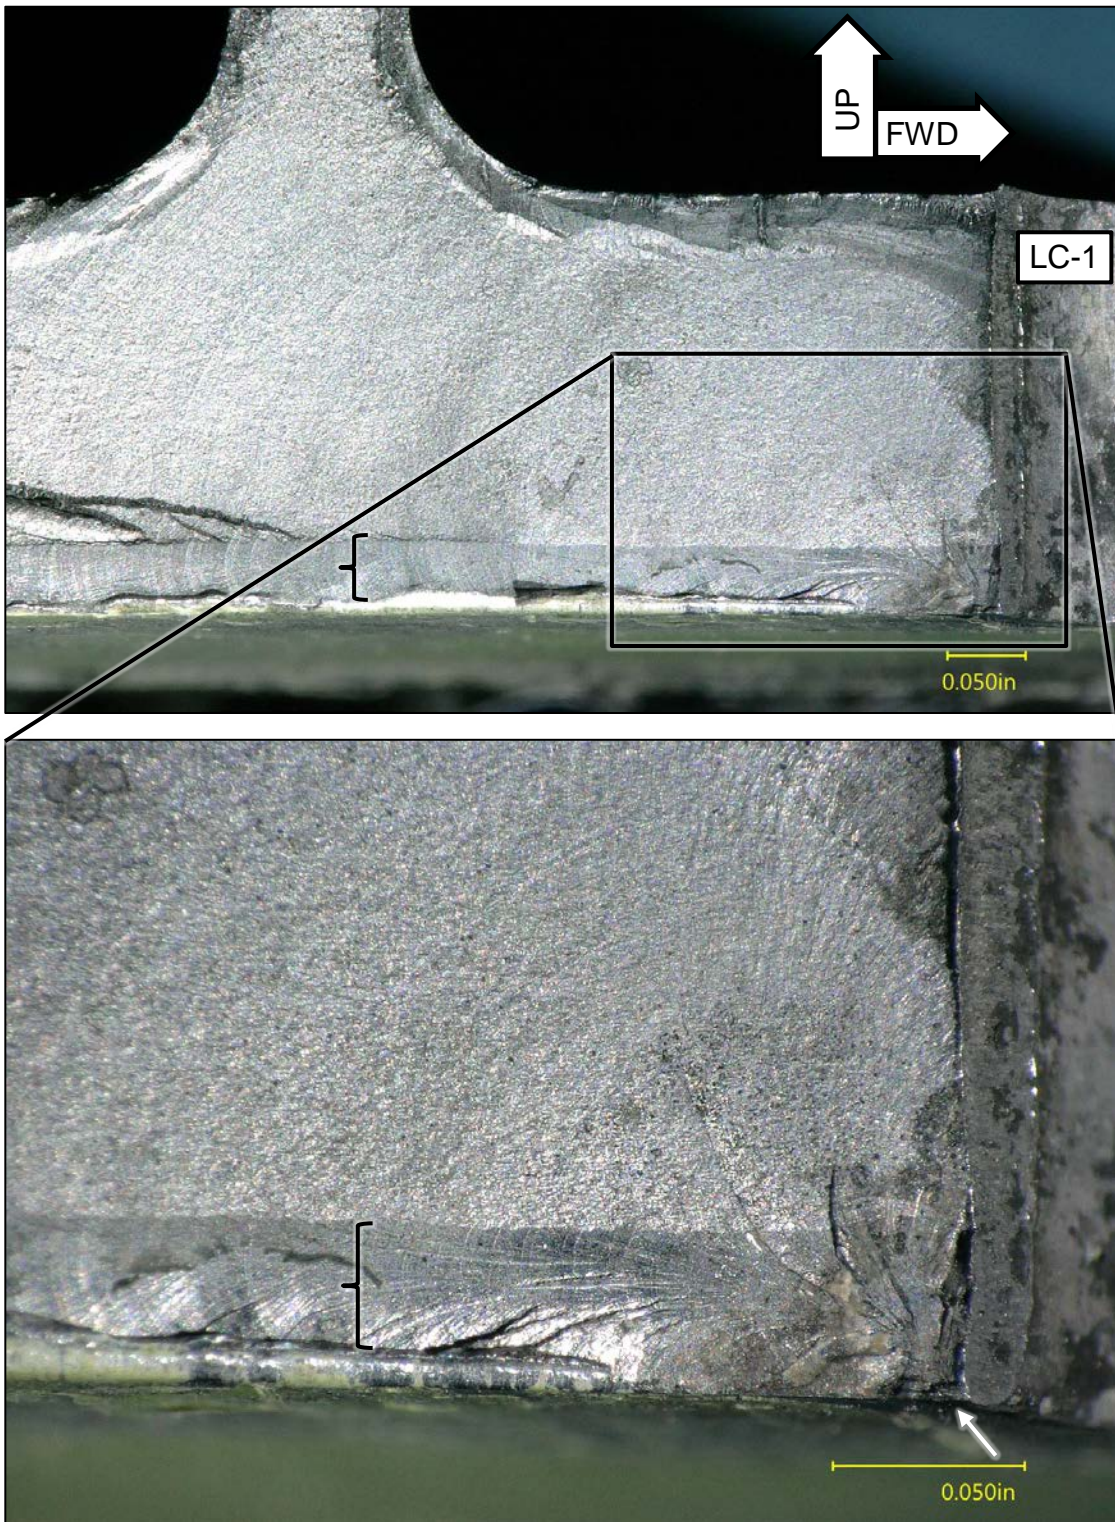
Closer views of the fatigue region aft of hole LC-1 are shown in figure 7. Near the surfaces of the spar cap, fatigue features had a different texture, appearing smoother than features near the middle of the thickness with a distinct boundary between the different-textured regions. Brackets in figure 7 indicate smoother areas at the lower surface of the spar cap.

Figure 7. Optical images of fatigue features aft of hole LC-1 including a view of the origin area at higher magnification (lower image). Unlabeled brackets indicate areas near the surface with relatively smoother fatigue features, and an unlabeled arrow indicates the fatigue origin area.

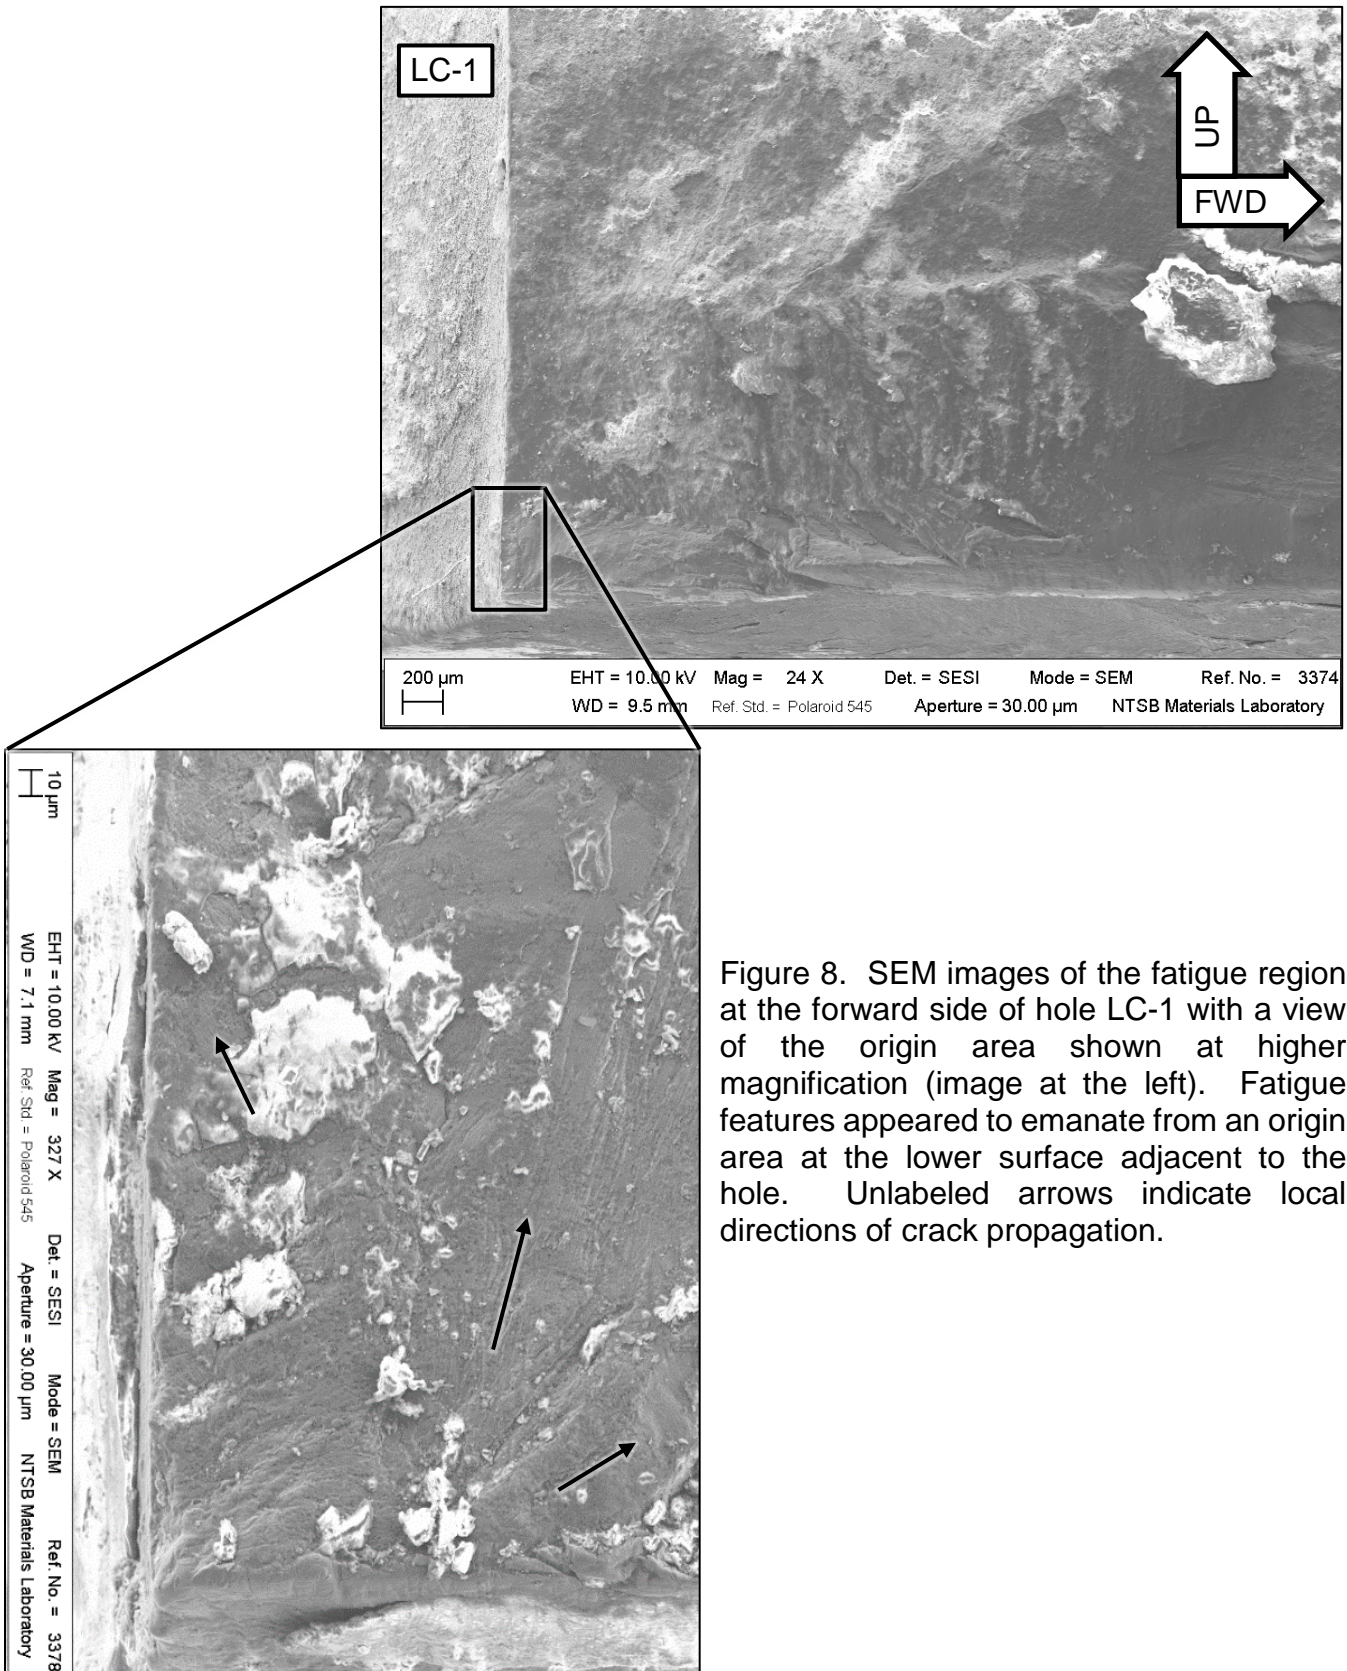
SEM views of the origin areas at the forward and aft sides of hole LC-1 are shown in figures 8 and 9. Unlabeled arrows in figures 8 and 9 indicate local directions of fatigue crack propagation based on available fracture features in the images. The origin areas in each location appeared partly obscured or damaged by post-fracture rubbing or deposits on the surface. However, fracture features appeared to emanate from origins at the lower surface of the spar cap adjacent to attachment hole LC-1.

Figure 8. SEM images of the fatigue region at the forward side of hole LC-1 with a view of the origin area shown at higher magnification (image at the left). Fatigue features appeared to emanate from an origin area at the lower surface adjacent to the hole. Unlabeled arrows indicate local directions of crack propagation.

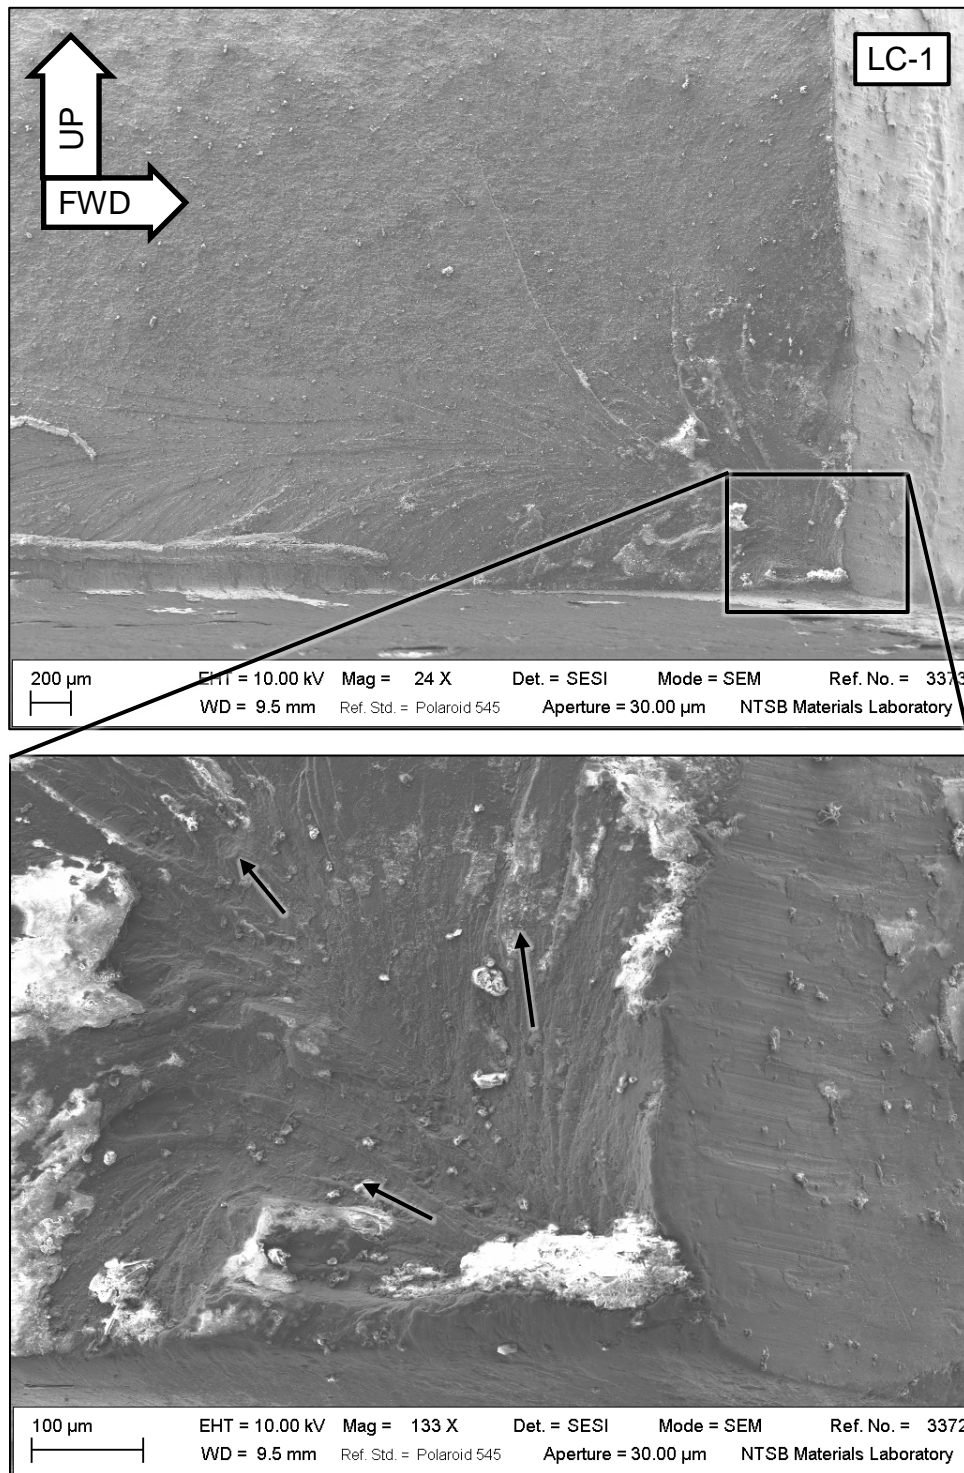
Figure 9. SEM images of fracture features at the aft side of hole LC-1 with a view of the origin area shown at higher magnification (lower image). Unlabeled arrows indicate local directions of crack propagation.

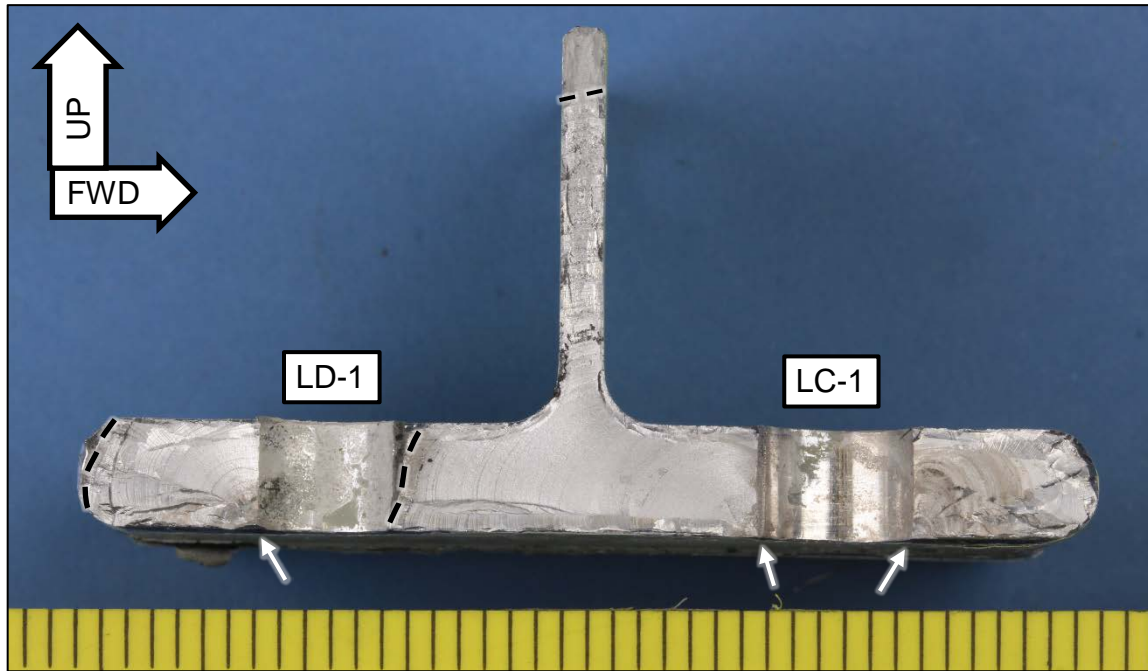
To further characterize the origin areas at the forward and aft sides of hole LC-1 on the lower spar cap, the fracture surface was cleaned by briefly submerging the piece with the fracture surface in a heated aqueous solution containing phosphoric acid and chromium trioxide. A photograph of the fracture surface after completion of the chemical cleaning process is shown in figure 10.

Figure 10. View of the lower spar cap fracture surface after chemical cleaning. Unlabeled arrows indicate fatigue origin areas, and dashed lines indicate fatigue boundaries.

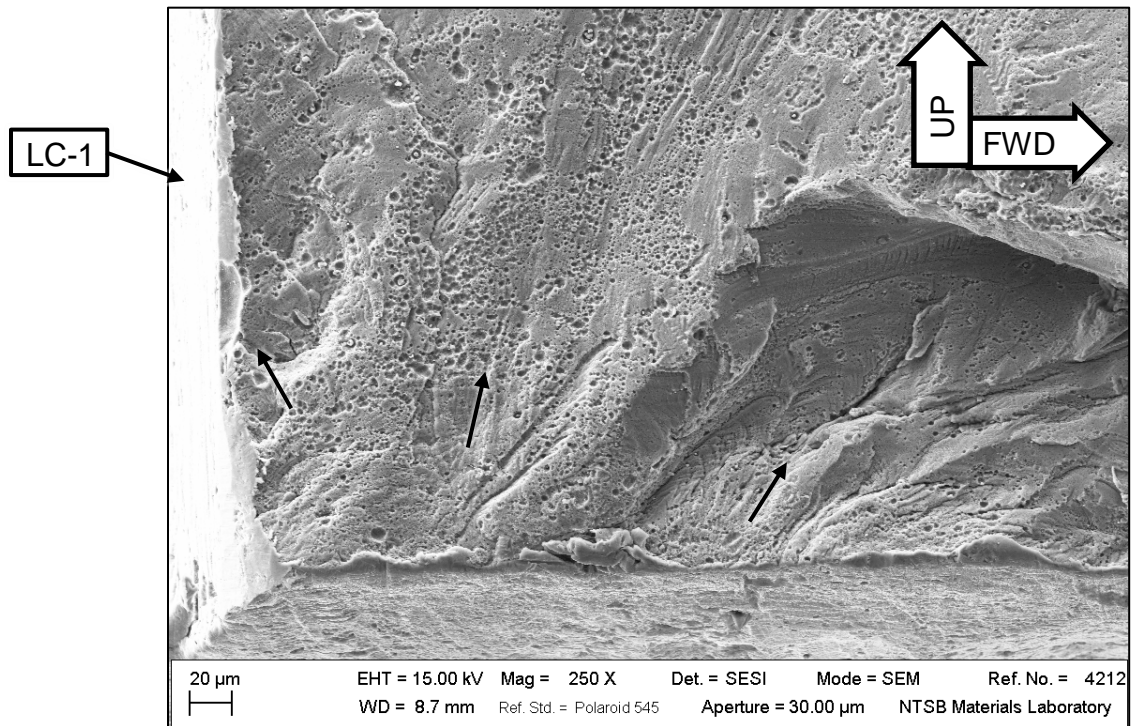
SEM images of the chemically cleaned origin areas at the forward and aft sides of hole LC-1 are shown in figures 11 and 12, respectively. After cleaning, deposits that partly obscured the origin areas were removed, revealing additional fracture features. At the forward side of hole LC-1, fracture features at the corner between hole LC-1 and the lower surface appeared rubbed. However, the direction of local crack propagation in adjacent areas of the fracture surface (see unlabeled arrows in figure 11) appeared to be consistent with a crack origin at the lower surface adjacent to hole LC-1. At the aft side of the hole shown in the upper image in figure 12, a deformed lip was present on the lower side of the fracture which obscured fracture features at the lower edge, and the fracture surface appeared deformed along the edge of hole LC-1 near the lower surface.

Figure 11. SEM image of the fatigue origin area at the forward side of hole LC-1 after chemical cleaning. Fatigue features appeared to emanate from an origin area at the lower surface adjacent to the hole, but a precise origin was not identified due to damage to the fracture surface. Unlabeled arrows indicate local directions of crack propagation.

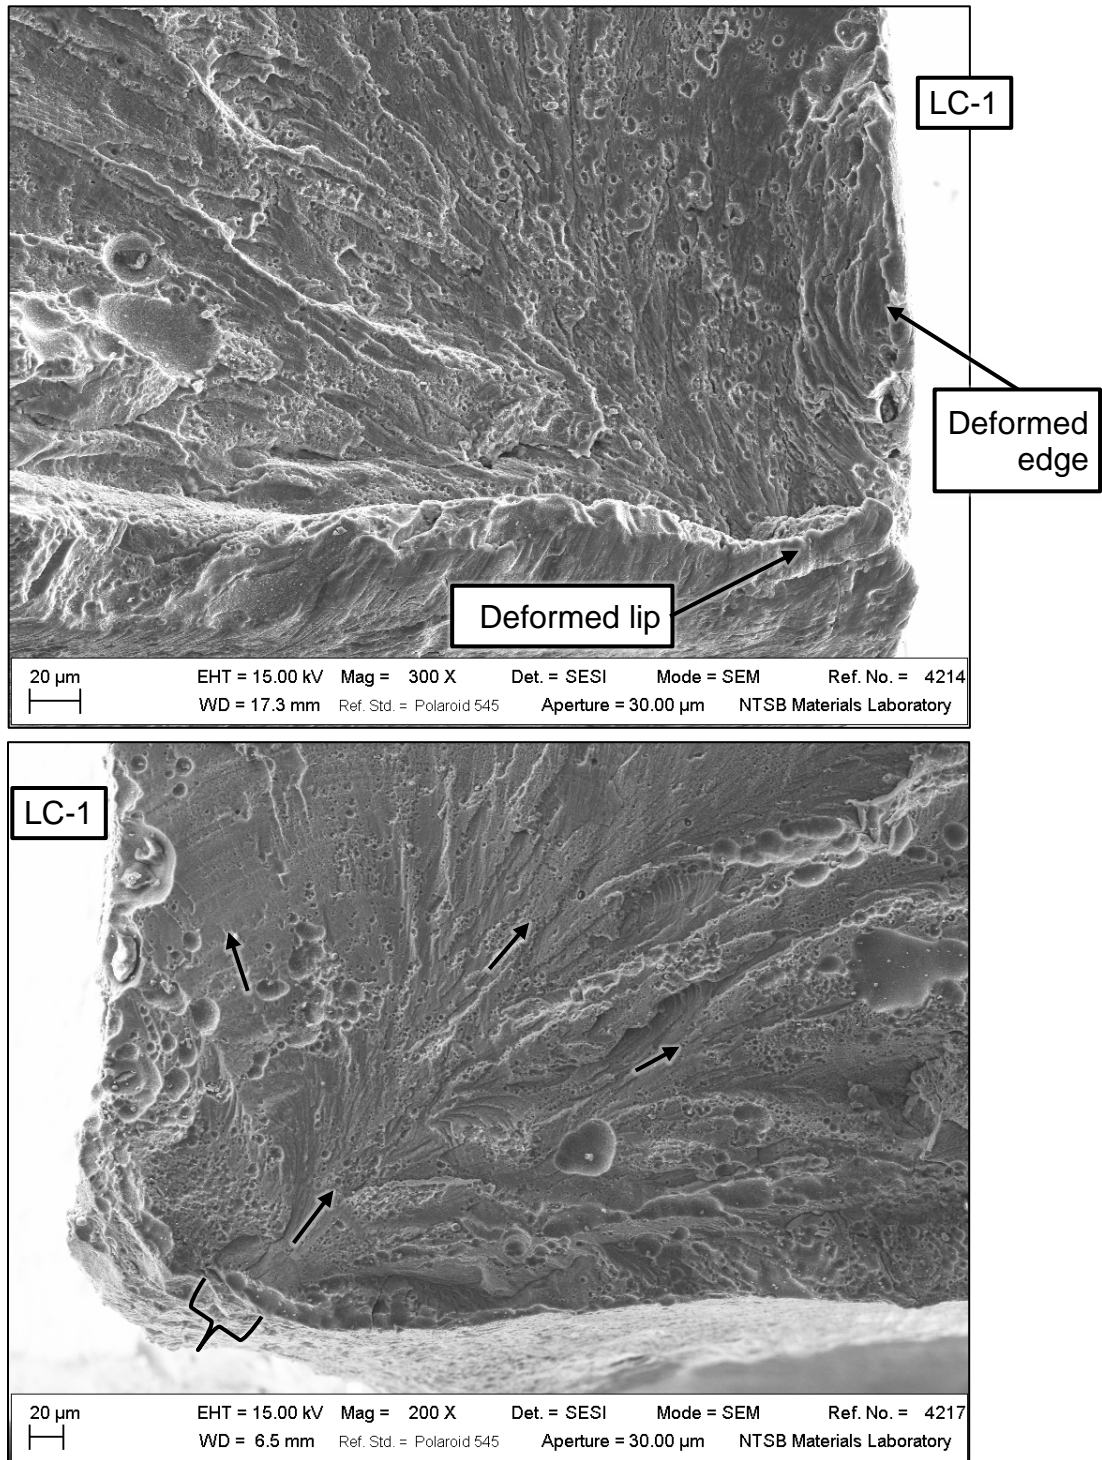
To further characterize the origin area at the aft side of hole LC-1, a transverse cut was made through the left wing main spar lower spar cap approximately 1 inch inboard of the fracture to facilitate an SEM examination of the mating (inboard) fracture surface. After sectioning, the fracture surface was cleaned with acetone followed by application and removal of acetate tape to lift off surface deposits. Next, the piece with the fracture surface was cleaned using the chemical method applied to the mating side of the fracture described above. A view of the origin area at the aft side of hole LC-1 after chemical cleaning is shown in the lower image in figure 12. A bracket in figure 12 indicates a fatigue origin area located in the chamfer between the lower surface and hole LC-1. Unlabeled arrows in the lower image in figure 12 indicate the local crack propagation directions emanating from the indicated origin area.

Figure 12. SEM images of mating fracture surfaces at the aft side of hole LC-1 showing the outboard side (upper image) and the inboard side (lower image) of the fracture after each surface had been chemically cleaned. An unlabeled bracket indicates the location of the origin area (identified with an unlabeled bracket) on the inboard side of the fracture which was damaged on the mating outboard side. Unlabeled arrows indicate local directions of crack propagation.

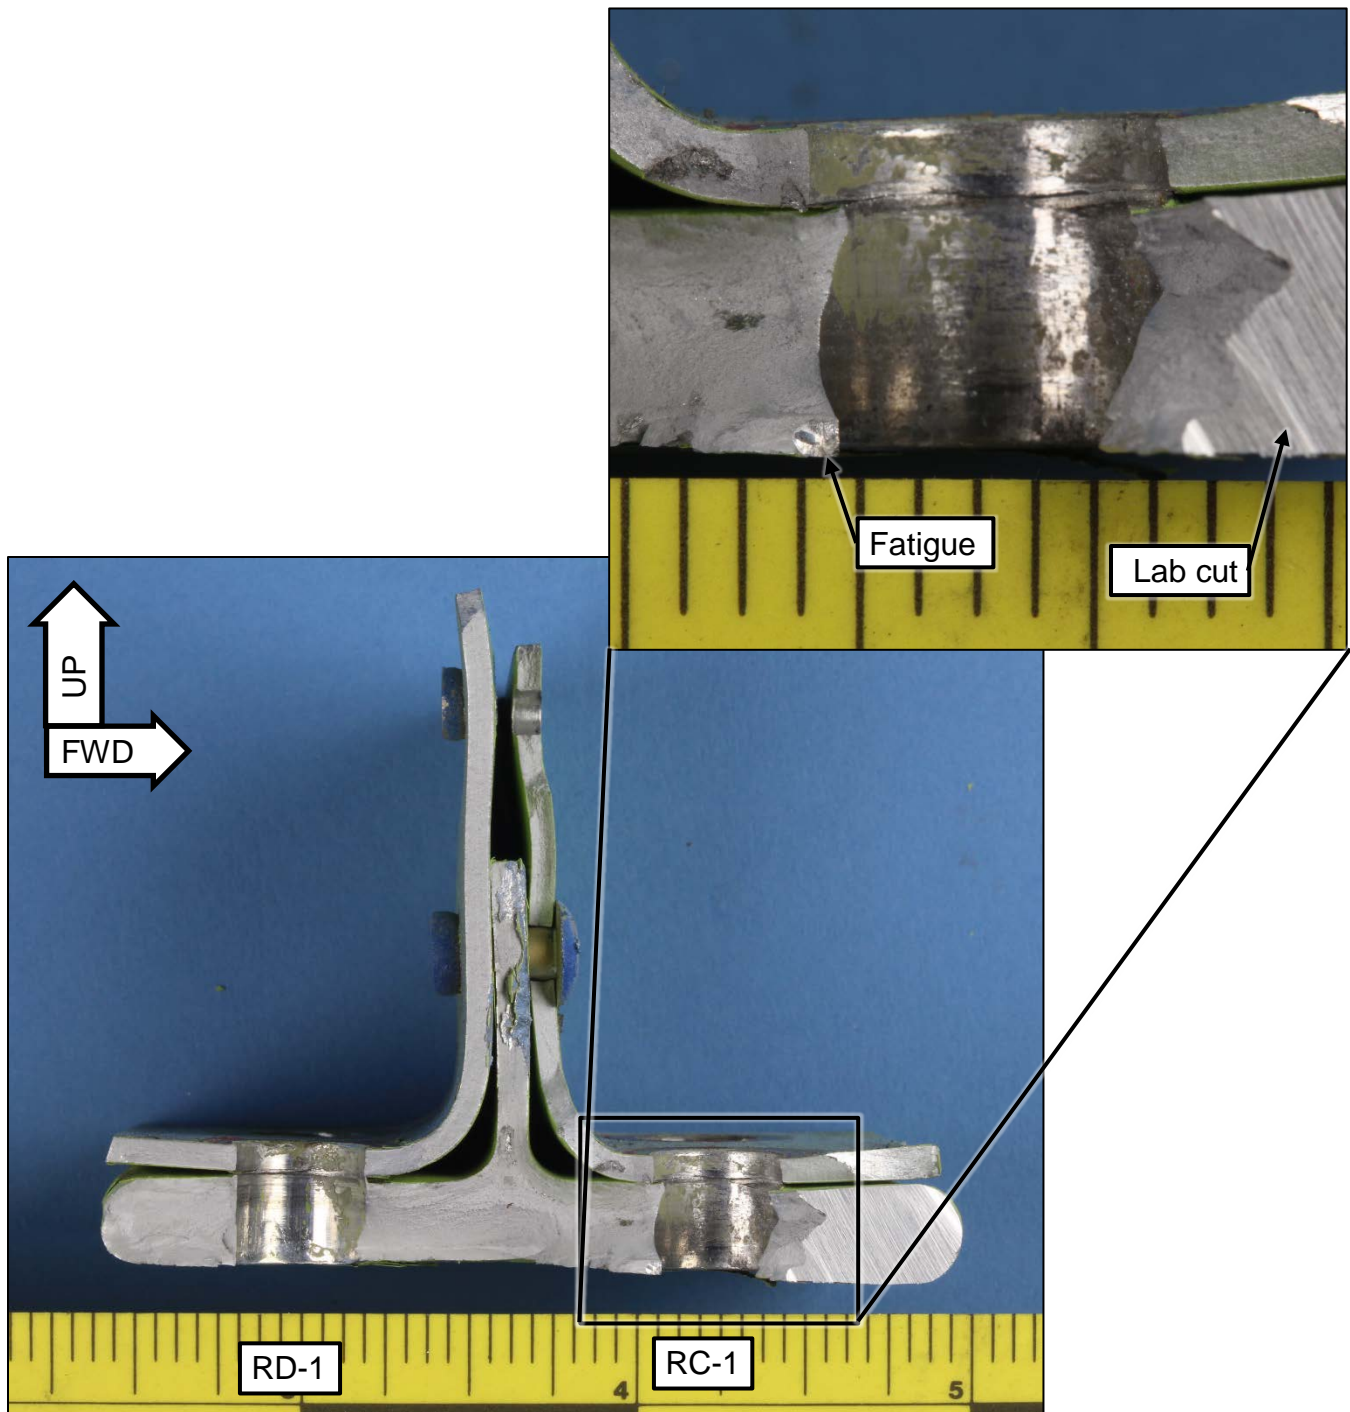
After torque measurements were completed, the right main spar piece was disassembled from the center wing box assembly, and cuts were made to facilitate separating the mating fracture surfaces. Views of the inboard side of the fracture after completing the break with a lab fracture is shown in figure 15. The fracture surface had mostly rough matte-gray features consistent with ductile overstress fracture. River patterns associated with the fracture emanated from hole RD-1 located aft of the spar web consistent with fracture initiation near hole RD-1. The overstress fracture in the right main spar lower spar cap emanated forward, intersecting hole RC-1. As shown in figure 15, a reflective area was observed on the fracture surface at the lower aft side of hole RC-1.

Figure 15. View of the right main spar lower spar cap and doublers from the accident airplane after the crack was opened by lab fracture. The fatigue region at the aft side of hole RC-1 is indicated.
