# NATIONAL TRANSPORTATION SAFETY BOARD

MATERIALS LABORATORY FACTUAL REPORT

Report No. 18-061

Place : Daytona Beach, Florida  
Date : April 4, 2018  
Vehicle : Piper PA-28R-201, N106ER  
NTSB No. : ERA18FA120  
Investigator : Aaron McCarter, AS-ERA / Clinton R. Crookshanks, AS-40

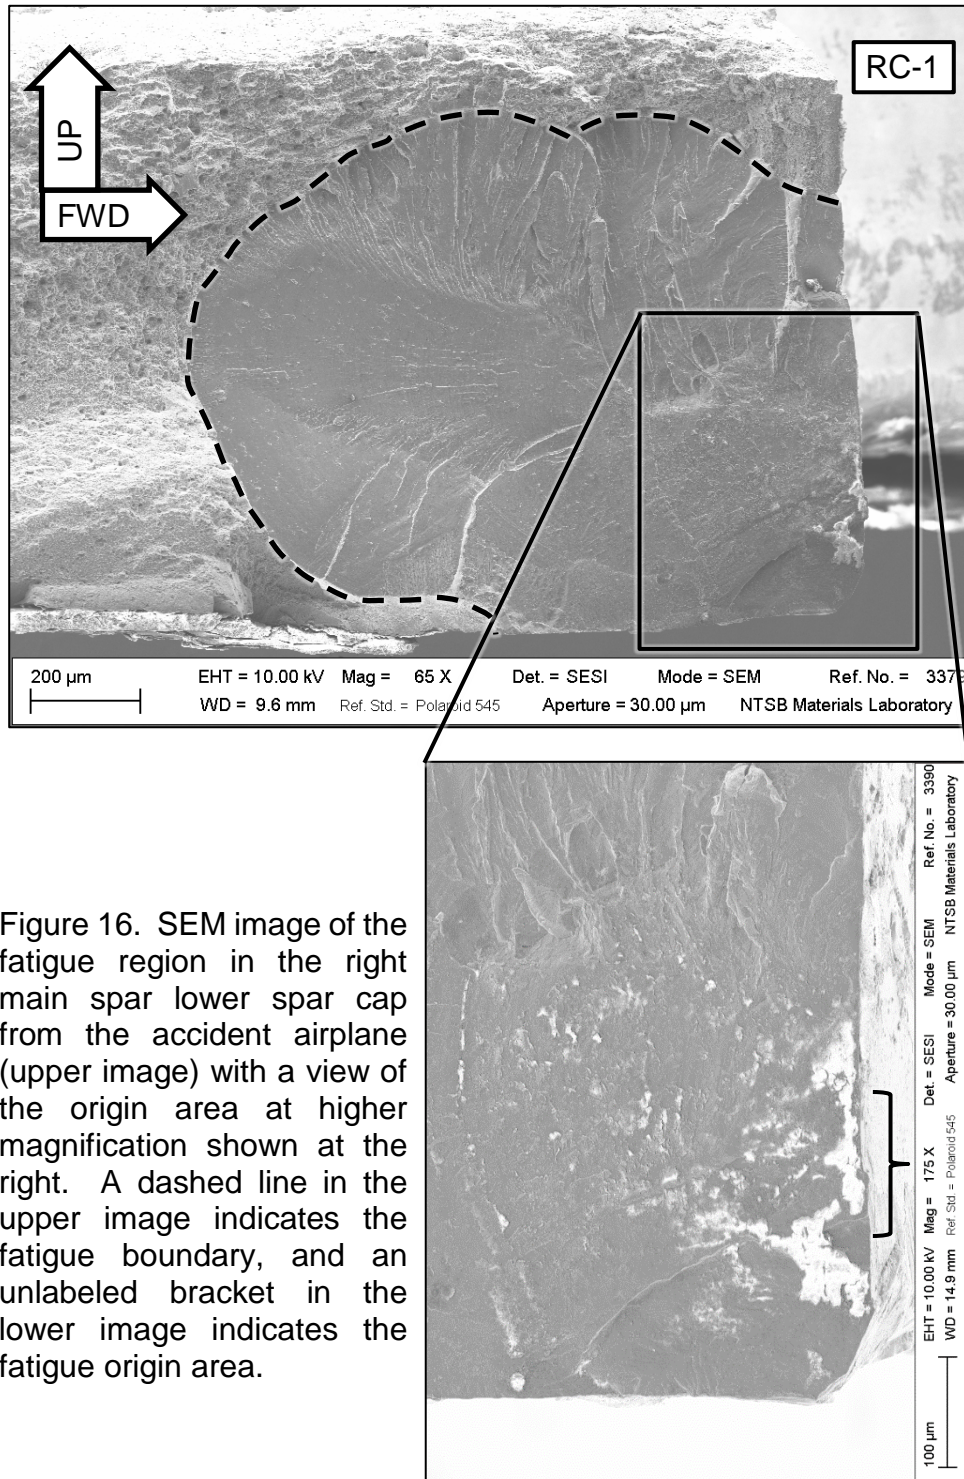
The right wing main spar lower spar cap piece shown in figure 15 was further examined using an SEM, and resulting images of the reflective area at the forward side of hole RC-1 are shown in figure 16. At higher magnification, striations were observed consistent with fatigue. Fatigue features emanated from an origin area located at the hole surface as indicated with a bracket in the lower image in figure 16. A dashed line in the upper image in figure 16 indicates the fatigue boundary, extending up to 0.047 inch aft of the hole and 0.038 inch upward from the lower surface. Where the fatigue region intersected the lower surface, the fatigue crack length was 0.026 inch. No evidence of a preexisting crack was observed at hole RD-1 (where the overstress fracture of the spar cap initiated).

Figure 16. SEM image of the fatigue region in the right main spar lower spar cap from the accident airplane (upper image) with a view of the origin area at higher magnification shown at the right. A dashed line in the upper image indicates the fatigue boundary, and an unlabeled bracket in the lower image indicates the fatigue origin area.

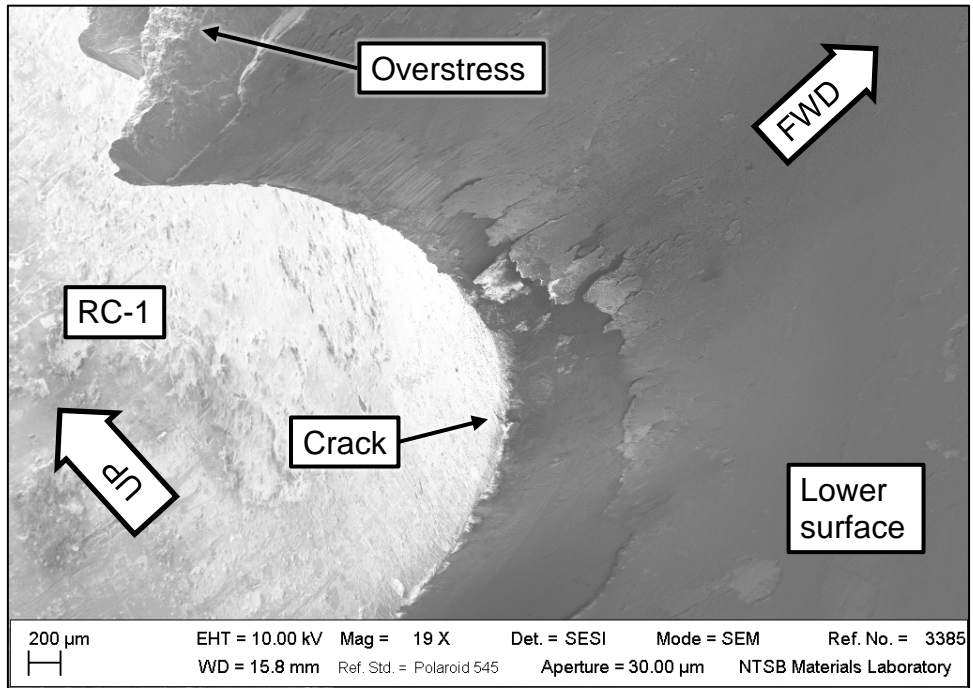
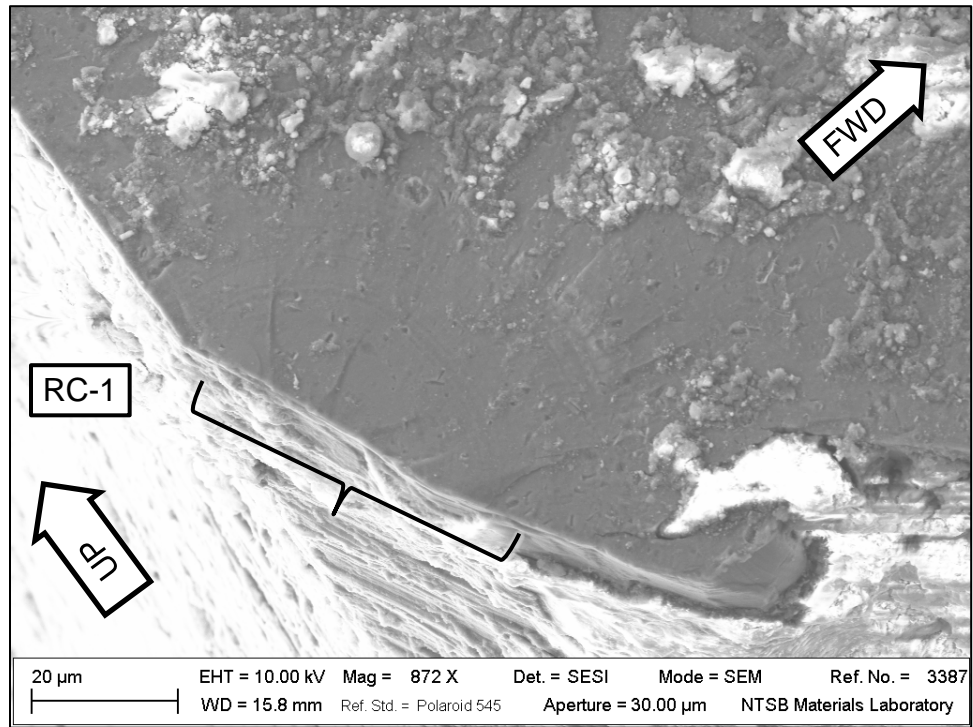
The overstress fracture at the forward side of the hole was located outboard of the transverse plane intersecting the hole center. A tilted view of the forward edge of the hole inboard of the overstress fracture is shown in the upper image in figure 17. As indicated, a crack was observed at the forward edge of the hole where it intersected the lower surface. A closer view of the crack fracture surface is shown in the lower image in figure 17. Smooth fracture features with curving crack arrest lines were observed consistent with fatigue fracture. Ratchet marks<sup>2</sup> were also observed, consistent with multiple fatigue origins. A bracket in the lower image in figure 17 indicates the fatigue origin area located in the chamfer between the hole bore and the lower surface of the main spar.

Figure 17. SEM images of a fatigue crack at the lower forward side of the forward hole in the right wing main spar lower spar cap from the accident airplane after lab fracture. The location of the crack is indicated in the upper image, and the fracture surface of the crack is shown in the lower image. An unlabeled bracket indicates the fatigue origin area.

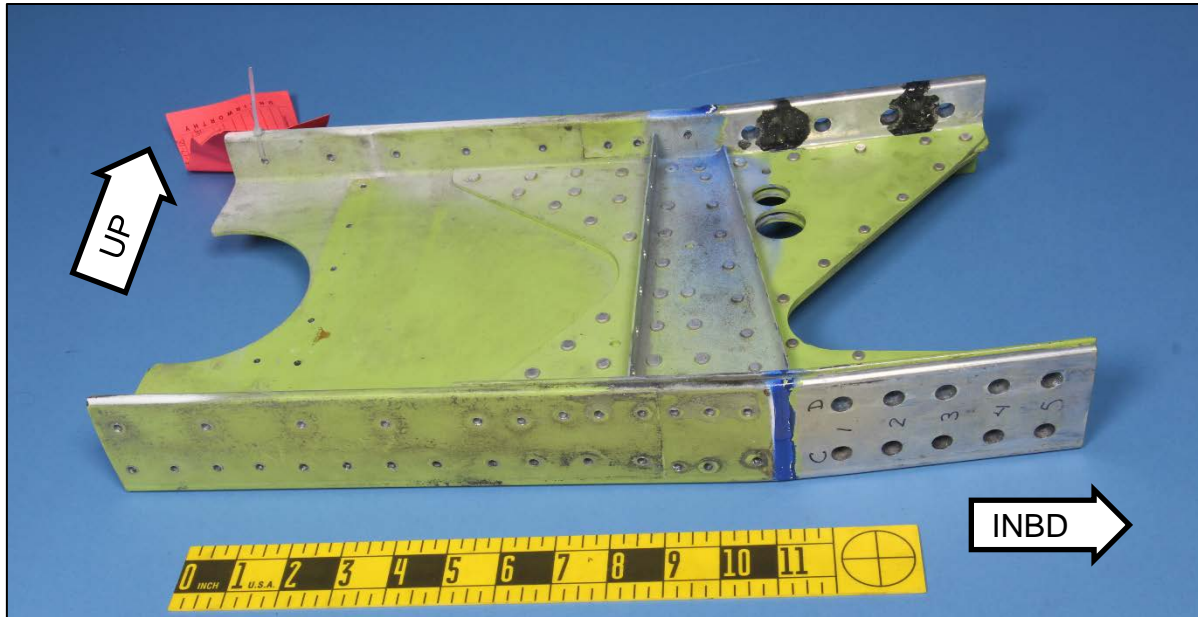
The inboard end of the wing spar was separated from the rest of the wing and sent to the NTSB Materials Laboratory for examination, and a view of the submitted piece is shown in figure 18. A crack feature was visible under optical magnification as shown in figure 19, where a bracket indicates the location of a crack feature extending from the forward side of hole LC-1. No crack features were detected under optical magnification at the aft side of hole LC-1.

Figure 18. Overall view of the left wing main spar from airplane N104ER.

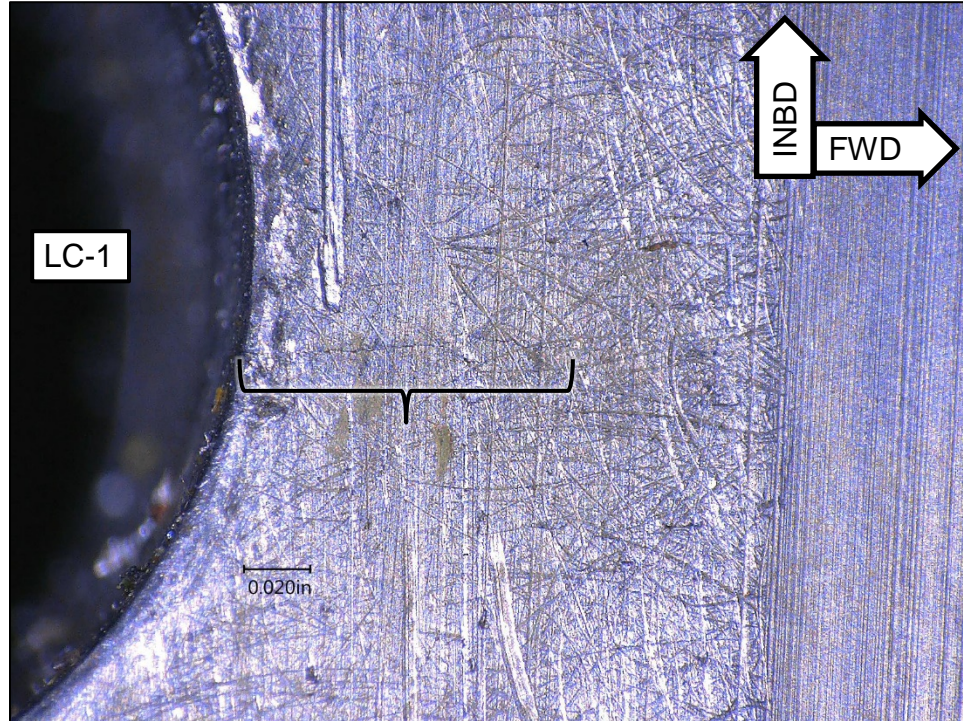
Next, the wing spar was cut to facilitate opening the crack by lab fracture. A transverse cut was made inboard of the attachment holes followed by a longitudinal horizontal cut through the web above the lower spar cap to separate the lower spar cap from the rest of the piece. Then a vertical cut was made through the row C attachment holes followed by a transverse cut through the forward edge of the lower spar cap toward the crack tip. The sectioned piece was then bent by hand to open the crack shown in figure 19.

Figure 19. Lower surface of the left wing main spar from airplane N104ER. A bracket indicates a crack extending from the forward side of hole LC-1.

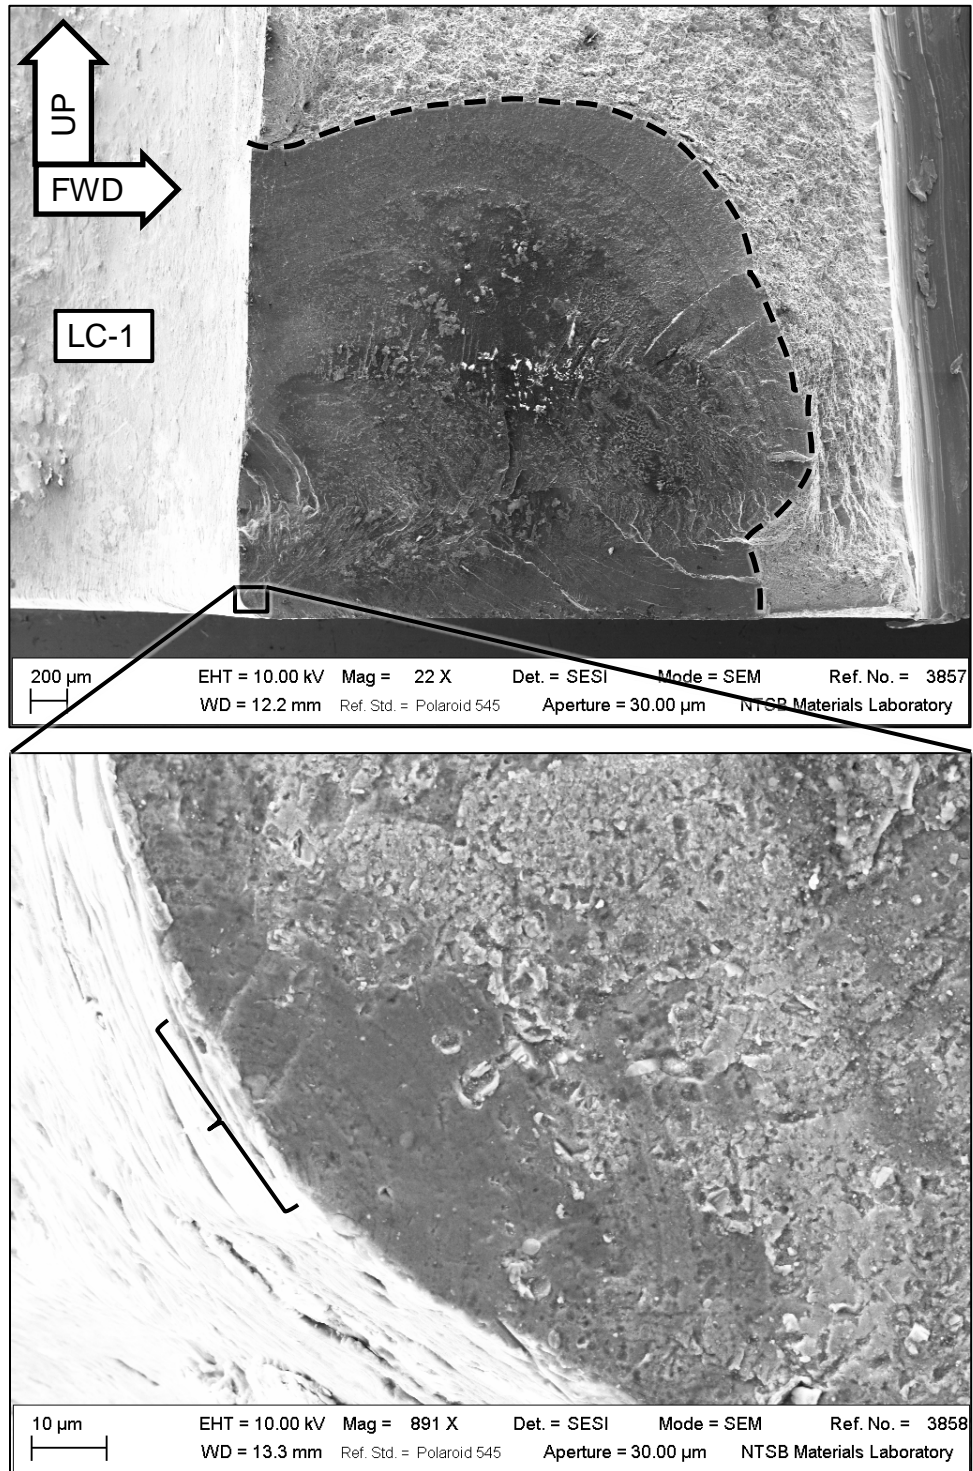
After an initial examination under an optical stereomicroscope, the lab fracture was placed in the SEM for further examination. The crack fracture surface exposed by the lab fracture had relatively smooth features with curving crack arrest lines, features consistent with fatigue. A dashed line in figure 20 indicates the extent of the fatigue region extending up to 0.126 inch forward from the hole surface and up to 0.115 inch upward from the lower surface. Where the fatigue region intersected the lower surface, the length from the hole surface to the fatigue boundary was 0.119 inch.

A closer view of the fatigue origin area is shown in the lower image in figure 20. Ratchet marks were observed indicating multiple fatigue origins within the area indicated by the unlabeled bracket. The origins were located within the corner radius between the hole LC-1 bore and main spar lower surface.

Figure 20. SEM images of the fatigue region in the left wing main spar lower spar cap from airplane N104ER. A dashed line in the upper image indicates the fatigue boundary, and an unlabeled bracket in the lower image indicates the fatigue origin area.
