# NATIONAL TRANSPORTATION SAFETY BOARD

## MATERIALS LABORATORY FACTUAL REPORT

Report No. 18-067

Place : Dallas, Texas  
Date : February 23, 2018  
Vehicle : Pipeline operated by Atmos Energy  
NTSB No. : PLD18FR002  
Investigator : Sara Lyons<sup>2</sup>

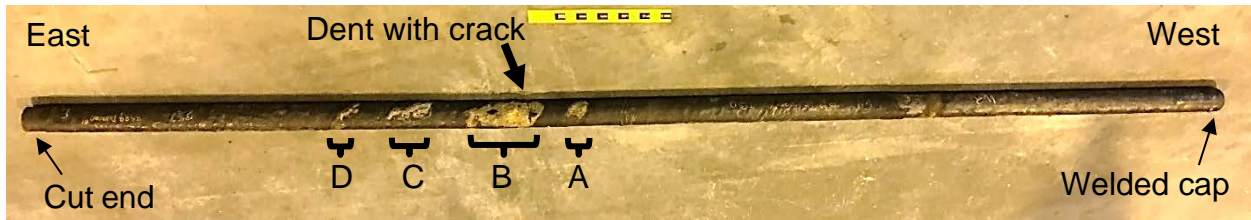
Figure 1 shows a photograph of the as-received 117.5-inch (10-foot) portion of the 2-inch diameter steel gas main that was installed behind the dwelling at 3539 Durango Drive. The gas main is located in an unpaved alley way. The gas main was installed in 1946 approximately four feet below the surface of the ground and is operated by Atmos Energy. The outer surface of the main was coated with a coal-tar enamel spiral wrap, with the outermost layer of the coating having a fine layer of Kraft paper. The maximum allowable operating pressure (MAOP) for the main was 55 pounds per square inch gauge (psig), and the main was cathodically protected against corrosion by consumable anodes.

Figure 1. As-received 10-foot segment of the main that was located behind dwelling 3539 Durango Drive showing the top surface and a dent with a circumferential crack. Exposed areas of the main with damaged coating are indicated by brackets “A”, “B”, “C”, and “D”.

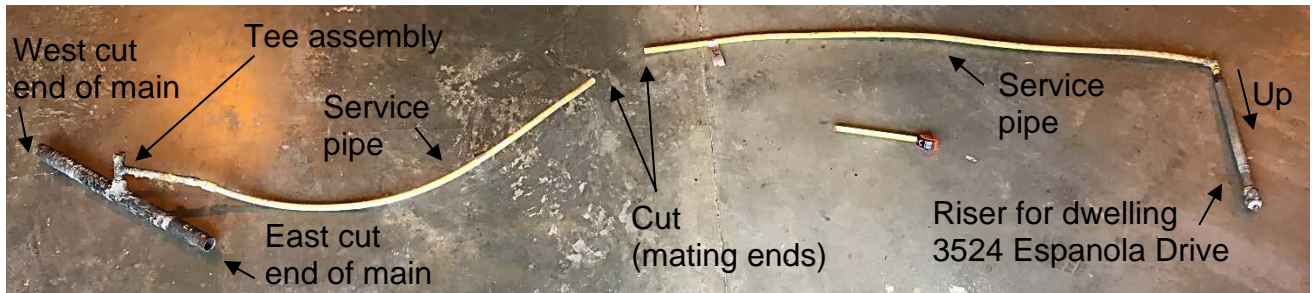
Another segment of the same main with a tee assembly was cut on-site from an area located behind the dwelling at 3524 Espanola Drive, see figure 2. A polyethylene service pipe extended between the steel tee assembly and a meter riser for the dwelling at 3524 Espanola Drive. The length of the service pipe between the meter riser and tee assembly measured approximately 103 inches (8.6 feet). The base portion of the tee assembly was welded to the main. The tee assembly exhibited indications of a leak during an on-site leak test performed by Atmos Energy. The service pipe was cut on-site to facilitate transportation and handling. Visual examination at the NTSB Materials Laboratory of the service pipe, tee

assembly, and main in figure 2 showed no evidence of a crack. Appendix 1 shows a map of the dwellings relative to each other and approximate location of the excised main segments.

Figure 2. As-received riser and service pipe for dwelling 3524 Espanola Drive that connects to the tee assembly and main.

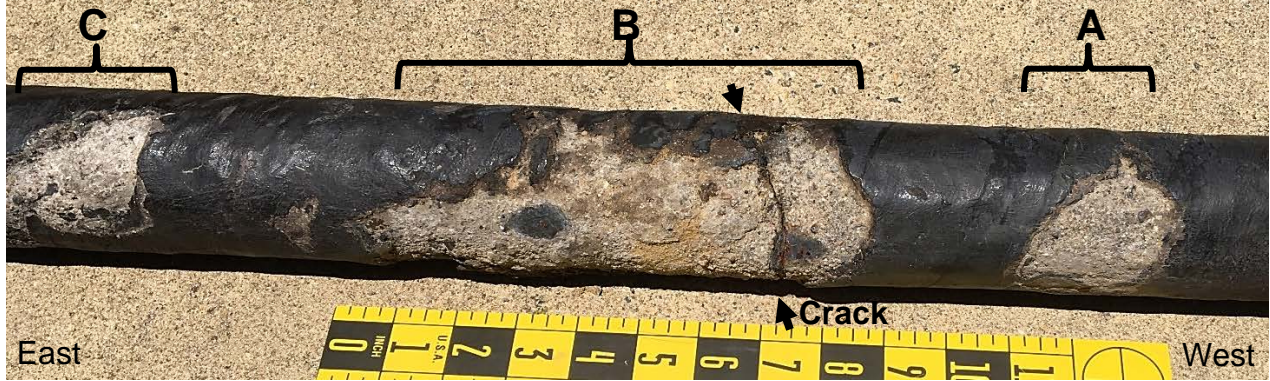
Visual examination of the as-received 10-foot gas main segment located behind dwelling 3539 Durango Drive revealed a circumferential crack on the top surface. The crack extended approximately halfway around the pipe circumference, in the area indicated in figures 3 and 4. The crack was located approximately 0.5 inches below the bottom surface of a 6-inch diameter polyvinylchloride (PVC) sanitary sewer pipe. The sewer pipe was oriented perpendicular to the length of the gas main. According to a representative from Dallas Water Utilities, the sewer pipe was built between 1995 and 1996. The sewer pipe was not submitted for examination. The outer face of the gas main was coated with a black tar enamel spiral wrap coating. The spiral coating was continuous and extended the length of the submitted main segment, with the exception of four isolated areas on the top side of the main indicated by brackets "A", "B", "C" and "D" in figure 1 where the coating had been damaged and was missing. The longitudinal length of the exposed areas of the main measured approximately 2 inches, 4 inches, 3 inches, and 2 inches, west to east, respectively. The exposed areas extended approximately halfway around the circumference of the main. The outer surface of the main in the area of the crack contained a depression relative to other areas, and this circumferential crack intersected the depression. Later in this report, the depression will be identified as a dent, see figure 5. The dent and crack were located approximately 68 inches from the west end of the as-received portion of the main. The exposed surface of the main in the four isolated areas was covered with a hard, compacted, adherent deposit. The deposit could not be removed with the scraping action of a wood tongue depressor. The coating outside of the four exposed areas was intact.

Figure 3. Close-up photograph of the top portion of the as-received main, showing exposed areas of the main with damaged coating, and dent with crack. The crack intersected the dent.

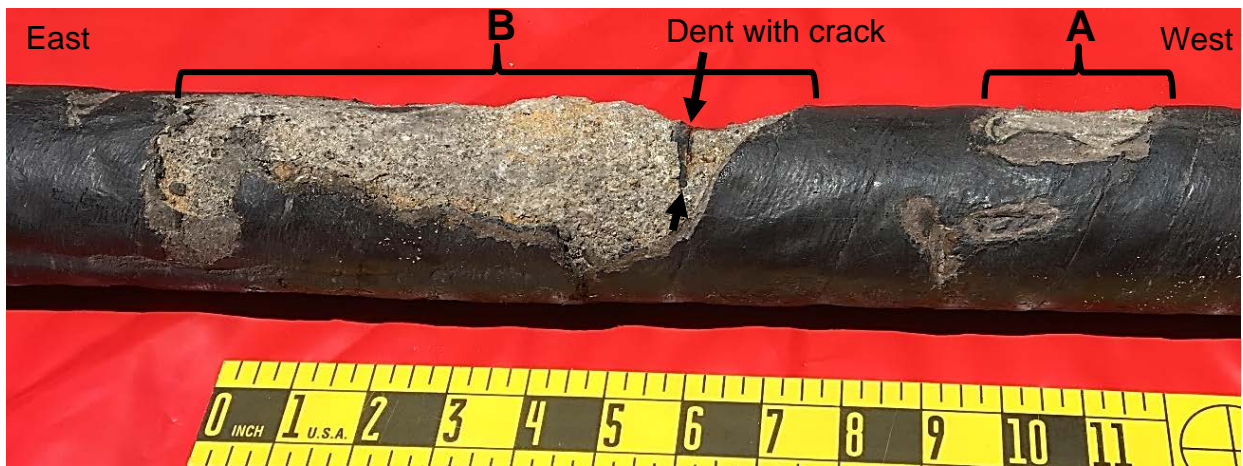
Figure 4. Side view of the as-received main showing the dent with a crack, in the region indicated by bracket "B" in figure 1. The crack intersected the dent.

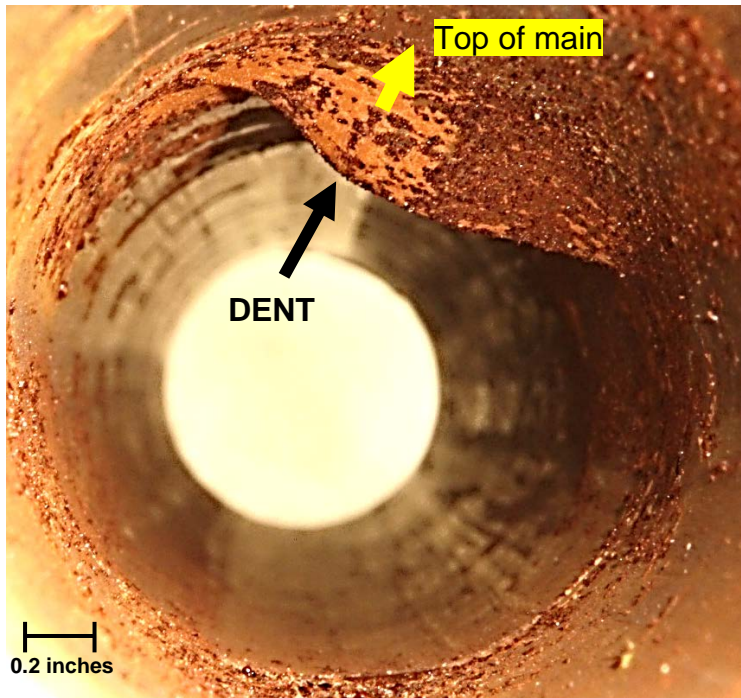
Figure 5. View of the inner surface of the main looking east showing a dent that intersected the circumferential crack. Arrow also points to the approximate top of the main.

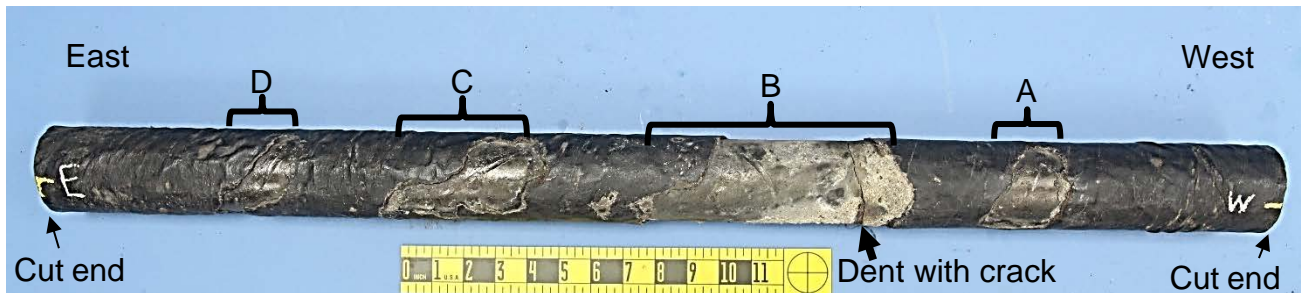
Figure 6. Top surface of the main showing areas where the coating was damaged, indicated by brackets "A", "B", "C", and "D", and dent with a crack, shown after removing hard deposit from exposed surfaces. The horizontal line next to the "East" and "West" position mark the top of the main.

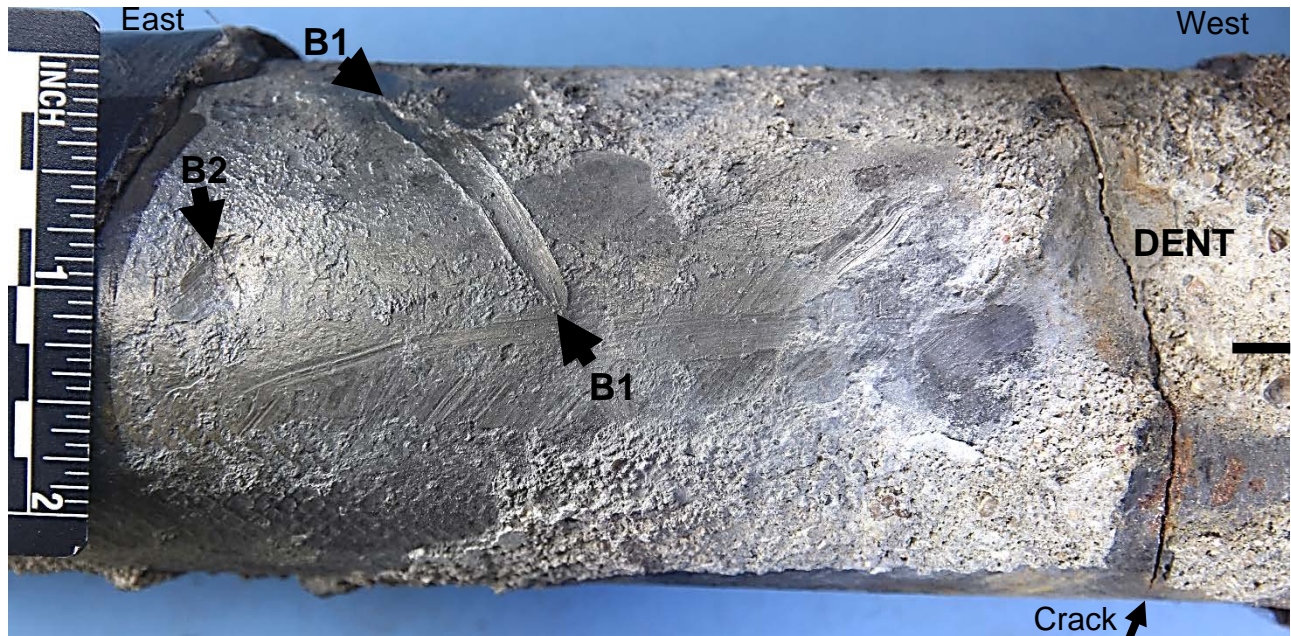
Figure 7. Close-up photograph of the top side of the main in region “B” in figure 6 showing the crack and dent, after removing hard deposit from the surface in areas outside of the dent and exposing a gouge between arrows “B1”. A smaller dent, approximately 0.25-inch diameter, was found in the area indicated by arrow “B2”. The exposed surface contained evidence of other gouges. The short black line on the side edge of this figure and those in figures 9, 10 and 11 indicate approximate top of the main.

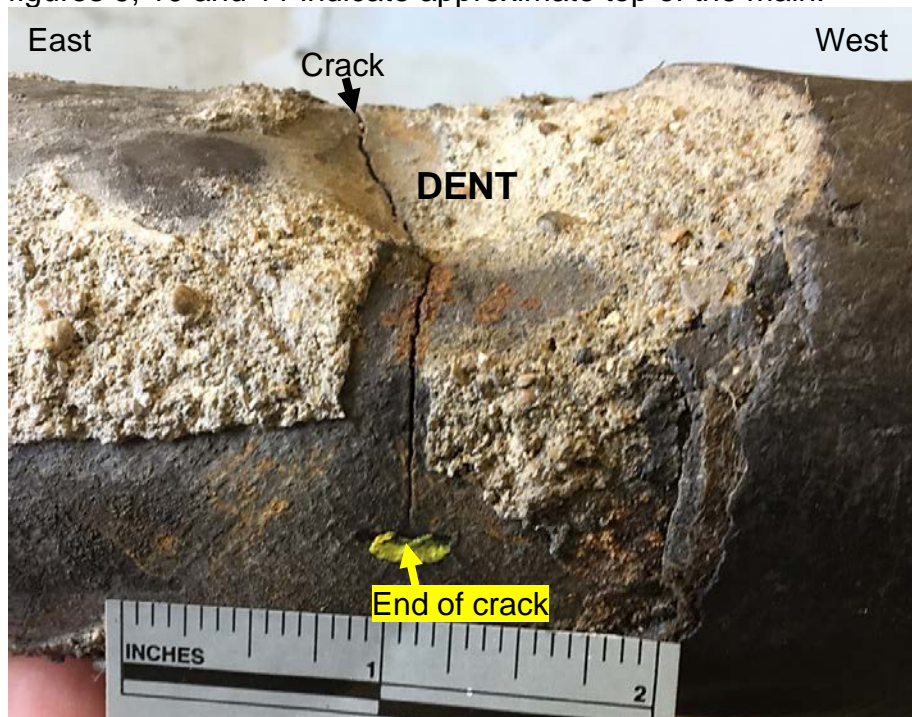
Figure 8. Close-up photograph of the side view of the main showing a crack that intersected the dent, region “B in figure 6. In this figure deposits were removed from the areas outside of the dent.

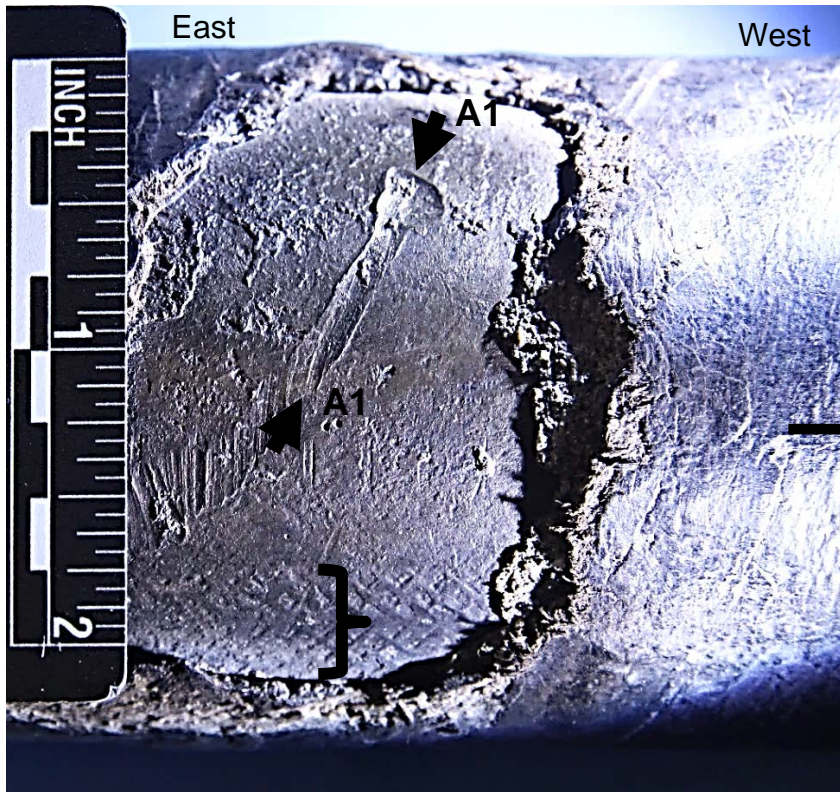
Figure 9. Close-up photograph of the top side of the main in region "A" in figure 6 showing the gouge between arrows "A1", after removing hard deposit from the surface. The length of the main on the outer surface contained a crisscross mechanical pattern between the 9 and 11 o'clock position and the 3 and 5 o'clock position, looking east, such as in area indicated by a bracket, where 12 o'clock is the top of the main.

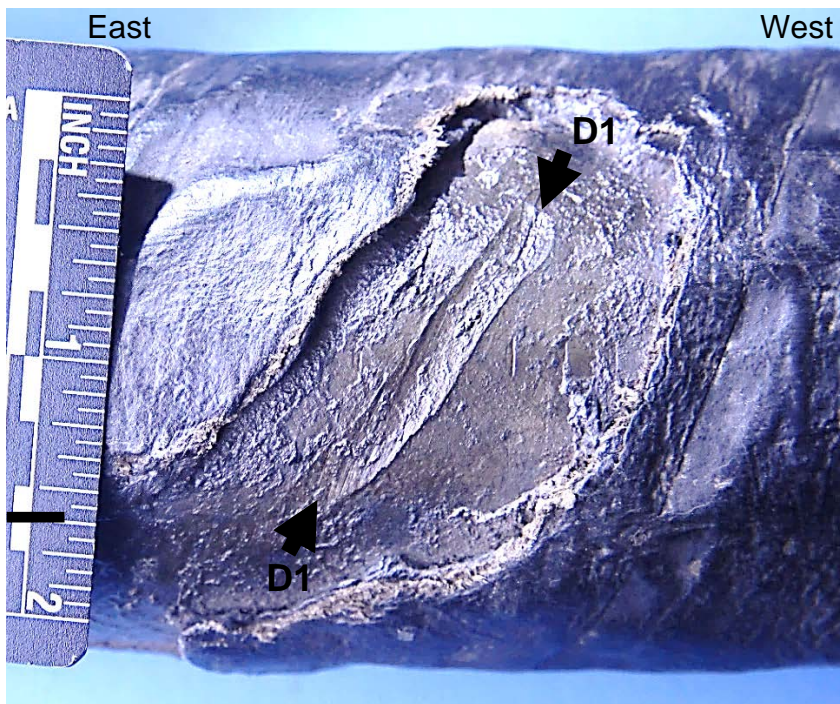
Figure 10. Close-up photograph of the top side of the main in region "D" in figure 6 showing the gouge between arrows "D1", after removing hard deposit from surface.

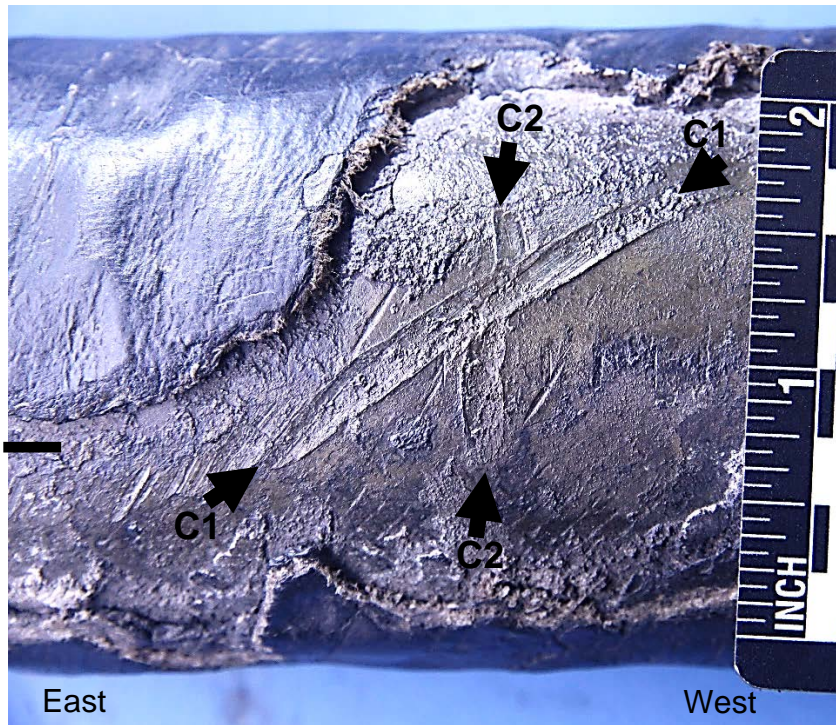
Figure 11. Close-up photograph of the top side of the main in region “C” in figure 6 showing the gouge between arrows “C1”, after removing hard deposit from the surface. This gouge had intersected another gouge between arrows “C2”.

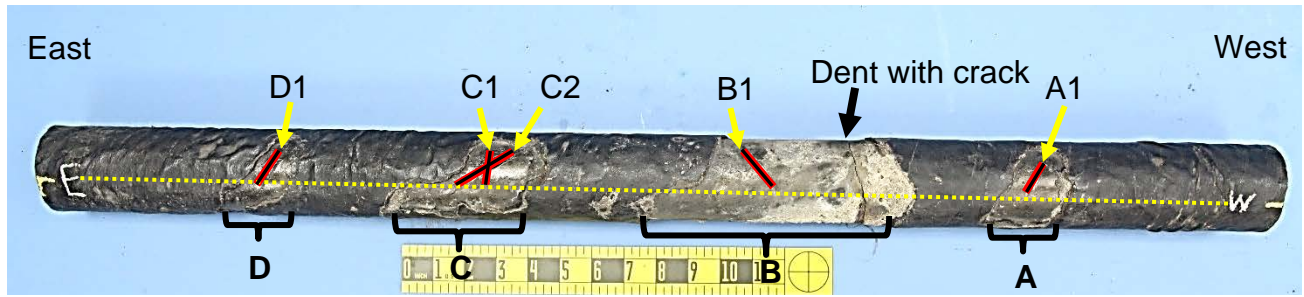
When visually inspecting the main, the cross section of each major gouge contained a round profile. Table 1 shows the measured length, width and depth of each major gouge. The length of the major gouges measured between 0.9 inch and 1.8 inches. The width of the gouges measured between 0.13 inch and 0.25 inch. The depth of each gouge measured roughly between approximately 0.007 inch and 0.018 inch. The areas next to each major gouge contained evidence of other minor gouges. The orientation of the minor gouges was different than that of a respective major gouge.

Figure 12. Top surface of the main showing location of five major gouges, “A1”, “B1”, “C1”, “C2”, and “D1”, indicated by black and red outlines (black and red outlines are not to scale). Top of main line is indicated by a yellow dashed line.

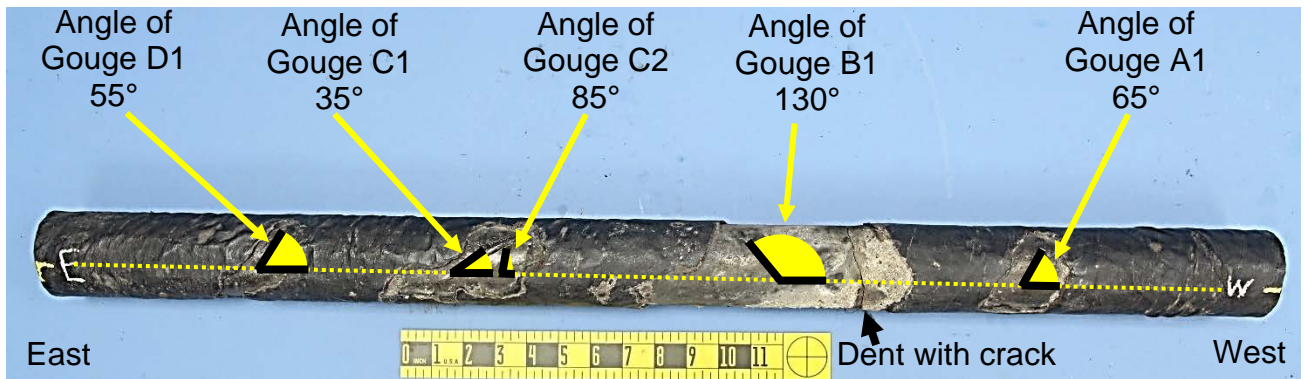
Figure 13 shows the top surface of the main with an imaginary line extending along the length of the top dead center. The end of each gouge nearly intersected the top dead center of the main. The angle of each gouge was measured relative to the West end of the main along the top dead center when looking down at the main. The angle of each gouge relative to the length of the main was measured at the intersection between the longitudinal imaginary line at the top dead center of the main and an imaginary line that extended along the length of a gouge. The west end of the main at the top dead center was arbitrarily selected as zero degrees and measurements were made counterclockwise with respect to zero degrees. The measured angle was different for each gouge. Figure 13 shows the measured angle of each major gouge. The measured angle of the gouges ranged between approximately 35 degrees and 130 degrees relative to the west end of the main, when looking down.

Figure 13. Top surface of the main showing the measured angle of major gouges “A1”, “B1”, “C1”, “C2”, and “D1”. The angle was measured at the intersection between an imaginary line that was drawn through a gouge and an imaginary line that was drawn through the top of main (yellow dashed line). West was arbitrarily referred as zero degrees and each angle was measured counterclockwise relative to zero degrees when looking down.

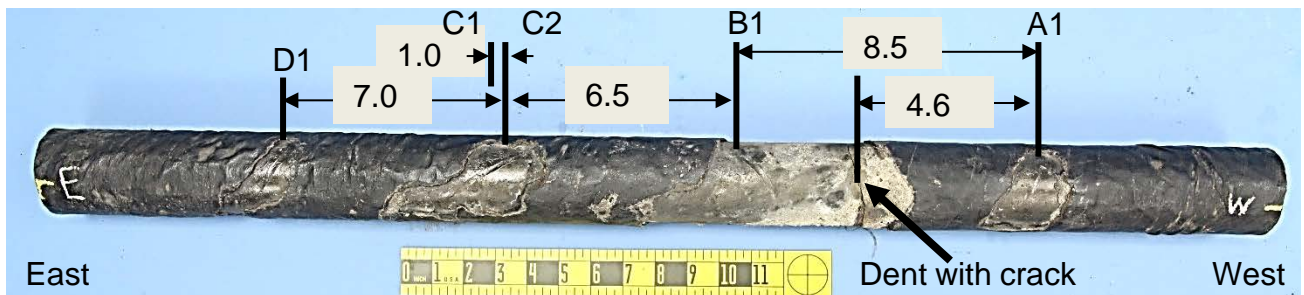
As indicated earlier, each gouge contained evidence of metal flow deformation, with metal flow deformation toward the north end of each gouge, consistent with a gouge that started at the south end of each gouge. Figure 14 shows the measured longitudinal distance between the approximate starting point of each gouge. The longitudinal distance between the approximate starting point of each gouge ranged between 1 inch and 8.5 inches.

Figure 14. Top surface of main showing measured distance in inches between the initial (start) position of gouges “A1”, “B1”, “C1”, “C2”, and “D1” relative to each other and the dent with a crack.

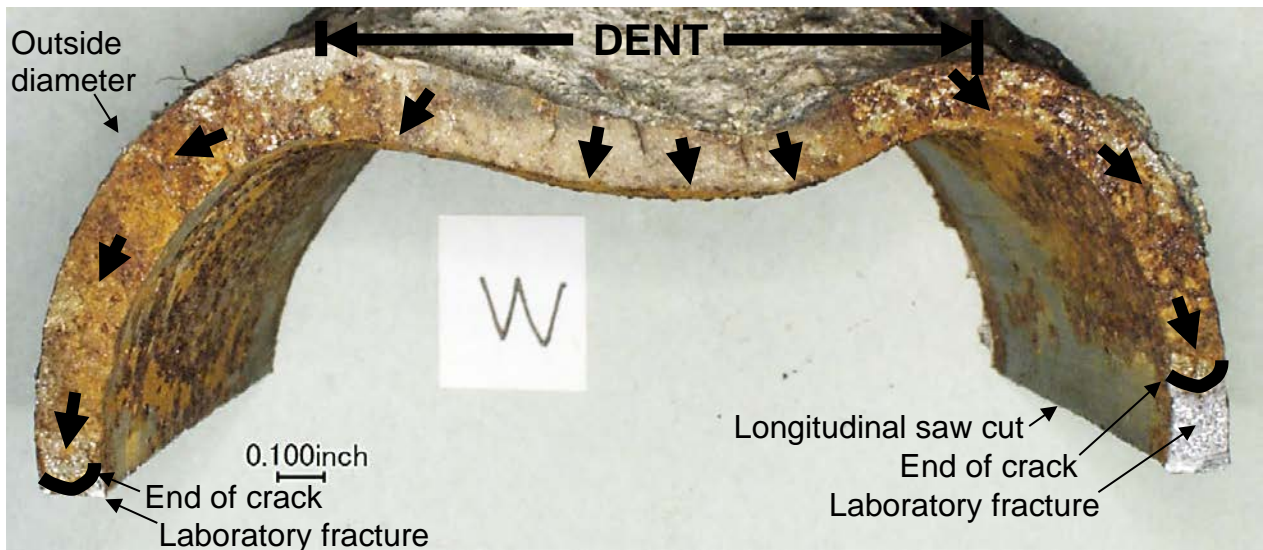
Bench binocular microscope examination of the west face of the fracture revealed ratchet marks indicative of a crack with multiple origins emanated from a dent at the outer surface, see figures 15 through 16. The face of the fracture for the most part was covered with brown oxide. The fracture face at the outer surface in several isolated areas of the dent contained evidence of minor shear lips, whereas, the inner surface in the area below the dent contained evidence of one major shear lip, see figure 16. The fracture face on the inner surface also contained evidence of minor shear lips on both sides of the major shear lip. The fracture propagated down and to each side of the dent. Fracture propagation was approximately through half of pipe circumference and terminated in the areas indicated by solid lines in figure 15. The fracture face outside of the dashed line in figure 15 was the laboratory induced fracture.

The greatest reduction in wall thickness along the fracture face was located in the area of the dent. The wall thickness in the area of the dent measured approximately 0.12 inch, whereas, in non-deformed areas measured approximately 0.15 inch, calculates to a wall reduction of 20%. The wall thickness was measured with a point micrometer.

Figure 15. West face of the fracture after separating the mating faces of the circumferential crack.

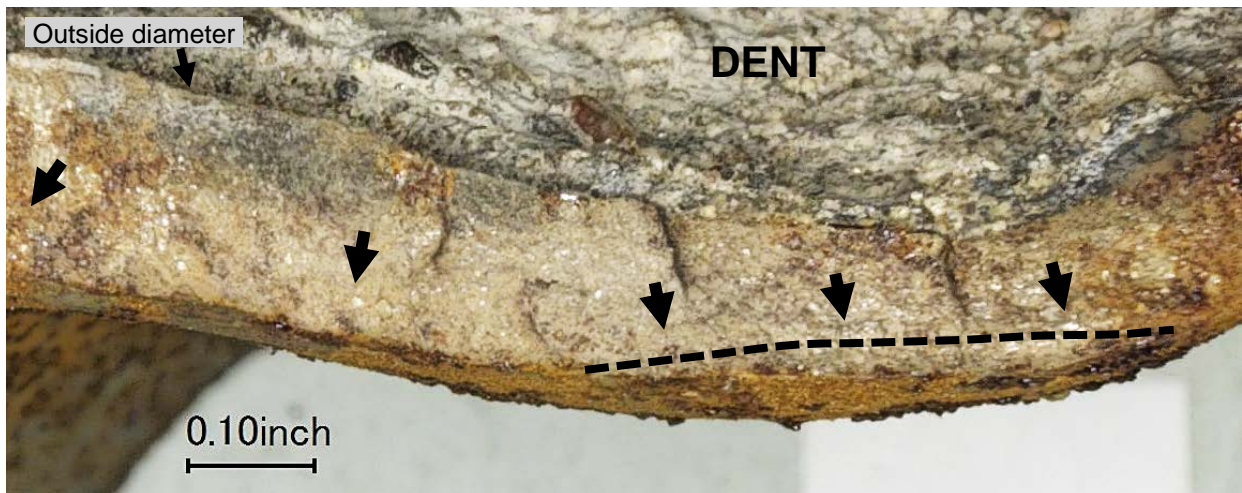
Figure 16. Close-up photograph of the west face of the fracture showing the bottom portion of the dent. A major shear lip was found on the inner surface in the area indicated by a dashed line. Minor shear lips were noted on the inner surface of the dent and on the outer surface in areas outside of the major dent (not readily visible at this magnification).

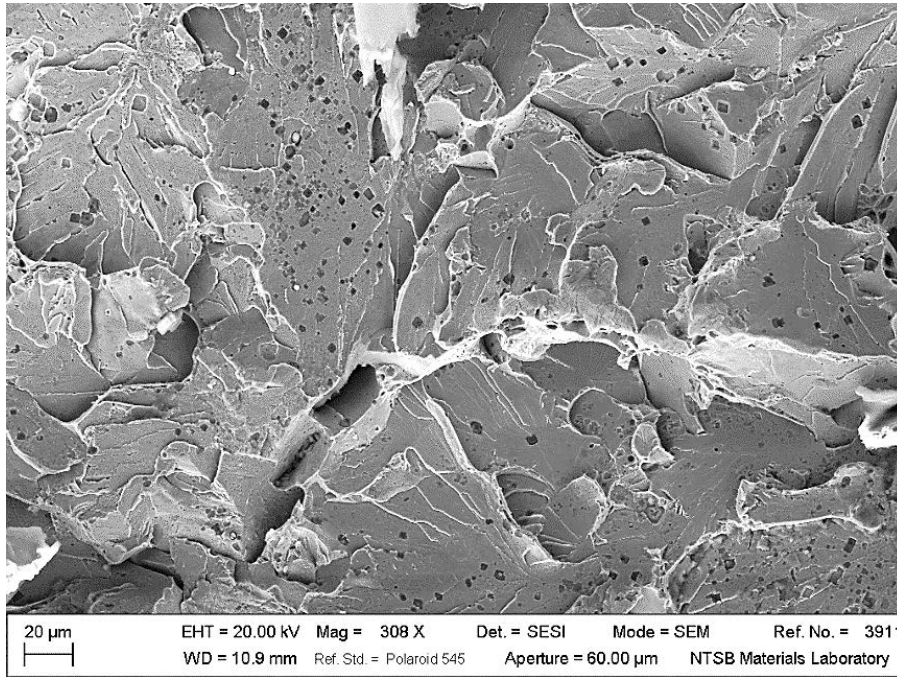
SEM examination of the west face of the fracture revealed cleavage fracture features that extended the entire length of the crack. The cleavage features showed evidence of pitting. The pitting was less severe near the ends of the crack, see figure 17. The pitted cleavage fracture features were observed on isolated portions of the fracture face prior to replica tape cleaning procedure. The fracture produced in the laboratory, located outside (below) the black lines in figure 15, contained several bands of cleavage fracture features that were separated by micro-void coalescence fracture features, with the end of the laboratory fracture face having evidence of micro-void coalescence fracture features typical of ductile overstress separation. Figure 18 shows a transition region between a cleavage fracture feature and micro-void coalescence fracture feature.

Figure 17. SEM image of cleavage fracture features in the portion of the crack near the dent. The fracture features contained evidence of pitting.

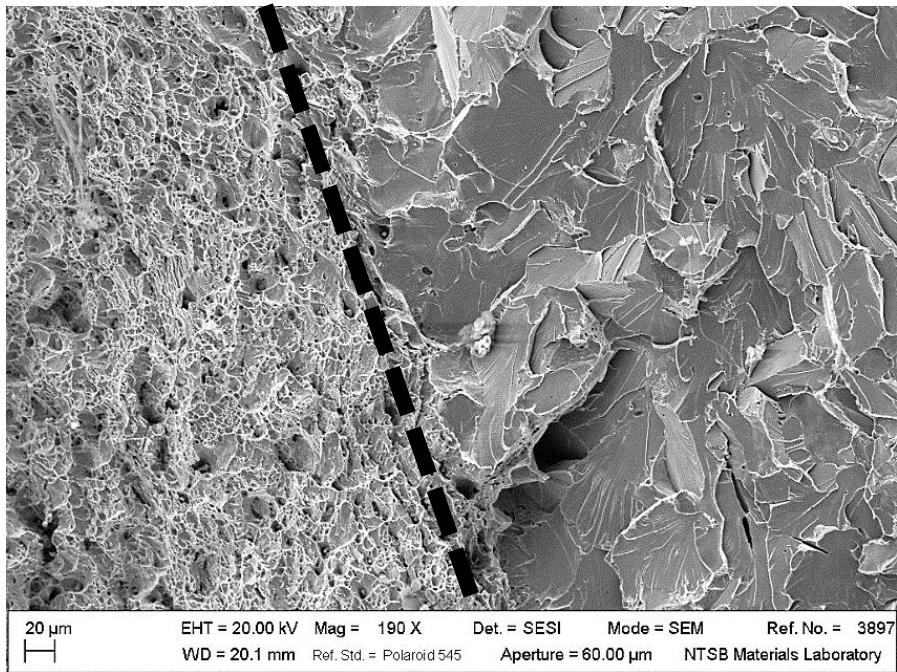
Figure 18. SEM image of the fracture at the border indicated by a dashed line between the terminus of the crack (cleavage features on the right) and laboratory induced fracture portion (micro-void coalescence fracture features on the left).

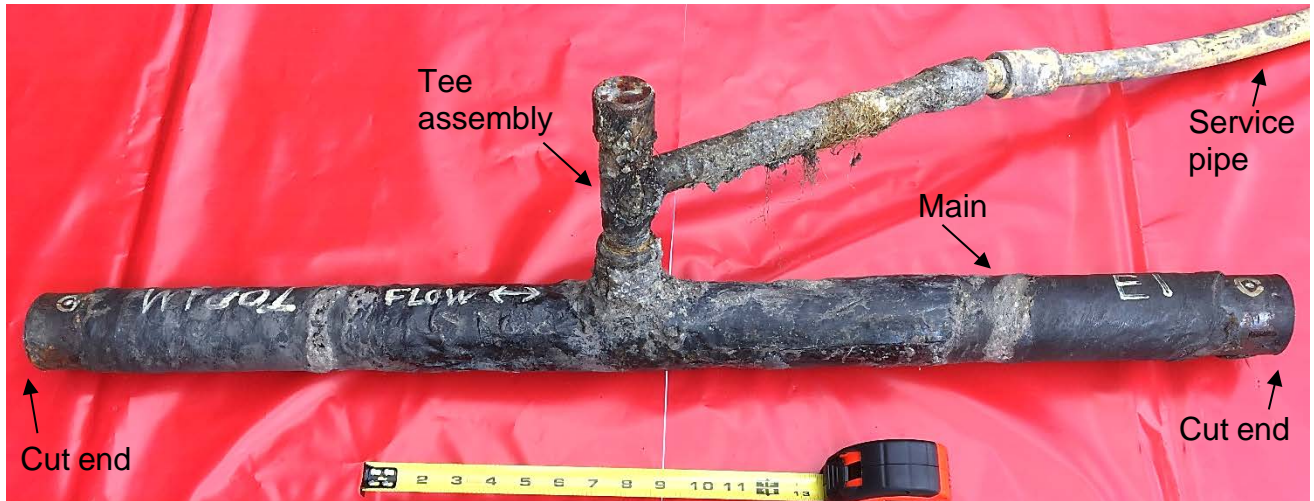
As indicated earlier, a tee assembly was installed between the service pipe and main. Both ends of the main were plugged with mechanical plug and the cut end of the service pipe was attached to a mechanical plug containing a pass-through port that allowed pressurized air to enter the service pipe, tee assembly and main. The measured pressure and flow rates are shown in table 3. The volumetric leak rate for air was converted to volumetric leak rate for natural gas, and the converted values are shown in table 3. At 55 psig the meter showed a flow rate of approximately 0.2 CFM, with no evidence of air flow below this 55 psig value. A soap solution was sprayed on various parts of the tee assembly, main, and service pipe, during all phases of the pressure testing. Areas that show evidence of bubbles are a positive indication of a leak. The tee assembly showed evidence of bubbles only when the pressure reached 55 psig. Soap bubbles were noted in the area below the cap and at the base of the tee assembly, evidence that there was a leak at these two locations of the tee assembly, see figures 19 and 20.

Figure 19. Close-up view of the Tee assembly and as-received portion of the main with the service pipe

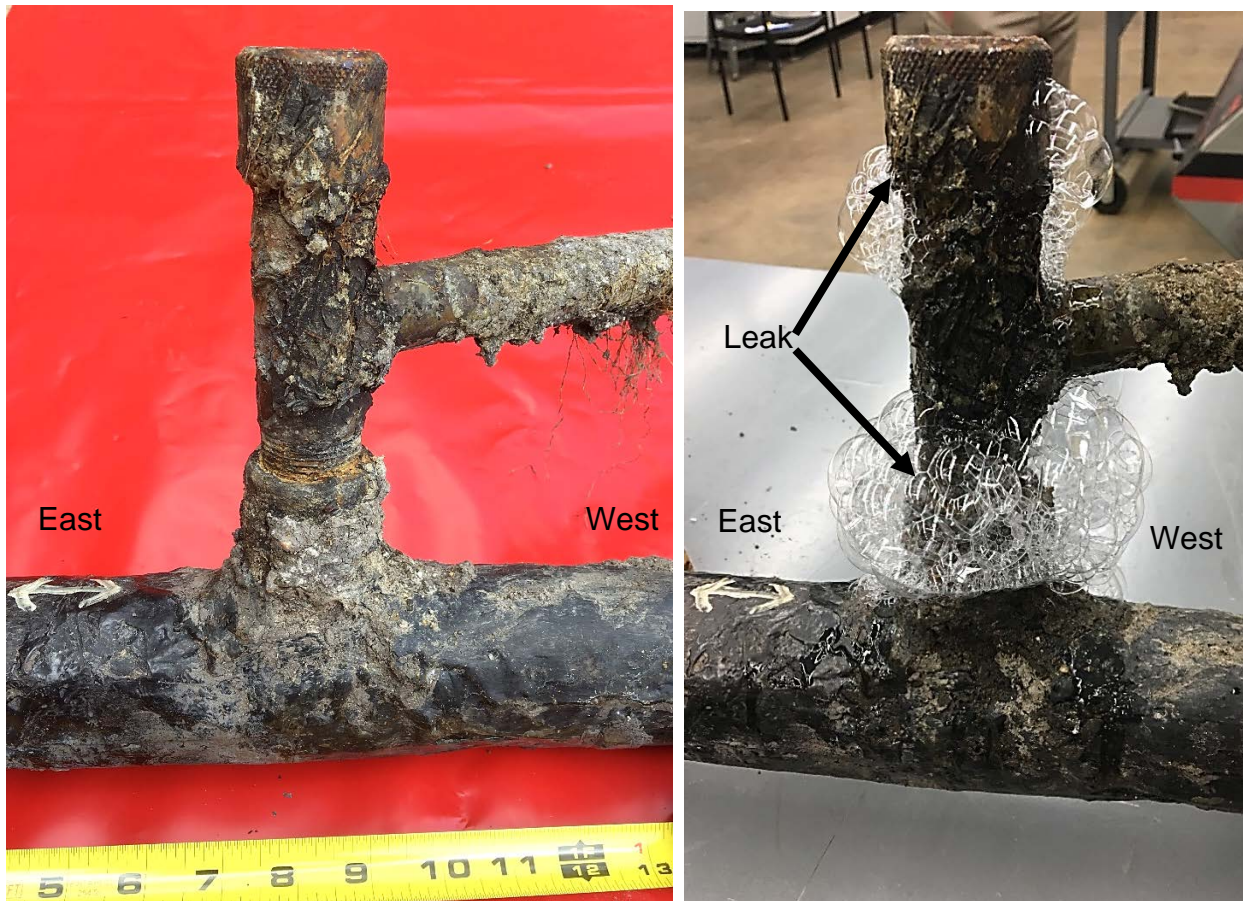
Figure 20. Side view of the tee assembly in the as-received condition (left) and when exposed to soap solution during pressure leak testing at NTSB showing soap bubbles emanating from an area below the cap and from the threaded joint at the base of the tee assembly indicating a leak (right).

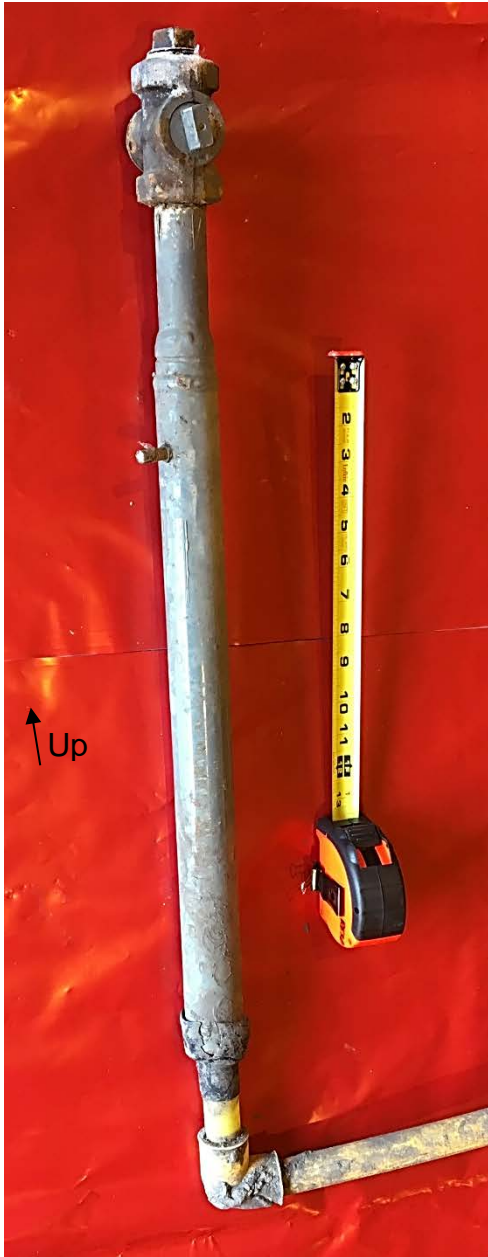
The cut end of the as-received service pipe was attached to a mechanical plug containing a pass-through port that allowed pressurized air to enter the service pipe. The upper end of the meter riser contained a plug that was installed on-site. The measured pressure and corresponding flow rates are shown in table 4. The service pipe was subjected to 56 psig and showed zero air flow. A soap solution was sprayed on various parts of the service pipe and meter riser. Areas that show evidence of bubbles are a positive indication of a leak. The service pipe and meter riser showed no evidence of bubbles, indication of no evidence of a leak, see figure 21.

Figure 21. Close-up photograph of the as-received gas meter riser and portion of the service pipe.

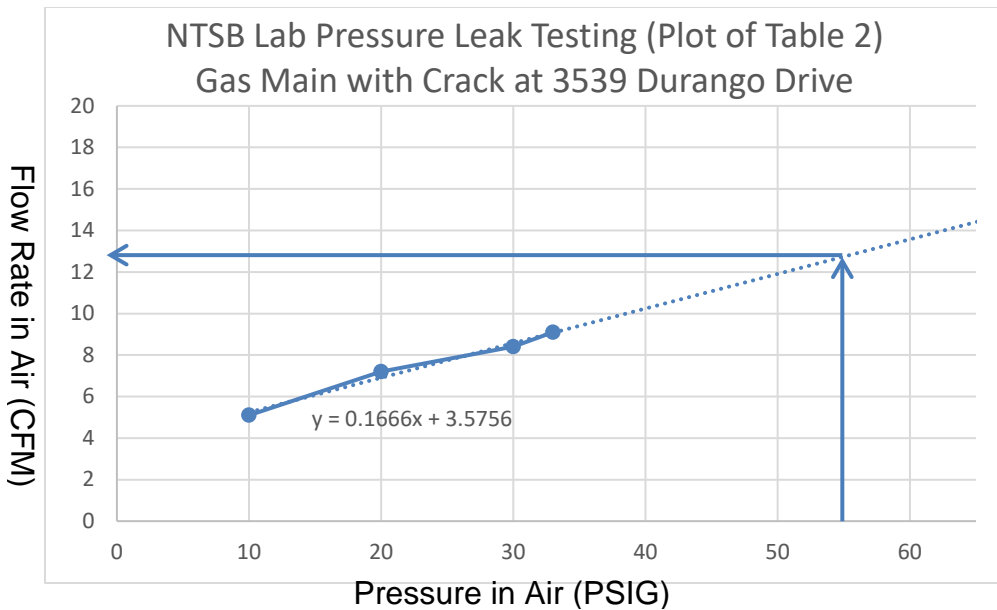
An attempt was made to pressurize the pipe to 55 psig, MAOP of the pipe, but this was not possible because air flowing out of the crack exceeded the capacity of the air compressor to provide the desired pressure. The pressure test was terminated at 33 psig. A plot of the pressure and flow rate are shown below table 2. A linear line was drawn through the plotted points to roughly extrapolate the value of the flow rate if the pressure was supplied at 55 psig. At 55 psig, the flow rate was estimated to be approximately 12.7 cubic feet per minute (CFM) for air which converted to a flow rate of approximately 16.5 CFM for natural gas. The tables also show the converted flow rate in cubic feet per hour (CFH).

Plot of pressure vs. flow rate in air from measured values in table 2. Dashed line represents a linear line that was extrapolated from the plotted data. At 55 PSIG, which is the MAOP, the flow rate in air would be approximately 12.7 CFM, which converts to approximately 16.5 CFM for natural gas.

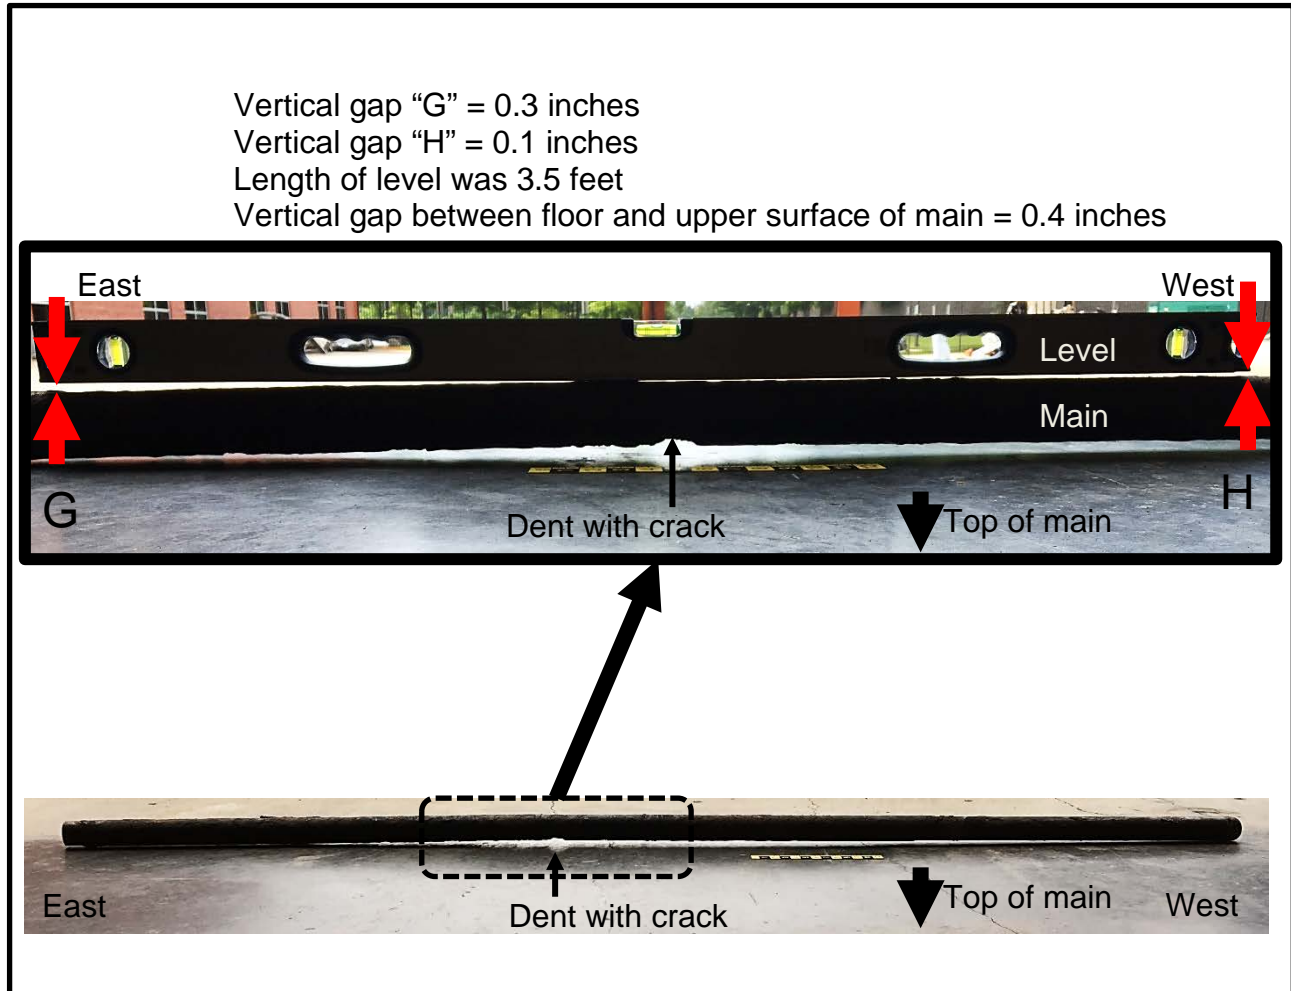
The gas main was gently rolled on the floor and a bow was noted along the length. A downward bow was noted below the general area of the crack. The bow deformation was located diametrically opposite the top portion of the main. With the crack facing down against the floor, a level was placed against the bottom of the main in the general area of the crack. This exercise disclosed an air gap between the bottom of the main and the ends of the level.

The gap between the main and the ends of the level measured approximately 0.3 inch and 0.1 inch, see Appendix 2. The maximum bow between the upper surface of the main and the floor was located in the general area of the crack and this vertical distance measured approximately 0.4 inch. Appendix 3 shows a photograph when the level was tilted to one side of the dent area. No evidence of a gap was noted on the side of the level in the area located away from the dent. When the level was placed on the bottom side of the main on other side of the dent, similar observations were noted (no gap in the area located away from the dent).

Appendix 2. Bottom photograph shows the side profile of the as-received 10-foot segment of the main with the dent and crack facing down to the ground. Top photograph shows a close-up view of the main in the area of the crack. A level was placed at the bottom portion of the main to show evidence of downward deformation in the area of the crack (top photograph). The greatest vertical deformation was located in the general area of the crack. Measured values are shown above the photograph.

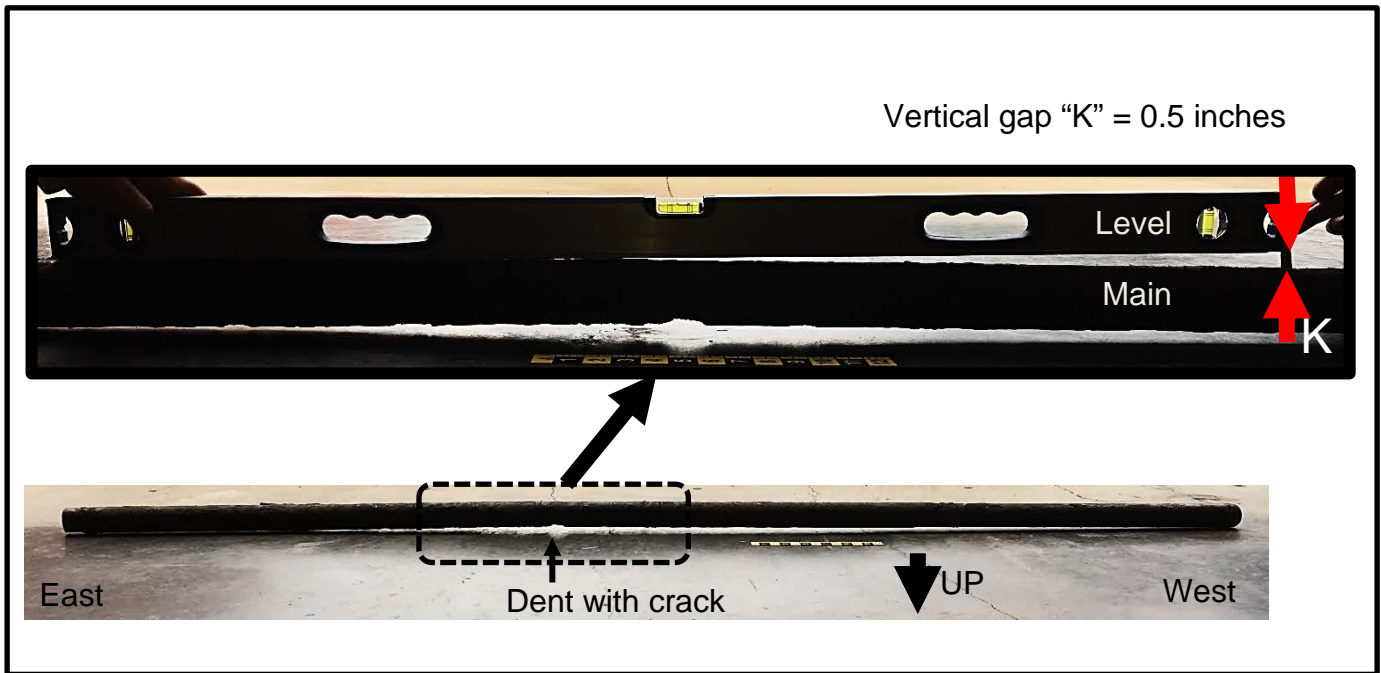
Appendix 3. Side view of the main (lower side of page) and a level that was resting at the bottom side of the main on one side of the dent (upper side of page).
