NATIONAL TRANSPORTATION SAFETY BOARD

MATERIALS LABORATORY FACTUAL REPORT

Report No. 18-096

Place : Dallas, Texas
Date : February 23, 2018
Vehicle : Pipeline operated by Atmos Energy
NTSB No. : PLD18FR002
Investigator : Sara Lyons²

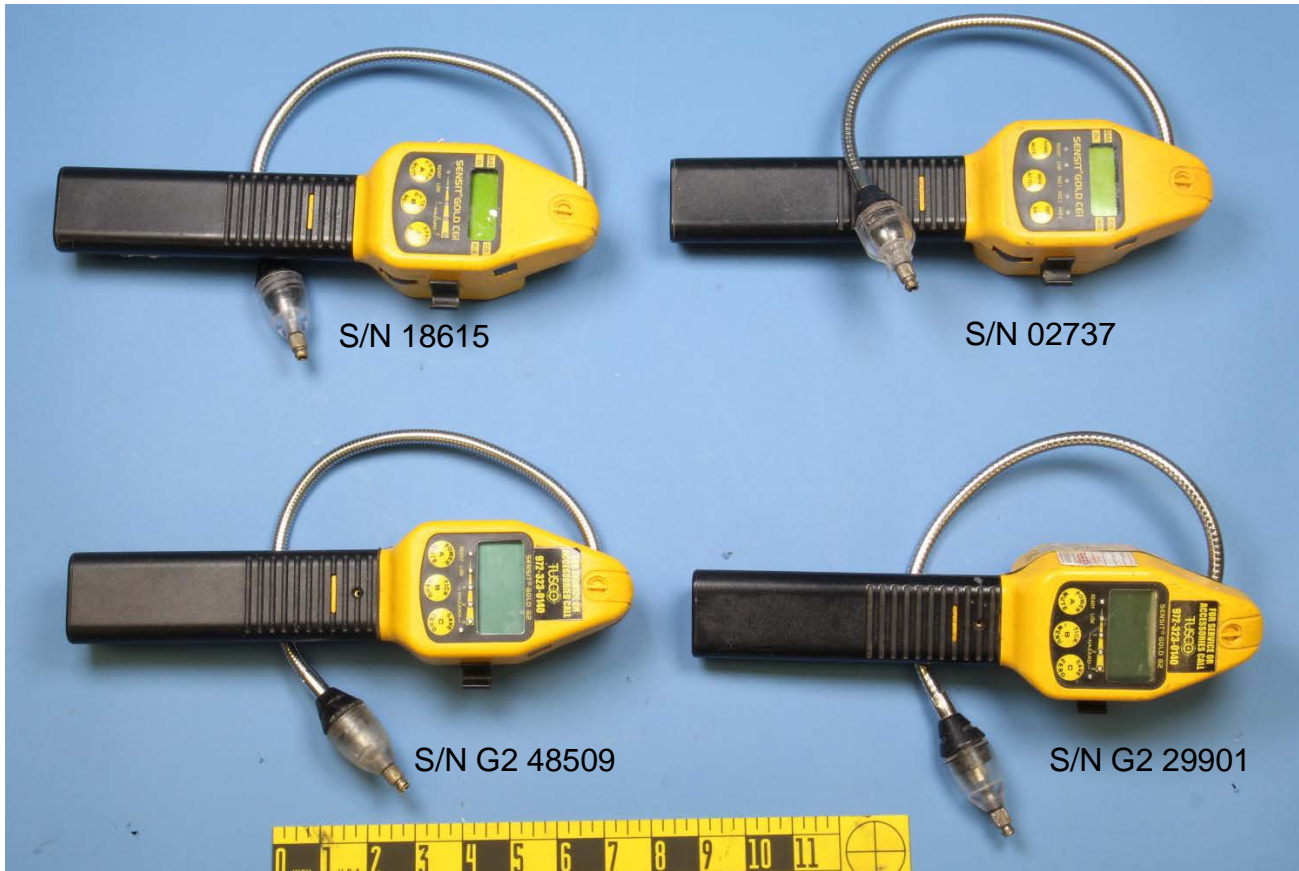
Figure 1 shows a photograph of the four as-received combustible gas indicators. Used during the accident investigation, the gas indicators are used in bar hole testing to determine the relative level of methane in the soil. The gas indicators were sent to Sensit Technologies, manufacturer of the instruments, to retrieve data that would indicate whether the gas indicators were calibrated for the period between February 20 and 24, 2018, which includes the day of the accident. At Sensit, the gas indicators were subjected to a 'bump test', a test of the unit's reaction to applicable standard calibration gases.

Figure 1. As-received combustible gas indicators shown with their corresponding serial numbers.
