NATIONAL TRANSPORTATION SAFETY BOARD

MATERIALS LABORATORY FACTUAL REPORT

Report No. 18-101

Place : Jean, Nevada
Date : September 5, 2018
Vehicle : Commander Aircraft Company 114TC
NTSB No. : WPR18FA253
Investigator : Albert Nixon (WPR-AS)

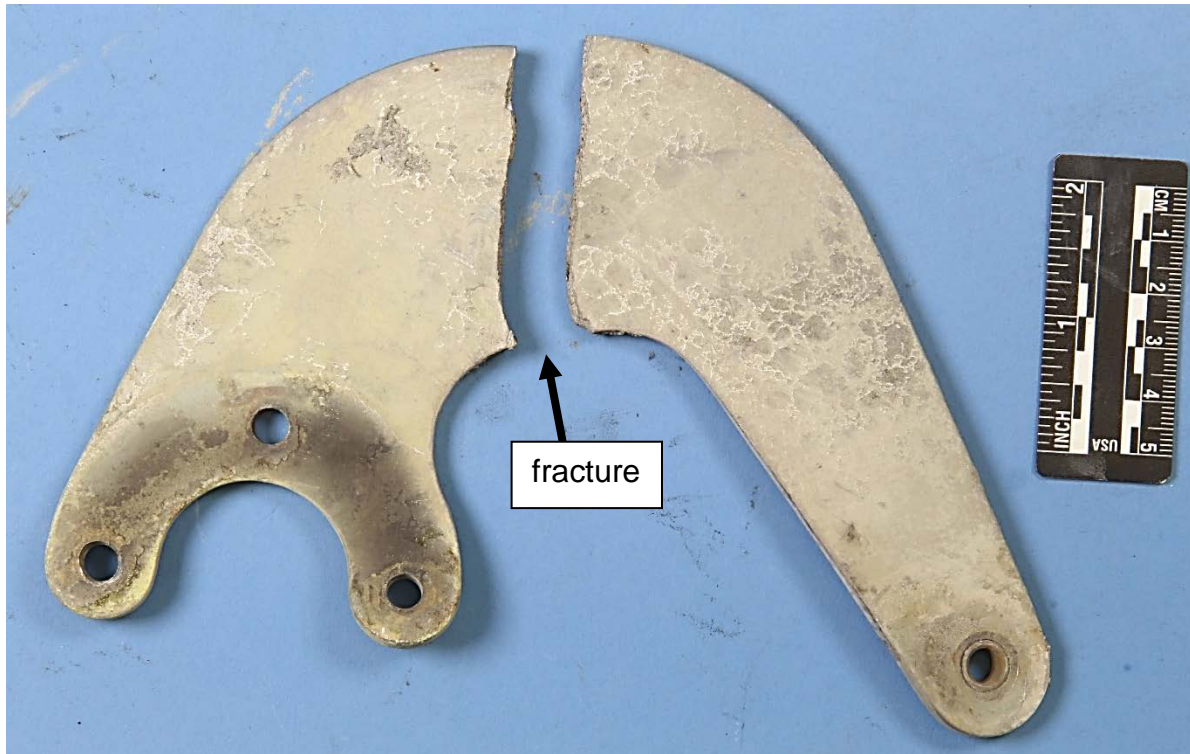
Figure 1 shows a photograph of the fractured elevator bell crank. Bench and scanning electron microscope examination of one half of the fracture face revealed laminar-like fracture features consistent with overstress separation with no evidence of fatigue cracking. Figures 2 and 3 show typical fracture features. Energy dispersive spectroscopy analysis of the fracture face produced a spectrum that contained a major elemental peak of aluminum, consistent with a part that was made from an aluminum alloy.

Figure 1. Photograph of the as-received elevator bell crank that contained a fracture.

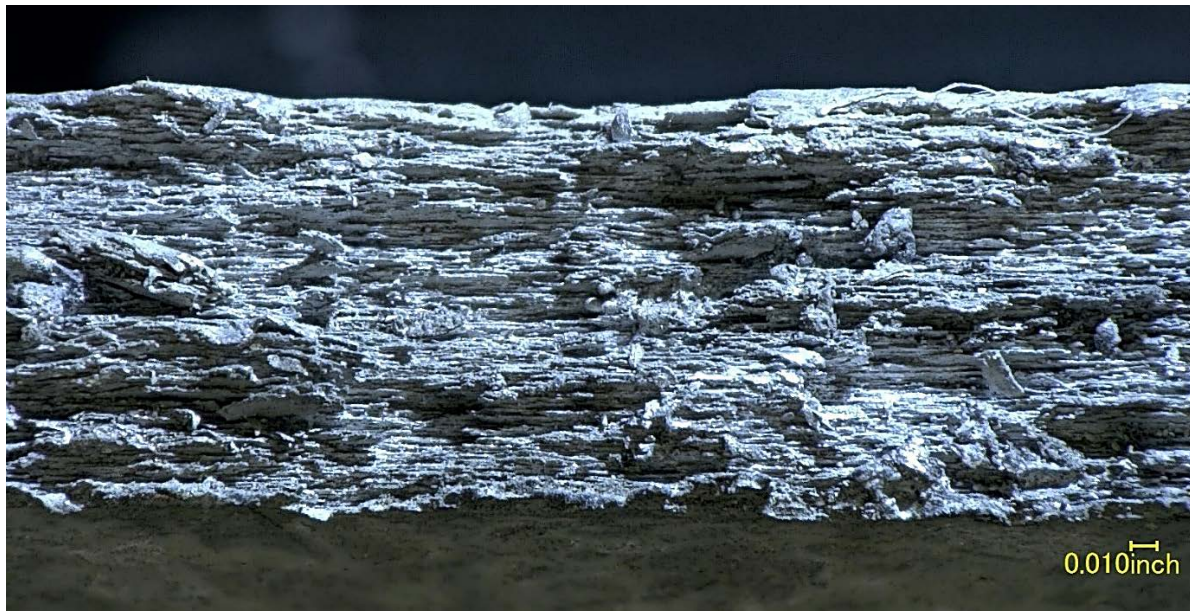
Figure 2. Bench binocular microscope photograph of a typical fracture feature found on one half of the elevator bell crank fracture face.

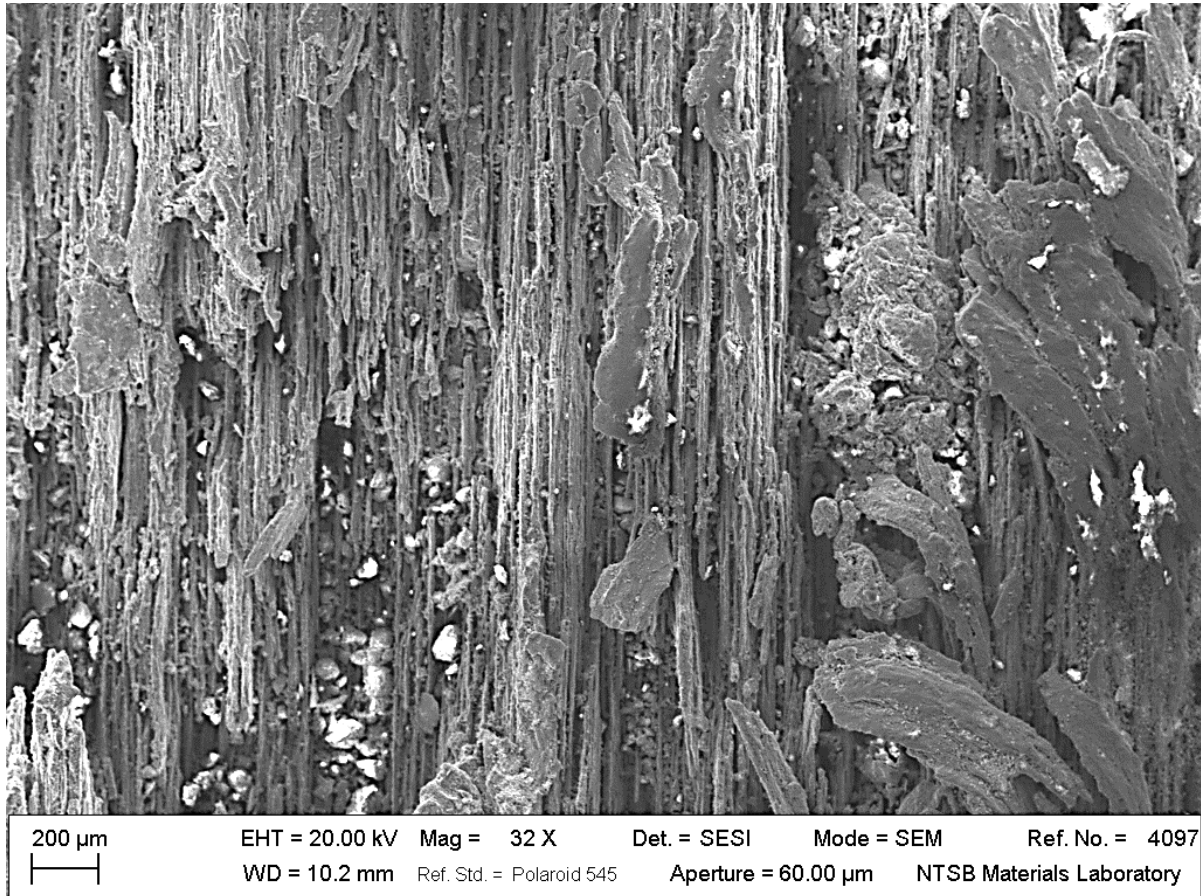
Figure 3. Bench binocular microscope photograph of a typical fracture feature found on one half of the fracture face.
