# NATIONAL TRANSPORTATION SAFETY BOARD

MATERIALS LABORATORY FACTUAL REPORT

Report No. 19-025

Place : Firebaugh, California  
Date : May 15, 2017  
Vehicle : Lancair Evolution  
NTSB No. : WPR17LA104  
Investigator : Stephen Stein, AS-WPR

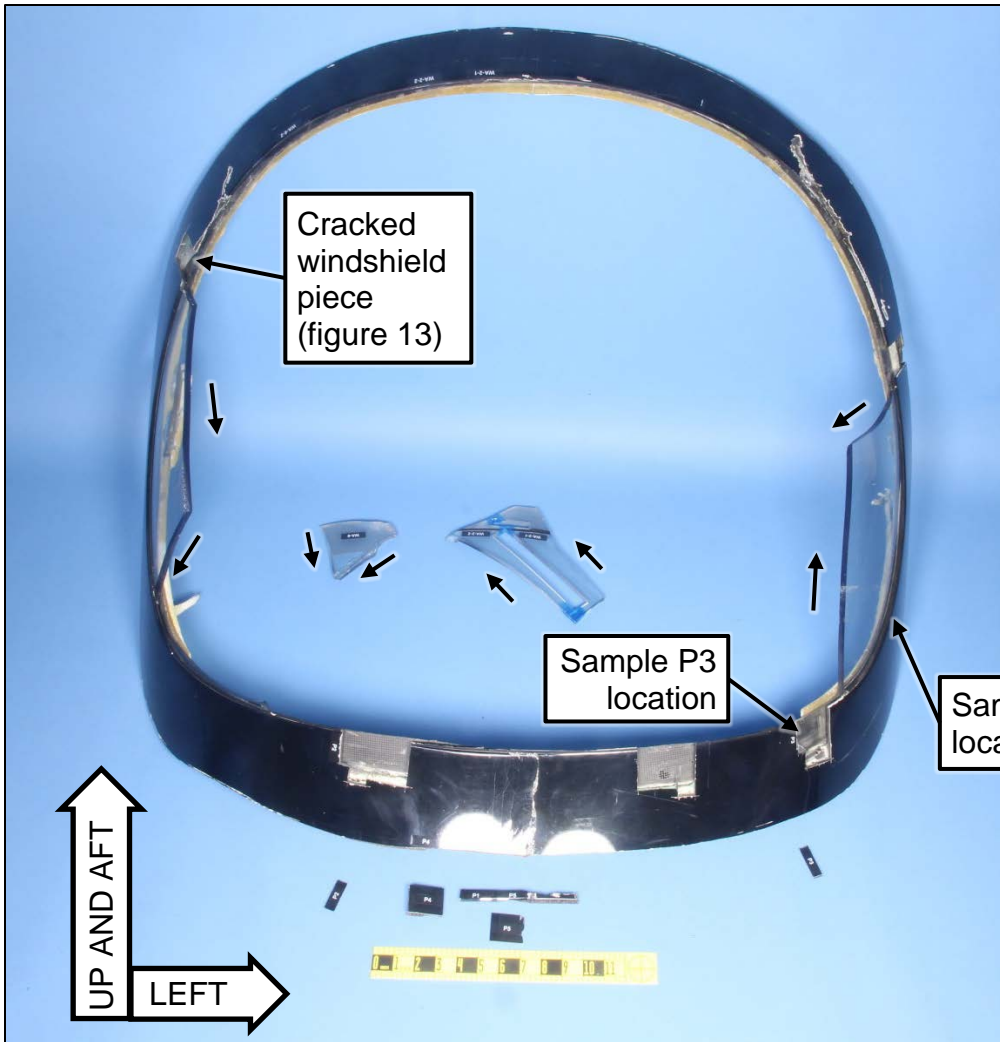
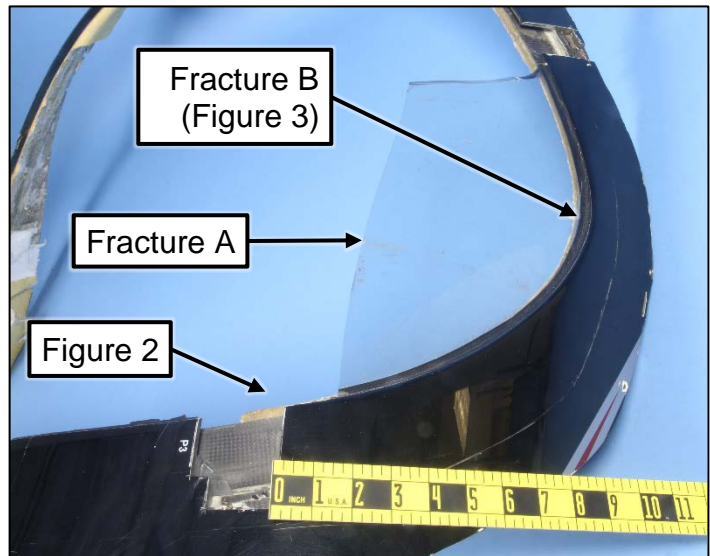
An overall view of the submitted windshield pieces and windshield frame is shown in figure 1. The windshield fractured in flight, and most of the windshield was missing from the submitted pieces. The windshield frame had been cut from the airplane fuselage, and before the components were submitted for examination at the NTSB Materials Laboratory, they had been sent to the National Institute for Aviation Research at Wichita State University in Wichita, Kansas, for examination and analysis. Several areas of the frame and windshield had been sectioned for that examination and analysis.

Pieces of the windshield were examined visually, and directions of fracture propagation were determined using fracture features including hackles, rib lines, and Wallner lines.<sup>3</sup> Unlabeled arrows in figure 1 indicate directions of fracture propagation on

the pieces shown. The small separate pieces shown in the middle of the frame in figure 1 were from the upper aft side of the frame to the right of the centerline.

A closer view of the windshield piece at the left side of the frame is shown in the lower right image in figure 1. The windshield piece included a longitudinal fracture that extended upward and aft, and the fracture was labeled fracture A for reference. The forward end of fracture A was visible within the windshield slot in the frame adjacent to one of the sample cutouts. A view of the forward end of fracture A within the windshield slot is shown in figure 2.

Figure 1. Overall view of the submitted windshield frame and windshield pieces (upper image) with a closer view of the windshield piece at the lower left side of the frame (lower image). Unlabeled arrows in the upper image indicate the directions of fracture propagation.

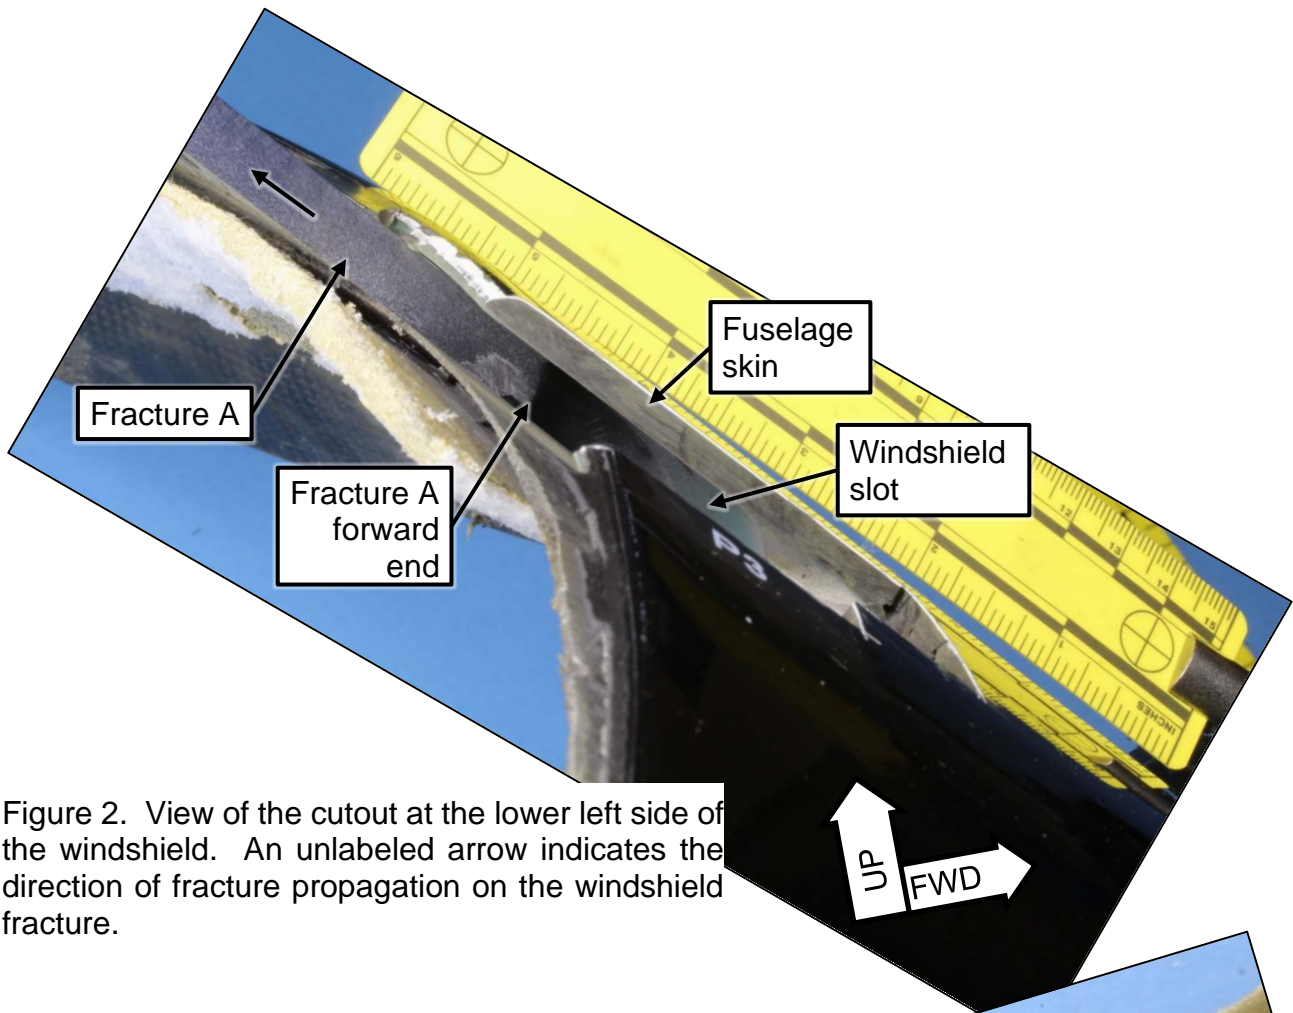
Figure 2. View of the cutout at the lower left side of the windshield. An unlabeled arrow indicates the direction of fracture propagation on the windshield fracture.

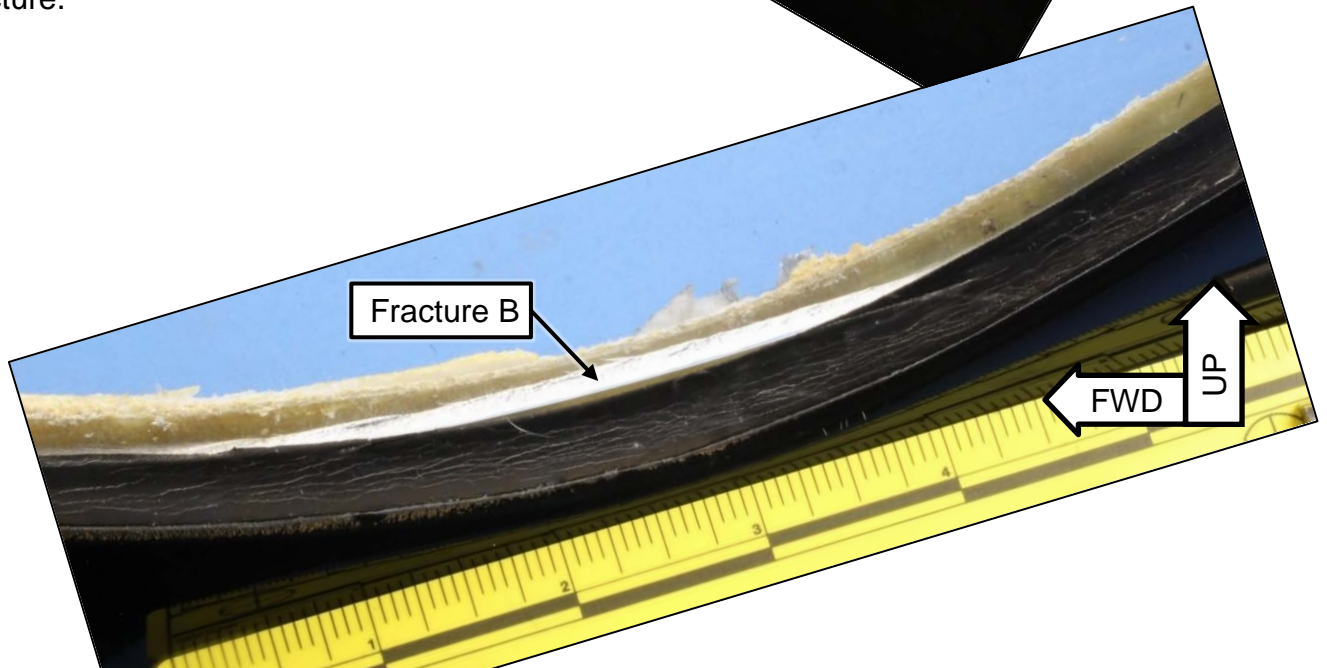
A crack in the left windshield piece was observed adjacent to the frame on the lower left side of the windshield and was labeled fracture B for reference as indicated in the lower right image in figure 1 and in a closer view in figure 3. To facilitate an examination of fracture B, the windshield frame was cut forward and aft of the windshield piece, and a chisel was used to pry open the windshield slot to facilitate separation of the windshield piece from the slot. The windshield piece was then pulled out of the slot as shown in figure 4.

Figure 3. Close view of the left side of the windshield showing fracture B in the windshield next to the window frame.

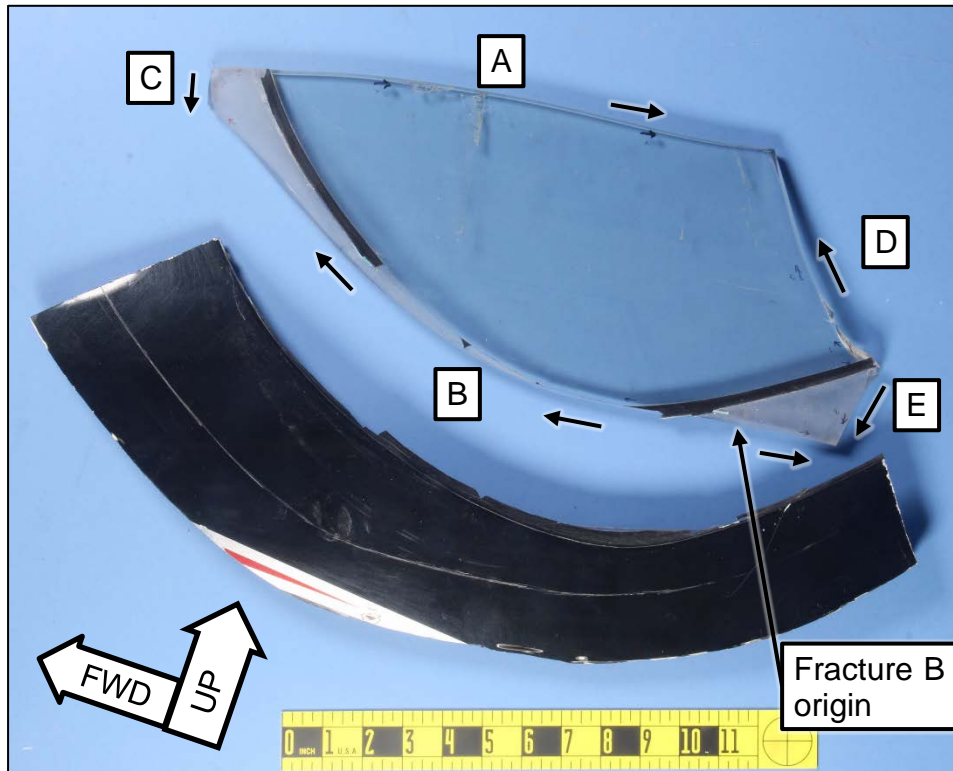
In figure 4, the fractures on the left windshield piece are shown labeled with letters for reference (including fractures A and B labeled in figure 1), and unlabeled arrows indicate fracture propagation directions. Fracture B had an origin located near the aft end of the crack as indicated in figure 4, a location that had been within the frame slot. From the origin area, fracture B propagated forward to fracture C and aft to fracture E. Based on the geometry of fracture intersections and fracture features at the intersections, fractures C, D, and E were secondary to fractures A and B.

The lower left edge of the windshield piece with the mating side of fracture B remained held within the windshield frame piece shown in figure 4. In order to remove the piece from the frame, the two sides of the frame slot were pulled apart by hand to separate the interior CFRP layers from the skin layers on the exterior side of the windshield slot. The remaining windshield piece was then removed from the frame, and the forward ends of the pieces are shown in figure 11 with mating sides of fracture B positioned in close proximity. As shown in figure 11, the forward end of fracture B intersected the forward edge of the windshield near the start of fracture A. However, the portion of fracture A forward of fracture C was missing. Therefore, it was inconclusive whether fracture A could have initiated as a result of fracture B.

Figure 4. View of the left side of the window frame and windshield piece after the frame was sectioned to facilitate separation of fracture B. Unlabeled arrows indicate directions of fracture propagation. Fracture surfaces on the left windshield piece are labeled A through E for reference in this report.

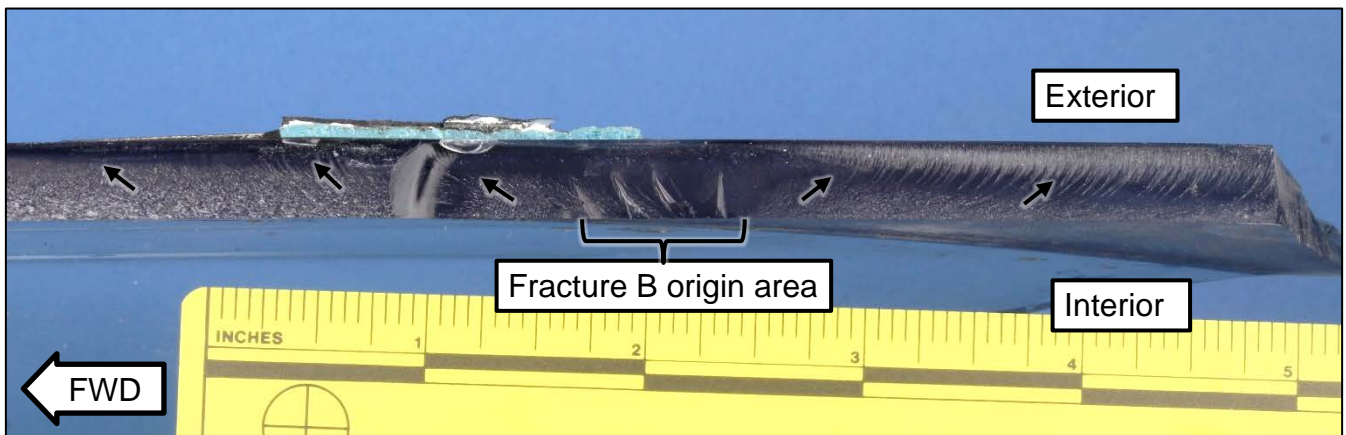
A photograph of the aft end of fracture B including the origin area is shown in figure 5. Ratchet marks emanated from the interior surface at the origin area, indicating fracture initiation on multiple slightly offset planes from the interior surface. The fracture progressed toward the exterior surface as the fracture front extended forward and aft as indicated by unlabeled arrows in figure 5. The overall progression from interior to exterior along the length of crack B was consistent with higher tension stress at the interior surface relative to the exterior, indicative of a combination of tension and bending loads during fracture.

Figure 5. Overall view of the fracture B origin area at the lower left side of the windshield. Unlabeled arrows indicate local fracture propagation directions.

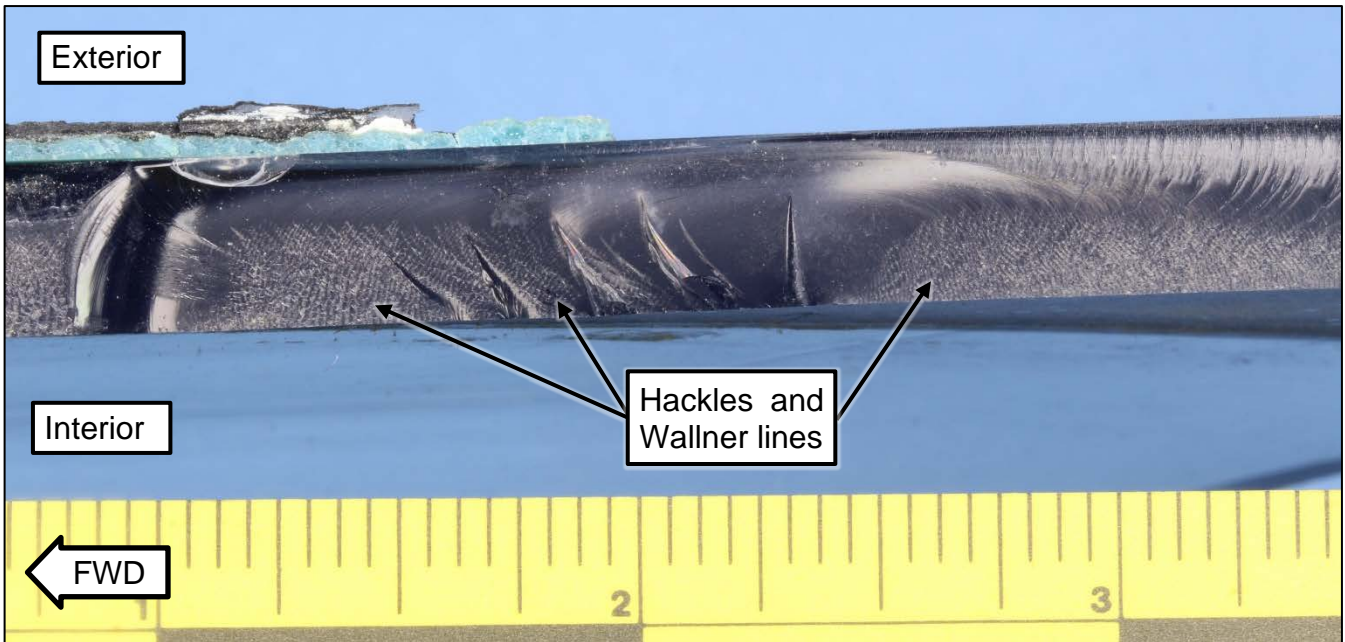
An optical image of the fracture B origin area is shown at higher magnification in figure 6. Hackles and Wallner lines were observed on the fracture surfaces emanating from the origin area, features consistent with rapid overstress fracture.

Figure 6. Closer view of the fracture B origin area showing hackles and Wallner lines consistent with rapid fracture.

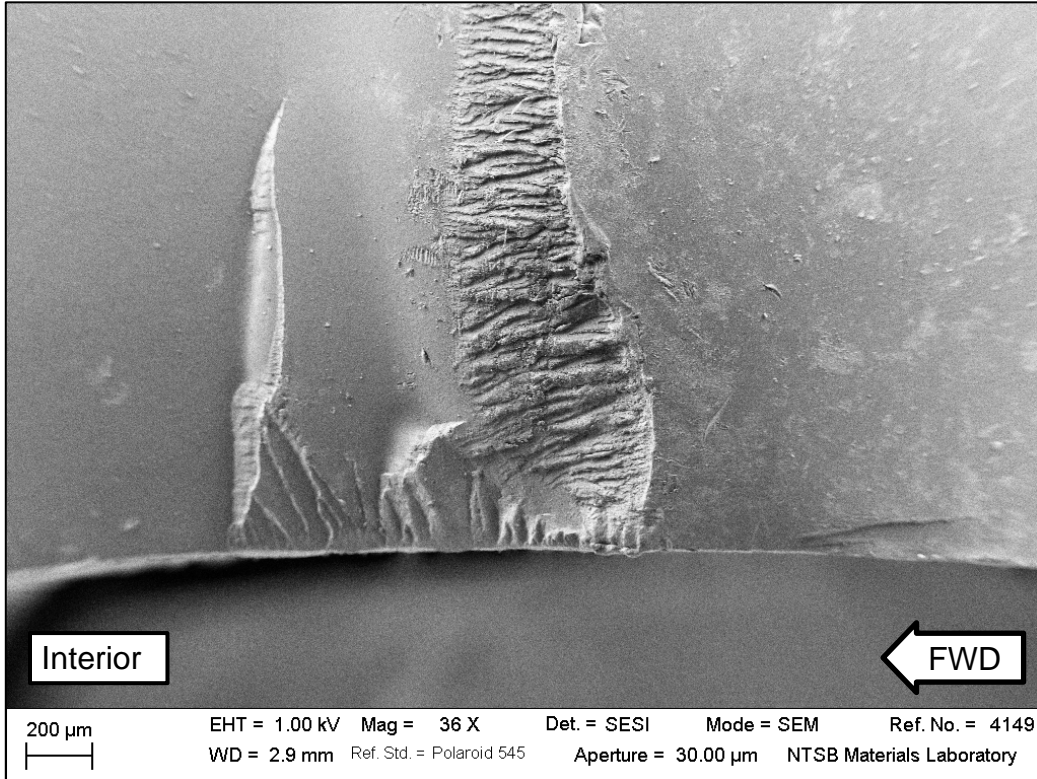
The left windshield piece was cut using a bandsaw to section the aft end of the fracture B fracture surface, including the origin area, from the rest of the piece to facilitate an examination using a scanning electron microscope (SEM). SEM images of the origin area are shown in figures 7 through 10. Fracture features at the aft end of the origin area were rubbed consistent with post-fracture recontact as shown in figure 8. However, the

Figure 7. SEM image of the fracture B origin area.

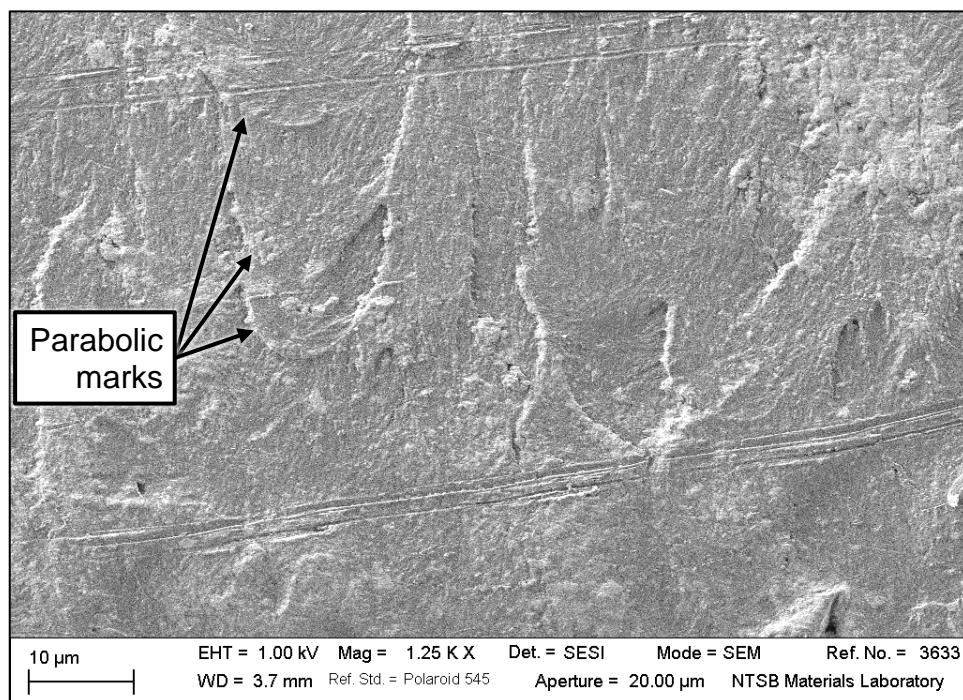
Figure 8. SEM image of fracture features toward the aft end of the fracture B origin area.

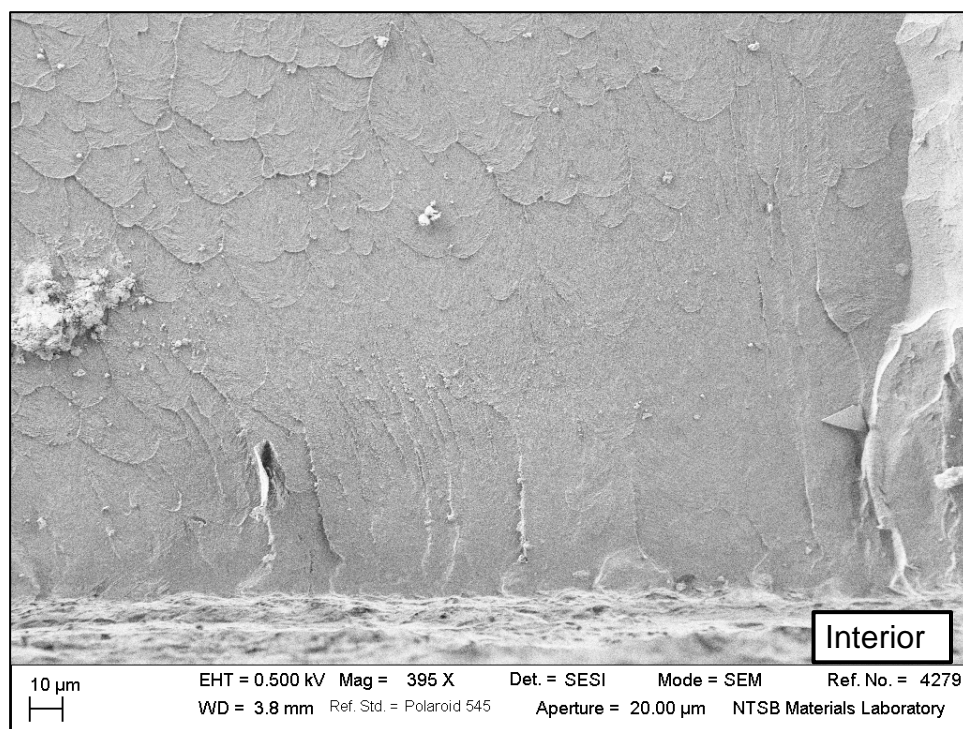
fracture surface showed evidence of microductility with small tear ridges, dimple features, and parabolic marks.<sup>4</sup> At the forward end of the origin area, the fracture surface showed similar evidence of microductility with limited rubbing damage. Figure 10 shows fracture features close to the interior surface where a parabolic mark was observed.

Figure 9. SEM image of fracture features toward the forward end of the fracture B origin area.

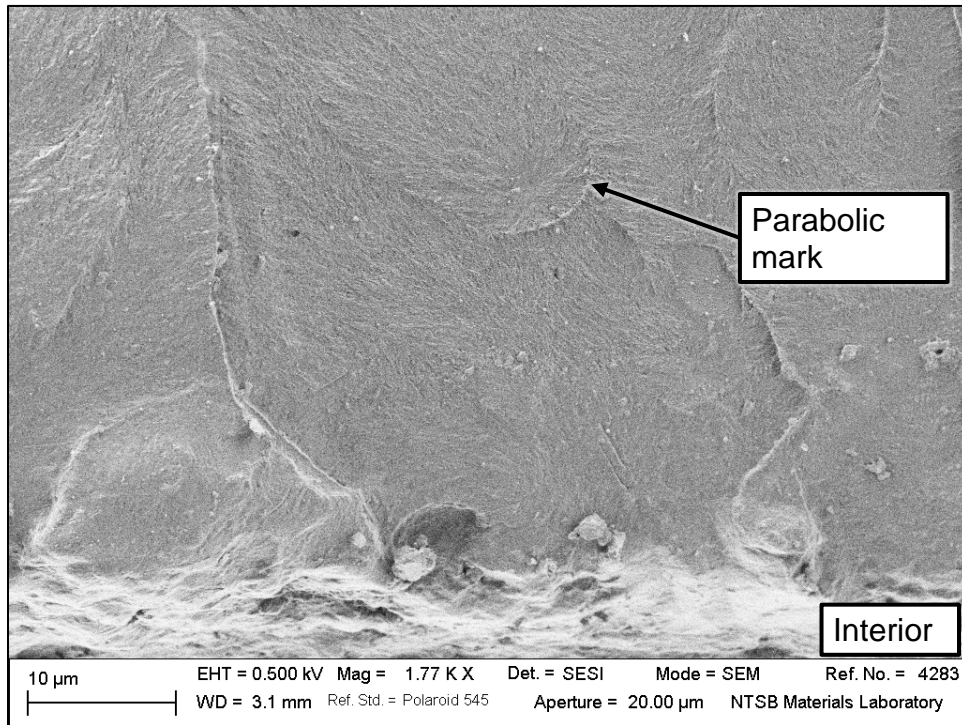
Figure 10. SEM image of fracture features at the forward end of the fracture B origin area shown at higher magnification.

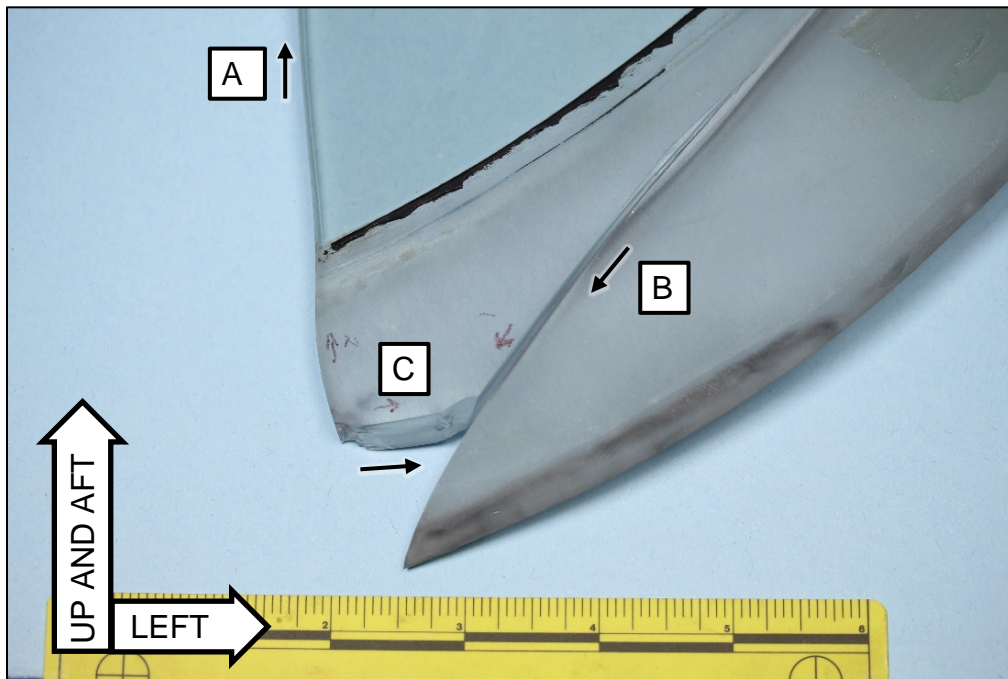
Figure 11. Fracture pattern at the forward end of fracture A and fracture B after both pieces of the windshield with mating sides of fracture B were removed from the windshield frame.

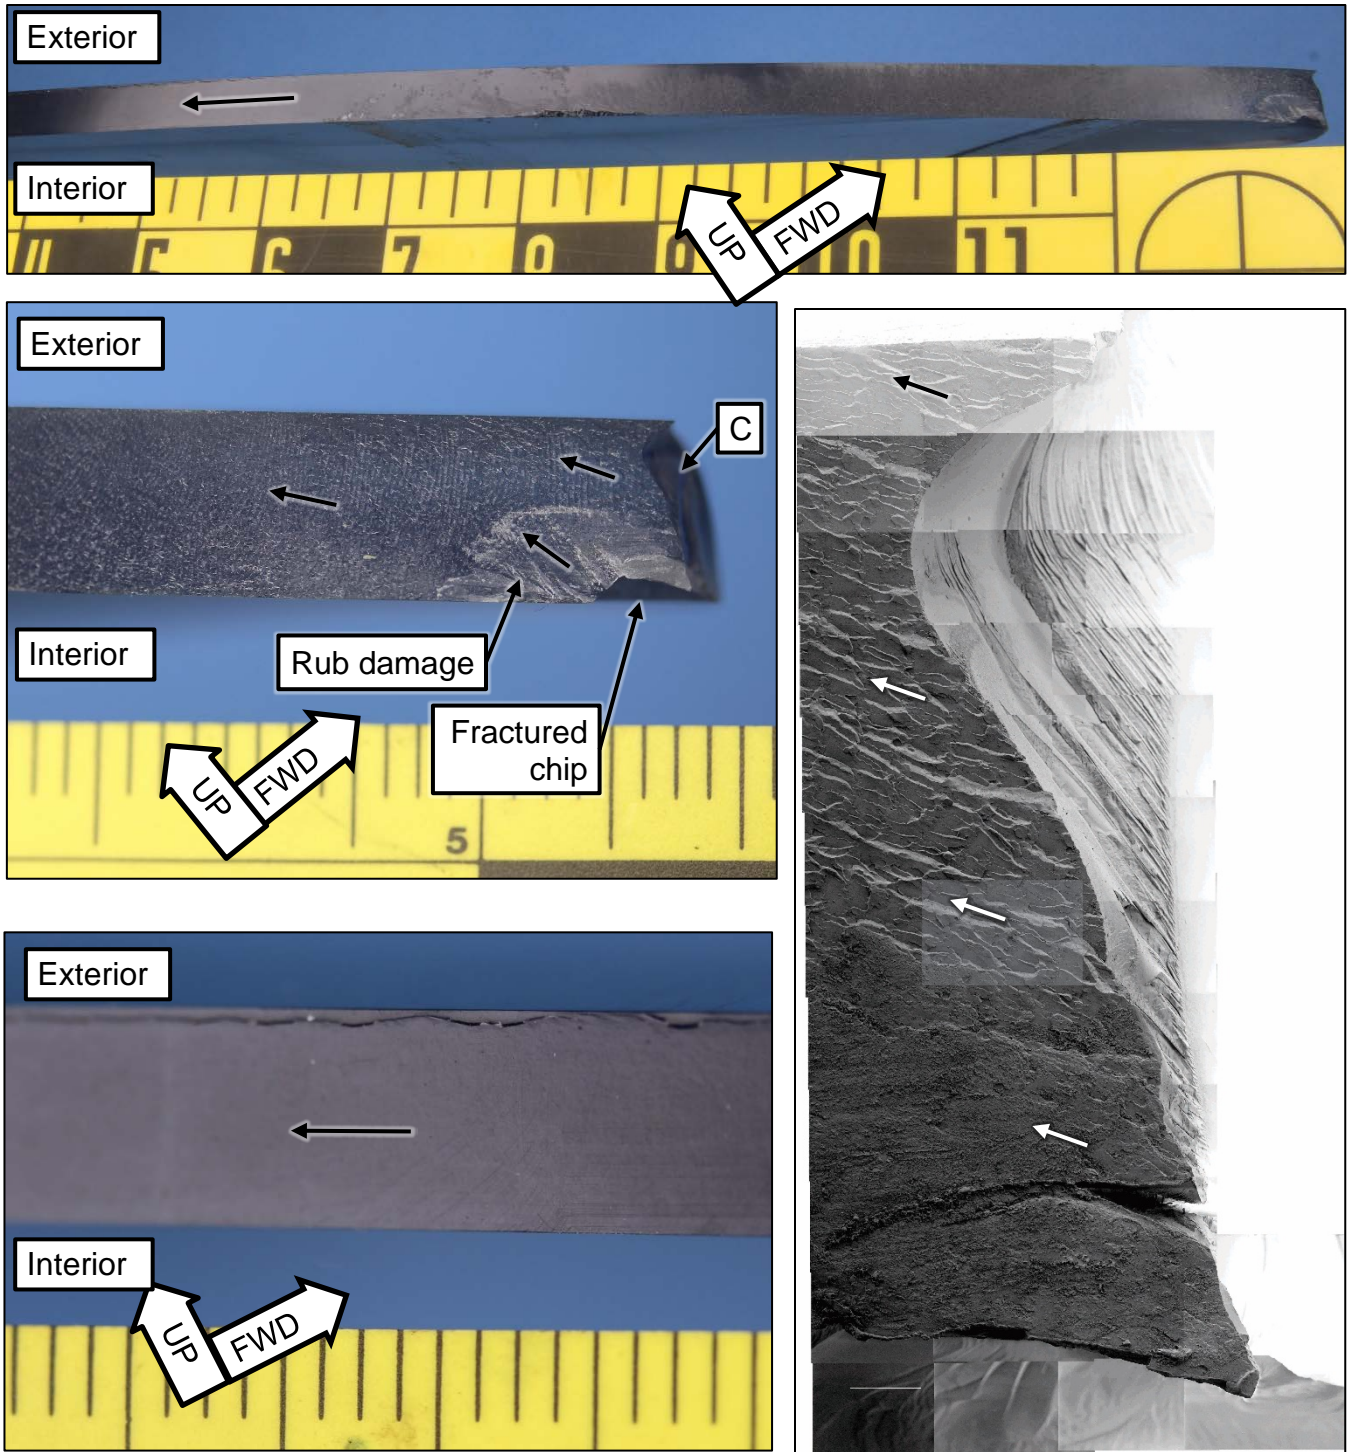
An overall view of the forward lower end of fracture A is shown in the upper image in figure 12. The fracture was flat and perpendicular to the interior and exterior surfaces across the thickness of the windshield along the length of the fracture consistent with fracture under primarily tension loading. At the forward lower end of the fracture shown in the middle left image in figure 12, Wallner lines and hackles were observed consistent with rapid fracture that transitioned to a mirror-like fracture further aft as shown in the lower left image in figure 12. The fracture features were consistent with fracture progressing primarily parallel to the interior and exterior surfaces, also consistent with fracture under primarily tension loading.

Fracture C intersected the forward end of fracture A at a sharp angle and appeared to intersect existing Wallner lines consistent with fracture C occurring secondary to fracture A. A montage of SEM images of the forward end of fracture A is shown at the right in figure 12. The local directions of fracture progression adjacent to fracture C were parallel across the thickness consistent with an origin to fracture A located forward of fracture C. However, an area of the interior surface adjacent to fractures A and C was fractured with a missing chunk of material. Fracture C originated from the fractured chip. On fracture A, ratchet marks emanated from the area of the surface chip consistent with a partial origin from the chipped surface. The area of fracture around the chipped surface appeared visually lighter, and when examined using an optical stereomicroscope, the surface appeared rubbed. While some of the fracture features emanated from the chipped surface, the cracks emanating from the chip appeared to merge with another fracture front that had emanated from an origin area forward of the chip.

Figure 12. Optical images of the lower forward portion of fracture A showing an overall image (upper image), a view of the beginning of the remaining fracture (middle left image), and fracture features near the middle of the extent of the remaining fracture (lower left image). A mosaic of SEM images of the lower forward end of fracture A is shown at the right. Unlabeled arrows in each image indicate the local direction of fracture propagation.

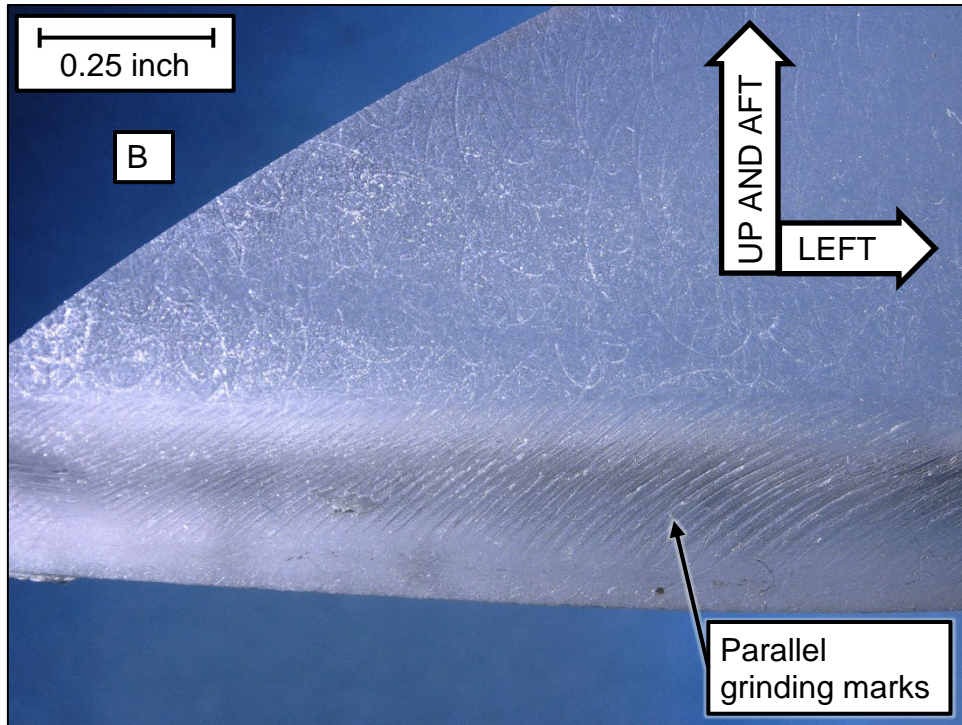
A close view of the windshield edge near where fracture B intersected the forward edge of the windshield is shown in figure 13. The edge of the windshield showed areas with a relatively flat bevel shape with a series of parallel curving grinding marks oriented at a nearly 45-degree angle to the windshield edge. The gouges were inconsistent with a rounded edge from a DA sander with 40-grit sandpaper.

Figure 13. Windshield bevel edge near the forward end of fracture B.

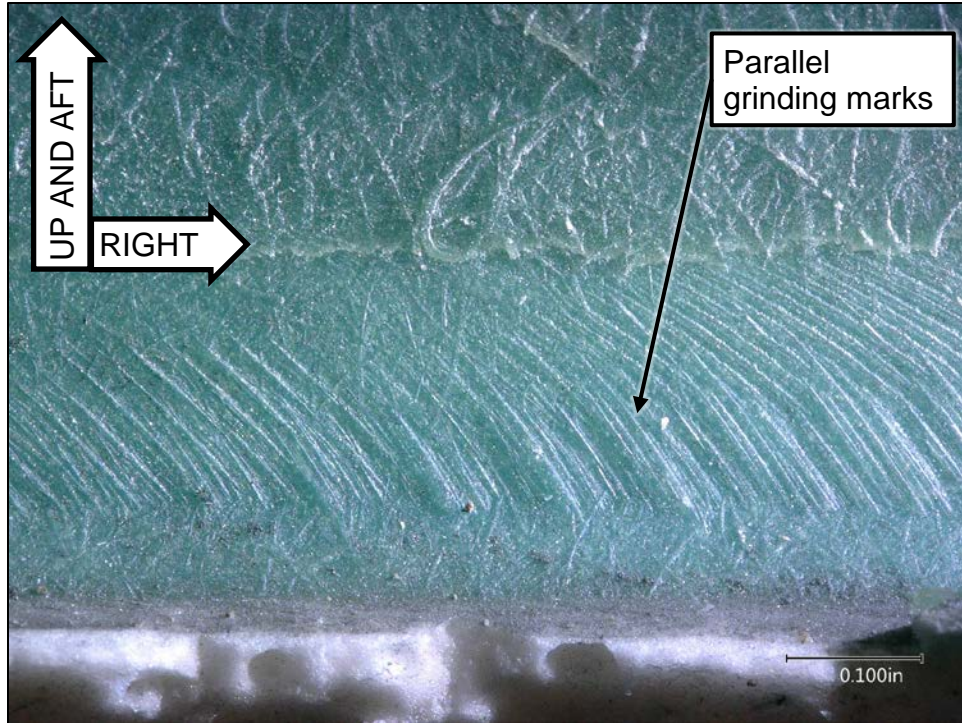
The windshield piece that included the forward edge of the windshield immediately to the right of fracture B was missing. However, an impression of the windshield edge remained intact on the mating Hysol adhesive surface on the window frame. The Hysol adhesive near the forward ends of fractures A and B was examined, and impressions of parallel curving grinding marks inconsistent with a DA sander with 40-grit sandpaper were observed in the area within approximately 2 inches of the forward end of fracture B as shown in figure 14.

Figure 14. Impressions in the Hysol adhesive corresponding to the edge of the windshield near the forward ends of fractures A and B.

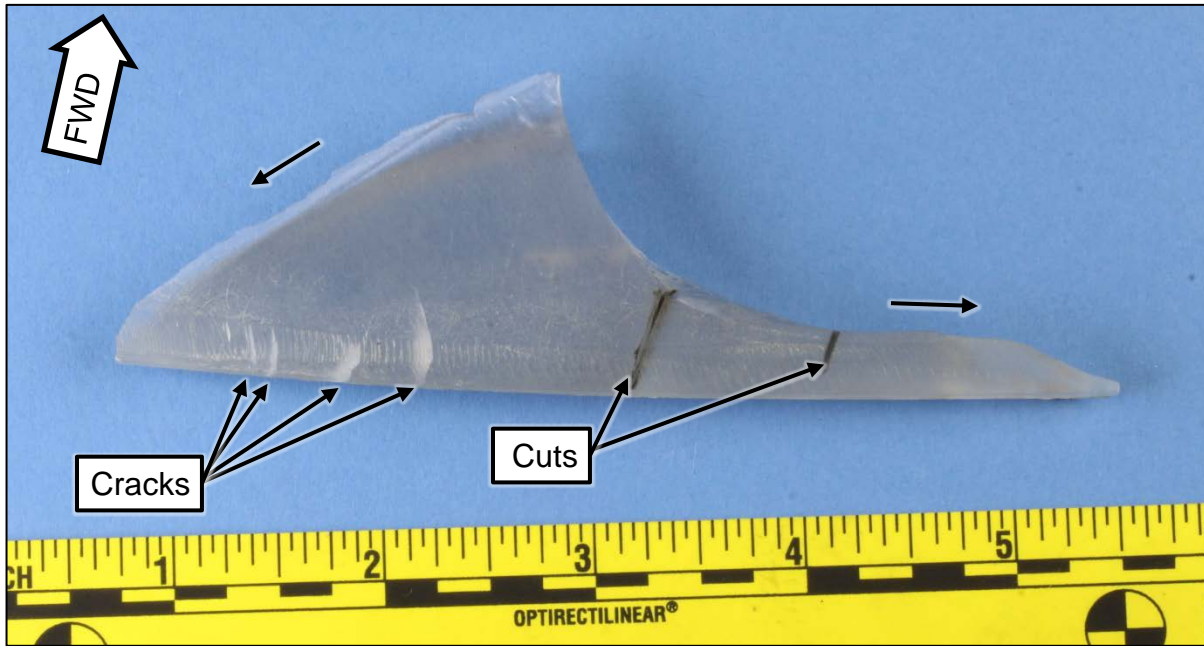
During the examination of the windshield, a loose piece of the windshield was removed from the upper right side of the windshield frame at the area indicated in figure 1, and the removed piece is shown in figure 15. Fractures on the forward side of the piece showed propagation extending toward the aft direction toward the aft edge as indicated by unlabeled arrows in figure 15. Before the NTSB Materials Laboratory examination, the windshield frame had been cut in the area where the windshield piece had been located, and the locations of two cuts that penetrated through part of the thickness are indicated. Additionally, several cracks were noted on the rounded edge of the piece in locations indicated in figure 15, and a closer view of the largest of the cracks is shown in figure 16. At the crack locations, a series of parallel curving grinding marks were observed in a flat bevel to the rounded edge.

Figure 15. Windshield piece from the upper right side of the windshield at the location indicated in figure 1. Unlabeled arrows indicate directions of fracture propagation.

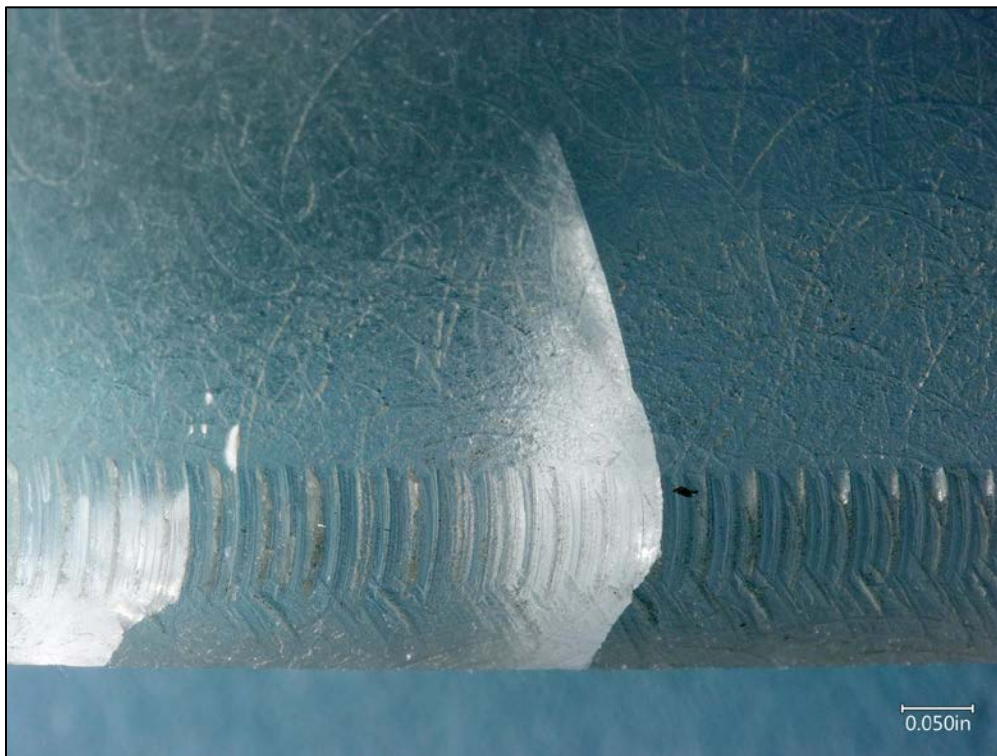
Figure 16. Closer view of cracks in the beveled edge of the windshield piece from the upper right side of the windshield.

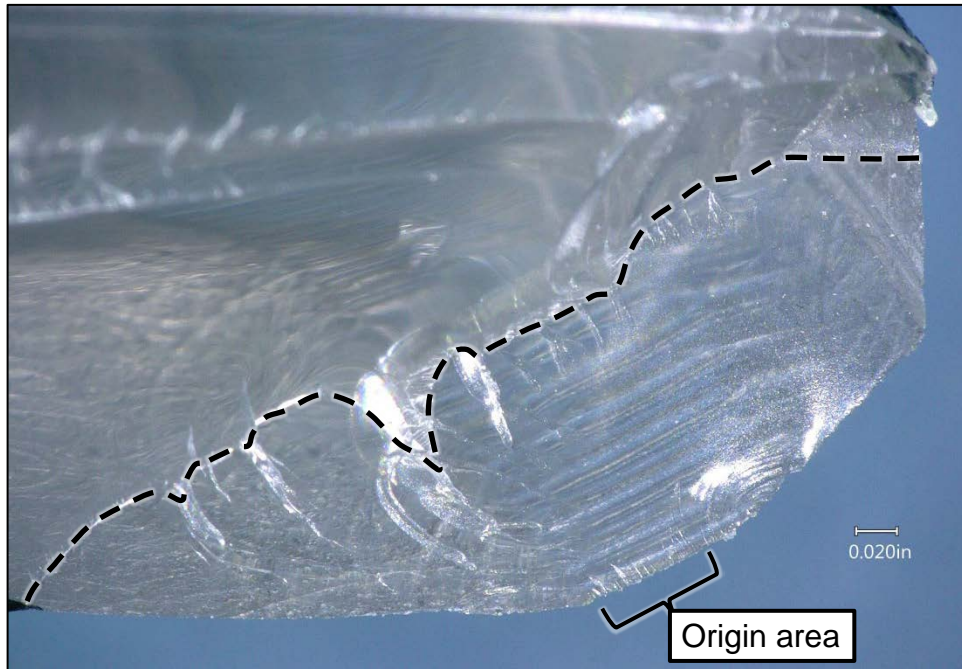
After documenting the extent of the largest crack, the cracked piece shown in figure 15 was placed in a vice, and a pair of vice-grips was used to apply a bending force to open the largest crack. The resulting lab-opened crack is shown in figure 17 where a dashed line indicates the boundary between the preexisting crack and the lab fracture. The origin area was located at the flat beveled edge with multiple origins from one of the grinding marks. Aside from hackles and ratchet marks, the fracture surface had a relatively smooth appearance with no evidence of Wallner lines.

Figure 17. Optical image of the largest crack in the piece from the upper right side after lab fracture. A dashed line indicates the boundary of the crack.

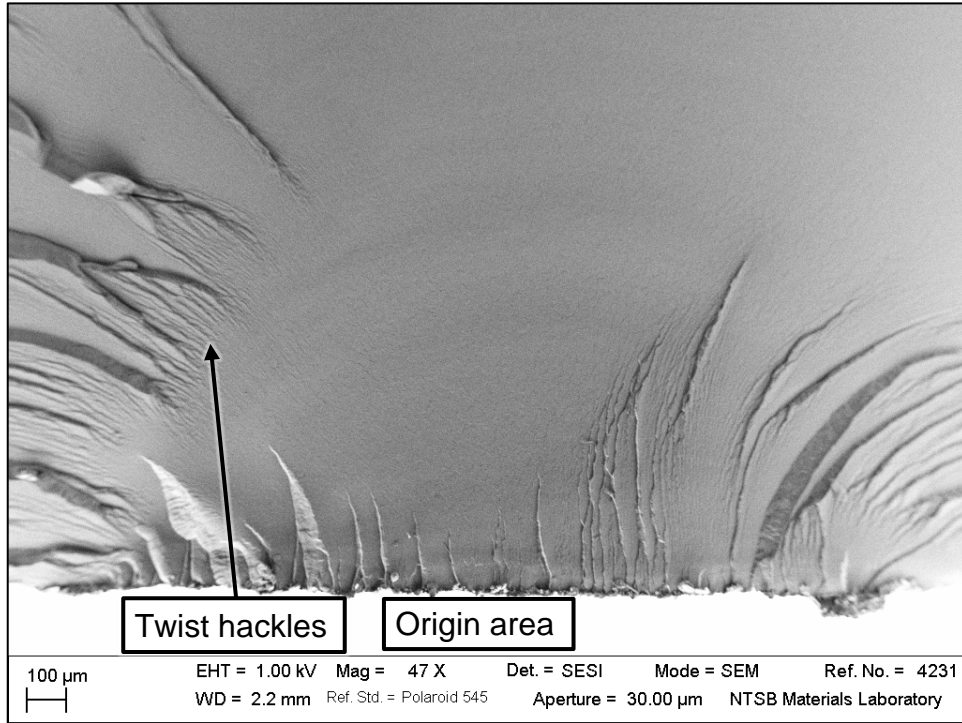
An SEM image of the crack origin area is shown in figure 18. Multiple ratchet marks were observed at the origin area consistent with multiple origins initiating on slightly different planes. Further from the origin, twist hackles were observed consistent with mixed-mode loading.<sup>5</sup> Closer views of the origin area are shown in figures 19 and 20, where evidence of microductility including dimple features and parabolic marks were observed between the ratchet marks.

Figure 18. Low-magnification SEM image of the origin area of the lab-opened crack in the windshield piece from the upper right side.

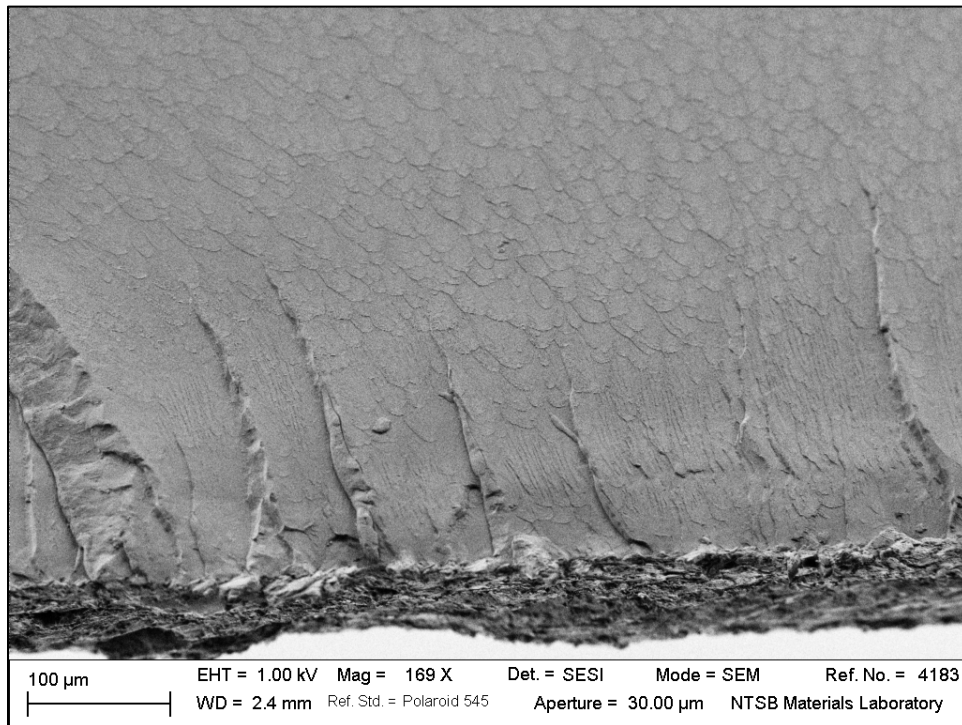
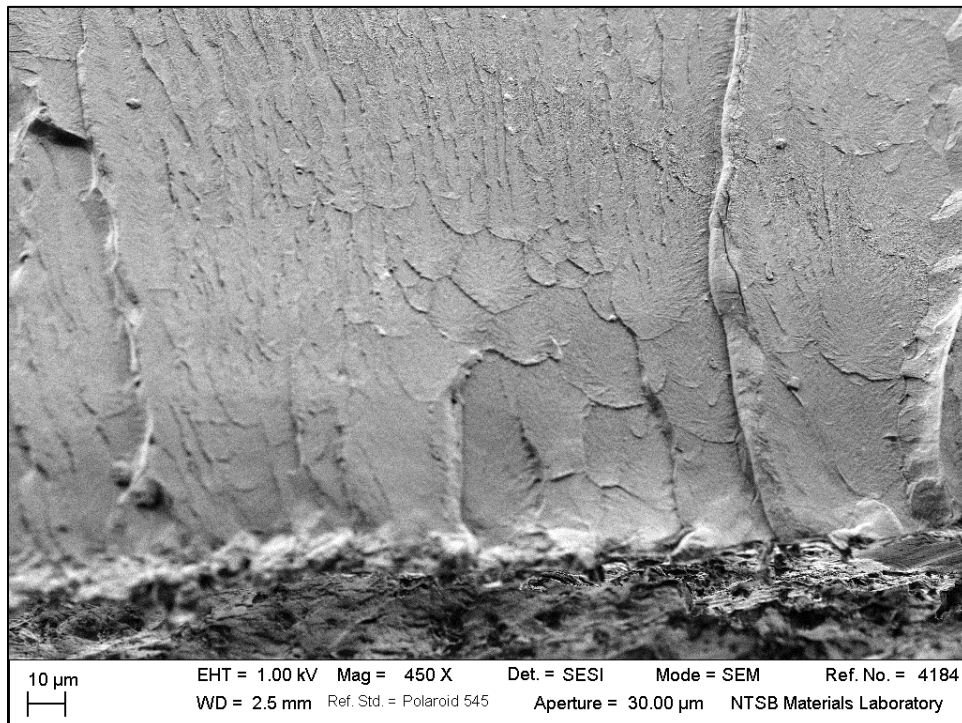
Figure 19. SEM images of the origin area of the lab-opened crack in the windshield piece from the upper right side shown at higher magnification.

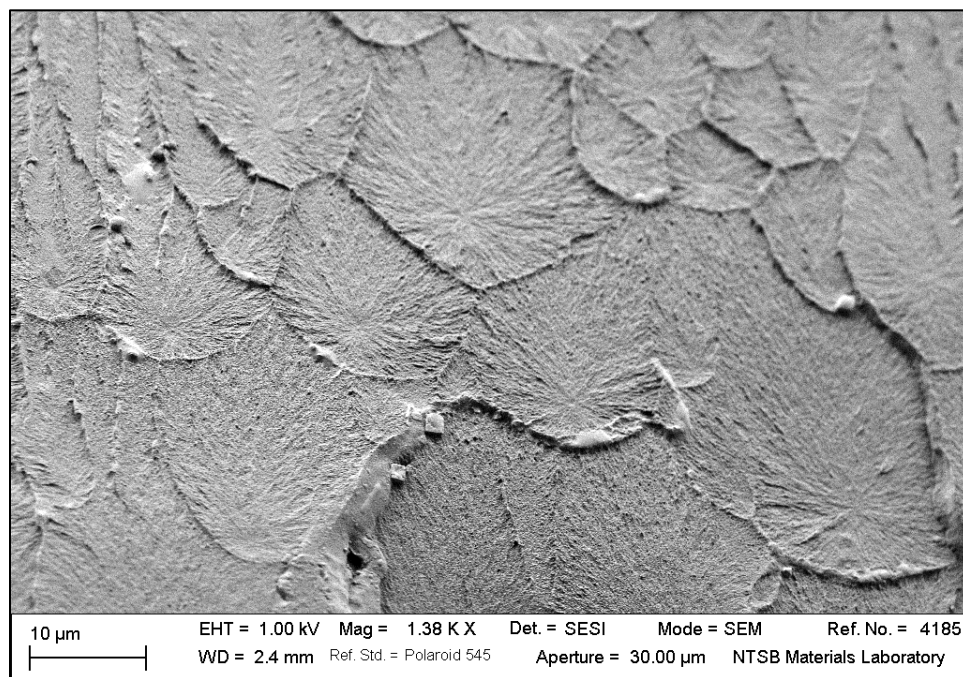
Figure 20. Higher-magnification SEM image of parabolic marks near the origin area of the lab-opened crack in the windshield piece from the upper right side.

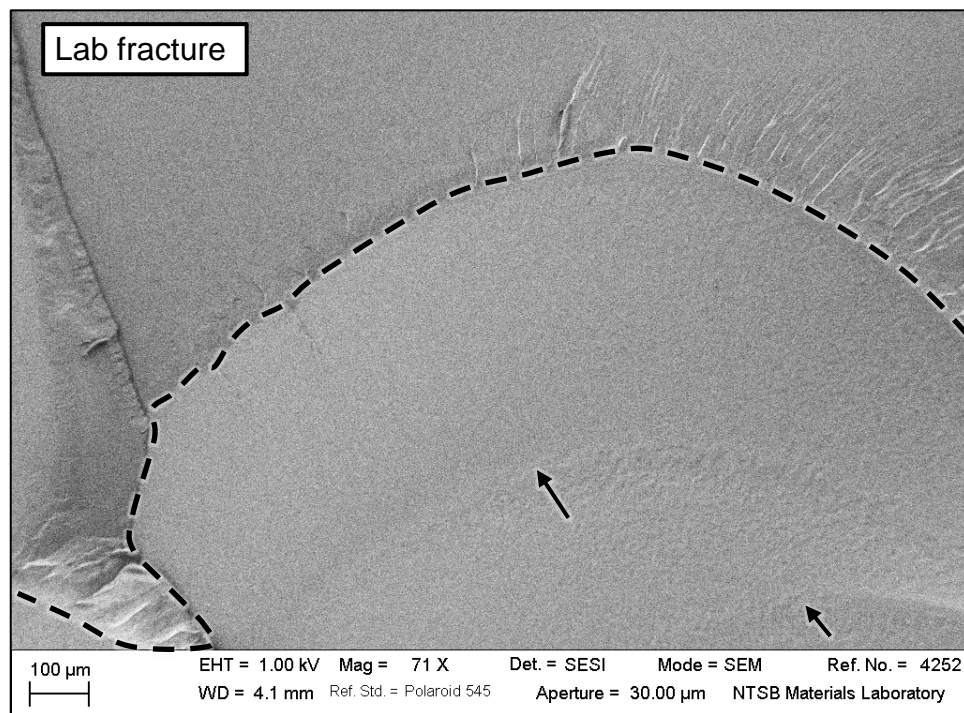
An SEM image from the crack boundary is shown in figure 21. Rib marks were observed on the crack surface such as the marks noted with unlabeled arrows in figure 21. At higher magnification, microductility was observed, but generally fewer parabolic marks were observed as shown in figure 22. In an adjacent area on the lab-fractured portion, many overlapping parabolic marks were observed as shown in figure 23.

Figure 21. SEM image of the crack boundary of the lab-opened crack in the windshield piece from the upper right side. A dashed line indicates the crack boundary, and unlabeled arrows indicate rib marks on the crack fracture surface.

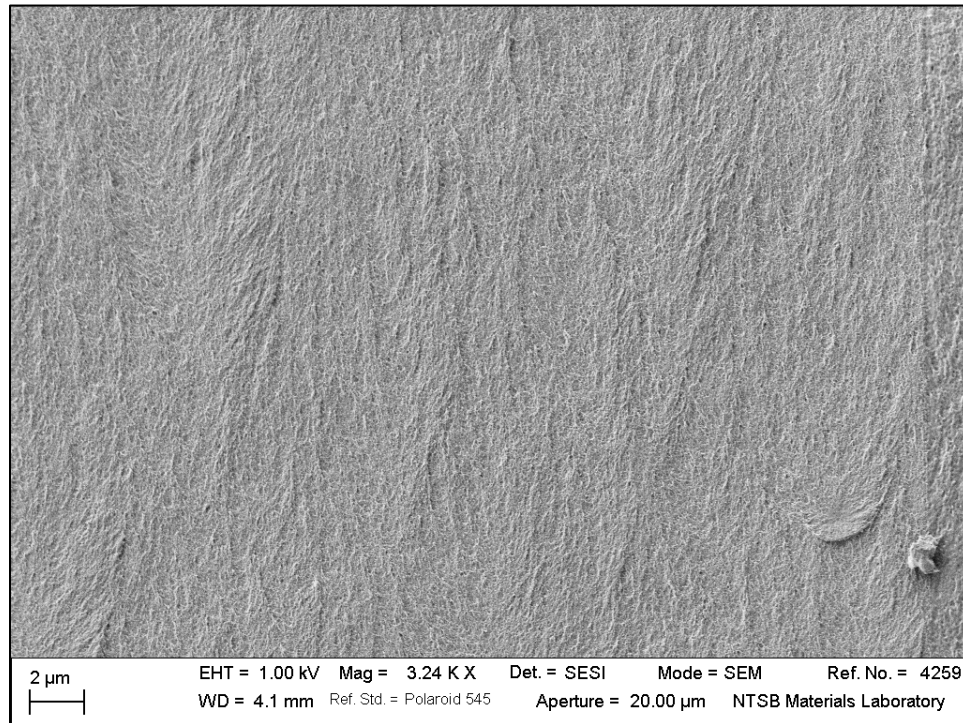
Figure 22. Higher-magnification SEM image of crack fracture features near the crack boundary.
