# NATIONAL TRANSPORTATION SAFETY BOARD

MATERIALS LABORATORY FACTUAL REPORT

Report No. 19-025

Place : Firebaugh, California  
Date : May 15, 2017  
Vehicle : Lancair Evolution  
NTSB No. : WPR17LA104  
Investigator : Stephen Stein, AS-WPR

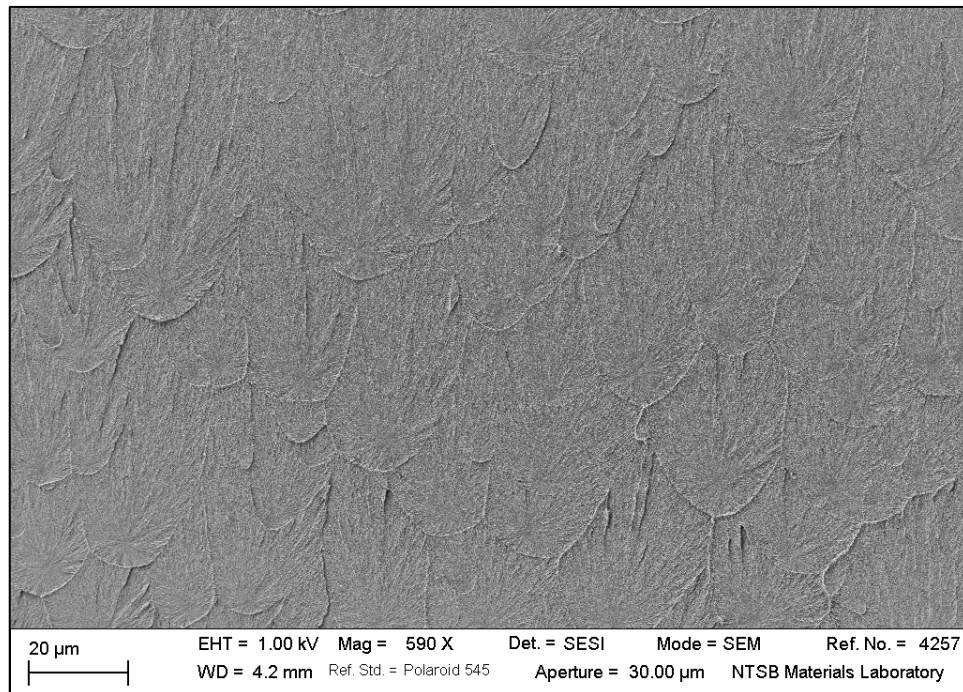
Figure 23. SEM image of fracture features in the lab-fractured portion of the opened crack in the piece from the upper right side of the windshield.

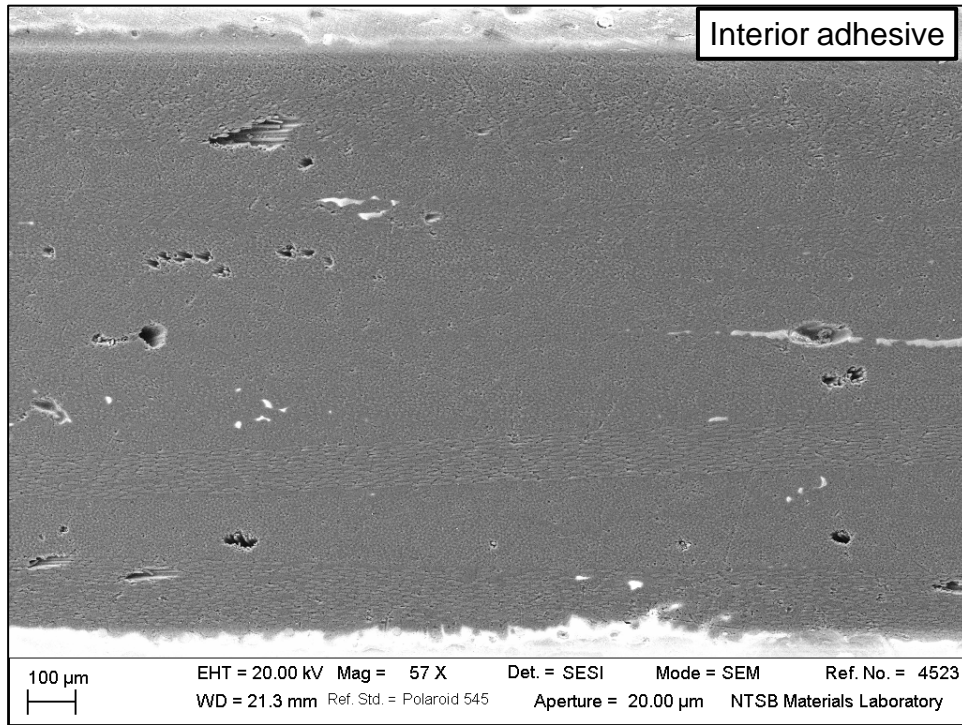
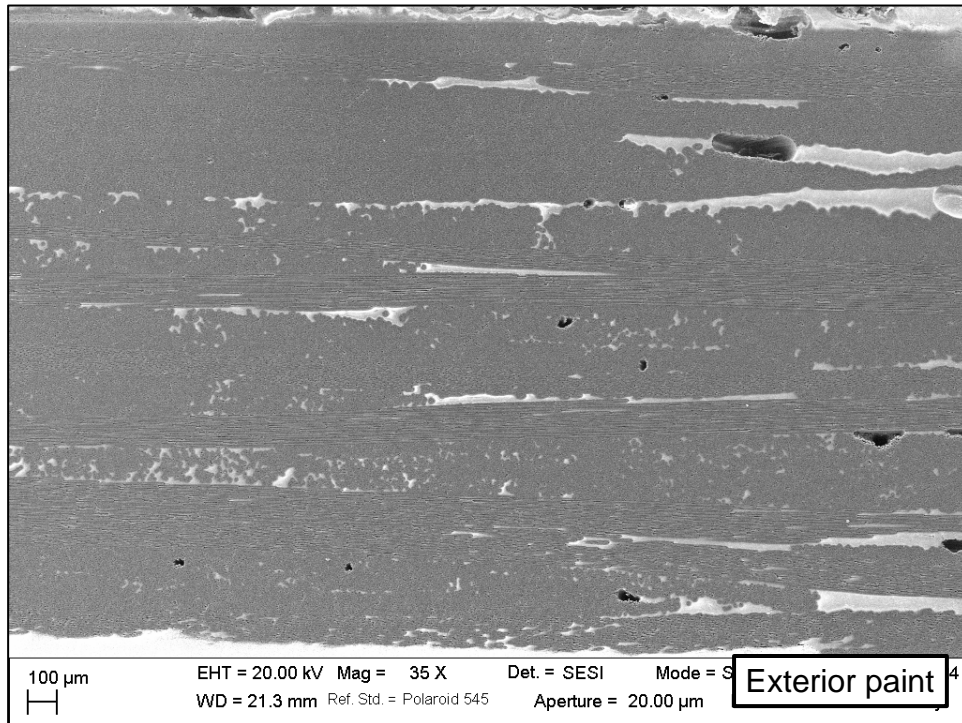
A piece of the windshield frame labeled P3 that had been cut from the forward left side of the frame near the forward end of fracture A (see figure 1) was roughly polished to view the layup<sup>6</sup> of the CFRP composite skins on the exterior side of the windshield slot. According to airplane construction drawings, the fuselage skin was a sandwich panel construction with exterior and interior CFRP skins separated by a honeycomb core. However, the location selected for the layup examination was from the area in the panel where the honeycomb was terminated to form a joggle for the windshield. SEM images showing the roughly-polished cross-sections for the exterior skin and the interior skin are shown in figure 28, where the upper image shows the interior skin and lower image shows the exterior skin. The layup observed on the sample cross-section is listed in table 1. The fiber orientations are referenced relative to the longitudinal centerline of the airplane, which was approximately 45 degrees away from the skin surface at the sample location. Therefore, the polished plane shown in figure 28 intersected 0/90 fabric layers at an approximately 45 degree angle and intersected  $\pm 45$  fabric layers at an orientation nearly parallel to one set of fiber bundles in the weave. The layup for the interior and exterior skins as observed on the polished plane differed from the expected layup schedule, also listed in table 1. The interior skin included 2 more layers than the total number listed in the layup schedule for that location, and the exterior skin included 4 more layers than expected.

Another piece of the windshield frame was cut from a location near the lowermost left point of the frame, and the piece was labeled L1 for reference (see figure 1). The piece was then placed in a lab furnace for 2 hours at 530 C followed by a furnace cool to burn off the resin. The resulting stack of carbon-fiber fabric layers was carefully separated and examined. The layup observed on the L1 sample and the corresponding layup schedule at that location are listed in table 2. The interior skin layers matched the

Figure 28. SEM images of a cross-section of the fuselage skin layers showing the interior skin layers (upper image) and the exterior skin layers (lower image).
